ARBORICULTURAL IMPACT ASSESSMENT REPORT

BOTANY AQUATIC CENTRE

STURT NOBLE ARBORICULTURE
CONSULTING ARBORISTS
Suite 91, 330 Wattle Street, ULTIMO NSW 2007

26th MARCH 2021

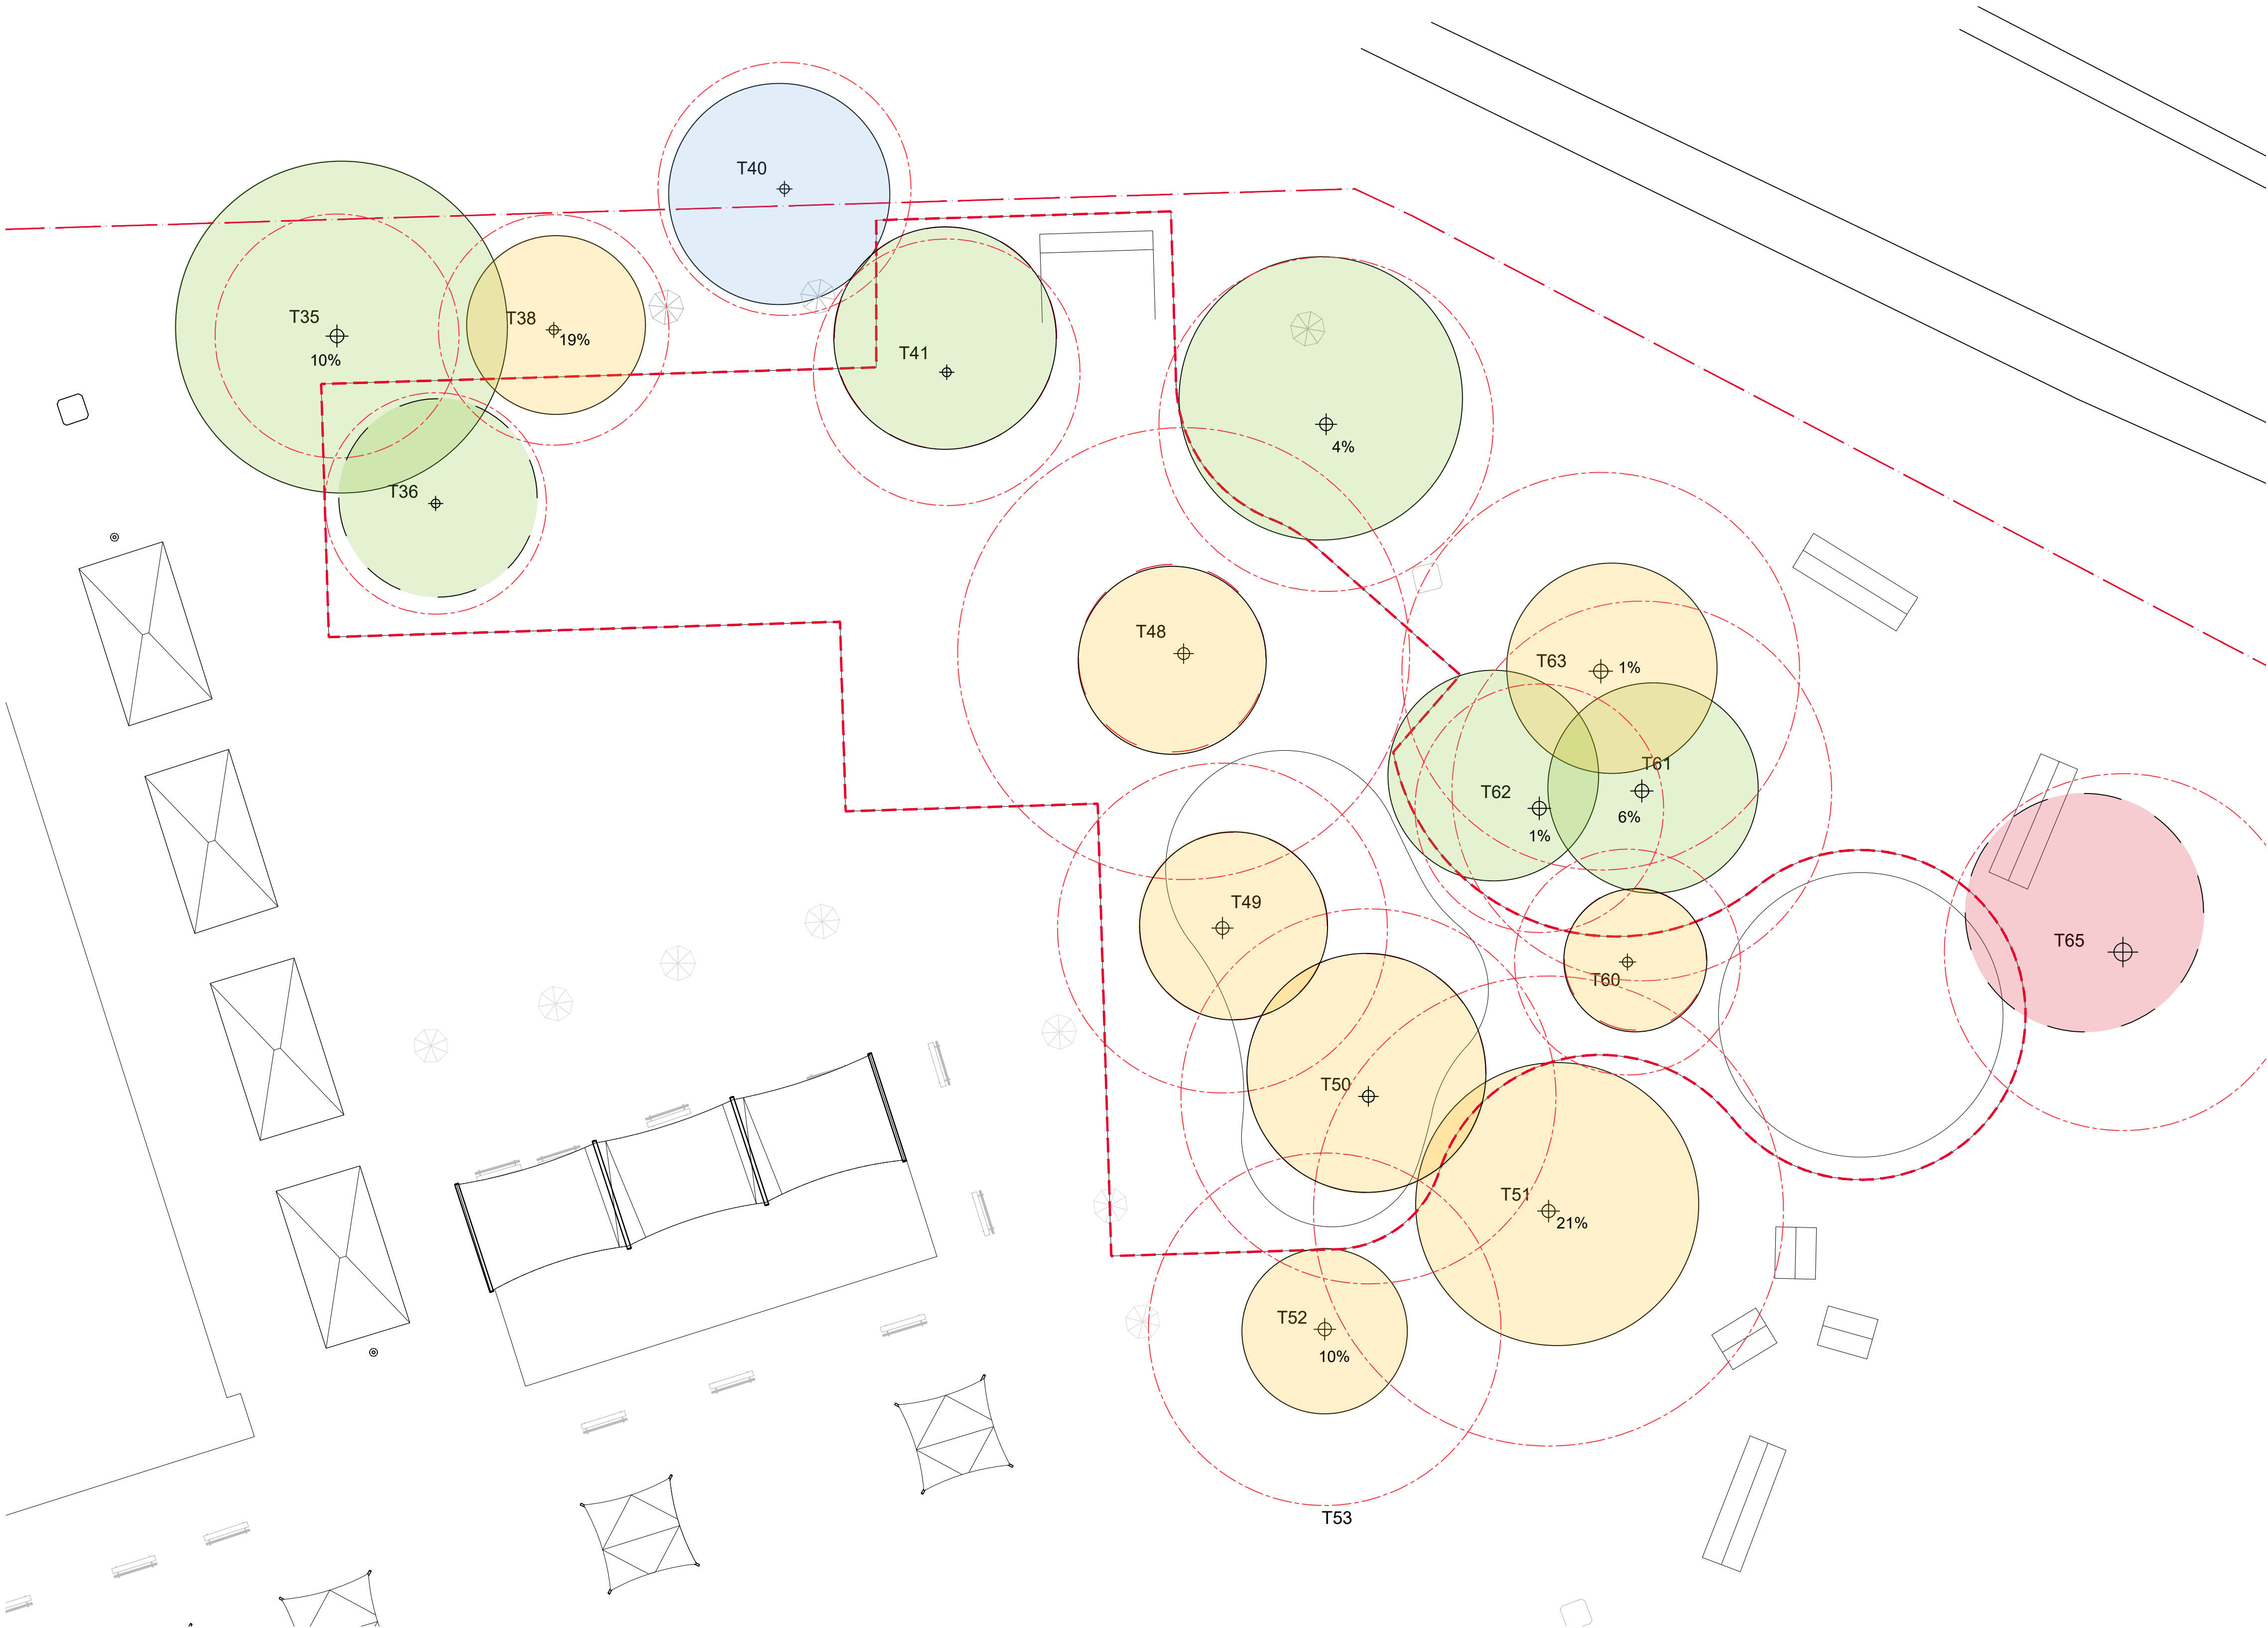
Figure 2: Existing Trees and Proposed Development

The existing tree plantings within the Botany Aquatic Centre consist of a range of both exotic and non-local native species. The trees that have been assessed as part of this project are predominantly native species and have all been identified by number in Figure 2.

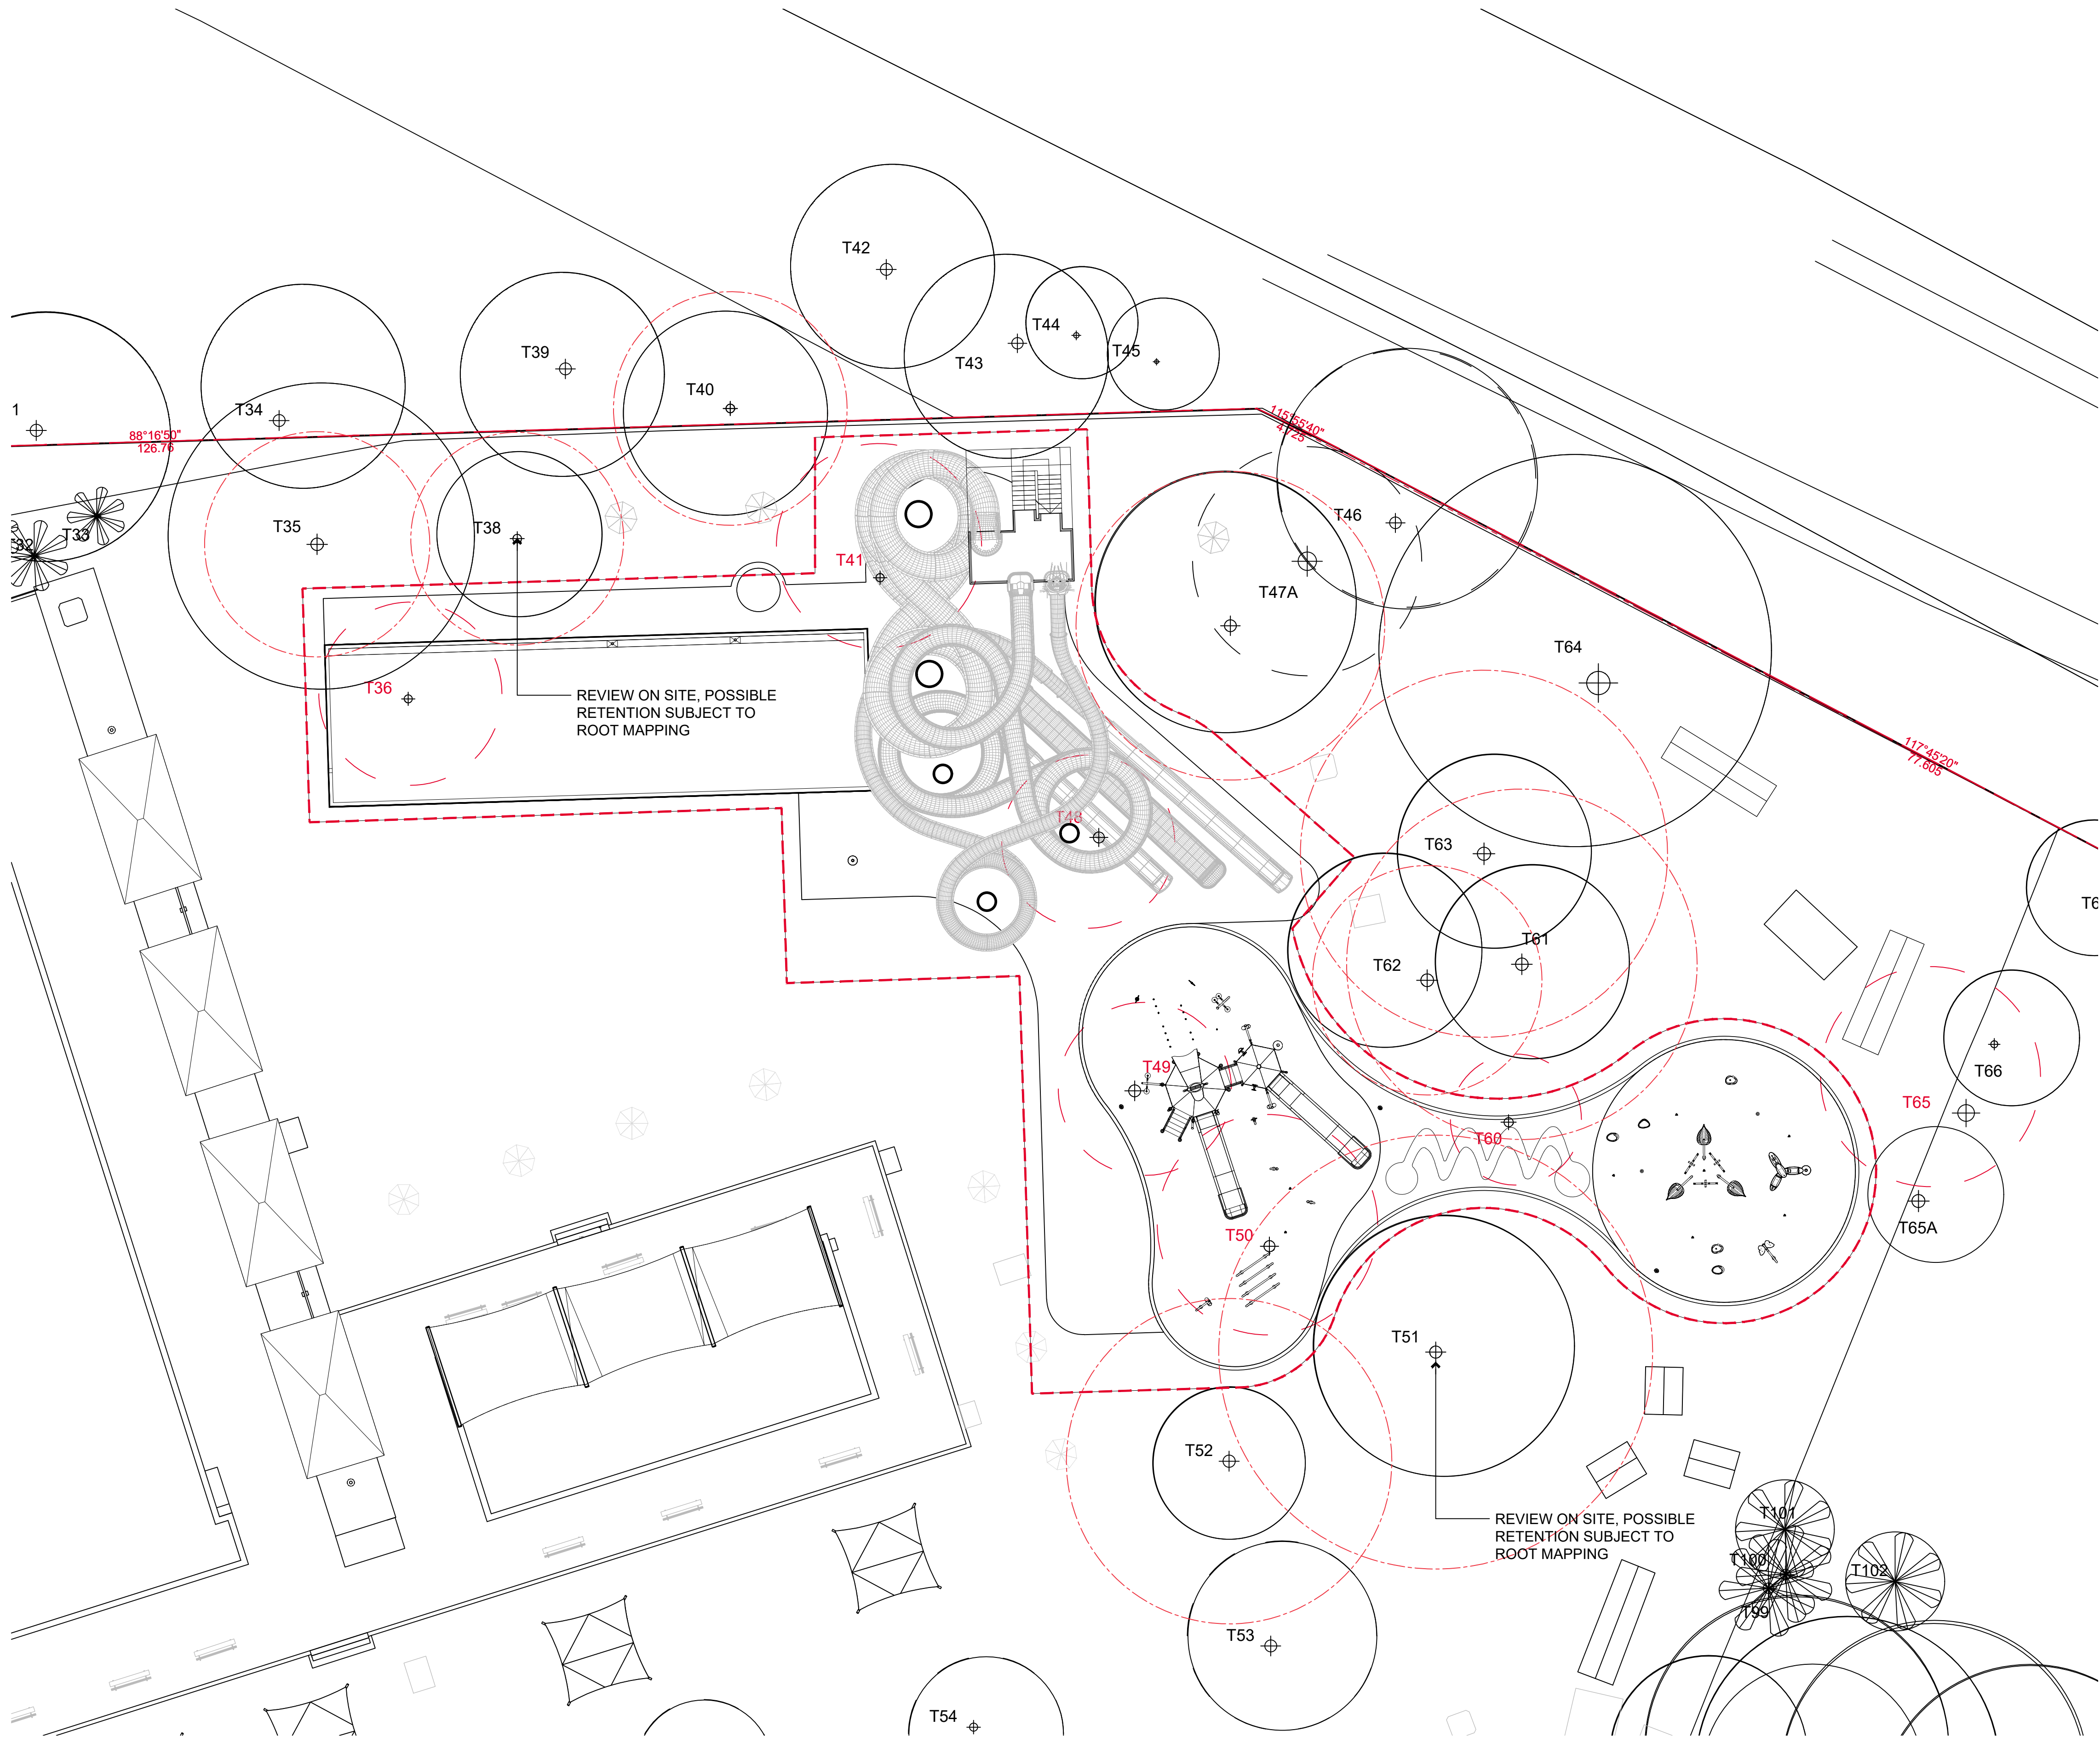
Figure 3: Proposed Tree Removal and Retention Plan

Seven (7) of the existing trees on site will require removal (Tree numbers 36, 41, 48, 49, 50, 60 & 65) as they are affected by the new works or are in poor condition.

Seven trees around the periphery of the site (Tree number 35, 40, 47, 52, 61, 62 & 63) may be affected by the new works. With the implementation of the tree protection measures it will be possible to retain these trees on the developed site. Two trees (trees 38 and 51) require further investigation to establish if retention is possible.

Application for the removal of the seven (7) trees noted above is sought as part of the Stage 1 Development Application.

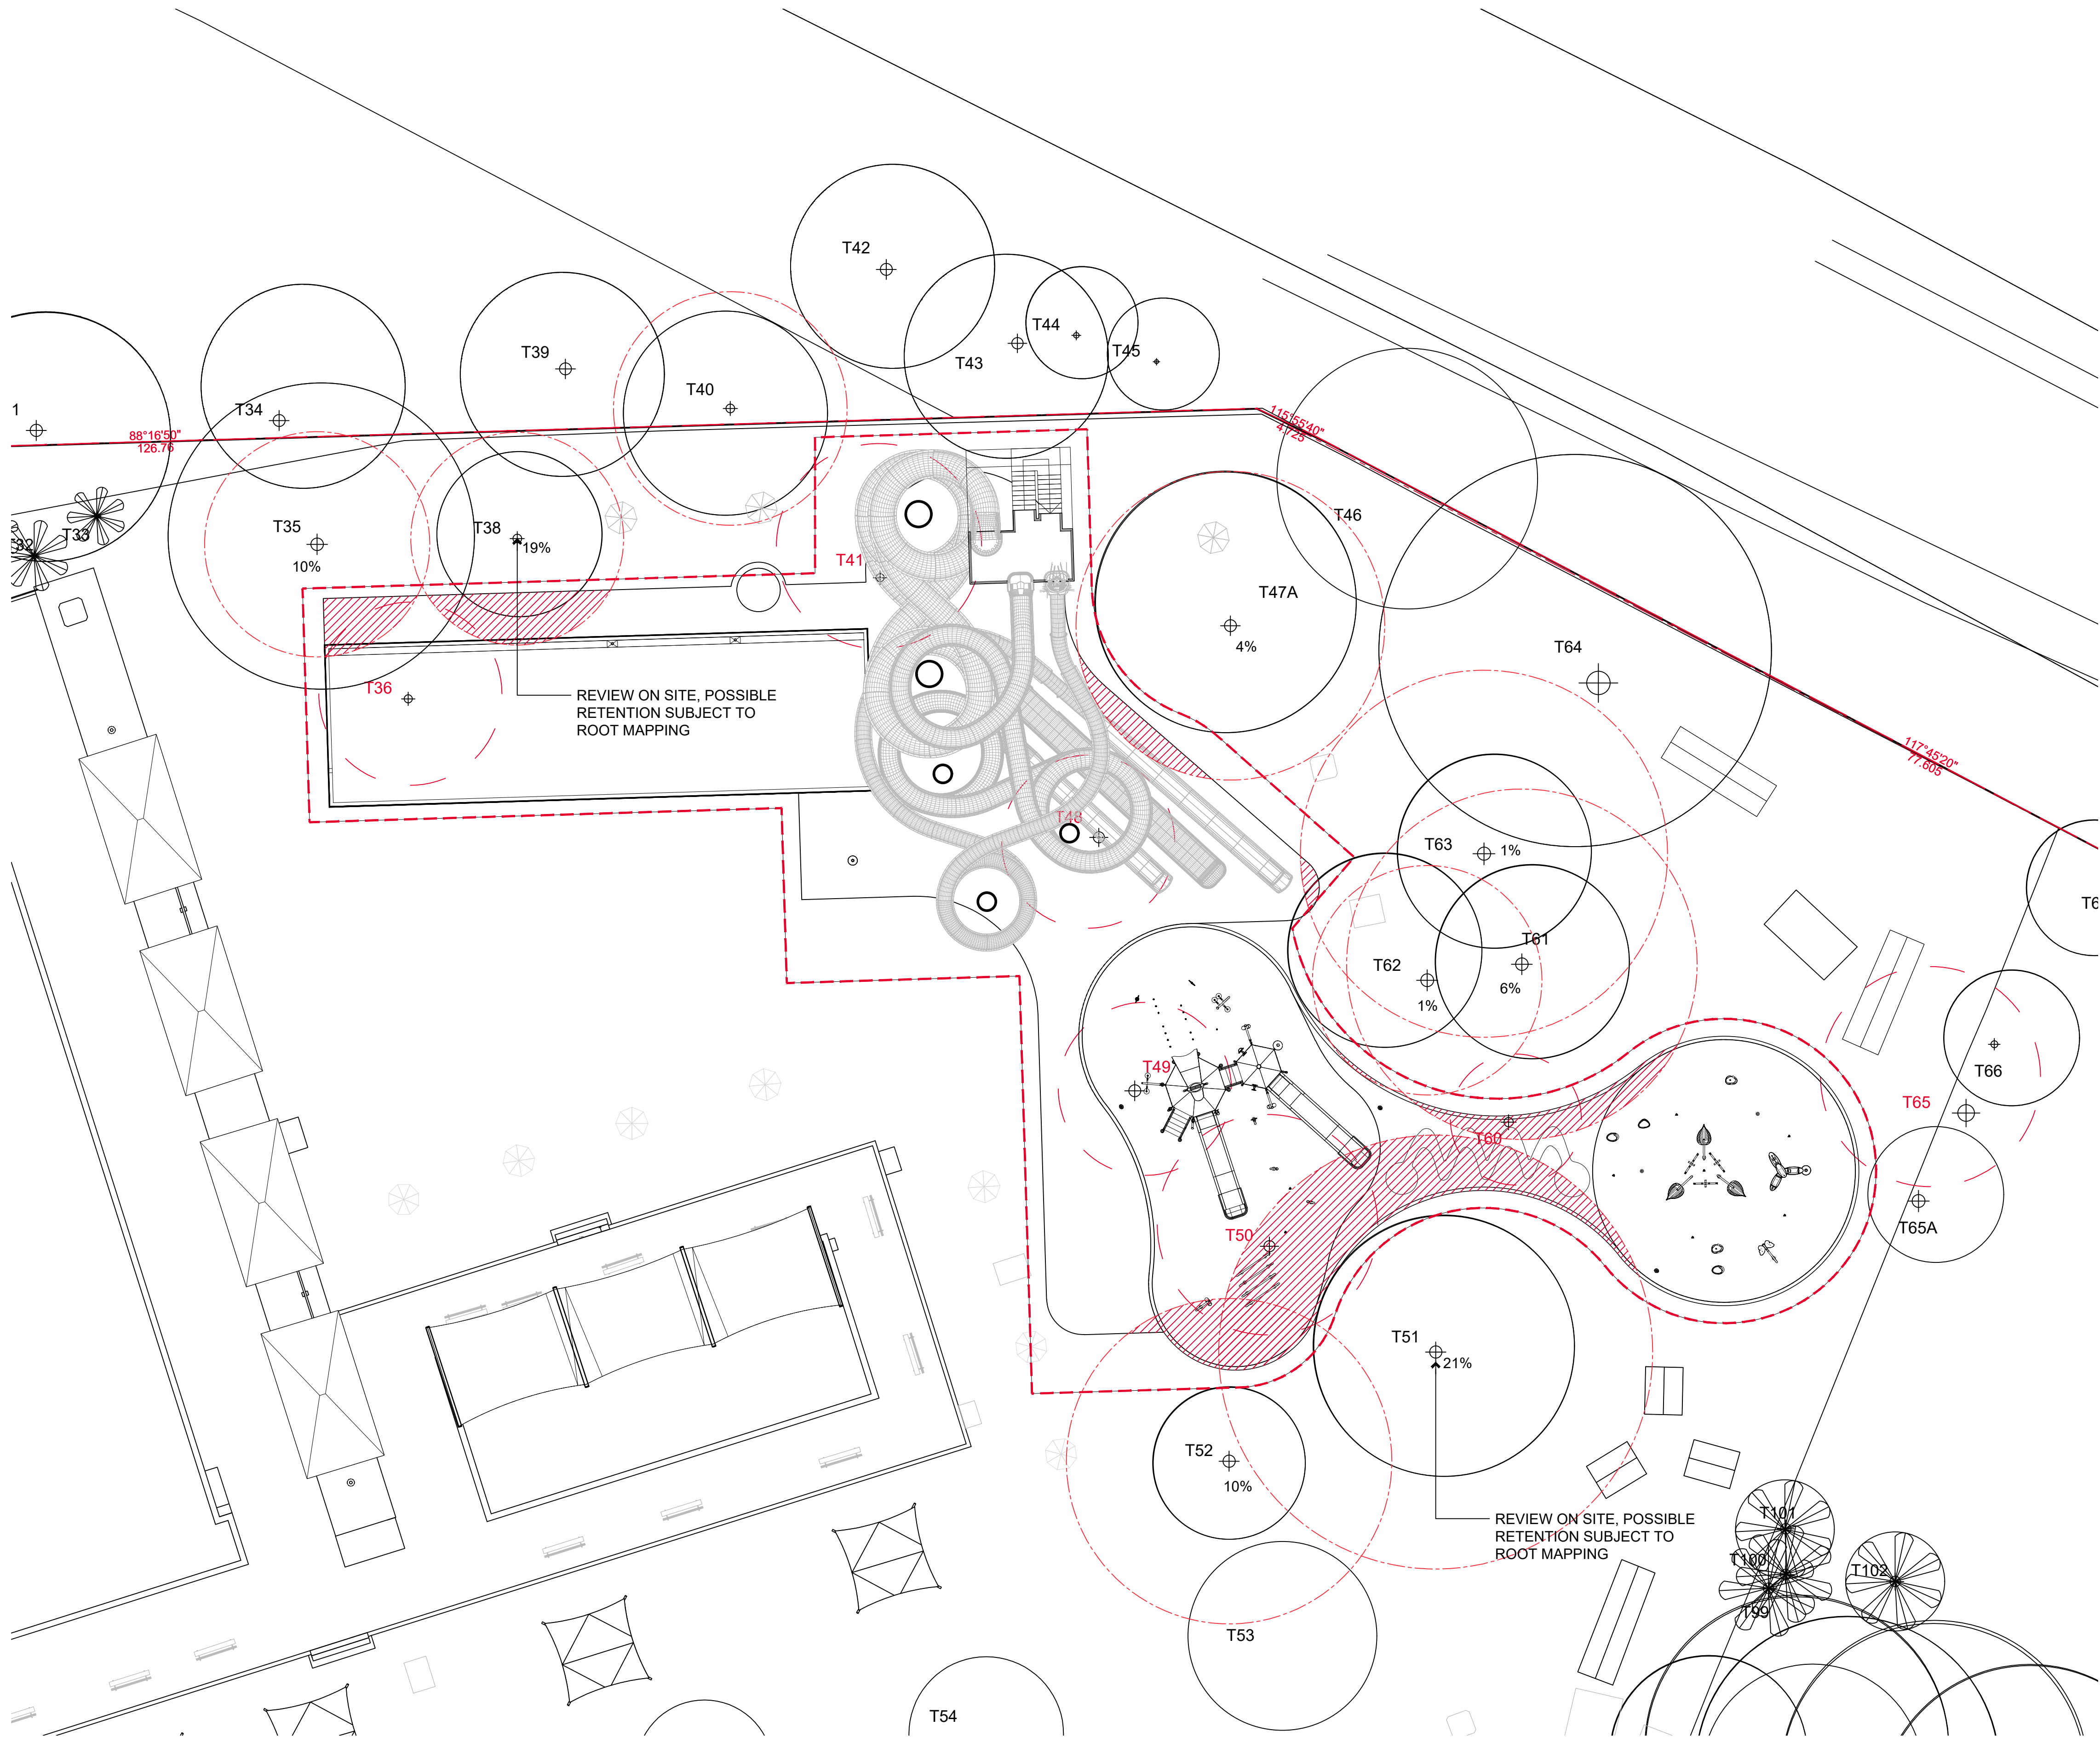
Figure 4: Impact Assessment Plan

Trees 38 and 51 will suffer 19% and 21% encroachment respectively and it is therefore recommended that further investigation and root mapping is used to determine possible retention.

We can consider the impacts of the Development acceptable with regard to potential impacts on the tree subject to adherence to the following tree protection measures in Section 6.0.
