ARBORICULTURAL IMPACT ASSESSMENT  
&  
TREE PROTECTION SPECIFICATION

REF: L&Co192028 | 22 April 2021 | v3  
SITE ADDRESS | Bondi Surf Bathers' Life Saving Club  
PREPARED FOR | Lockhart-Krause Architects  
PREPARED BY | Dr Matthew Laurence

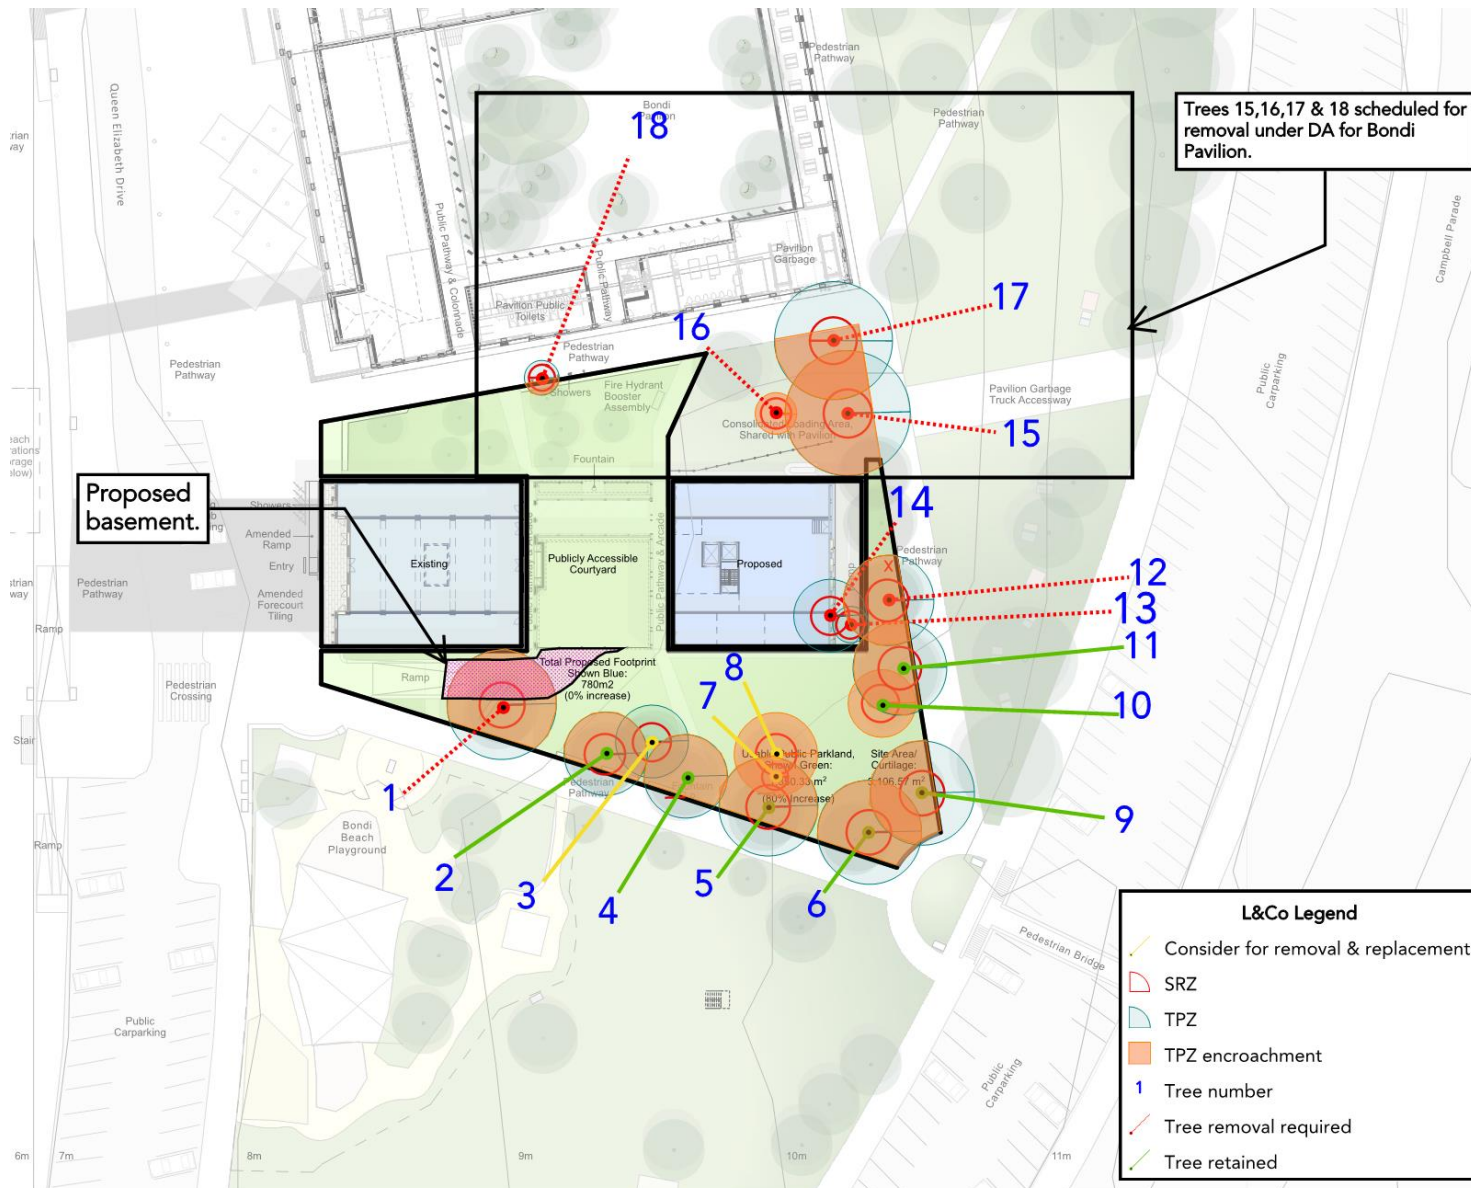
## 9.0 APPENDIX 5| ARBORICULTURAL IMPACT ASSESSMENT PLAN

3.1.3 The supplied plans show the proposed ramp, basement, turfing and paving works are within the SRZ of Tree 1 and represents 84.2% of the total TPZ area. Works within the SRZ represent a *Major Encroachment* as defined by AS-4970 as root severance within the SRZ can lead to the destabilisation of the tree.

3.2.2 The supplied plans show the proposed turf works are within the SRZ of Trees 2, 4, 5, 6, 9, 10 & 11 with existing paving removal within the SRZ of Tree 2. Works within the SRZ represent a *Major Encroachment* as defined by AS-4970 as root severance within the SRZ can lead to the destabilisation of the tree. These works all represented TPZ encroachments greater than 40%, which also represents a *Major Encroachment* as defined by AS-4970. However, Clause 3.3.4 of AS-4970 does allow for major encroachments if design factors (e.g. tree sensitive construction methods) are used to minimise negative impacts from the proposed development.

- 3.4.5 The supplied plans show the proposed ramp and turf works are within the SRZ of Tree 12. Works within the SRZ represent a *Major Encroachment* as defined by AS-4970 as root severance within the SRZ can lead to the destabilisation of the tree. The overall TPZ encroachment was estimated to be 72%, which also represents a *Major Encroachment* as defined by AS-4970. Tree 12 is highly likely to be compromised by the proposed encroachment and the tree will need to be removed to accommodate the works.

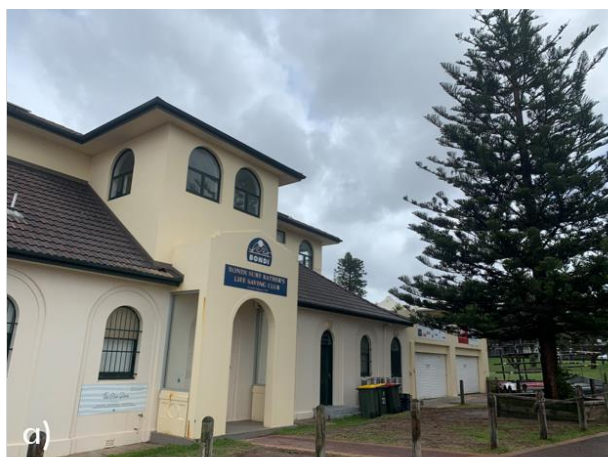
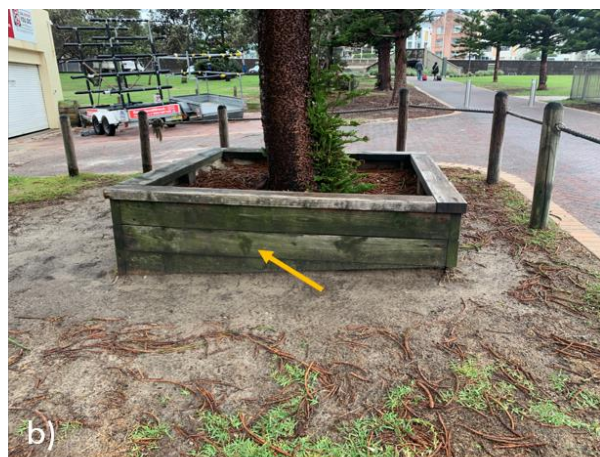
3.1.1 Tree 1 was identified as *Araucaria heterophylla* (Norfolk Island Pine) and was allocated a Moderate Landscape Significance Value and a Retention Value of *Consider for Retention*.

3.1.2 The tree was in good physiological condition as indicated by the full crown density, normal leaf colour and low volumes of dead wood and epicormic growth.

3.1.4 The proposed basement will result in the loss of approximately 50% of the structural roots and the tree will need to be removed to accommodate the works.

a) Showing current building at site and Tree 1. b) Showing Tree 1 and raised bed. c) Showing Trees 2, 4 & 5. d) Showing Trees 2, 4, 5, 6, 7 & 8 e) Showing Trees 11, 12 & 14. f) Showing Trees 15 & 16.

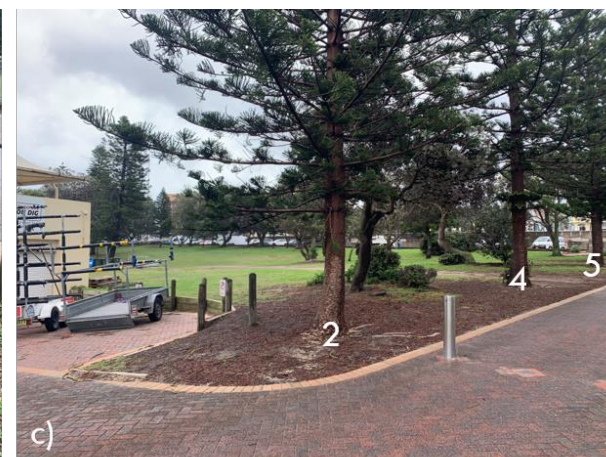
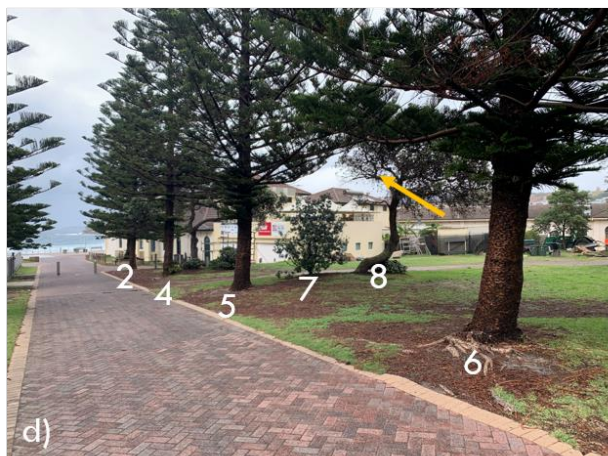
3.2.3 Given these trees were mostly in good physiological condition, the proposed turf works can be accommodated without affecting the long term structural and physiological viability of the trees if the following tree sensitive construction methods and protection measures are carefully implemented under the supervision of the Project Arborist.

3.2.5 TPZ fencing should be installed prior to any site works and remain in place for the duration of the demolition and construction phases associated with the building works. Strictly no materials, waste storage and temporary services should not be located within the TPZ fenced area.

- 3.2.8 Ideally the existing turf should remain in place. However, if removal and replacement is required, then tree sensitive methods should be used for the removal of existing grass within the TPZ areas. The grass should be removed by hand to prevent root damage.

- 3.2.9 New turf (including sub-soil materials) should be installed above or at the existing grade.
- 3.2.10 The existing paving in Tree 2's TPZ should be removed by hand and under supervision of the Project Arborist to minimise root disturbance.

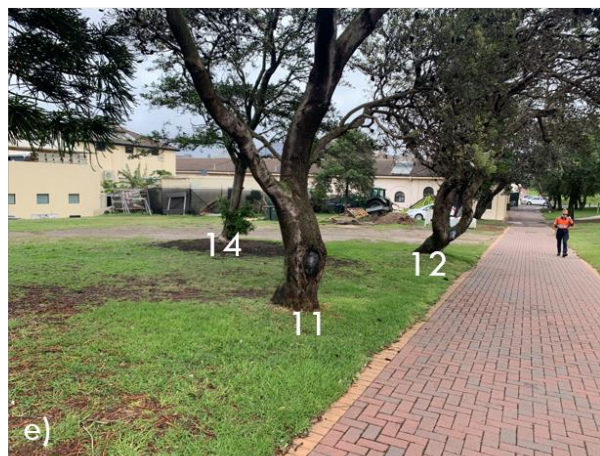
- 3.4.2 Tree 12 was in poor physiological condition as indicated by reduced crown density and localised death of the upper crown and central leader. The crown density was estimated to be 50-75% of an idealised example of this species. The localised crown death included small and large diameter branches (<50mm to 100mmØ).

- 3.4.3 The Tree was also allocated a poor structural rating due to a cavity observed in the main trunk and crown. The column of decay associated with the cavity is likely to extend above and below the opening. However, internal investigations on the extent of the decay column were beyond the scope of this Report.

- 3.4.4 A cavity of this size is unlikely to fully occlude, and the prognosis is for further decay over the medium term. Furthermore, compartmentalisation of the decay cavity is likely to be compromised by the poor tree vigour and as this species is generally regarded to poorly compartmentalise decay (Lonsdale et al. 1999).

- 3.4.6 Given the poor physiological and structural condition, removal and replacement with a healthy advanced size specimen would replace the loss of amenity within a short timeframe.

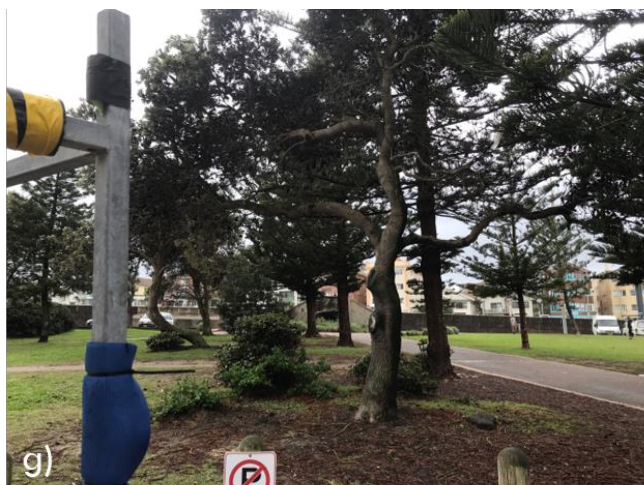
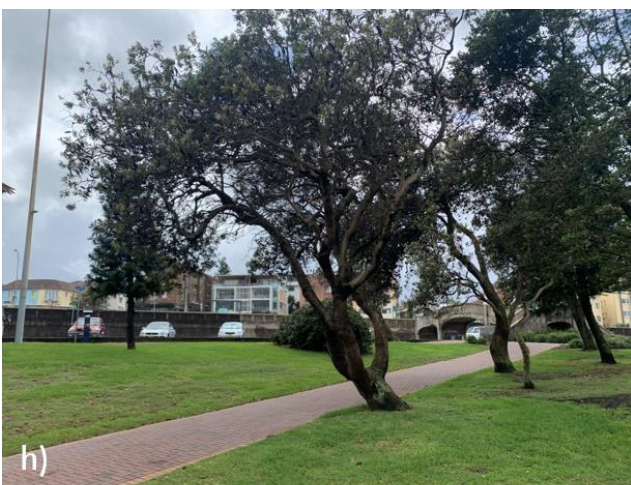
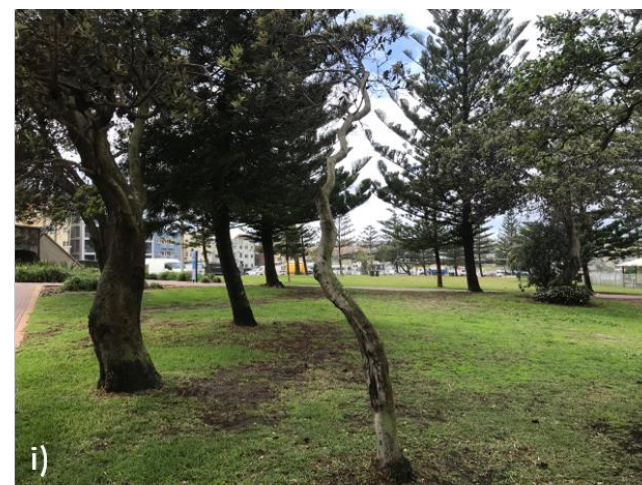
- 3.3.2 Trees 3 & 8 were in poor physiological condition as indicated by reduced crown density and localised death of the upper crown. The crown density was estimated to be 50-75% of an idealised example of this species. The localised crown death included small and large diameter branches (<50mm to 100mmØ) and was estimated to represent approximately 20% of the total crown volume.

- 3.3.3 Tree 7 was a young specimen (<3m height) with poor form due to congested branches.
- 3.3.4 Refer to Appendix 9 Plates.
- 3.3.5 The supplied plans show turf works within the TPZ of Trees 3, 7 & 8 as per Trees 2, 4, 5, 6, 9, 10 & 11. However, given the poor physiological condition, the long-term viability of Trees 3 & 8 is highly likely to be compromised by the proposed encroachment and tree removal should be considered. Removal and replacement of Tree 7 should be considered from a small size and structural form perspective.

g-i) Showing Trees displaying poor physiological health and poor form that will need to be removed to accommodate the proposed works. (k) Showing trees 15, 16 & 17. Showing Tree 18. According to Lockhart-Krause Architects, Trees 15, 16, 17 & 18 have been removed as part of a separate Development Application since the site inspection conducted for the current report (16.03.2020)

- 3.3.6 Removal and replacement with a healthy advanced size specimen would replace the loss of amenity within a short to medium timeframe.
- 3.3.7 Refer to Appendix 5, 6 & 7 for detail.
