ARBORICULTURAL IMPACT ASSESSMENT (AIA) REPORT

Leichhardt Park Community Boatshed

An AIA report prepared for the Community Rowing Club Inc. for a proposed development at Part Lot 120 DP 1279860 – 66-68 Mary Street LILYFIELD

DATE: 13/02/2024

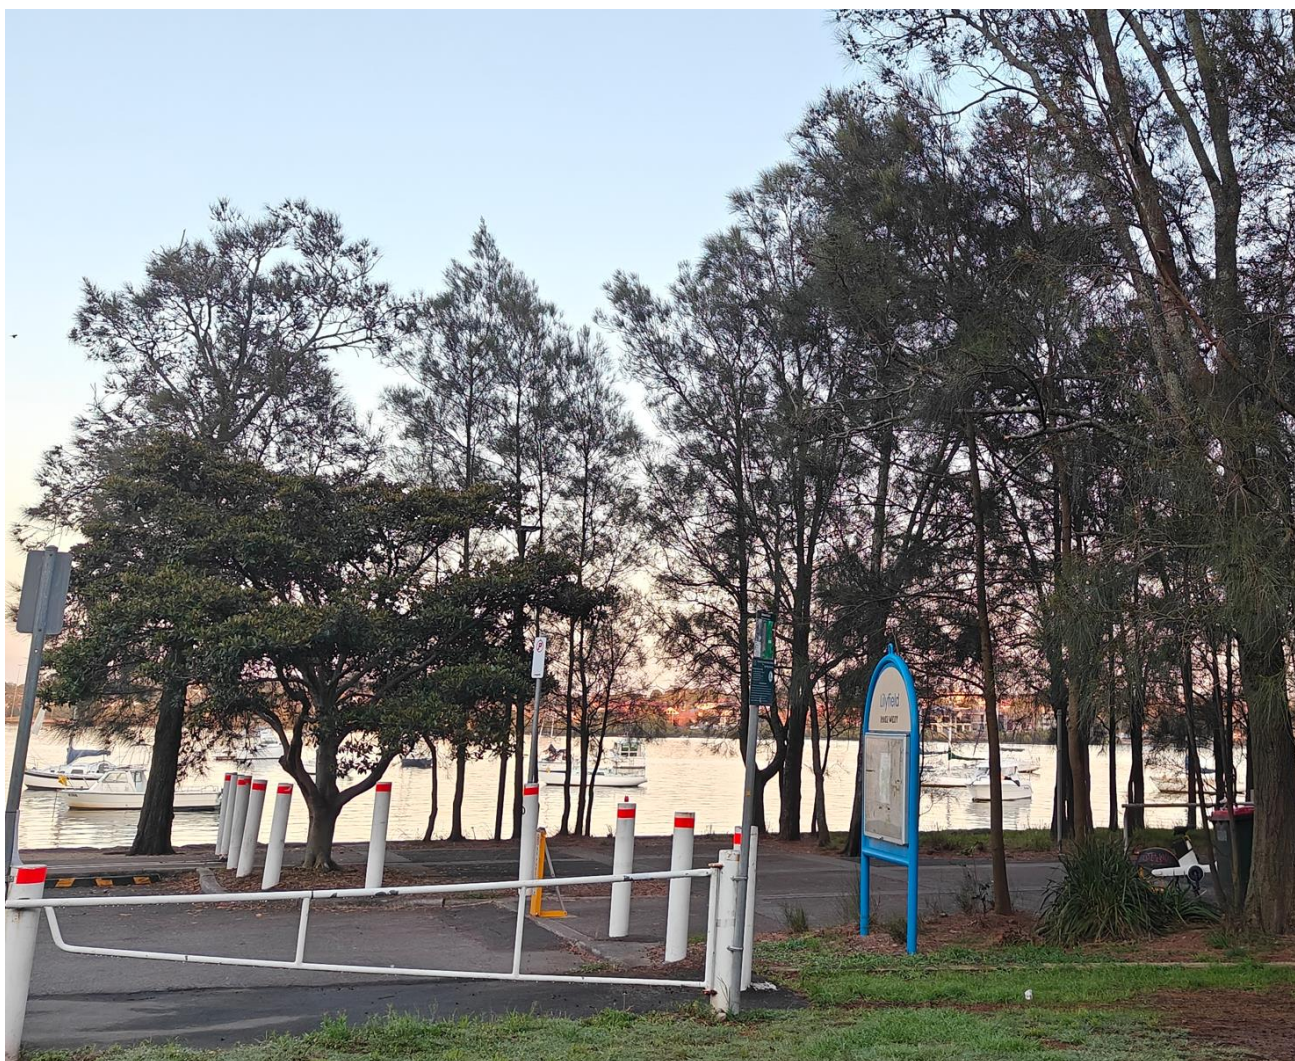
- 5.6.** The pathway changes that have been proposed to accommodate the boat trailer movements can be seen in Figure 10. The pathway changes will require Tree 1 and most of Group 1 trees to be removed. It will also require trees located along the Western edge of Groups 2, 4 and 5 to be removed. These trees were assessed to be relatively young and a moderate retention value and can be replaced. A final assessment on which trees will require removal will need to be undertaken by the Project Arborist once the new pathway changes have been confirmed.

Figure 4 Photo showing Tree 1 and Group 1. The gate is the entrance to Leichardt Oval No.3

- 6.4.1. Groups 1, 2, 4 and 5 will require minor canopy lift pruning of small ~25-50mm diameter branches once the pathway changes proposed in Figure 10 have been completed. They should be pruned so that there is enough clearance to avoid accidental damage from construction related activities. This work should be undertaken by a Practicing Arborist to AS4737-2007 and with the approval of council. All work should be undertaken with the supervision of the project Arborist.

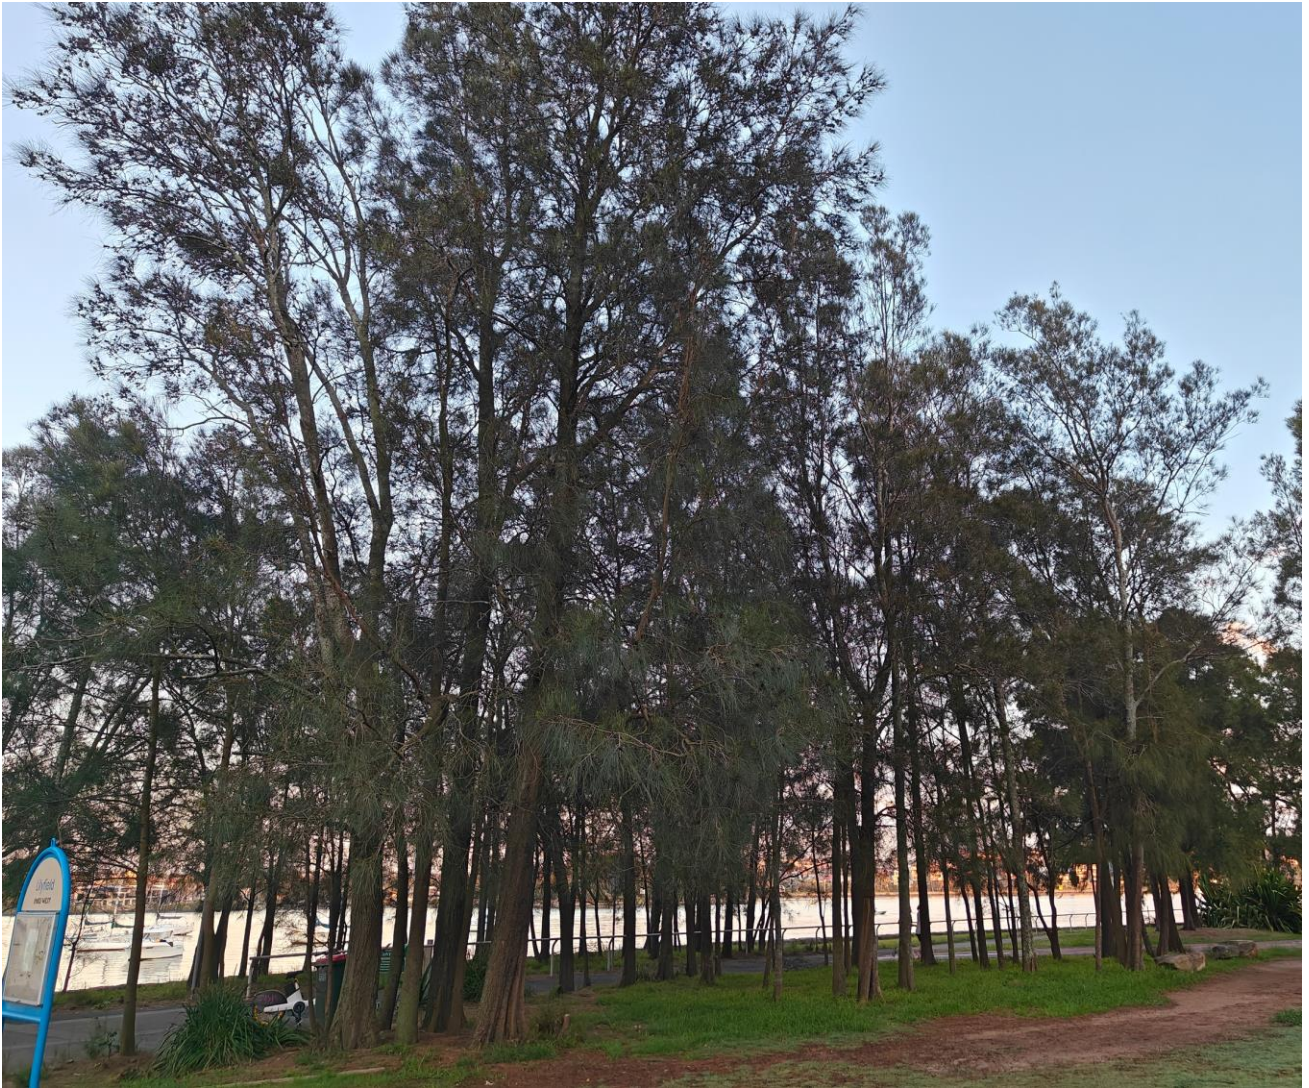
Figure 5 Photo of Group 2. Maliyawul St is to the left of frame

6.8.1. Ground protection to be installed on the East side of Group 2 and South side of Group 3 to prevent unnecessary damage to the tree roots during construction activities. An example of these can be seen in Figure 2 below.

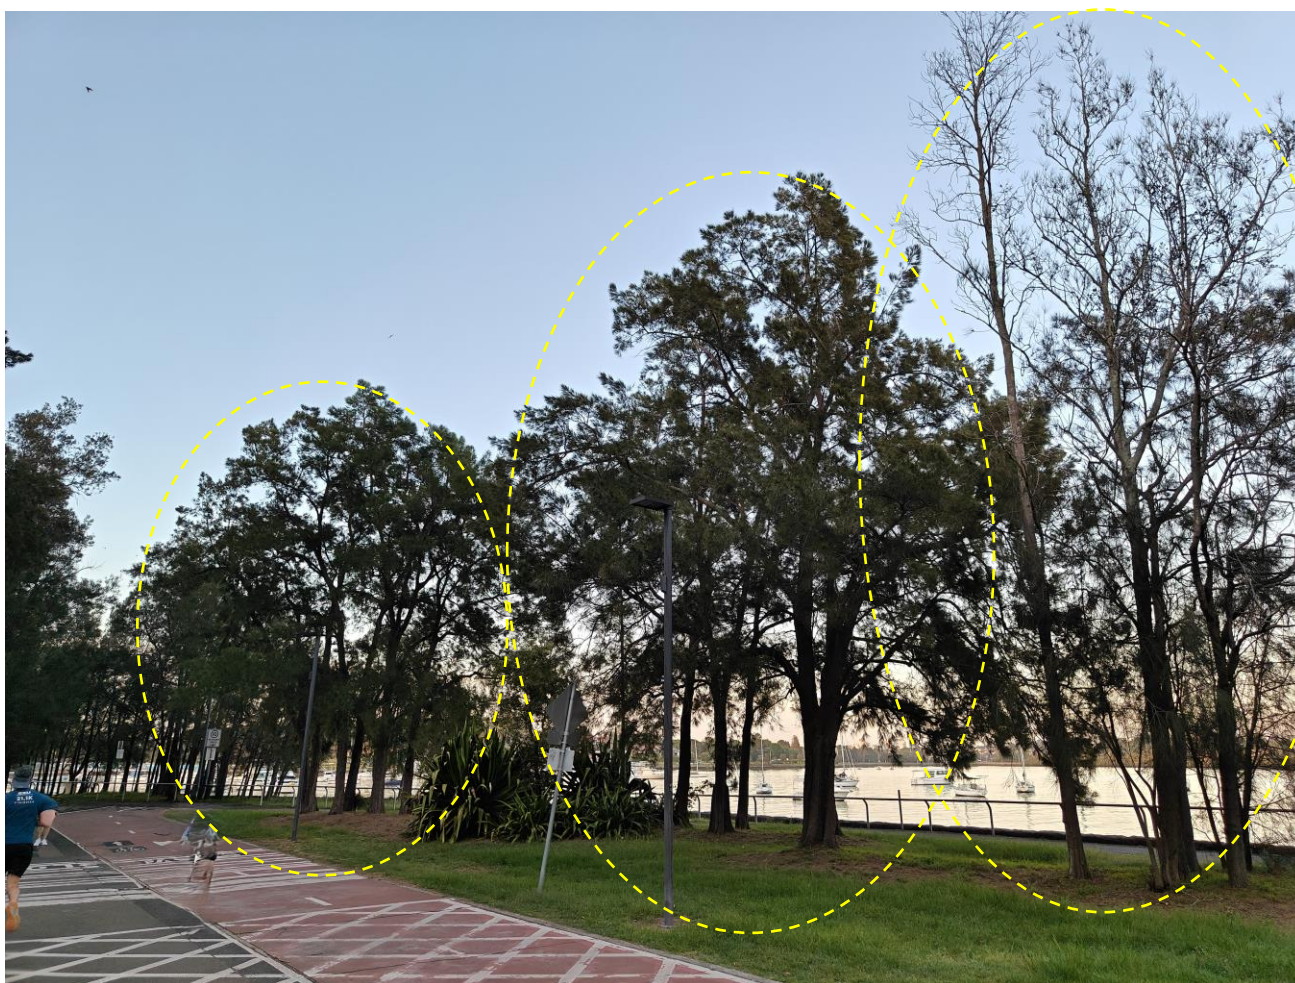
Figure 6 Photo of Group's 4, 5 (part of) and 6 looking South along the bay run. Group 6 was observed to be in poor, declining health.

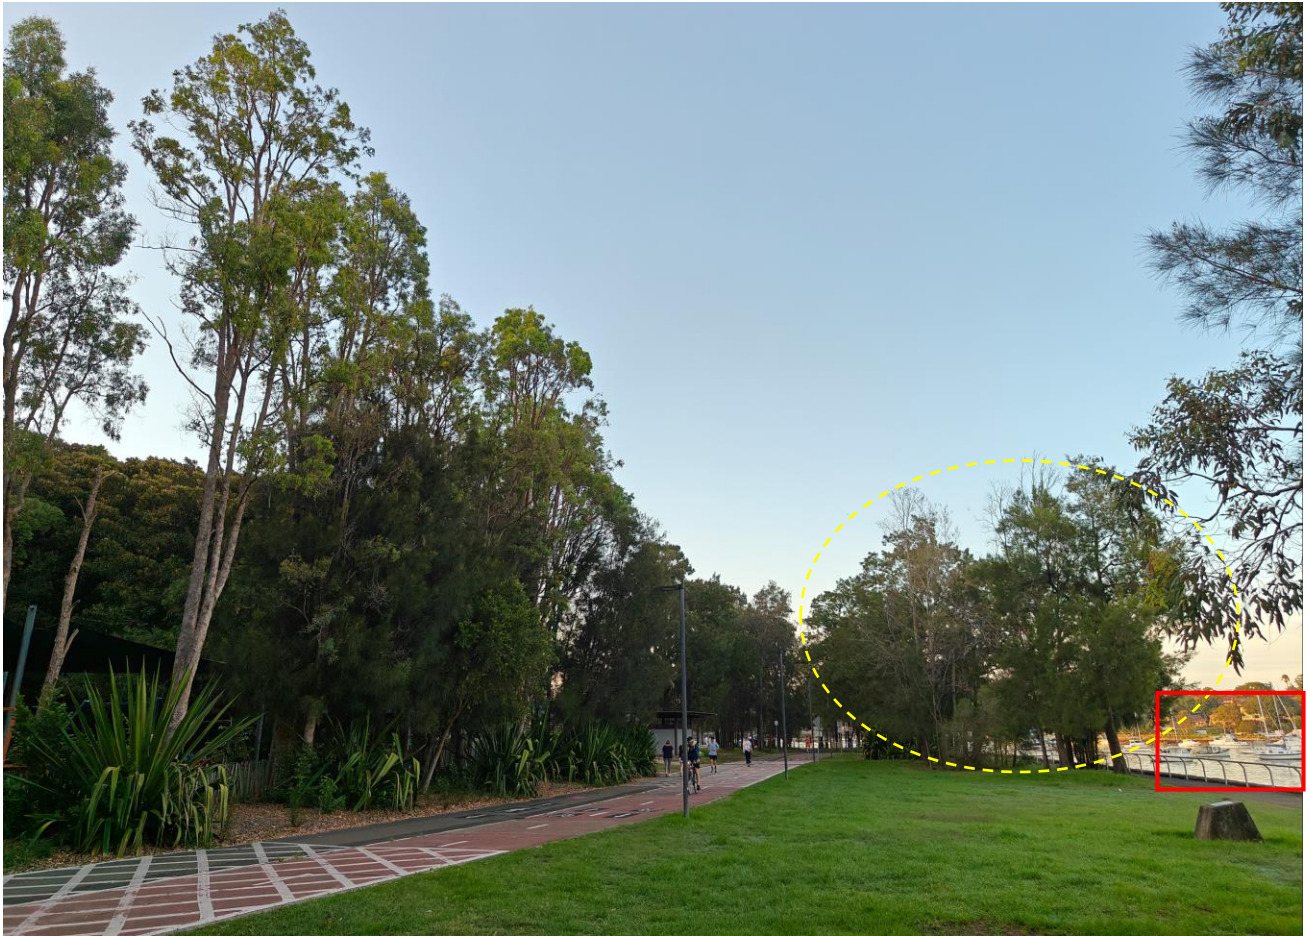
Figure 7 Photo showing Group 5 and 6 (marked yellow) and the approximate position of the boatshed

Group 5	Casuarina spp (She Oak)	100-300	300	3.6	2.00	Both	Minor	Yes	1. Impact from development works specifically for the Boatshed are calculated to be Minor (overall <10%) however there are ~2 trees closest to the building that might be impacted due to the proximity to construction activities. It is suggested that the shoreline path be used to traffic any materials where/when possible to avoid the bay run. 2. Install tree protection fencing around this group of trees prior to construction work. 3. Monitor health and condition throughout development works
Group 6	Casuarina spp (She Oak)	50-300	50-350	3.6	2.13	None calculated	Minor to none	Yes	1. Impact from development works specifically for the Boatshed are calculated to be Minor to none. 2. This group of trees was observed at the time of site inspection to be in serious decline of health and condition and may not survive. 3. Tree protection fencing has been recommended around this group as part of the larger Group 5 recommendations 3. Monitor health and condition throughout development works

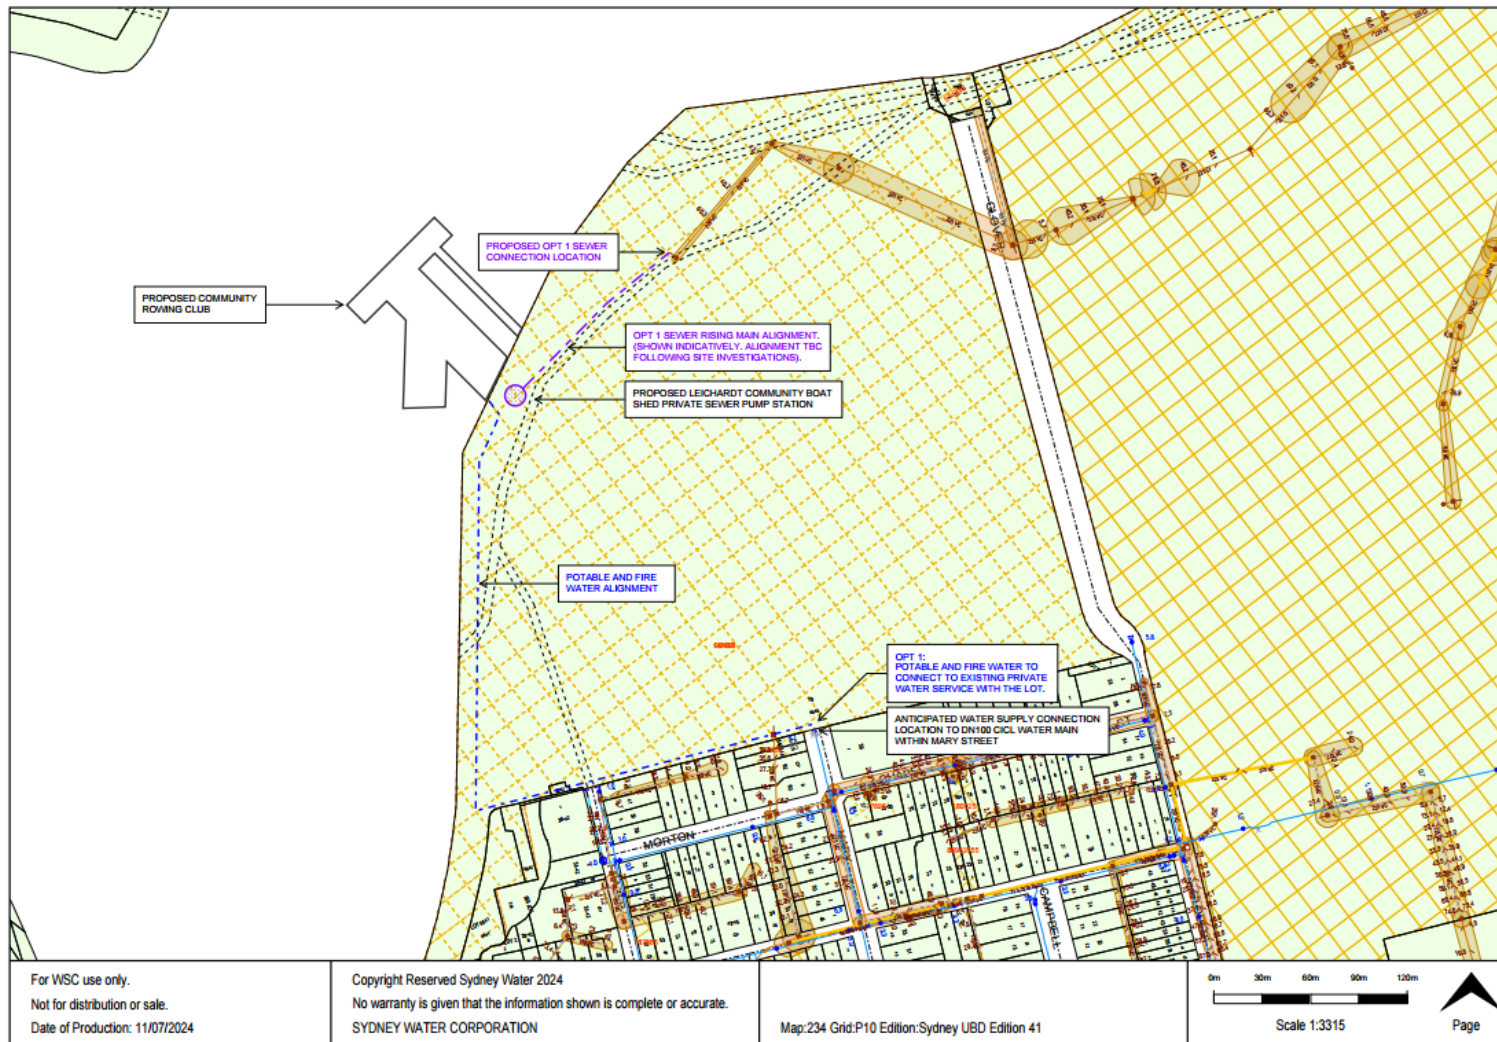
Figure 12 Proposed sewer connection provided by email by Client 13/2/2025

- 5.9.** The proposed sewer connection will have a major impact to Group 7 trees and any trees located on the next to the bay run on the west side. Recommendations have been provided to reduce some of the potential impacts in Section 6 below.

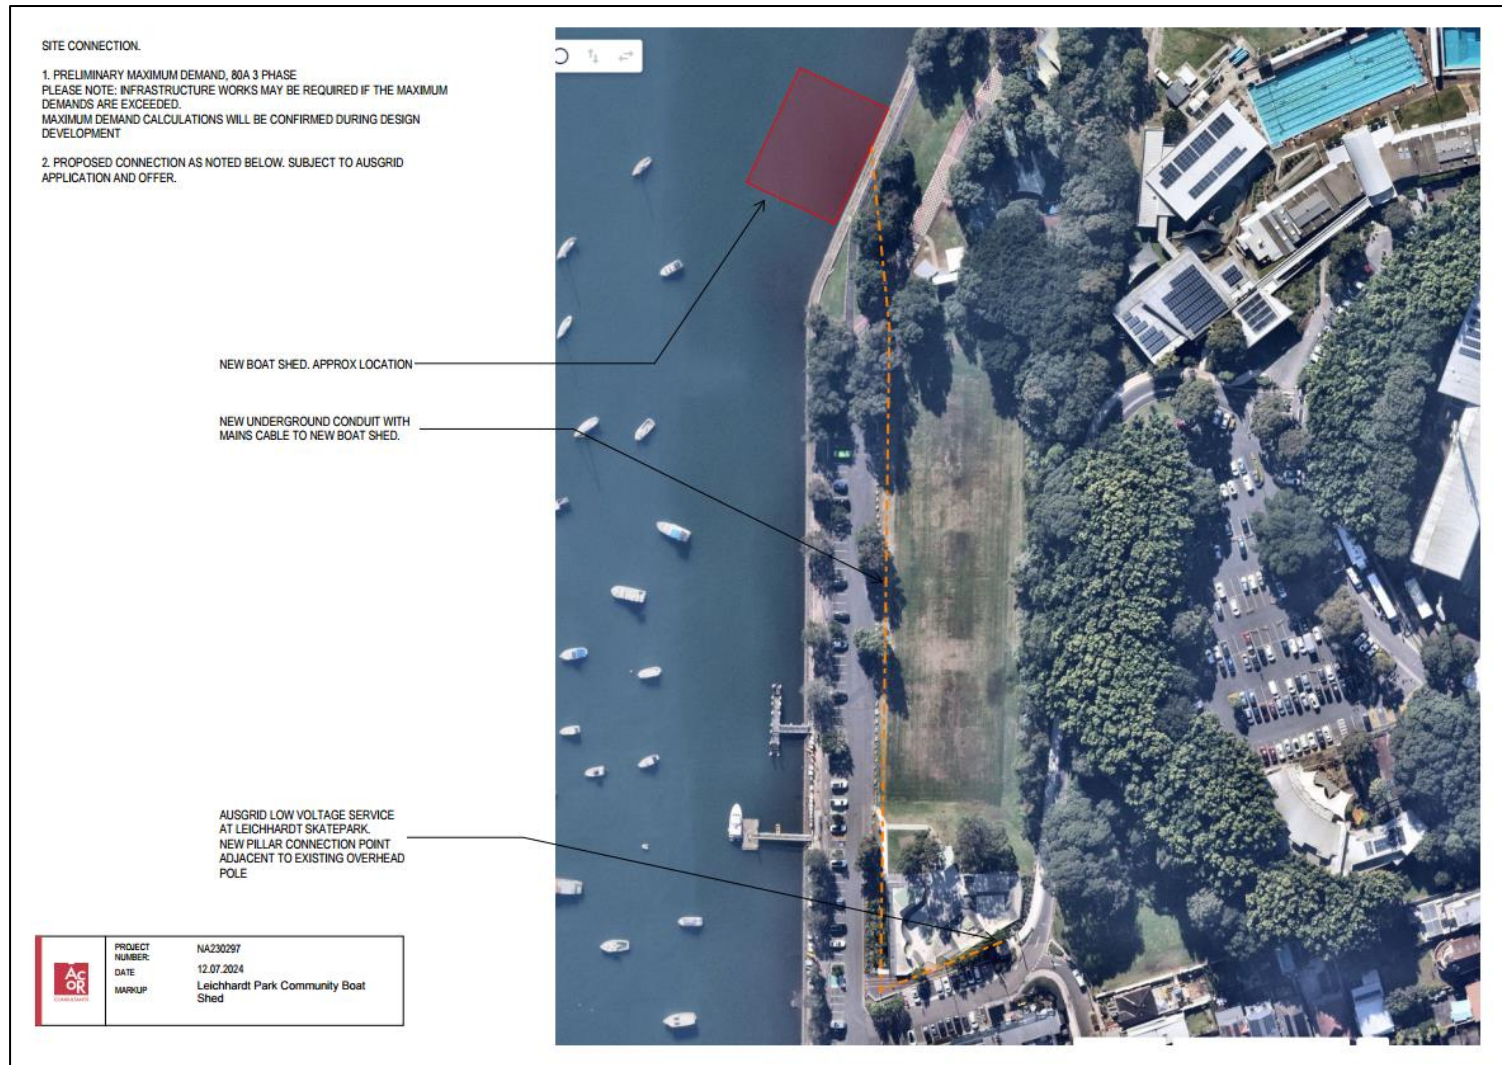
Figure 13 Proposed Electrical connection provided by email by Client 13/2/2025

- 5.8.** The proposed electrical connection will require a trench nearby to trees located along Maliyawul Street, see Figure 13. If the trench can be dug approximately 3m away from these trees (not formally assessed) it will be outside their structural root zone and should minimise any potential impact to their roots. Alternative routes to other possible connection points are shown in Figure 14. The proposed locations for water connections are from Frazer Street, see Figure 11. Possible connection routes to these points can be seen in Figure 14. The site inspection located existing water services at Frazer Street that if connection here is possible it would avoid impacting the Fig trees near Mary Street. These connection points would require a trench to be dug however would

only potentially impact some of trees within Group 2, 3 and 5 depending on the route that was agreed upon.
