Report on
Geotechnical Investigation

Alterations and Additions
20 Illawong Avenue, Tamarama

Prepared for
Strata Plan 1731

Project 72261.06
November 2018

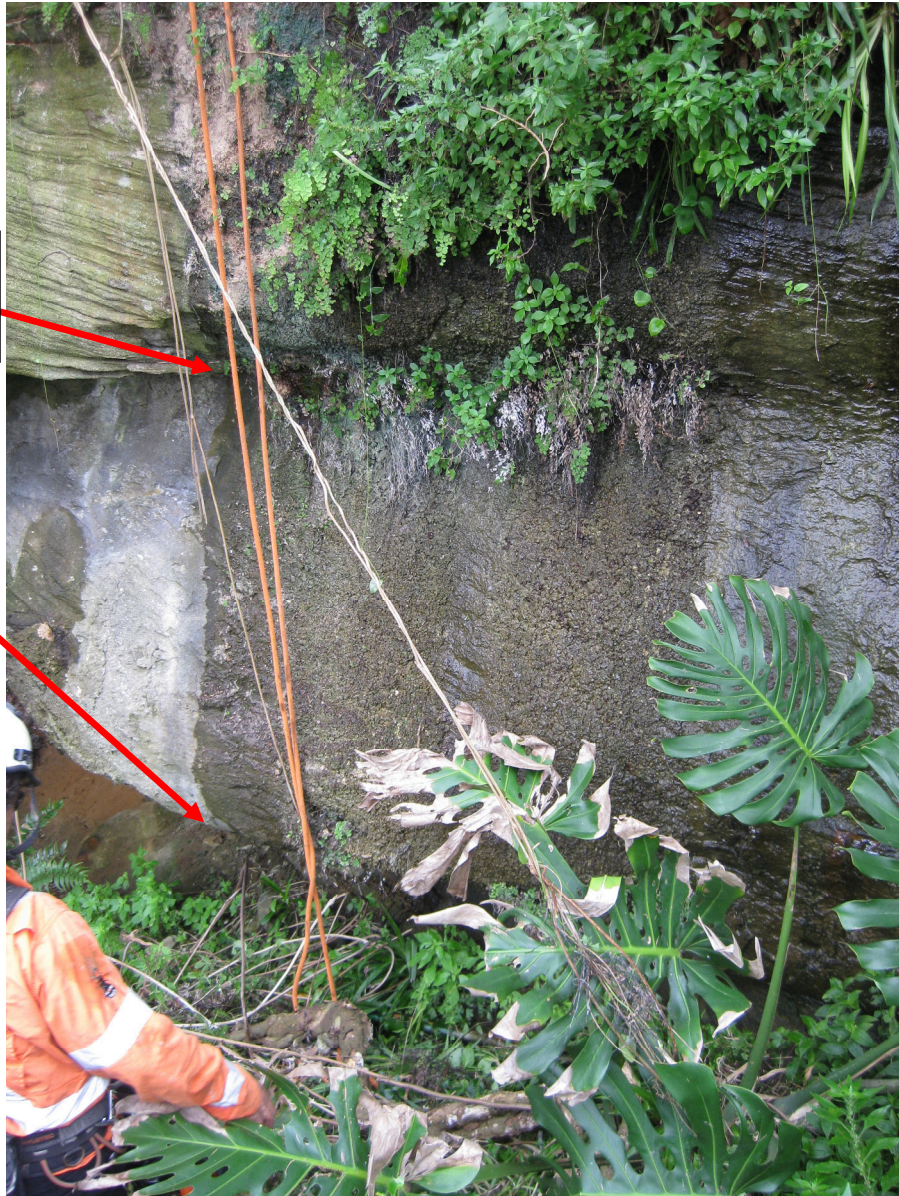
Mapping Traverse 101, Photo 3 – View of lower portion of slope along mapping traverse 101. High strength cross-bedded sandstone exposed, and with an overhang formed above a bedding parting defect which extends more than 10 m to either side of the section line.

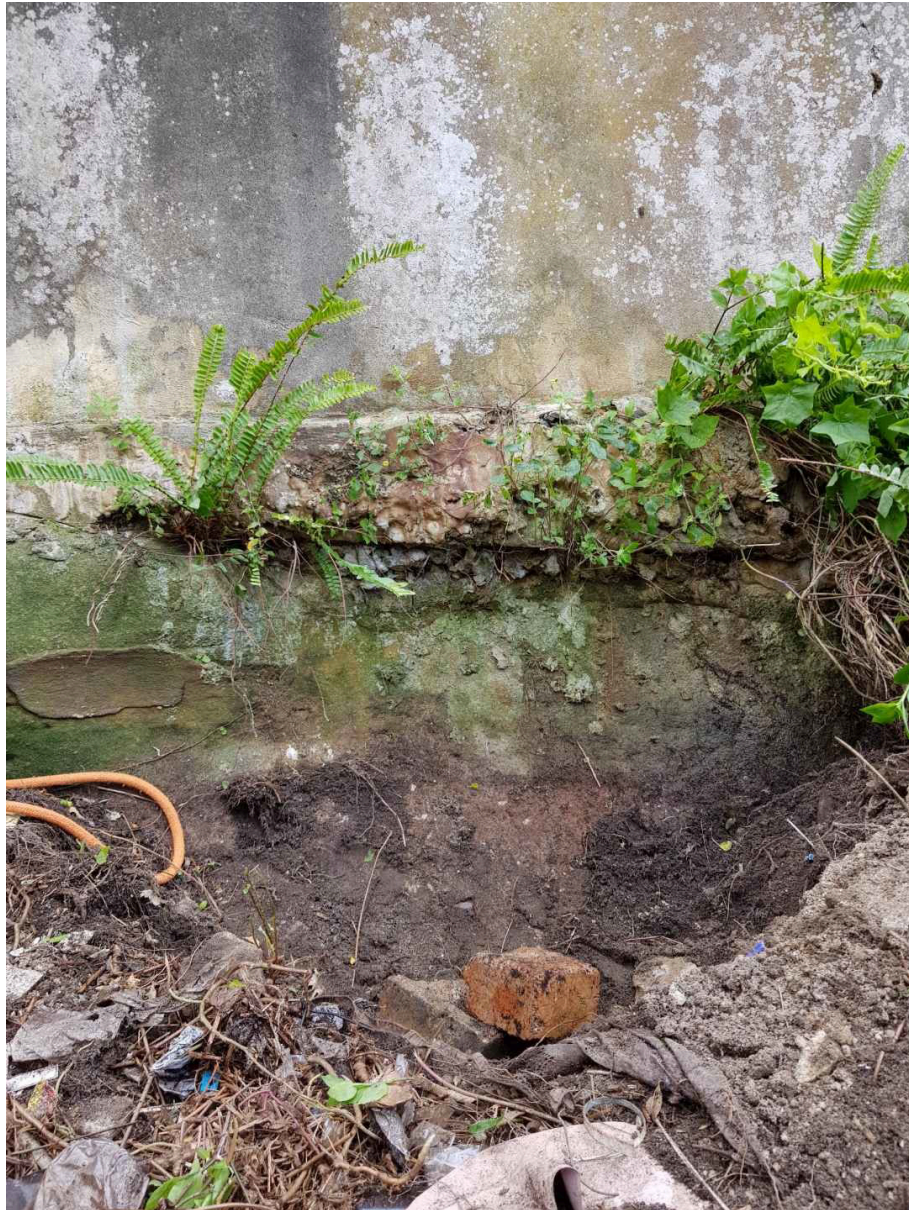
Mapping Traverse 102, Photo 1 – View of interface between rendered brick retaining wall and the underlying sandstone at mapping traverse 102, showing a thin layer of “levelling” concrete on top of the sandstone.

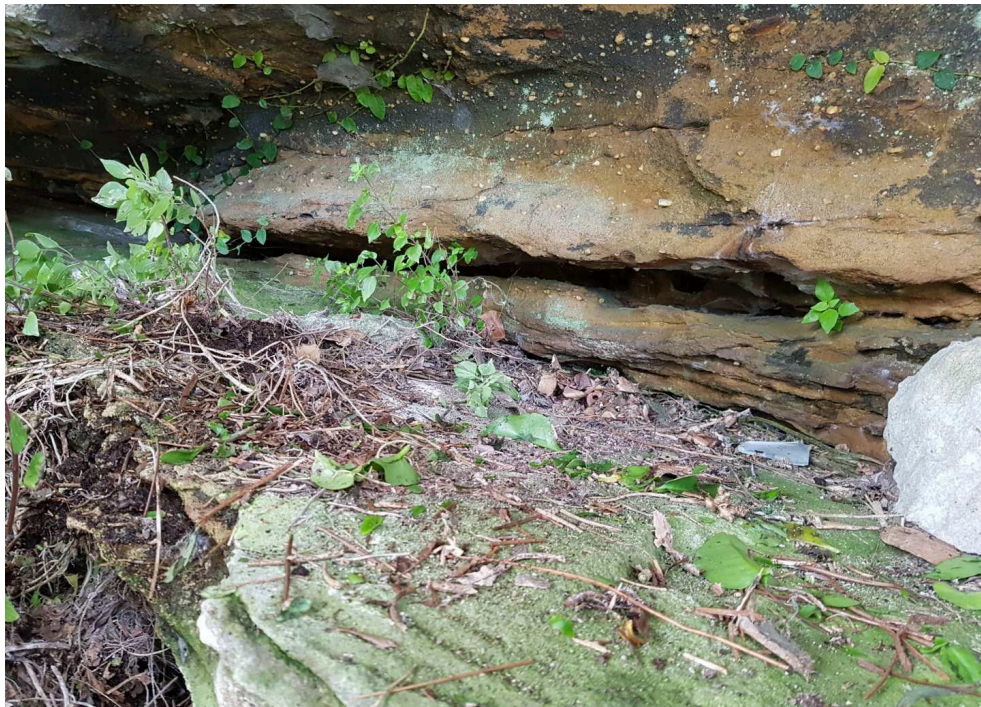
Mapping Traverse 102, Photo 2 – View of a continuous bedding parting defect and overhang (cave) at mapping traverse 102, with a sub-vertical, iron-stained joint plane forming the rear of the 'cave'.

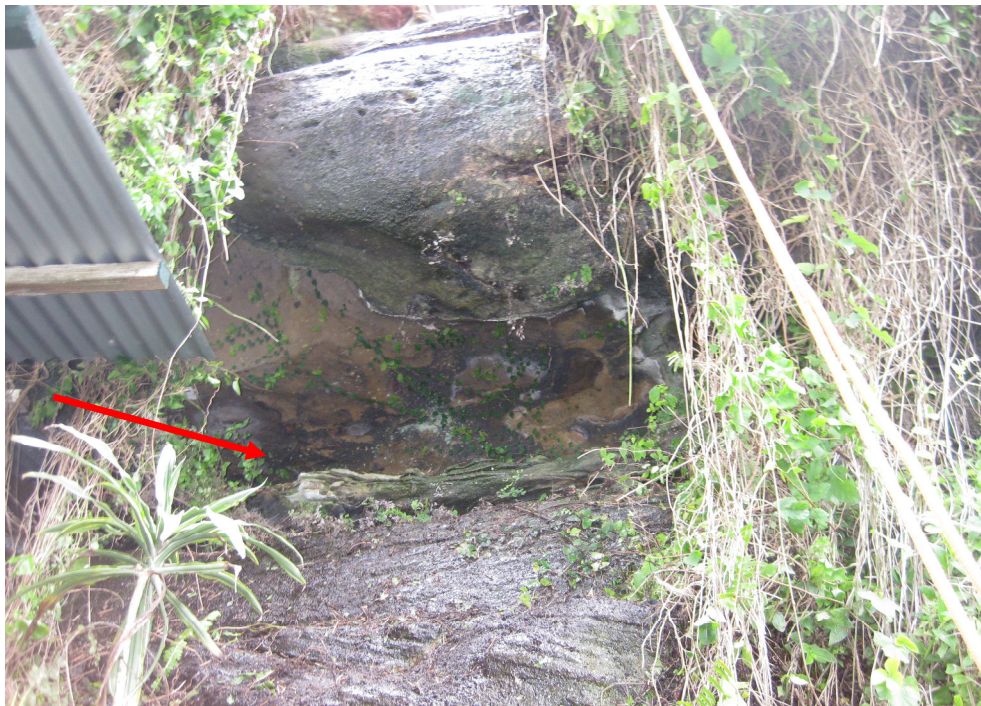
Mapping Traverse 102, Photo 3 – View of overhang at RL51 m on mapping traverse 102, with a bed of massive sandstone above and cross-bedded sandstone below. Cave location is indicated as shown.

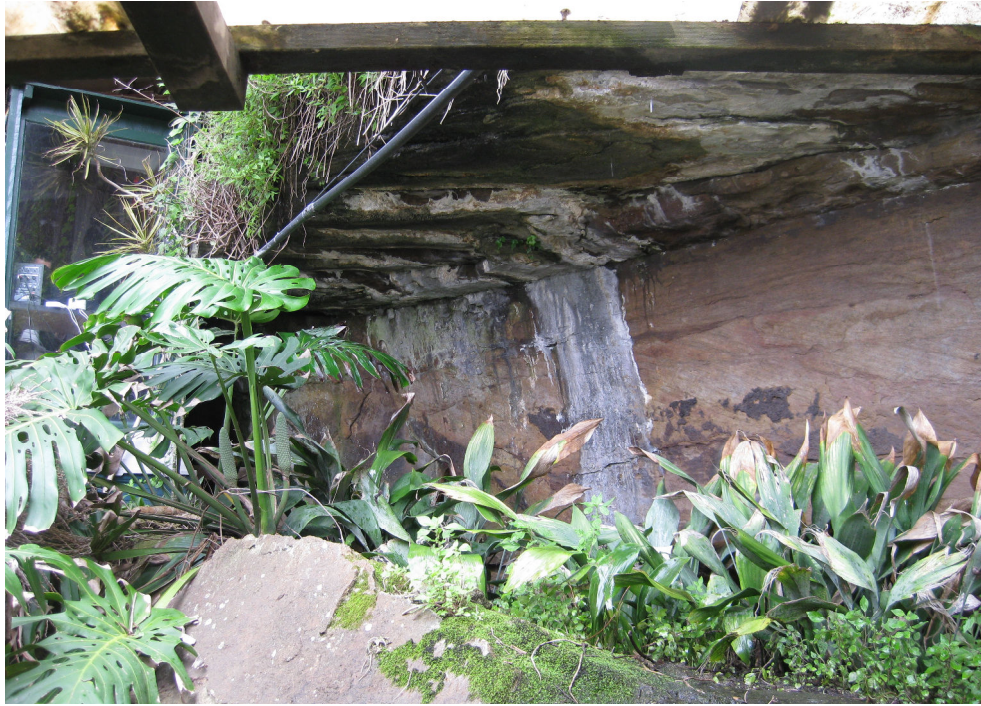
Mapping Traverse 102, Photo 4 – View of overhang in cross-bedded sandstone (RL47.5 m) at mapping traverse 102, with a sub-vertical, iron-stained joint plane forming the rear of the overhang.

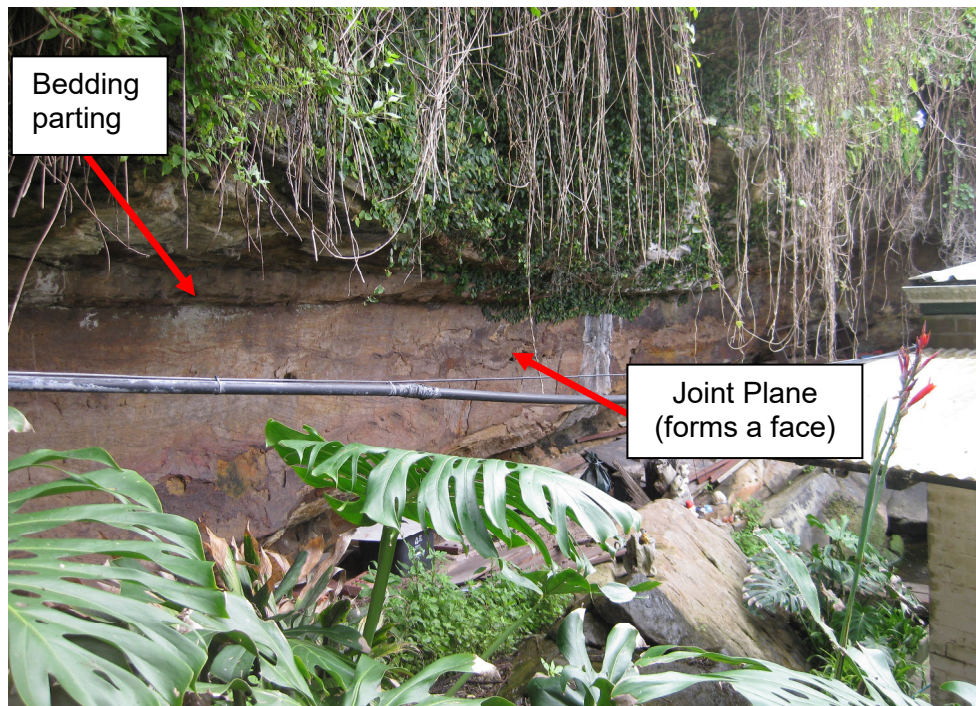
Mapping Traverse 102, Photo 5 – View of overhang in cross-bedded sandstone to the north of traverse 102. Continuous bedding plane and undulating joint plane indicated as shown.

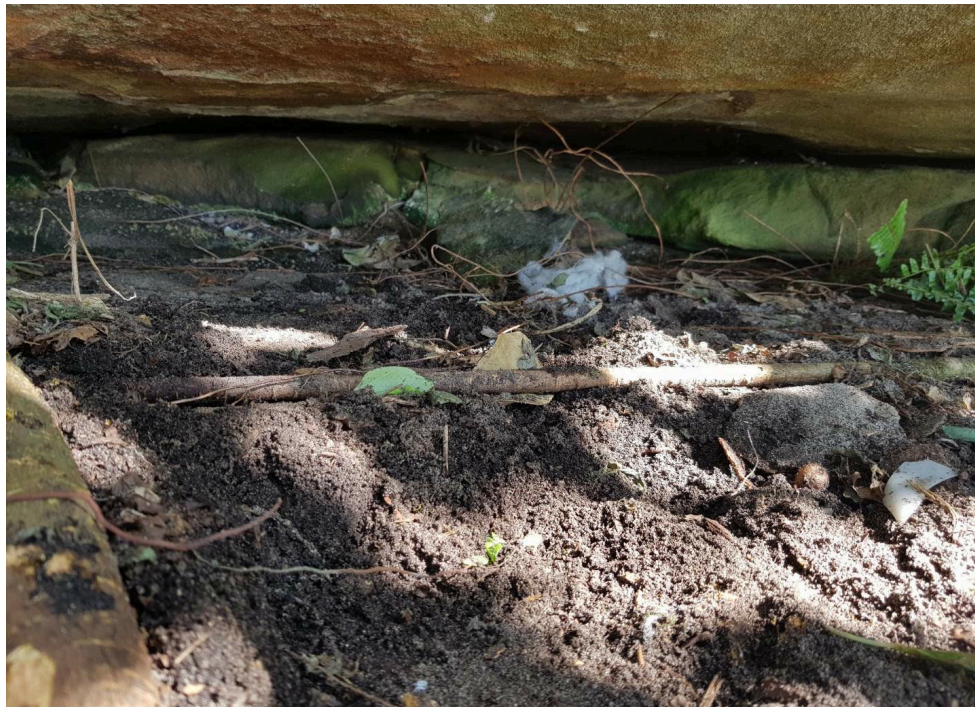
Mapping Traverse 105, Photo 1 – View within a cave formed below a bed of massive sandstone, along a bedding parting defect. Depth of cave from front face is 1.2 m, with sandy colluvium on floor of cave.

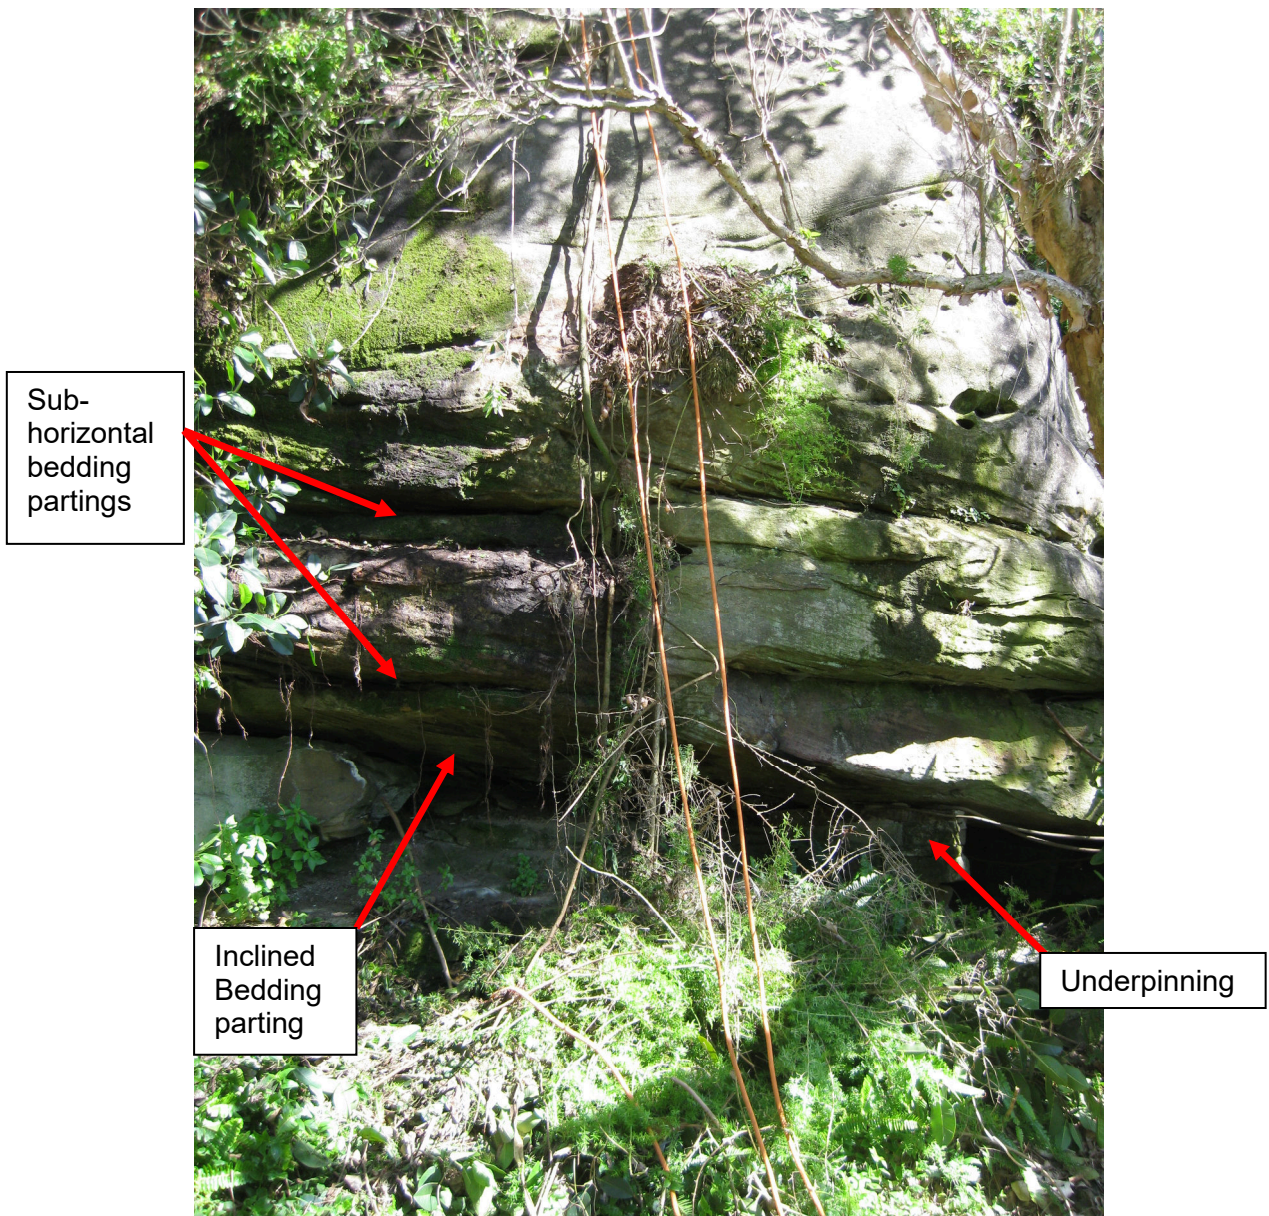
Mapping Traverse 105, Photo 3 – View towards the existing unit building at mapping traverse 105. Overhang and cave formed within cross-bedded sandstone at toe of slope. Sub-horizontal and inclined bedding partings, and a mortared brick underpinning column observed within cave, indicated as shown.

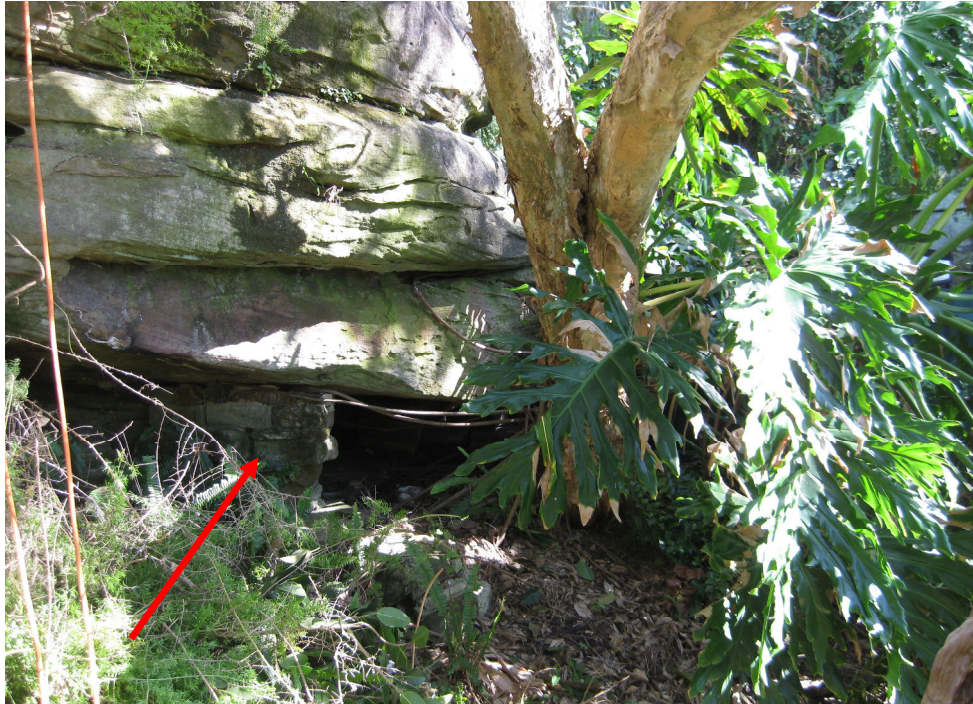
Mapping Traverse 105, Photo 4 – View towards traverse 104 from traverse 105. Overhang and cave formed within cross-bedded sandstone at toe of slope. Mortared brick underpinning observed within cave, indicated as shown.

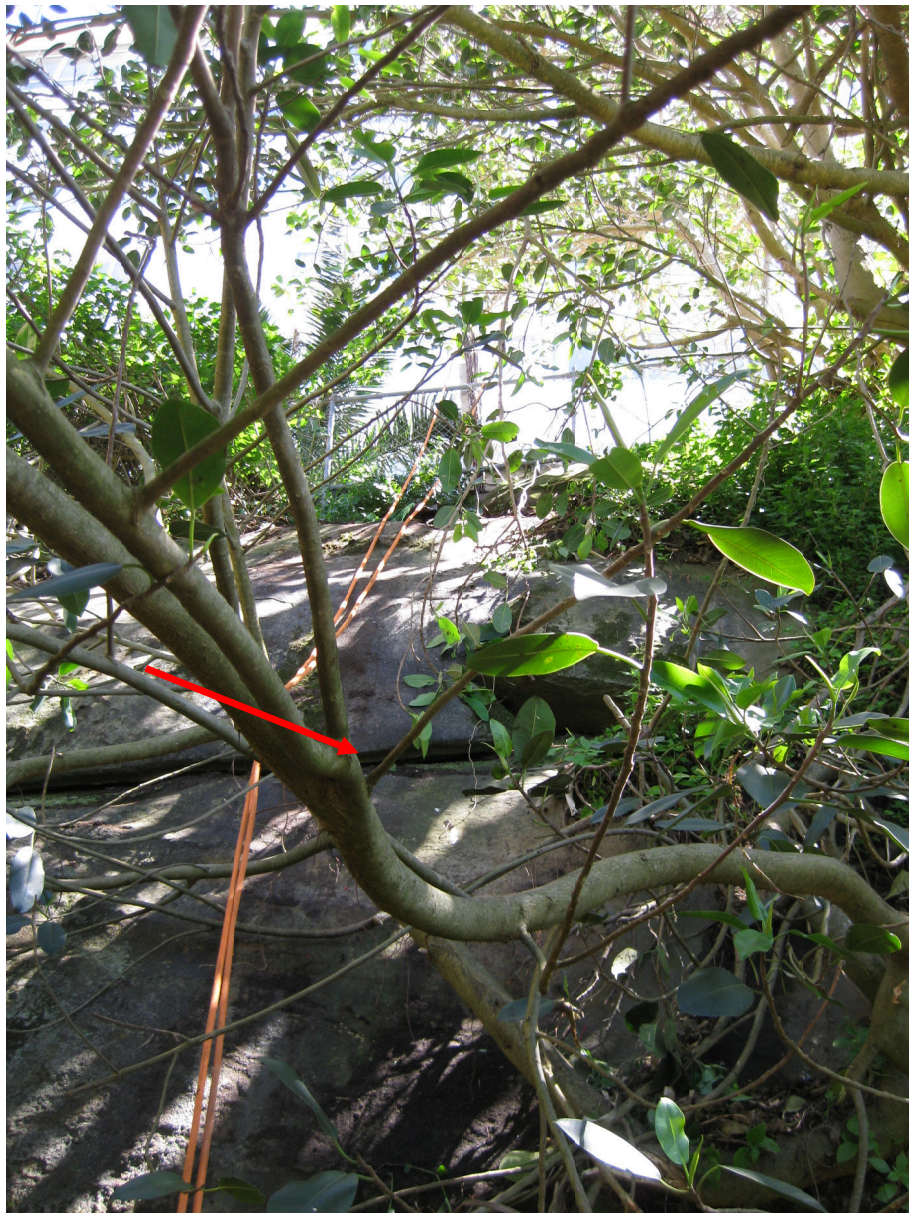
Mapping Traverse 106, Photo 2 – View upslope at mapping traverse 106, with a weathered, inclined and discontinuous bedding parting defect indicated as shown.

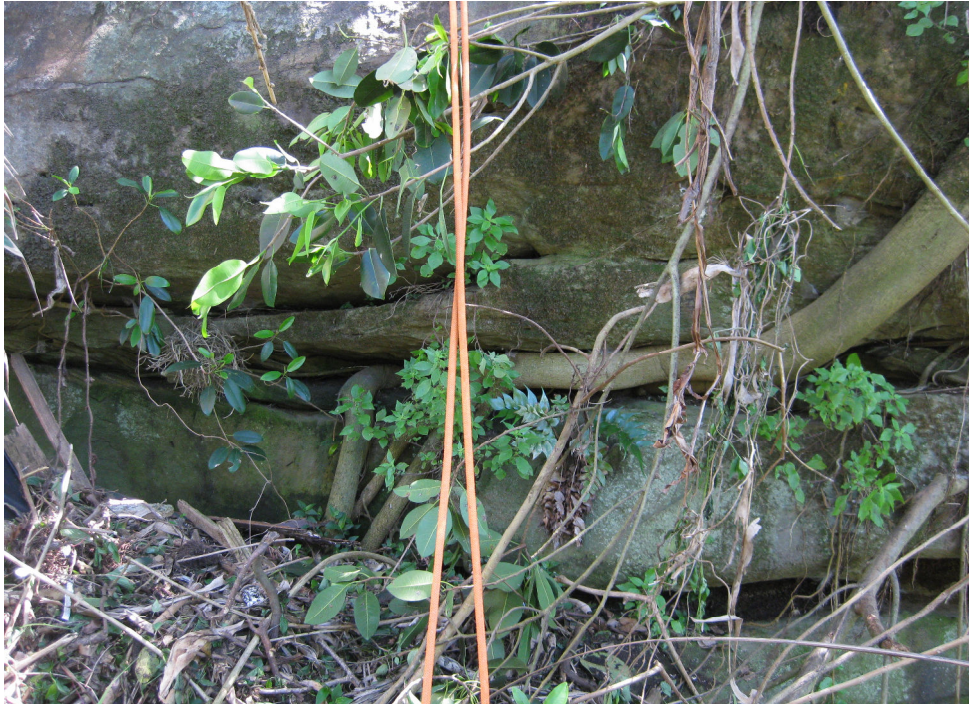
Mapping Traverse 106, Photo 3 – View of base of cliff at mapping traverse 106. Fig tree roots and evidence of past seepage were observed within small caves and overhangs formed in cross-bedded sandstone.

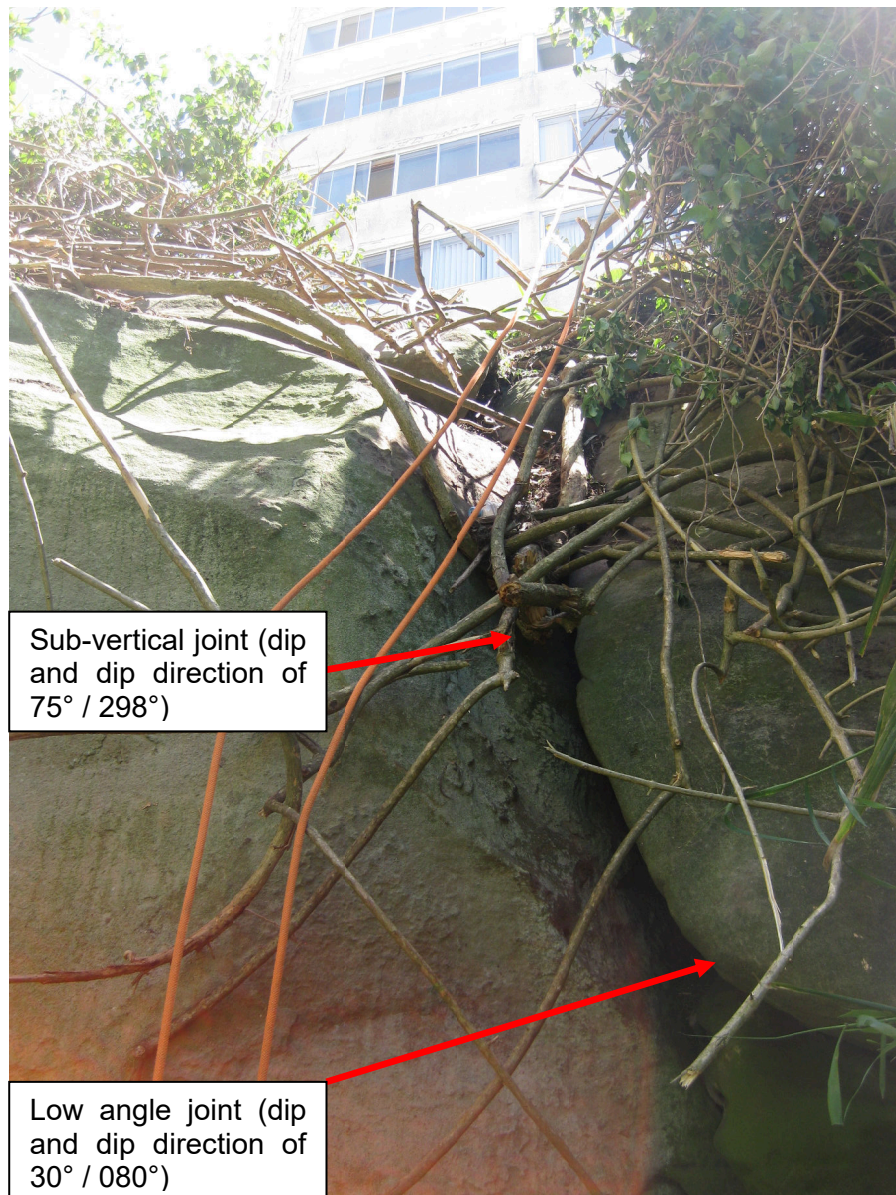
Mapping Traverse 107, Photo 3 – View upslope from base of traverse 107, of sub-vertical and inclined joints within a bed of massive sandstone. The joints and their orientations are indicated as shown.

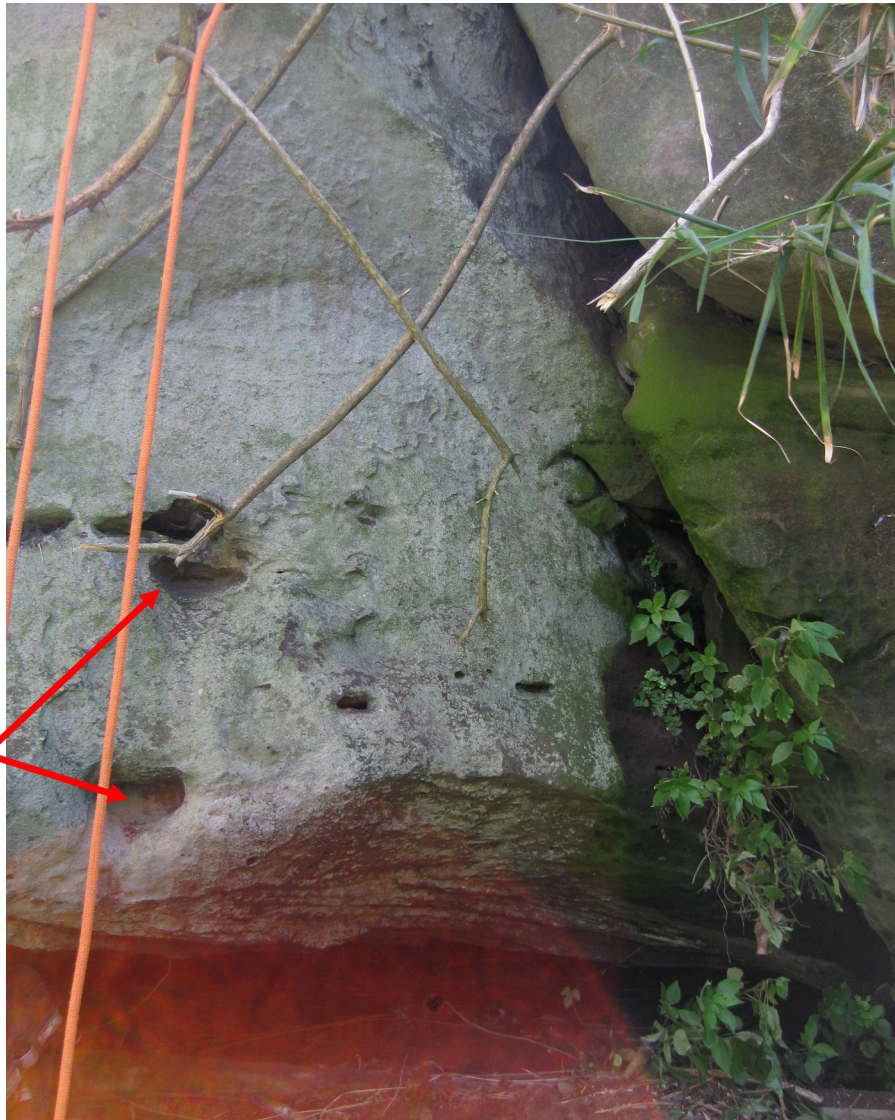
Mapping Traverse 107, Photo 4 – View of lower part of slope along mapping traverse 107, below Photo 3. Lenticular 'pockets' or holes are present in the sandstone, indicated as shown..

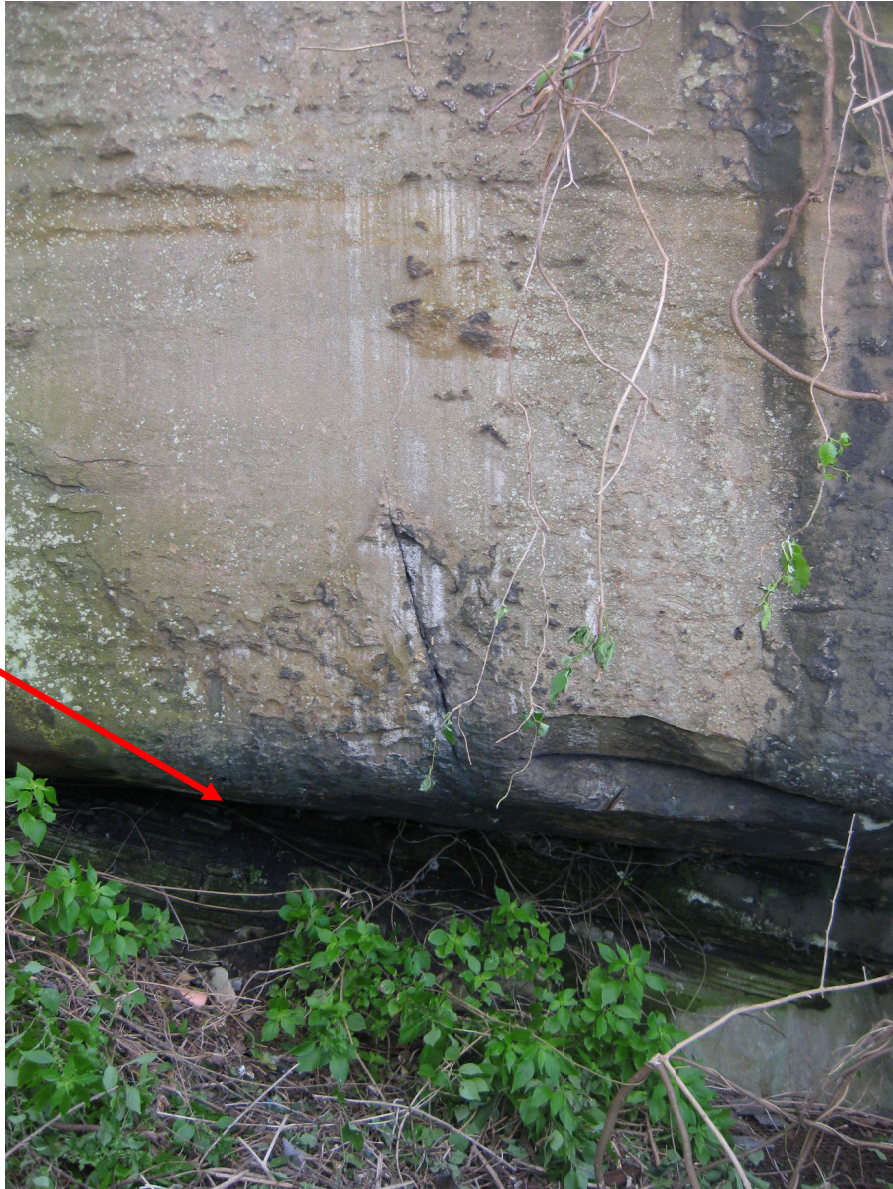
Mapping Traverse 108, Photo 3 – View of lower part of slope along mapping traverse 108, below Photo 2. Overhang formed on continuous bedding parting defect, indicated as shown.

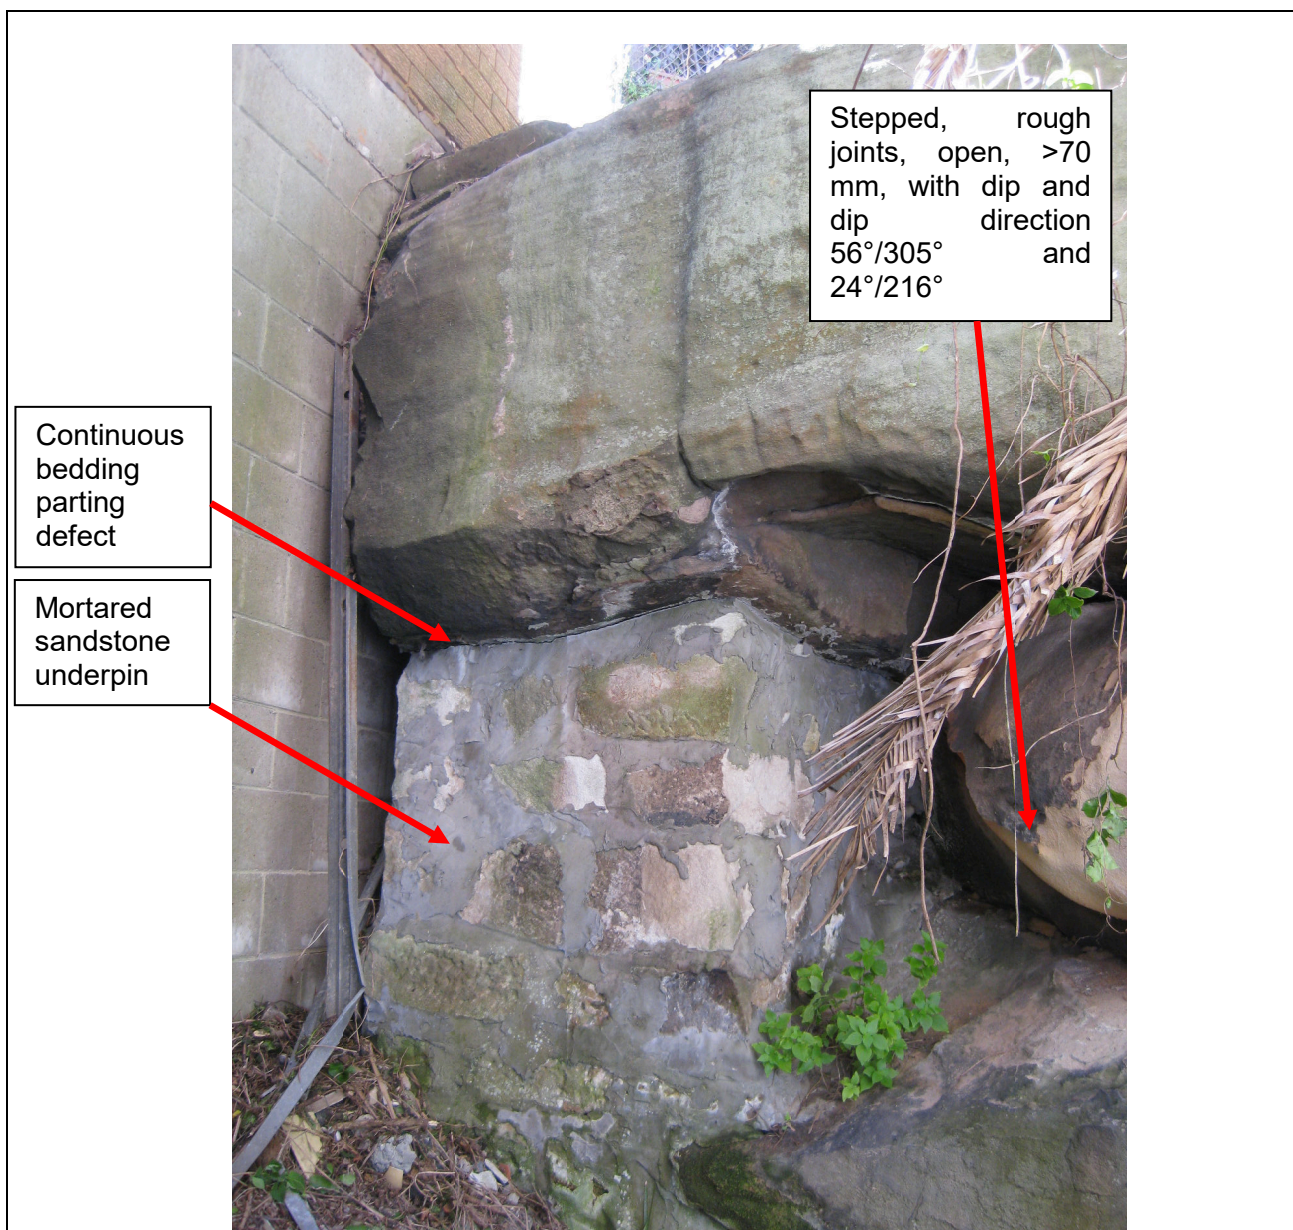
Mapping Traverse 109, Photo 1 – View of southern end of cliff line at mapping traverse 109. Mortared sandstone underpinning is present as indicated. Low angle and moderately dipping joints were present as indicated, adjacent to a 2.3 m deep void.

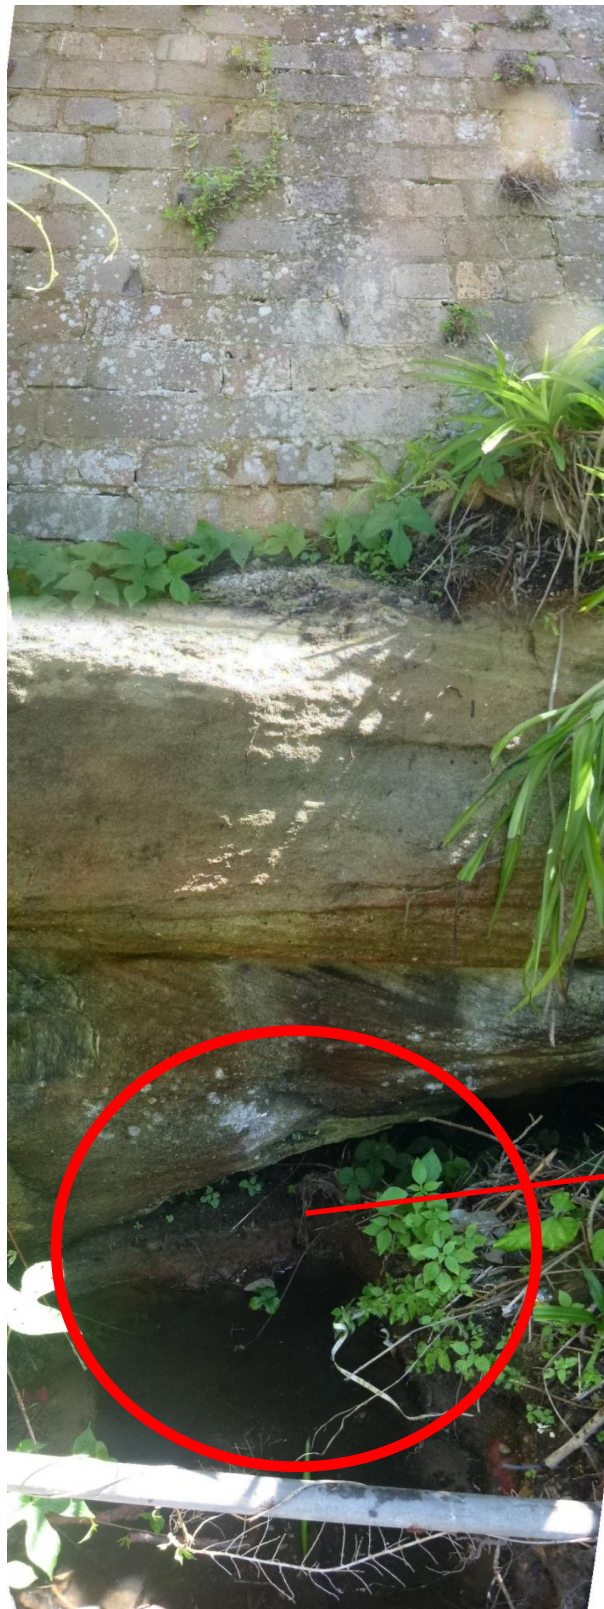
Photo 3. Cross Section 1; contact between brick terrace wall and sandstone bedrock showing lower very low strength rock.

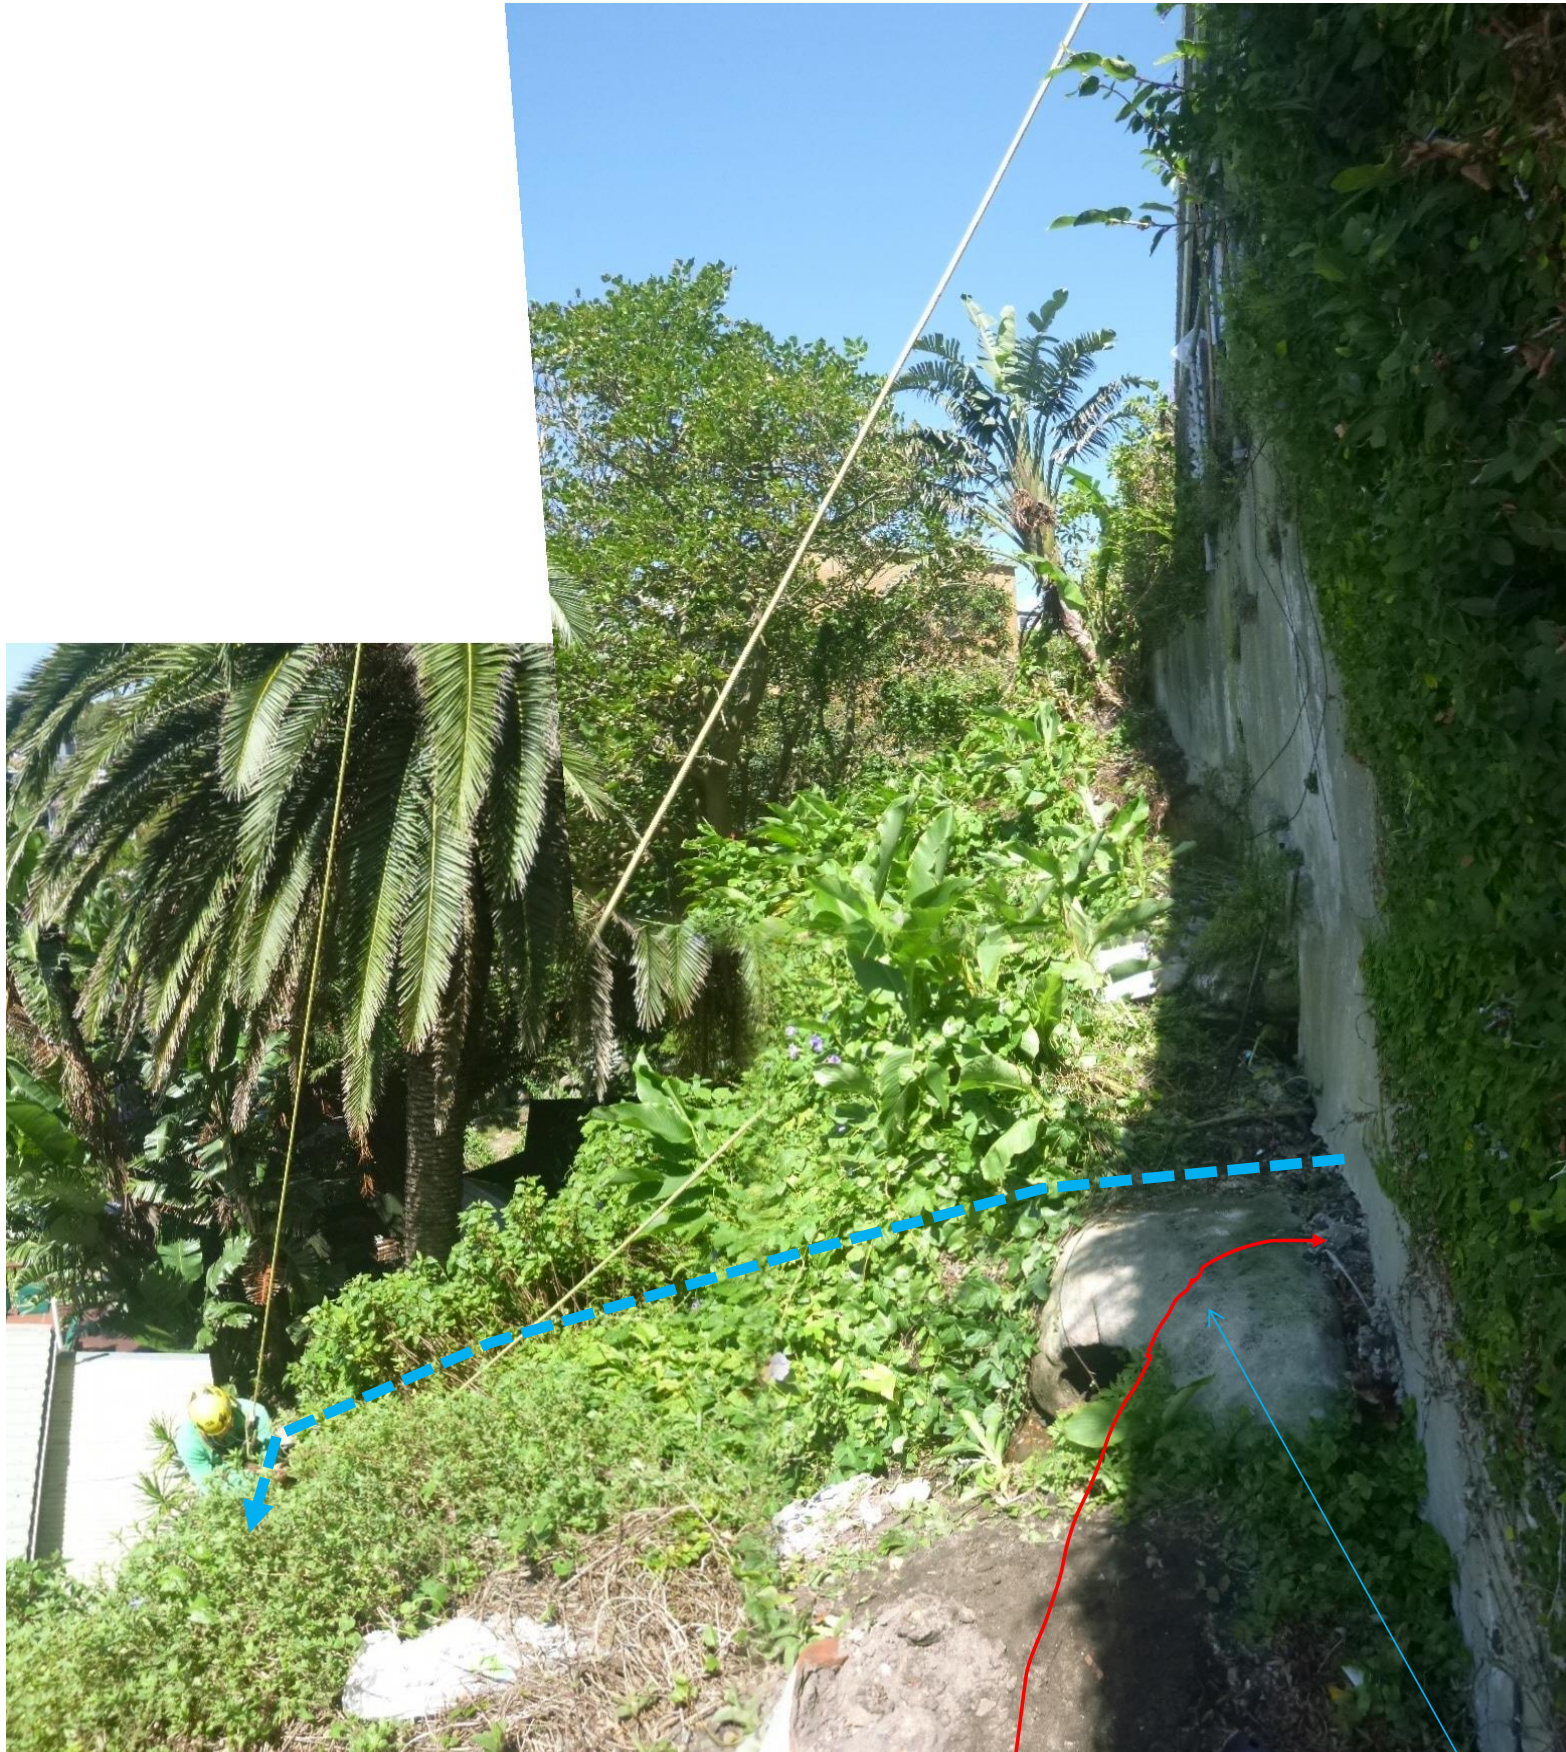
Photo 7. Cross Section 3 viewed towards the south-west. Note adjacent terrace wall has been cut down through detached sandstone block of the outcrop .

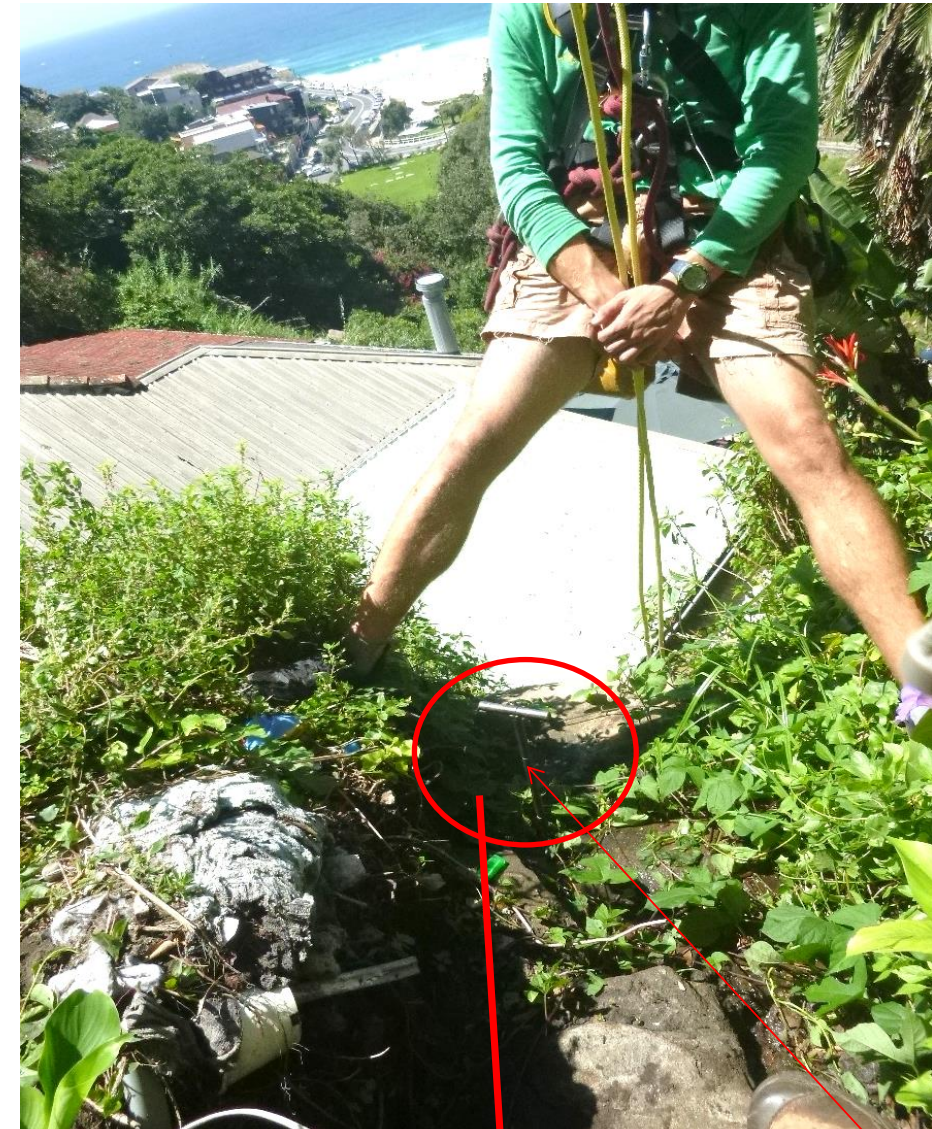
Photo 8. Outer edge of Section 3. Note 1m long steel test probe inserted 700mm into an open, though sand filled, joint, approximately 700mm back from the cliff crest.

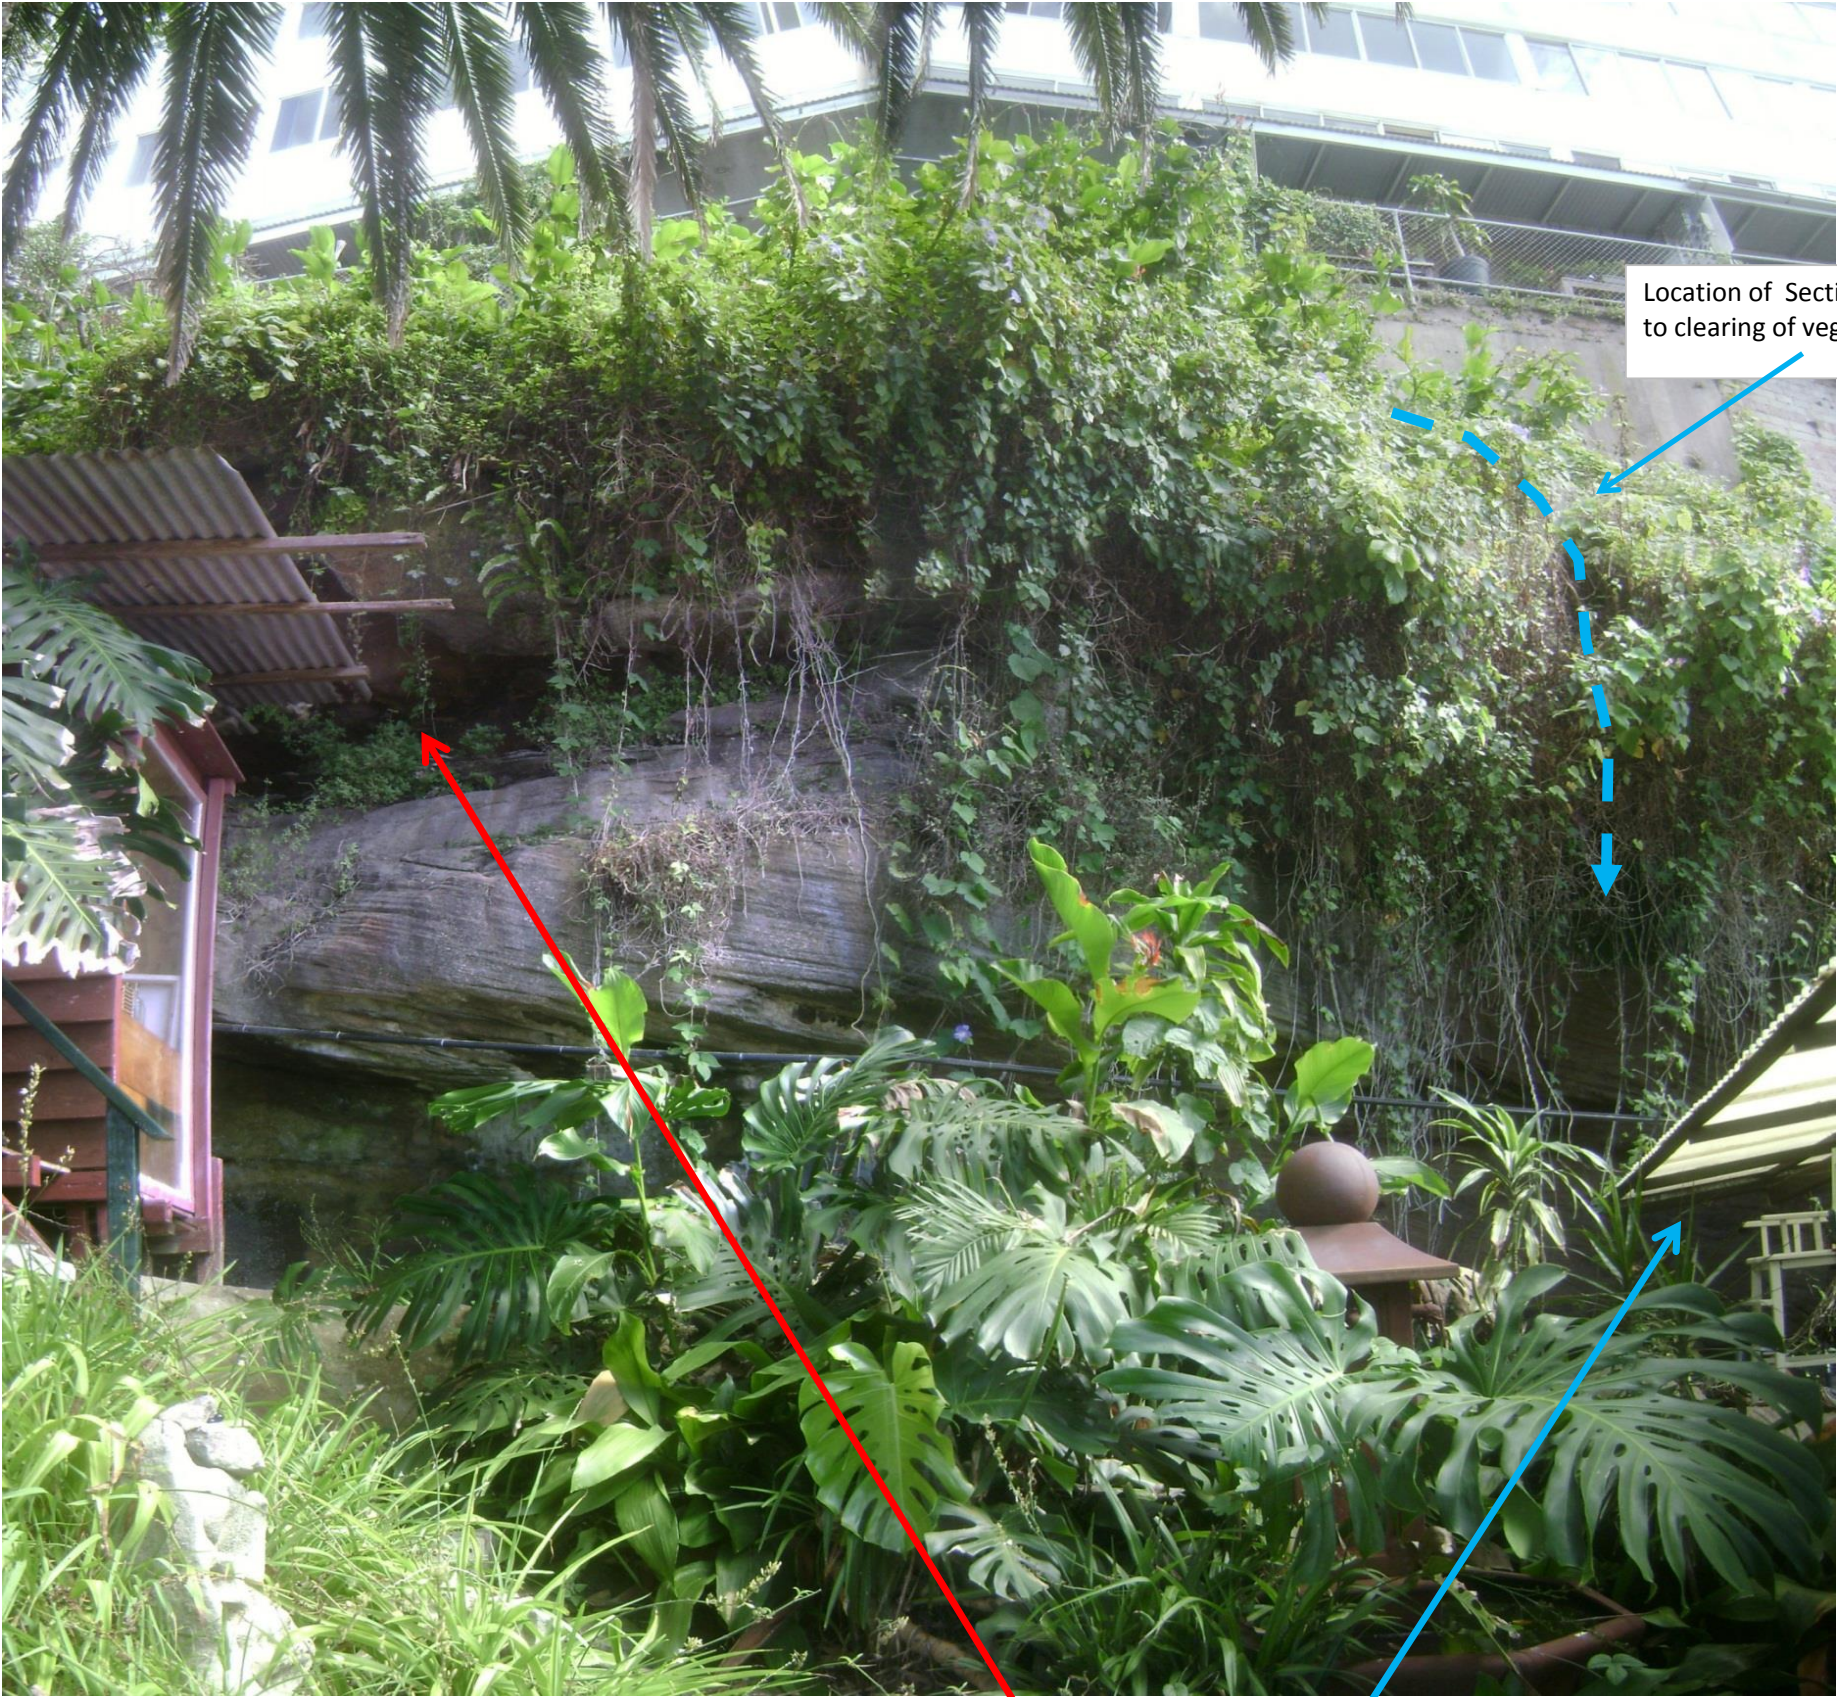
Photo 9. Area to the south-west of Section 3. Note higher level (of less extensive) undercut than the major undercut (refer to Drawing 2 to 4 photos) further to the north at Sections 1 to 3.
