Report on
Geotechnical Investigation

Alterations and Additions
20 Illawong Avenue, Tamarama

Prepared for
Strata Plan 1731

Project 72261.06
November 2018

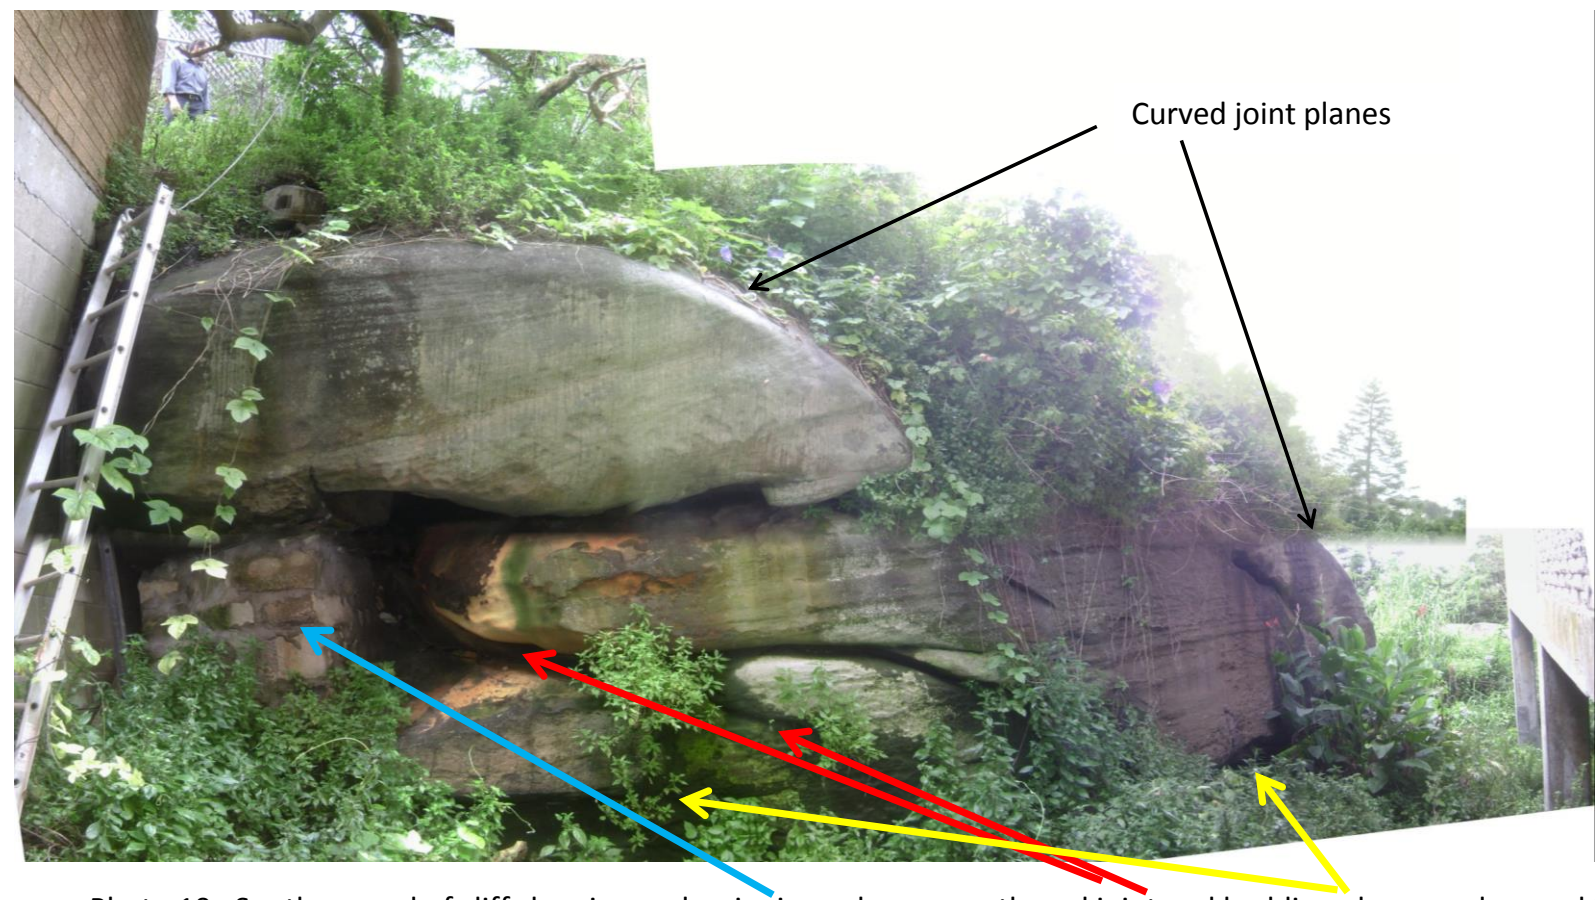
Photo 10. Southern end of cliff showing underpinning column, weathered joint and bedding planes and curved joint planes.

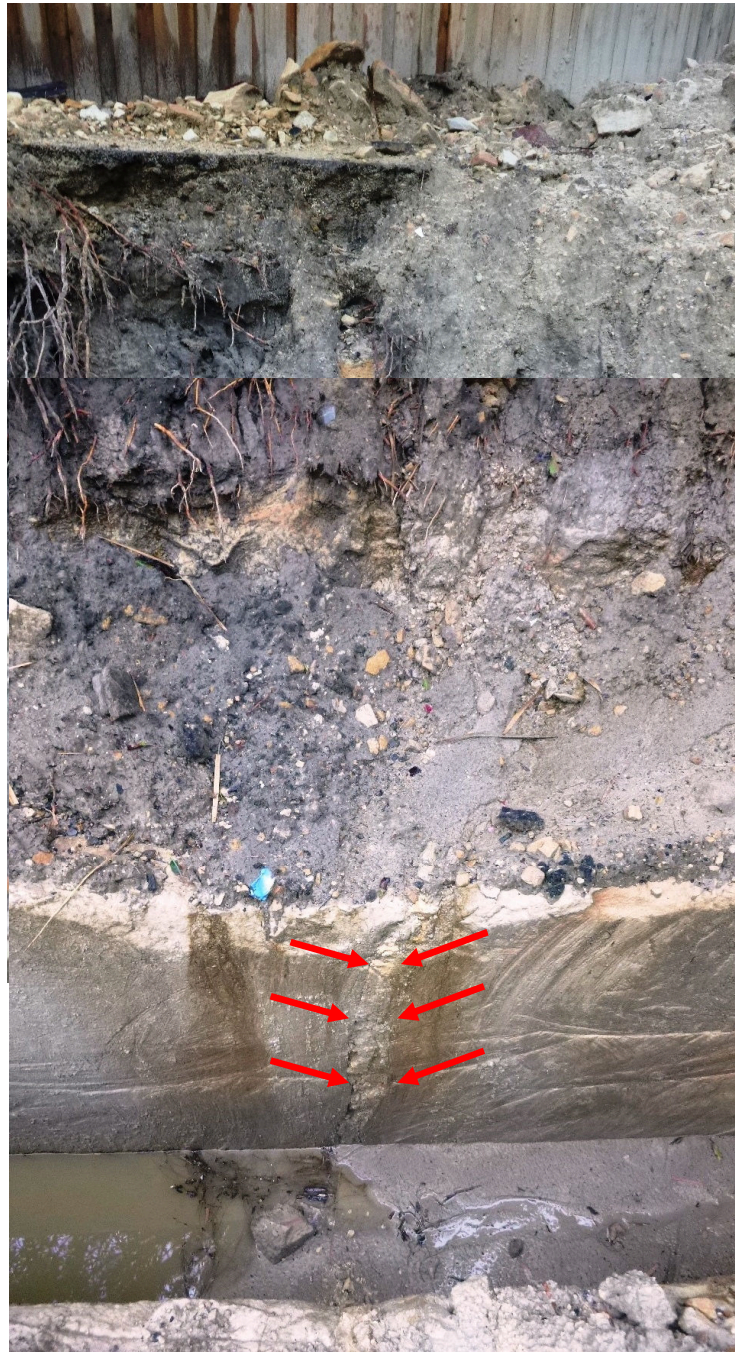
It is noted that the PWD report identified a “clay-infilled ... sub-vertical joint” within the sewer diversion trench, in the vicinity of boreholes BH3, BH5 and BH103. Site observations by DP of this feature interpreted it to be a thin (100-150 mm thick), sub-vertical vein of igneous material which had weathered to clay (refer to Plates F3 and F4 within Appendix F). The orientation of this feature was measured to have a dip and dip direction of 85-90°/200°. This feature was not encountered in any of the boreholes, and was not observed within the cliffline on the south-eastern side of the unit block. In the few cases where sub-vertical joints were encountered in boreholes, thick clay coatings were not observed.

Historical Site Photograph of Sewer Diversion Trench, Photo 4 – View to north-west near Borehole BH5 and BH103. Sub-vertical, clay-infilled undulating defect in rock (indicated between arrows as shown), inferred to be an intrusive dyke weathered to clay, or a clay-infilled joint defect.
