20 Illawong Avenue, Tamarama

Pre-commencement of Works

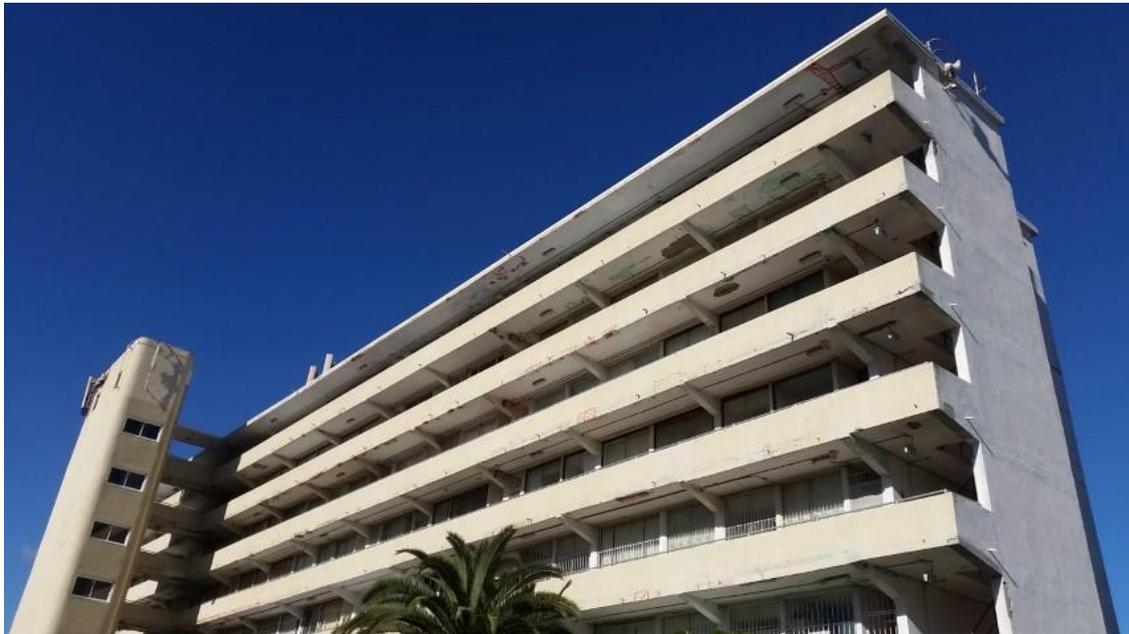
Image 8: Southwest view showing various locations of concrete spalling.

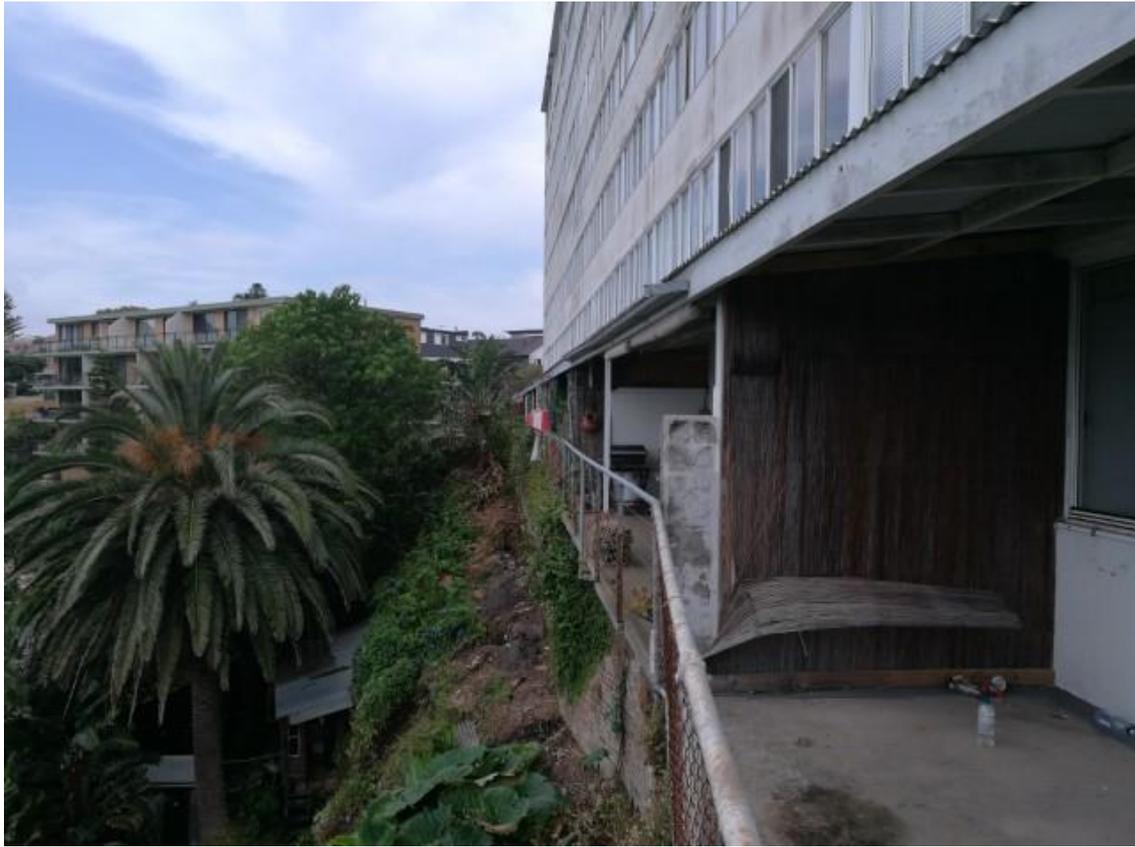
Image 9: Northeast ground floor balcony and façade condition

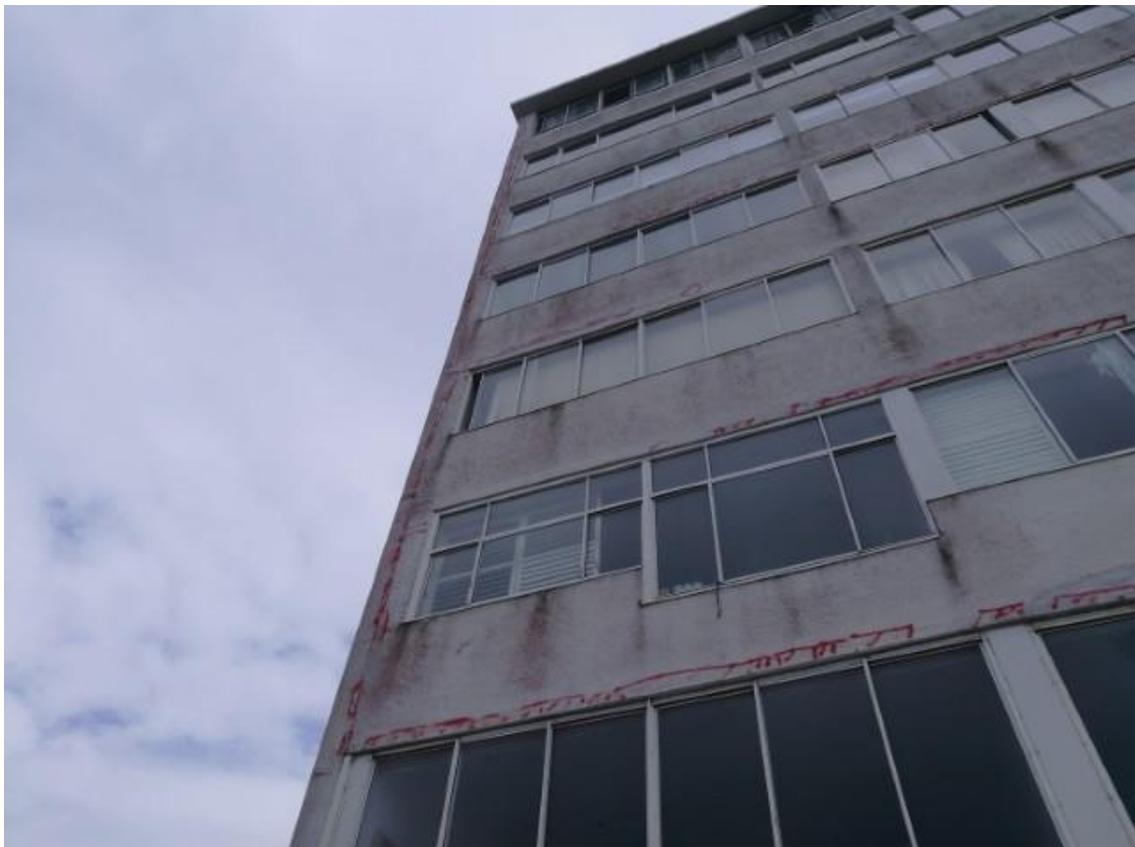
Image 10: Red markings on southeast facade indicate locations of drummy concrete due to the underlying issue of concrete spalling

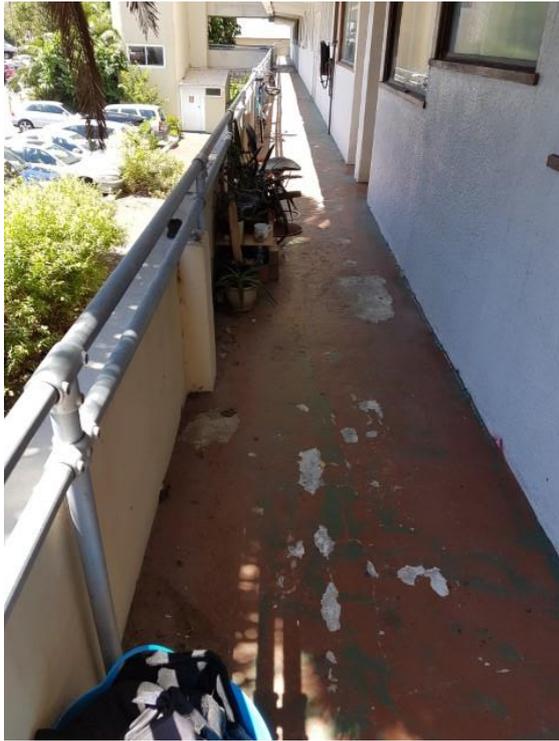
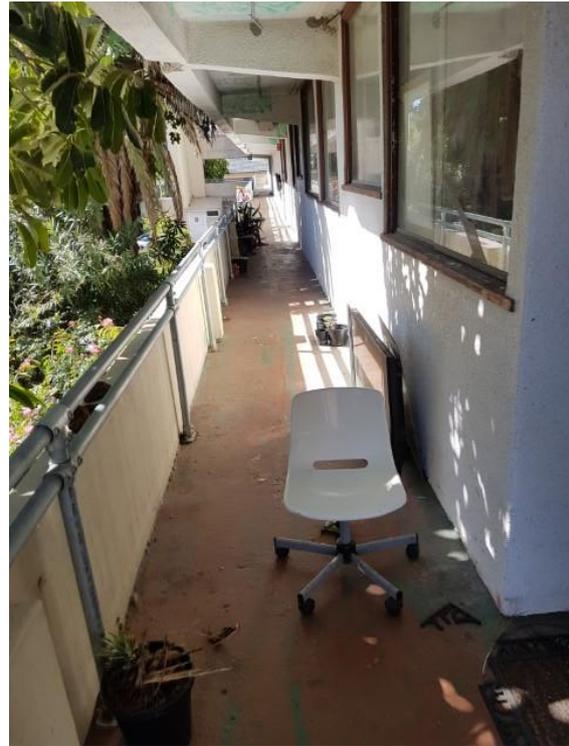
Image 11 & 12: Original condition of the western walkway with visible signs of deterioration and use for storage.

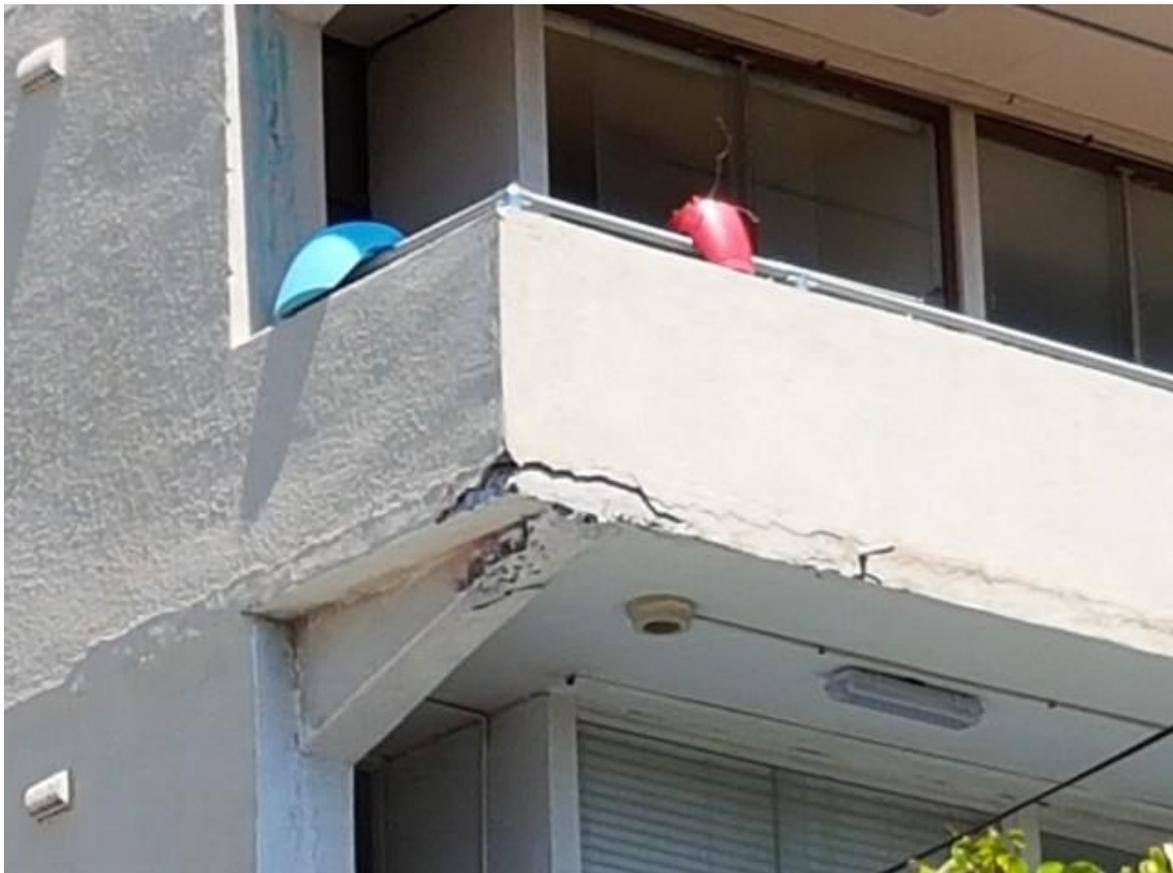
Image 13: Concrete spalling to western walkway

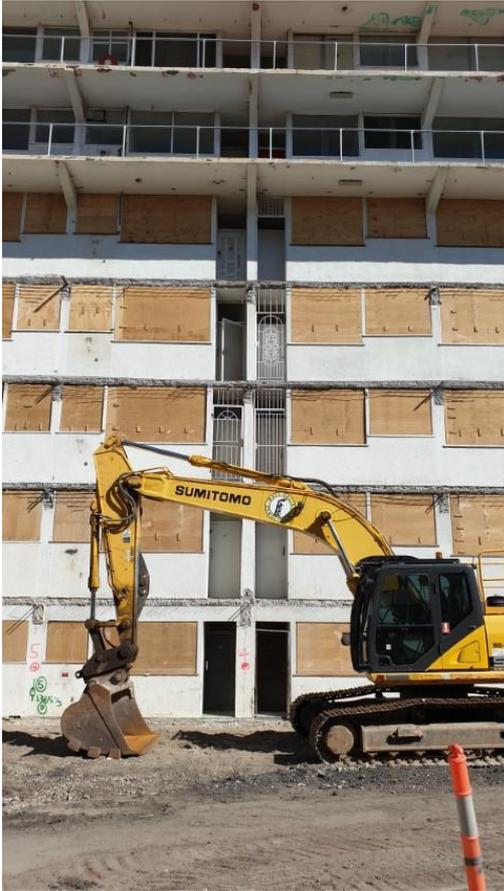
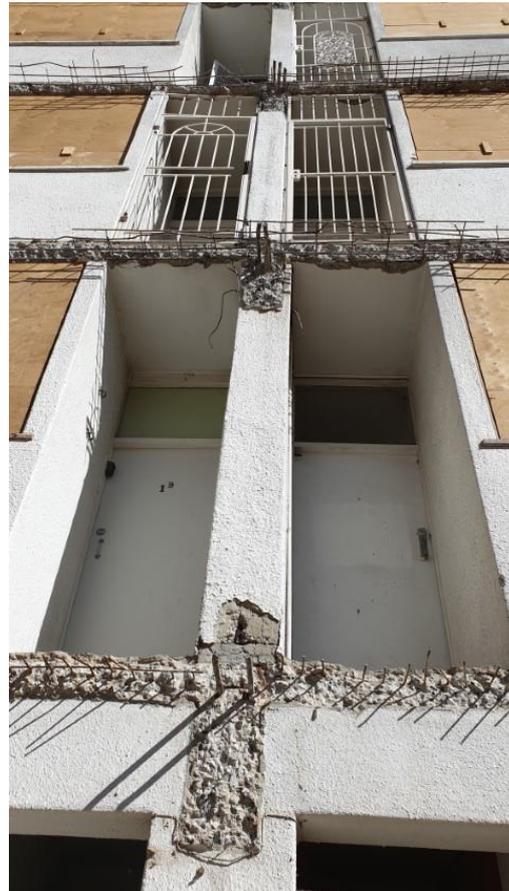
Image 14: Western walkway demolition

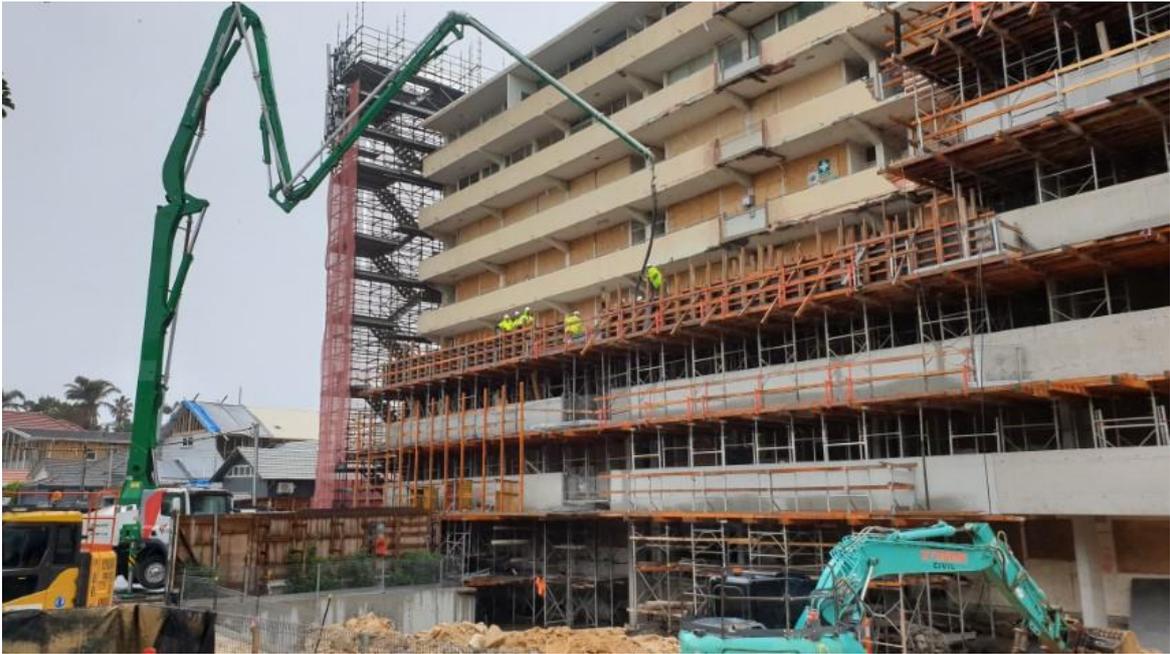
Image 16: removal of existing lift shaft and formation of the western walkway.
