Woollahra Council

Bellevue Gardens Rock Remediation Assessment

Domain 5

September 2019

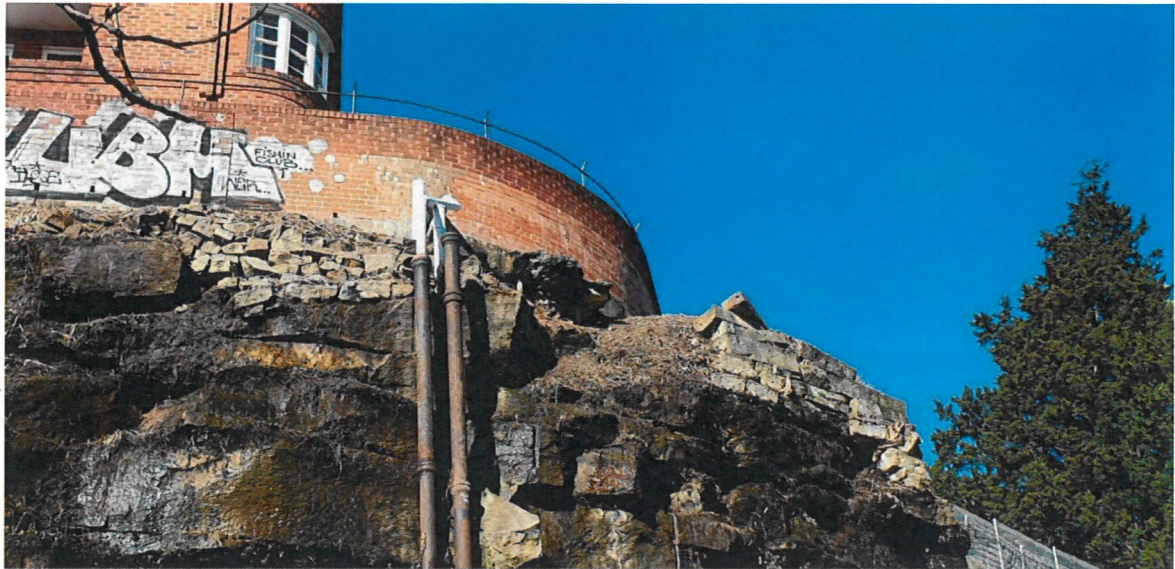
- Various partially detached blocks and wedges of sandstone
- Accumulations of soil, rock debris and building refuse on rock ledges, particularly along the crest of the rock faces
- Various old and ineffectual stacked rock walls located along the crest of the rock face.

Plate 1 Domain 5, Ineffectual stacked rock walls above rock face.

- The scaling removal of selected rock masses and soil accumulations from the face and crest of the rock faces.
- The removal of a knob of deformed/ ineffectual sandstone block wall and the battering back re-profiling of soil/ fill.
- The battering back re-profiling of selected soil/ fill/ debris zones on nominated ledge and crest areas.
- The installation of 6 x 1.5m and 3 x 4m long rock bolts.
- The application of a zone of reinforced shotcrete at the base of the existing sandstone block retaining wall.
- The installation of a panel of rockfall containment mesh over a segment of the existing sandstone block retaining wall. The mesh is to be supported by fully grouted mesh support dowels.

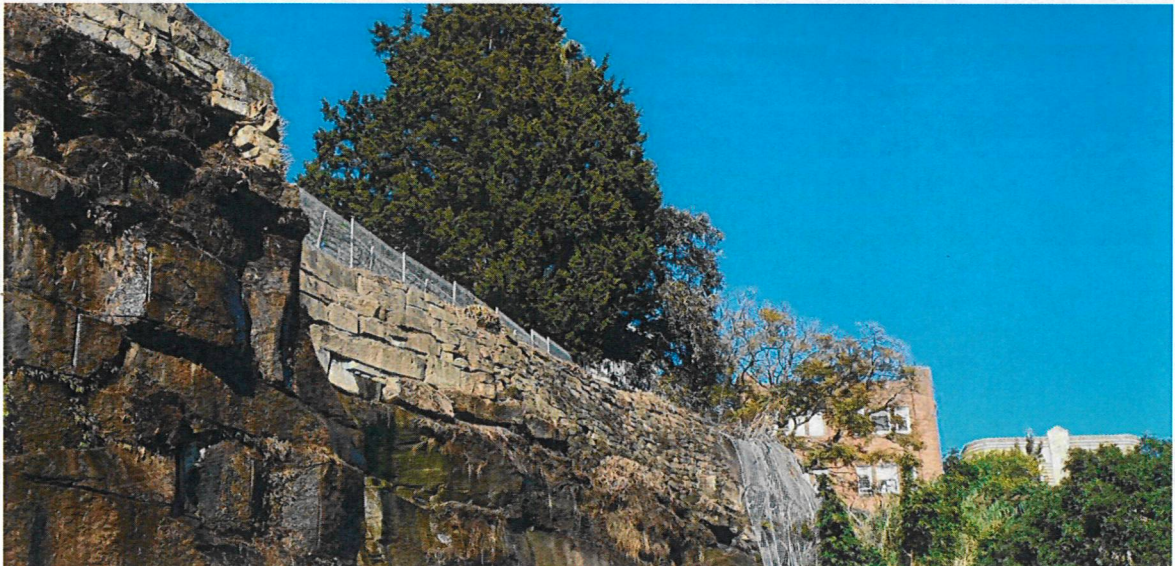
Plate 2 Domain 5, Stacked rock walls supporting car parking areas of unit complex above.

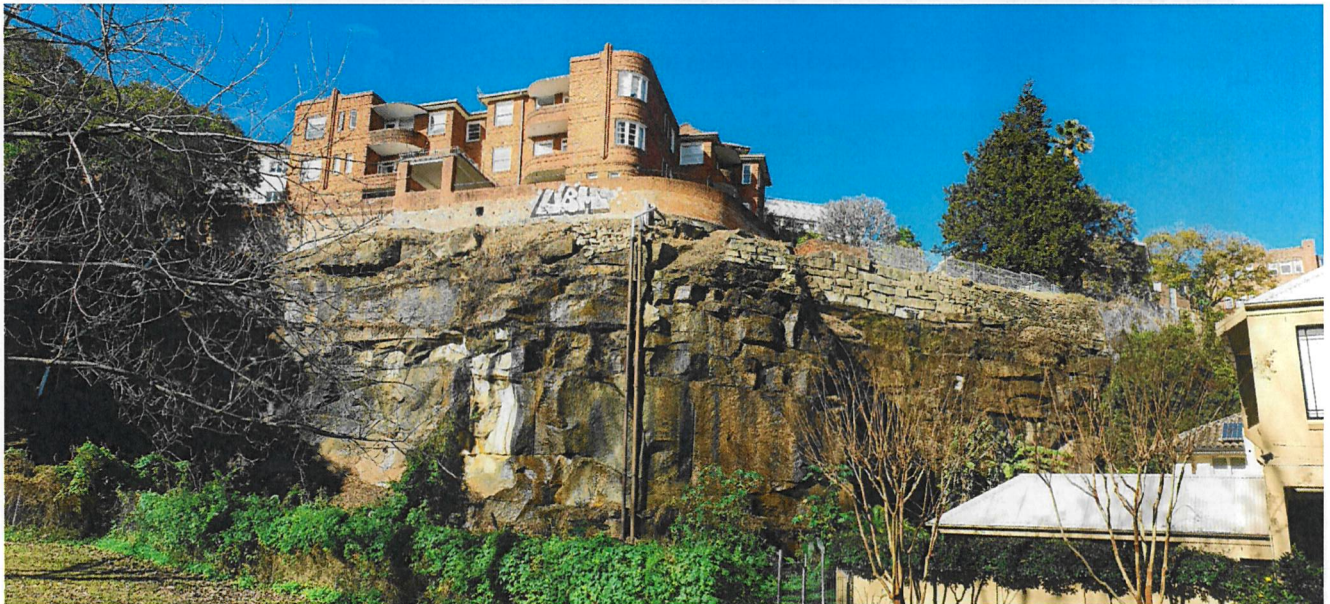
GHD observed Domain 5 on 25 June 2019, following the de-vegetation works carried out by Council. During the site visit, we compared the photomosaics of the rock faces prepared as part of our 2011 report. The geotechnical conditions appears to be broadly similar to the conditions observed in 2011, however it appears that a number of small detached rock blocks have been removed from the rock face as part of the recent de-vegetation works.

Plate 3 Domain 5, Photomosaic showing Domain 5 following recent revegetation works.

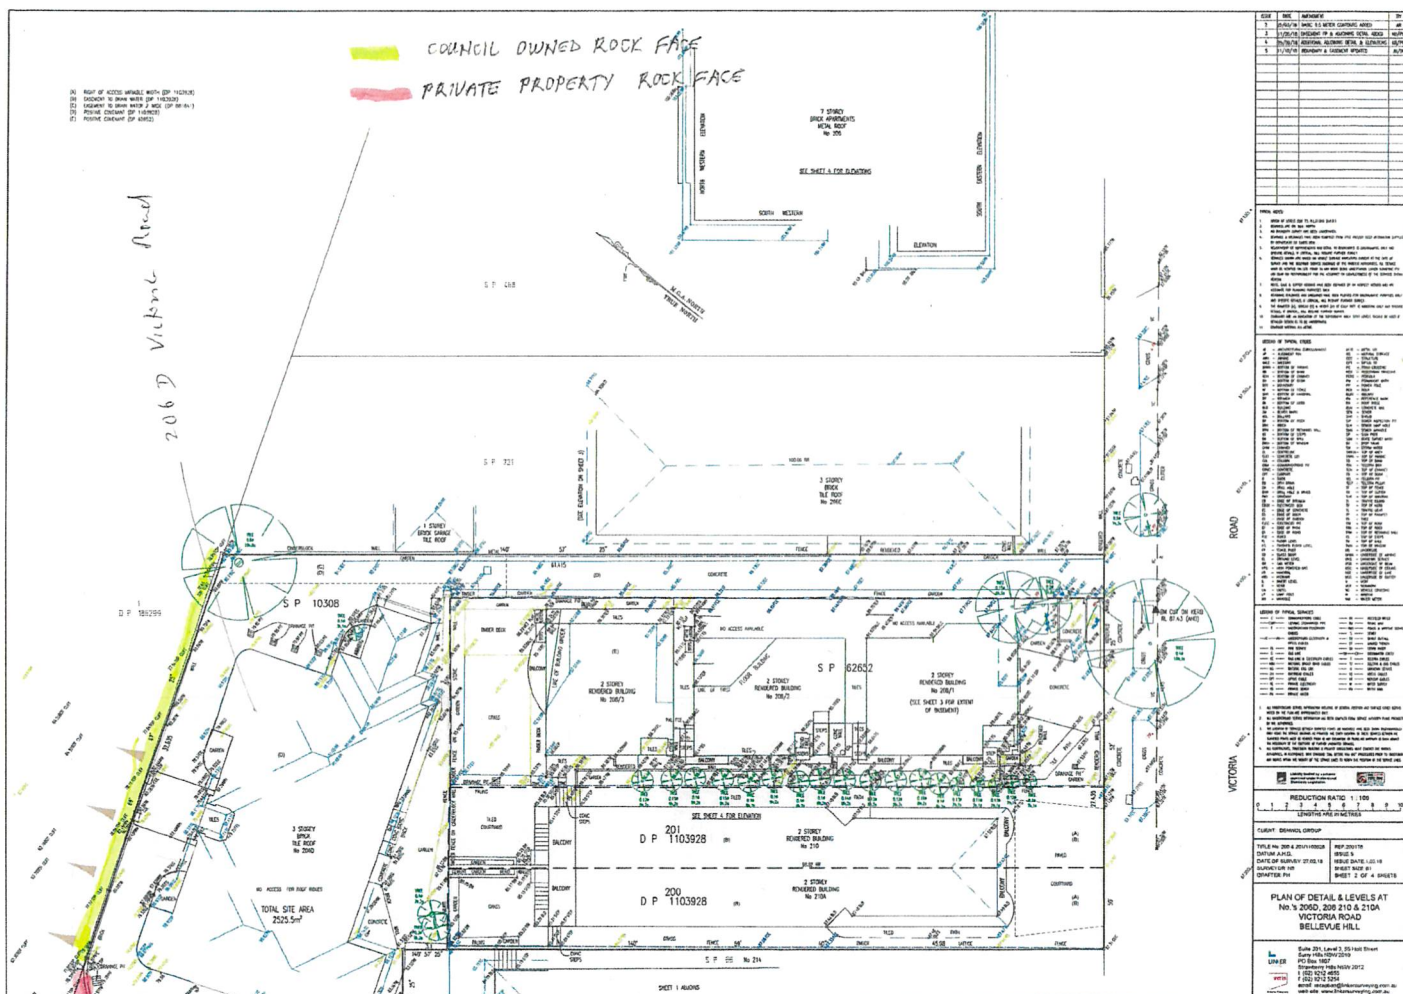
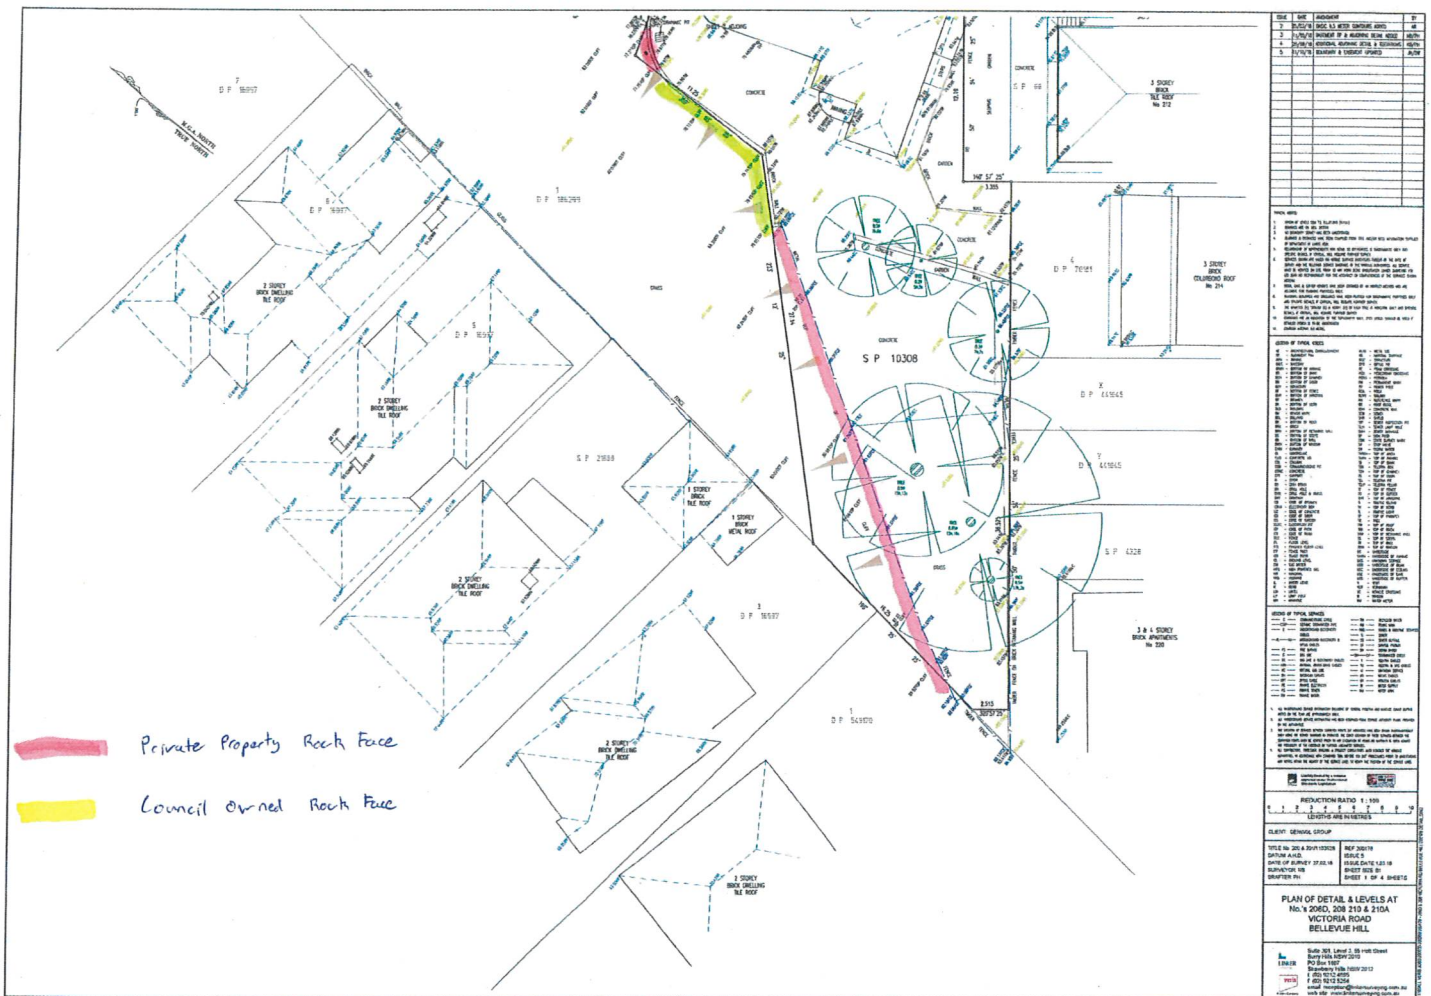
Appendix C – Survey Plans

It would appear that a small section of the sharp return corner of the rock face in the northern part of Domain 5 may be on private land. In addition, the southern section of Domain 5 may also be on private land.
