# Arboricultural Impact Assessment

**Champagnat Catholic College, Maroubra - Block B**  
**Quinn O'Hanlon Architects Pty Ltd c/- SCS Planning and Facilities**  
**35 Donovan Street**  
**Maroubra NSW 2035**

**21 January 2020**

**Arboricultural Impact Assessment for twenty-eight (28) trees located within the vicinity of proposed project type at Champagnat Catholic College and 35 Donovan Street, Maroubra.**

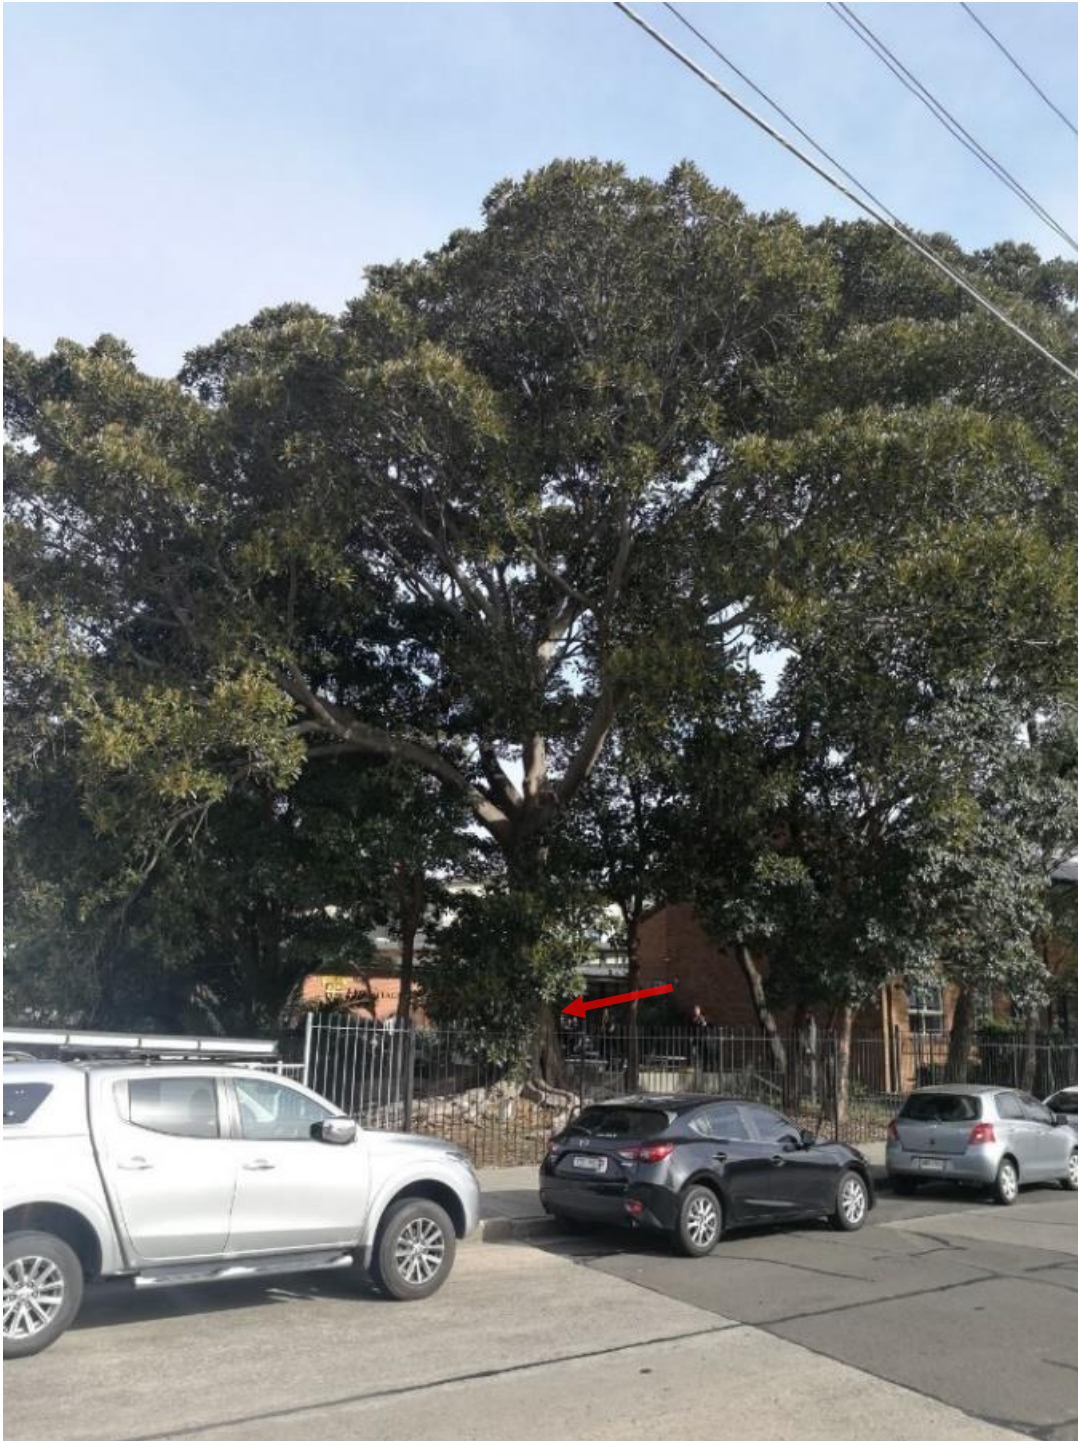
- 6.2.3 Tree 58 was a mature *Ficus macrophylla* (Moreton Bay Fig) located in the north-eastern corner of the site (Figure 6).
- 6.2.4 Tree 58 was of good health and structure, of large physical dimensions, was visible from surrounding properties and had a ULE of greater than fifty years (>50 years).
- 6.2.5 The TPZ for Tree 58 was 12.4m measured at a radial distance from the centre of the trunk.

Figure 6. View to south-west of Tree 58 (Moreton Bay Fig) in its growing environment. (Kane Hollstein, 26 July 2019).

8.2.1 Nine (9) trees, numbered 51, 52, 53, 55, 56, 57, 58, 61 and 72 were recommended for retention and require specific protection measures during construction to ensure it remains viable following the completion of works. The TPZ of these trees should be protected using rumble boards and/or track mats and trunk and branch protection as per Section 8.7.

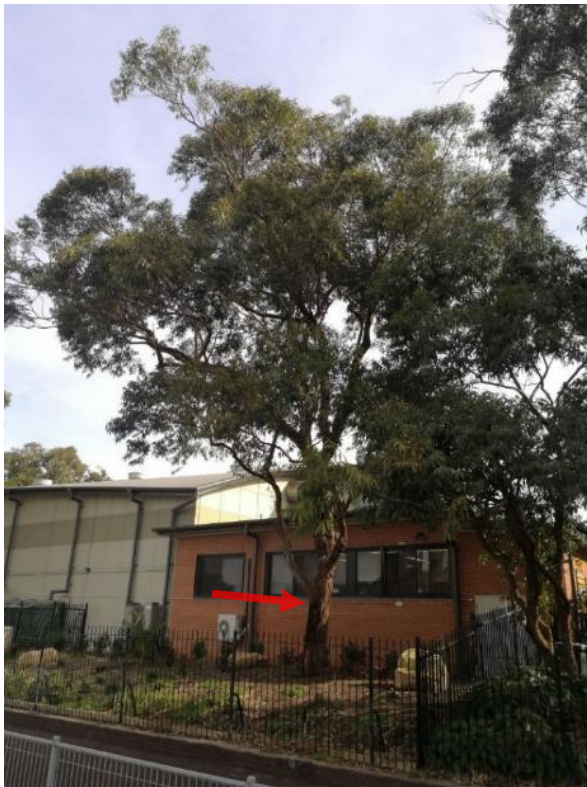
- 6.3.3 Tree 49 was a *Eucalyptus botryoides* (Southern Mahogany) and is shown in Figure 8. The tree was located along the eastern property boundary adjacent to the stormwater canal.
- 6.3.4 Tree 49 as of good health and fair structure and had a ULE of 15–25 years.
- 6.3.5 The TPZ for Tree 49 was 6.4m measured at a radial distance from the centre of the trunk.
- 6.3.6 Tree 71 was also a *Eucalyptus botryoides* (Southern Mahogany) and is shown in Figure 9. The tree was located along the northern property boundary.
- 6.3.7 Tree 71 was of good health and fair structure and had a ULE of 15–25 years.
- 6.3.8 The TPZ for Tree 71 was 6.1m measured at a radial distance from the centre of the trunk.

Figure 8. View to west of Tree 49 (Southern Mahogany) in its growing environment. (Kane Hollstein, 26 July 2019).

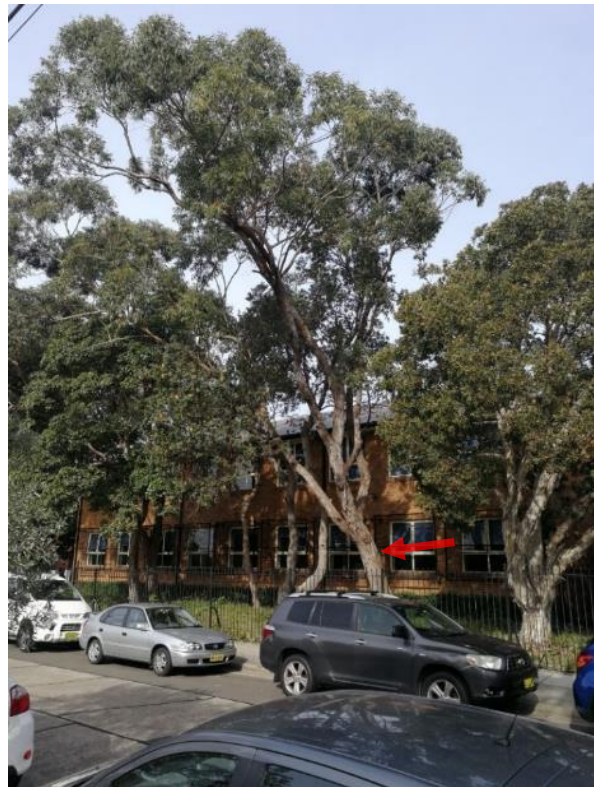
Figure 9. View to south of Tree 71 (Southern Mahogany) in its growing environment. (Kane Hollstein, 26 July 2019).

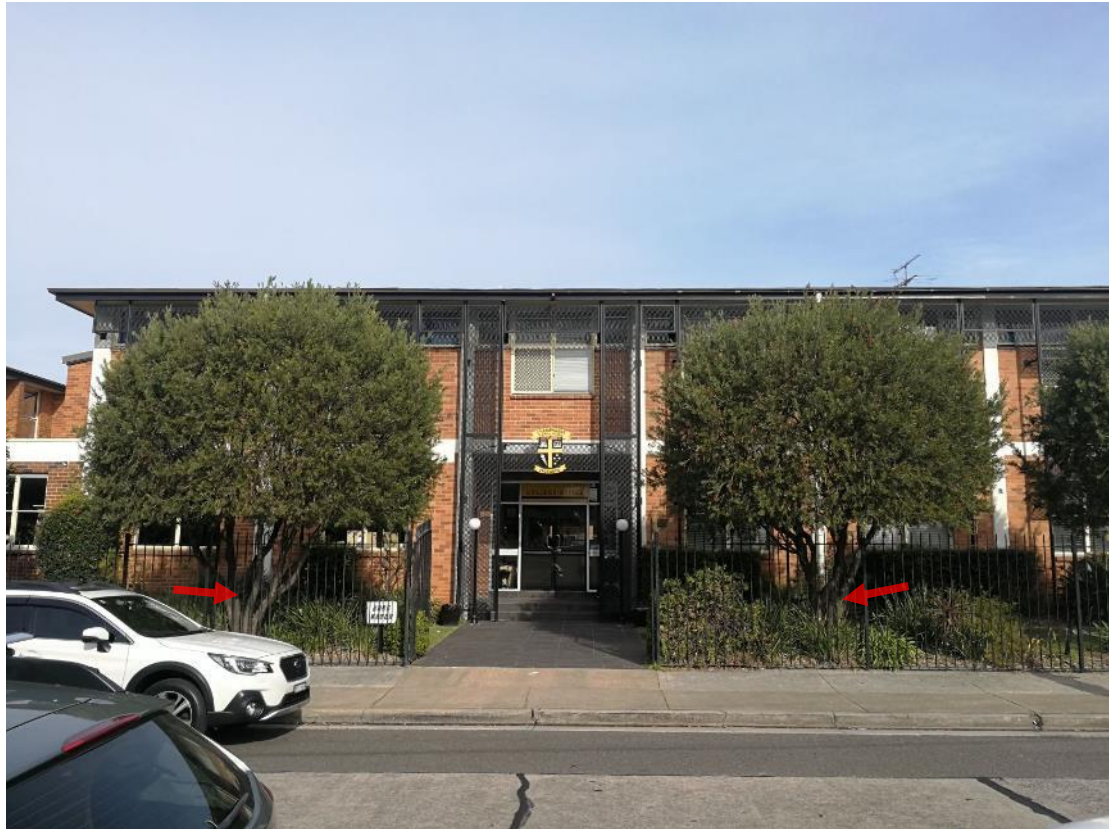
- 6.4.3 Trees 1 and 2 were *Callistemon viminalis* (Weeping Bottlebrush) located in front of the entrance to the administration building of the college (Figure 11). The trees had been pruned to retain their shape as a hedge and are therefore of small size and not true to form.
- 6.4.4 The TPZ for Tree 1 was 2.8m measured at a radial distance from the centre trunk.
- 6.4.5 The TPZ for Tree 2 was 3.1m measured at a radial distance from the centre trunk.

Figure 11. View to south of Tree 1 (left) and 2 (right) in their growing environment. (Kane Hollstein, 26 July 2019).

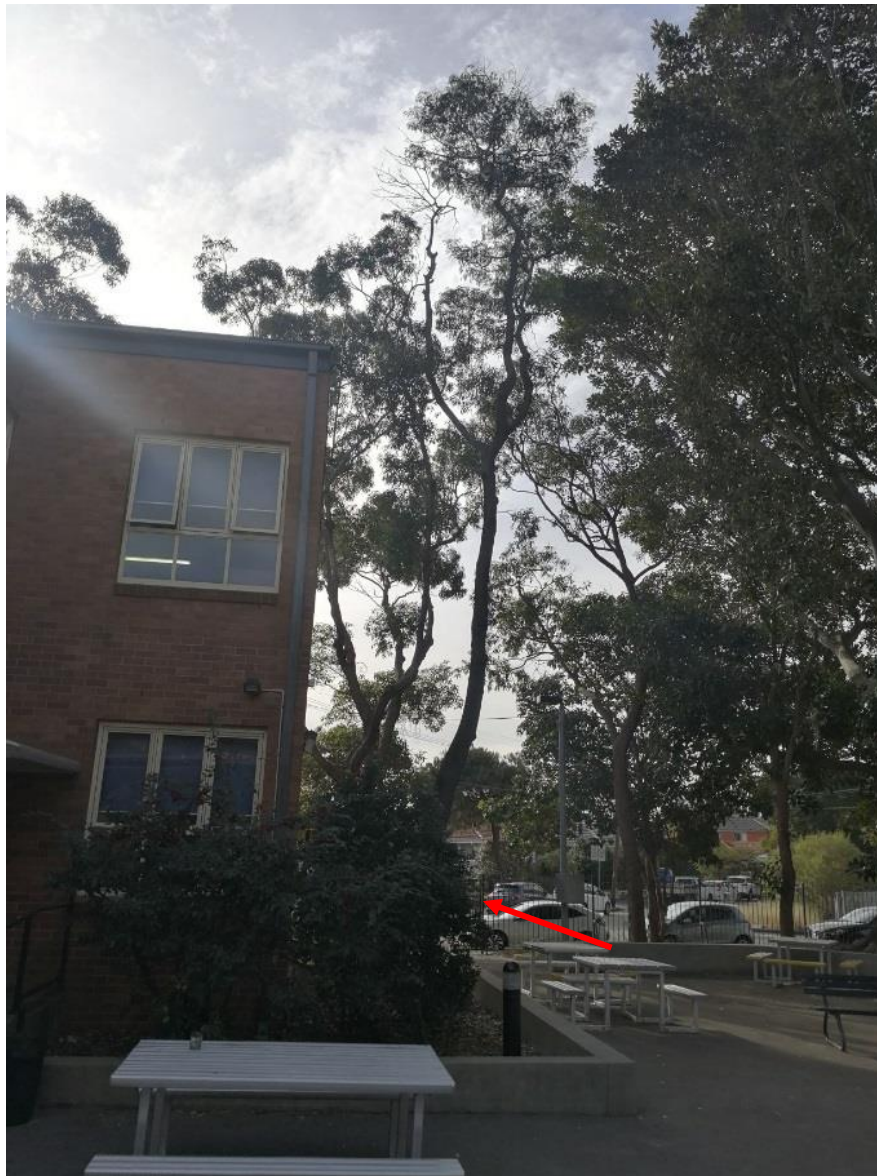
- 6.5.3 Tree 59 was a semi-mature *Eucalyptus botryoides* (Southern Mahogany) which had been poorly and excessively pruned resulting in misshapen and uncharacterised form for the species. The majority of live foliage consisted of epicormic growth.
- 6.5.4 Tree 64 was a mature *Acacia elata* (Cedar Wattle) in advanced decline with an estimated 20% live foliage remaining. The tree was located within a courtyard to the east of the site (Figure 13).

Figure 13. View to north of Tree 64 (Cedar Wattle) in its growing environment. (Kane Hollstein, 26 July 2019).

8.1.2 Two (2) trees were recommended for removal irrespective of future development on the site. These are trees 59 and 64.
