**BROOKVALE PUBLIC SCHOOL
2-8 OLD PITTWATER ROAD, BROOKVALE**

ALTERATIONS & ADDITIONS INCLUDING CONSTRUCTION OF A NEW SCHOOL HALL

**DA 2019/0411 – NORTHERN BEACHES COUNCIL
SYDNEY NORTH PLANNING PANEL REF. PPSSNH-24
PANEL MEETING 25 SEPTEMBER 2019**

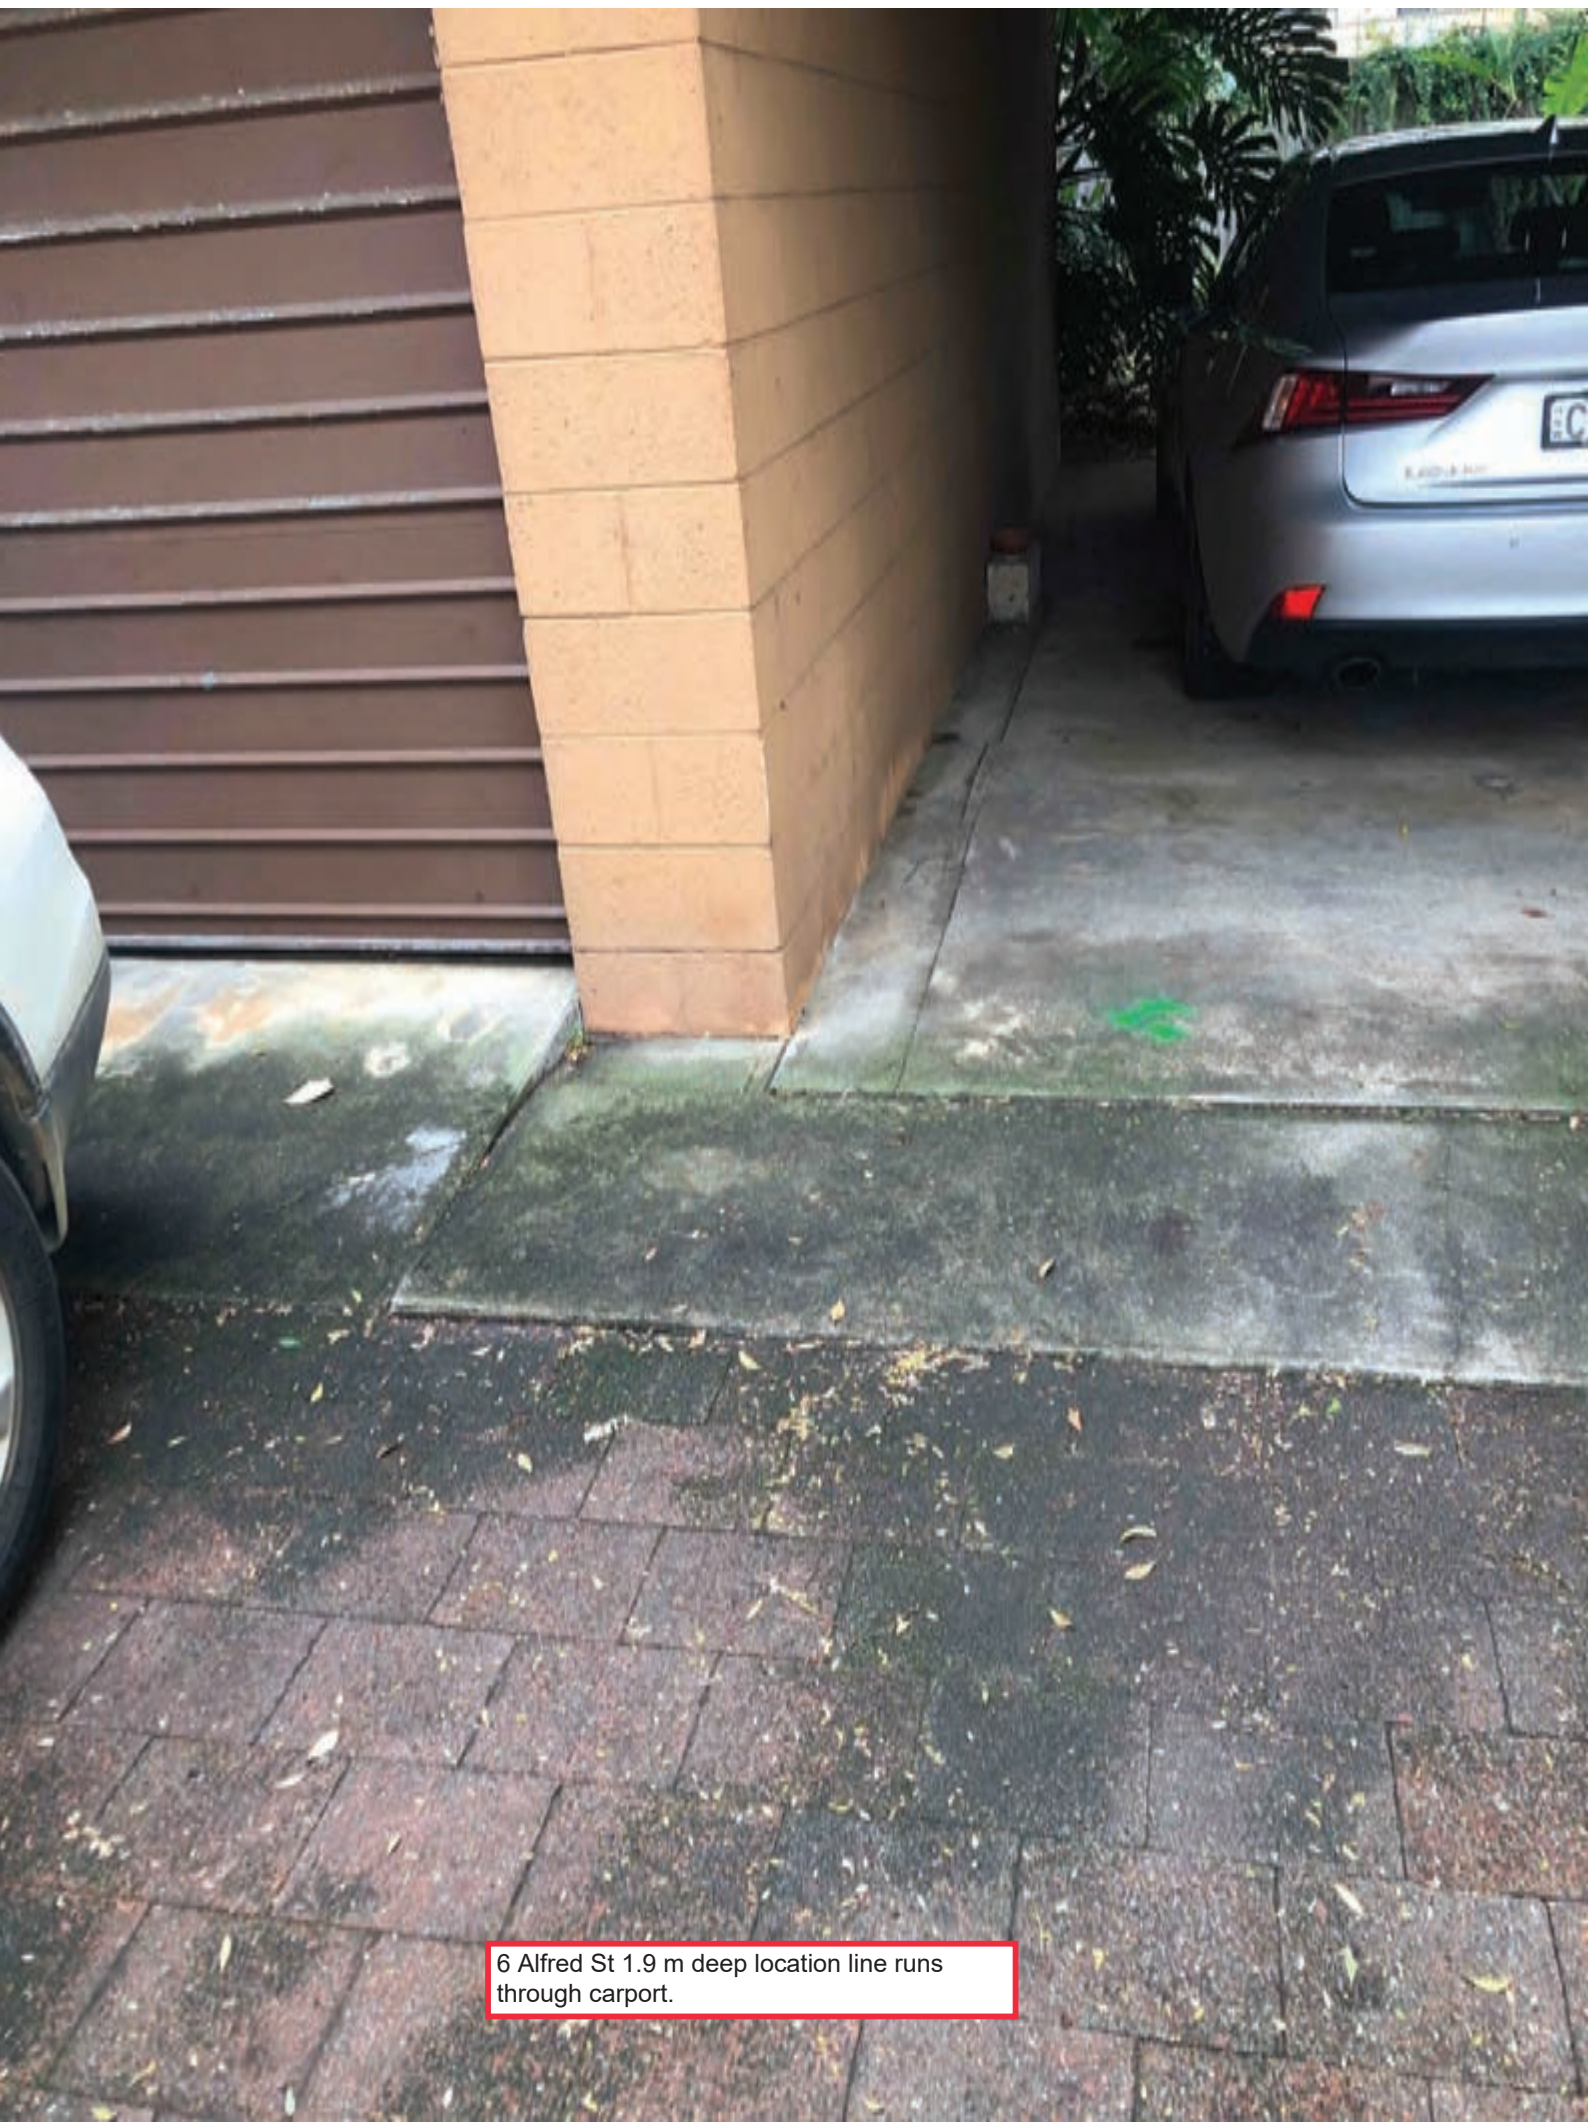
6 Alfred St 1.9 m deep location line runs through carport.

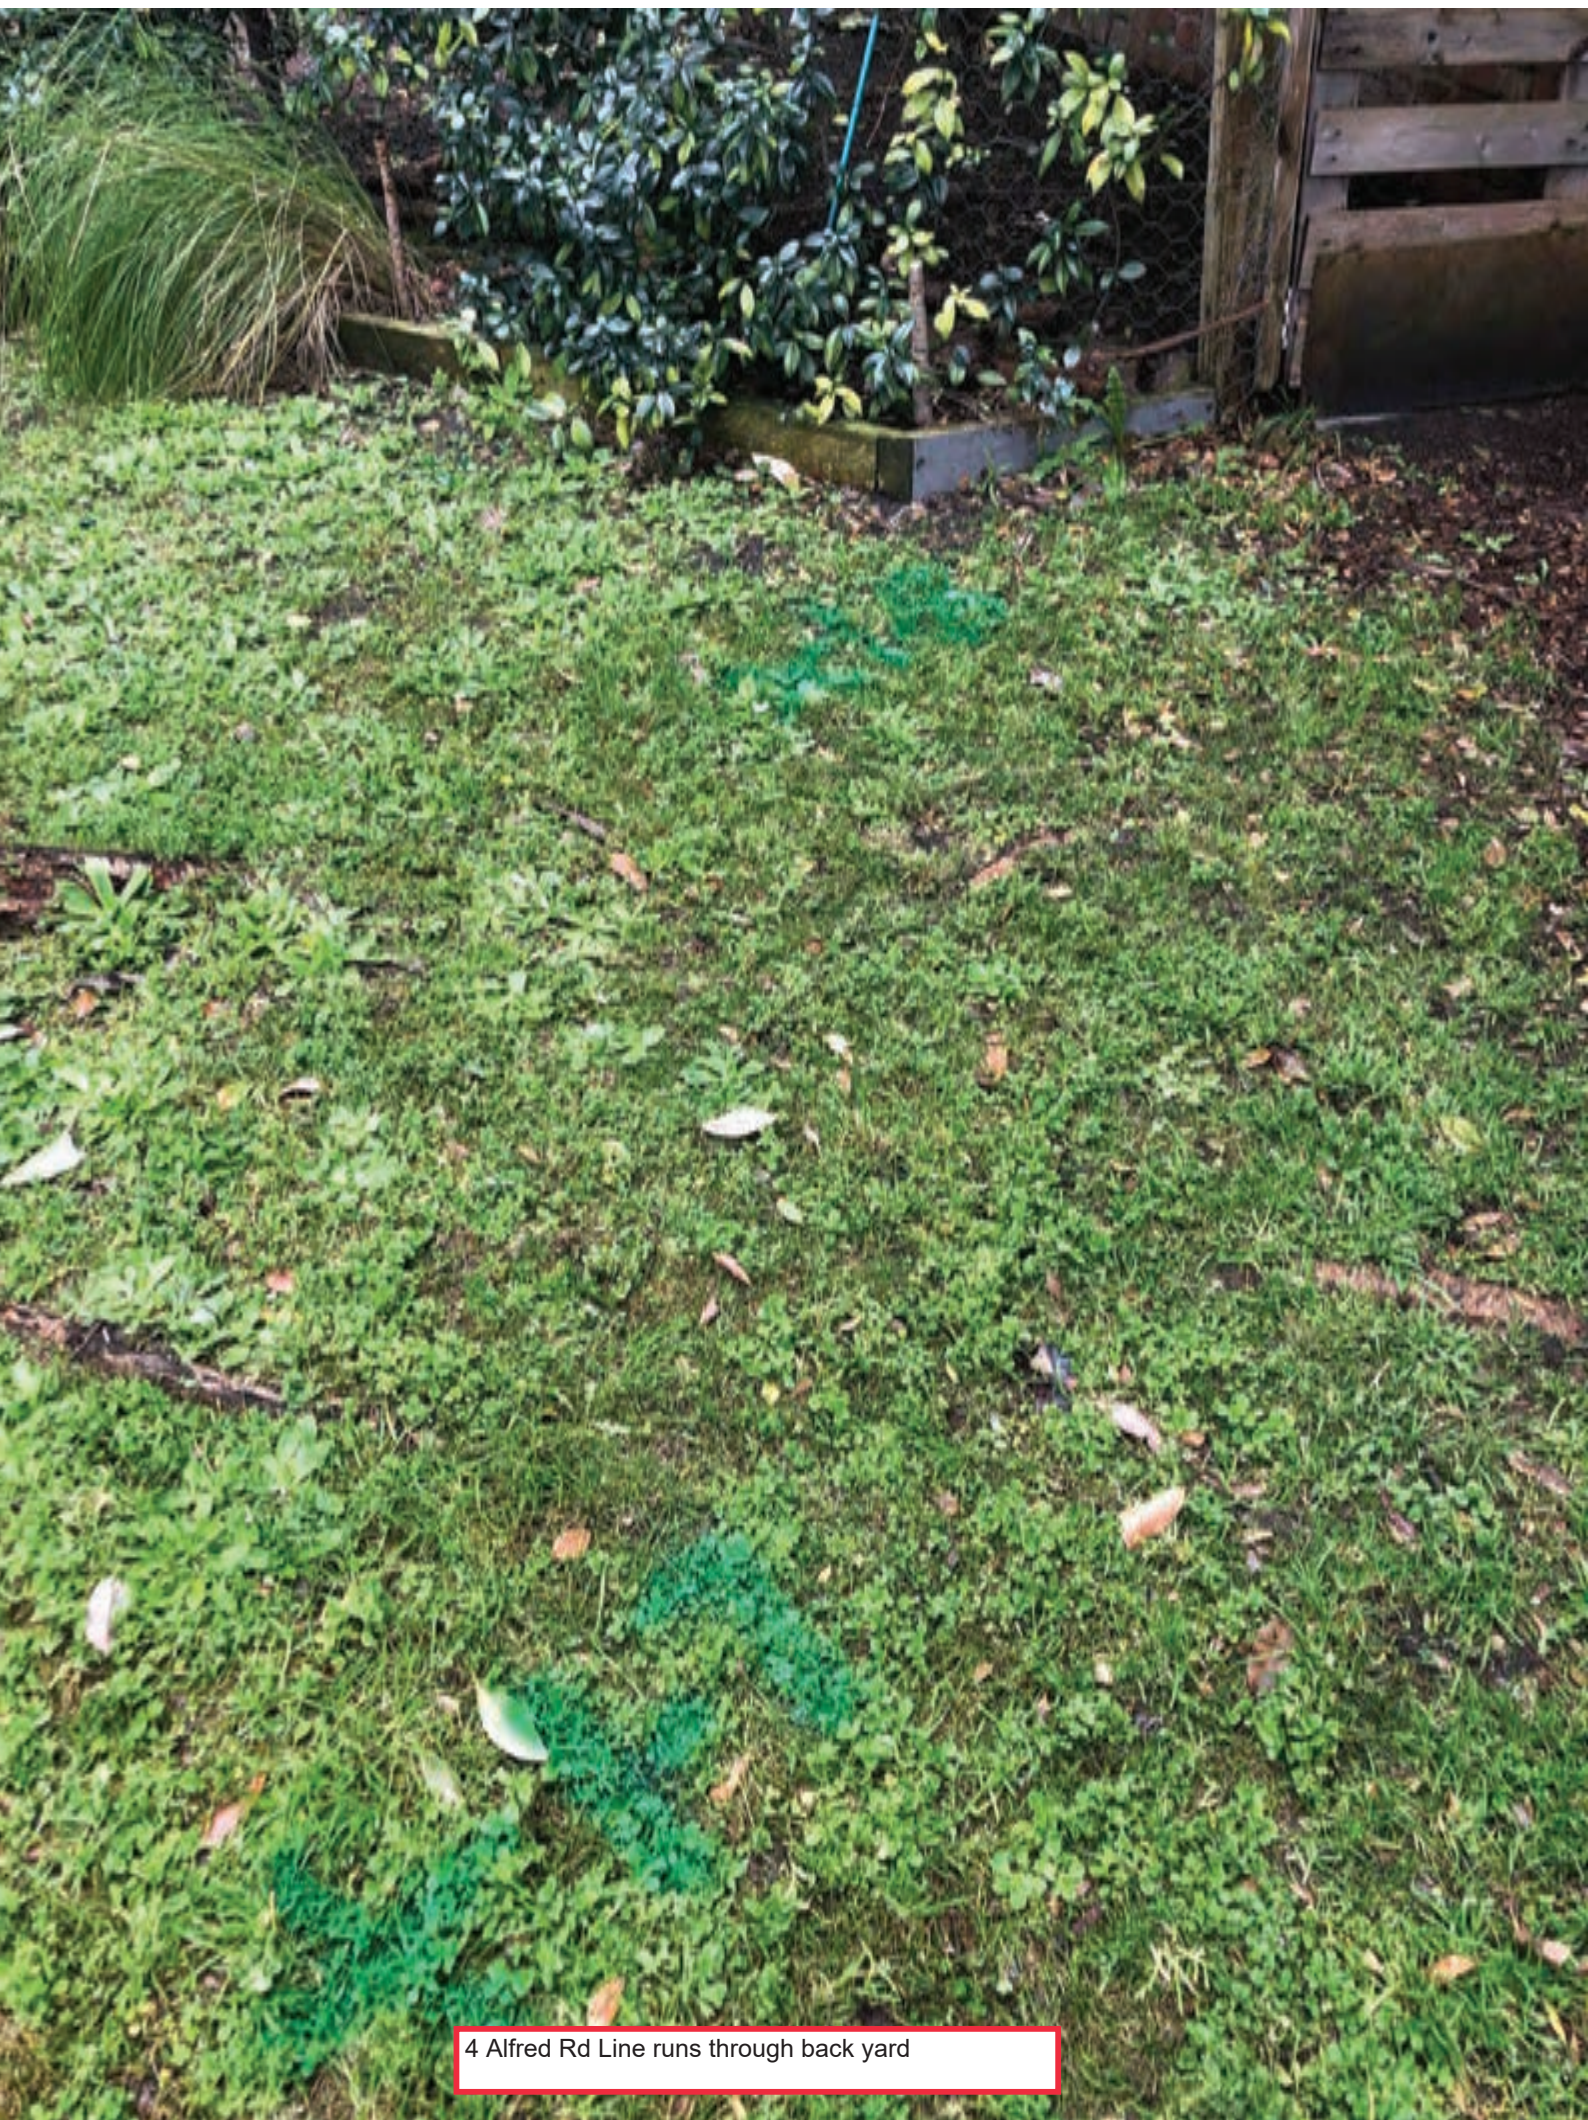
4 Alfred Rd Line runs through back yard

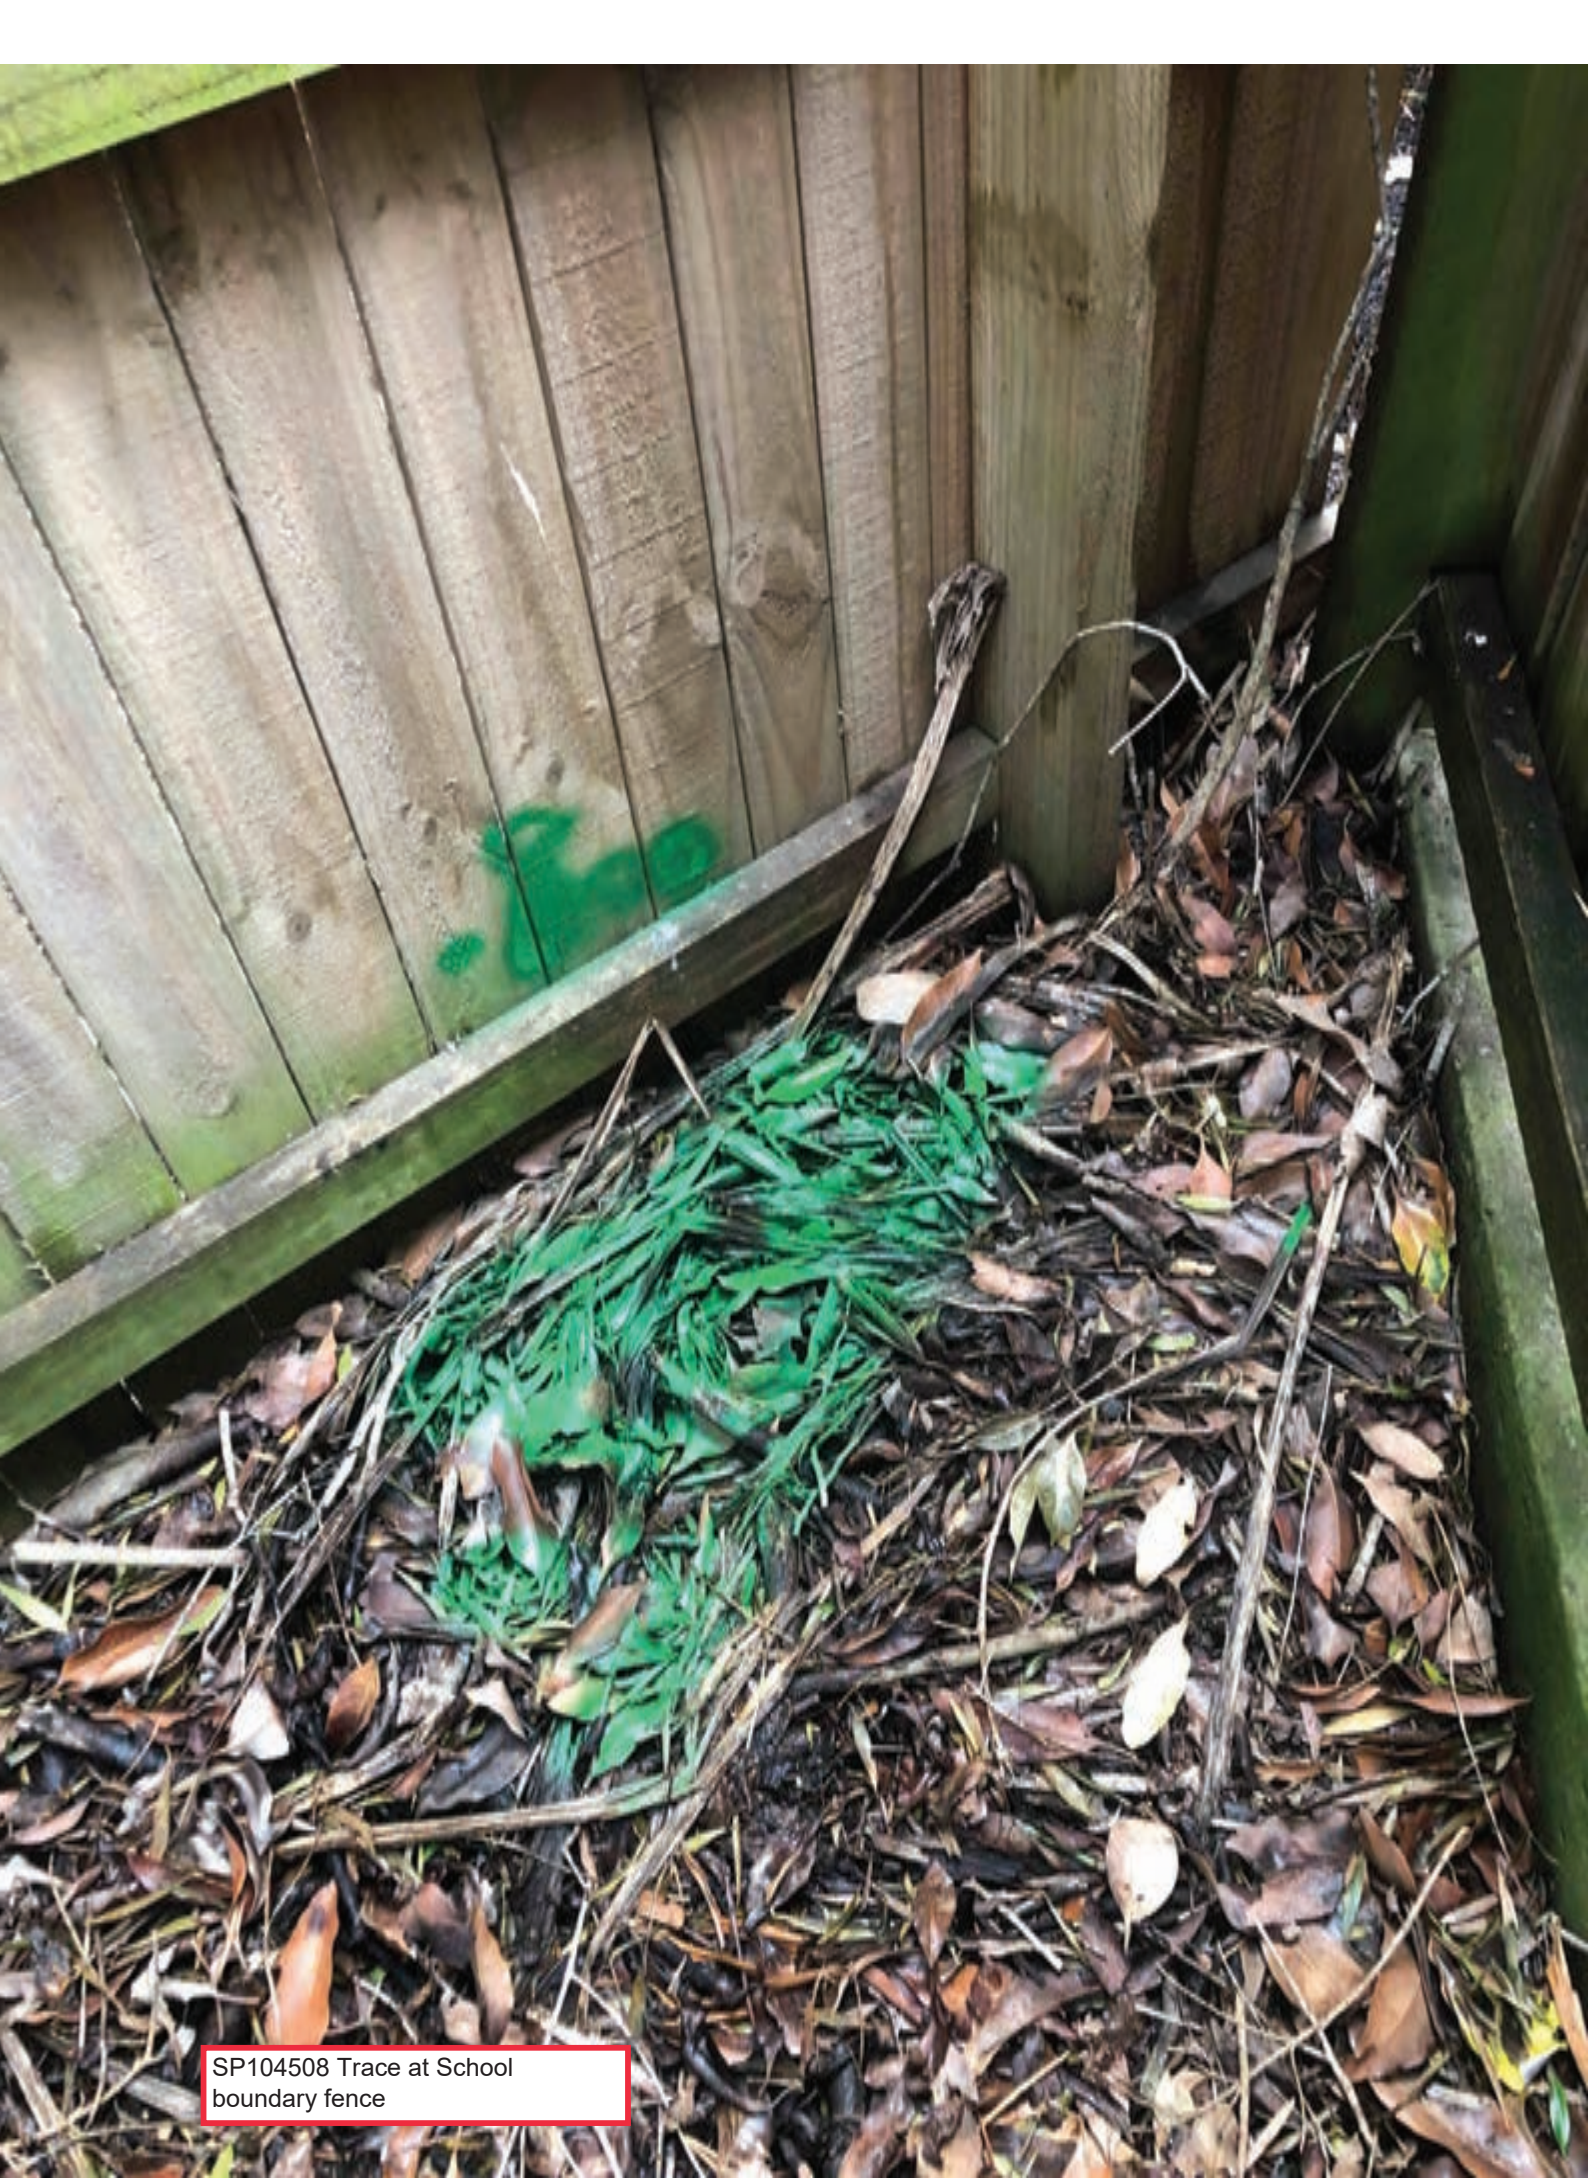
SP104508 Trace at School
boundary fence

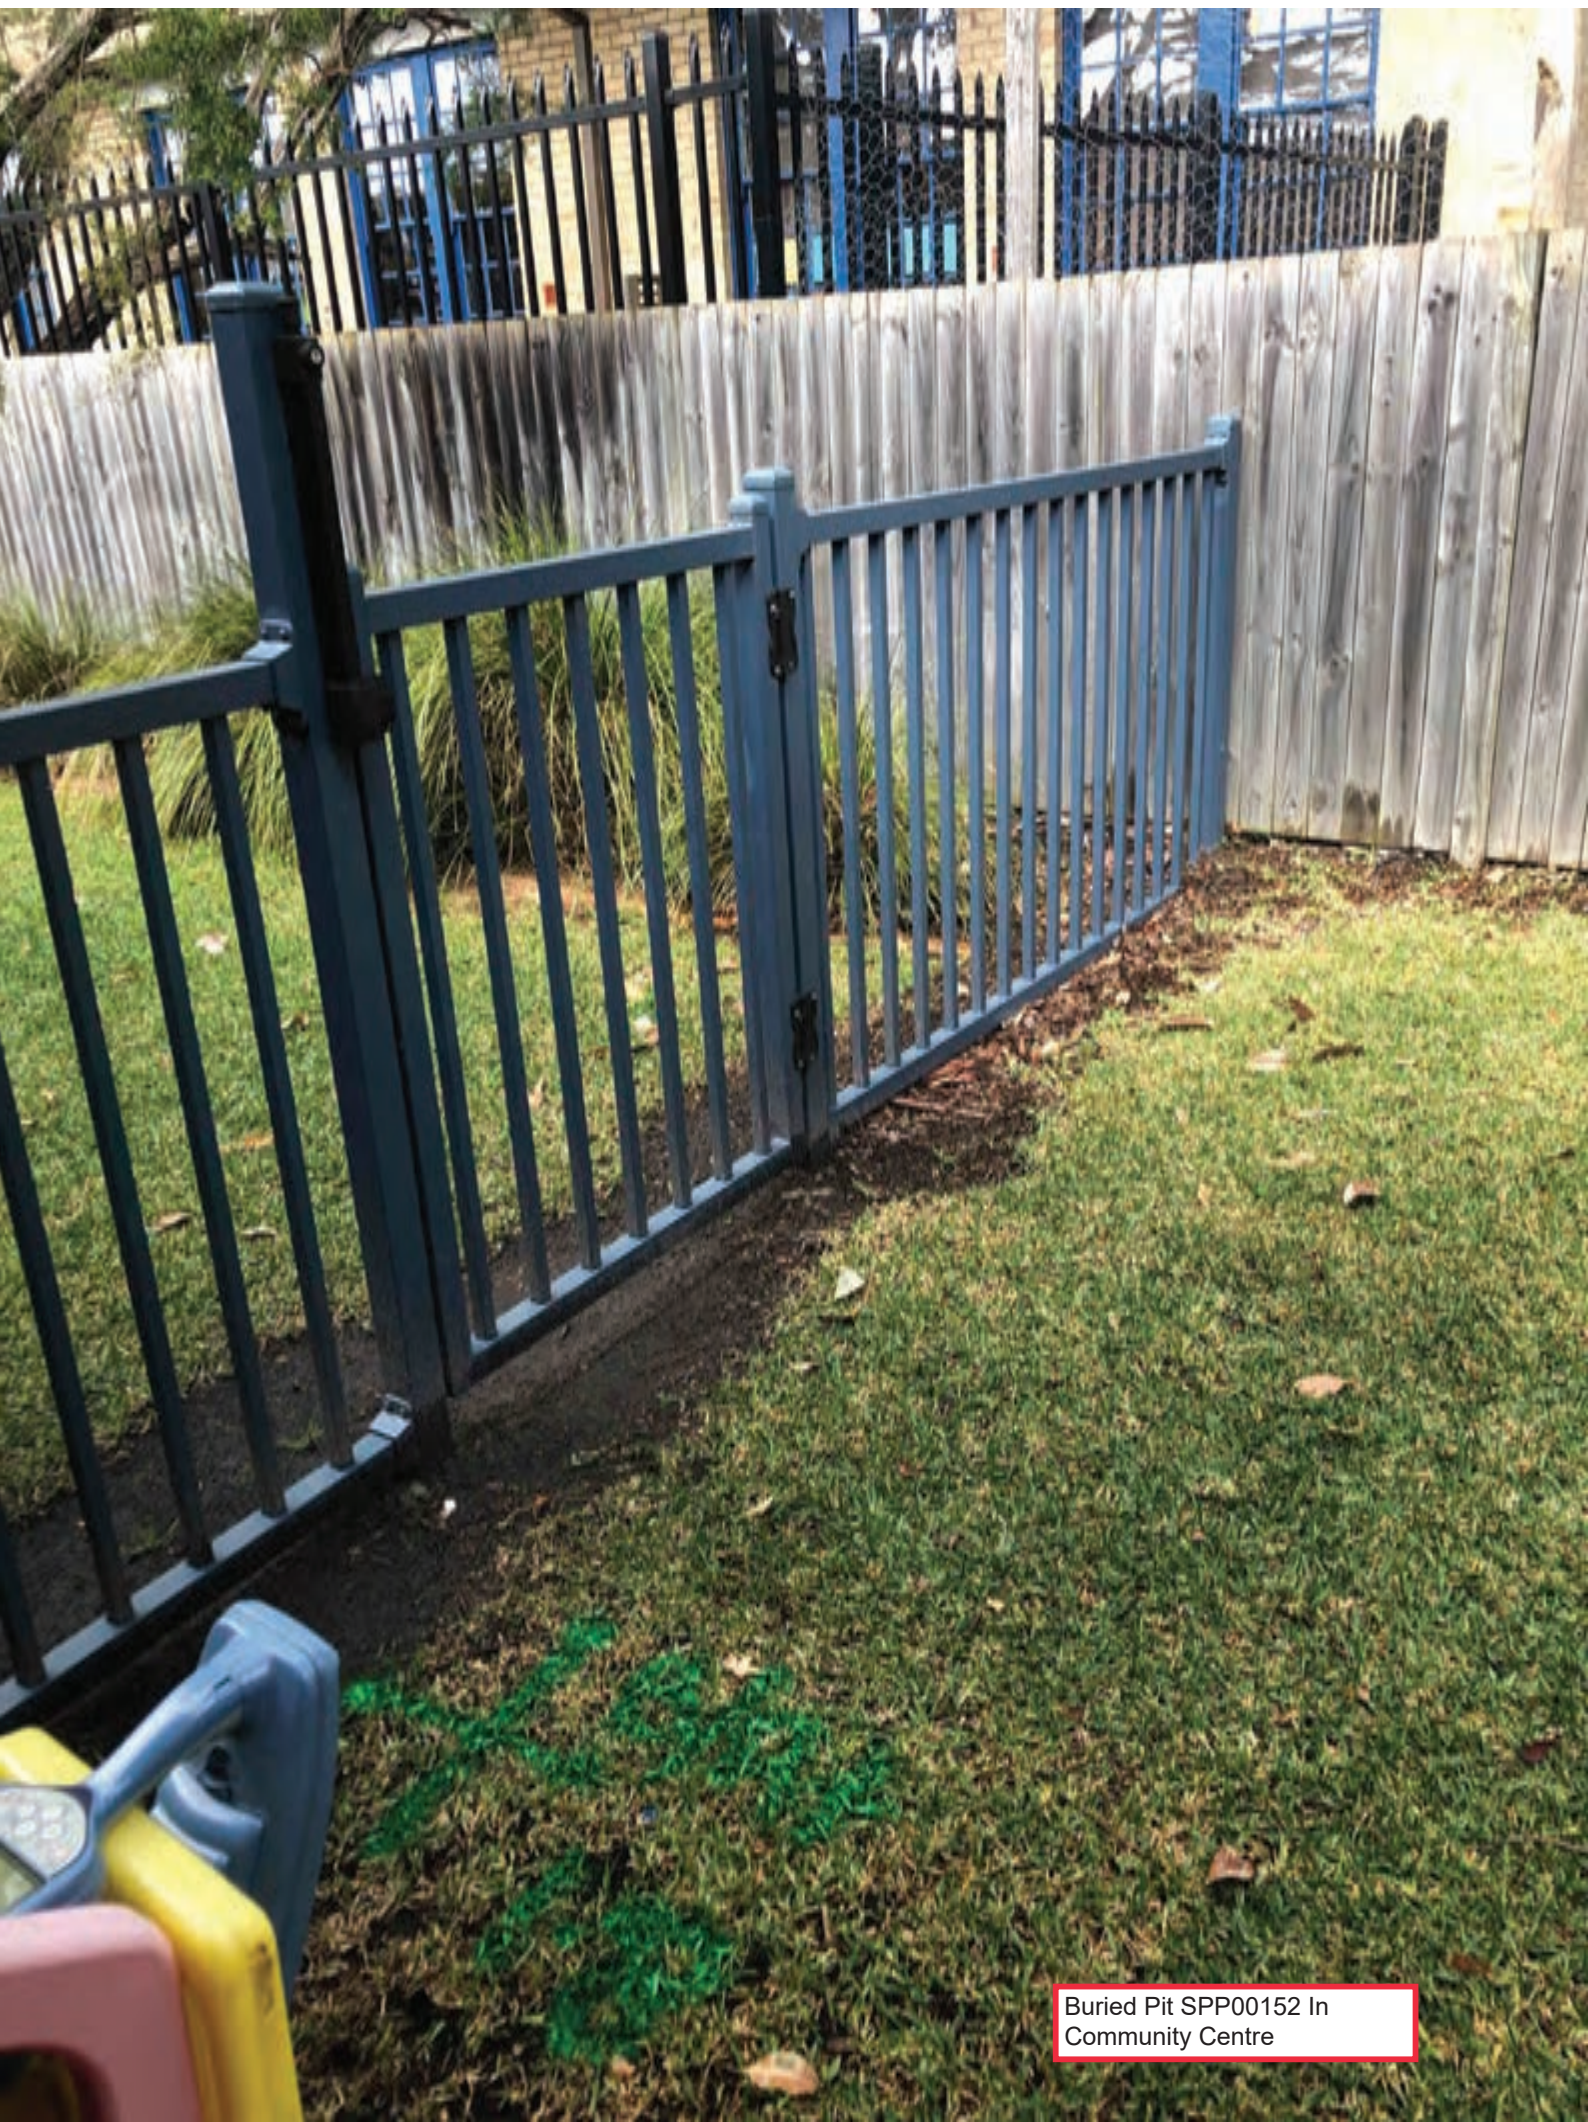
Buried Pit SPP00152 In
Community Centre

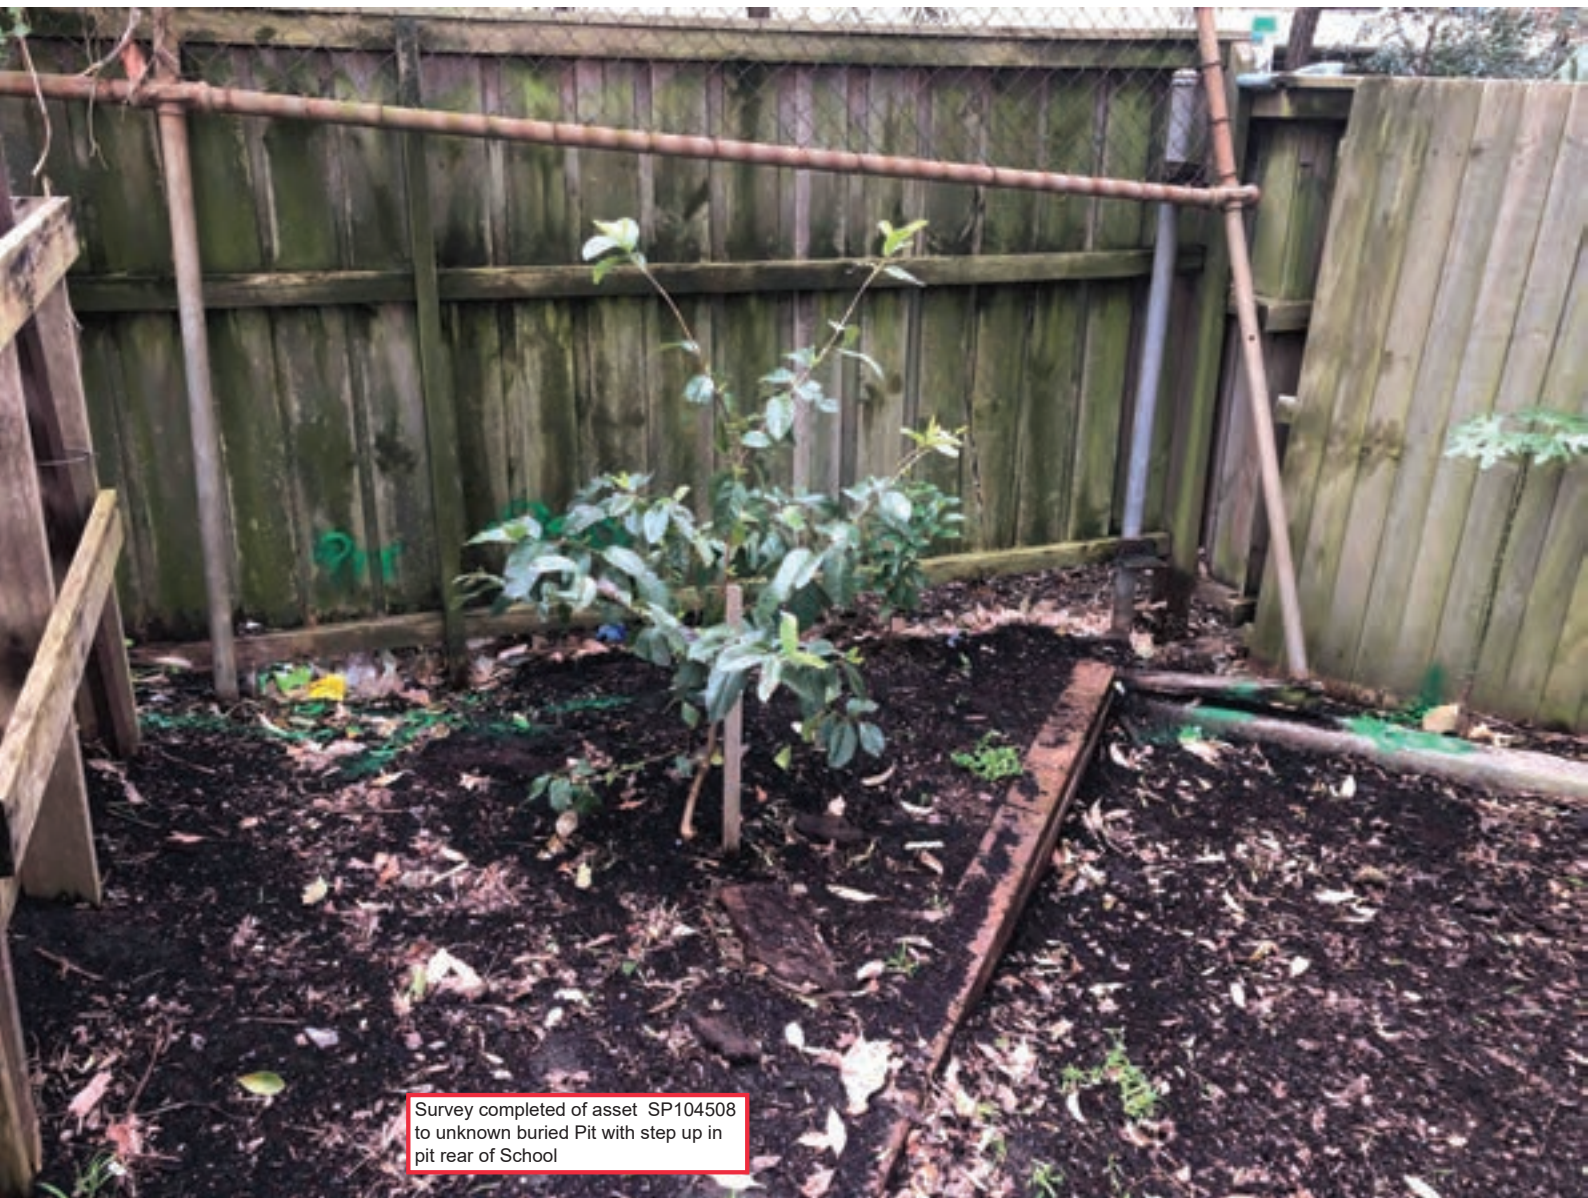
Survey completed of asset SP104508
to unknown buried Pit with step up in
pit rear of School

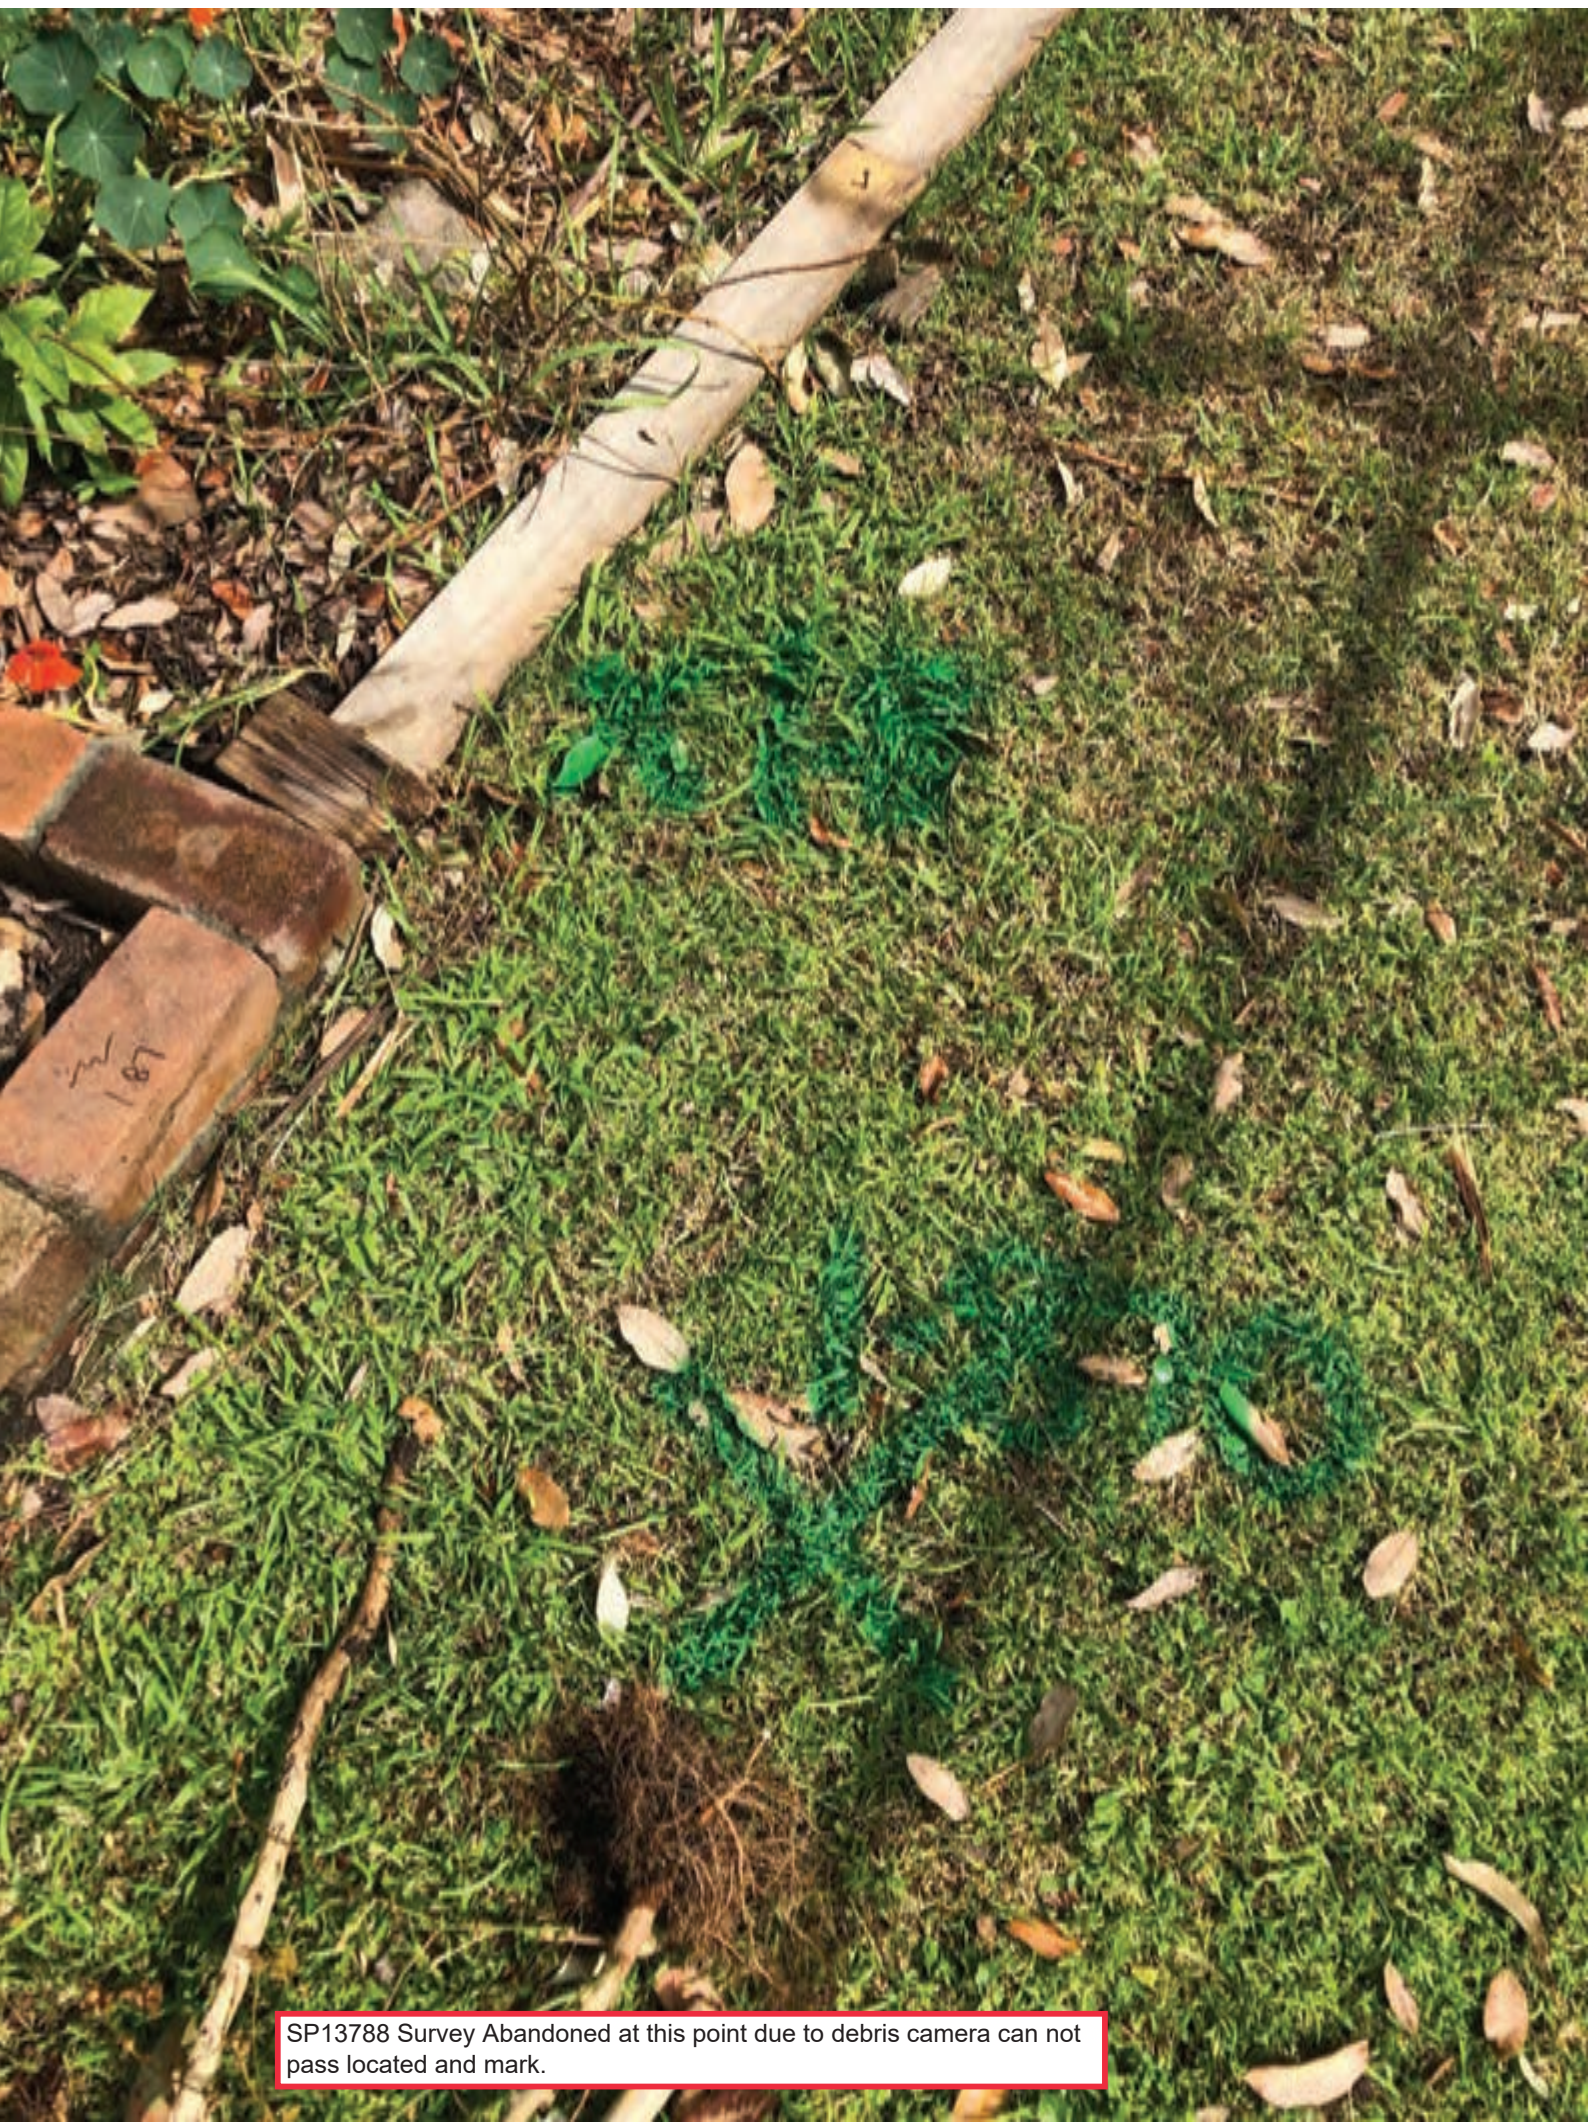
SP13788 Survey Abandoned at this point due to debris camera can not pass located and mark.

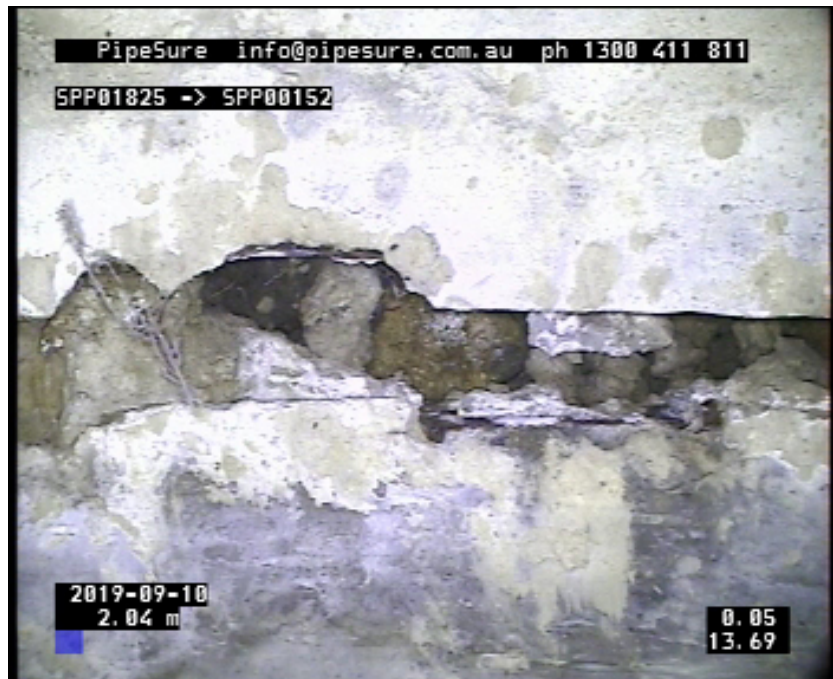
Photo: 1_4A, Media No:: 100919_1, 00:01:32
2.04m, Missing mortar, depth less or equal to 15 mm, at joint, at 12 o'clock

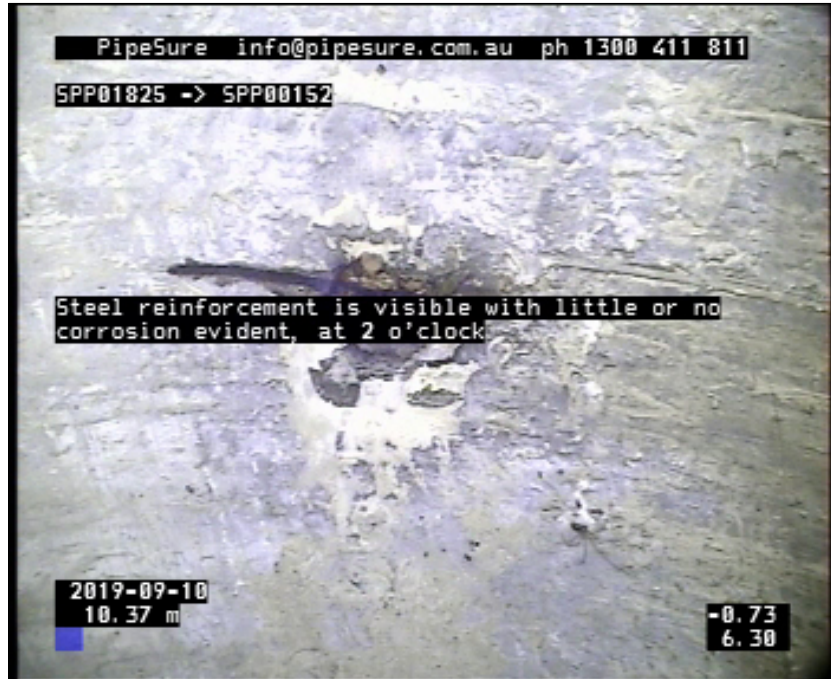
Photo: 1_7A, Media No:: 100919_1, 00:04:13
10.37m, Steel reinforcement is visible with little or no corrosion evident, at 2 o'clock

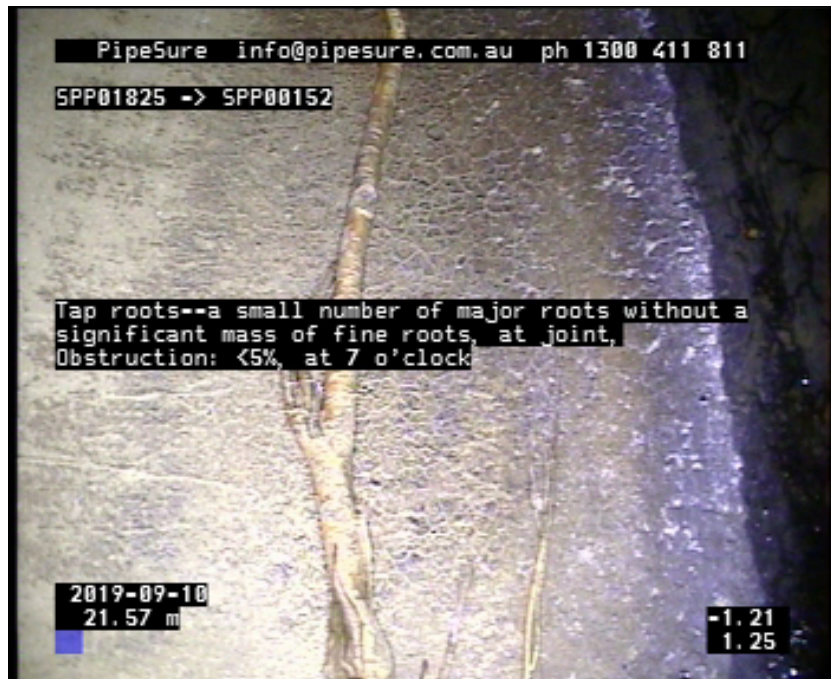
Photo: 1_9A, Media No:: 100919_1, 00:07:24
21.57m, Tap roots--a small number of major roots without a significant mass of fine roots, at joint, Obstruction: <5%, at 7 o'clock

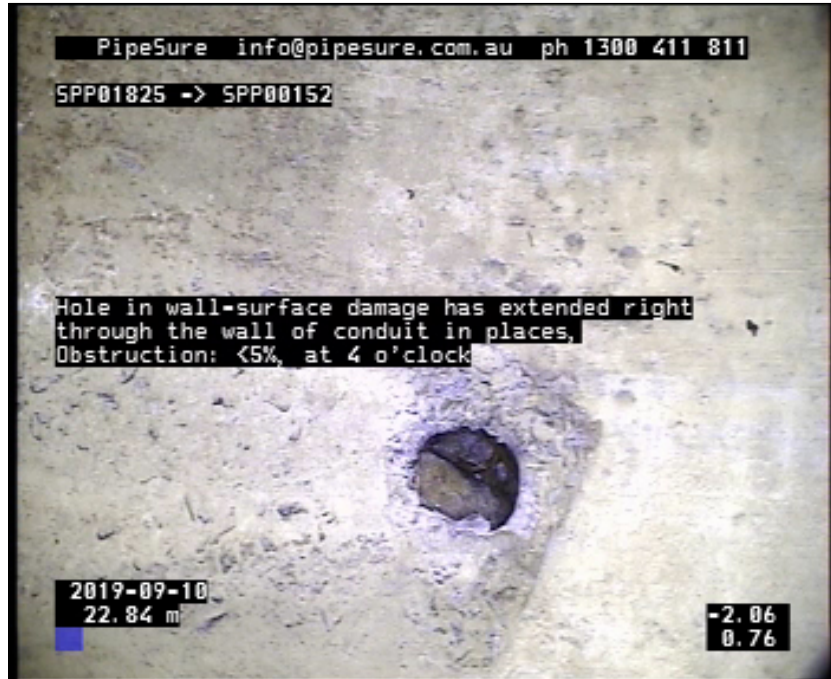
Photo: 1_10A, Media No.: 100919_1, 00:07:49
22.84m, Hole in wall-surface damage has extended right through the wall of conduit in places, Obstruction: <5%, at 4 o'clock

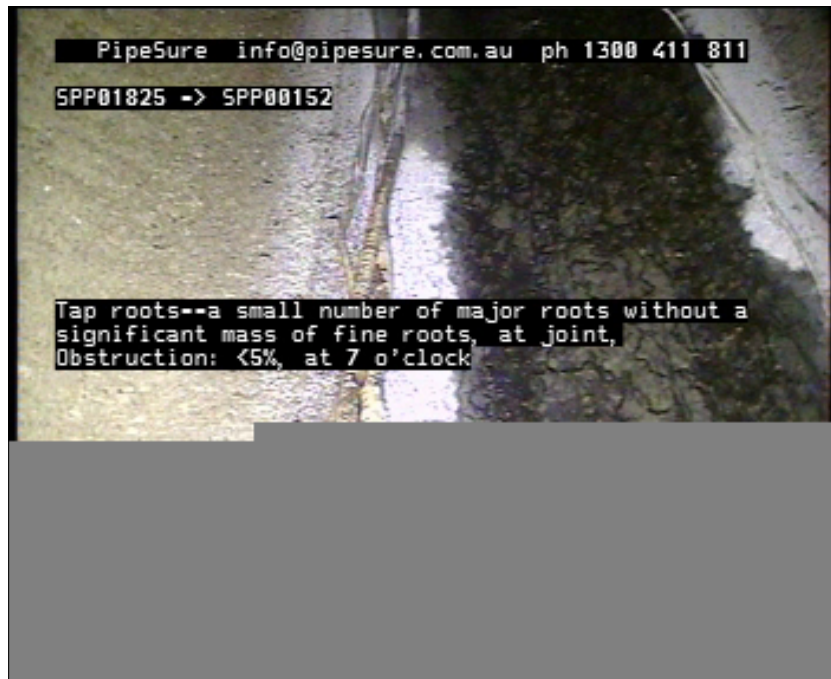
Photo: 1_11A, Media No.: 100919_1, 00:08:42
24.06m, Tap roots--a small number of major roots without a significant mass of fine roots, at joint, Obstruction: <5%, at 7 o'clock

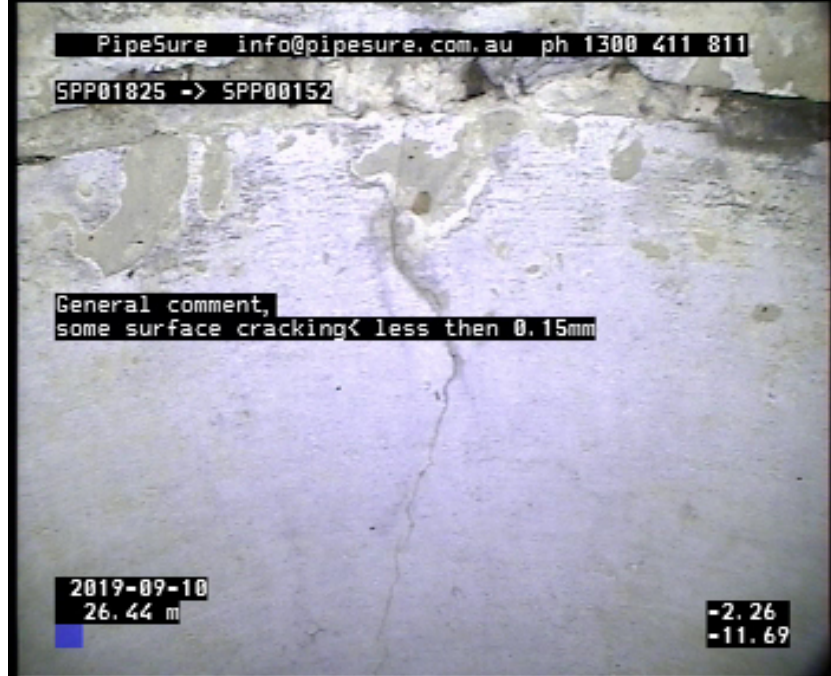
Photo: 1_12A, Media No:: 100919_1, 00:09:06
26.44m, General comment, some surface cracking< less then 0.15mm / some surface cracking< less then 0.15mm

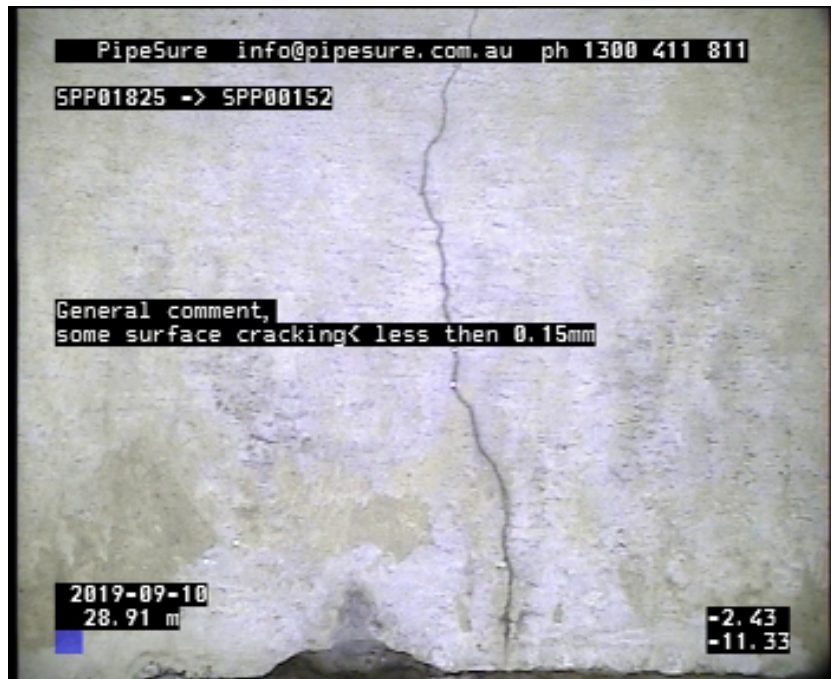
Photo: 1_13A, Media No:: 100919_1, 00:09:56
28.91m, General comment, some surface cracking< less then 0.15mm / some surface cracking< less then 0.15mm
