**BROOKVALE PUBLIC SCHOOL
2-8 OLD PITTWATER ROAD, BROOKVALE**

ALTERATIONS & ADDITIONS INCLUDING CONSTRUCTION OF A NEW SCHOOL HALL

**DA 2019/0411 – NORTHERN BEACHES COUNCIL
SYDNEY NORTH PLANNING PANEL REF. PPSSNH-24
PANEL MEETING 25 SEPTEMBER 2019**

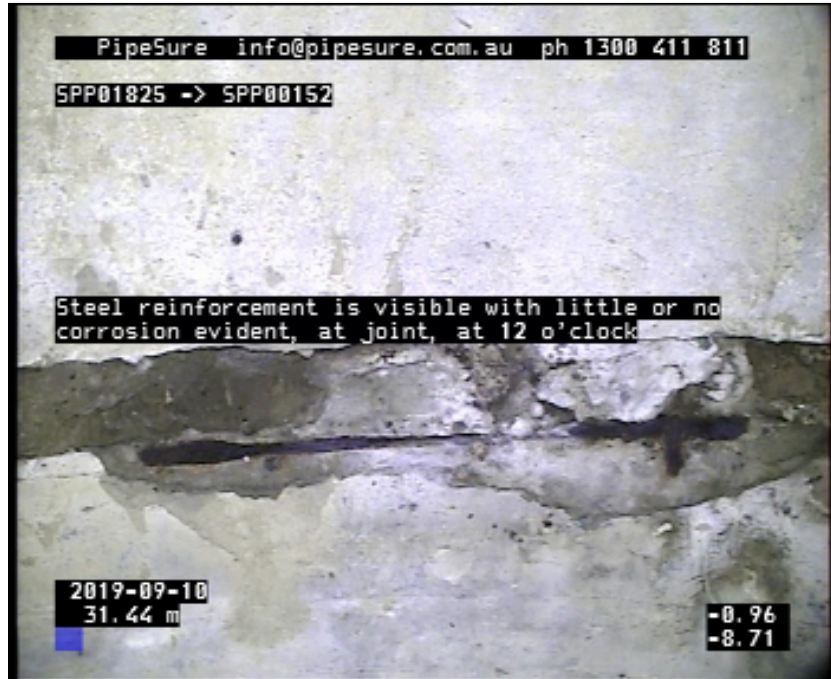
Photo: 1_14A, Media No:: 100919_1, 00:10:56
31.44m, Steel reinforcement is visible with little or no corrosion evident, at joint, at 12 o'clock

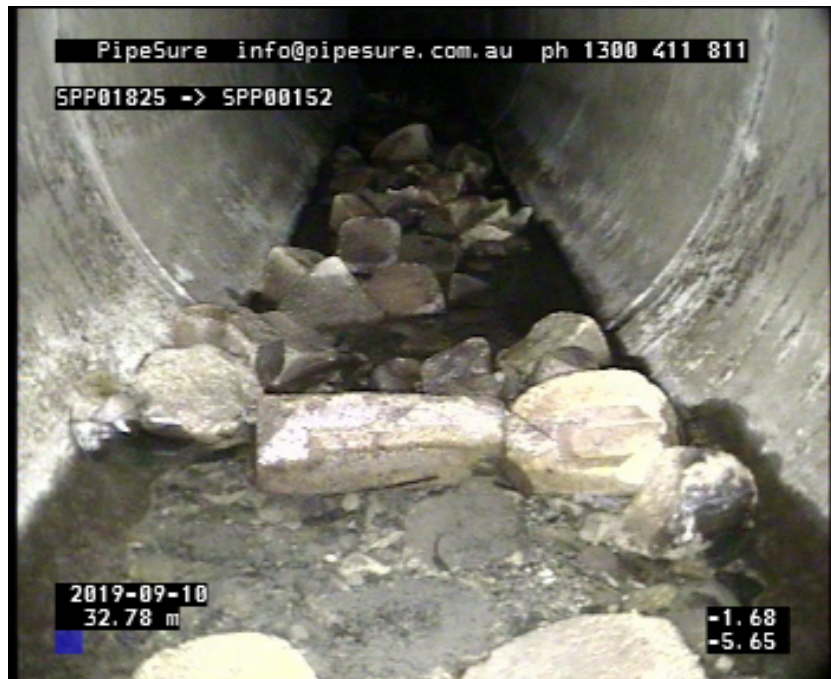
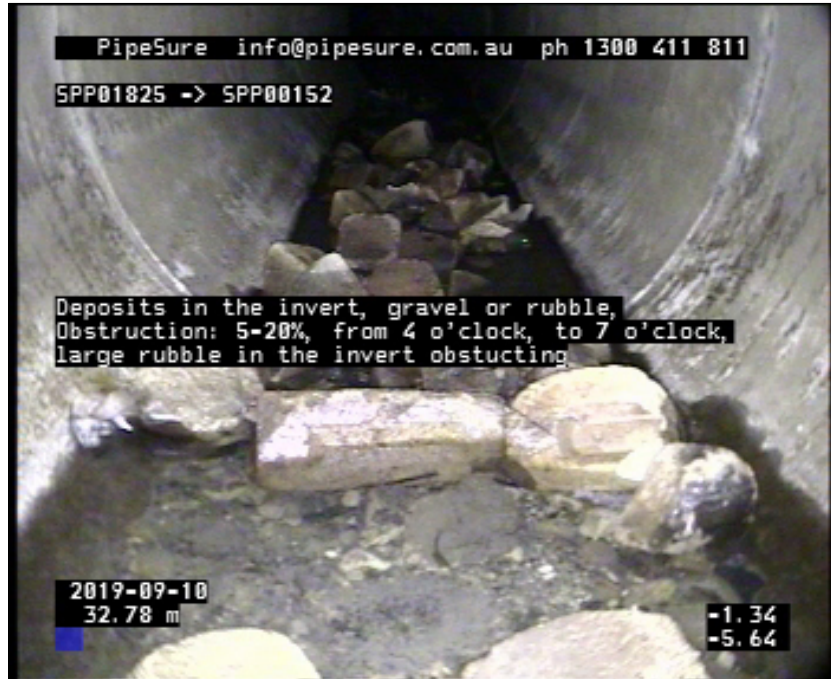
Photo: 1_15A, Media No:: 100919_1, 00:11:33
32.78m, Deposits in the invert, gravel or rubble, Obstruction: 5-20%, from 4 o'clock, to 7 o'clock, large rubble in the invert obstructing / large rubble in the invert obstructing

Photo: 1_15B, Media No.: 100919_1, 00:11:33
32.78m, Deposits in the invert, gravel or rubble, Obstruction: 5-20%, from 4 o'clock, to 7 o'clock, large rubble in the invert obstructing / large rubble in the invert obstructing

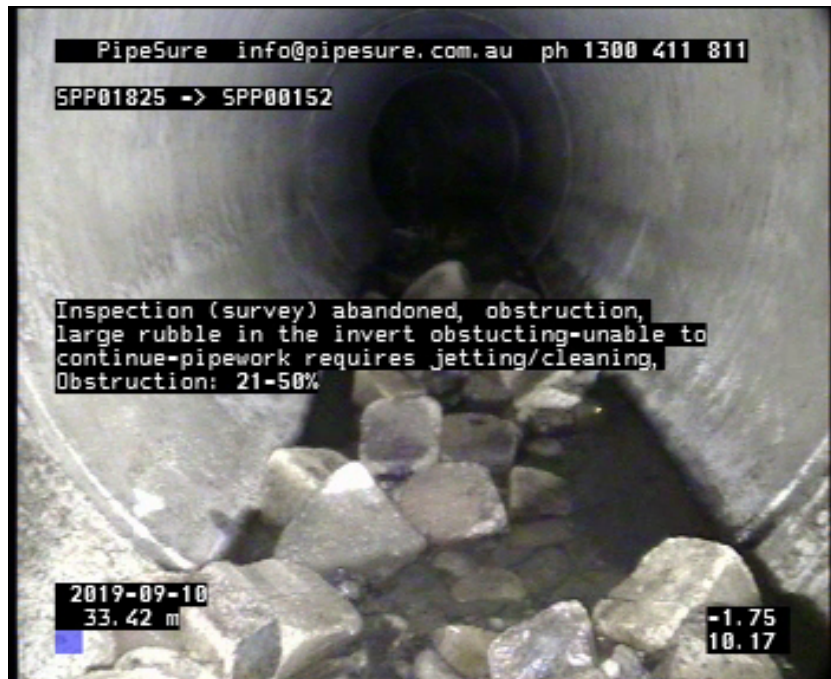
Photo: 1_16A, Media No.: 100919_1, 00:11:58
33.42m, Inspection (survey) abandoned, obstruction, large rubble in the invert obstructing-unable to continue-pipework requires jetting/cleaning, Obstruction: 21-50% / large rubble in the invert obstructing-unable to continue-pipework requires jetting/cleaning

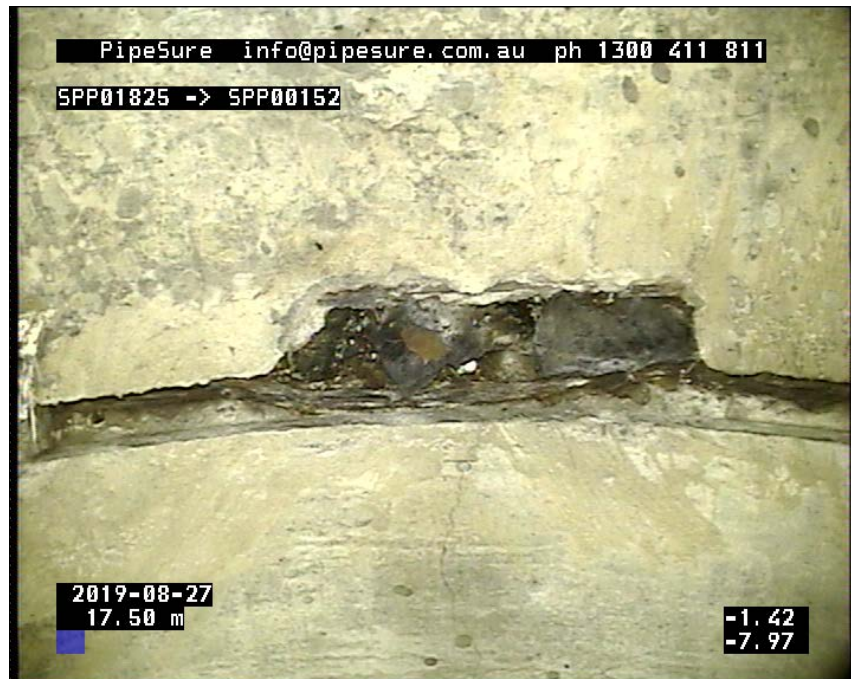
Photo: 1_3A, Media No:: 280819_1, 00:05:35
17.5m, Breaking, some pieces are missing, length of break: 100mm, at 12 o'clock

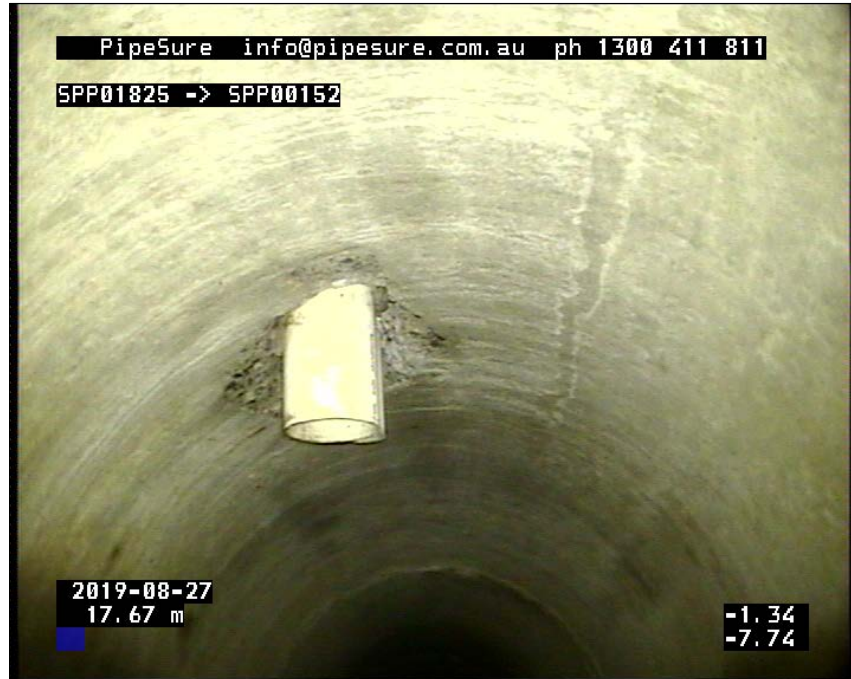
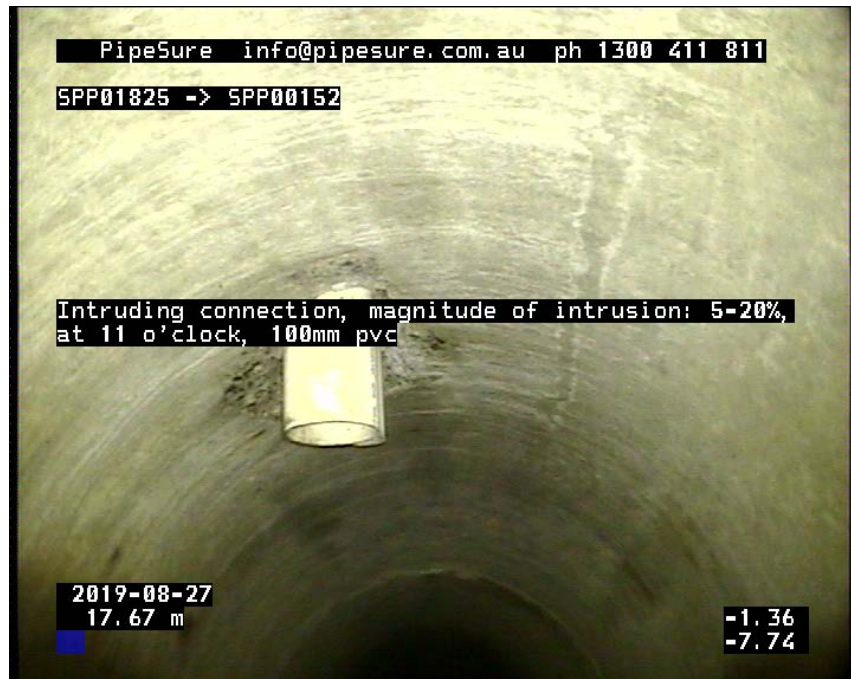
Photo: 1_4A, Media No:: 280819_1, 00:05:50
17.67m, Intruding connection, magnitude of intrusion: 5-20%, at 11 o'clock, 100mm pvc / 100mm pvc

Photo: 1_5A, Media No:: 280819_1, 00:05:50
17.67m, Intruding connection, magnitude of intrusion: 5-20%, at 11 o'clock, 100mm pvc / 100mm pvc

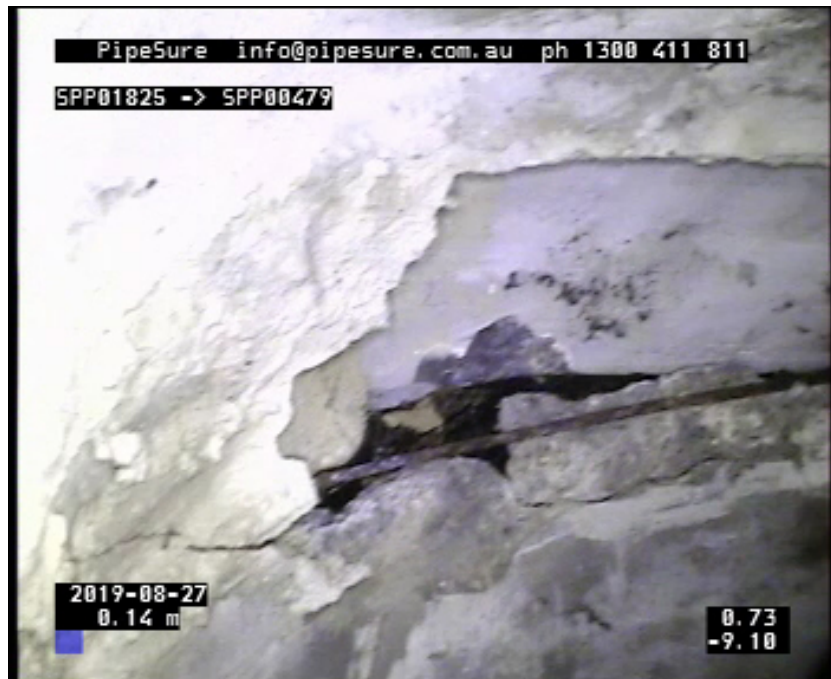
Photo: 3_3A, Media No:: 280819_1, 00:08:37
0.14m, Steel reinforcement is visible and projecting into the conduit, at joint , from 10 to 2 o'clock

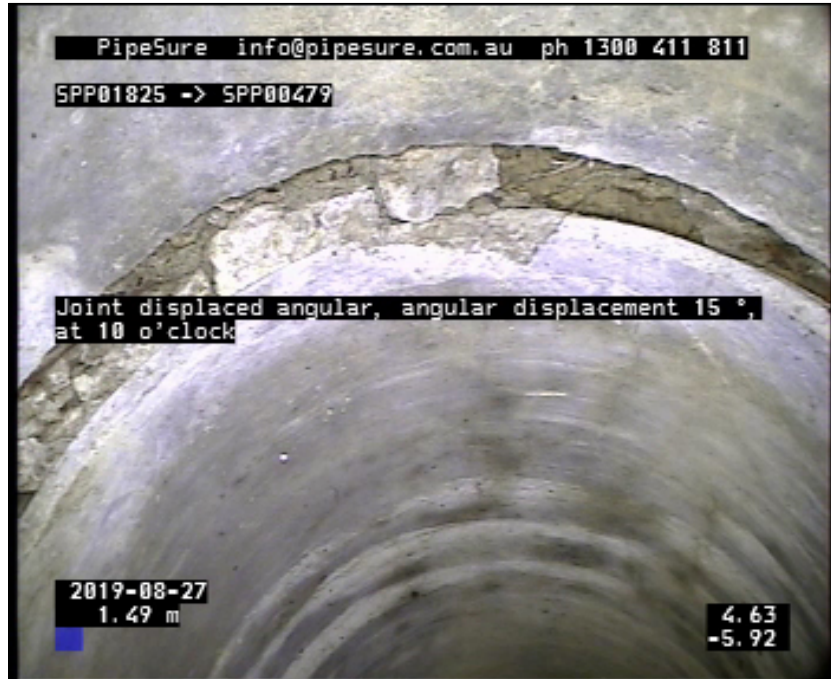
Photo: 3_4A, Media No:: 280819_1, 00:01:38
1.49m, Joint displaced angular, angular displacement 15 °, at 10 o'clock

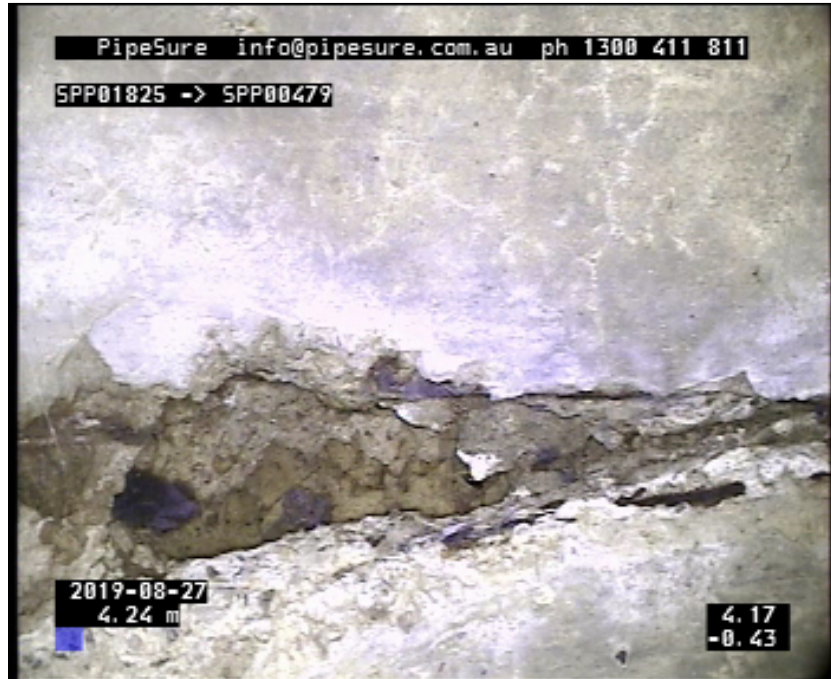
Photo: 3_6A, Media No:: 280819_1, 00:02:53
4.24m, Joint displaced angular, angular displacement 10 °, at 11 o'clock

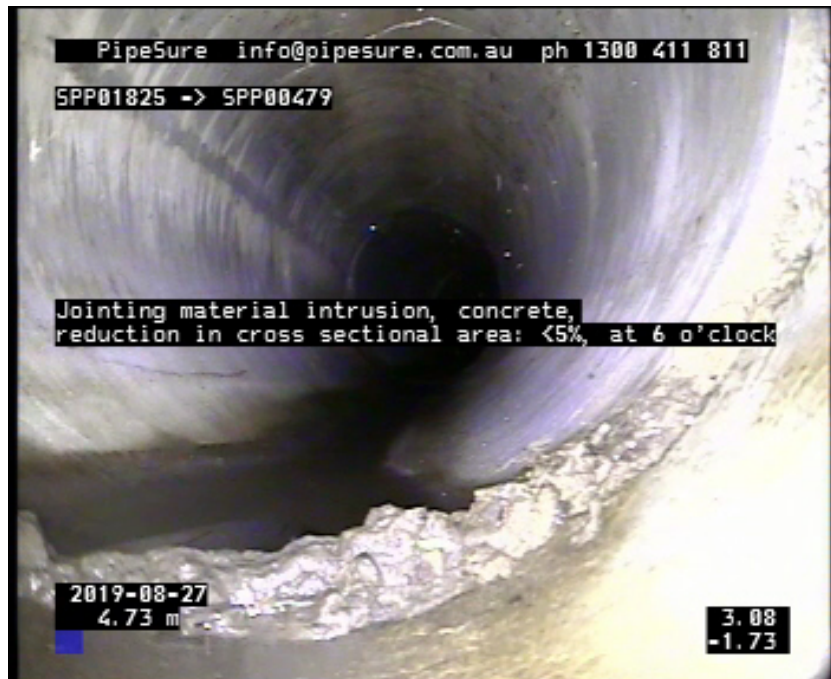
Photo: 3_7A, Media No:: 280819_1, 00:03:08
4.72m, Jointing material intrusion, concrete, reduction in cross sectional area: <5%, at 6 o'clock

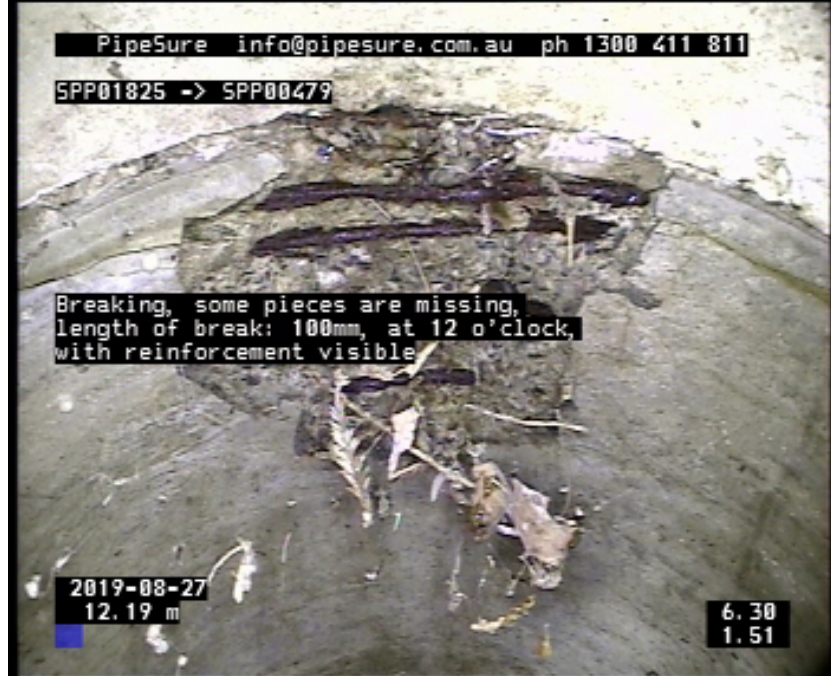
Photo: 3_9A, Media No:: 280819_1, 00:06:56
12.19m, Breaking, some pieces are missing, length of break: 100mm, at 12 o'clock, with reinforcement visible / with reinforcement visible

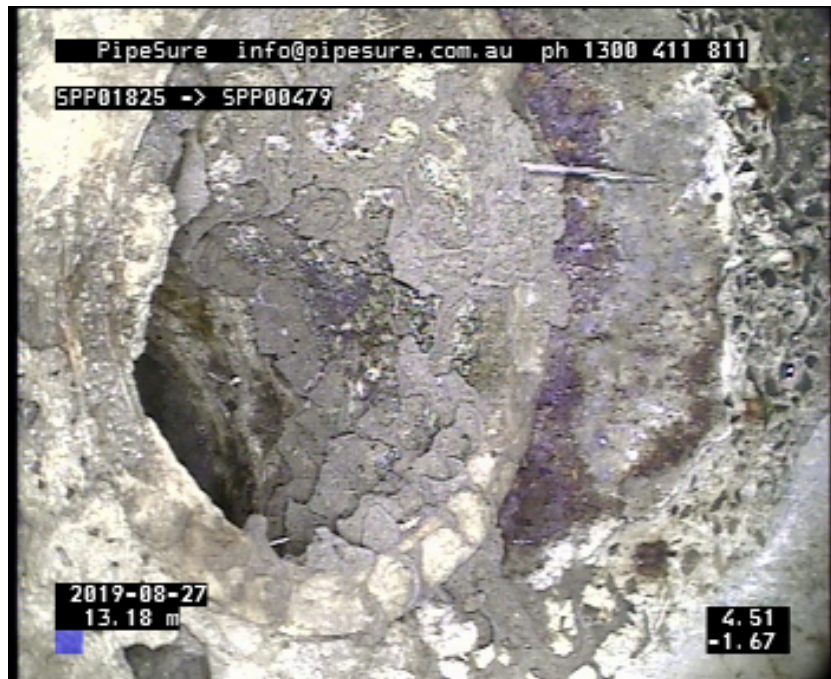
Photo: 3_10A, Media No:: 280819_1, 00:07:45
13.18m, Connection, poor workmanship, connection appears to be open, height: 225 mm, width: 0 mm, at 8 o'clock

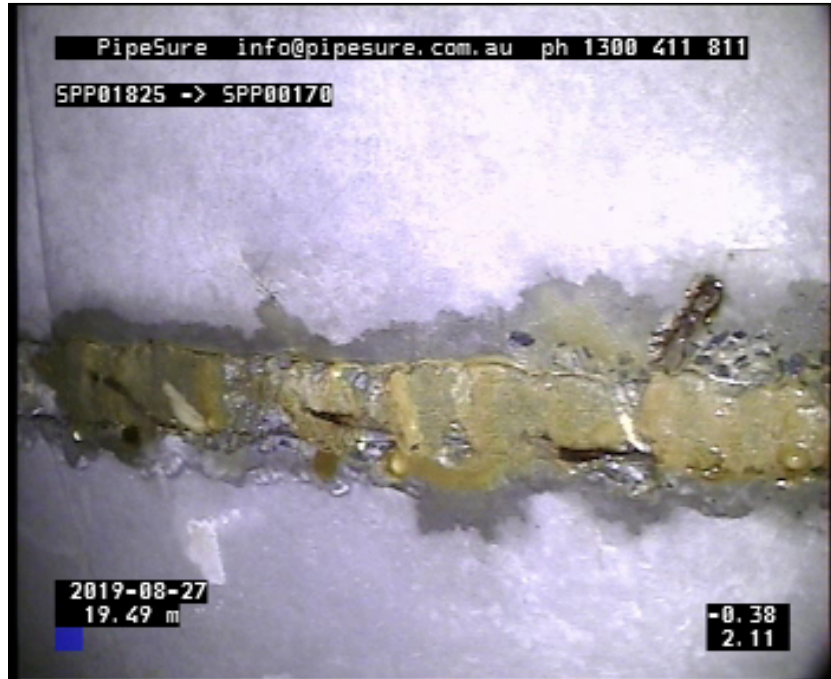
Photo: 4_4A, Media No:: 280819_1, 00:05:40
19.49m, Infiltration, sweating--slow ingress of water, no visible drips, from 12 o'clock, to 12 o'clock, at the joint<less then 5% / at the joint<less then 5%
