Hazardous Materials Survey

13-19 Canberra Avenue, St Leonards NSW

Report No: E25217.E10_Rev1

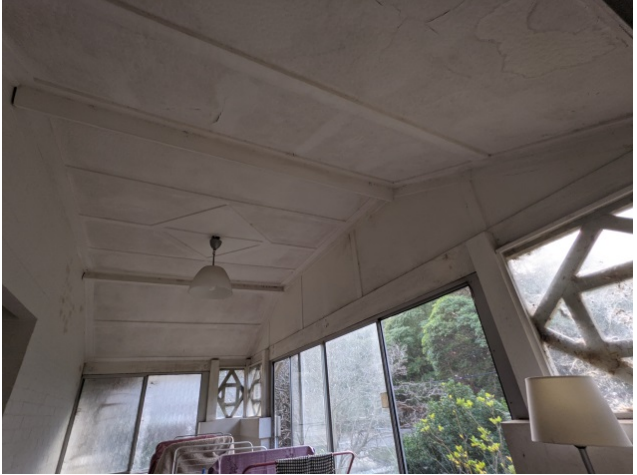
Hazardous Materials Register 13-19 Canberra Avenue, St Leonards NSW									
Location	Material Type	Friability	Sample	Analysis Result:	Quantity	Condition and Accessibility	Priority	Recommendations/ Comments	Photograph of material
19 Canberra Avenue									
Inaccessible									
Internal, ceiling, floor and/or wall cavities	Possible hazardous materials	Unknown	Inaccessible	NA	Not determined	Unknown (Inaccessible)	NA	<u>No access available at time of inspection.</u> <u>When areas are accessible, confirm status of hazardous materials.</u>	No Photograph Taken
Asbestos									
Main house, External, Rear eaves & wall panels	FCS	Non-friable	Visual Inspection (due to height restriction)	Assumed positive for asbestos	20m ²	Good (Maintenance only)	Priority 4: Negligible Risk Level	Remove prior to demolition works	 
Main house, Internal, Front sun room, Ceiling & upper wall	FCS	Non-friable	Visual Inspection (due to height restriction)	Assumed positive for asbestos	25m ²	Good (Maintenance only)	Priority 4: Negligible Risk Level	Remove prior to demolition works

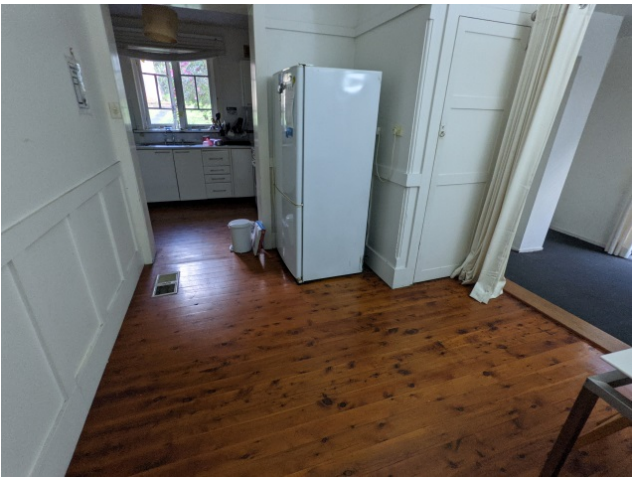
Main house, Internal, Hall, adjacent to kitchen, Walls	FCS	Non- friable	Visual Inspection (due to height restriction)	Assumed positive for asbestos	30m ²	Good (Maintenance only)	Priority 4: Negligible Risk Level	Remove prior to demolition works

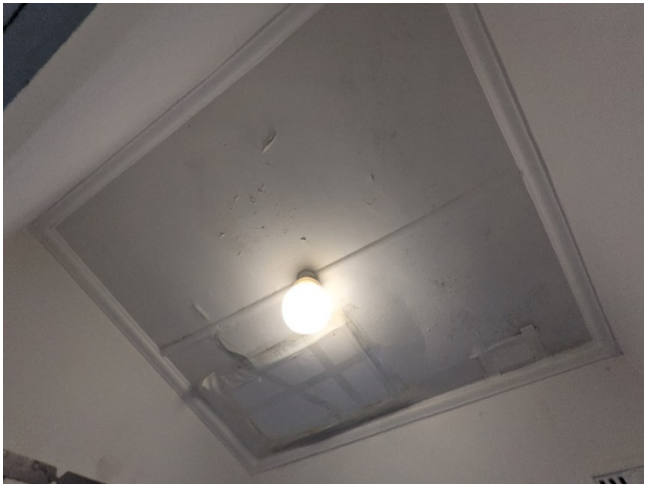
Main house, Internal, Laundry, Ceiling	FCS	Non- friable	Visual Inspection (due to height restriction)	Assumed positive for asbestos	>10m ²	Good (Maintenance only)	Priority 4: Negligible Risk Level	Remove prior to demolition works

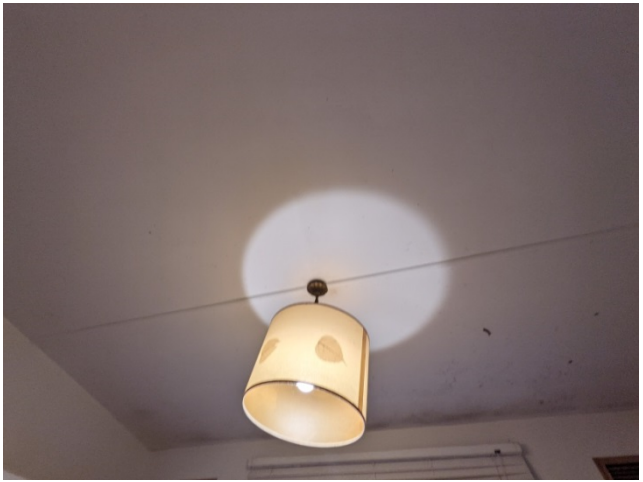
Main house, Internal, Kitchen, Ceiling	FCS	Non- friable	Visual Inspection (due to height restriction)	Assumed positive for asbestos	>10m ²	Good (Maintenance only)	Priority 4: Negligible Risk Level	Remove prior to demolition works

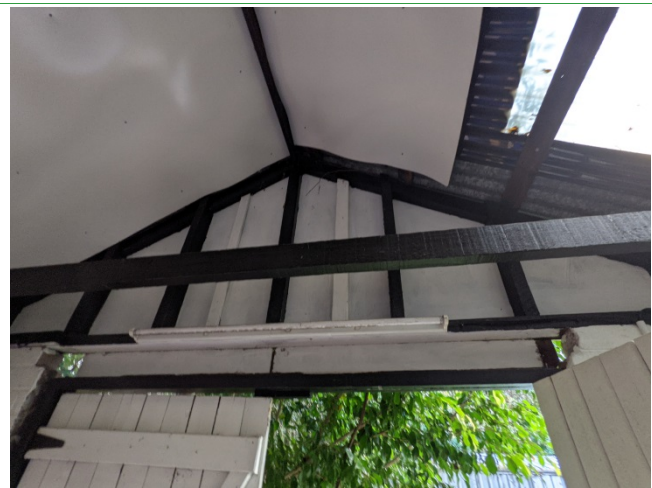
Garage, External, Eaves and gable	FCS	Not friable	Visual inspection (due to height restriction)	Assumed positive for asbestos	<10 m ²	Good (Maintenance only)	Priority 4: Negligible Risk Level	Remove prior to demolition works	 
Outhouse, External, Gable	FCS	NA	Visual inspection (due to height restriction)	Assumed positive for asbestos	<10 m ²	Good (Maintenance only)	Priority 4: Negligible Risk Level	Remove prior to demolition works

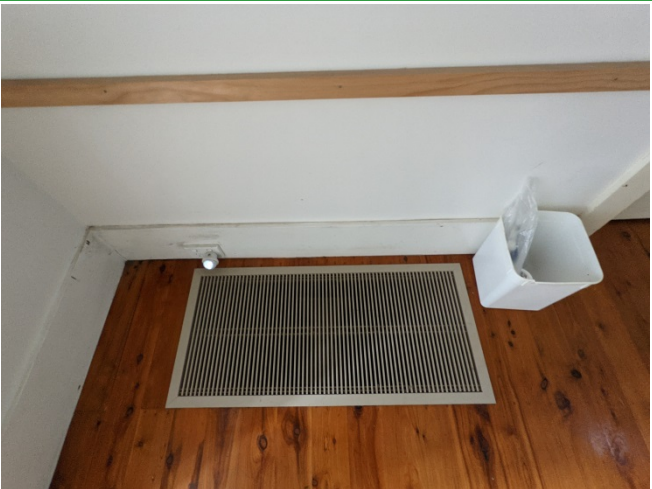
SMF									
Main house, Internal, ceiling and floor cavity, ducting	SMF Insulation	Not friable	Visual inspection (due to height restriction)	Assumed positive for SMFs	Unknown	Good (Maintenance only)	Priority 4: Negligible Risk Level	Remove during demolition works

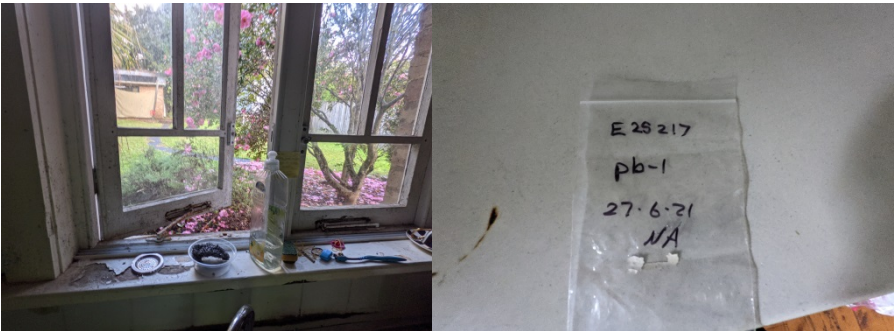
Main house, Internal, External Wall, window, door frame	White Paint	Non- friable	Pb-1	Positive for LBPs (0.65%w/w)	>100m ²	Good to Fair (Maintenance only)	Priority 4: Negligible Risk Level	Avoid abrasive disturbances and dust generation during demolition.

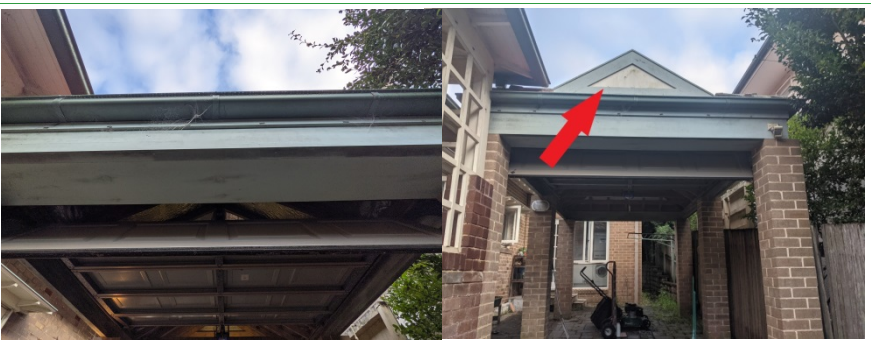
Carport, External, Gable and eaves	FCS	Non- friable	Visual inspection (due to height restriction)	Assumed positive for asbestos	<10 m ²	Good (Maintenance only)	Priority 4: Negligible Risk Level	Remove prior to demolition works

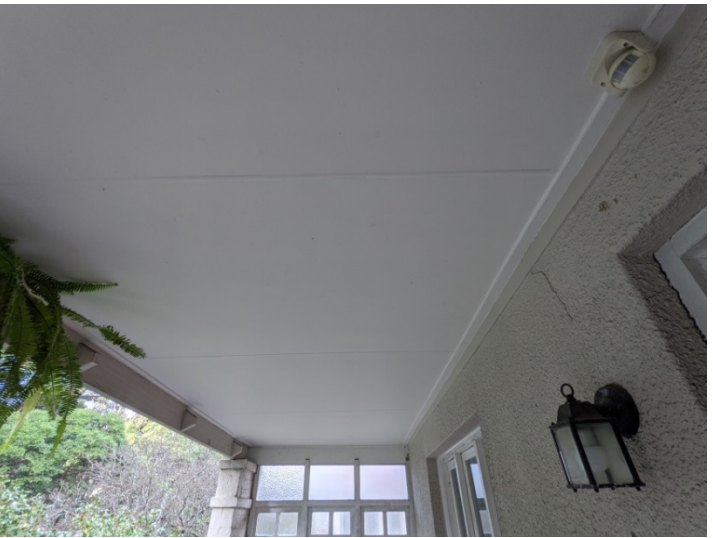
Main house, External, Porch ceiling	FCS	Not friable	Visual inspection (due to height restriction)	Assumed positive for asbestos	15 m ²	Good (Maintenance only)	Priority 4: Negligible Risk Level	Remove prior to demolition works

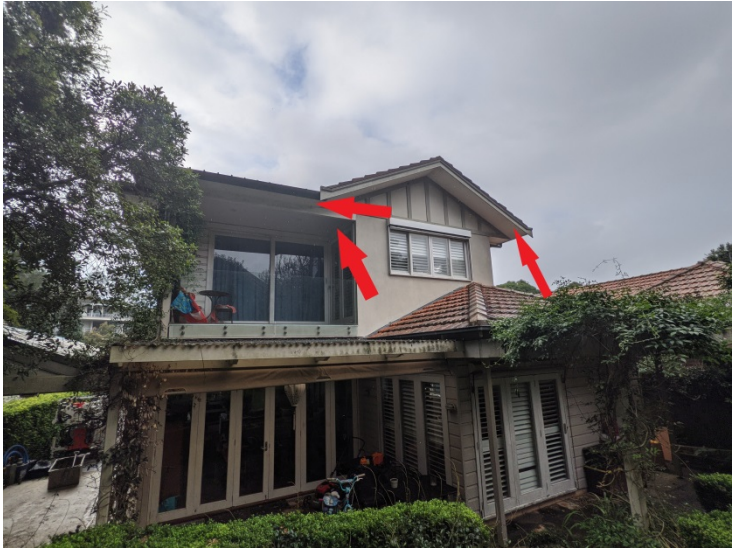
Main house, External, First floor balcony ceiling, eaves amd gable	FCS	Not friable	Visual inspection (due to height restriction)	Assumed positive for asbestos	<10 m ²	Good (Maintenance only)	Priority 4: Negligible Risk Level	Remove prior to demolition works

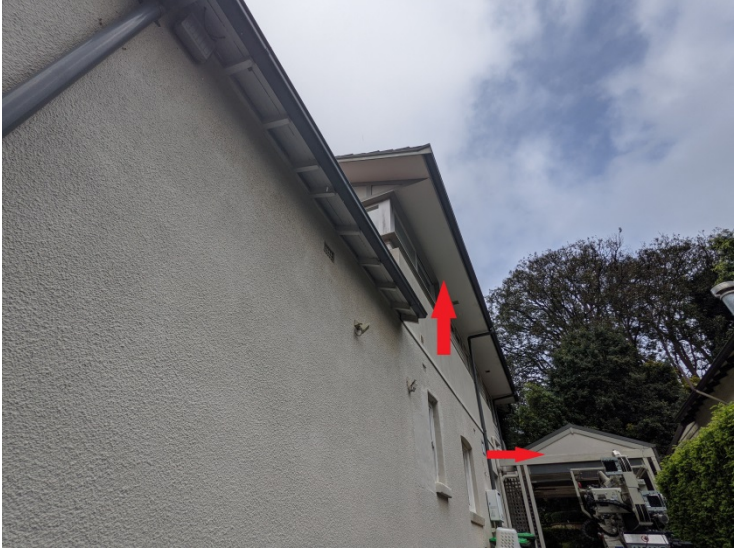
Main house, External, Eaves & Carport, External, Gable	FCS	Not friable	Visual inspection (due to height restriction)	Assumed positive for asbestos	<10 m ²	Good (Maintenance only)	Priority 4: Negligible Risk Level	Remove prior to demolition works

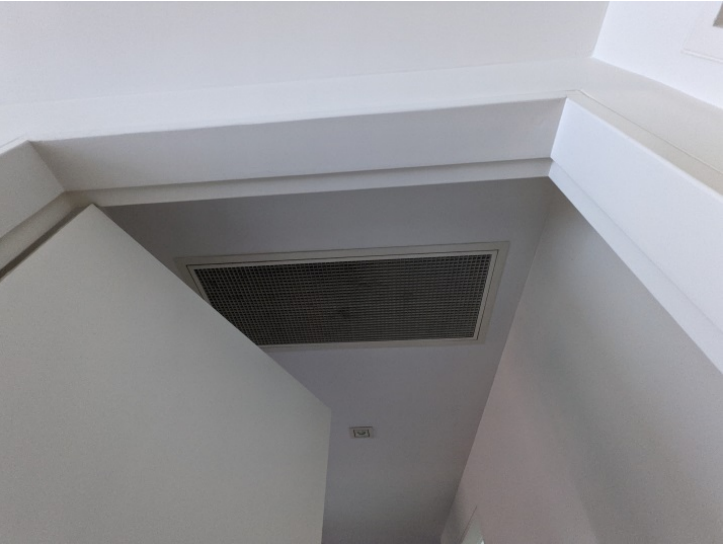
Hazardous Materials Register									
13-19 Canberra Avenue, St Leonards NSW									
Location	Material Type	Friability	Sample	Analysis Result:	Quantity	Condition and Accessibility	Priority	Recommendations/ Comments	Photograph of material
SMF									
Main house, Internal, Wall and ceiling cavity	Ventilation ducting fitting	NA	Visual inspection (due to height restriction and confined space)	Assumed positive for SMFs	Unknown	Good (Maintenance only)	Priority 4: Negligible Risk Level	Remove during demolition works

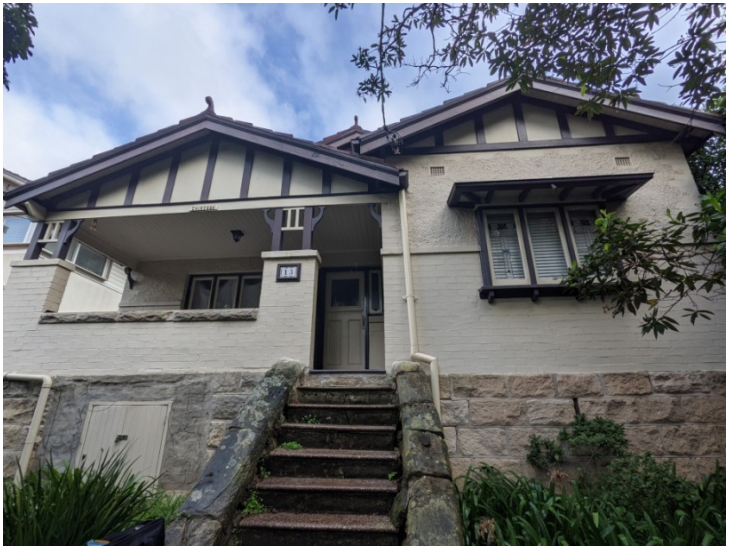
Main house, External, Gable and side eaves	FCS	Non- friable	Visual inspection (due to height restriction)	Assumed positive for asbestos	20 m ²	Good (Maintenance only)	Priority 4: Negligible Risk Level	Remove prior to demolition works

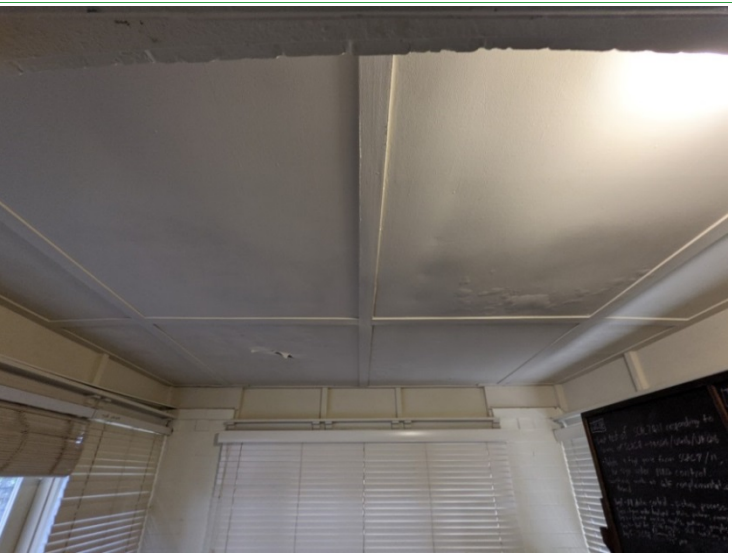
Main house, Internal, Ceiling and extension walls on brick walls	FCS	Non- friable	Visual inspection (due to height restriction)	Assumed positive for asbestos	20 m ²	Good (Maintenance only)	Priority 4: Negligible Risk Level	Remove prior to demolition works

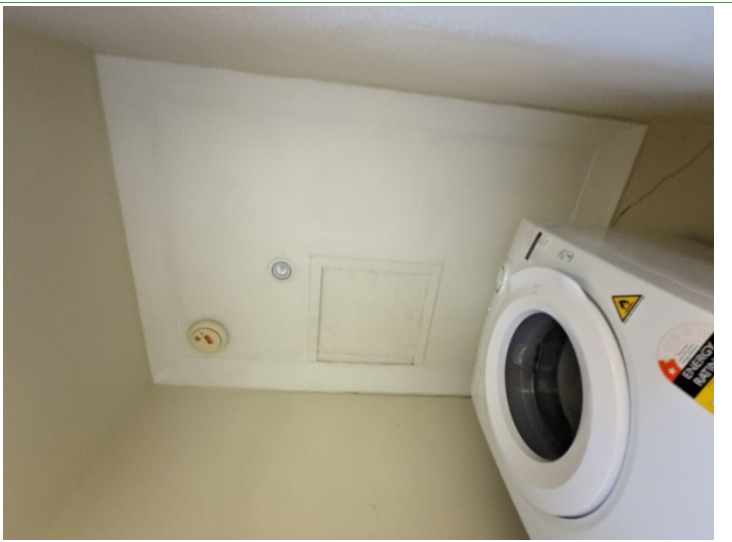
Main house, Internal, Laundry, Ceiling	FCS	Non- friable	Visual inspection (due to height restriction)	Assumed positive for asbestos	<10 m ²	Good (Maintenance only)	Priority 4: Negligible Risk Level	Remove prior to demolition works
