## ARBORICULTURAL IMPACT ASSESSMENT REPORT

Prepared For: New Hope Evergreen  
On Behalf of: NSW Department of Planning & Environment

Site Address: St Leonards South Precinct  
Canberra, Holdsworth & Marshall Avenues,  
St Leonards

Inspection Dates: 25<sup>th</sup> October 2021  
Report Date: 17<sup>th</sup> February 2022  
Revised Date: 31<sup>st</sup> August 2022 (Version 3)

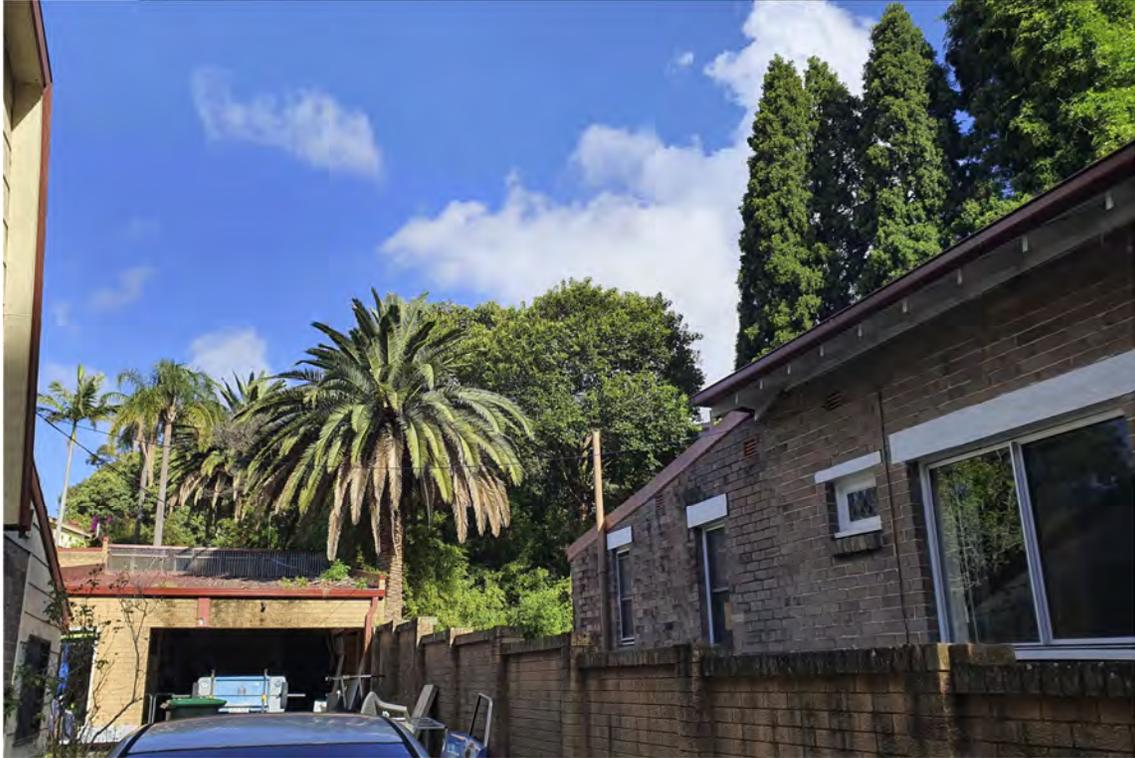
*Image 3: A view of the vegetation on the site from 3 Canberra Ave. T5 pictured [centre].*

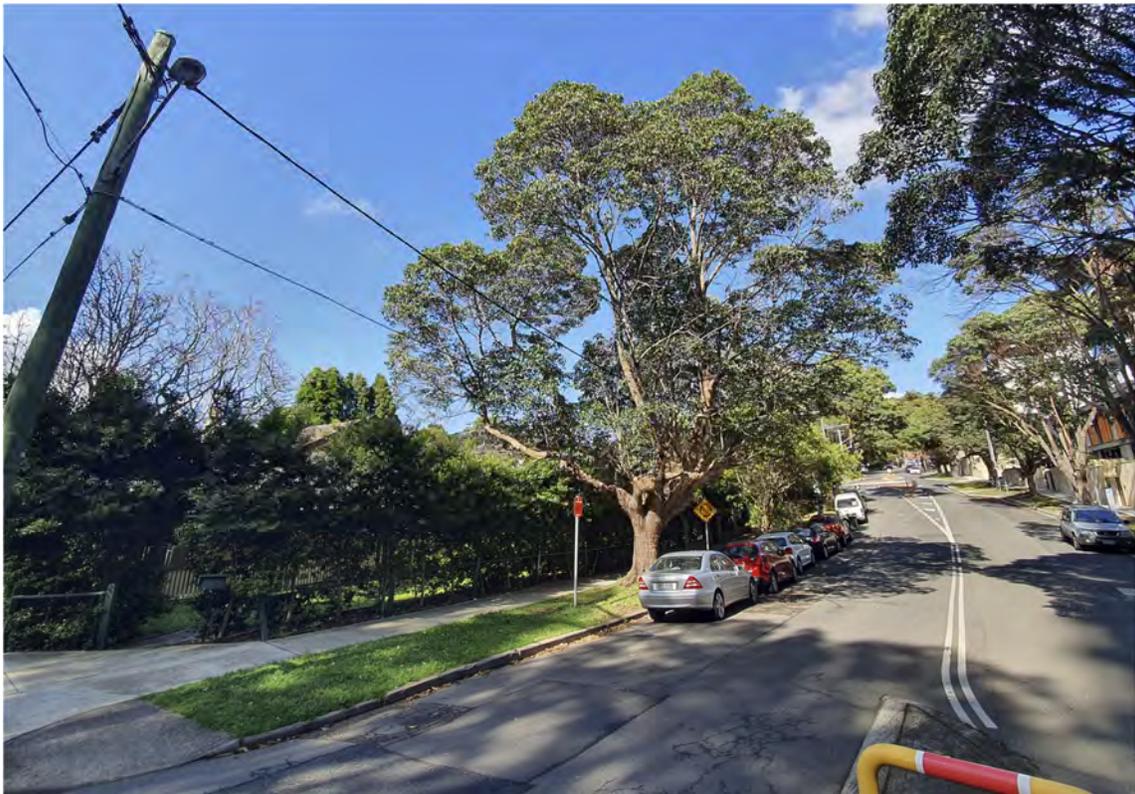
*Image 4: Street trees and vegetation along Marshall Ave as seen.*
