## Hazardous Materials Survey

67 Mars Road, Lane Cove West NSW

**Report No:** E25663.E10\_Rev0

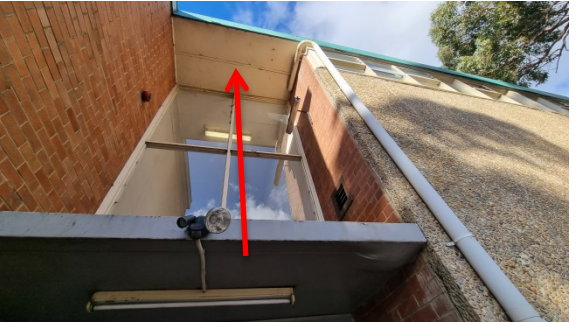
Eaves	Asbestos cement sheeting	Non-friable	Visual inspection (positive)	-	<50m <sup>2</sup>	Good Maintenance only	Priority 4: Negligible Risk Level	Remove prior to demolition works

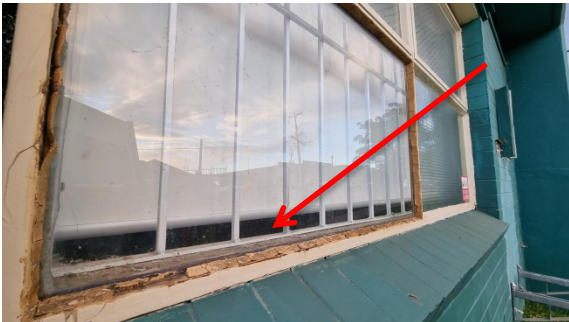
Window frame	Putty	Non-friable	A11	No asbestos detected	-	-	-	-

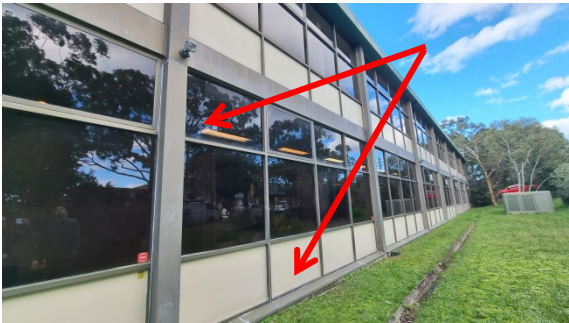
Walls	Asbestos cement sheeting	Non-friable	Visual inspection (positive)	-	Throughout	Good Regular	Priority 3: Low Risk Level	Remove prior to demolition works

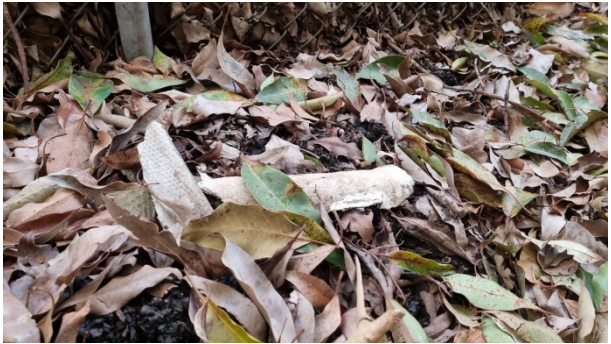
Building surroundings, floor debris	Asbestos cement sheeting debris	Non-friable	Visual inspection (positive)	-	Unknown	Good Regular	Priority 4: Negligible Risk Level	Remove prior to demolition works

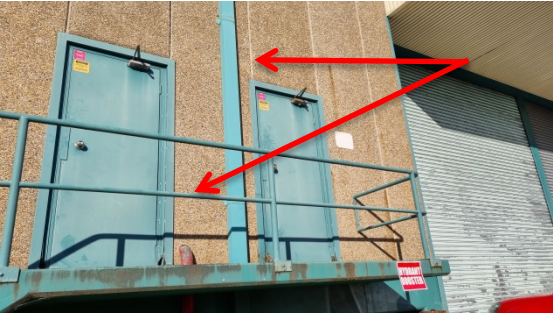
Doors, eaves and frames	Green LBP	Not flaking	Visual inspection (positive)	-	Throughout	Good Regular and Maintenance Only	Priority 4: Negligible Risk Level	Remove prior to demolition works

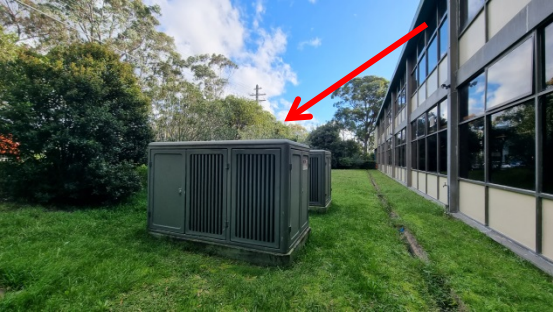
Substations (southern site boundary)	PCB containing capacitor	NA	Visual inspection (positive)	-	2 Units	Good Maintenance Only	Priority 4: Negligible Risk Level	Remove prior to demolition works (if required)

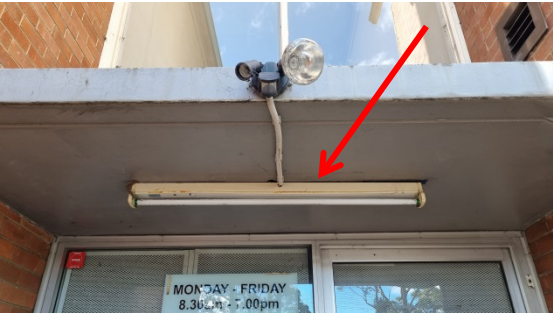
Ceiling	PCB containing single tube fluorescent light fittings	NA	Visual Inspection (positive)	-	2 Units	Fair Maintenance Only	Priority 4: Negligible Risk Level	Remove prior to demolition works

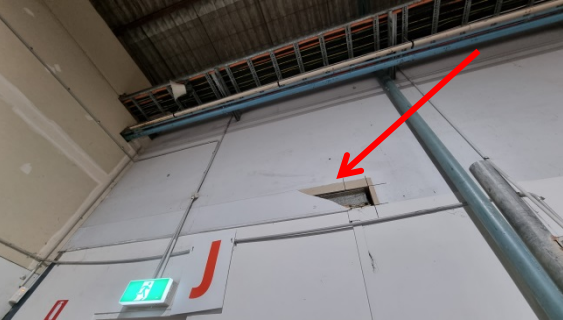
Location	Material Type	Friability	Sample	Analysis Result:	Quantity	Condition and Accessibility	Priority	Recommendations/ Comments	Photograph of material
Internal - First floor									
Inaccessible/Limited Access									
Internal, subfloor and ceiling spaces	Potential hazardous materials	Unknown	Inaccessible	-	Not determined	Unknown Maintenance only	Unknown	Inaccessible at the time of inspection due to height restriction and safety concerns.  When areas are accessible, confirm status of hazardous materials.	
Asbestos									
Infill panels (warehouse area)	Asbestos cement sheeting	Non-friable	Visual inspection (positive)	-	NA	Fair Maintenance Only	Priority 4: Negligible Risk Level	Remove prior to demolition works

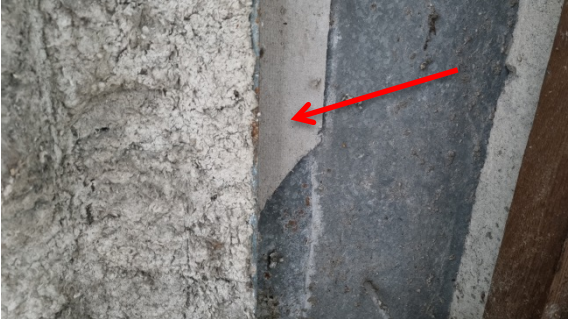
Asbestos cement sheeting	Non-Friable	A3	Amosite, Chrysotile & Crocidolite Asbestos Detected	NA	Fair Maintenance Only	Priority 4: Negligible Risk Level	Remove prior to demolition works

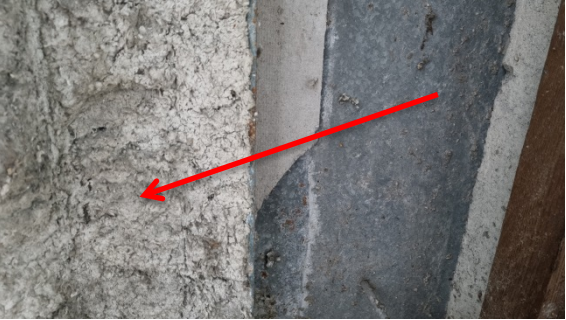
Walls and support beam ceiling (warehouse area)	White spongy fibrous material	A2	No asbestos detected	Throughout	-	-	-

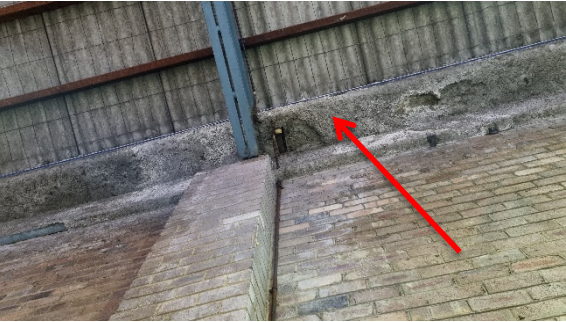
Ceiling building edges (warehouse area)	Grey spongy fibrous material	Friable	A4	No asbestos detected SMF detected	Throughout	Fair Regular and Maintenance Only	Priority 3: Low Risk Level	Remove prior to demolition works

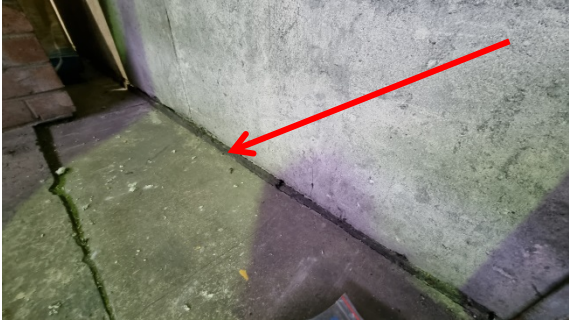
Floor (warehouse area)	Sealant	Non-friable	A5	No asbestos detected	<20m <sup>2</sup>	-	-	-

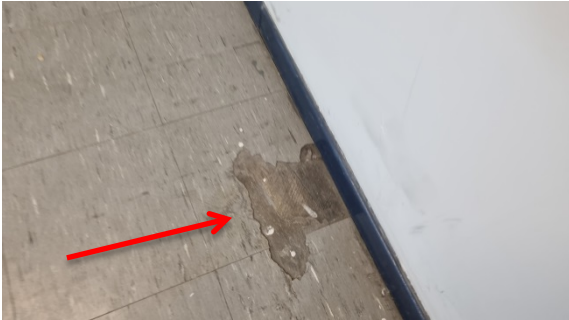
Floor – (office area)	Grey vinyl floor tile	Non-friable	A6	No asbestos detected	<50m <sup>2</sup>	-	-	-

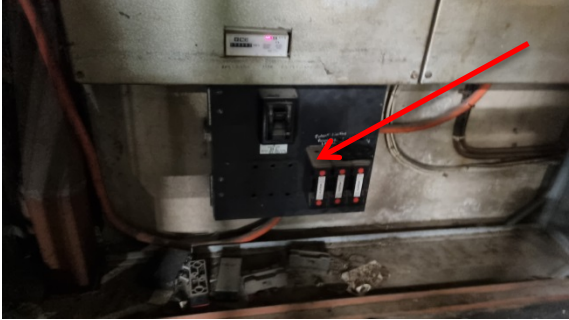
Electrical switchboard	Back board and millboard	Non-friable	Visual inspection (positive)	-	6 Units	Good Maintenance Only	Priority 4: Negligible Risk Level	Remove prior to demolition works

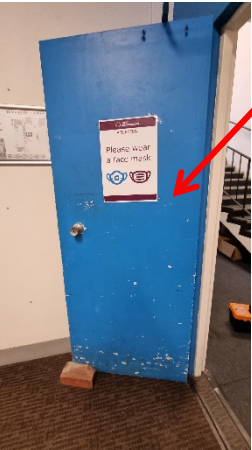
Doors	LBP	Not flaking	Visual Inspection (positive)	-	Throughout	Good Regular and Maintenance Only	Priority 4: Negligible Risk Level	Remove prior to demolition works

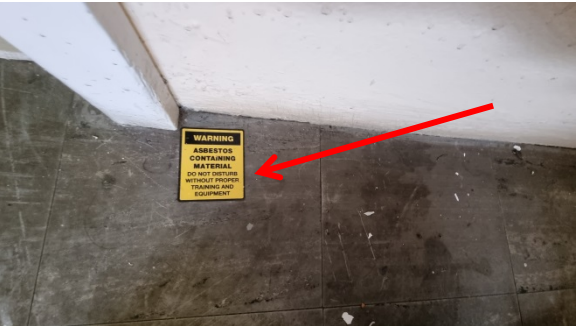
Floor (bathroom)	Grey vinyl floor tile	Non-friable	Visual inspection (positive)	-	<20m <sup>2</sup>	Fair Regular and Maintenance Only	Priority 4: Negligible Risk Level	Remove prior to demolition works

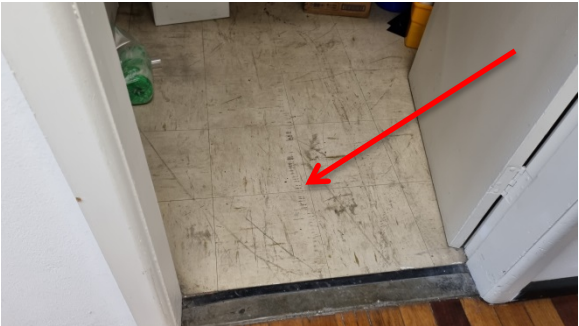
Floor (cleaning room)	Cream vinyl floor tile	Non-friable	A7	No asbestos detected	<10m <sup>2</sup>	-	-	-

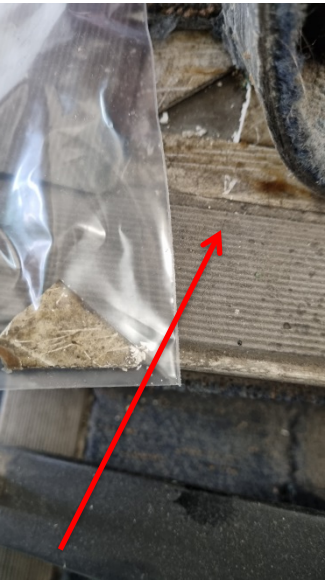
Beneath carpet	Cream vinyl floor tile	Non-friable	A8	No asbestos detected	NA	-	-	-

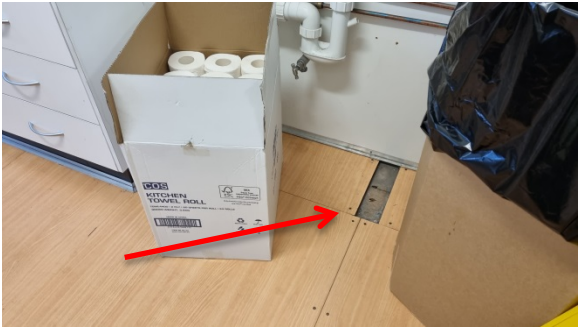
Beneath wooden floor	Grey vinyl floor tile	Non-friable	A9	No asbestos detected	NA	-	-	-

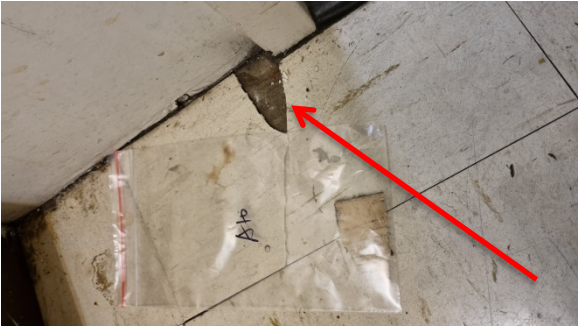
Floor (kitchen)	White vinyl floor tile	Non-friable	A10	No asbestos detected	<10m <sup>2</sup>	-	-	-

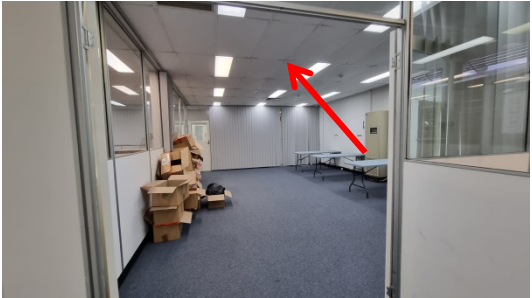
SMF									
Ceiling (office area)	Compressed SMF	NA	Visual inspection (positive)	-	Throughout	Fair Maintenance Only	Priority 4: Negligible Risk Level	Remove prior to demolition works

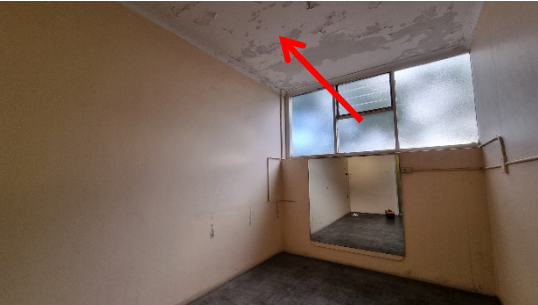
Ceiling (bathroom)	White LBP	Flaking	P1	0.049%w/w	<10m <sup>2</sup>	-	-	-

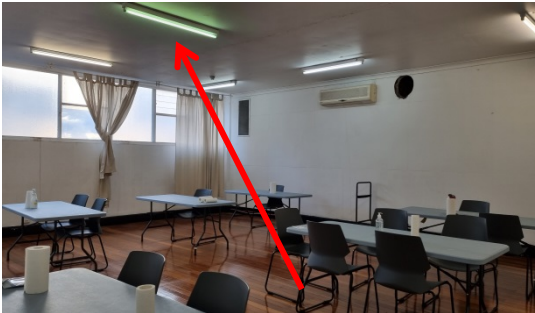
Ceiling	PCB containing single tube fluorescent light fittings	NA	Visual Inspection (positive)	-	Throughout	Good Maintenance Only	Priority 4: Negligible Risk Level	Remove prior to demolition works

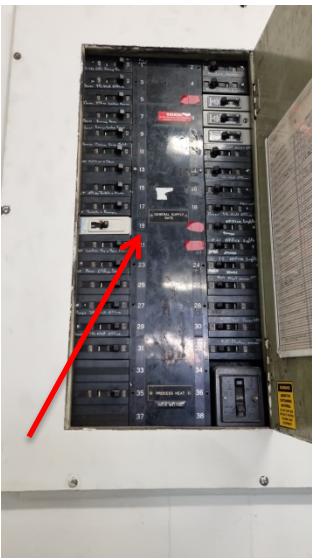
Electrical switchboard	PCB containing capacitor	NA	Visual Inspection (positive)	-	6 Units	Fair to Good Maintenance Only	Priority 4: Negligible Risk Level	Remove prior to demolition works
