Structural Engineering Peer Review - Structural Response to Applicant's Response to Submissions Report

North Sydney Olympic Pool Redevelopment DA 347/19

North Sydney Council / 3 June 2020

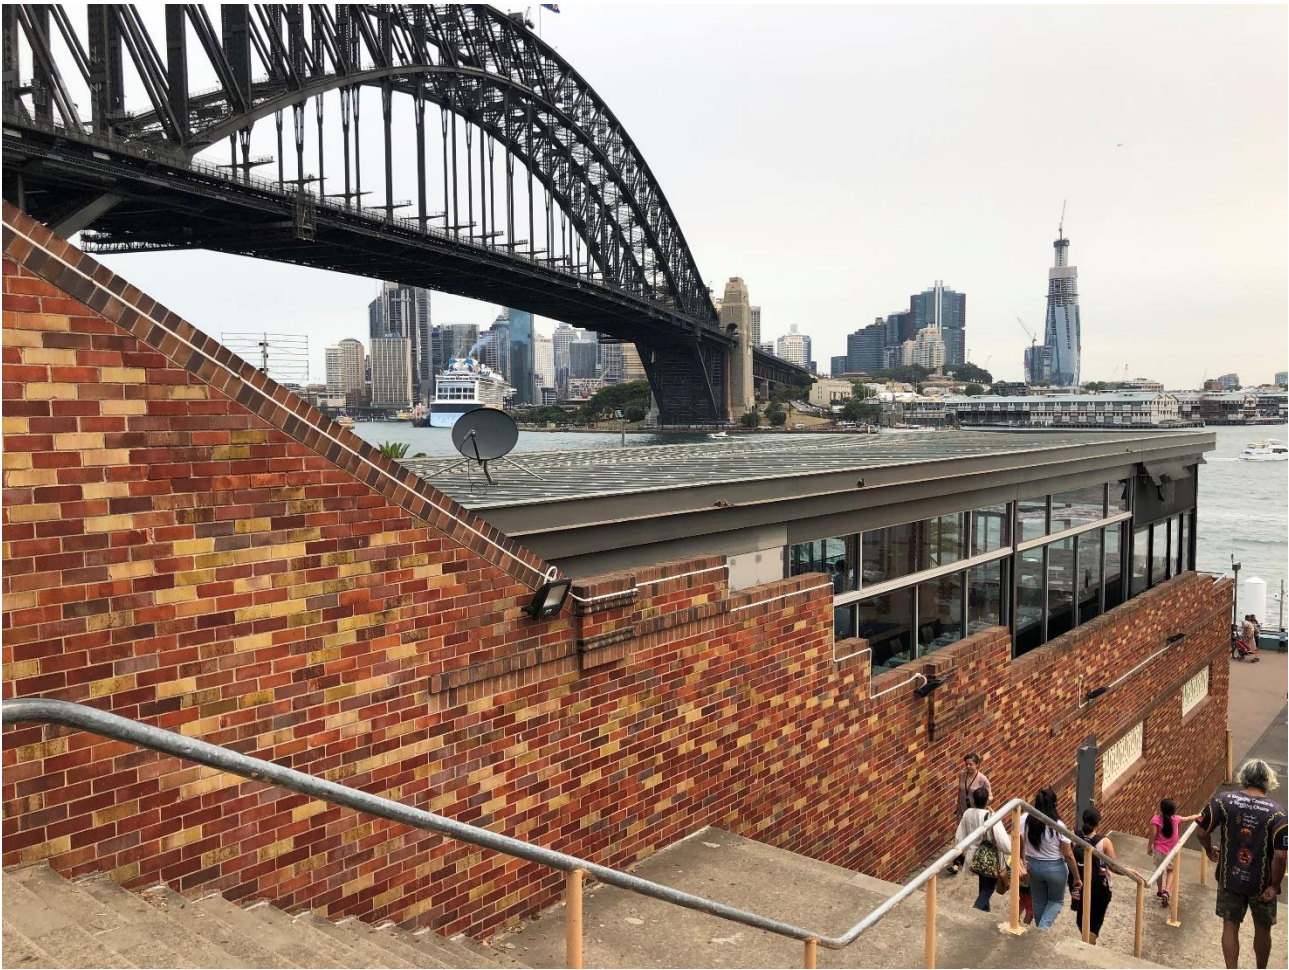
- Upstand hobs along the sides of the staircase will alter the appearance of the staircase and its relationship to the polychrome brickwork. Presently, the stair treads abut walls either side of the staircase without hobs. Introducing hobs will result in details different to the two photographs on page G-24 of Appendix G, the Landscape Report and Plans, referenced by the Applicant's Response to Submissions Report.

- From the brickwork bond and period of construction, it is our assessment that the polychrome brickwork wall is a cavity wall. The means by which a cavity wall prevents water penetrating and entering a building is via the cavity. Typically, the cavity channels any rainwater that penetrates the outside skin (and cappings) to cavity flashings that then drain the water externally. Presently the cavity wall passed the staircase and the staircase abuts the wall – there are no cavity flashings above the staircase level to drain water via. Therefore, removing the wall beneath staircase level – to open the sub-stair space as an indoor gymnasium space – will cause the cavity to drain into the building unless cavity flashings are constructed above the staircase level, i.e. above new roof level. NCC Performance Requirement FP1.4 requires that, 'A roof and external wall (including openings around windows and doors) must prevent the penetration of water that could cause (a) unhealthy or dangerous conditions, or loss of amenity for occupants; and (b) undue dampness or deterioration of building elements'. In our opinion a hob and pressure seal to the wall face, as described by the Applicant's project team's response, will not prevent the penetration of water and will therefore not meet NCC Performance Requirement FP1.4.

Figure 1 - Western wall and staircase – Presently the concrete staircase appears to be constructed against the wall, and the cavity wall runs past the staircase to the ground. Removing the wall – to open the space beneath the staircase as habitable space – and reconstructing the staircase as a roof will require a waterproofing detail that meets NCC Performance Requirement FP1.4.

- Describing a joint as being both 'drained and sealed' is not understood by us. A sketch of this detail by the Applicant's project team would be of assistance to understand how waterproofing will be achieved.
