Structural Engineering Peer Review

North Sydney Olympic Pool Redevelopment

DA 347/19

North Sydney Council / 28 February 2020

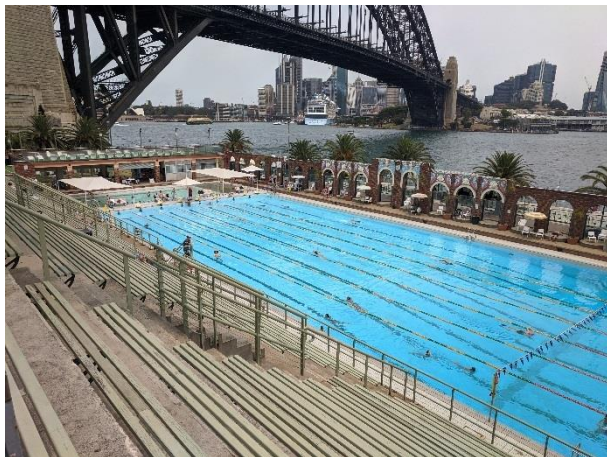
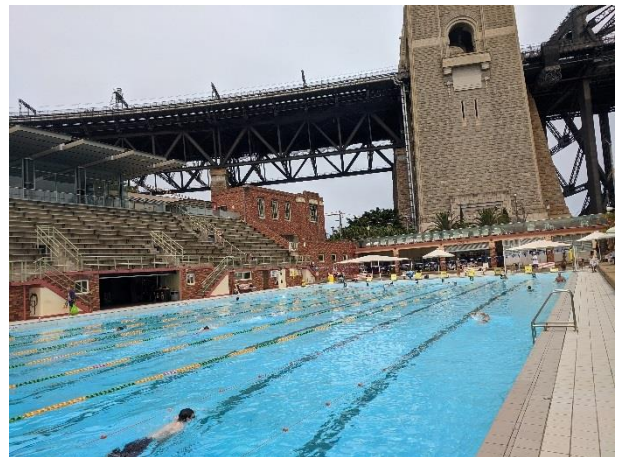
- Pool deck tiles are drummy, indicating delamination from the substrate below.
- TTW was advised by the facilities manager that the pool deck along the harbour side has previously had load restrictions placed on it, following a structural review.
- TTW was advised that access below the pool deck was not possible due to the area being a confined space. It is understood from Mott MacDonald's structural report that water penetrates between the pool walls and bottom slab.

Figure 3 – Existing 50m Pool Overview

Figure 4 – Existing 50m Pool Overview

In our opinion, options for conserving the existing concrete structure of the 50m pool are limited because of the reported poor condition of reinforced concrete and continuing water leaks. It is unlikely that the pool slab will be able to be kept as any moisture in the ground will continue to corrode reinforcement and the expansion

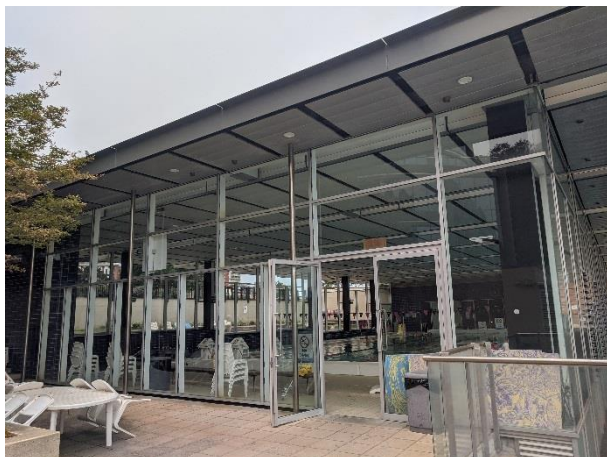
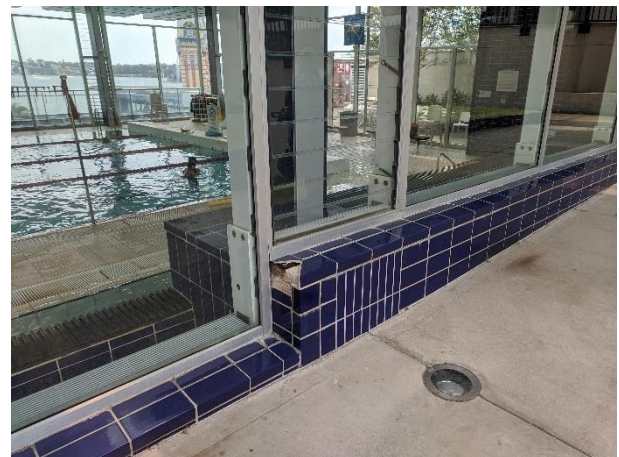
- The steel framed roof canopy is in a deteriorated condition, with corroded structural steel and cladding sections noted, and significant paint peeling.
- Several steel connections to concrete hobs are in a severely corroded condition.
- Concrete vertical sections below ground, forming the pool structure show efflorescent staining but the concrete appears sound. There was no evidence of reinforcement corrosion observed.

Figure 5 – existing indoor pool structure overview

Figure 6 – existing indoor pool structure

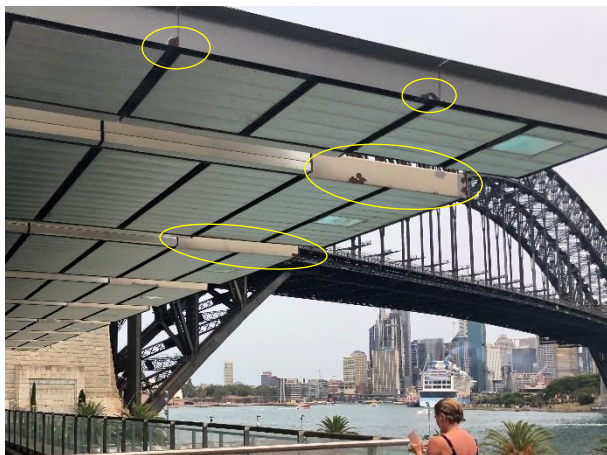
The existing pool hall building is in a relatively unmaintained state in terms of general building maintenance and is showing its age. The swimming pool environment and proximity to the harbour both generate microclimates that are aggressive to painted steel and aluminium. This would have been considered when the building was designed, however the long period since the building was last painted to protect it is evident. There is corrosion to structural steel and cladding sections – such as steel eave fascia – and there is significant peeling of paint more generally. Tiling around the bottom of the glazed walls have spalled, revealing heavily corrode structural steel baseplates.

Figure 7 – Areas where corrosion is occurring – typical of all fascia

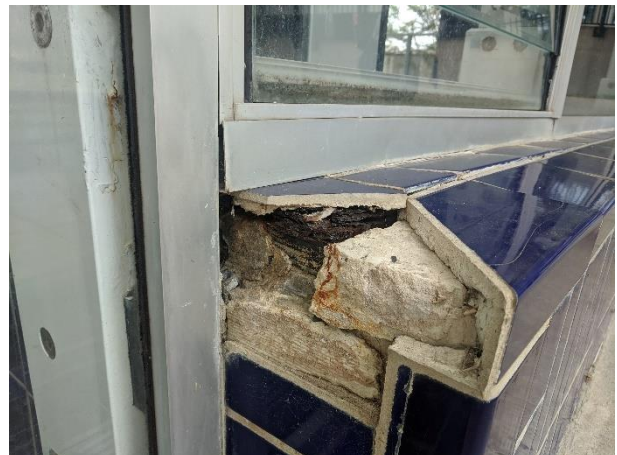
Figure 8 – External view. Spalled tiles at base of glazing revealing severely corrode structural steel baseplate. Painted steel frame to left of photo (inside building) also significantly corroded.

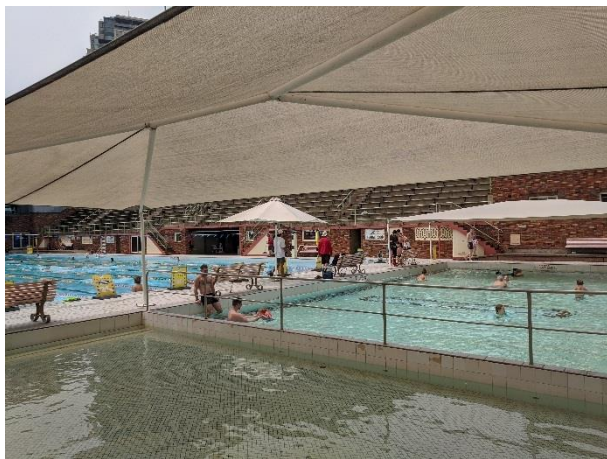
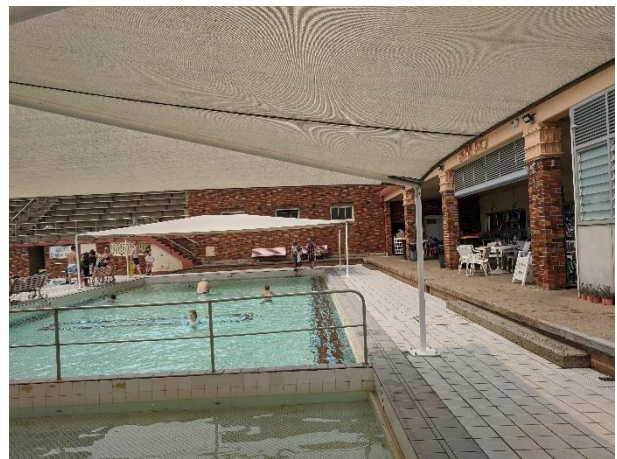
- The shade cloth is in an aged condition and requires cleaning. Shade cloth of this type has a short life, of say a maximum 10 years, before it needs replacing.
- The steel structure supporting the shade cloth is in a deteriorated condition with corrosion visible and paint peeling.
- Floor tiles surrounding the pool are drummy indicating delamination from the concrete substrate below and likely water ingress.

Figure 9 – Existing Wading Pool and Shade Structure, looking across towards the children's pool

Figure 10 – Existing Wading Pool and Shade Structure, looking across at the children's pool

In our opinion, options for conserving the children's and wading pool structures as they stand are limited because of the age of the structure. The condition of reinforced concrete to these pools will be similar to that of the 50m pool, which concrete testing and investigations have shown to be poor. The modern, basic shade cloth structures above both these pools are also close to the end of their service life.

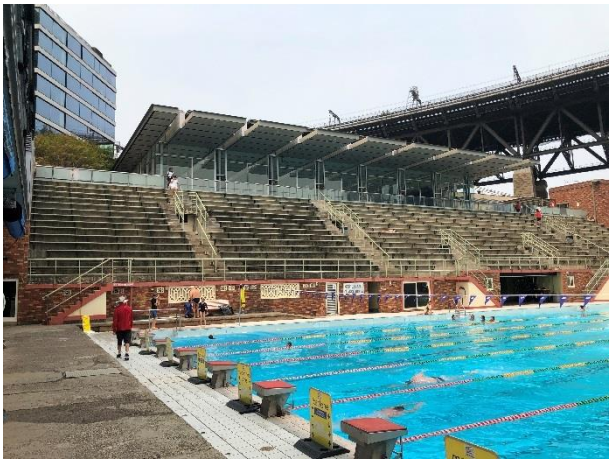
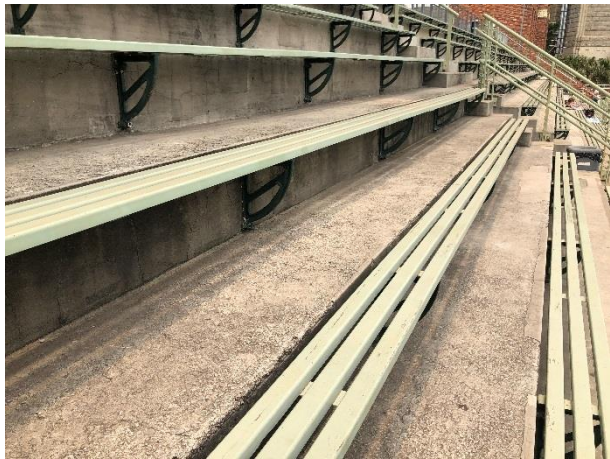
- Mahaffey Associates' investigations and tests found that the concrete cover to the reinforcement in the steps is inadequate, at 15mm. The depth of concrete carbonation exceeds the depth of reinforcement, making the reinforcement vulnerable to corrosion.

- Mahaffey Associates' concrete tests found that the chloride ion content exceeds recommended limits in several locations, giving rise to the risk of chloride-induced corrosion of reinforcement.

- Commencement of corrosion of reinforcement was evident where Mahaffey exposed reinforcement in four locations.
- From our observations, in some locations spalling of concrete is occurring, indicating the corrosion of reinforcement.

- Concrete patch repairs have been previously made to the exposed upper faces of the grandstand terrace at numerous locations, with render repairs in several locations.

Figure 11 – Grandstand overview

Figure 12 – Grandstand terrace

We concur with Mott MacDonald's general view on the strength and load capacity of the grandstand. We would also advise that in our opinion it does not meet NCC requirements for access and egress. In addition, there are vertical supports – reinforced concrete columns – beneath the back of the grandstand that we believe to be corroded and spalled; where encasing brickwork is cracked vertically. These would need to be repaired and strengthened to allow the grandstand to be reused.

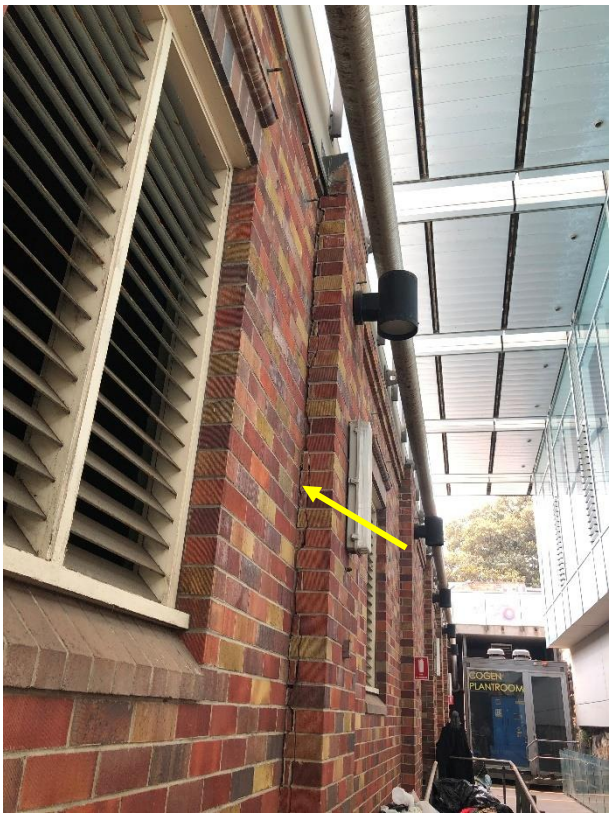
- Below the terrace, there is significant cracking of brickwork that encases concrete columns. We strongly suspect that this indicates corrosion and expansion of the column reinforcement and spalling of the columns. If this is the case this is of significant structural concern.

Figure 13 – Vertically cracked brickwork encasing a column to the back of the grandstand, which suggests that the column reinforcement is likely corroding and the concrete spalled

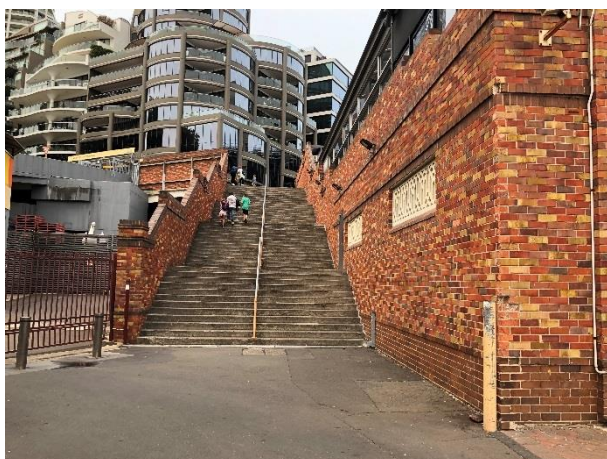
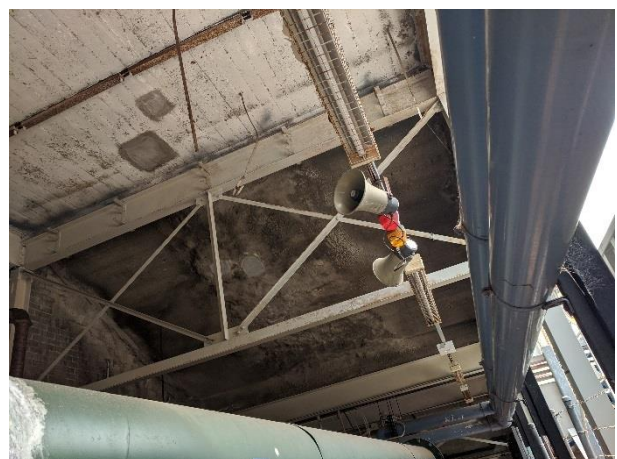
- From below, the concrete landings and treads appear to have undergone significant patch and sprayed concrete repairs over time.
- Supporting structural steelwork is in a corroded condition. Close access to inspect the extent and severity of corrosion and measure sections was not possible at our inspection, however from photographs taken severe corrosion pitting can be seen to some sections, indicating loss of steel section and strength.
- The Brickwork wall along the north-west side of the staircase, facing Luna Park has steel post and rail stiffeners behind it, strengthening the brickwork⁷. The strength and integrity of this wall is unknown.

Figure 14 – Existing Western Staircase Overview

Figure 15 – Existing Western Staircase Underside

The steelwork supporting the western staircase is corroded and the suspended concrete landings and flights have been extensively repaired previously. In our opinion, options for conserving and reusing the staircase are limited because of its poor condition. Also, it would not be effective and waterproof as a roof to enclose the proposed gym and plantroom extensions.

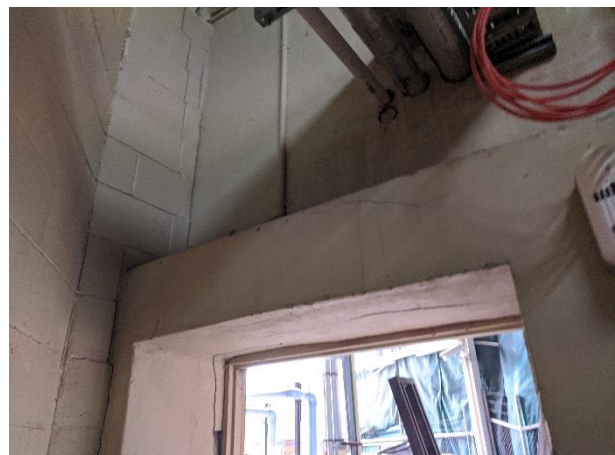
Figure 17 – Cracking Around Plantroom Door Entrance

It is reasonable that redevelopment of the pool complex to the extent proposed will require new and extended plantrooms. The walls marked for demolition are back-of-house and in poor condition. The north-western wall is badly cracked around the door leading to the external area beneath the western staircase. This wall requires reconstruction, to support the reconstructed stair. In our opinion, there is limited scope to conserve these elements of the building.

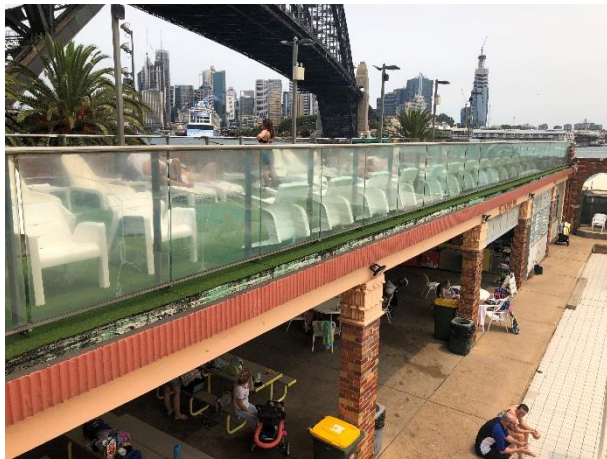
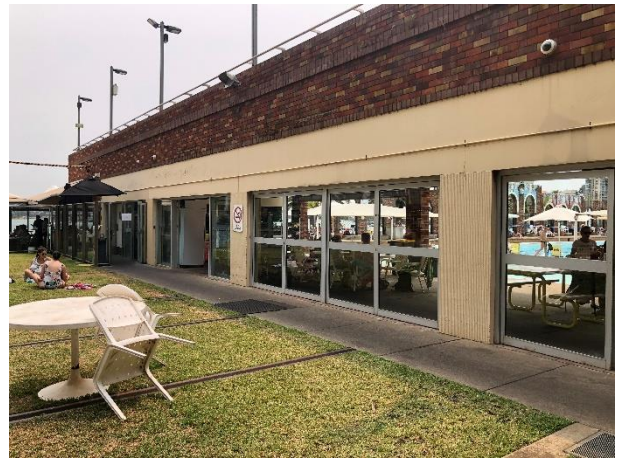
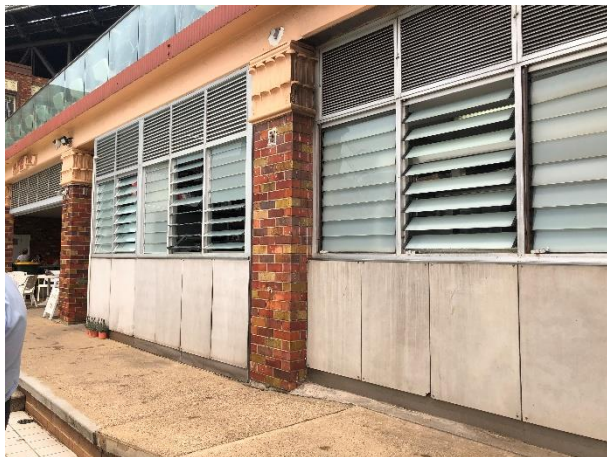
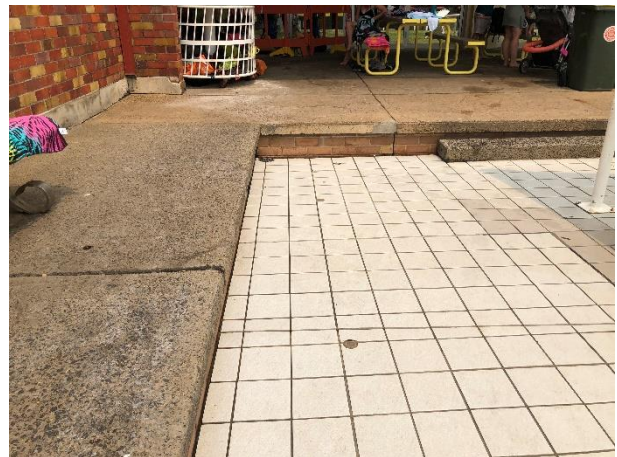
- Brick faces to several columns were deteriorating due to hard cementitious mortar having been used for repointing.
- Cracks were noted to concrete edge beams, suggesting the onset of reinforcement corrosion.
- Several cracks were noted to the sun deck masonry parapets, to the east and north.
- Plant growth was evident within bed joints around header courses in the masonry parapets.
- The existing brick parapets may require strengthening for earthquake actions.
- The aluminium door, window and louver frames are tired-looking and unattractive.
- The Ripples Café enclosure uses fibre cement which is dilapidated and unattractive.
- The colonnade beneath the sun deck (intended for children's pool and family use) has a concrete path around it at a higher level than the pool surround and not in keeping with the pool surround. The single step is a potential trip hazard for pool users.

Figure 18 – Sun deck and west elevation, facing the 50m pool

Figure 19 – Sun deck east elevation. Painted concrete, aluminium-framed glazed doors and original brick parapet above

Figure 20 – Back wall to Ripples Café, facing the wading pool. Aluminium-framed glazed louvres and fibre cement board in poor condition

Figure 21 – Concrete path surrounding sun deck at different level to pool

When taking down the sun deck we would advise that every effort be made to salvage bricks and other materials for repair works elsewhere in the complex.

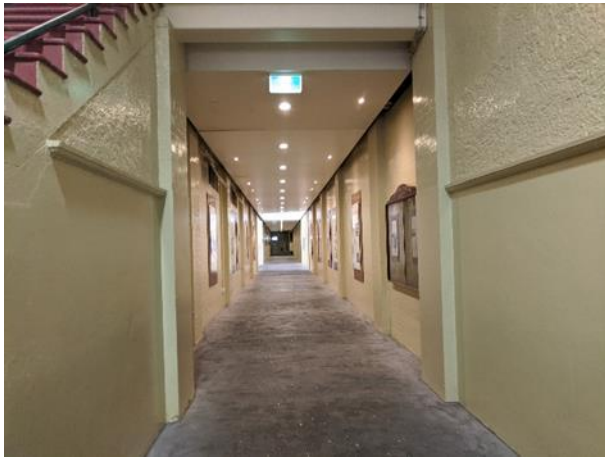
The eastern portion of the Hall of Fame, dating from 1936, appears to be in reasonable condition structurally and does not necessitate demolition. It presently provided connection from the lower entrance lobby to the central entrance onto the 50m pool. It provides a display area showcasing the history of the pool and World Records set.

Figure 22 – c1936 eastern portion of Hall of Fame, looking west from the N-E entrance lobby

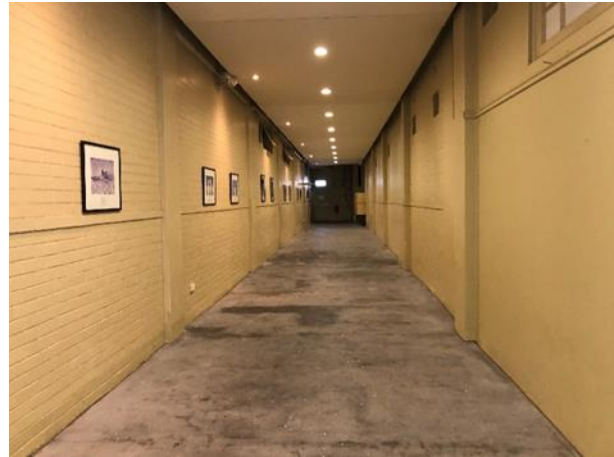
The western half – behind the male changing room – we understand is not original and the floor above is open to the elements albeit beneath the cantilevering roof of the 50m pool. The grandstand columns above this section are believed to be corroded and spalling.

Figure 23 – Non-original western portion of Hall of Fame, looking west

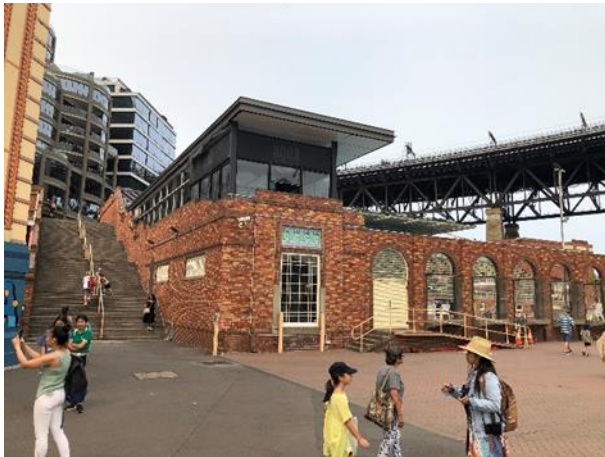
Figure 24 – Western Corner Building, adjacent to Luna Park

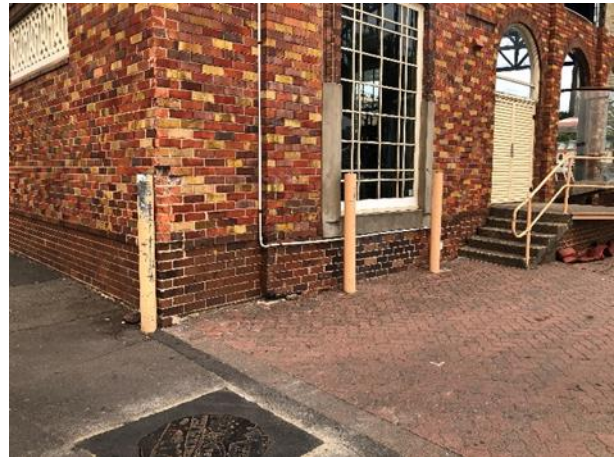
- To the south-west wall, facing the harbour, several cracks exist in the brickwork and concrete/rendered window surround section. The masonry below this area appears to be bowing outwards and may have subsided. It is possible that the base of the wall retains fill material and the lateral force is push the wall outwards. It is also possible that stormwater from the site is drained to the harbour via a pipe at this corner and if the pipe is broken it is causing washout of the foundation. Equally, the 50m pool may leak at this corner. This is the only point on the site where we observed apparent settlement of a masonry wall. The cause(s) of this movement should be investigated and repaired, and the wall underpinned if necessary

Figure 25 – Wall face (beneath window) where settlement appears to have occurred

Before development works at this corner proceed, we would recommend that the cause(s) of the apparent movement or settlement of the harbour-facing wall be investigated. The cause of movement should be repaired, and the wall underpinned if necessary.

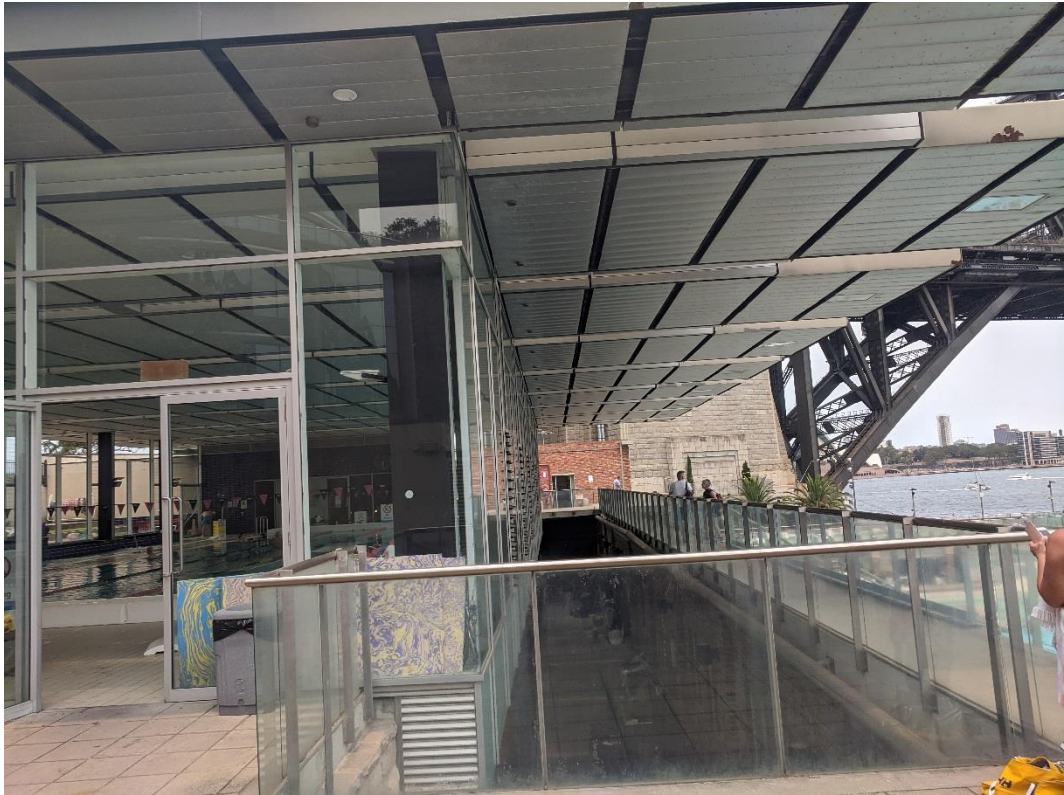
- Balustrades to the pool side of the grandstand and steps are in a very heavily corroded condition.
- Brick infill walls below the grandstand along the pedestrian area adjacent to the pool were in generally reasonable condition but with vertical cracking at door entrances and return corners. This was not investigated but may indicate corrosion of embedded steel elements.

Figure 28 – Balustrade Above Pool Grandstand

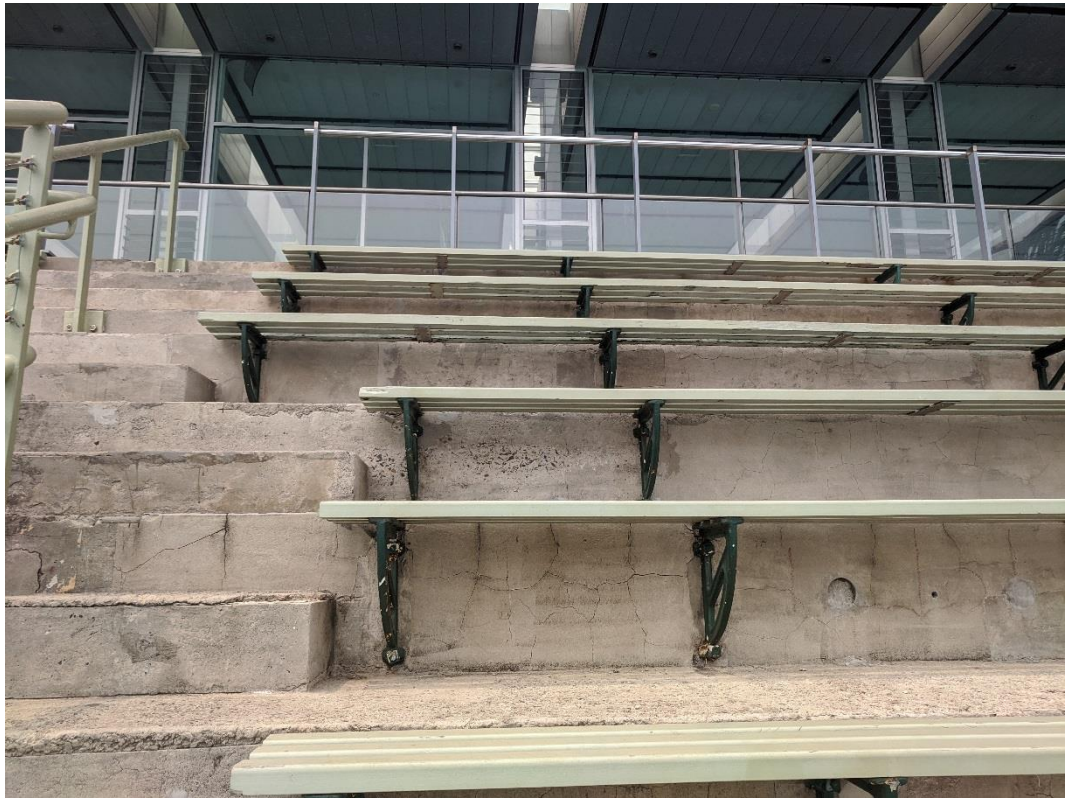
Figure 32 – Render Delaminating from Concrete Grandstand

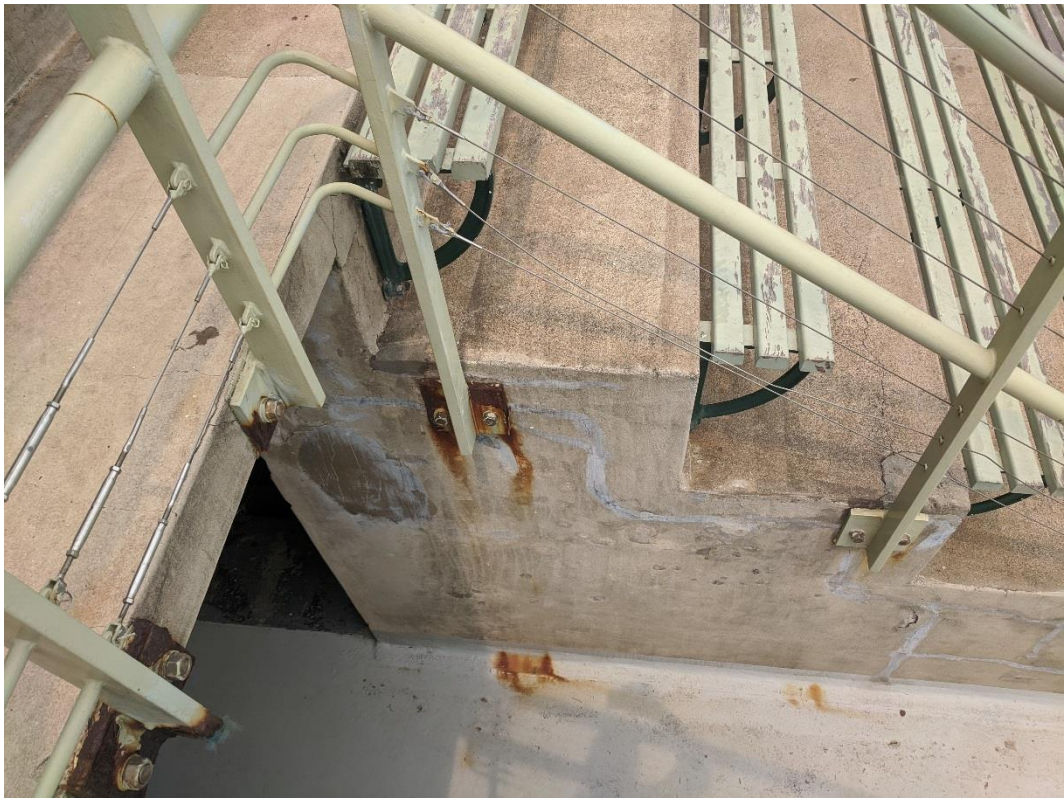
Figure 33 – Corrosion to Balustrade Base Plates to Grandstand

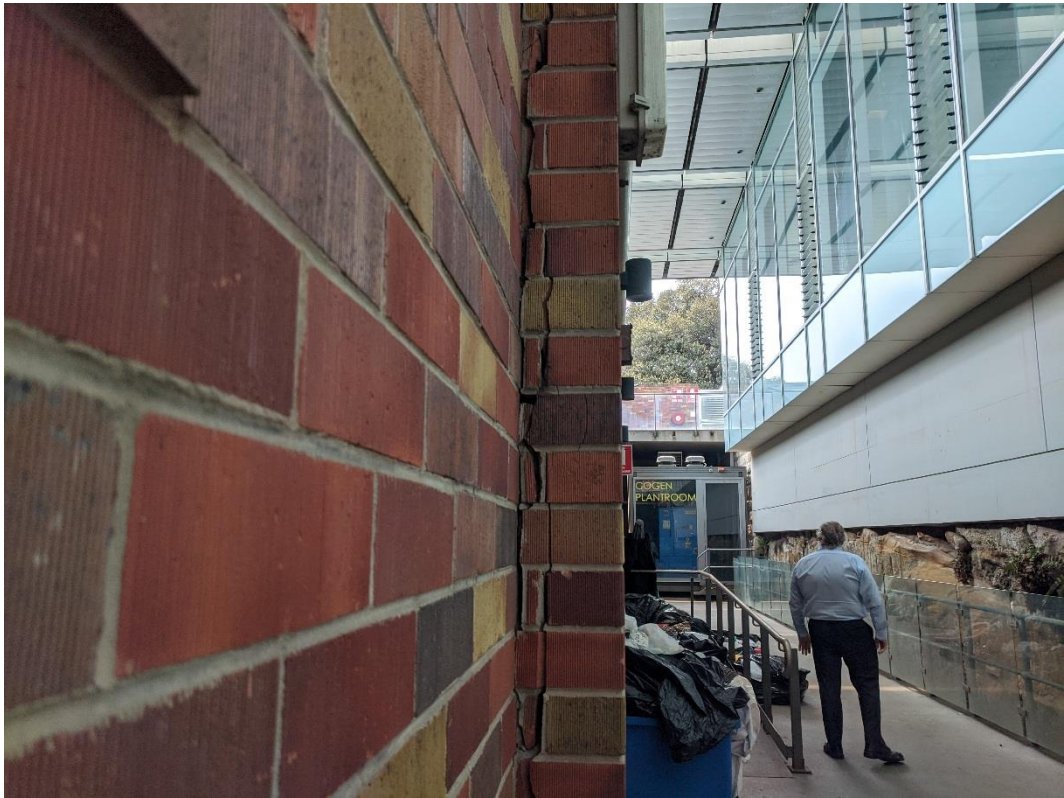
Figure 34 – Cracking to Masonry Skin to Grandstand Concrete Column (Likely Corrosion of Reinforcement)

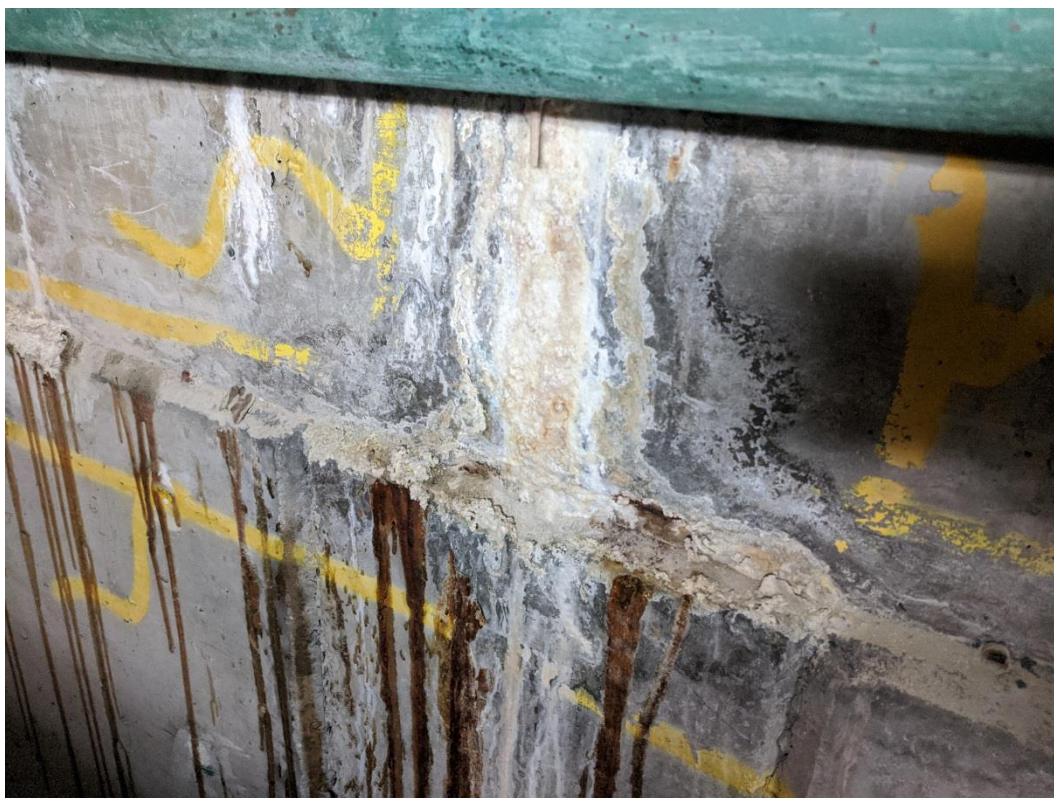
Figure 35 – Significant Efflorescent Staining to Underside Of 25m Pool

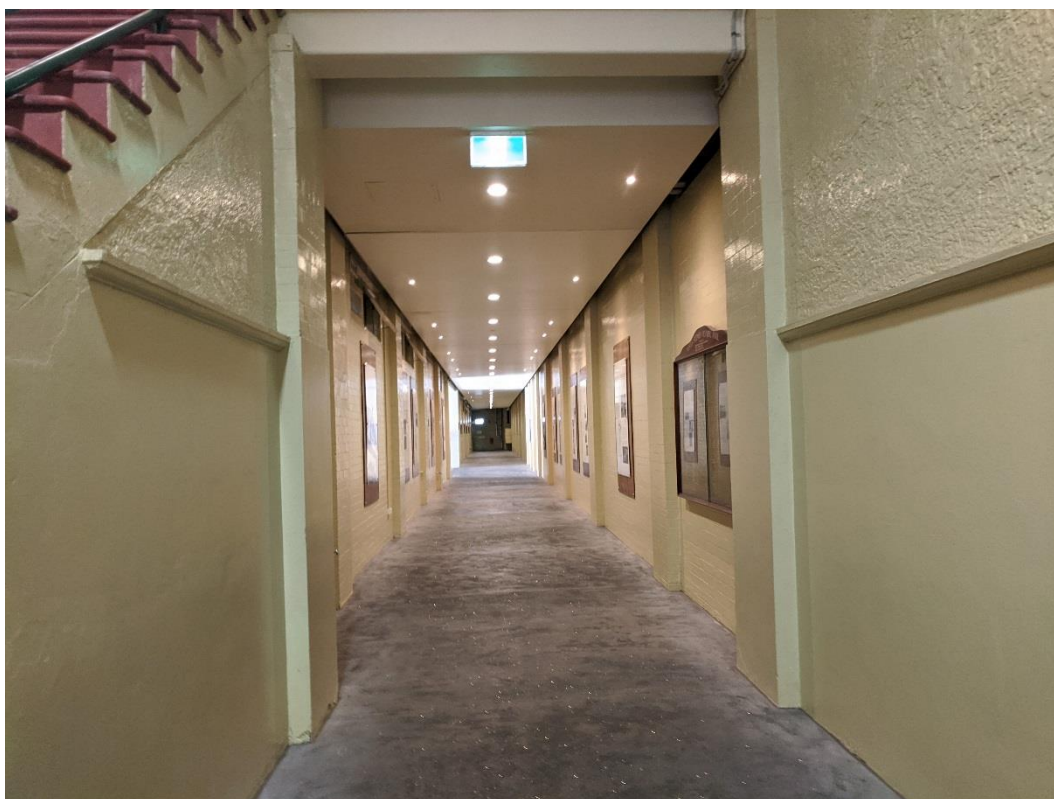
Figure 36 – Overview of Eastern Portion of Hall of Fame (Masonry Walls in Good Condition)

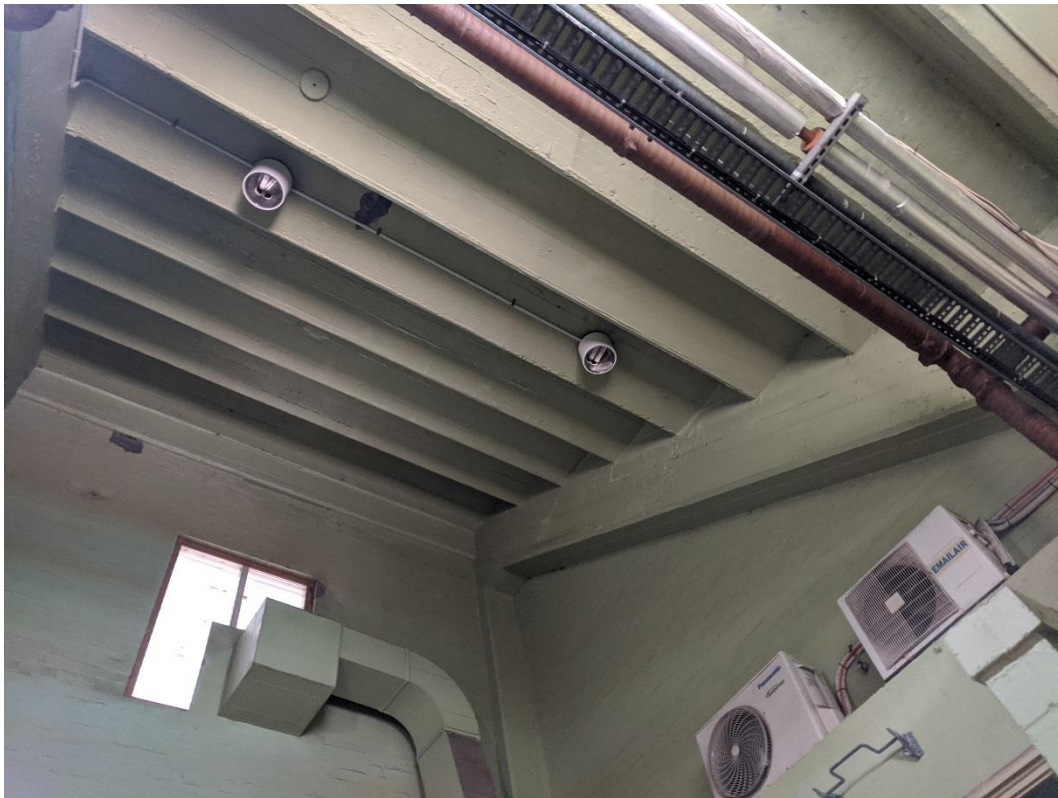
Figure 37 – Overview of Grandstand Concrete Soffit (Areas of Previous Repair Observed)

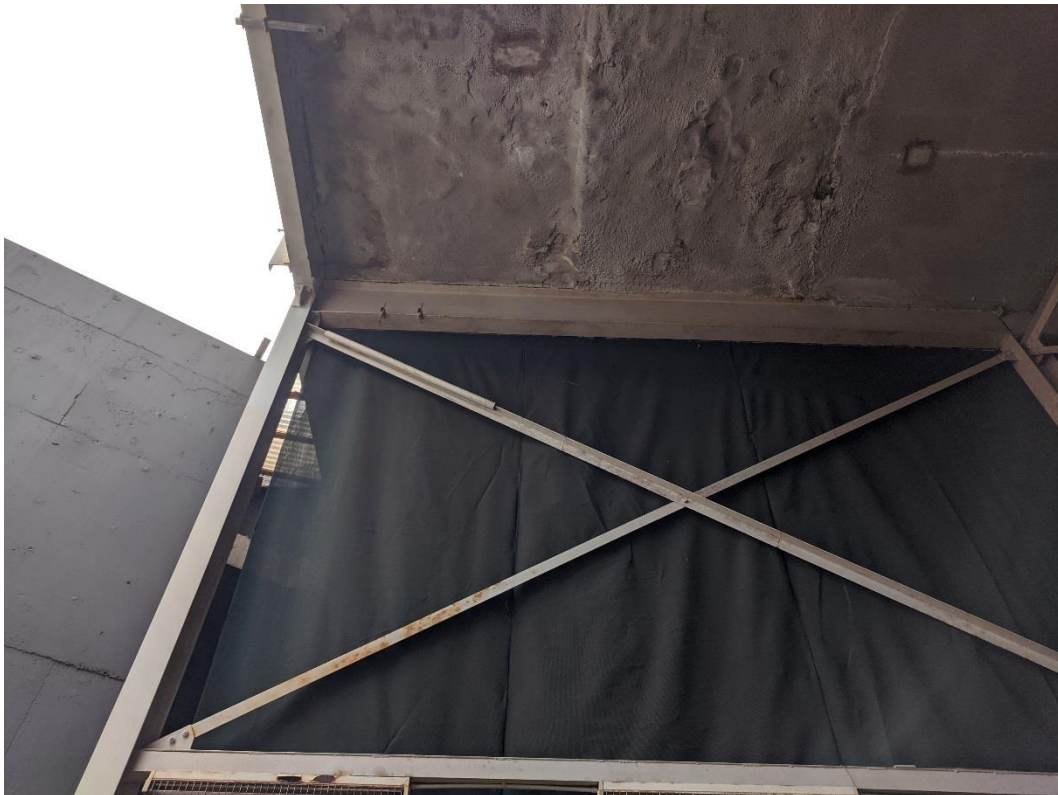
Figure 38 – Overview of Western Staircase Soffit in Deteriorated Condition

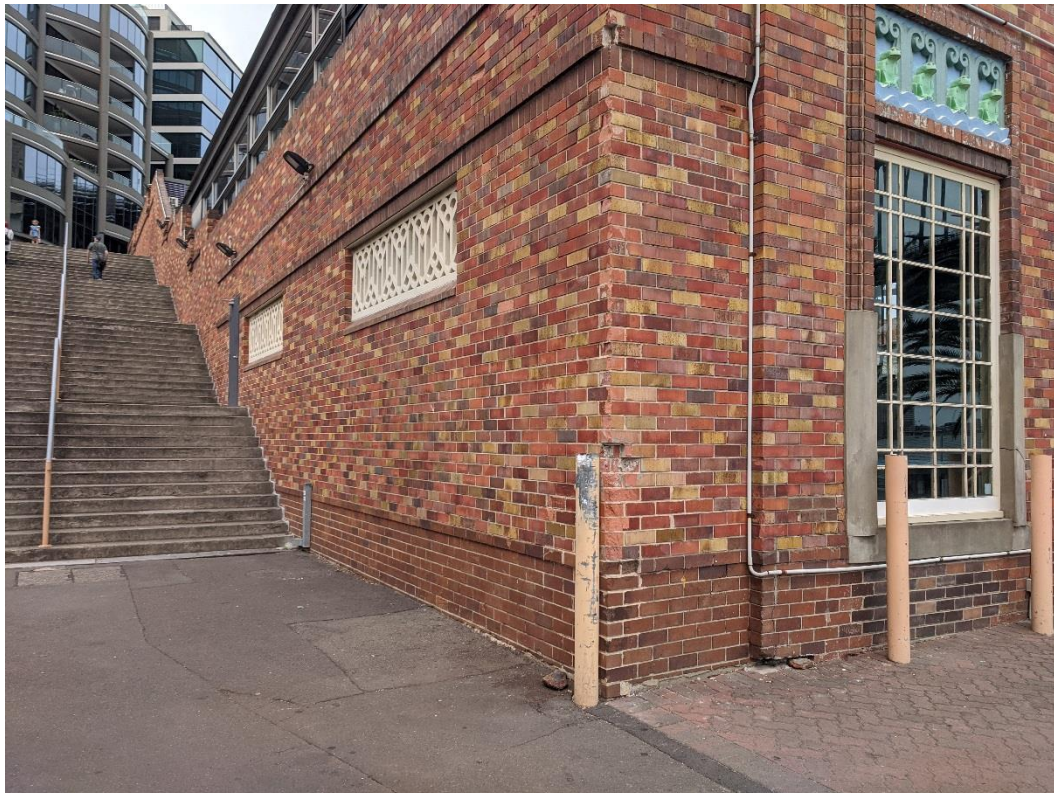
Figure 42 – Overview of Western Corner with Brickwork Requiring Remedial Repair and Possible Underpinning
