Arboricultural Impact Assessment Report V 3.0

Client: Taylor Developments Group Pty Ltd

Job Address: Castle Cove Country Club, 68 Deepwater Road, Castle Cove. NSW. 2069.

Date: 29 November, 2023

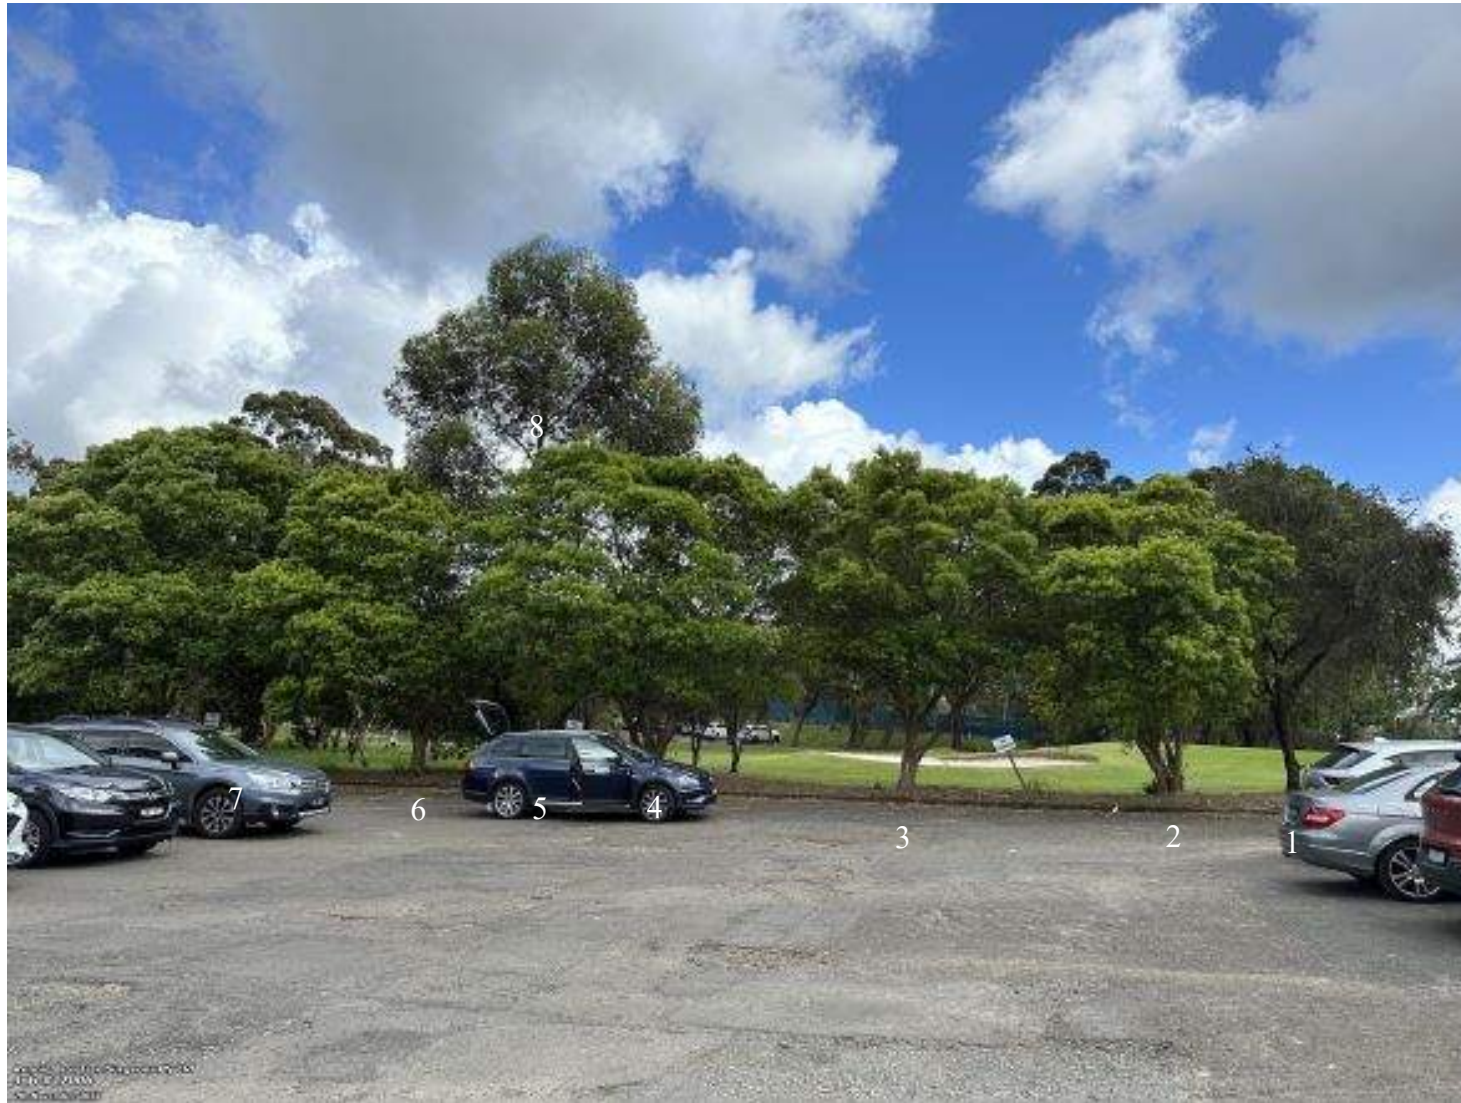
Photo 1: T1- *Callistemon viminalis*; T2, T3, T4, T5, T6, T7- *Tristaniopsis laurina*, T8- *Eucalyptus saligna*

- i. Eight (8) trees within this group are conflicted by the proposal and require removal: T1, T2, T3, T4, T5, T6, T7, T8. The author considers the Water Gums not to be visually prominent and could be replaced with more suitable long-lived specimens elsewhere on site. T9 is the best specimen of the group of Water Gums, is not impacted by the proposal and can be retained.

- ii. One (1) tree T8 Sydney Blue Gum has a High retention value, however is semi-mature and could be replaced with an advanced specimen (minimum 3mH) of the same species in a location suitable for long-term growth.

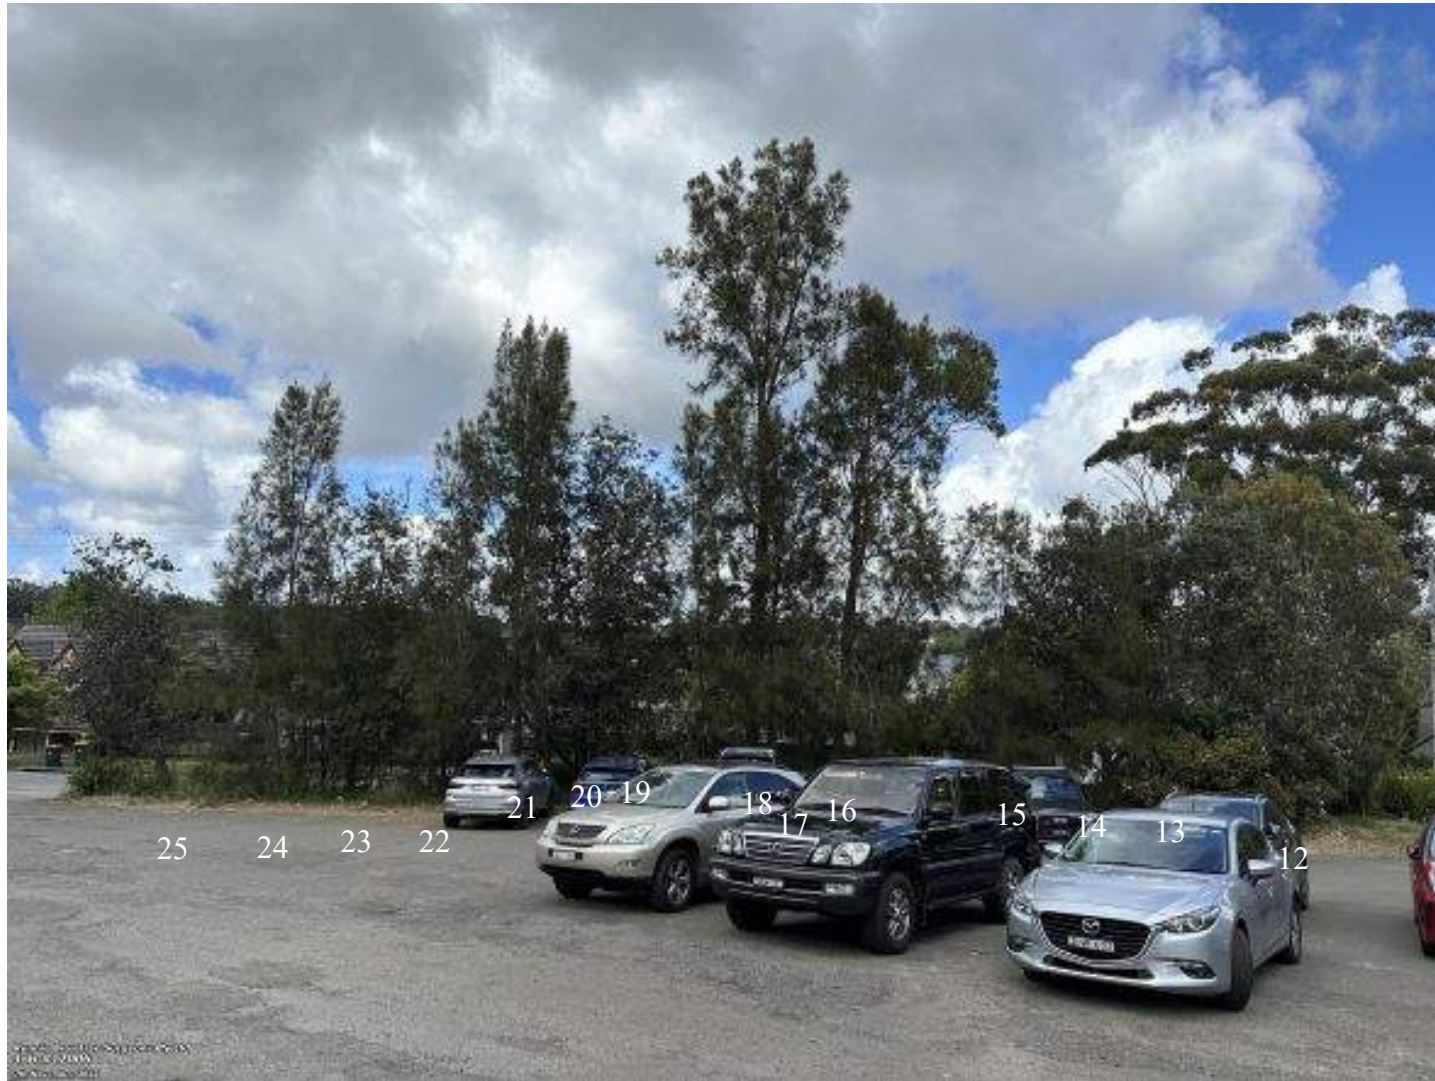
- b. Group 2 includes sixteen (16) trees: T10, T11, T12, T13, T14, T15, T16, T17, T18, T19, T20, T21, T22, T23, T24, T25. These Council trees are growing within the grass verge along Deepwater Road. The trees are over-crowded by adjacent trees with many self-sown *Casuarina*'s arising from the parent *Casuarina*, T18. These trees have a Low to Medium retention values and due to their fair to poor condition and smaller size could easily be replaced with more suitable, longer-lived species in alternative locations on site.

Assessment: <ul style="list-style-type: none"> • Council tree located on the Council verge on Deepwater Road. Photo 4. • This tree is part of the group of trees along Deepwater Road. They are overcrowded with limited available soil volume to enable adequate growth. • The tree is not impacted by the proposal and can be retained, however could be replaced by a longer-lived species selected from Willoughby Council's native tree list, refer to Appendix H: Willoughby City Council Recommended Street Trees and Native Planting. • Council approval is required for removal.

- ii. The Arborist recommends this group of trees are replaced with longer-lived species to improve the landscape design of the site. All of these trees have a Low STARS rating and are not important to retain. The trees could be replaced with longer-lived species selected from Willoughby Council's native tree list, refer to Appendix H: Willoughby City Council Recommended Street Trees and Native Planting.

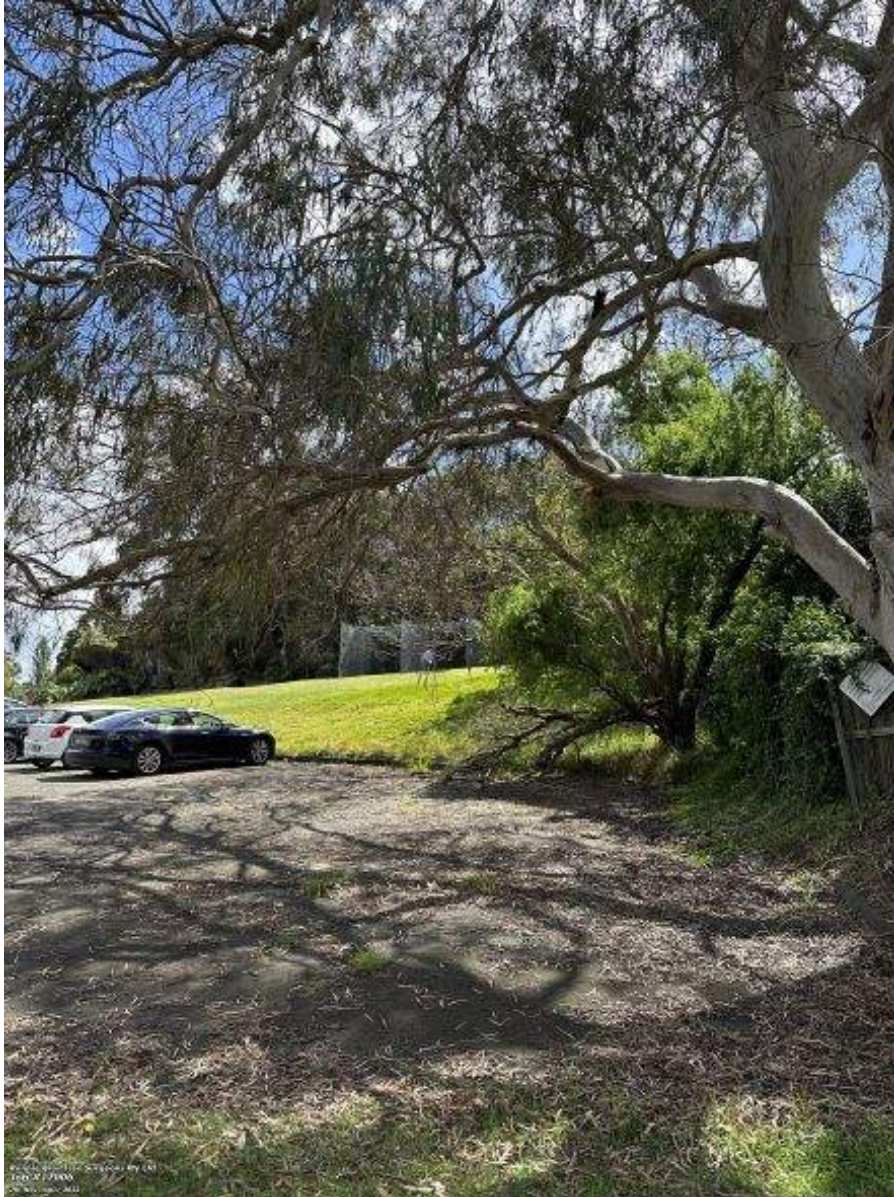
Photo 8: Tree 26- *Eucalyptus scoparia*, pruning required back to collar
 RENNIE BROS TREE SURGEONS AIA V3. 29/11/23, Castle Cove Country Club

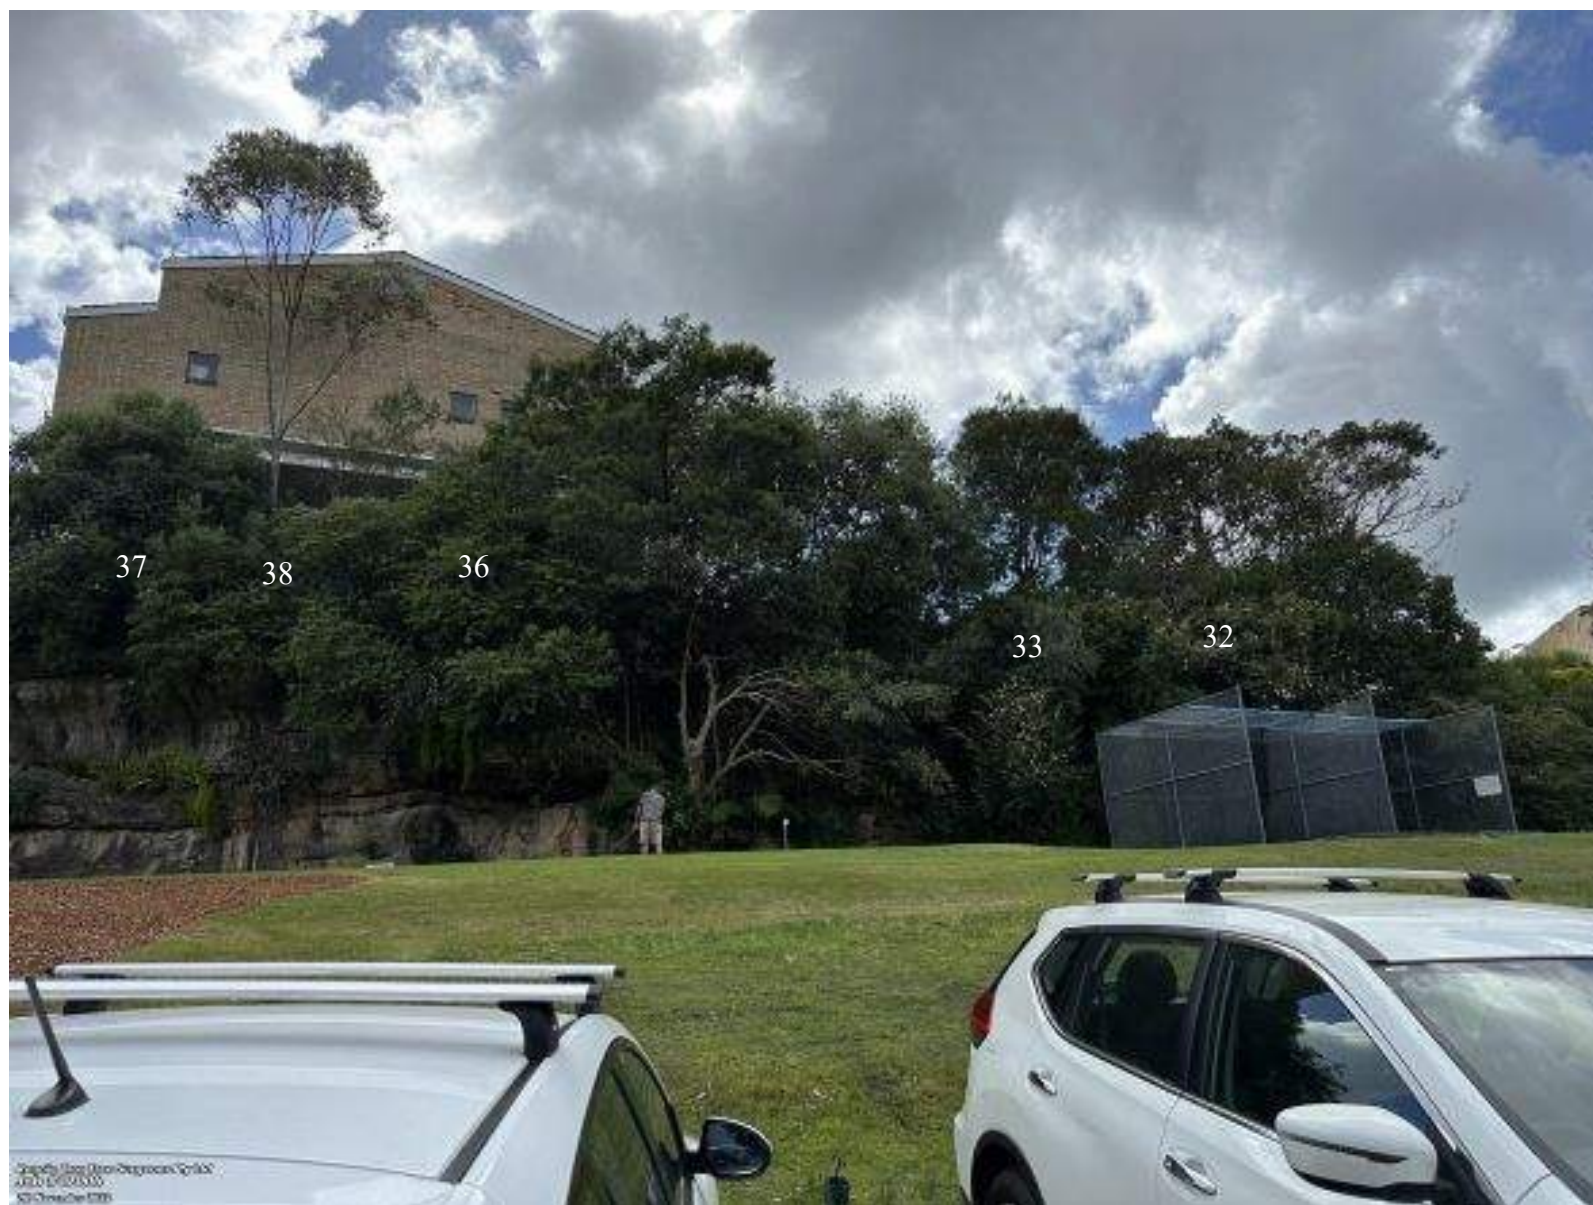
Photo 12: T32- *Ficus rubiginosa*, T33- *Allocasuarina littoralis*; T36, T37- *Oleo europaea subsp. cuspidata*, T38- *Eucalyptus species*
 RENNIE BROS TREE SURGEONS AIA V3. 29/11/23, Castle Cove Country Club

- d. Group 4 includes eight (8) trees: T31, T32, T33, T34, T35, T36, T37, T38. These site trees are growing on or below a steep embankment below the existing brick clubhouse at the rear of the site. The trees are over planted in an area with limited soil volume. All trees have a Low retention value, are not important to retain and could be replaced with better specimens.

- ii. Five (5) trees T31, T34, T35, T36, T37 are exempt species and can be removed without Council approval.
 - iii. T38 is a semi-mature *Eucalyptus species* growing on the side of an embankment with limited soil volume. The Arborist recommends replacing this tree with a better specimen in a location suitable for long-term growth. Council approval is required for removal.

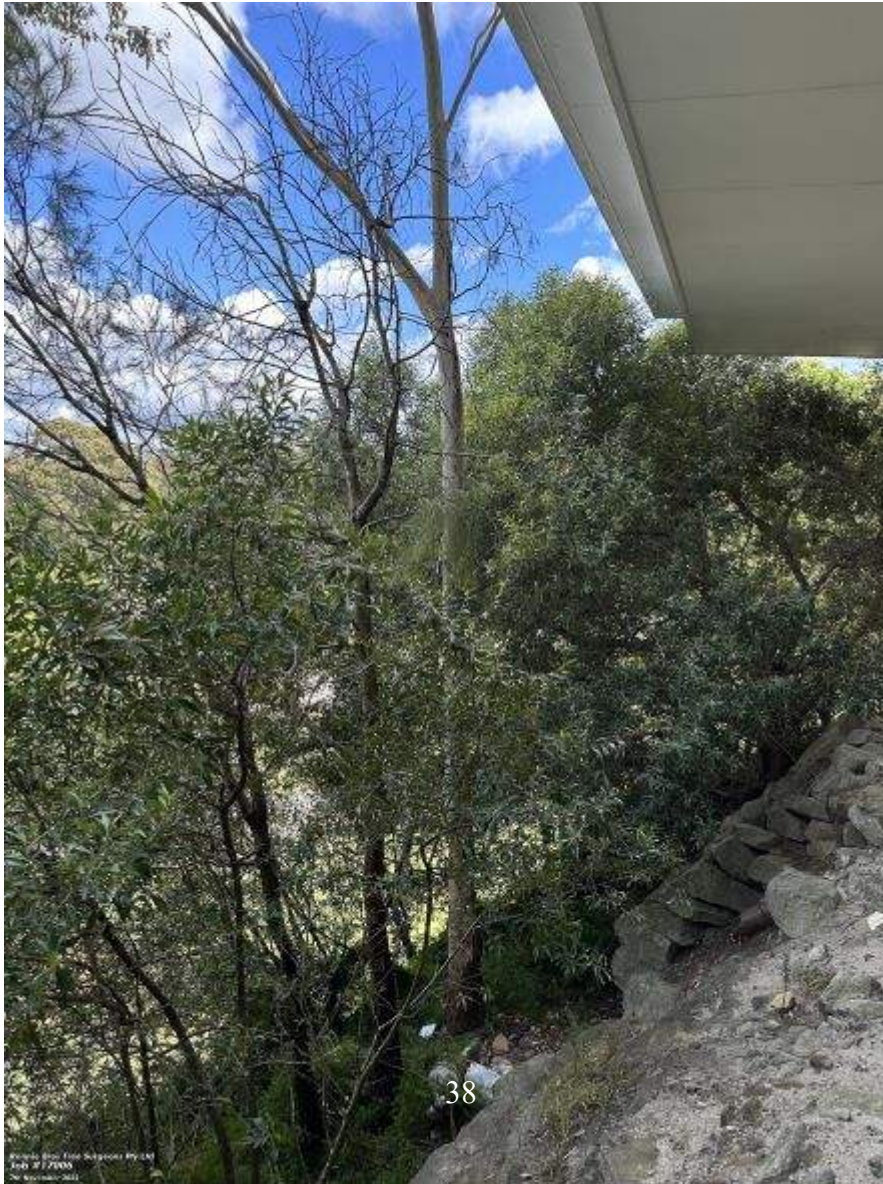
Photo 15: T38 – *Eucalyptus species*

- ii. One (1) of these trees, T38 is growing on the side of an embankment with limited soil volume. This tree could be considered for removal and replacement. Council approval is required for removal.

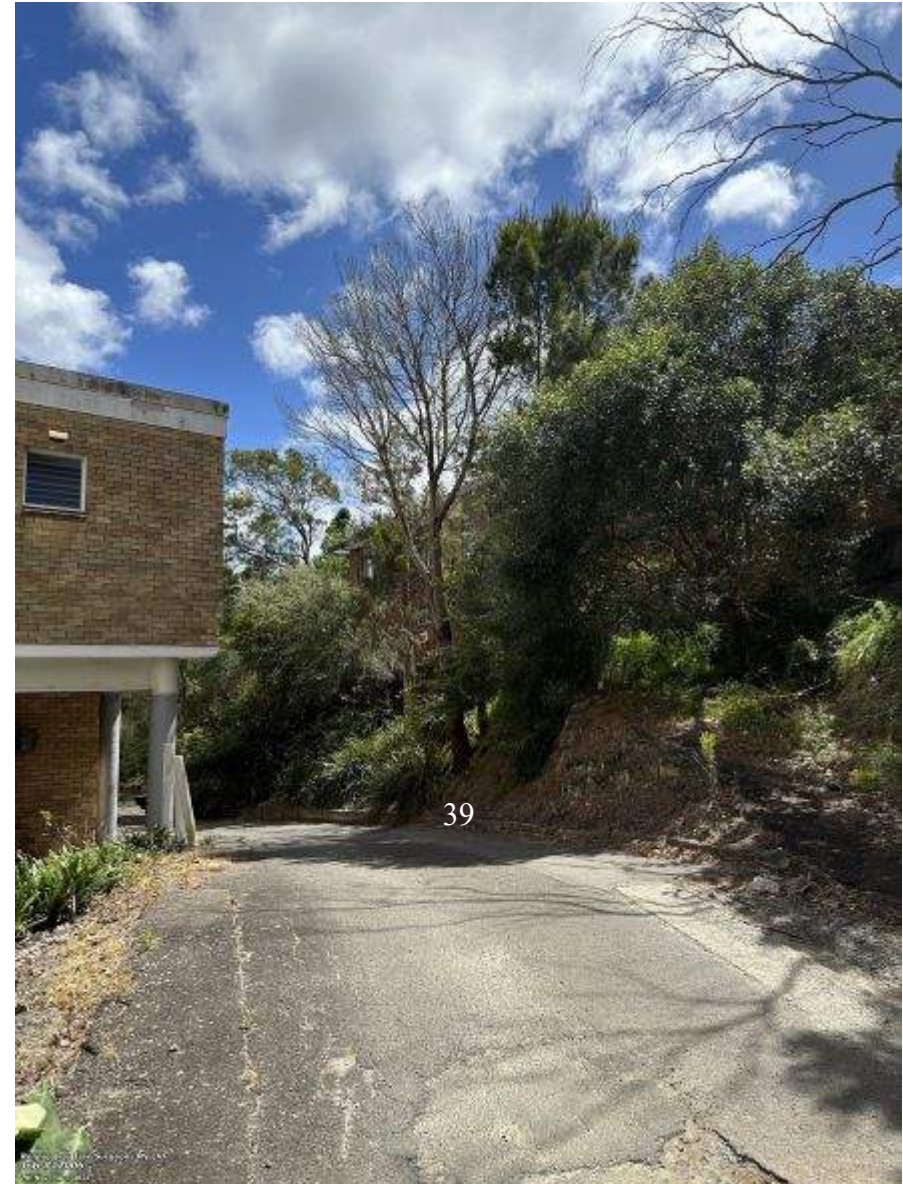
Photo 16: T39- Dead *Casuarina species*

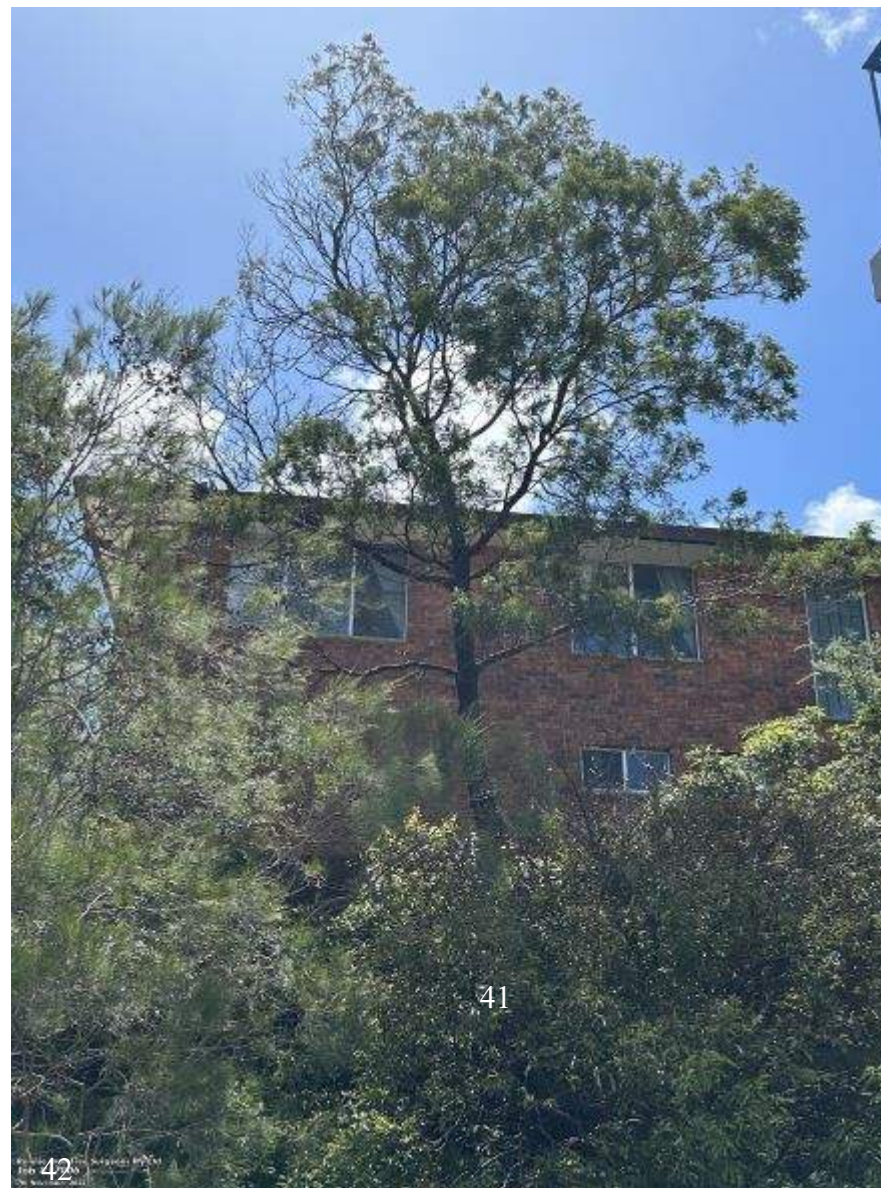
Photo 18: T41, T42- *Acacia mearnsii*

- iii. One (1) tree T41 has borer damage and is in poor condition.
 - iv. These trees could be replaced with longer-lived indigenous or endemic species in locations suitable for long-term growth.

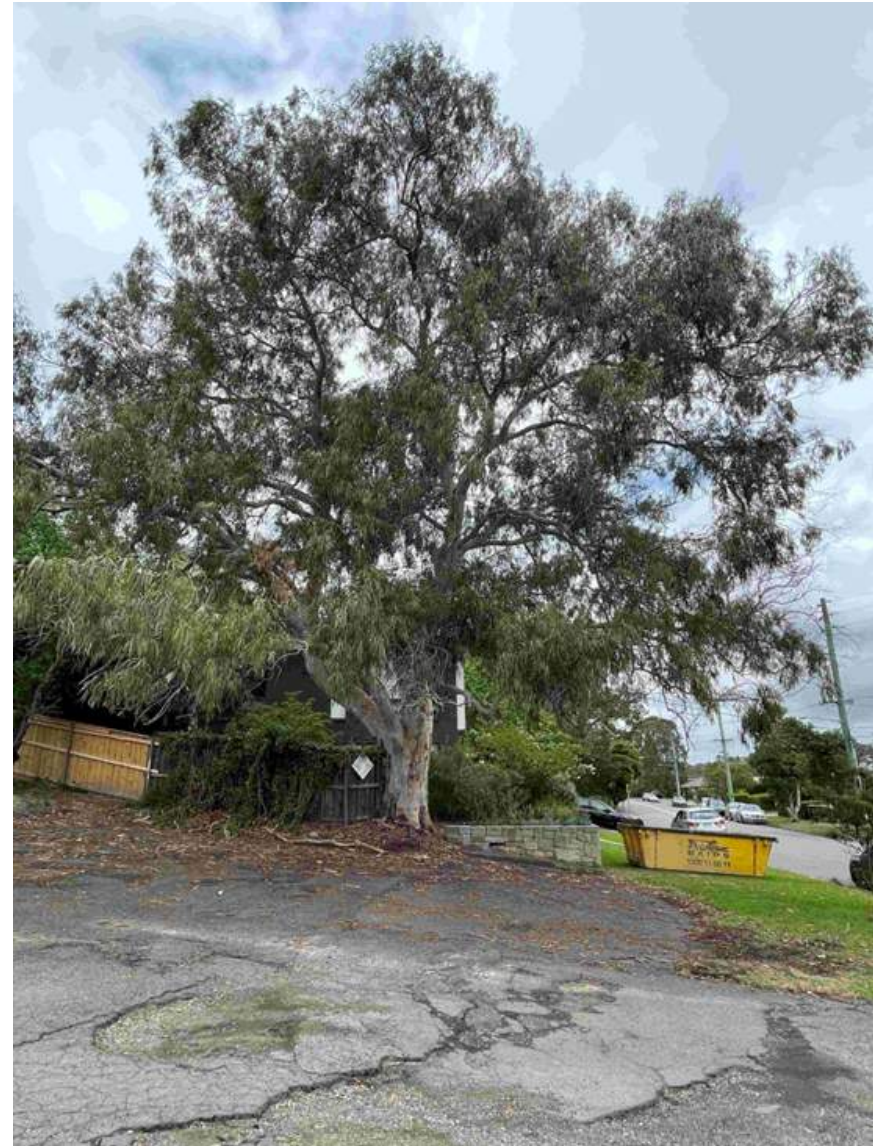
- ii. T26 is a neighbouring tree with a Medium retention value. The tree will have a TPZ encroachment of 27.4% due to the driveway, crossover and entrance pathway. This is a major TPZ encroachment as defined by AS 4970-2009 Protection of trees on development sites (Standards Australia, 2009). The drawing 'Section Through Ramp-Excavation' in Appendix G: Plans shows the planned excavation ranges from 360mm at the southern end of the TPZ to 1480mm at the northern edge of the TPZ. It is likely this tree would be impacted by the proposal. For this tree to be retained, the Arborist recommends the following;

Photo 22: T26- *Eucalyptus scoparia* viewed from the west. Surface roots have created cracks in the bitumen surface.

- 4 Design the driveway, crossover and entrance pathway on the existing grade or supported on piers to provide a minimum clearance of 100mm above the roots, ideally creating a void between the ground and roots. This design will allow for the essential exchange of gases between the soil air and the atmosphere (aeration) and the removal of excess water from the soil (drainage). The roots must be protected to prevent damage by blue metal and the alkaline impact of wet cement. A suitable material to cover the roots is polyethylene expandable joint and space filler (for example AbelFlex). Roots should be protected prior to the construction of the driveway and crossover.

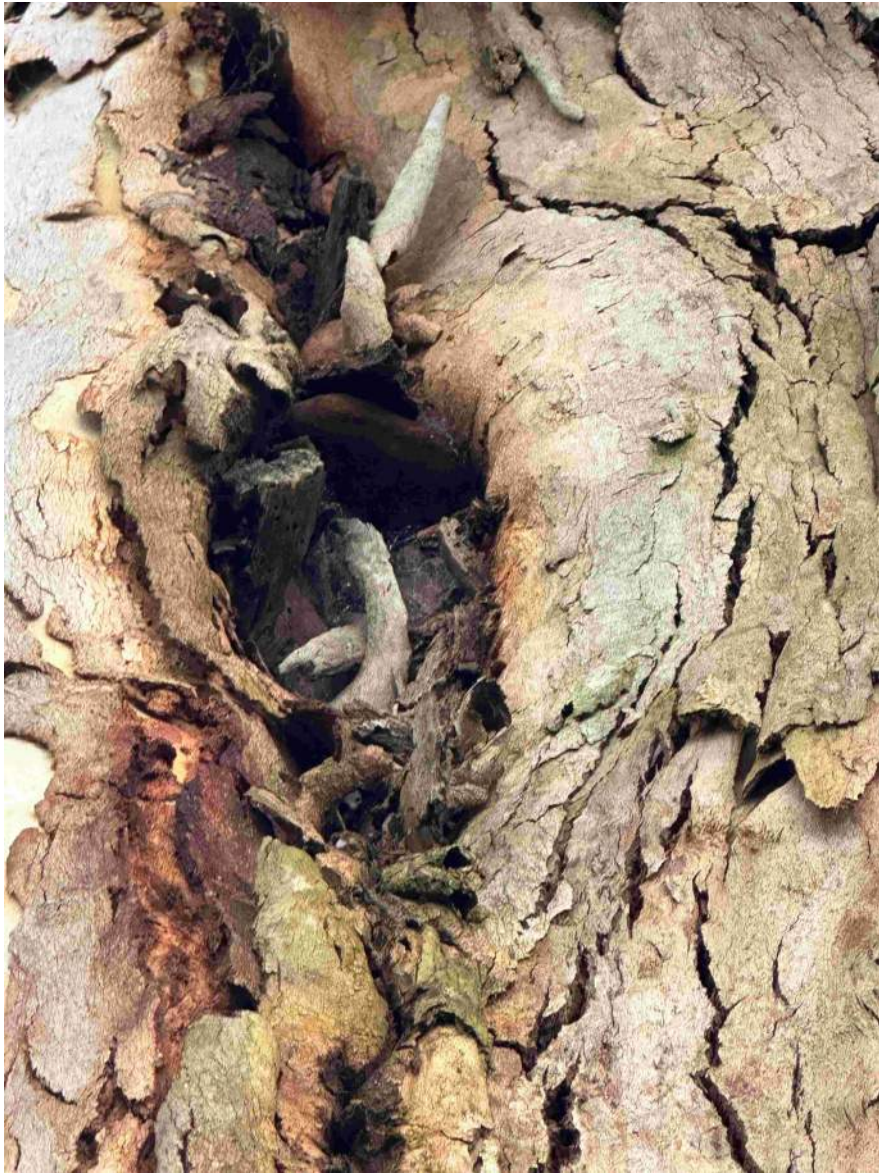
Photo 23: T26-*Eucalyptus scoparia*, *Phellinus robustus* located within wound on southern side of trunk

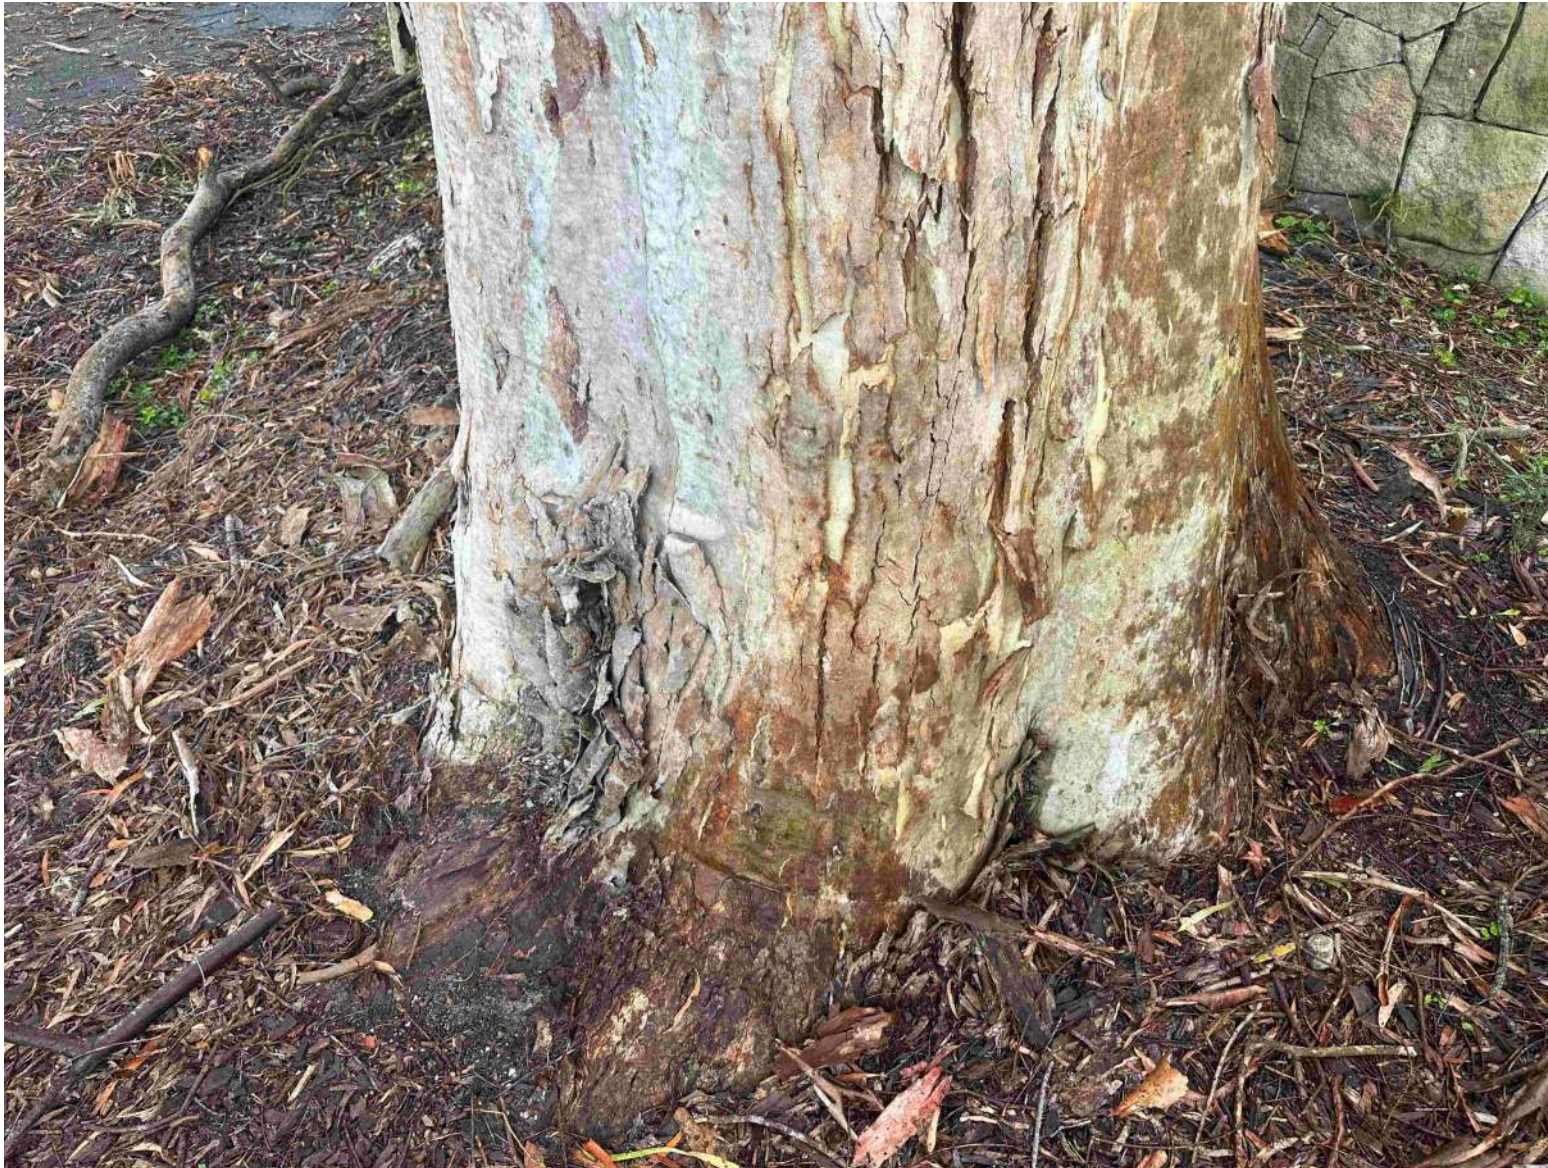
Photo 24: T26- *Eucalyptus scoparia*, root collar dominant towards the neighbouring property.

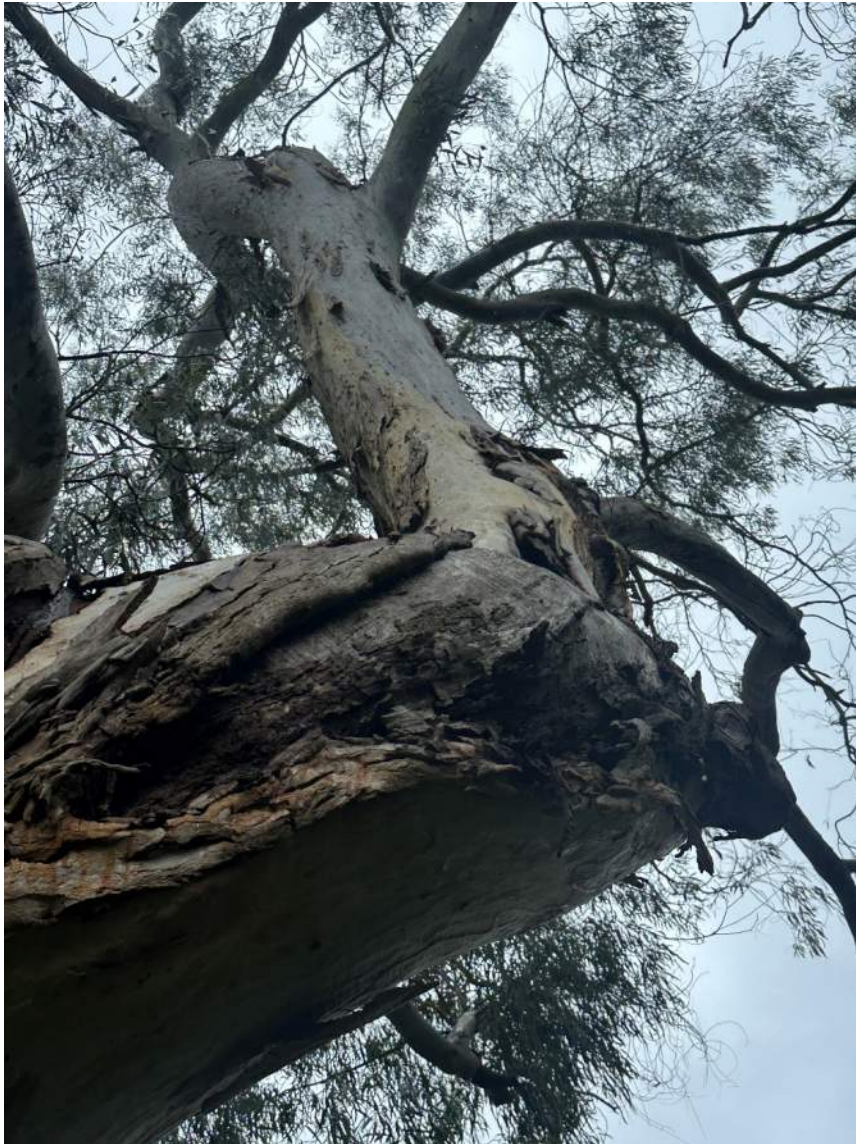
Photo 25: T26, wound on underside of branch

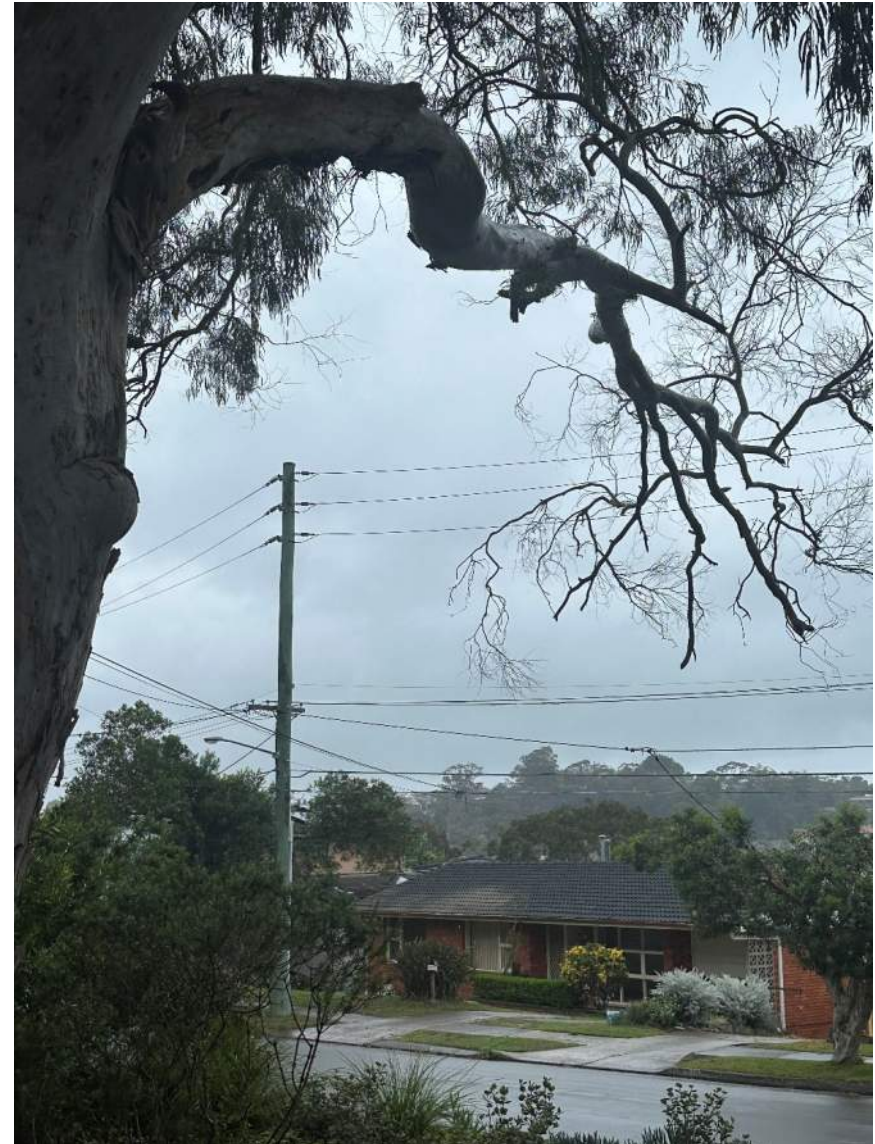
Photo 26: T26, dead branch extending south over Deepwater Road
