# SCHEDULE OF CONSERVATION WORKS

*Former Roche Facility*

**100 South Creek Road**

**Cromer**

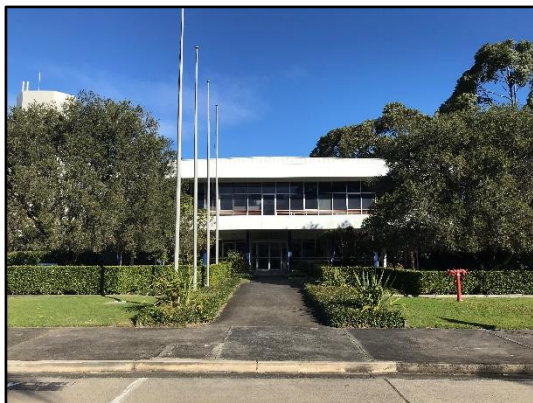
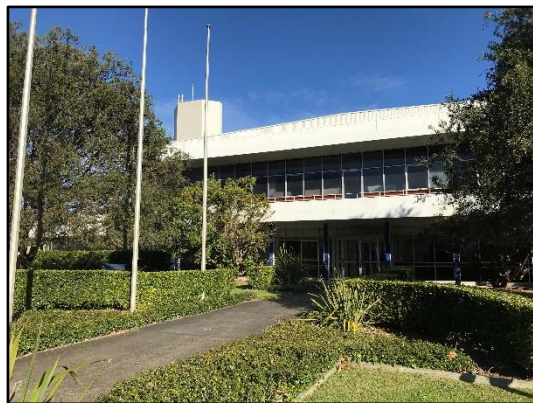
DESCRIPTION	Soft-landscaping includes hedges, trees and plantings within an established layout. Flagpoles, installed in 1977, remain in situ and are intrinsically linked to the established landscaping.				
SIGNIFICANCE	EXCEPTIONAL	HIGH	MODERATE	LITTLE	INTRUSIVE
CONDITION	VERY GOOD	GOOD	FAIR	POOR	VERY POOR
	Good condition, well maintained despite the vacancy of the site.				
VISUAL SURVEY

Figure 48. View to Building 1, facing south-west.			Figure 49. View towards Building 1, facing east.

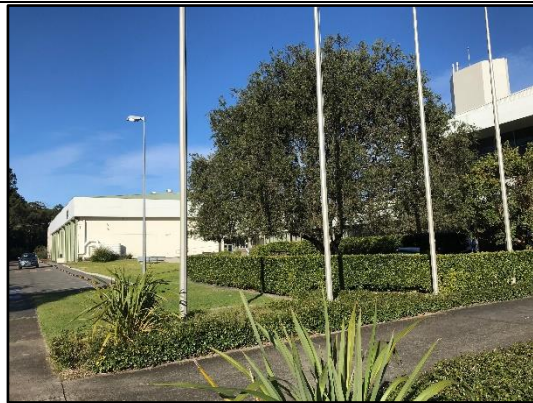
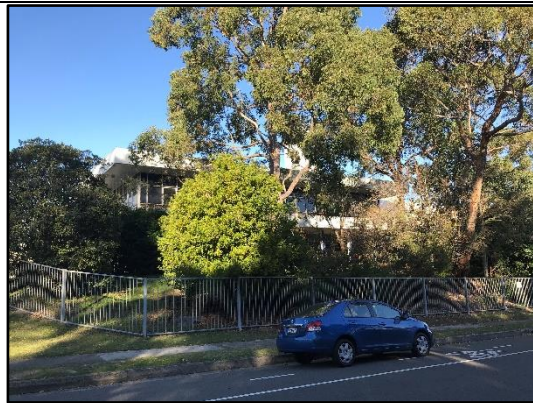
Figure 50. View to soft landscaping, including flag poles, facing north-east, within the subject site.			Figure 51. View to the soft landscaping surrounding Building 1, facing east from Inman Road.		
ELEMENT		CONSERVATION ACTION			
General Recommendations		<ul style="list-style-type: none"><li>The advice of a suitably qualified arborist with heritage experience is to be obtained to ascertain the species of trees within the landscape. Native trees are to be retained and conserved;</li><li>An appropriate landscaped area within the subject site is to be retained as it is considered significant to the heritage significance of the site. The advice of a Landscape Architect is to be obtained with regards to the required landscaped area surrounding the building;</li><li>Where a native tree is to be removed due to decay, it is to be replaced with the same species of tree; and</li></ul>

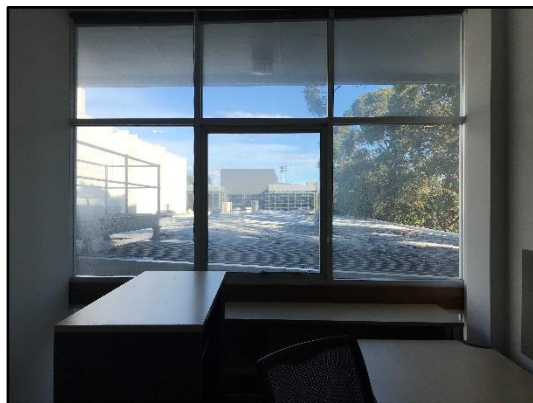
DESCRIPTION	Openings within Building 1 include aluminium framed windows along the exterior, a skylight within the foyer and internal timber and glass doors.				
	Aluminium Window Frames				
SIGNIFICANCE	EXCEPTIONAL	HIGH	MODERATE	LITTLE	INTRUSIVE
CONDITION	VERY GOOD	GOOD	FAIR	POOR	VERY POOR
	Good condition, little signs of deterioration.				
	Internal Timber & Glass Doors				
SIGNIFICANCE	EXCEPTIONAL	HIGH	MODERATE	LITTLE	INTRUSIVE
CONDITION	VERY GOOD	GOOD	FAIR	POOR	VERY POOR
	Good condition.				
VISUAL SURVEY

<b>Figure 60.</b> View to internal glass partitions and doors through the ground floor, facing south-east.			<b>Figure 61.</b> View to existing aluminium framed windows within Building 1.

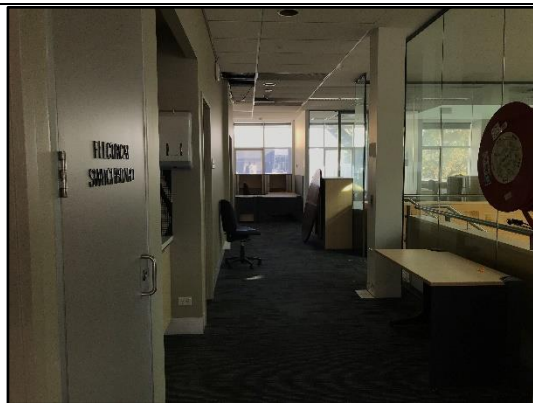
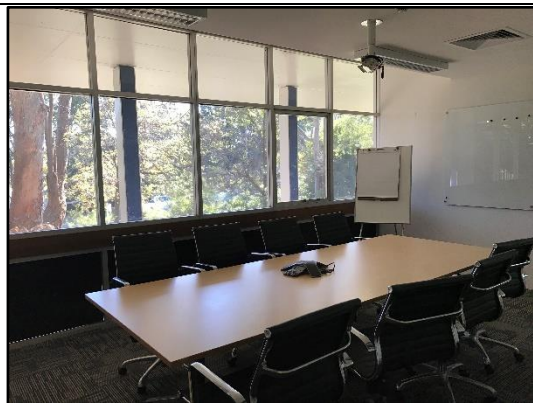
<b>Figure 62.</b> View to the interior of level 1 of Building 1, facing north-west. Note the internal glazing, timber door and the aluminium framed windows.			<b>Figure 63.</b> View to existing windows, facing north-west.

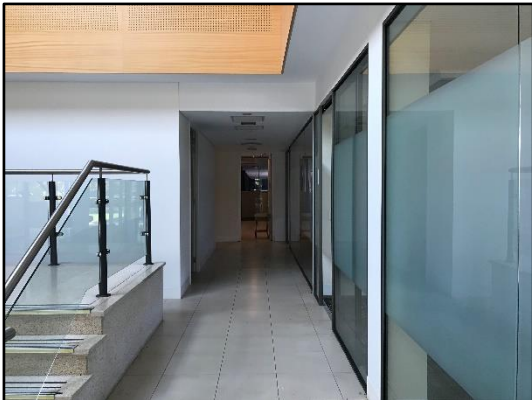
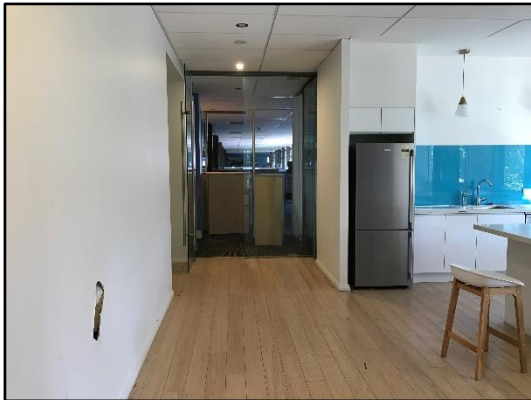
DESCRIPTION	Concrete floor structure, with flooring finishes comprising of carpet, tiles and floating floorboards. Likely introduced within the internal renovations undertaken in 2006.				
SIGNIFICANCE	EXCEPTIONAL	HIGH	MODERATE	LITTLE	INTRUSIVE
CONDITION	VERY GOOD	GOOD	FAIR	POOR	VERY POOR
	Good condition, general signs of wear and tear.				
VISUAL SURVEY

Figure 64. View to the interior of Building 1 ground floor, note the tiling.			Figure 65. View to the interior of Building 1 ground floor, note the floating floorboards.

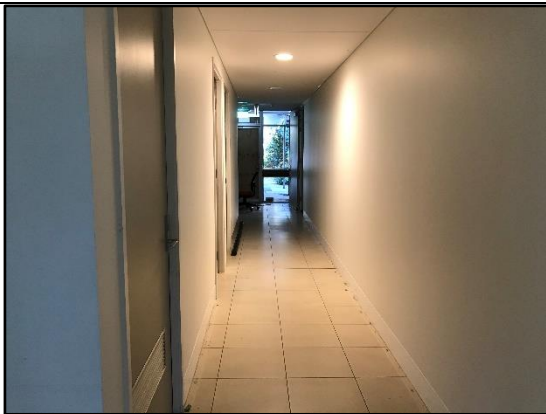
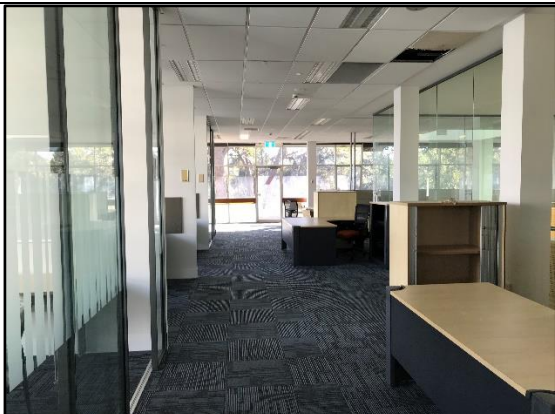
Figure 66. View to the interior of Building 1 ground floor, note the tiling.			Figure 67. View to the interior of the Building 1 first floor, note the carpeting.		
ELEMENT	CONSERVATION ACTION				
General Recommendations	<ul style="list-style-type: none"><li>Retain the original floor structure and conserve in situ;</li><li>Check structural stability of floor structure in consultation with a registered structural engineer. Allow to replace elements as directed by the structural engineer;</li><li>Limit repairs only to members which are structurally unsound or dangerous;</li><li>Where damage to fabric is small (less than 5mm), infill is not necessary;</li><li>Intrusive flooring may be removed and replaced with a sympathetic flooring;</li></ul>

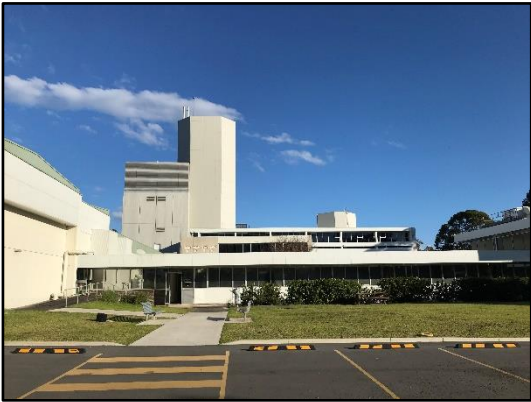
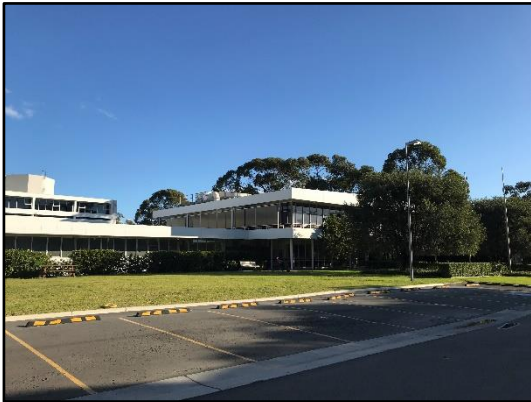
DESCRIPTION	The flat roof of Building 2 comprises Colorbond sheeting.				
SIGNIFICANCE	EXCEPTIONAL	HIGH	MODERATE	LITTLE	INTRUSIVE
CONDITION	VERY GOOD	GOOD	FAIR	POOR	VERY POOR
	Fair condition, access to the roof would be required.				
VISUAL SURVEY

Figure 74. View to Building 2 from within the site, facing south-east.			Figure 75. View to Buildings 1 & 2, primary facade.		
ELEMENT		CONSERVATION ACTION			
General Recommendations		<ul style="list-style-type: none"><li>• Retain and conserve roof forms, materials and pitch;</li><li>• Conserve and retain original timber beams, rafters and purlin where possible. Engage a structural engineer and pest exterminator to assess and advise respectively as to structural soundness and pest control;</li><li>• Conserve and retain original timber eaves, fascia and bargeboards;</li><li>• New elements and materials used for the conservation works are to match existing details in all respects;</li><li>• Key maintenance objective for the roof is to keep roof planes free of debris – good practice is to regularly sweep lower angle sections and to periodically clean upper roof section; and</li><li>• Allow the heritage architect to carry out intermediate and final inspection of the work as it ensues.</li></ul>

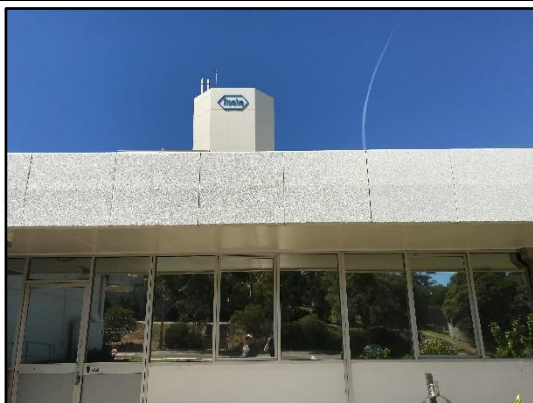
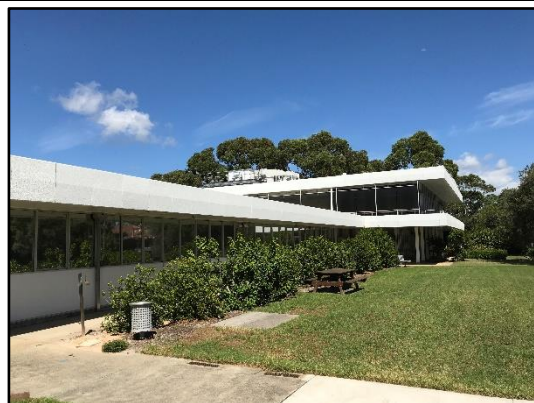
DESCRIPTION	The walls of Building 2, constructed 1964, comprise off-form concrete.				
SIGNIFICANCE	EXCEPTIONAL	HIGH	MODERATE	LITTLE	INTRUSUVE
CONDITION	VERY GOOD	GOOD	FAIR	POOR	VERY POOR
	Good condition, little signs of deterioration.				
VISUAL SURVEY

<p><b>Figure 76.</b> View to Building 2, facing south-east. (Source: Heritage 21, 7 February 2018)</p>			<p><b>Figure 77.</b> View to Building 2, facing towards Building 1. (Source: Heritage 21, 7 February 2018)</p>

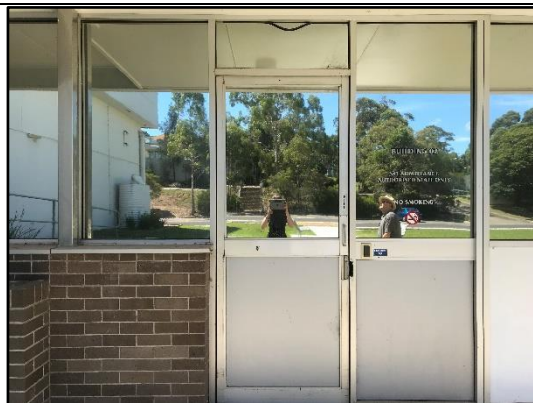
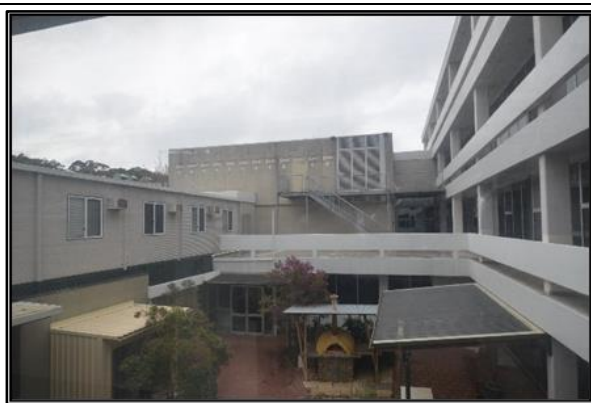
<p><b>Figure 78.</b> Close-up view to ground floor of Building 2, facing south-east. (Source: Heritage 21, 7 February 2018)</p>			<p><b>Figure 79.</b> Close-up view to the rear elevation of Building 2, obstructed by Building 44. (Source: Heritage 21, Conservation Management Plan, Section 4.6)</p>		
ELEMENT	CONSERVATION ACTION				
General Recommendations	<ul style="list-style-type: none"><li>• Original concrete is to be retained and made good;</li><li>• The works to be carried out under the approval should in general, involve the least possible level of physical intervention to significant fabric.</li><li>• Designer/architect to provide details of changes to concrete walls to appointed Heritage Architect for approval.</li><li>• The heritage architect is to carry out intermediate and final inspection of the work as it ensues.</li></ul>

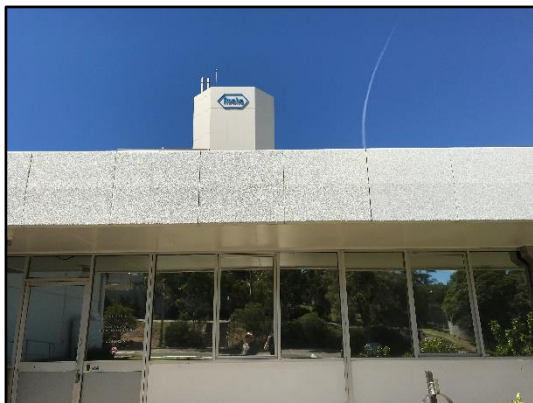
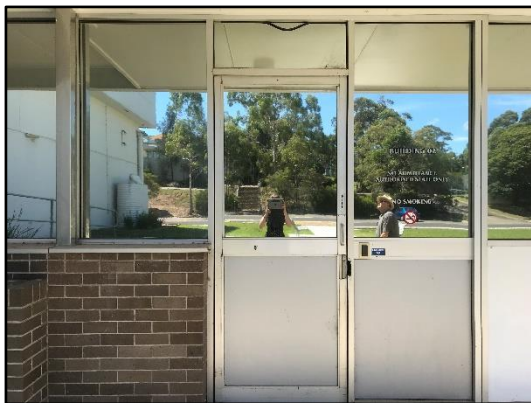
DESCRIPTION	Aluminium glazed windows along the northern elevation of the building. Single entrance door to the building, in-keeping with the aluminium glazing.				
SIGNIFICANCE	EXCEPTIONAL	HIGH	MODERATE	LITTLE	INTRUSIVE
CONDITION	VERY GOOD	GOOD	FAIR	POOR	VERY POOR
	Good condition, little signs of deterioration.				
VISUAL SURVEY

<b>Figure 80.</b> Close-up view to Building 2, primary facade. (Source: Heritage 21, 7 February 2018)			<b>Figure 81.</b> Close-up view to ground floor of Building 2, facing south-east. (Source: Heritage 21, 7 February 2018)		
ELEMENT	CONSERVATION ACTION				
General Recommendations	<ul style="list-style-type: none"><li>• Retain original metal elements;</li><li>• Only missing or unsound elements are to be formed, or recast and replaced;</li><li>• Maintain protective coatings on ferrous metals;</li><li>• Do not alter the colour, texture, tone or patina of a metal through inappropriate cleanings. It is important to note that all metal cleaners are abrasive to a degree; and</li><li>• Allow the heritage architect to carry out intermediate and final inspection of the work as it ensues.</li></ul>

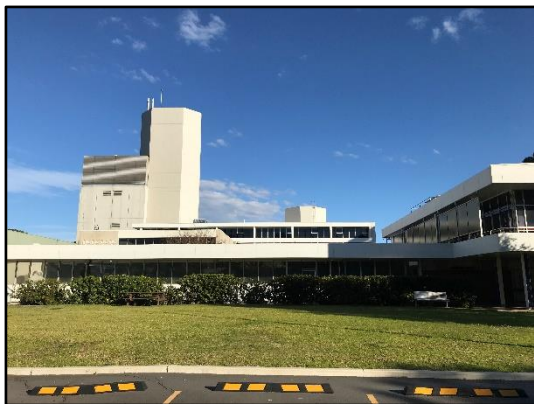
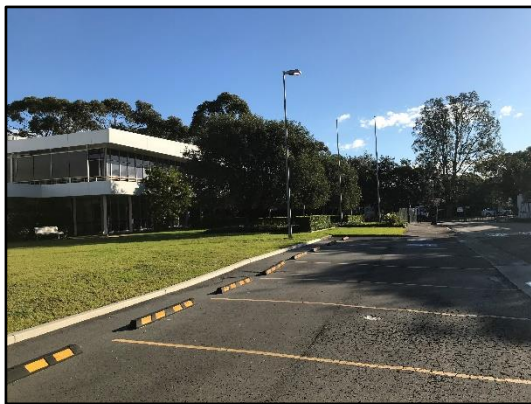
DESCRIPTION	Soft-landscaping includes low lying bushes and grass. In-keeping with the soft landscaping that extends across Building 1.				
SIGNIFICANCE	EXCEPTIONAL	HIGH	MODERATE	LITTLE	INTRUSIVE
CONDITION	VERY GOOD	GOOD	FAIR	POOR	VERY POOR
	Good condition, well maintained despite the vacancy of the site.				
VISUAL SURVEY

Figure 82. View to Building 2, facing south-west.			Figure 83. View towards Building 1, facing east.		
ELEMENT	CONSERVATION ACTION				
General Recommendations	<ul style="list-style-type: none"><li>• The advice of an arborist is to be obtained to ascertain the species of trees within the landscape. Native trees are to be retained and conserved;</li><li>• An appropriate landscaped area within the subject site is to be retained as it is considered significant to the heritage significance of the site. The advice of a Landscape Architect is to be obtained with regards to the required landscaped area surrounding the building;</li><li>• Where a native tree is to be removed due to decay, it is to be replaced with the same species of tree;</li><li>• The existing grassed area and setback should be retained; and</li><li>• Allow the heritage architect to carry out intermediate and final inspection of the work as it ensues.</li></ul>

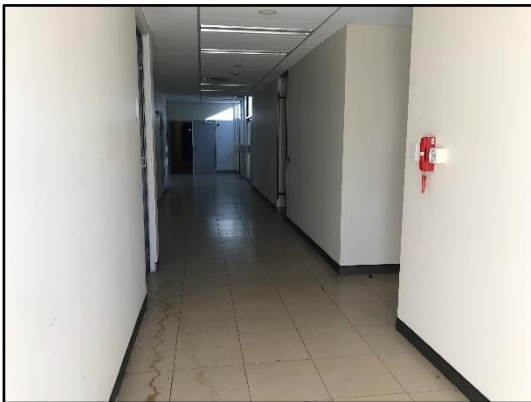
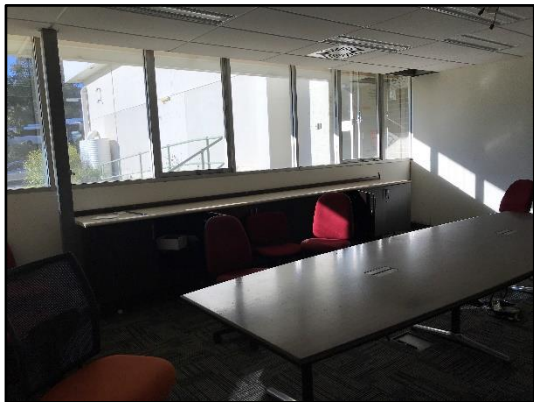
DESCRIPTION	Steel framed structure for the two-storey rectangular building, constructed 1964.				
SIGNIFICANCE	EXCEPTIONAL	HIGH	MODERATE	LITTLE	INTRUSIVE
CONDITION	VERY GOOD	GOOD	FAIR	POOR	VERY POOR
	Good condition, little signs of deterioration.				
VISUAL SURVEY

Figure 84. View to the interior of Building 2, facing south-east.			Figure 85. View to the interior of Building 2, facing north.		
ELEMENT		CONSERVATION ACTION			
General Recommendations		<ul style="list-style-type: none"><li>• Retain original metal elements;</li><li>• Only missing or unsound elements are to be formed, or recast and replaced;</li><li>• Maintain protective coatings on ferrous metals;</li><li>• Do not alter the colour, texture, tone or patina of a metal through inappropriate cleanings. It is important to note that all metal cleaners are abrasive to a degree.</li><li>• Where corrosion is found, it is important to remove the cause of corrosion. If not possible, the mildest cleaning agent available is to be used, followed by a reversible sealant;</li><li>• Where rust is found, it is to be removed by a Heritage metalworker in accordance with pertinent Australian Standards. Heritage metalworker is to treat rust throughout with rust inhibitor and a paint equivalent to red oxide paint (red oxide paint contains lead and should not be used); and</li><li>• Allow the heritage architect to carry out intermediate and final inspection of the work as it ensues.</li></ul>

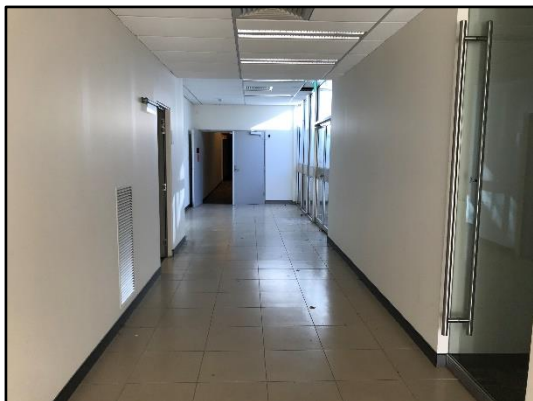
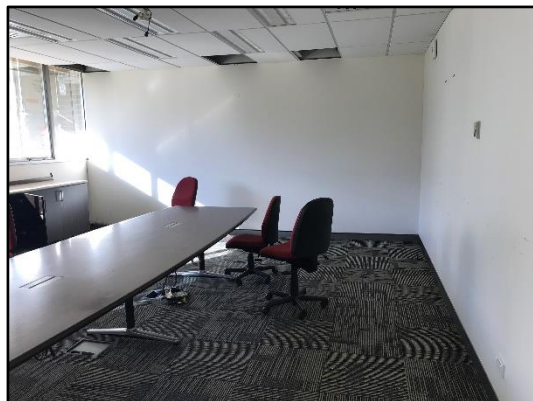
DESCRIPTION	Internal walls comprise of plasterboard, the ceilings comprise of plasterboard and suspended ceiling tiles.				
SIGNIFICANCE	EXCEPTIONAL	HIGH	MODERATE	LITTLE	INTRUSIVE
CONDITION	VERY GOOD	GOOD	FAIR	POOR	VERY POOR
	Good condition, little signs of deterioration, general signs of wear and tear.				
VISUAL SURVEY

Figure 86. View to the interior of Building 2 ground floor, facing south-east.			Figure 87. View to the interior of Building 2 ground floor, facing north-east towards the first floor.

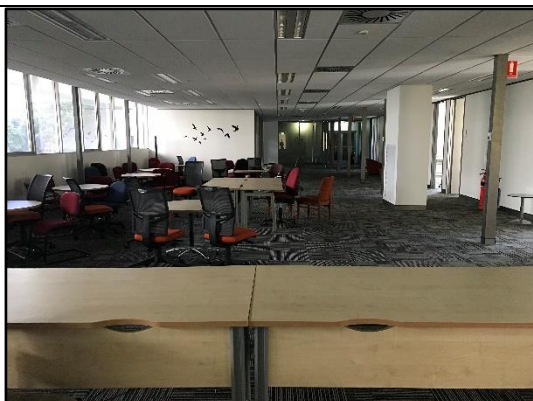
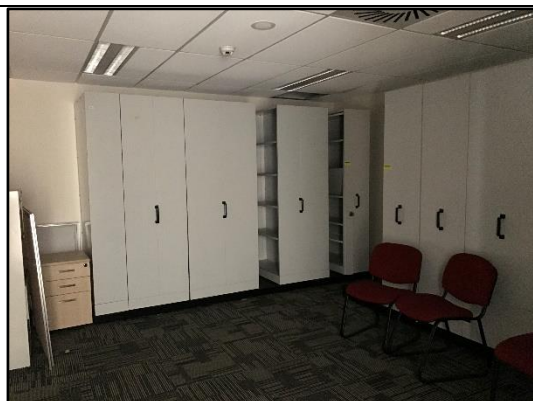
Figure 88. View to interior of Building 2 ground floor.			Figure 89. View to interior of Building 2 ground floor.		
ELEMENT	CONSERVATION ACTION				
General Recommendations	<ul style="list-style-type: none"><li>Removal of plasterboard and glass partitions permissible, in order to change the existing layout;</li><li>Plasterboard ceilings encouraged, the use of suspended ceiling tiles is discouraged; and</li><li>Allow the heritage architect to carry out intermediate and final inspection of the work as it ensues.</li></ul>

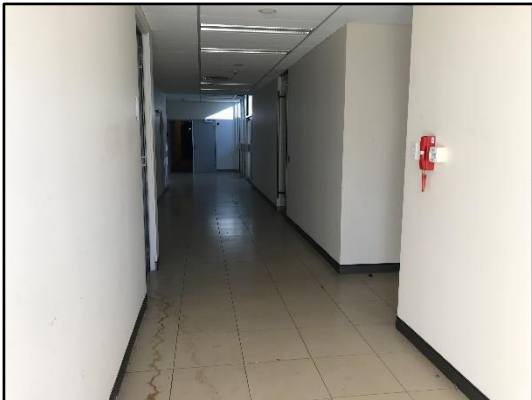
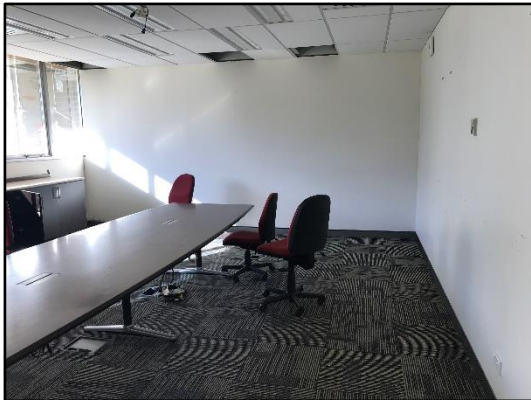
DESCRIPTION	Concrete floor structure, with flooring finishes comprising carpeting, tiles and floating floorboards. Likely introduced within the internal renovations undertaken in 2006.				
SIGNIFICANCE	EXCEPTIONAL	HIGH	MODERATE	LITTLE	INTRUSIVE
CONDITION	VERY GOOD	GOOD	FAIR	POOR	VERY POOR
	Good condition, general signs of wear and tear.				
VISUAL SURVEY

Figure 93. View to the interior of Building 2 ground floor, note the tiling.			Figure 94. View to the interior of Building 2 ground floor, note the carpeting.		
ELEMENT	CONSERVATION ACTION				
General Recommendations	<ul style="list-style-type: none"><li>• Retain the original floor structure and conserve in situ;</li><li>• Check structural stability of floor structure in consultation with a registered structural engineer. Allow to replace elements as directed by the structural engineer;</li><li>• Limit repairs only to members which are structurally unsound or dangerous;</li><li>• Where damage to fabric is small (less than 5mm), infill is not necessary;</li><li>• Intrusive flooring may be removed and replaced with a sympathetic flooring;</li><li>• Where flooring is to be replaced, the advice of a Heritage Architect is to be obtained before the commencement of works;</li><li>• Where tiling has been damaged, it is to be repaired; and</li><li>• Allow the heritage architect to carry out intermediate and final inspection of the work as it ensues.</li></ul>

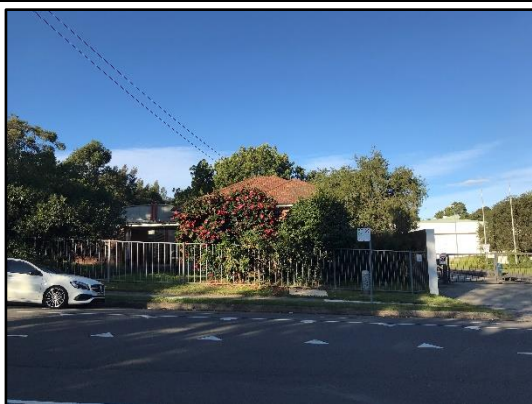
DESCRIPTION	Single-storey cottage with a terracotta tile hipped roof and Colourbond gutters and downpipes.				
SIGNIFICANCE	EXCEPTIONAL	HIGH	MODERATE	LITTLE	INTRUSIVE
CONDITION	VERY GOOD	GOOD	FAIR	POOR	VERY POOR
	Good condition, further inspection would be required. Various gutters and downpipes, all in good condition.				
VISUAL SURVEY

Figure 97. View to Building 5 from Inman Road, facing north-east.			Figure 98. View to Building 5, primary façade, facing east.

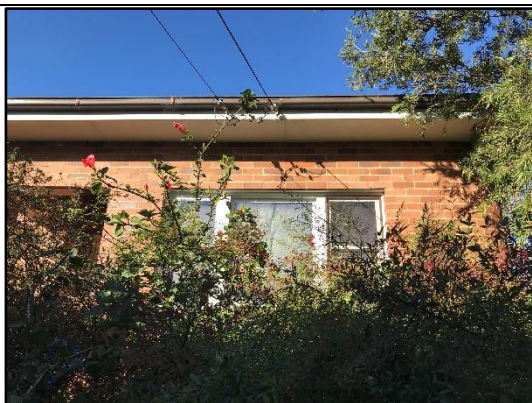
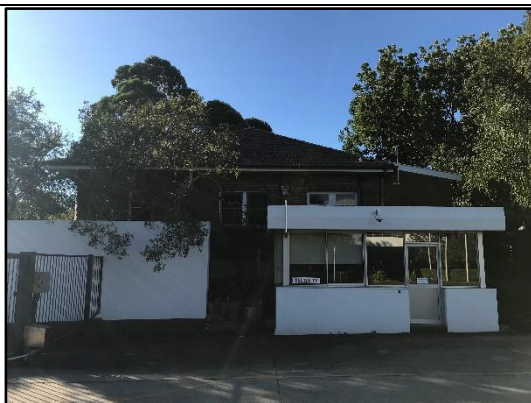
Figure 99. Close-up view towards the primary façade of Building 5, facing north-east.			Figure 100. View to the southern elevation of Building 05, facing north from within the subject site.		
ELEMENT		CONSERVATION ACTION			
General Recommendations		<ul style="list-style-type: none"><li>Retain and conserve roof forms, materials and pitch;</li><li>Conserve and retain original timber beams, rafters and purlin where possible. Engage a structural engineer and pest exterminator to assess and advise respectively as to structural soundness and pest control;</li><li>Conserve and retain original timber eaves, fascia and bargeboards;</li><li>New elements and materials used for the conservation works are to match existing details in all respects;</li></ul>

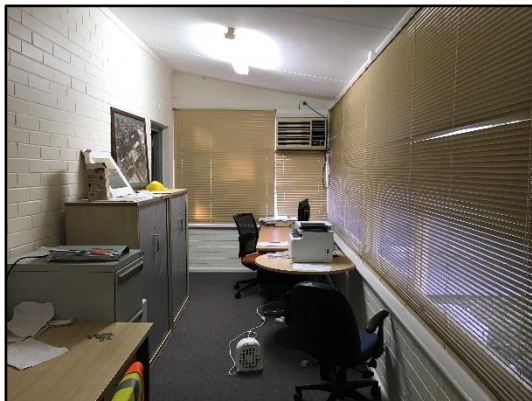
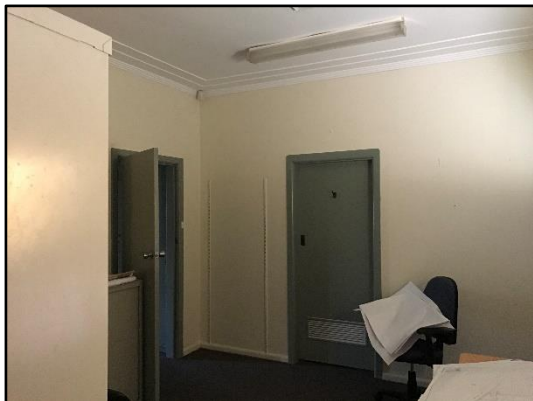
<p><b>Figure 121.</b> View to the interior of the enclosed verandah, facing north-west. Note the early plasterboard.</p>			<p><b>Figure 122.</b> View to the interior of Building 05. Note the plasterboard.</p>

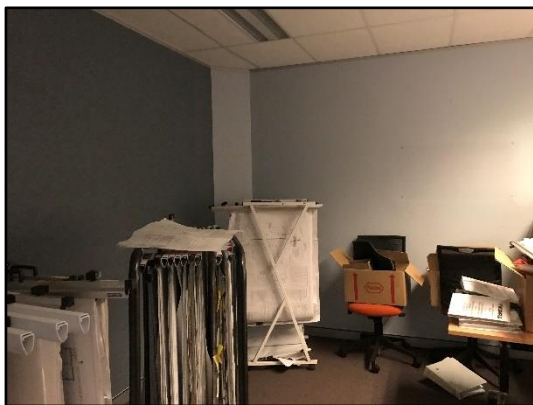
<p><b>Figure 123.</b> View to the interior of the corridor. Note the plasterboard.</p>			<p><b>Figure 124.</b> View to the interior of room in use as a storage space. Note the suspended ceiling tiles.</p>		
ELEMENT		CONSERVATION ACTION			
General Recommendations		<ul style="list-style-type: none"><li>Retain and conserve original ceilings;</li><li>Engage an expert plasterer to assess the condition of the plaster ceilings and cornices on a room by room basis and identify causes (s) of failure (damp or structural failure). Decisions regarding the viability of repairs, wholesale replacement or a combination of both need to be made under the guidance of the appointed heritage architect;</li><li>Where ceilings/cornices are damaged, they are to be made good;</li></ul>

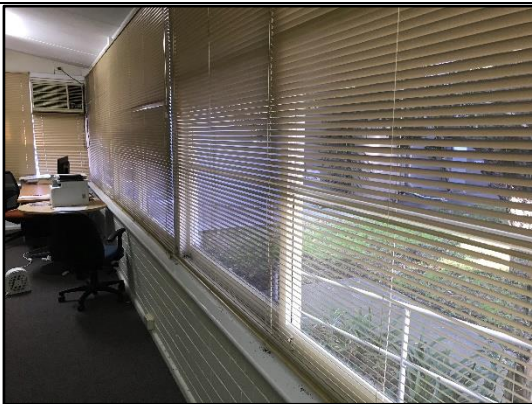
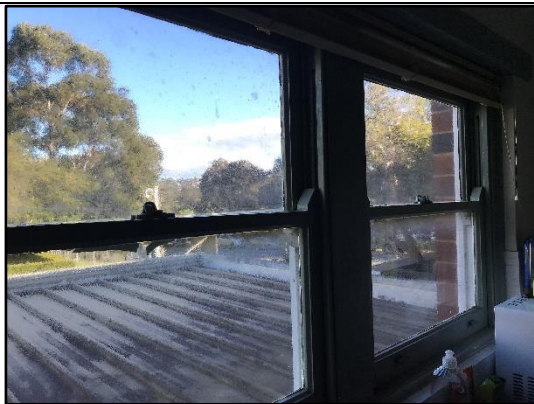
Figure 137. View to the interior of timber framed openings within the eastern elevation.			Figure 138. View to the interior of timber framed openings within the southern elevation.		
ELEMENT		CONSERVATION ACTION			
General Recommendations		<ul style="list-style-type: none"><li>• A qualified heritage carpenter is to inspect all existing timber elements and determine the condition of each as identified in the Schedule of Conservation Works;</li><li>• The works to be carried out under the approval should in general, involve the least possible level of physical intervention to significant fabric;</li><li>• Timber is to be protected with protective material during demolition and conservation works to other fabric;</li><li>• Original timber elements are to be retained, conserved and made good in situ;</li><li>• Where repairs are required to timber, works are to be taken in situ using the geometric splicing method. This includes removing the entire</li></ul>

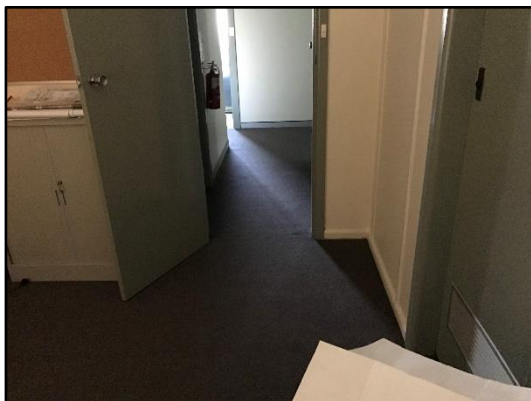
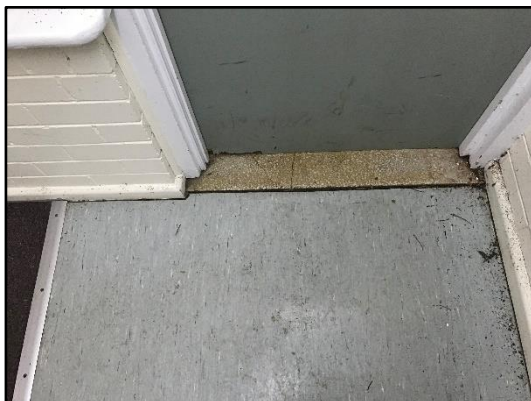
Figure 139. View to the carpet within the corridor.			Figure 140. View to the linoleum and terrazzo threshold.

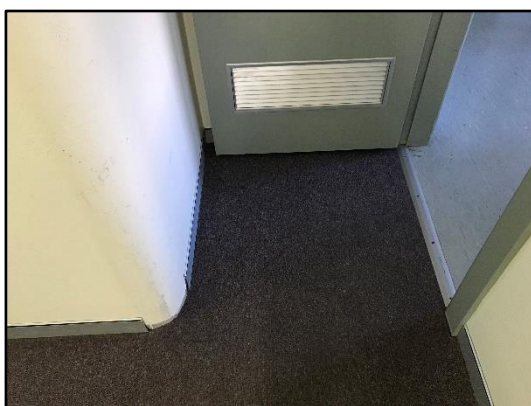
Figure 141. View to the tiling in the main bathroom.			Figure 142. View to the carpet within the main corridor and linoleum in the kitchen.		
ELEMENT		CONSERVATION ACTION			
General Recommendations		<ul style="list-style-type: none"><li>Remove non-original carpets or vinyl matting to expose original flooring underneath;</li></ul>
