# REMEDIATION ACTION PLAN FOR LEAD (DUST) AND THERMAL/ACOUSTIC INSULATION (SYNTHETIC MINERAL FIBRES) IMPACTED ROOF

MAY 2020

GALSTON AQUATIC & LEISURE CENTRE  
412 GALSTON ROAD  
GALSTON, NSW 2159

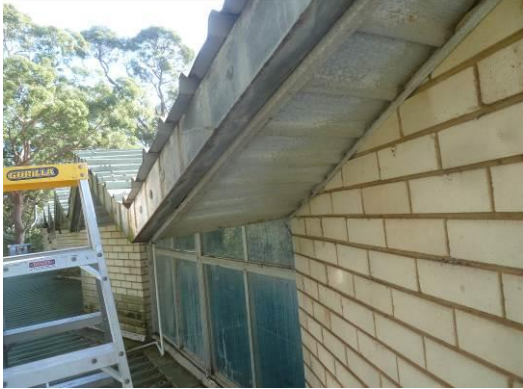
| NO | LOCATION | PHOTOGRAPH | OBSERVATIONS /COMMENTS | CONSEQUENCE | LIKELIHOOD | RISK RATING |
|---|---|---|---|---|---|---|
| 1. | Eaves of GALC | | <ul style="list-style-type: none"> <li>▪ Metal</li> <li>▪ No concern</li> </ul> | Insignificant | Unlikely | Low |

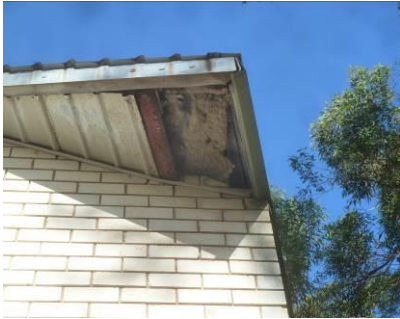
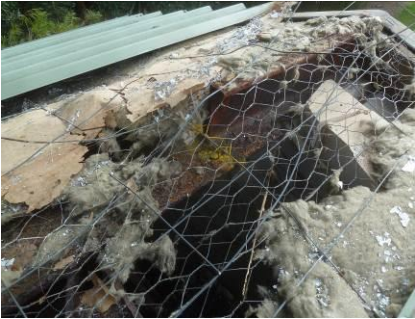
| NO | LOCATION | PHOTOGRAPH | OBSERVATIONS /COMMENTS | CONSEQUENCE | LIKELIHOOD | RISK RATING |
|---|---|---|---|---|---|---|
| 2. | Roof / Eaves Cavity | | <ul style="list-style-type: none"> <li>▪ Thermal/Acoustic Insulation (Synthetic Mineral Fibres)</li> </ul> | Moderate | Likely | High |

### 6.4 Removal of Acoustic/Thermal Insulation

- Removal
  - The acoustic/thermal insulation shall be removed to a practicably achievable standard as assessed and determined by the onsite occupational hygienist. Generally, what is classified as practicably achievable, is that acoustic/thermal insulation which can be removed by scraping (with a paint scraper), wire brushing, damp wiping, vacuuming or other appropriate techniques. At the completion of the works no visible, accessible, macroscopic synthetic mineral fibres will be allowed to remain present. The decision on what, if any, acoustic/thermal insulation can be allowed to remain will rest solely with the onsite occupational hygienist.

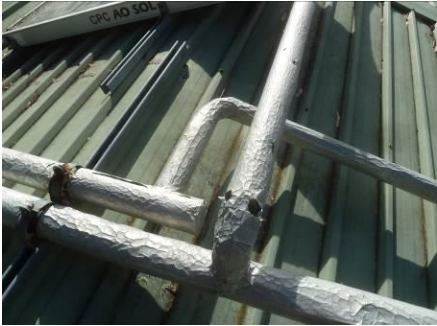
| NO | LOCATION | PHOTOGRAPH | OBSERVATIONS /COMMENTS | CONSEQUENCE | LIKELIHOOD | RISK RATING |
|---|---|---|---|---|---|---|
| 3. | Insulated pipping on roof-top | | <ul style="list-style-type: none"> <li>▪ Thermal/Acoustic Insulation (Synthetic Mineral Fibres)</li> </ul> | Minor | Possible | Medium |

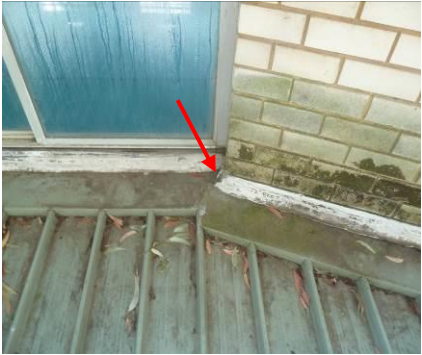
| 4. | Lead flashing | | <ul style="list-style-type: none"> <li>Lead containing material</li> </ul> | Minor | Likely | High |

- Onsite occupational hygienist will need to be informed of any lead flashing that is required to be removed. The quantities removed will need to reconcile with the waste disposal dockets.
- All flashing removed will need to be double bagged prior to disposal.

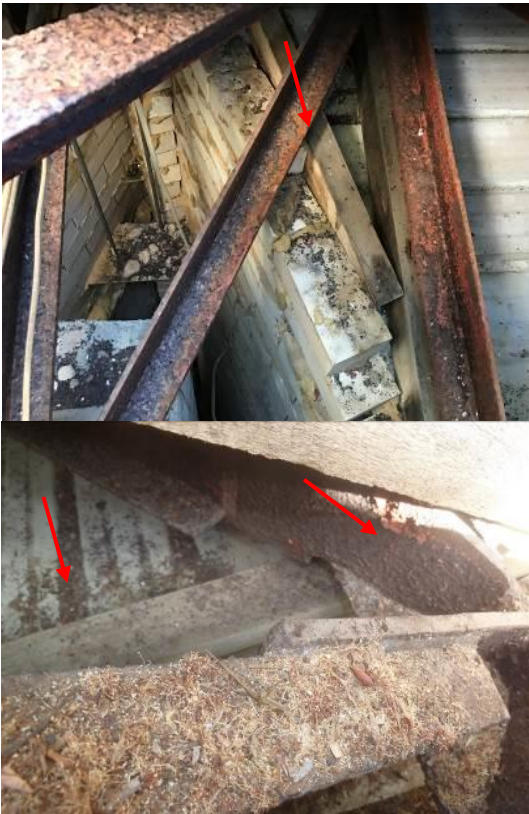
- Settled lead dust – two settled dust samples were taken from the roof of GALC; one sample from the north and the other from the east. Lead concentration from both samples were well above the adopted recommended criteria of 8,600  $\mu\text{g}/\text{m}^2$ . It was noted that settled dust is distributed across the roof cavity of the GALC.
- Lead flashing - Lead flashing is observed around window frames and likely to be used within roof cavity to prevent moisture incursion.
- Roof thermal/acoustic insulation - site inspection of the roof cavity indicated that there is the presence of thermal/acoustic insulation within the roof cavity of GALC and used as pipe insulation for the hot water pipping on the roof-top. The thermal/acoustic insulation is made of synthetic mineral fibres.

| 5. | Settled dust within roof cavity | | <ul style="list-style-type: none"> <li>Two settled dust samples were taken from the roof of GALC; one sample from the north and the other from the east. Lead dust was swabbed from an area of approximately 100cm<sup>2</sup> using a wet wipe. Sampling and analysis was done in accordance to Australian Standard AS 4361.2 (2017) Guide to lead paint management Part 2: Residential and Commercial Buildings.</li> <li>Lead concentration from both samples were well above the adopted recommended criteria of 8,600 µg/m<sup>2</sup>. It was noted that settled dust is distributed across the roof cavity of the GALC.</li> </ul> | Moderate | Likely | High |

### 6.2 Settled Lead Dust:

- Removal can be a combination of the methods below:
  - Vacuum all surfaces using industrial vacuum cleaner fitted with HEPA filter, starting from the roof and working towards the false ceiling.

- For significant amount of settled dust, use water spray to wet down settled dust and debris before using damp cloth
  - For minor settled dust on surface, wipe down hard surfaces within the ceiling cavity with damp cloth

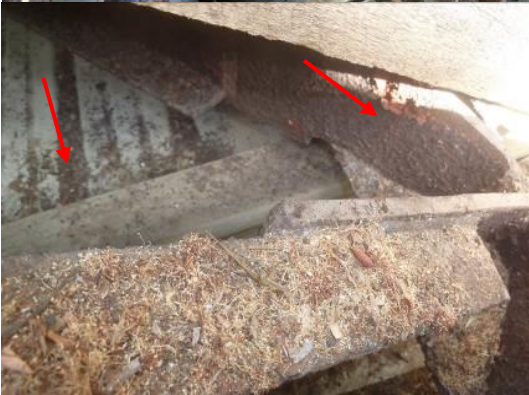
| 6. | Paint Flakes (off corroded structural steel) | | <ul style="list-style-type: none"> <li>Two paint flakes were analysed with lead content less than 0.1% lead which under the Standard for the Uniform Scheduling of Drugs and Poisons (National Drugs and Poisons Schedule Committee July 2000), this will be classified as Lead free paint.</li> </ul> | Insignificant | Unlikely | Low |

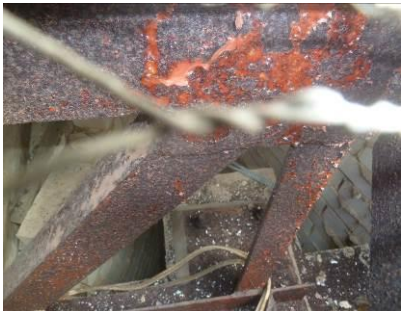
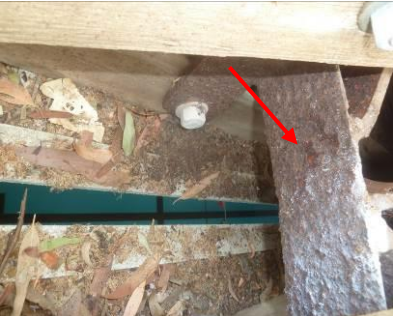
| 7. | Corroded structural steel pieces | | <ul style="list-style-type: none"> <li>A single bulk corroded steel sample was taken showing result to be below the adopted recommended criteria of 300 mg/kg. It should be noted that the main constituents of structural steel will include; iron, carbon and manganese. While lead can be found in steel, the lead content is generally minute and remain in steel not as part of the alloy but in the form of inclusion</li> </ul> | Insignificant | Unlikely | Low |

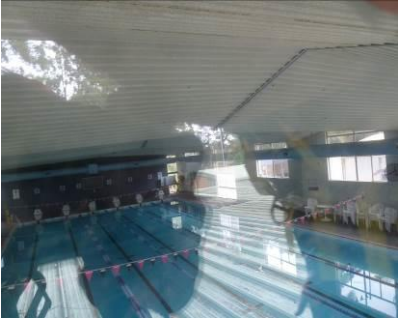
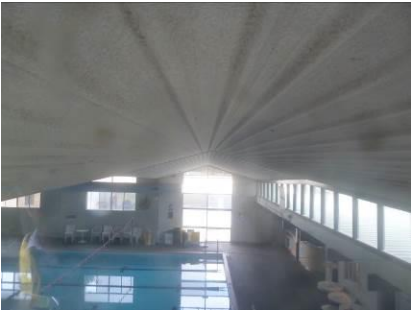
| 8. | Ceiling | | <ul style="list-style-type: none"> <li>Corrugated sheet metal</li> <li>No concern</li> </ul> | Insignificant | Unlikely | Low |
