Hazardous Building Materials (HBM) Survey

Kogarah War Memorial Pool  
78 Carwar Avenue  
Carss Park NSW

Prepared for  
SJB Architects  
C/- SJB Planning

Project 99751.02  
August 2020

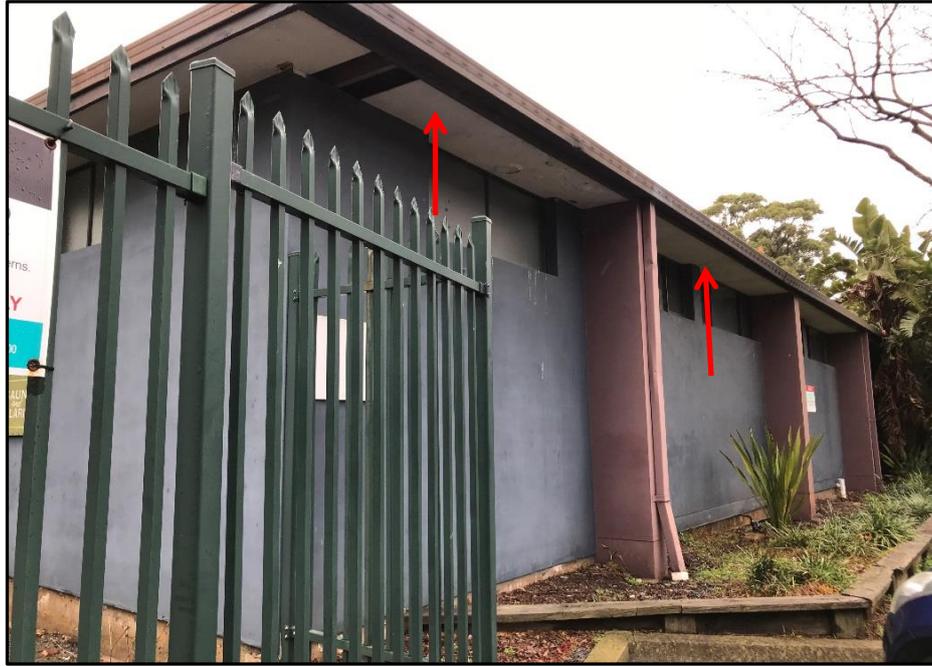
Photograph 1: Main Building, exterior, lower eave lining, fibre cement sheeting, asbestos detected by analysis.

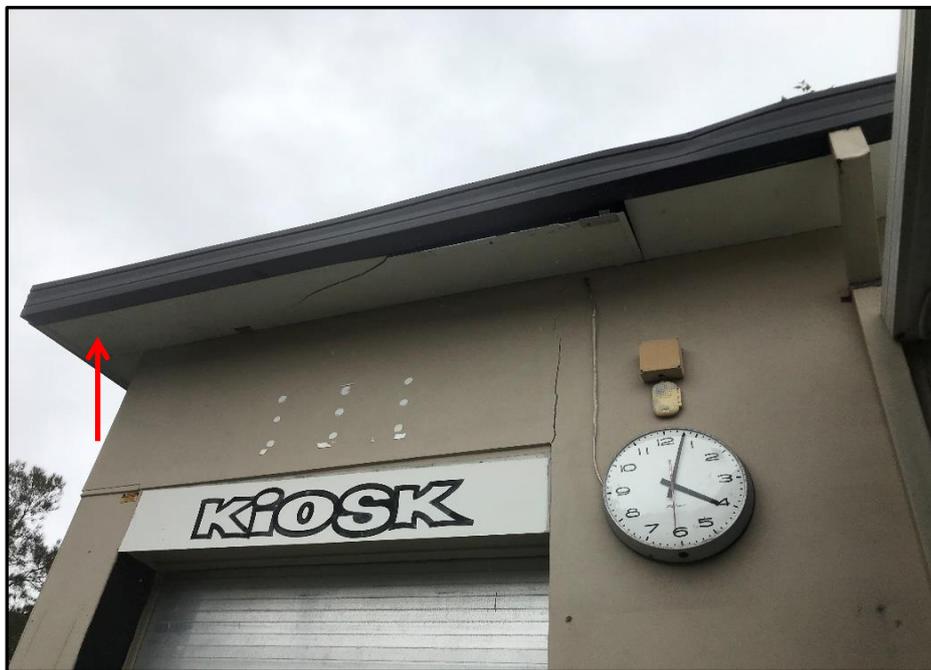
Photograph 2: Main Building, exterior, eastern façade, upper eave lining above canteen, fibre cement sheeting, no asbestos detected by analysis.

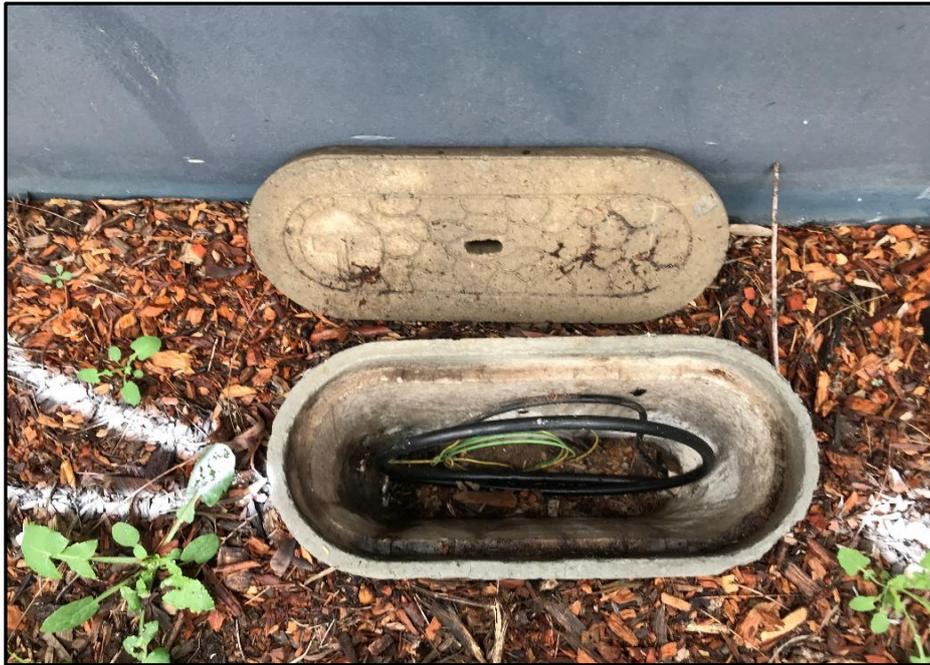
Photograph 3: Main Building, exterior, western façade, south end, Telstra pit, fibre cement product, suspected asbestos.

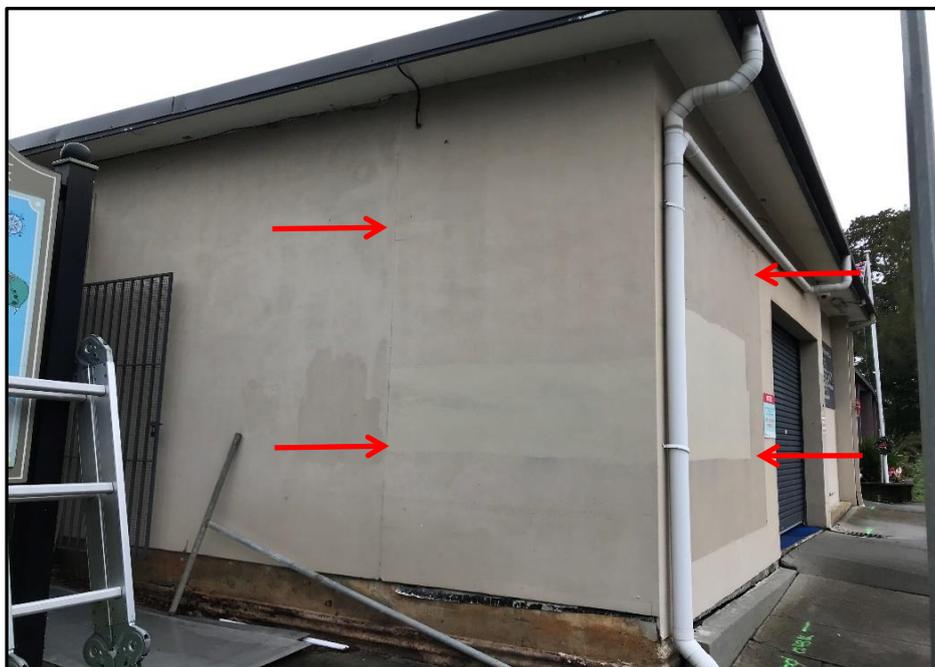
Photograph 4: Main Building, exterior, western façade, centre section of building, portion of walls, fibre cement sheeting, no asbestos detected by analysis.

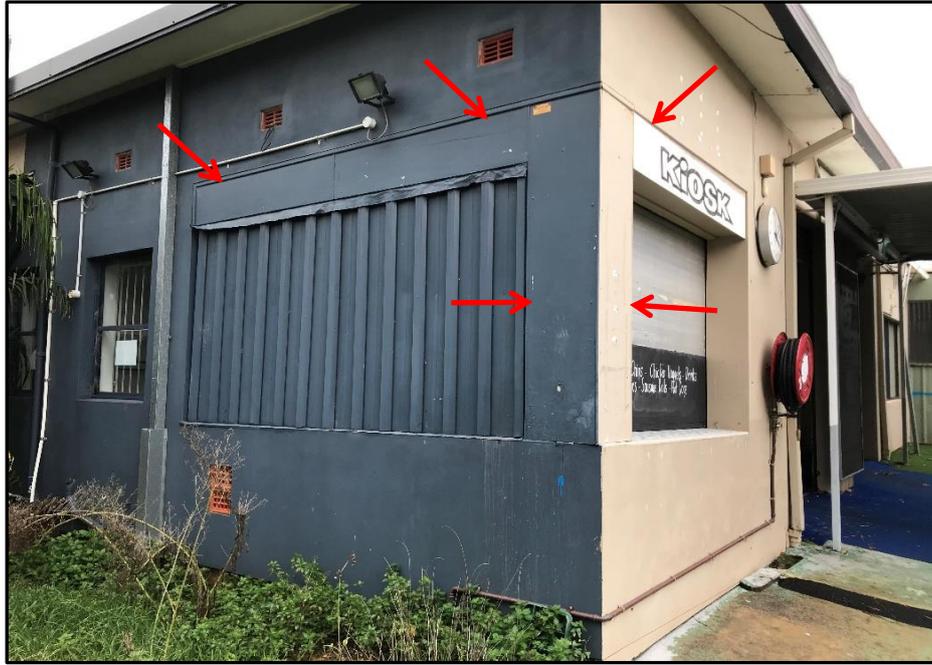
Photograph 5: Main Building, exterior, eastern façade, canteen, walls, infill panels generally, fibre cement sheeting, suspected asbestos.

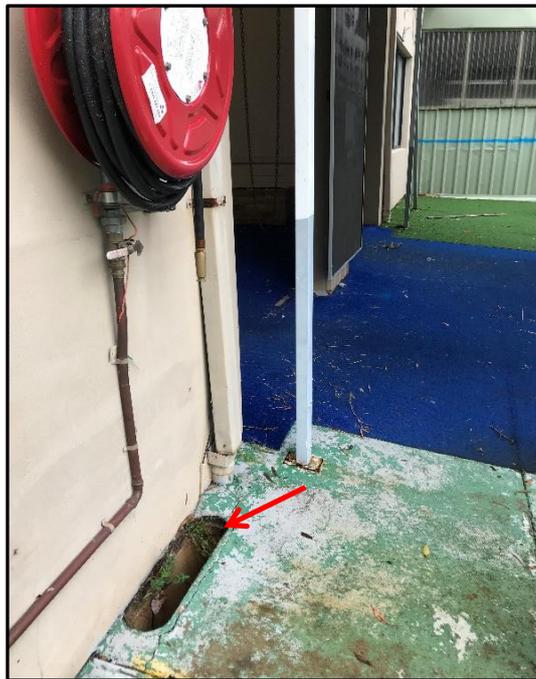
Photograph 6: Main Building, exterior, eastern façade, centre section, service pit, cement product, no asbestos detected by analysis.

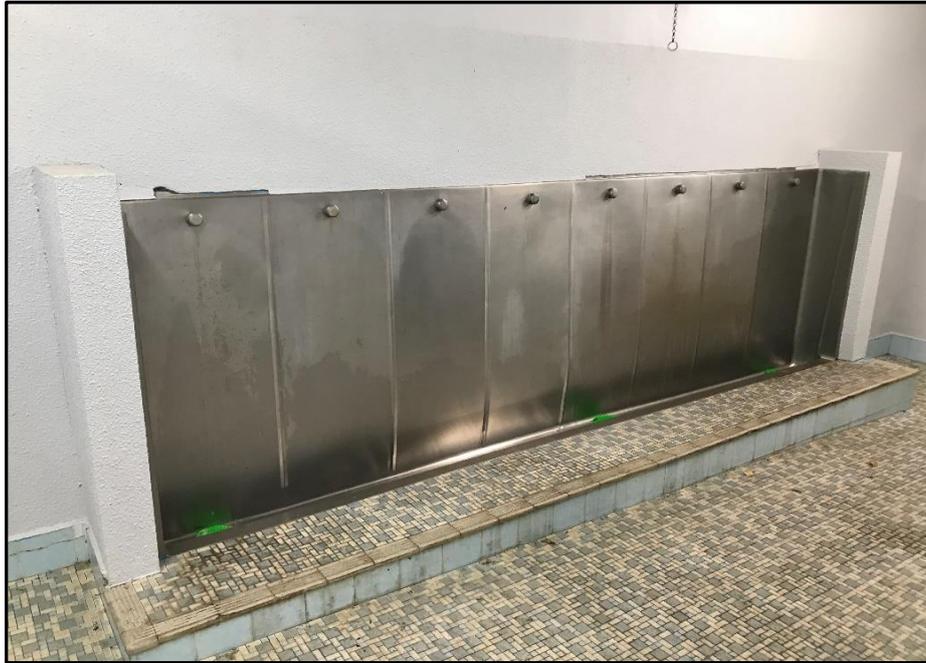
Photograph 7: Main Building, interior, northern section, male toilets, urinal(s), lining to rear of urinal (if present), may contain asbestos.

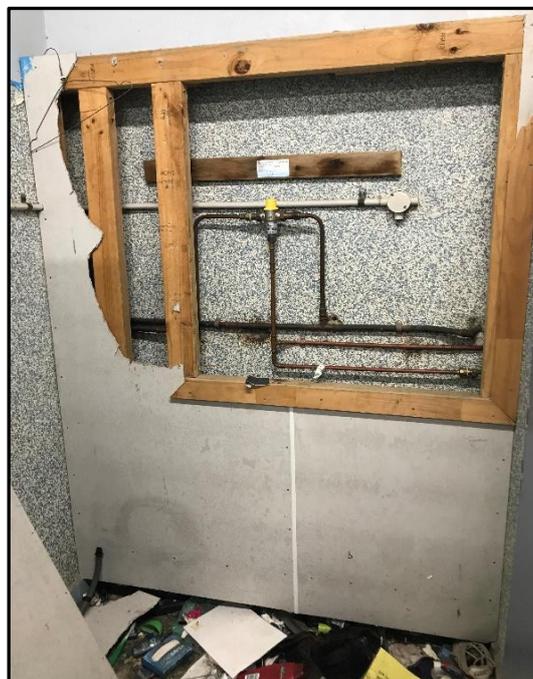
Photograph 8: Main Building, interior, northern section, male toilets, southwest corner, wall lining and associated dust/debris, fibre cement sheeting, no asbestos detected by analysis.

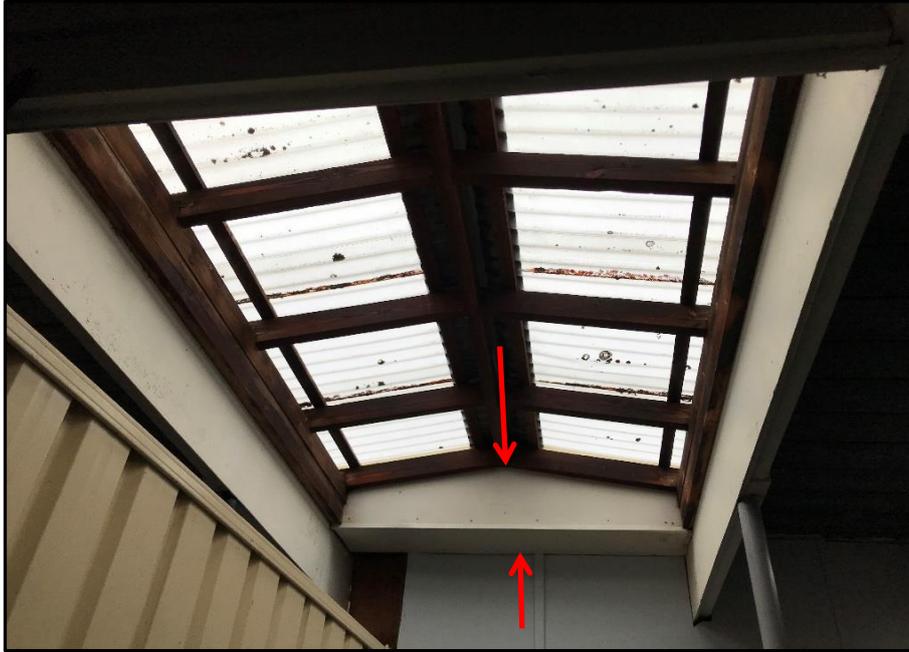
Photograph 9: Main Building, interior, northern section, male change room, below skylight, infill panels generally, fibre cement sheeting, suspected asbestos.

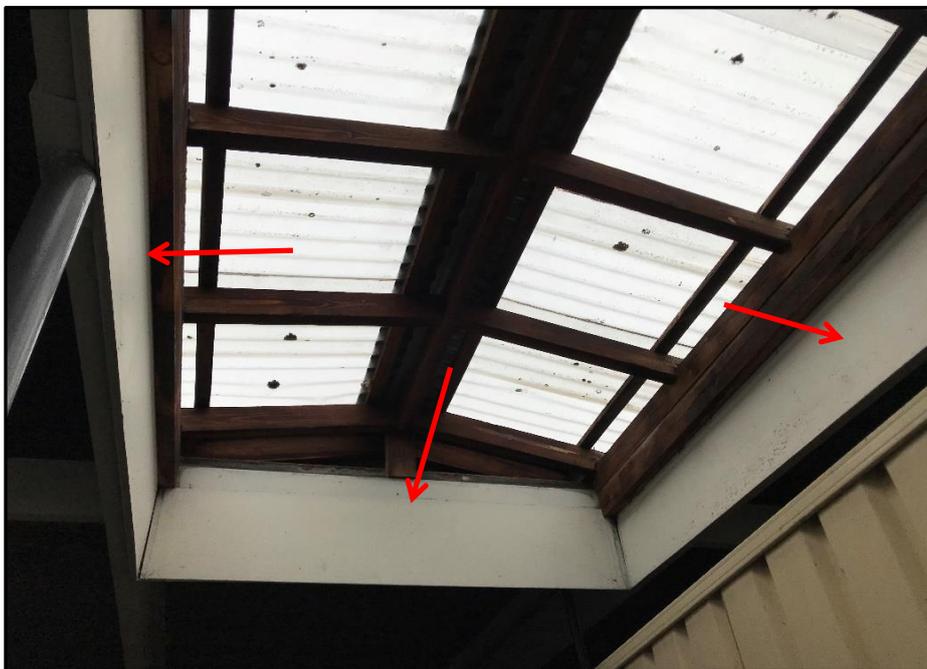
Photograph 10: Main Building, interior, northern section, male change room, below skylight, linings to timber beams, fibre cement sheeting, asbestos detected by analysis.

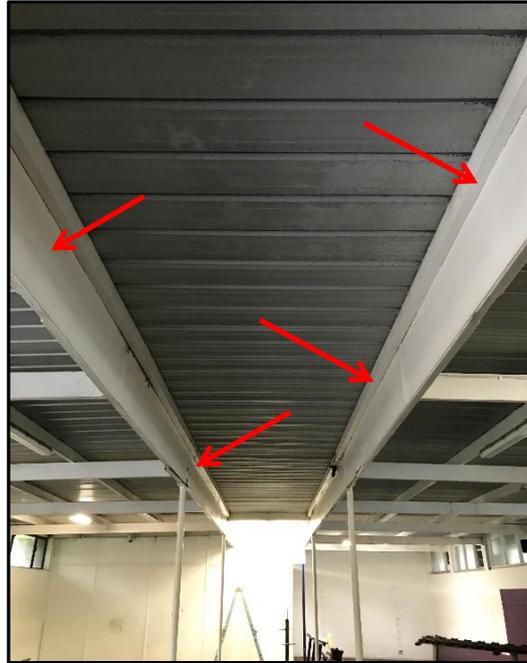
Photograph 11: Main Building, interior, northern section, main gymnasium, lining to centre section of roof structure, fibre cement sheeting, suspected asbestos.

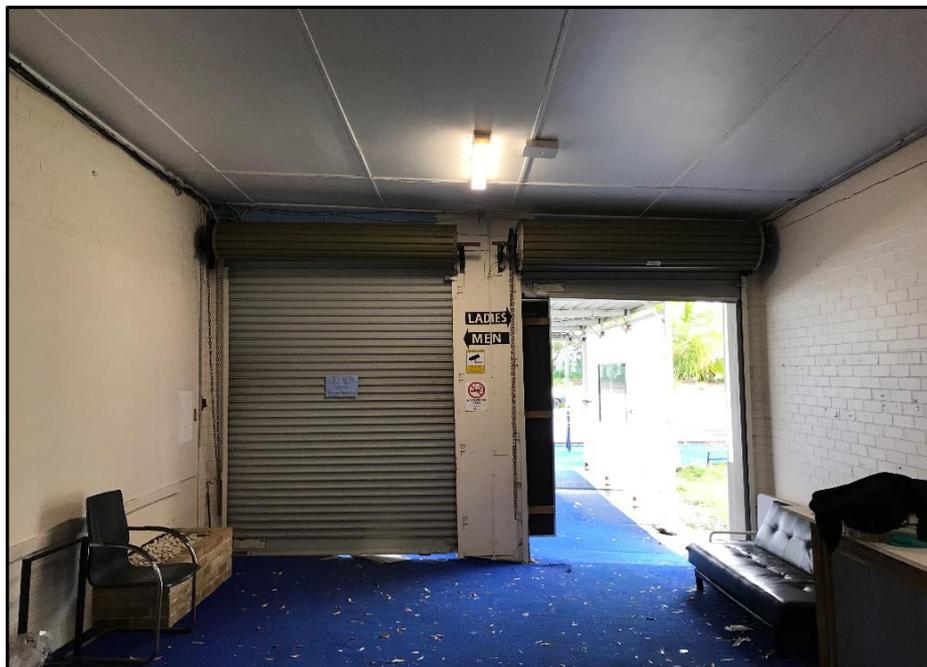
Photograph 12: Main Building, interior, centre section, reception area, western wall, infill panels to roller door, fibre cement sheeting, asbestos detected by analysis.

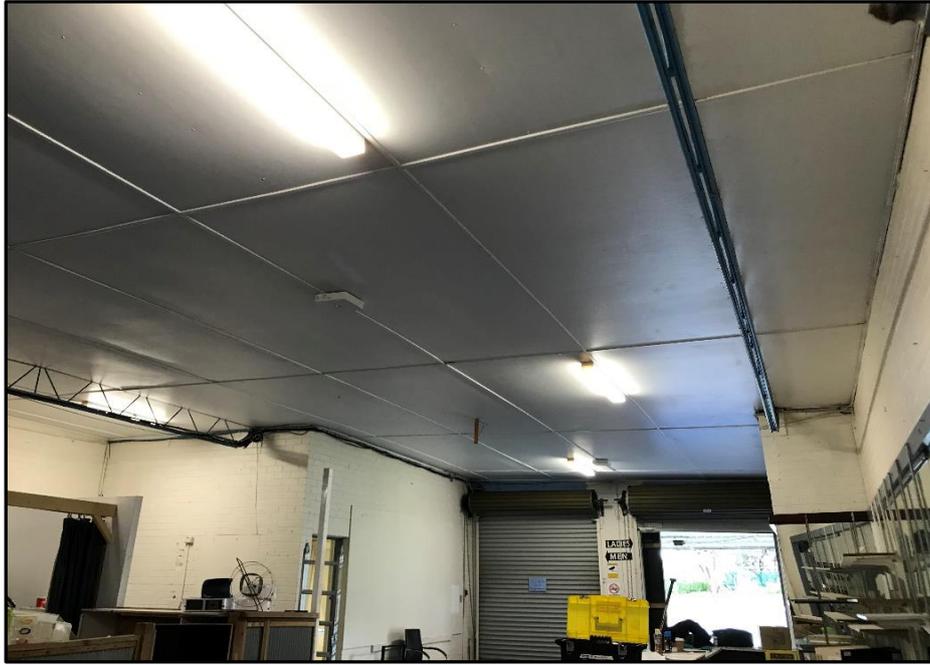
Photograph 13: Main Building, interior, centre section, reception area, ceiling, fibre cement sheeting, asbestos detected by analysis.

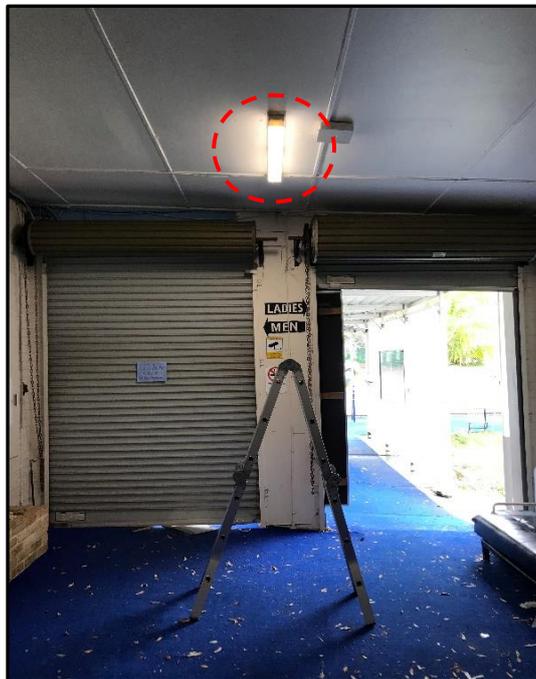
Photograph 14: Main Building, interior, centre section, reception area, fluorescent light fittings, internal components (e.g. capacitors/ballasts), may contain PCB.

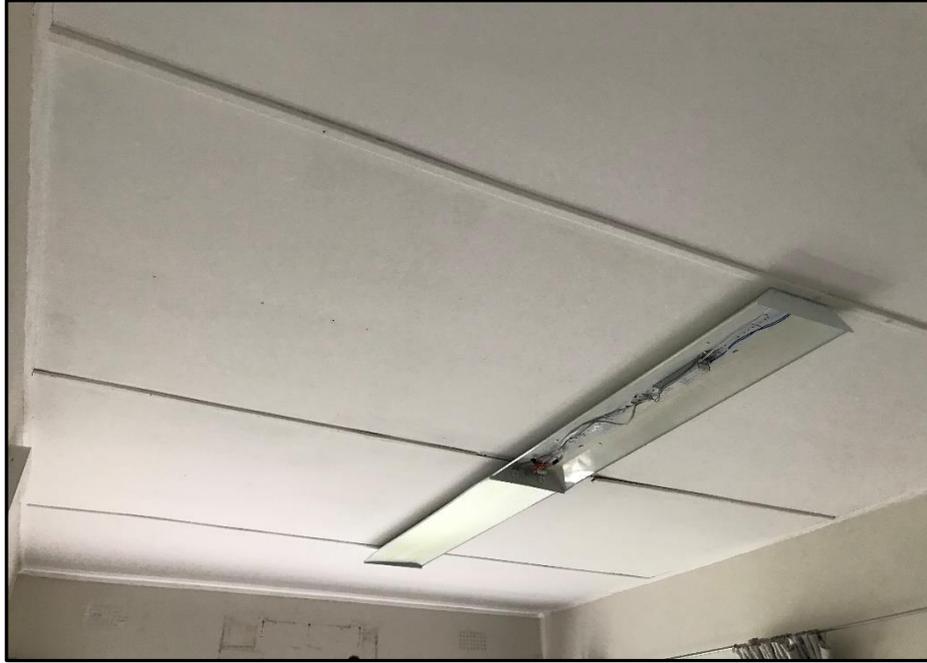
Photograph 15: Main Building, interior, centre section, massage room, ceiling, fibre cement sheeting, asbestos detected by analysis.

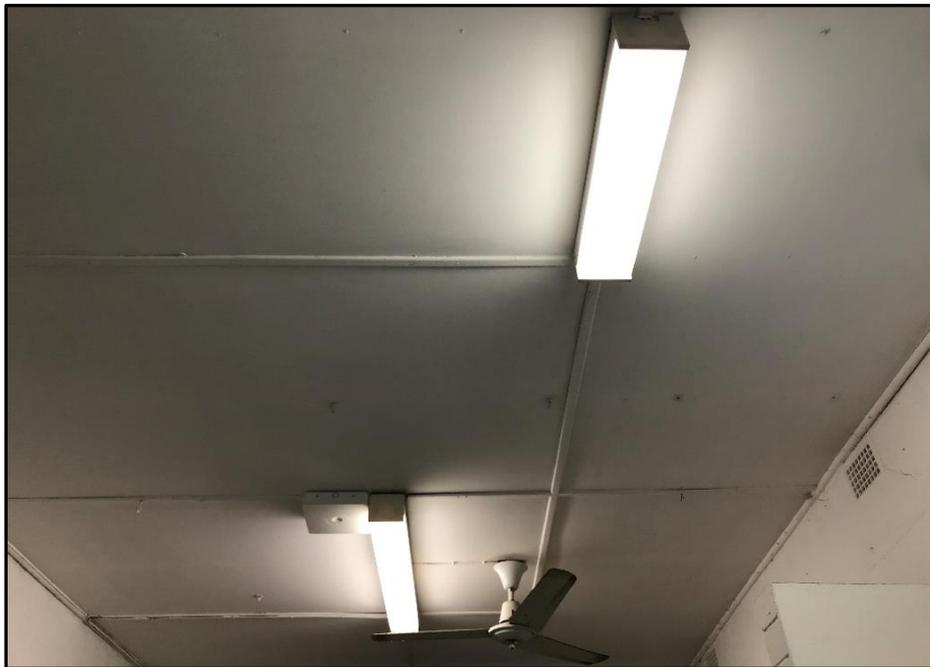
Photograph 16: Main Building, interior, centre section, canteen, ceiling, fibre cement sheeting, suspected asbestos.

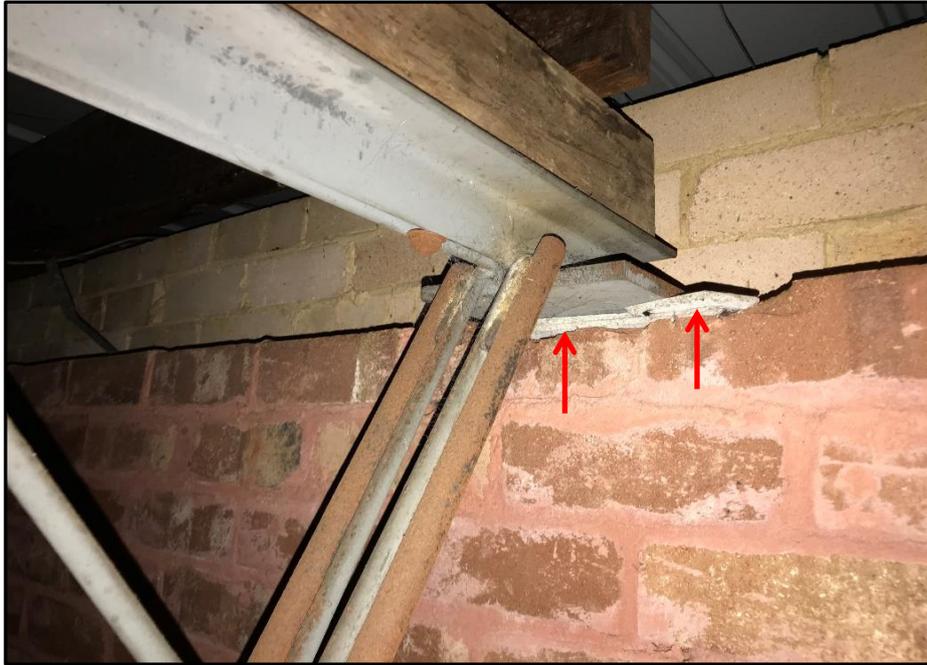
Photograph 17: Main Building, interior, centre section, southwestern store room, ceiling cavity, packing materials, fibre cement sheeting, asbestos detected by analysis.

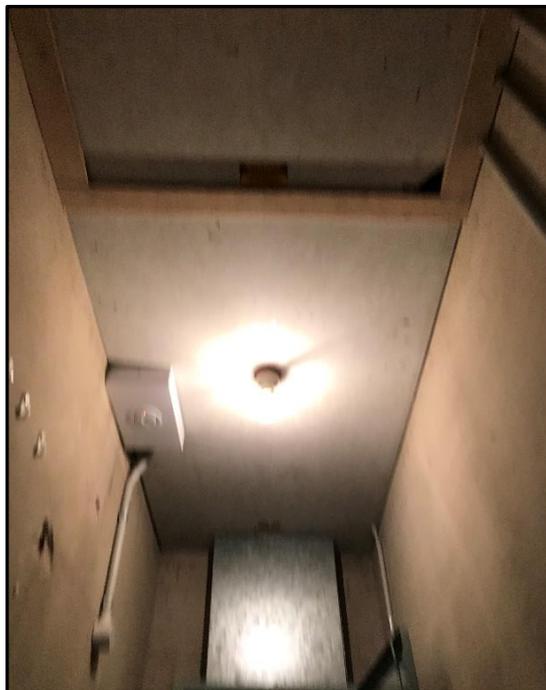
Photograph 18: Main Building, interior, centre section, electrical room, ceiling, fibre cement sheeting, suspected asbestos.

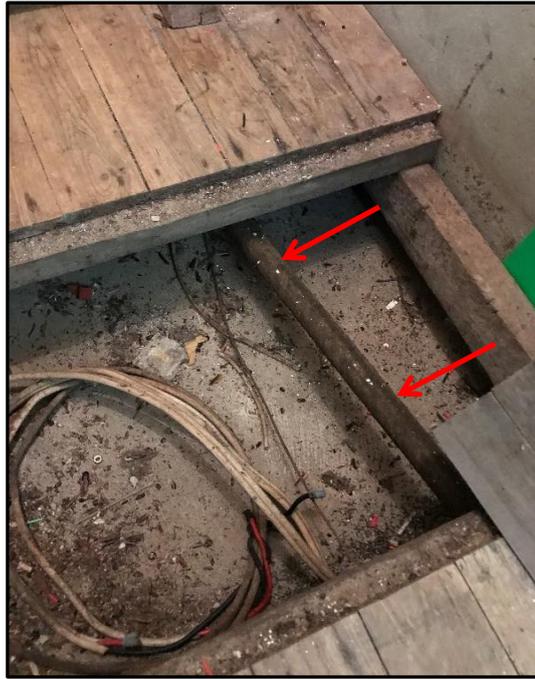
Photograph 19: Main Building, interior, centre section, electrical room, subfloor, electrical cable, bituminous wrapping, suspected asbestos.

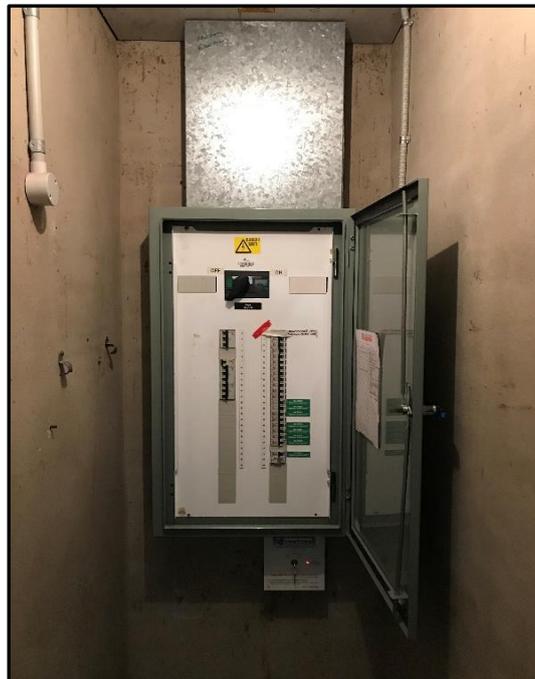
Photograph 20: Main Building, interior, centre section, electrical room, electrical cabinet, internal components, inaccessible.

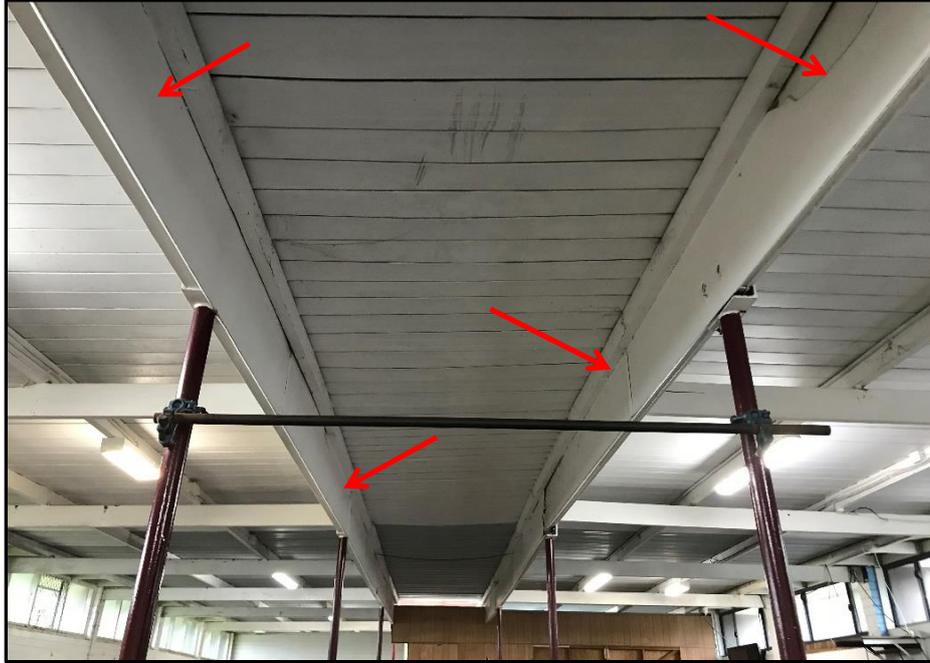
Photograph 21: Main Building, interior, southern section, gymnasium and change room, centre of ceiling, lining to timber beams, fibre cement sheeting, asbestos detected by analysis.

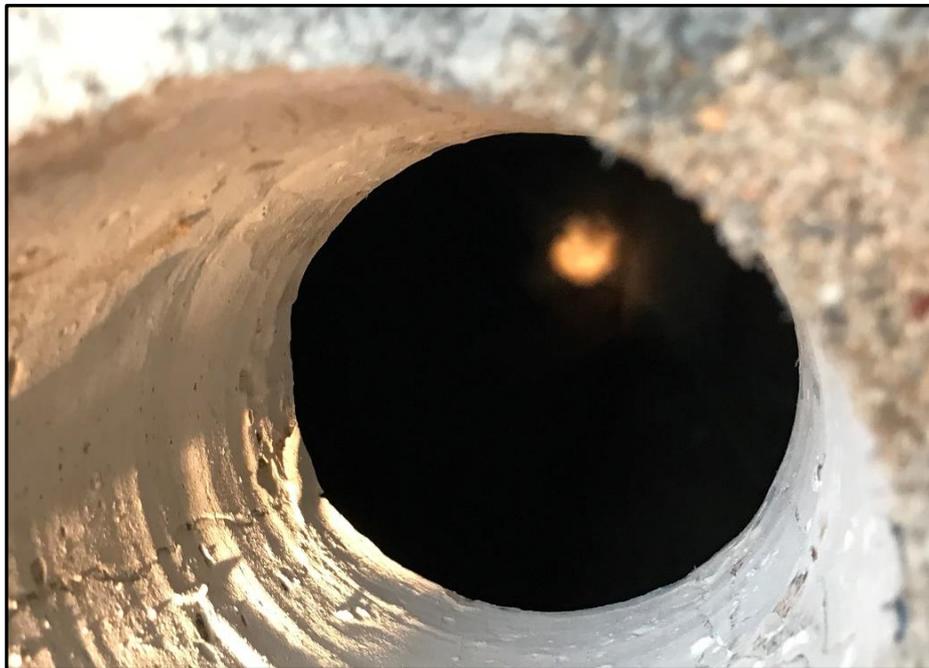
Photograph 22: Main Building, building in general, below concrete slab, subfloor void, materials in general, inaccessible.

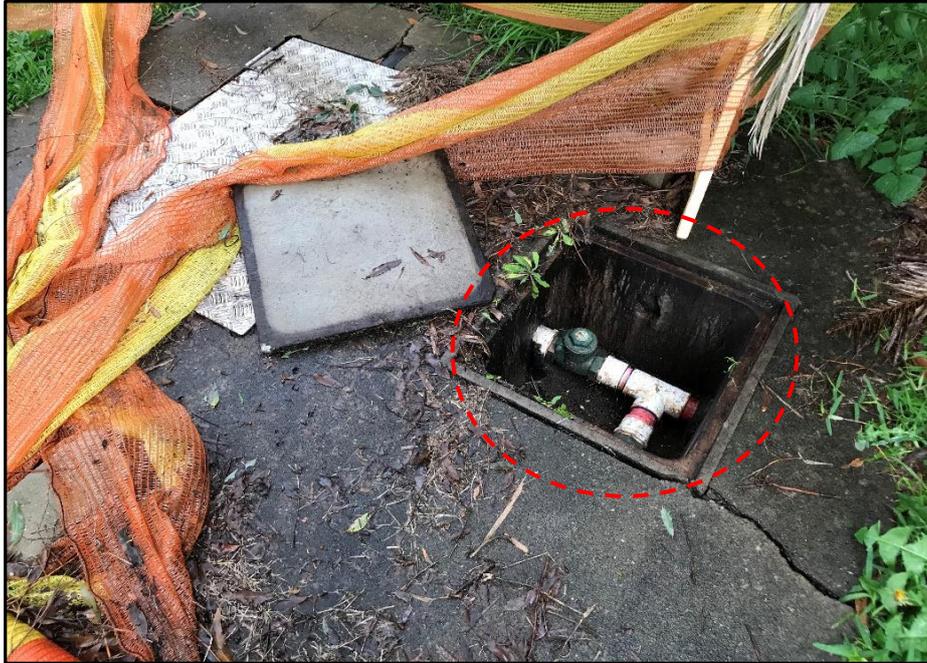
Photograph 23: Pump House, exterior, adjacent northwest, service pit, fibre reinforced pit, no asbestos detected by analysis. SMF detected.

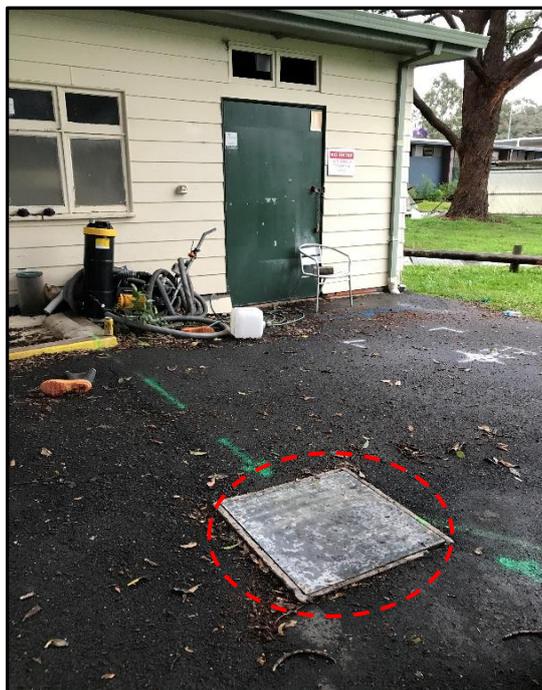
Photograph 24: Pump House, exterior, adjacent east, service pit, fibre reinforced pit, no asbestos detected by analysis. SMF detected.

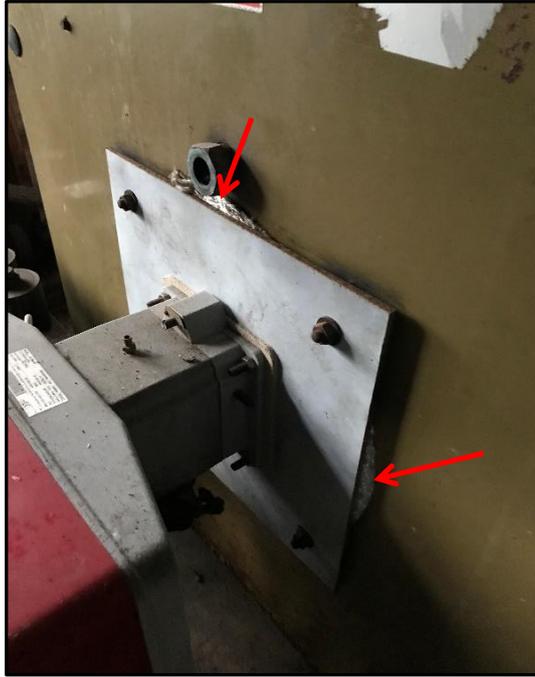
Photograph 25: Pump House, interior, boiler, external woven gasket, suspected asbestos.

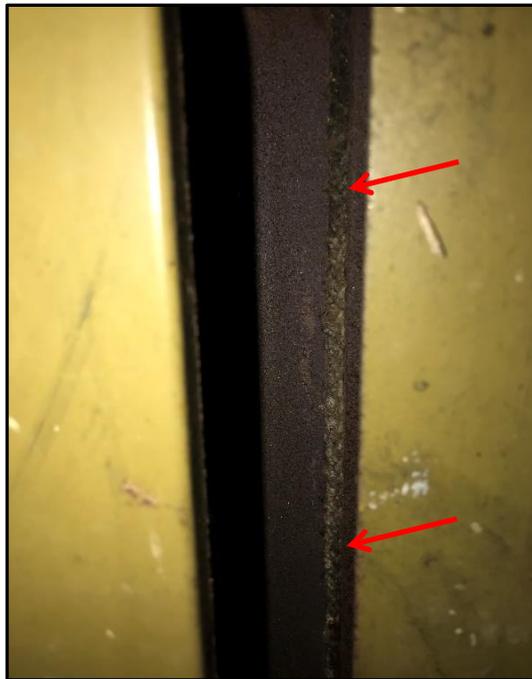
Photograph 26: Pump House, interior, boiler, internal gasket, asbestos detected by analysis.

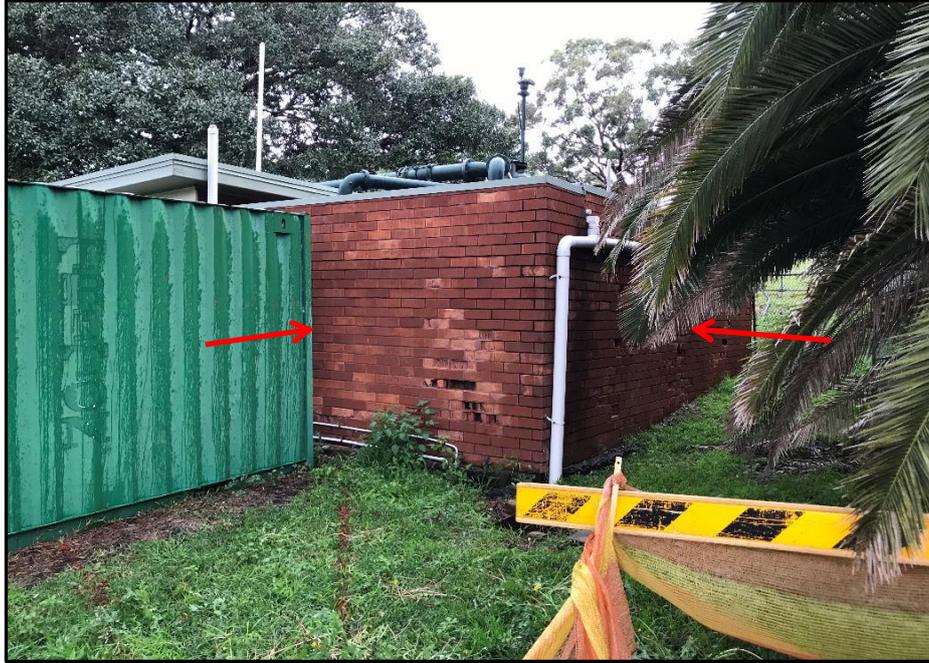
Photograph 27: Pump House, western section of building, throughout, materials in general, inaccessible.

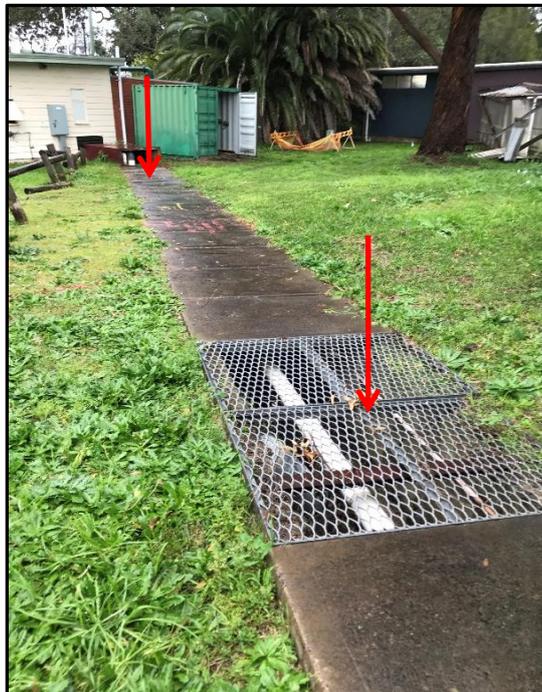
Photograph 28: General grounds, between Pump House and Olympic pool, service trench, pipes (x2), fibre cement pipes and associated components, asbestos detected by analysis.

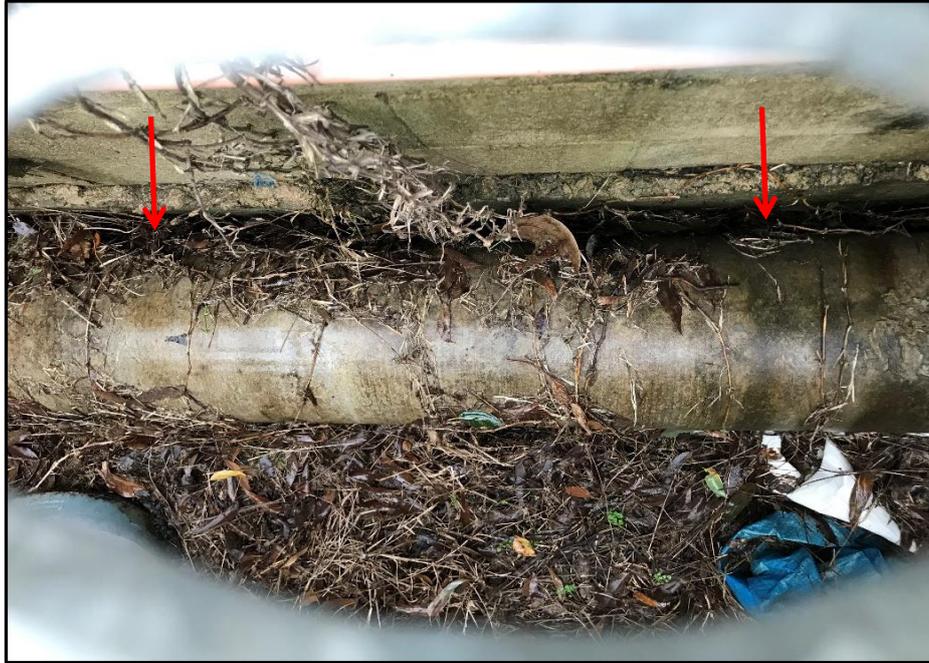
Photograph 29: General grounds, between Pump House and Olympic pool, service trench, pipes (x2), fibre cement pipes and associated components, asbestos detected by analysis.

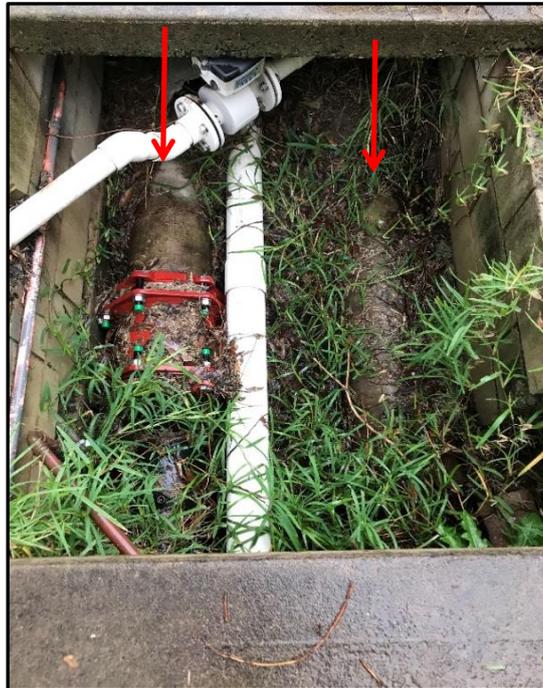
Photograph 30: General grounds, between Pump House and Olympic pool, service trench, pipes (x2), fibre cement pipes and associated components, asbestos detected by analysis.

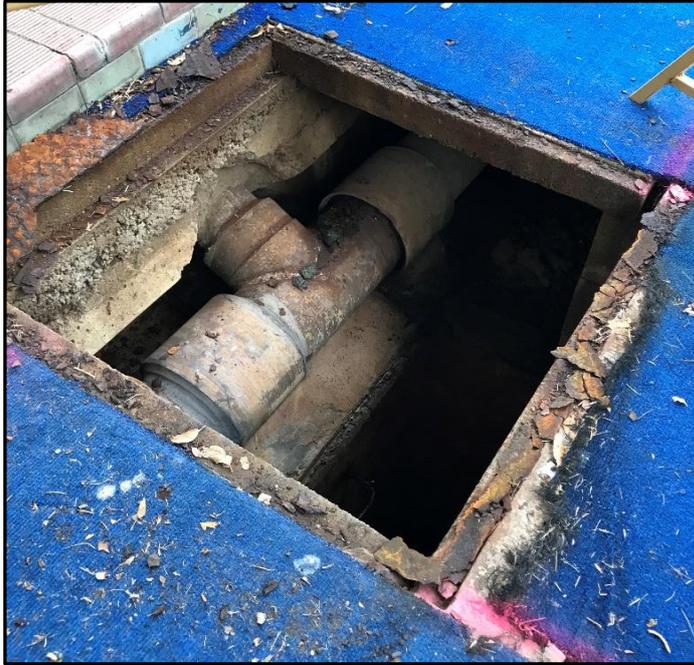
Photograph 31: General grounds, pool area, in-ground reticulation system, fibre cement pipes and associated components, asbestos detected by analysis.

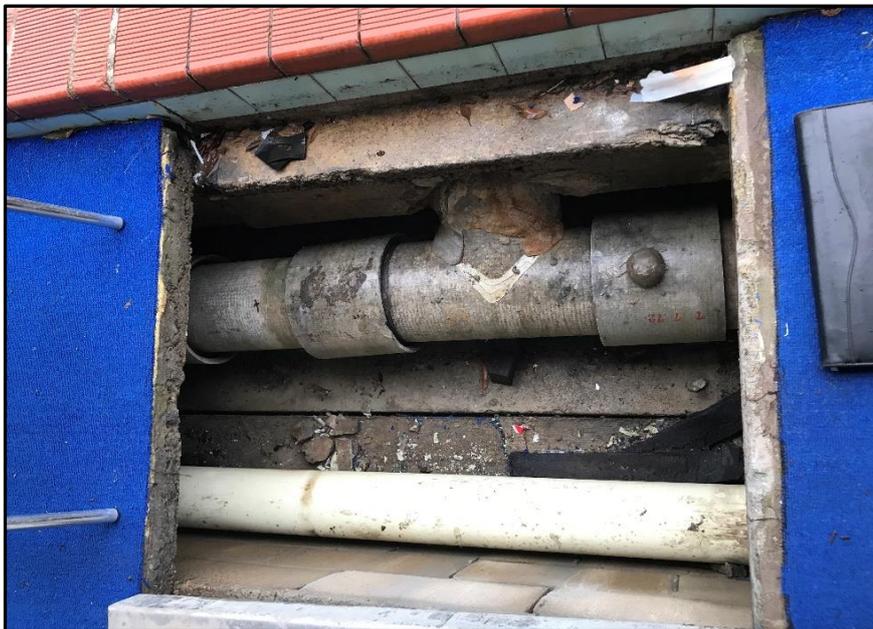
Photograph 32: General grounds, pool area, in-ground reticulation system, fibre cement pipes and associated components, asbestos detected by analysis.

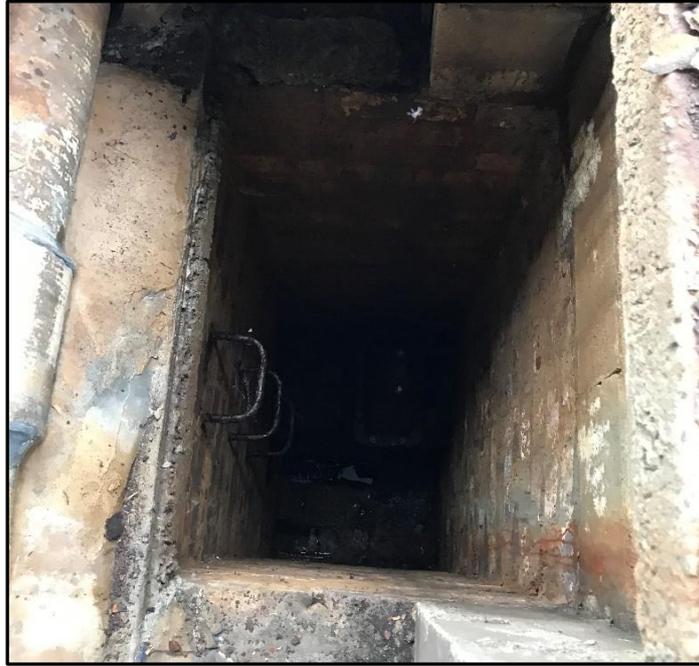
Photograph 33: General grounds, pool area, in-ground pits, service/plant areas and other voids, materials in general, inaccessible.

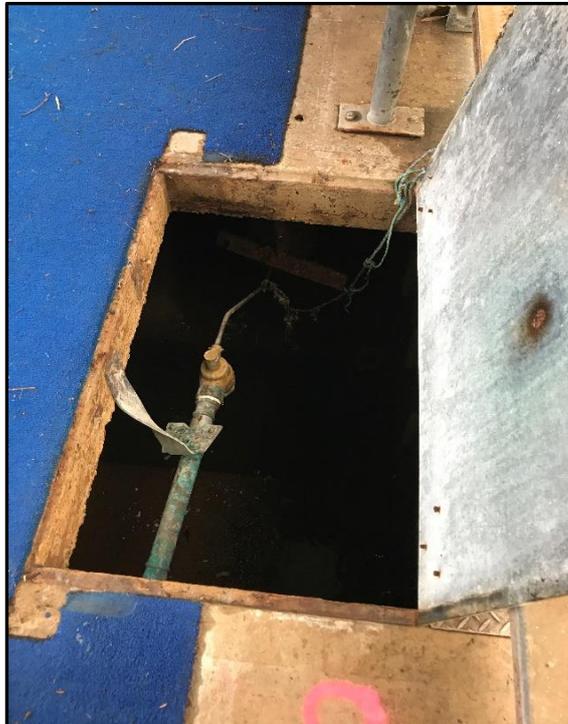
Photograph 34: General grounds, pool area, in-ground pits, service/plant areas and other voids, materials in general, inaccessible.

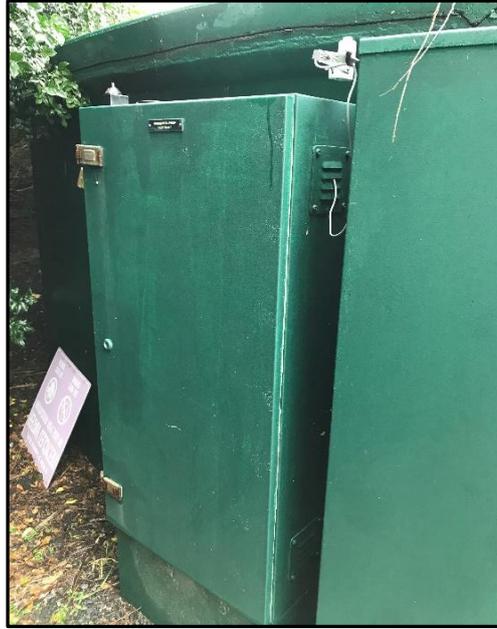
Photograph 35: General grounds, water tank area, irrigation pump controls, internal components, inaccessible.

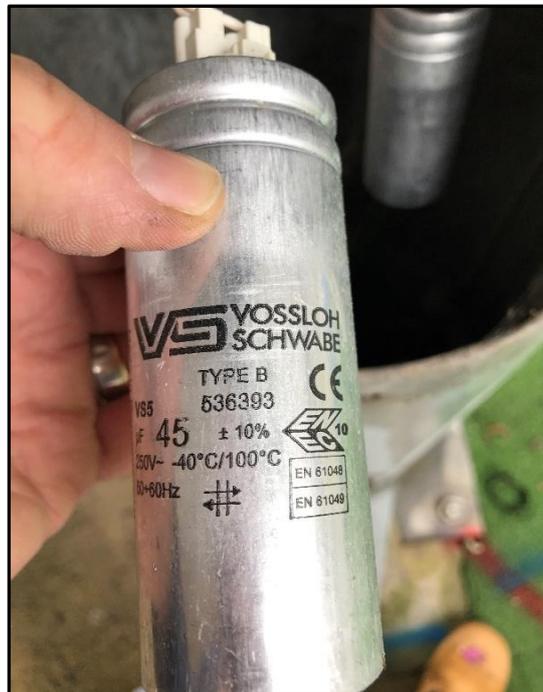
Photograph 36: General grounds, pool area, flood lights, internal components, Vossloh Schwabe capacitors (VS5, Type B, 45 µf +/-10%), suspected nil-PCB.

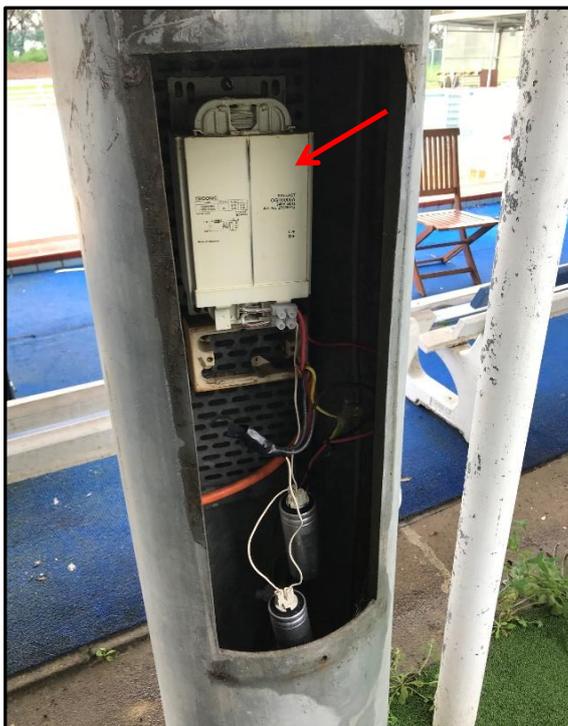
Photograph 37: General grounds, pool area, flood lights, internal components, Tridonic ballast OGH 1000A, may contain PCB.

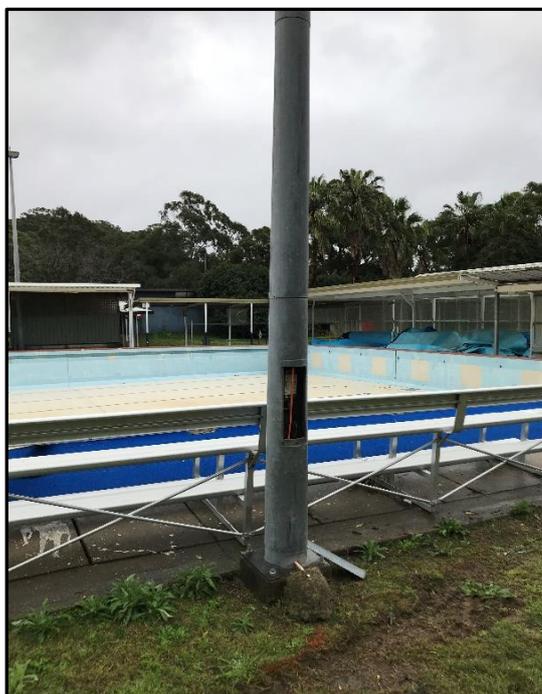
Photograph 38: General Grounds, pool area, flood lights, internal components (e.g. capacitors and/or ballasts), may contain PCB.

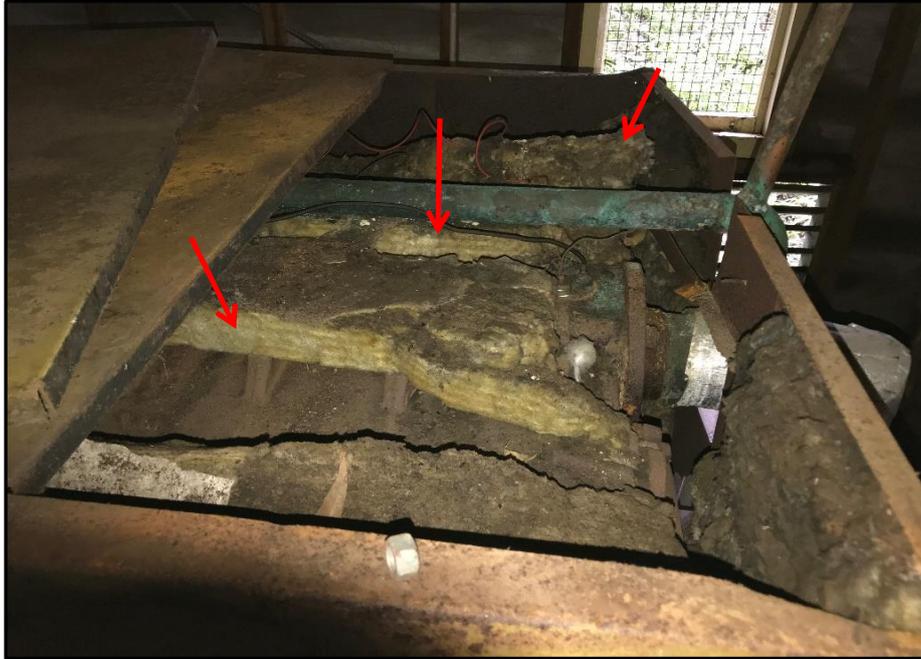
Photograph 39: Pump House, interior, boiler, accessible bulk insulation, SMF identified visually.

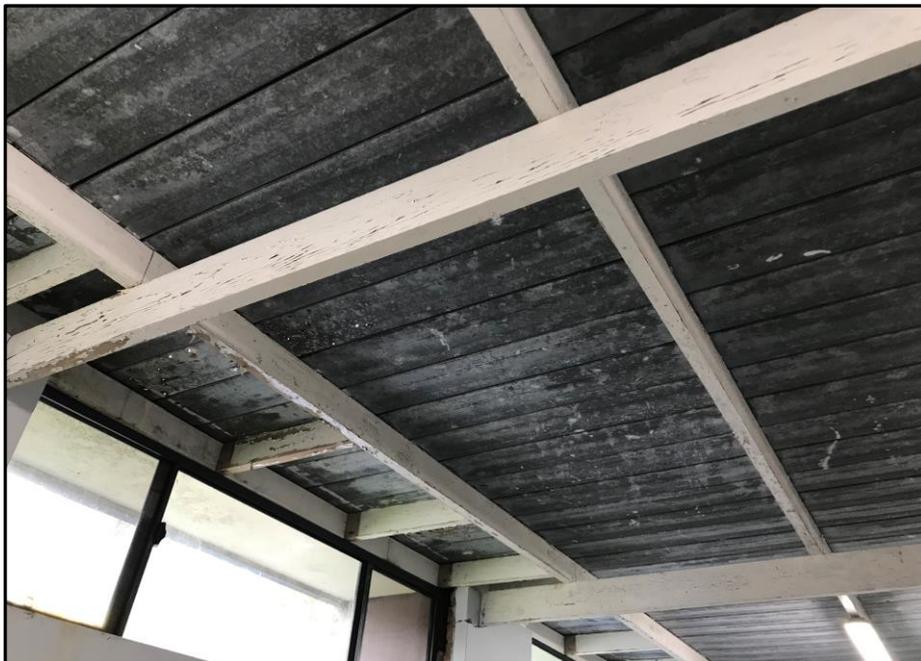
Photograph 40: Main Building, interior, northern section, male toilets, timber roof support, white paint system, lead paint (>0.1% lead w/w).

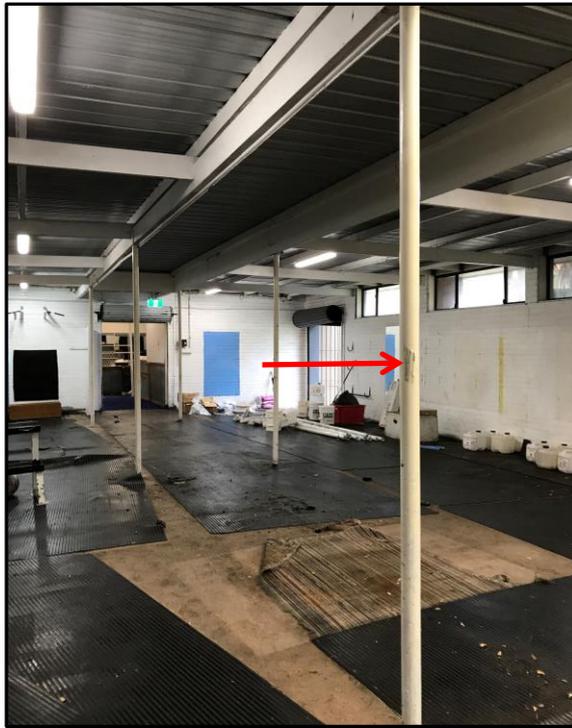
Photograph 41: Main Building, interior, northern section, main gymnasium, metal poles, white paint system, lead paint (>0.1% lead w/w).

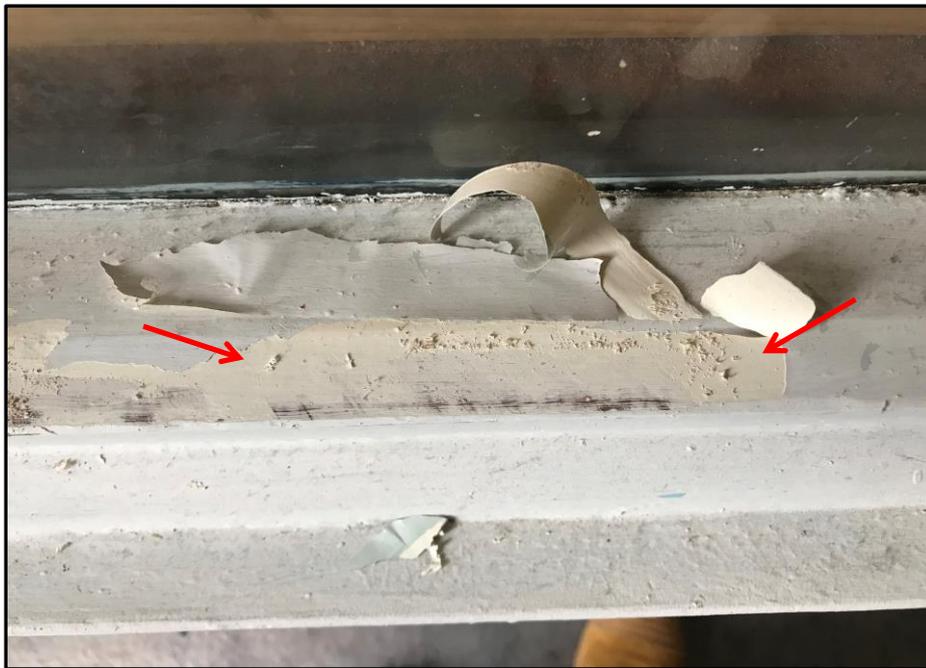
Photograph 42: Main Building, interior, centre section, massage room, window sill, underlying cream paint, lead paint (>0.1% lead w/w).
