# Arboricultural Development Assessment Report

Kogarah War Memorial Pool  
Carss Park NSW 2221  
September 2020  
*Final*  
(Updated 22<sup>nd</sup> Feb 2021)

Prepared for: Georges River Council

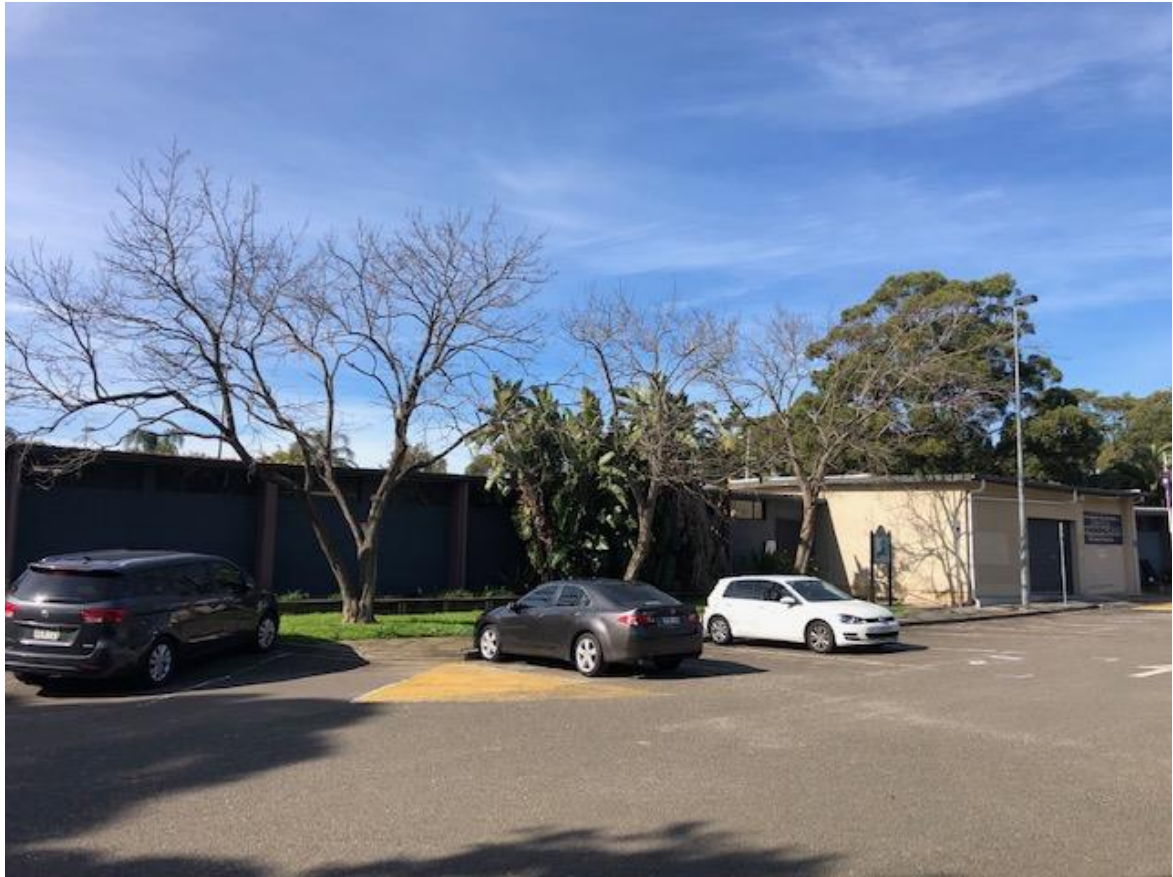
**Plate 1:** Image showing Trees 14-16 (*Robinia sp.*). P. Vezgoff

| Tree | Species | Height (m) | Spread (m) | DBH (m) | Live canopy % | Defects | SULE | Condition | Age | Comments | TPZ (m) | SRZ (m) | Native | Exotic |
|---|---|---|---|---|---|---|---|---|---|---|---|---|---|---|
| 14 | Black locust (Robinia pseudoacacia 'Frisia') | 8 | 4.8 | 0.34 | 90 | No visual defects | 2c removed for more suitable planting | Good | Mature | | 4.1 | 2.3 | | |

Based on the demolition works and soil remediation required, Trees required to be removed are numbered as 14-16, 33-65, 74-93, 97. The majority of these trees are exotic specimens.

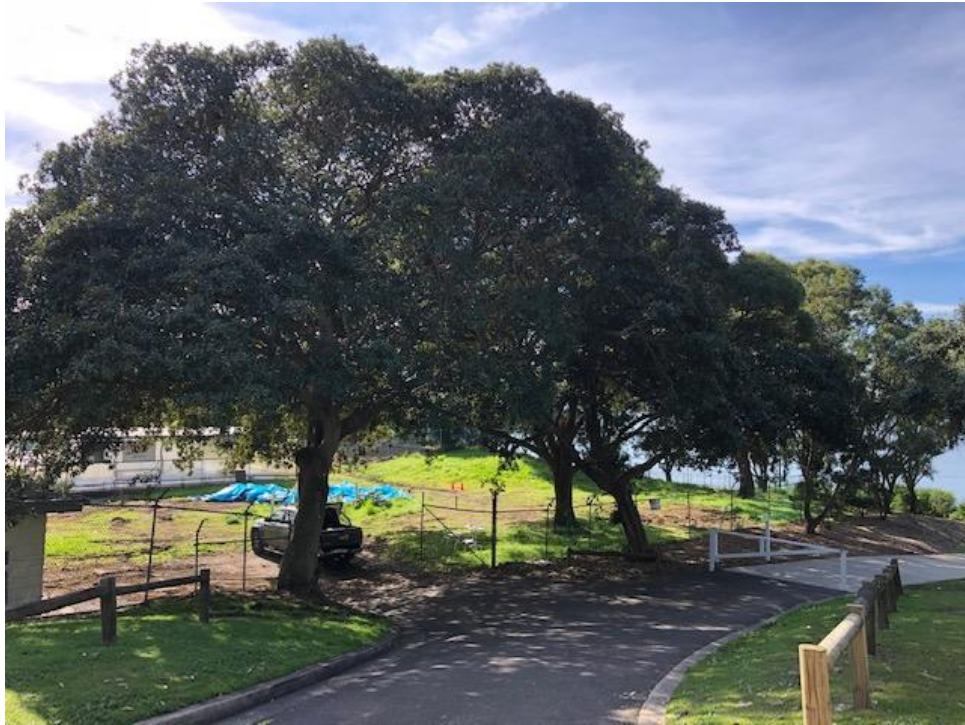
**Plate 2:** Image showing Port jackson fig (*Ficus rubiginosa*) by the side gate. P. Vezgoff

| Tree | Species | Height (m) | Spread (m) | DBH (m) | Live canopy % | Defects | SULE | Condition | Age | Comments | TPZ (m) | SRZ (m) | Native | Exotic |
|---|---|---|---|---|---|---|---|---|---|---|---|---|---|---|
| 23 | Port jackson fig (Ficus rubiginosa) | 14 | 12 | 0.85 | 90 | No visual defects | 2a May only live for 15-40 years | Fair | Mature | Twin stems with mechanical damage on the main stems mine die back | 10.2 | 3.1 | | |

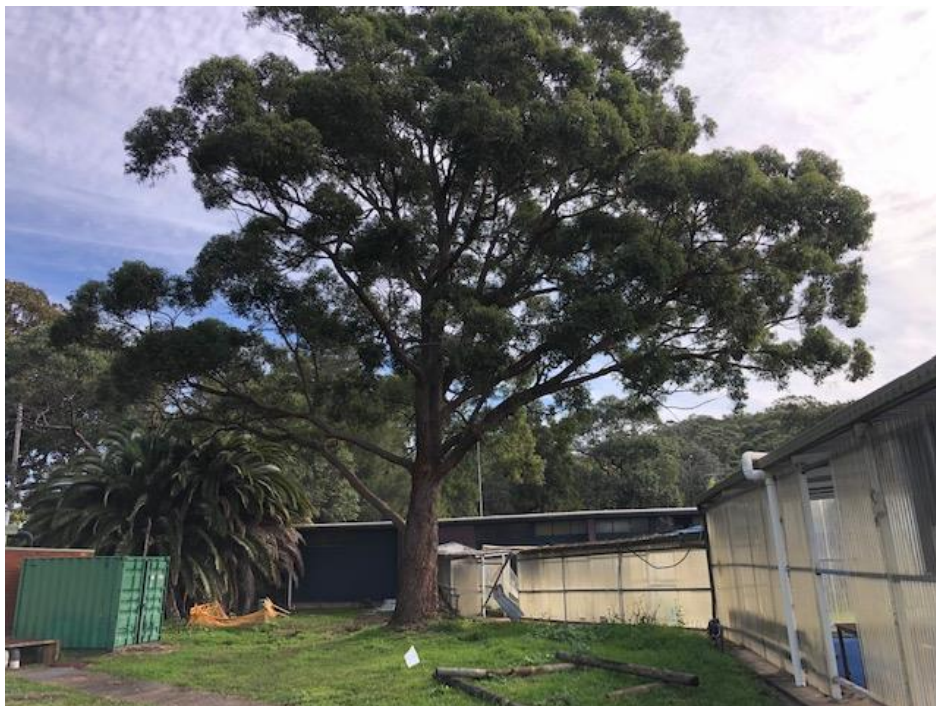
- 3.6** Along the southern vehicle entry to the site are the larger native specimens being Trees 23, 24, 27 and 32. These species consist of Tallowwood (*Eucalyptus microcorys*), Port jackson fig (*Ficus rubiginosa*), Forest Oak (*Allocasurina torulosa*). The Ficus has suffered from mechanical damage over the years however it is worthy of retention (Plate 2). The Tallowwood specimens within the pool grounds are large prominent specimens that are worthy of retaining, provided the soil remediation works do not impact these trees (Plate 3).

**Plate 3:** Image showing Tree 32. P. Vezgoff

| Tree | Species | Height (m) | Spread (m) | DBH (m) | Live canopy % | Defects | SULE | Condition | Age | Comments | TPZ (m) | SRZ (m) | Native | Exotic |
|---|---|---|---|---|---|---|---|---|---|---|---|---|---|---|
| 32 | Tallowwood (Eucalyptus microcorys) | 21 | 13 | 1.1 | 100 | No visual defects | 1a >40 years | Good | Mature | | 13.2 | 3.5 | | |

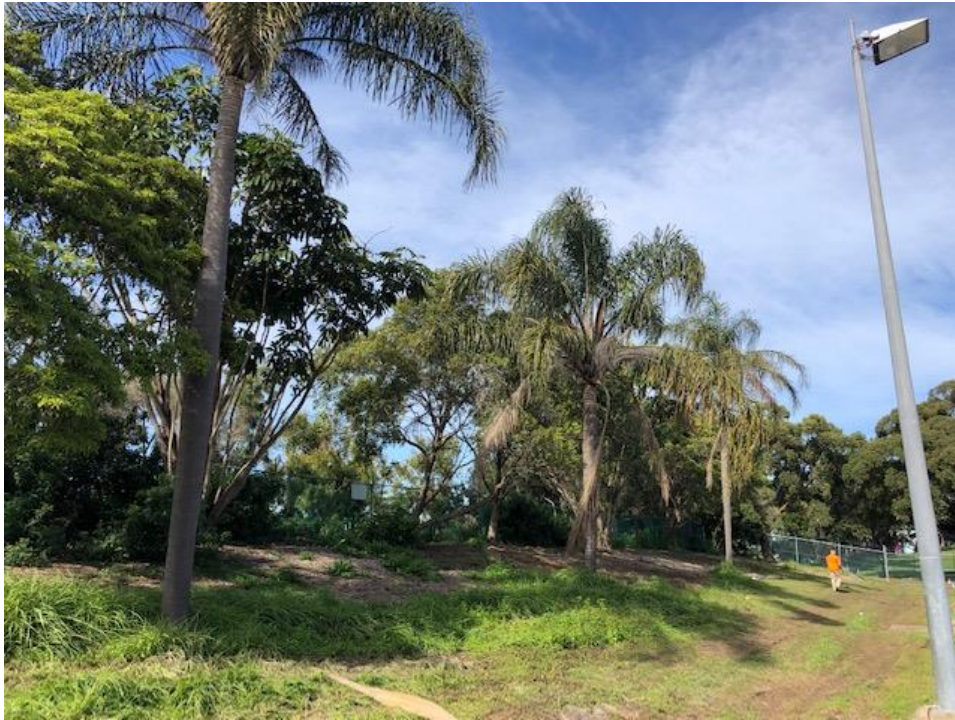
- 3.7 Other trees within the Pool area, that are mostly exotic specimens, consist of Kentia Palm (*Howea fosteriana*), *Dyopsis decaryi*, Hill's weeping fig (*Ficus microcarpa* var. *Hillii*), Native daphne (*Pittosporum undulatum*), Umbrella tree (*Shefflera actinophylla*), Cocos palm (*Syagrus romanzoffiana*), Jacaranda (*Jacaranda mimosifolia*) and a row of several Mexican fan palms (*Washingtonia robusta*).

**Plate 4:** Image showing some of the many exotic specimens surrounding the pool garden area. P. Vezgoff

In general, the site trees were mostly assessed as being in good health and condition with long ratings being 1a and 2a but the exotic specimens for the purpose of this project would be considered to have a 2c rating that being; *2c removed for more suitable planting.*

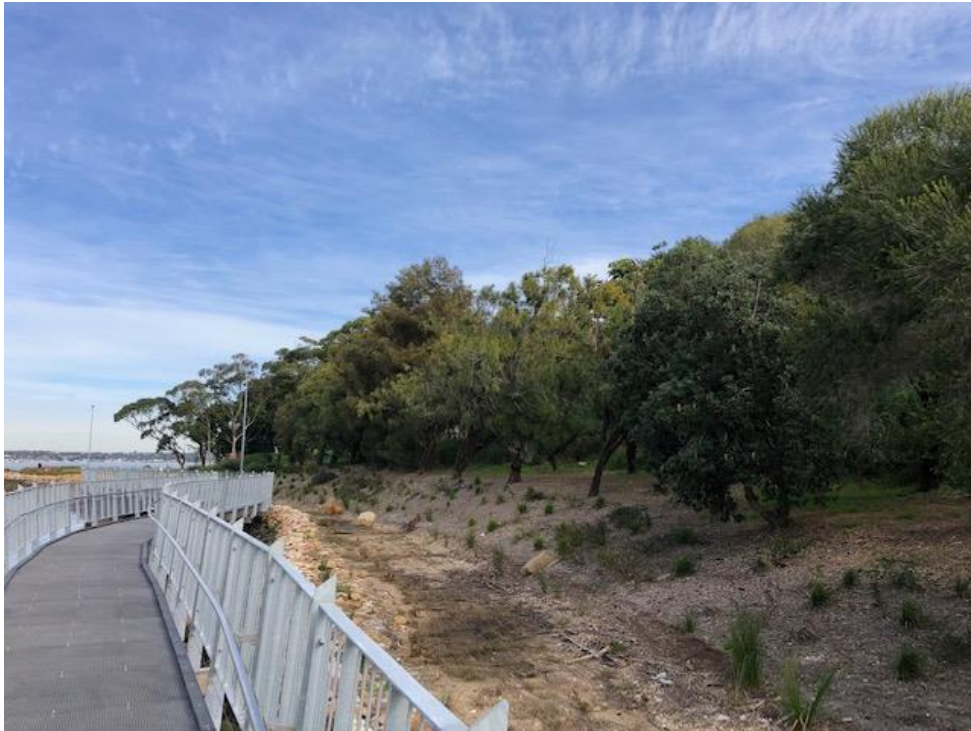
- 3.8 Along the foreshore area is a row of what is mostly Forest Oak (*Allocasurina torulosa*) with some individual semi mature *Eucalyptus* specimens. Many of these specimens are of a stunted nature and are not very tall (Plate 5). The dense vegetation along the northern boundary of the pool and the park appear to be shrubs that have long since died due to being overrun by vigorous *Bougainvillea* plants.

**Plate 5:** Image showing the trees along the foreshore area. P. Vezgoff
