Hazardous Materials Survey

64-70 King Georges Road & 280-300 Lakemba
Street, Wiley Park NSW

Report No: E25377.E10_Rev0

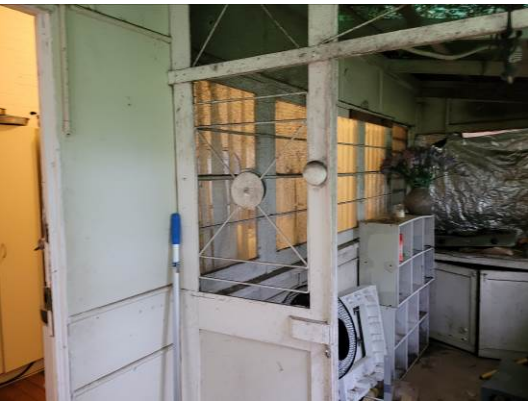
Internal, rear extension, rear walls	Asbestos cement sheeting	Non-friable	Asb04	Amosite & Chrysotile Asbestos Detected	5m ²	Good Regular	Priority 4 – Negligible Risk Level	Remove prior to demolition works

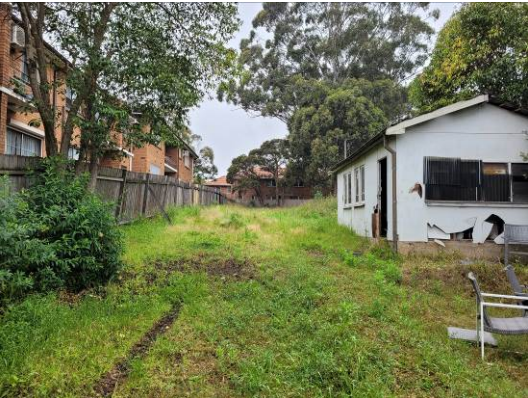
External, rear extension, infill panels	Asbestos cement sheeting (assumed)	Non-friable	Visual Inspection similar to Asb05	-	5m ²	Good-fair Regular	Priority 4 – Negligible Risk Level	Remove prior to demolition works

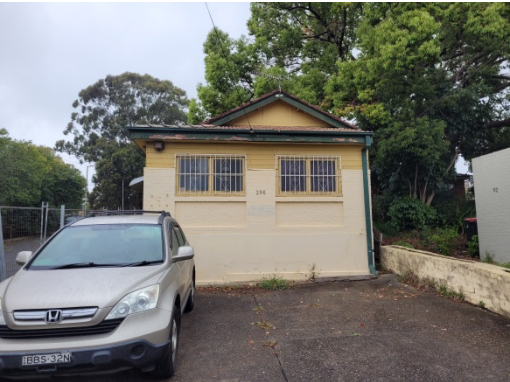
External, main building, eaves	Asbestos cement sheeting	Non-friable	Asb07	Chrysotile Asbestos Detected Organic Fibres Detected	5m ²	Good Regular	Priority 4 – Negligible Risk Level	Remove prior to demolition works

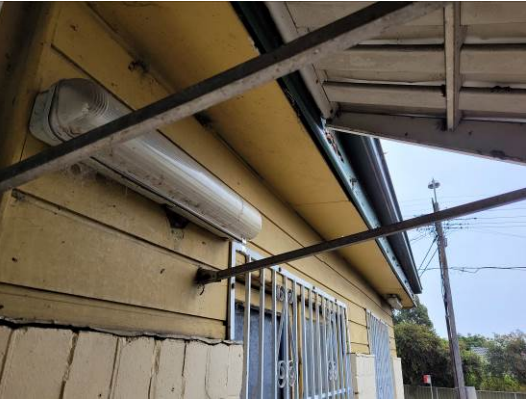
External, main building, eave ends	Asbestos cement sheeting	Non-friable	Asb08	Amosite & Chrysotile Asbestos Detected Organic Fibres Detected	<1m ²	Good Regular	Priority 4 – Negligible Risk Level	Remove prior to demolition works

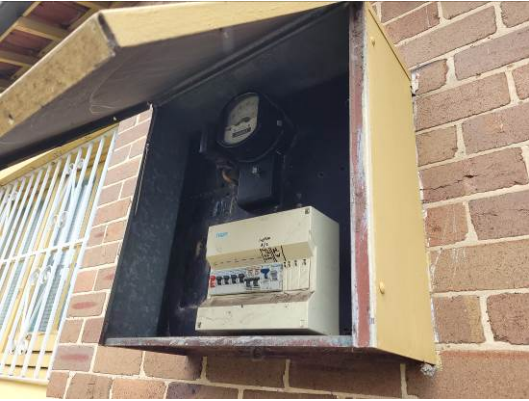
External, eastern wall, electrical unit	Asbestos backing board (assumed)	Non-friable	Visual Inspection	-	1x unit	Good Regular	Priority 4 – Negligible Risk Level	Remove prior to demolition works

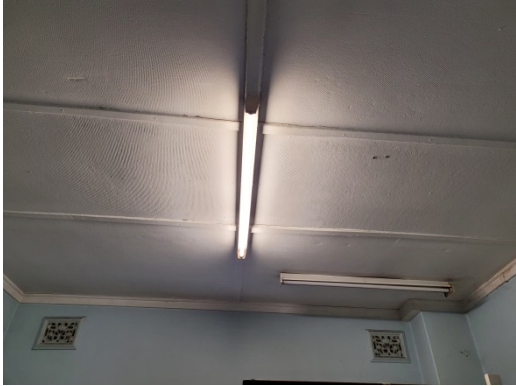
Internal, dining room ceiling, adjacent to kitchen	Fibre cement sheeting (Assumed)	N/A	Visual Inspection	-	20m ²	Good Regular	Priority 4 – Negligible Risk Level	Remove prior to demolition works

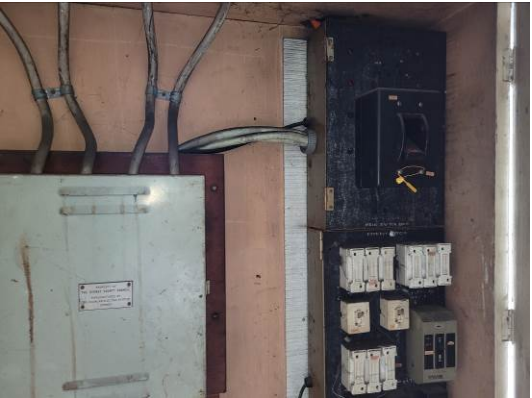
Blazin Grillz – Internal, dining area, electrical unit	Asbestos backing board (assumed)	Non-friable	Visual Inspection	-	1x unit	Good Maintenance only	Priority 4 – Negligible Risk Level	Remove prior to demolition works

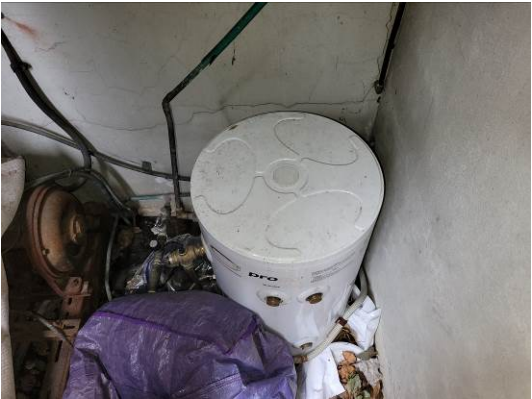
White Heaven Turkish Cuisine – External, rear yard	SMF Insulation	Non-friable	Visual Inspection	-	1x hot water unit	Good Maintenance Only	Priority 4: Negligible Risk Level	Remove prior to demolition works
