## INTRUSIVE HAZARDOUS MATERIALS REGISTER

KE1784

Date of assessment: 03 December 2019

Address: 360A Alderson Place, Tralee NSW 2620

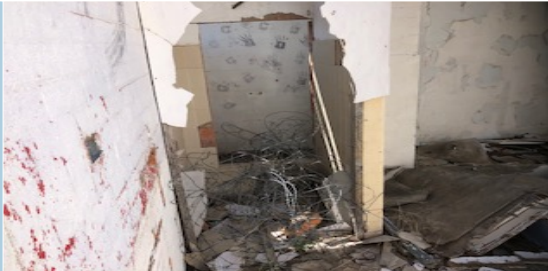
| Asbestos detected | | | | Presumed to contain asbestos | | | No asbestos detected | |
|---|---|---|---|---|---|---|---|---|
| To shower wall in toilet/shower block | Sheet | A1 | - | N/A | N/A | No Asbestos Detected | No further action required | |

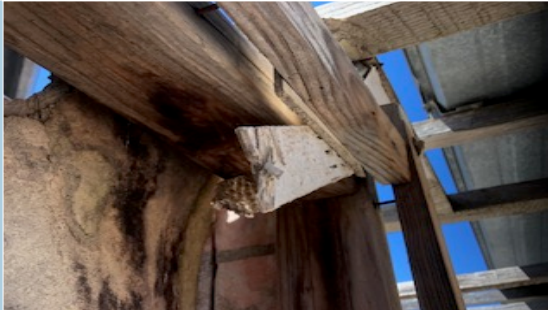
| Asbestos detected | | | | Presumed to contain asbestos | | | No asbestos detected | |
|---|---|---|---|---|---|---|---|---|
| Packers between shower wall timbers in toilet/shower block | Sheet | A2 | - | N/A | N/A | No Asbestos Detected | No further action required | |

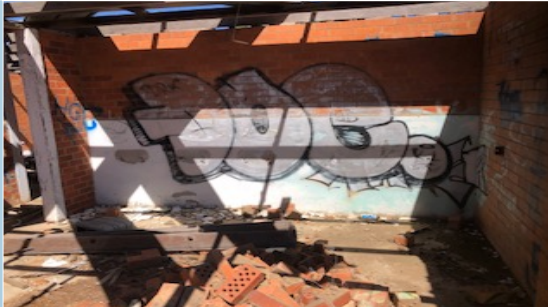
| Asbestos detected | | | | Presumed to contain asbestos | | | No asbestos detected | |
|---|---|---|---|---|---|---|---|---|
| Rear toilet walls in toilet/shower block | Sheet | A3 | - | N/A | N/A | No Asbestos Detected | No further action required | |

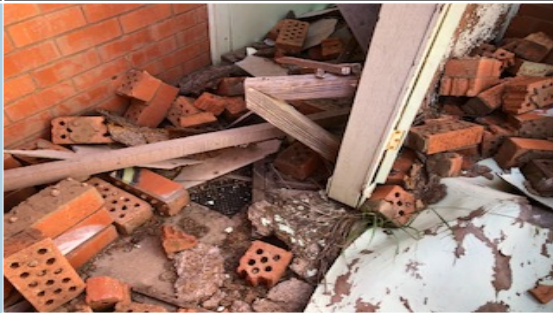
| Asbestos detected | | | | Presumed to contain asbestos | | | No asbestos detected | |
|---|---|---|---|---|---|---|---|---|
| Debris to toilet riser and in toilet/shower block | Sheet | A4 | - | N/A | N/A | No Asbestos Detected | No further action required | |

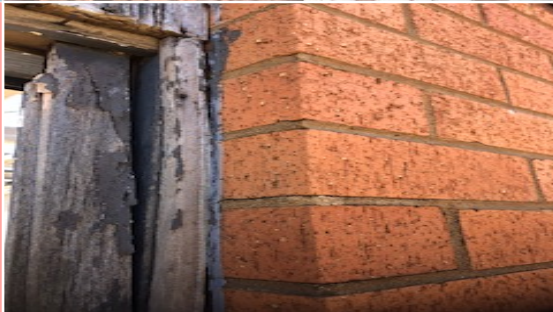
| Asbestos detected | | | | Presumed to contain asbestos | | | No asbestos detected | |
|---|---|---|---|---|---|---|---|---|
| Mastic to window frames in toilet/shower block | Mastic | A5 | 12lm | Non friable & fair | Very Low | Chrysotile Asbestos Detected | Remove prior to demolition works commencing | |

The asbestos containing material (ACM) noted in the asbestos register must be removed prior to demolition works commencing. The unexpected finds procedure must be used at Appendix B if any suspected ACM is found that is not noted in this document.

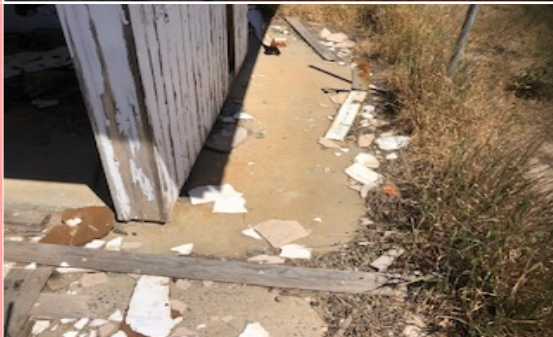
| Asbestos detected | | | | Presumed to contain asbestos | | | No asbestos detected | |
|---|---|---|---|---|---|---|---|---|
| Debris around Kiosk | Sheet | A6 | 4 | Non friable & poor | Low Moderate if disturbed | Chrysotile Asbestos Detected | Remove prior to demolition works commencing | |

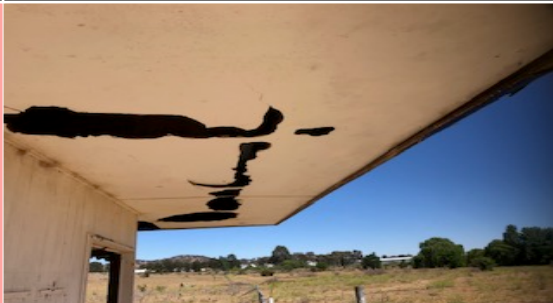
| Asbestos detected | | | | Presumed to contain asbestos | | | No asbestos detected | |
|---|---|---|---|---|---|---|---|---|
| Kiosk eaves | Sheet | A7 | 16lm | Non friable & fair damaged | Low | Chrysotile Asbestos Detected | Remove prior to demolition works commencing | |

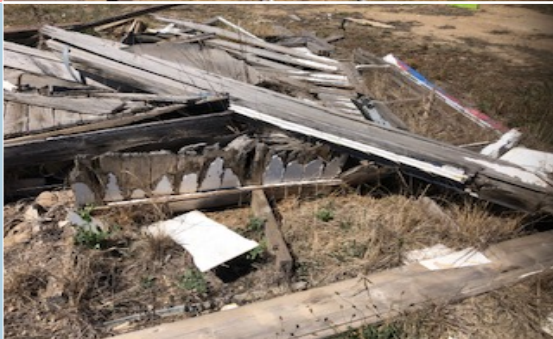
| Asbestos detected | | | | Presumed to contain asbestos | | | No asbestos detected | |
|---|---|---|---|---|---|---|---|---|
| Debris to mound in middle of speedway | Sheet | A8 | - | N/A | N/A | No Asbestos Detected | No further action required | |

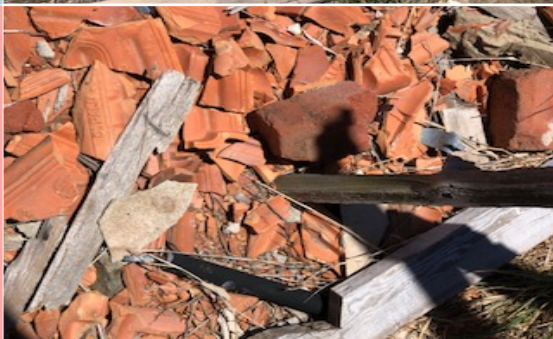
| Asbestos detected | | | | Presumed to contain asbestos | | | No asbestos detected | |
|---|---|---|---|---|---|---|---|---|
| Sheet debris at the front of stone house | Sheet | A9 | <1 | Non friable & fair | Low | Chrysotile Asbestos Detected | Remove prior to demolition works commencing | |

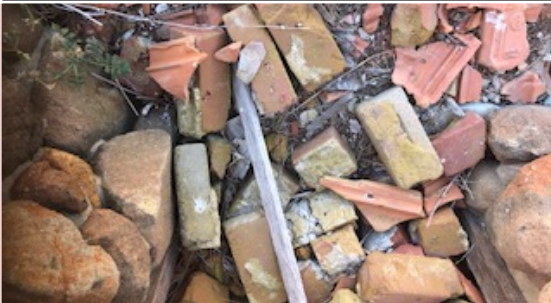
| Asbestos detected | | | | Presumed to contain asbestos | | | No asbestos detected | |
|---|---|---|---|---|---|---|---|---|
| Sheet debris at the around the stone house | Sheet | A10 | <1 | Non friable & fair | Low | Amosite, Chrysotile Asbestos Detected | Remove prior to demolition works commencing | |

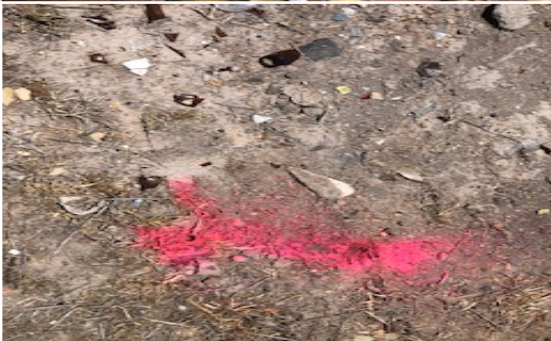
| Asbestos detected | | | | Presumed to contain asbestos | | | No asbestos detected | |
|---|---|---|---|---|---|---|---|---|
| North side of AEC 6 - see site plan | Sheet | A11 | - | Friable & good | Low. High if disturbed | Amosite, Chrysotile Asbestos Detected | Remove prior to demolition works commencing | |

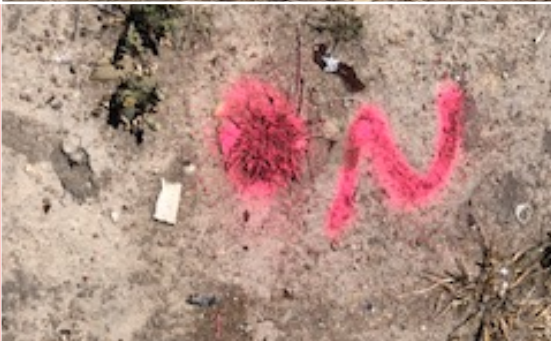
| Asbestos detected | | | | Presumed to contain asbestos | | | No asbestos detected | |
|---|---|---|---|---|---|---|---|---|
| South side of AEC 6 - see site plan | Sheet | A12 | - | Friable & good | Low. High if disturbed | Amosite, Chrysotile Asbestos Detected | Remove prior to demolition works commencing | |

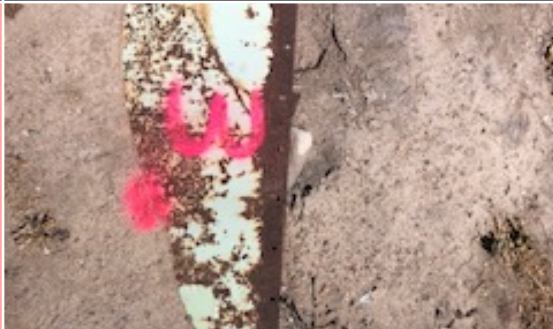
| Asbestos detected | | | | Presumed to contain asbestos | | | No asbestos detected | |
|---|---|---|---|---|---|---|---|---|
| East side of AEC 6 - see site plan | Sheet | A13 | - | Non friable & fair | Low | Amosite, Chrysotile Asbestos Detected | Remove prior to demolition works commencing | |

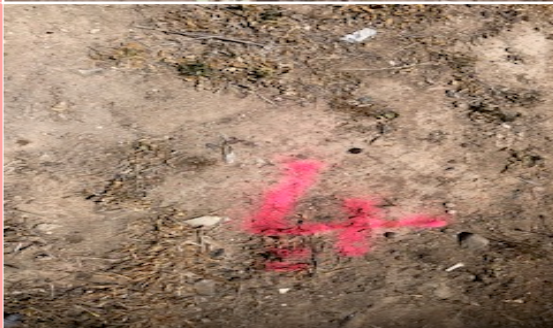
| Asbestos detected | | | | Presumed to contain asbestos | | | No asbestos detected | |
|---|---|---|---|---|---|---|---|---|
| West side of AEC 6 - see site plan | Sheet | A14 | - | Non friable & fair | Low | Amosite, Chrysotile Asbestos Detected | Remove prior to demolition works commencing | |

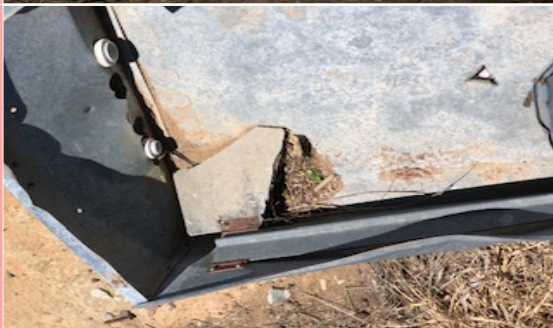
| Asbestos detected | | | | Presumed to contain asbestos | | | No asbestos detected | |
|---|---|---|---|---|---|---|---|---|
| ESWB and debris to eastern edge of speedway track | Sheet | A15 | - | Non friable & fair | Low | Chrysotile Asbestos Detected | Remove prior to demolition works commencing | |

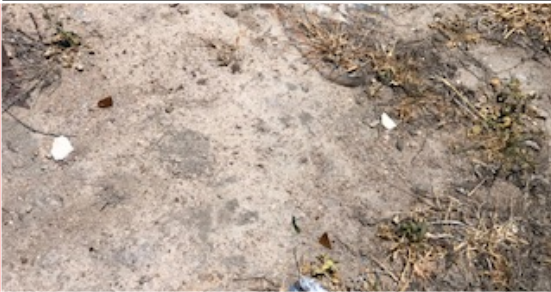
| Asbestos detected | | | | Presumed to contain asbestos | | | No asbestos detected | |
|---|---|---|---|---|---|---|---|---|
| Debris east side outside of speedway track - removed during sampling | Sheet | A16 | - | Non friable & fair | Low | Chrysotile Asbestos Detected | Remove prior to demolition works commencing | |

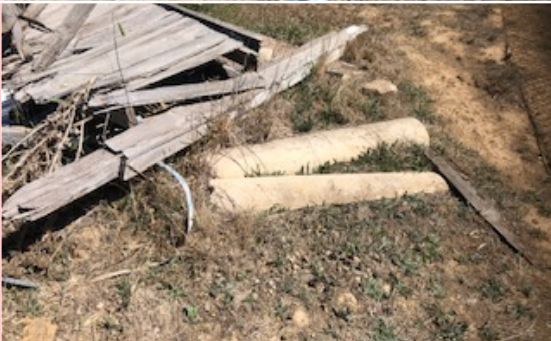
| Asbestos detected | | | | Presumed to contain asbestos | | | No asbestos detected | |
|---|---|---|---|---|---|---|---|---|
| SW corner outside track - mixed with rubble - pipe and debris | Sheet | A17 | 20 | Non friable & fair | Low | Chrysotile Asbestos Detected | Remove prior to demolition works commencing | |

**Notes: The fire damaged material and construction waste must be as asbestos contaminated waste. Asbestos pipe conduits and sheet debris was found at the south west area of the site and may be buried at depth. Additionally an area (see attached plan) has asbestos contamination in the soil (AEC 6) and should be stockpiled and waste classified prior to disposal off site.**

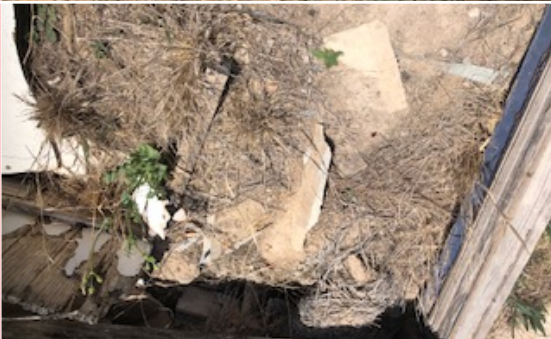
| Asbestos detected | | | | Presumed to contain asbestos | | | No asbestos detected | |
|---|---|---|---|---|---|---|---|---|
| SW corner outside track - mixed with rubble sheet debris - possibly buried at depth | Sheet | A18 | >20m3 | Non friable & fair | Low | Chrysotile Asbestos Detected | Remove prior to demolition works commencing | |

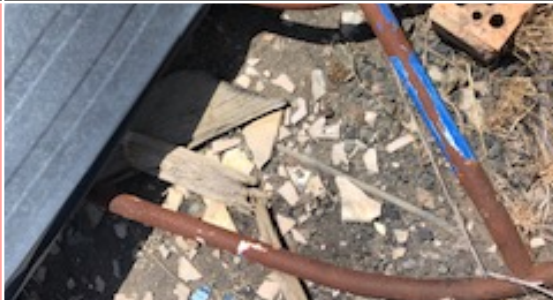
| Asbestos detected | | | | Presumed to contain asbestos | | | No asbestos detected | |
|---|---|---|---|---|---|---|---|---|
| Fire damaged sheet debris see site plan | Sheet | A19 | 50m3 | Non friable & good | Low | Chrysotile Asbestos Detected | Remove prior to demolition works commencing | |

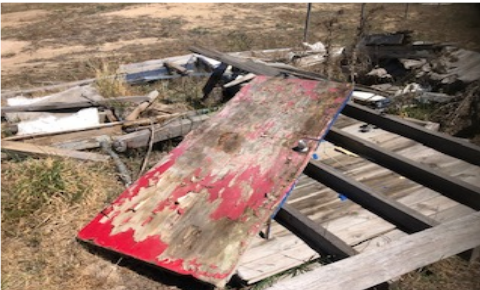
| LOCATION | COLOUR | SAMPLE ID | TYPE & CONDITION | RESULT | COMMENTS | PHOTO OF PAINT |
|---|---|---|---|---|---|---|
| To site debris | Red | P1 | Lead & Fair | <0.17 | No action required | |

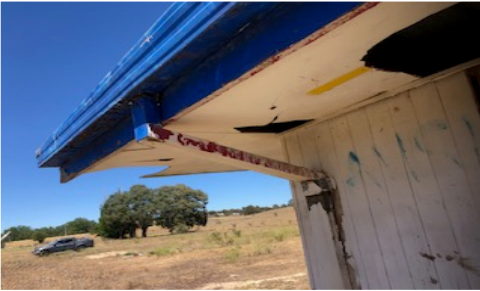
| LOCATION | COLOUR | SAMPLE ID | TYPE & CONDITION | RESULT | COMMENTS | PHOTO OF PAINT |
|---|---|---|---|---|---|---|
| To Kiosk fascia panels | Blue | P2 | Lead & Fair | 0.70 | No action required | |

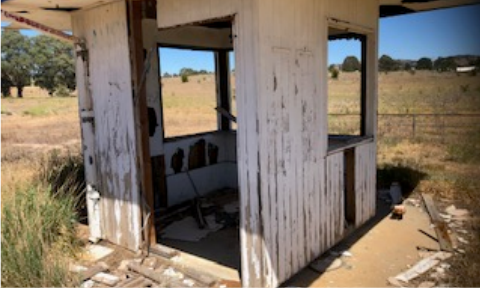
| LOCATION | COLOUR | SAMPLE ID | TYPE & CONDITION | RESULT | COMMENTS | PHOTO OF PAINT |
|---|---|---|---|---|---|---|
| To Kiosk walls | White | P3 | Lead Free | 0.080 | No action required | |

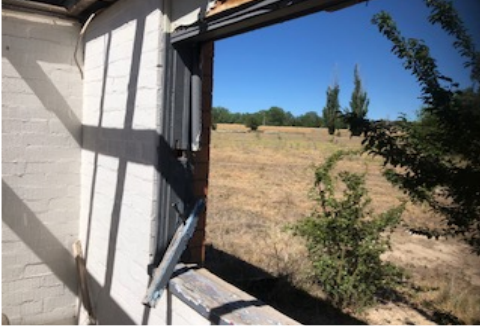
| LOCATION | COLOUR | SAMPLE ID | TYPE & CONDITION | RESULT | COMMENTS | PHOTO OF PAINT |
|---|---|---|---|---|---|---|
| To window frames and door frames to main building | Grey | P4 | Lead & Fair | <0.13 | No action required | |

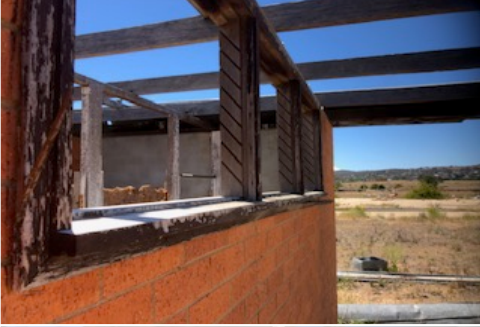
| LOCATION | COLOUR | SAMPLE ID | TYPE & CONDITION | RESULT | COMMENTS | PHOTO OF PAINT |
|---|---|---|---|---|---|---|
| To window frame and walk way to main building and attach metal walk way | Brown | P5 | Lead Free | 0.005 | No action required | |

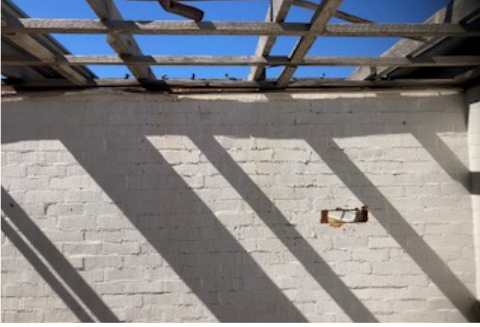
| LOCATION | COLOUR | SAMPLE ID | TYPE & CONDITION | RESULT | COMMENTS | PHOTO OF PAINT |
|---|---|---|---|---|---|---|
| To internal walls | White | P6 | Lead & Fair | 0.14 | No action required | |

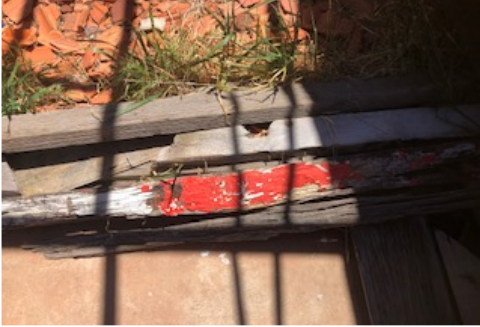
| LOCATION | COLOUR | SAMPLE ID | TYPE & CONDITION | RESULT | COMMENTS | PHOTO OF PAINT |
|---|---|---|---|---|---|---|
| To timbers at the house and rear of house | Red/White | P7 | Lead Free | <0.01 | No action required | |

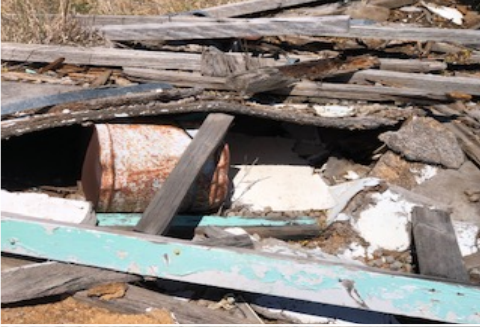
| LOCATION | COLOUR | SAMPLE ID | TYPE & CONDITION | RESULT | COMMENTS | PHOTO OF PAINT |
|---|---|---|---|---|---|---|
| To timbers at the house and rear of house | Blue/White | P8 | Lead & Fair | 0.22 | No action required | |

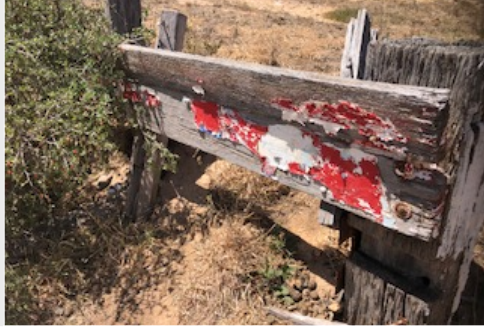
| LOCATION | COLOUR | SAMPLE ID | TYPE & CONDITION | RESULT | COMMENTS | PHOTO OF PAINT |
|---|---|---|---|---|---|---|
| To timber retaining walls around speedway track | White/red | P10 | Lead & Fair | 0.14 | No action required | |

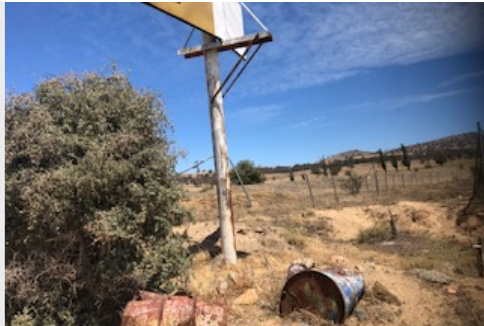
| LOCATION | COLOUR | SAMPLE ID | TYPE & CONDITION | RESULT | COMMENTS | PHOTO OF PAINT |
|---|---|---|---|---|---|---|
| To metal posts | White | P11 | Lead Free | 0.01 | No action required | |

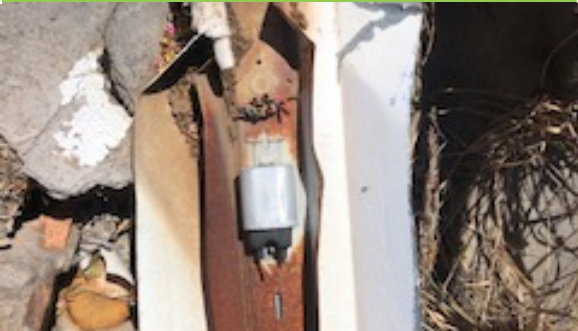
| LOCATION | MATERIAL | QUANTITY | TYPE | RECOMMENDATIONS | PHOTO |
|---|---|---|---|---|---|
| To small single fluorescent light fittings in debris | PCB | 1 | Ducon | Remove prior to demolition dispose of as hazardous waste | |

Light fittings were found to contain Polychlorinated Biphenyls (PCB) capacitors and must be removed prior to demolition works commencing and disposed of as hazardous waste.

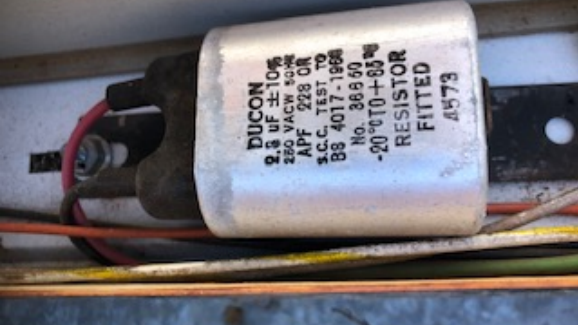
| LOCATION | MATERIAL | QUANTITY | TYPE | RECOMMENDATIONS | PHOTO |
|---|---|---|---|---|---|
| To light fittings on metal signage board south east of speedway track | PCB | 12 | Ducon APF 228 CR | Remove prior to demolition dispose of as hazardous waste | |

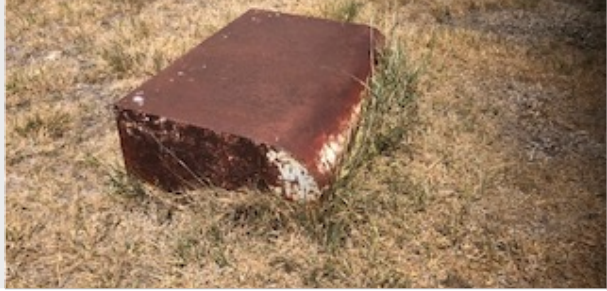
| LOCATION | TYPE OF STORAGE TANK | TYPE | RECOMMENDATIONS | PHOTO |
|---|---|---|---|---|
| At north side of site | Fuel | AST | Remove prior to site development | |

A small redundant AST were observed on the north side of the site, and must be checked for residual fuel prior to disposal..
