INTRUSIVE HAZARDOUS MATERIALS REGISTER

KE1784

Date of assessment: 03 December 2019

Address: 360A Alderson Place, Tralee NSW 2620

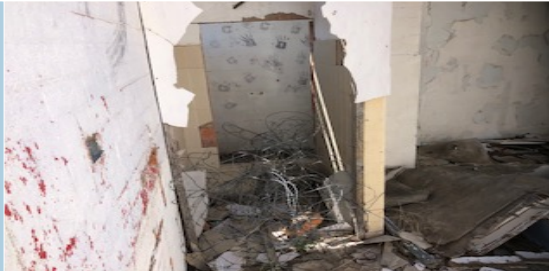
Asbestos detected				Presumed to contain asbestos			No asbestos detected	
LOCATION	MATERIAL	SAMPLE ID	Approx Qty m ²	TYPE & CONDITION	RISK OF EXPOSURE	RESULT	RECOMMENDATIONS	PHOTO
To shower wall in toilet/shower block	Sheet	A1	-	N/A	N/A	No Asbestos Detected	No further action required

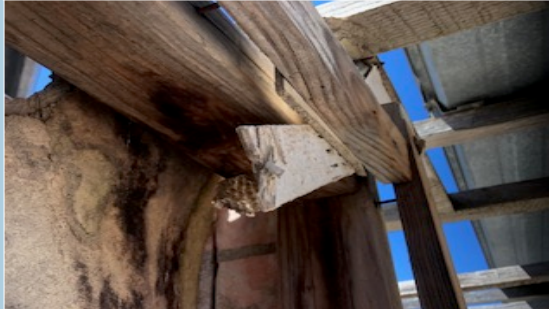
Packers between shower wall timbers in toilet/shower block	Sheet	A2	-	N/A	N/A	No Asbestos Detected	No further action required

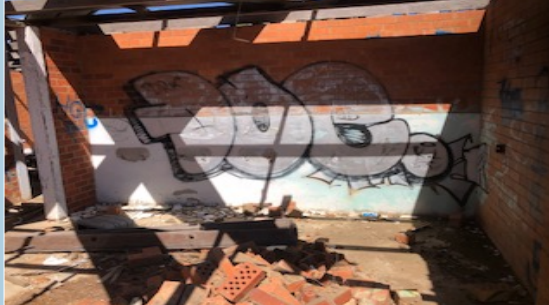
Rear toilet walls in toilet/shower block	Sheet	A3	-	N/A	N/A	No Asbestos Detected	No further action required

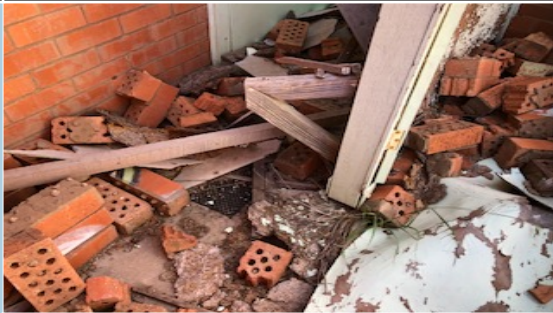
Asbestos detected				Presumed to contain asbestos			No asbestos detected	
LOCATION	MATERIAL	SAMPLE ID	Approx Qty m ²	TYPE & CONDITION	RISK OF EXPOSURE	RESULT	RECOMMENDATIONS	PHOTO
Debris to toilet riser and in toilet/shower block	Sheet	A4	-	N/A	N/A	No Asbestos Detected	No further action required

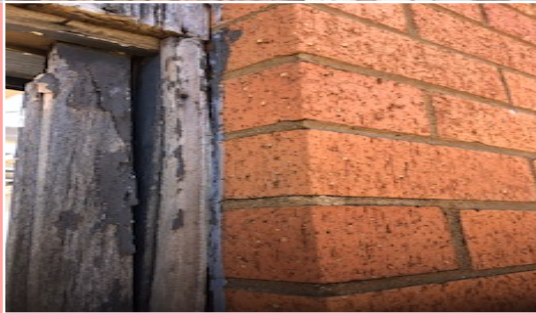
Mastic to window frames in toilet/shower block	Mastic	A5	12lm	Non friable & fair	Very Low	Chrysotile Asbestos Detected	Remove prior to demolition works commencing

The asbestos containing material (ACM) noted in the asbestos register must be removed prior to demolition works commencing. The unexpected finds procedure must be used at Appendix B if any suspected ACM is found that is not noted in this document.

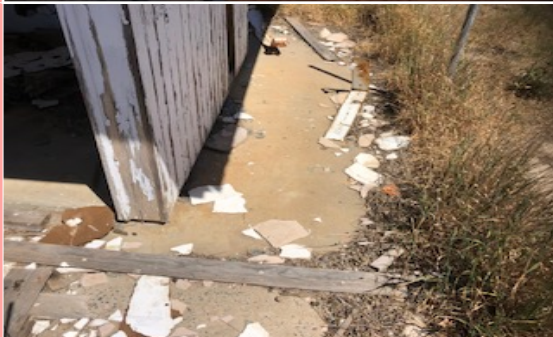
Debris around Kiosk	Sheet	A6	4	Non friable & poor	Low Moderate if disturbed	Chrysotile Asbestos Detected	Remove prior to demolition works commencing

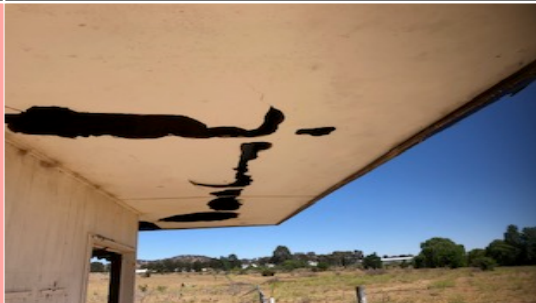
Asbestos detected				Presumed to contain asbestos			No asbestos detected	
LOCATION	MATERIAL	SAMPLE ID	Approx Qty m ²	TYPE & CONDITION	RISK OF EXPOSURE	RESULT	RECOMMENDATIONS	PHOTO
Kiosk eaves	Sheet	A7	16lm	Non friable & fair damaged	Low	Chrysotile Asbestos Detected	Remove prior to demolition works commencing

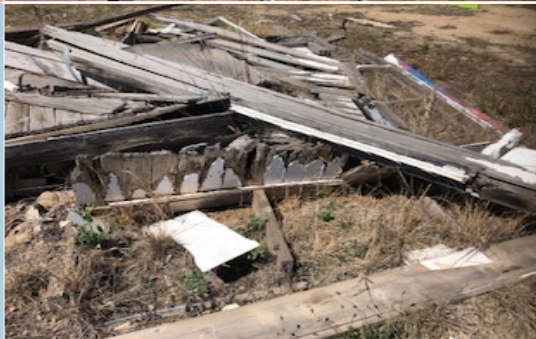
Debris to mound in middle of speedway	Sheet	A8	-	N/A	N/A	No Asbestos Detected	No further action required

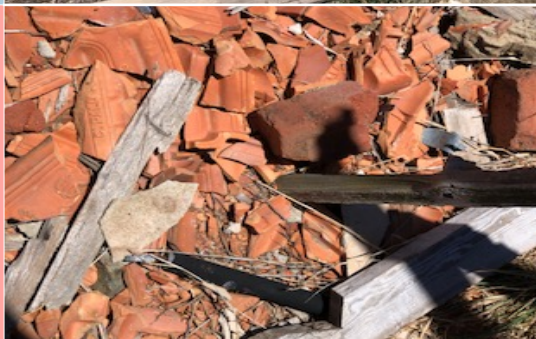
Sheet debris at the front of stone house	Sheet	A9	<1	Non friable & fair	Low	Chrysotile Asbestos Detected	Remove prior to demolition works commencing

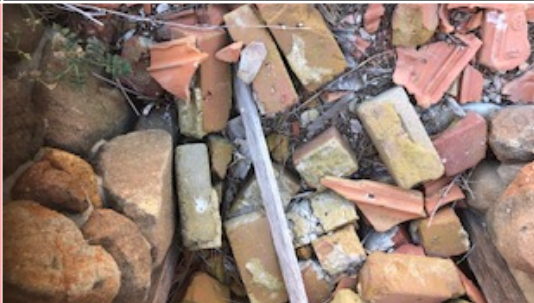
Asbestos detected				Presumed to contain asbestos			No asbestos detected	
LOCATION	MATERIAL	SAMPLE ID	Approx Qty m ²	TYPE & CONDITION	RISK OF EXPOSURE	RESULT	RECOMMENDATIONS	PHOTO
Sheet debris at the around the stone house	Sheet	A10	<1	Non friable & fair	Low	Amosite, Chrysotile Asbestos Detected	Remove prior to demolition works commencing

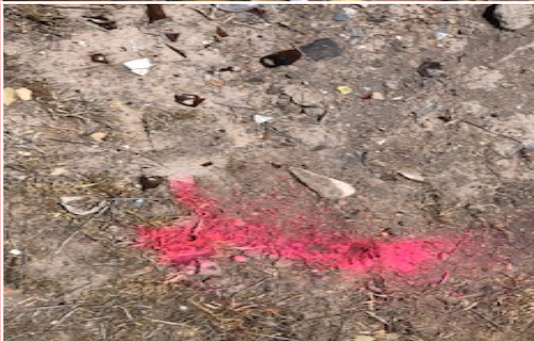
North side of AEC 1 - see site plan	Sheet	A11	-	Friable & good	Low. High if disturbed	Amosite, Chrysotile Asbestos Detected	Remove prior to demolition works commencing

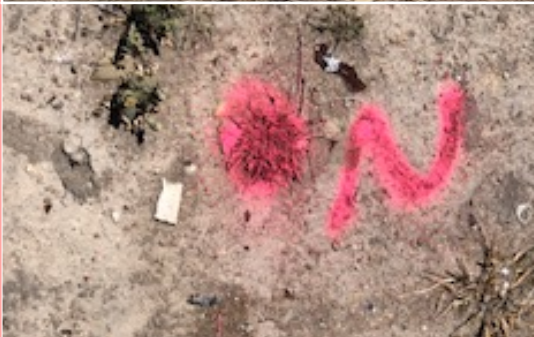
South side of AEC 1 - see site plan	Sheet	A12	-	Friable & good	Low. High if disturbed	Amosite, Chrysotile Asbestos Detected	Remove prior to demolition works commencing

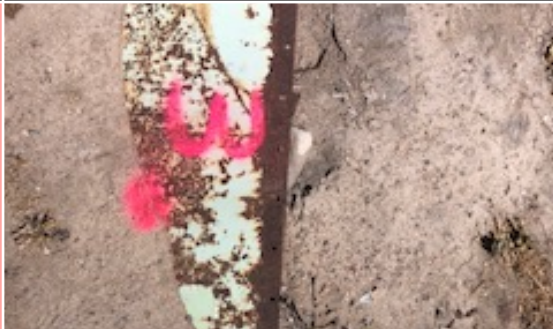
Asbestos detected				Presumed to contain asbestos			No asbestos detected	
LOCATION	MATERIAL	SAMPLE ID	Approx Qty m ²	TYPE & CONDITION	RISK OF EXPOSURE	RESULT	RECOMMENDATIONS	PHOTO
East side of AEC 1 - see site plan	Sheet	A13	-	Non friable & fair	Low	Amosite, Chrysotile Asbestos Detected	Remove prior to demolition works commencing

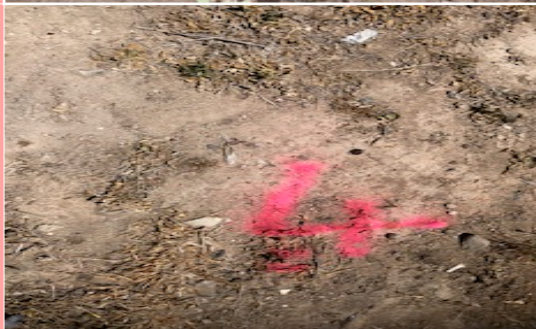
West side of AEC 1 - see site plan	Sheet	A14	-	Non friable & fair	Low	Amosite, Chrysotile Asbestos Detected	Remove prior to demolition works commencing

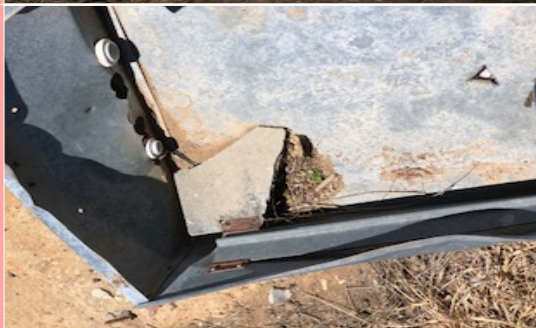
ESWB and debris to eastern edge of speedway track	Sheet	A15	-	Non friable & fair	Low	Chrysotile Asbestos Detected	Remove prior to demolition works commencing

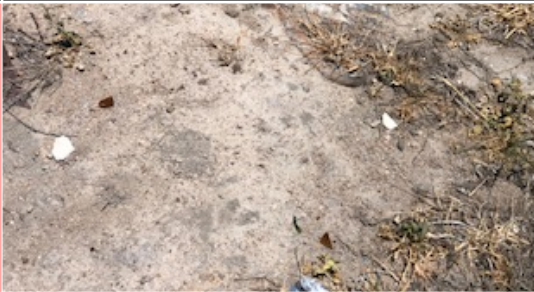
Asbestos detected				Presumed to contain asbestos			No asbestos detected	
LOCATION	MATERIAL	SAMPLE ID	Approx Qty m ²	TYPE & CONDITION	RISK OF EXPOSURE	RESULT	RECOMMENDATIONS	PHOTO
Debris east side outside of speedway track - removed during sampling	Sheet	A16	-	Non friable & fair	Low	Chrysotile Asbestos Detected	Remove prior to demolition works commencing

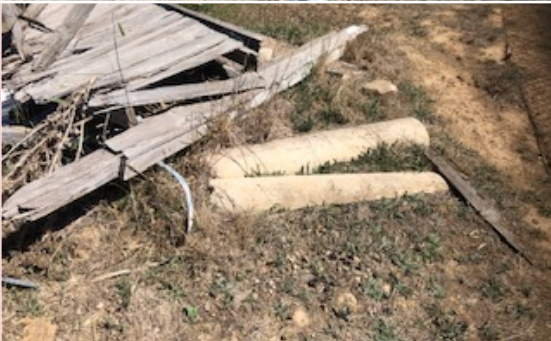
SW corner outside track - mixed with rubble - pipe and debris	Sheet	A17	20	Non friable & fair	Low	Chrysotile Asbestos Detected	Remove prior to demolition works commencing

Notes: The fire damaged material and construction waste must be as asbestos contaminated waste. Asbestos pipe conduits and sheet debris was found at the south west area of the site and may be buried at depth. Additionally an area (see attached plan) has asbestos contamination in the soil and should be stockpiled and waste classified prior to disposal off site.

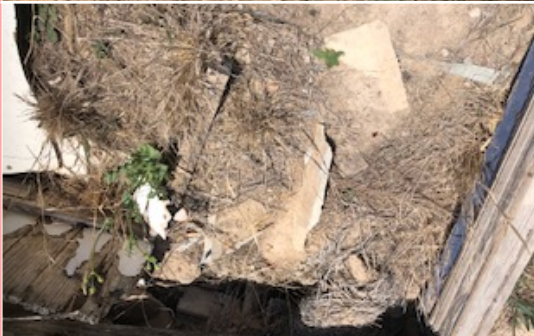
SW corner outside track - mixed with rubble sheet debris - possibly buried at depth	Sheet	A18	>20m3	Non friable & fair	Low	Chrysotile Asbestos Detected	Remove prior to demolition works commencing

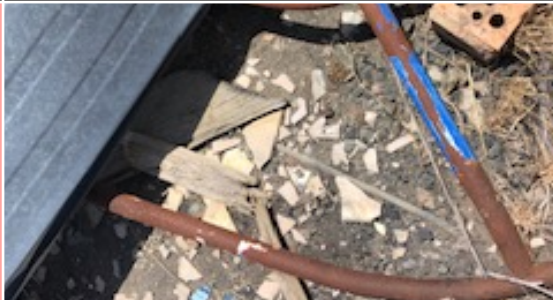
Asbestos detected				Presumed to contain asbestos			No asbestos detected	
LOCATION	MATERIAL	SAMPLE ID	Approx Qty m ²	TYPE & CONDITION	RISK OF EXPOSURE	RESULT	RECOMMENDATIONS	PHOTO
Fire damaged sheet debris see site plan	Sheet	A19	50m3	Non friable & good	Low	Chrysotile Asbestos Detected	Remove prior to demolition works commencing

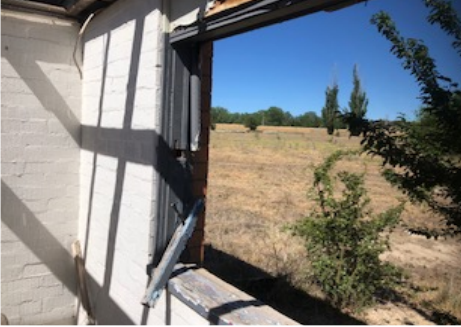
LOCATION	COLOUR	SAMPLE ID	TYPE & CONDITION	RESULT	COMMENTS	PHOTO OF PAINT
To window frames and door frames to main building	Grey	P4	Lead & Fair	<0.13	No action required
