# ARBORICULTURAL REPORT & TREE PROTECTION SPECIFICATION

SANCTUARY POINT LIBRARY Paradise Beach Road Lots 944-947 in DP 27857 and Lot 4 in DP 806393 13<sup>th</sup> December 2021 *FINAL* Updated 23 February 2023

Prepared for: Brewster Hjorth Architects

Prepared by: Paul Vezgoff Consulting Arborist ISA, AA Arboriculture Australia Registered Consultant

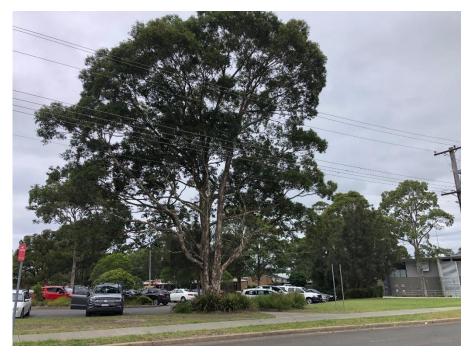
- **3.5** In and around the proposed library area are Trees 1-10 and 20-35 including Swamp oak *(Casuarina glauca)* and Water gum *(Tristaniopsis laurina)*, with the largest specimen in this area being Tree 7, a Spotted gum. Tree 7 is visually prominent from the streetscape and several road junctions.

**Plate 1:** Image showing Tree 7 being visually prominent from the streetscape and several road junctions.

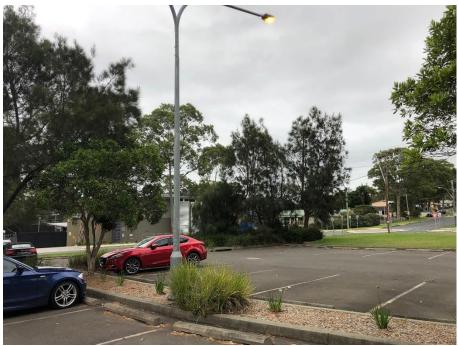
Plate 2: Trees 1-6 being less significant trees to the site. P. Vezgoff.

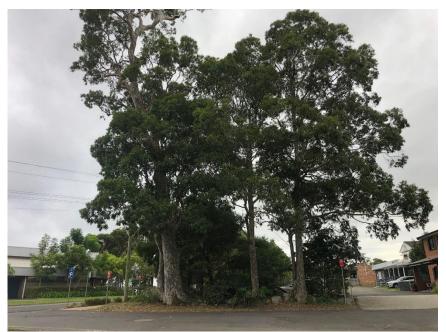
3.6 Trees 9-11 are very tall trees located on the adjoining property to the east (Plate 3). These trees have codominant canopies and are visually prominent from the streetscape. The TPZ and SRZ for these trees will extend across the existing driveway entry and any services that will require excavation in this area will need to be assessed carefully.

Plate 3: Trees 9-11 are located off site but are large significant trees. P. Vezgoff

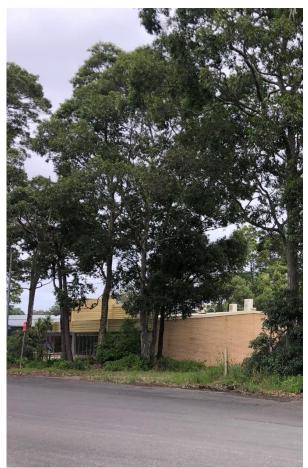
3.7 Trees 20-25 (Plate 4) are a small group of mostly Spotted gums near the existing building. These trees are in good health and condition. They have value as a group but not as individual specimens.

Plate 4: Trees 20-25 have value as a group but not as individual specimens.

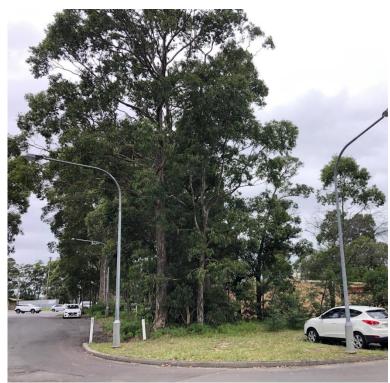
**3.8** As with Trees 20-25, Trees 26-29 are a small group of mostly Spotted gums also near the existing building. These trees are in good health and condition. They have value as a group but not as individual specimens (Plate 5).

Plate 5: Trees 26-29 are good as a group but not as individual specimens.

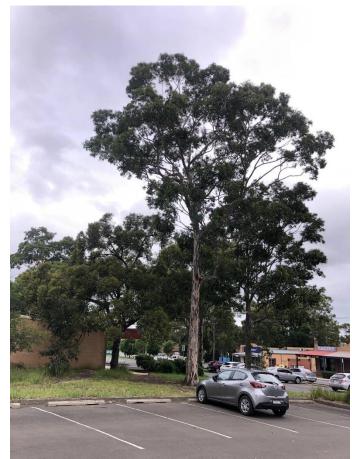
**3.11** Along the entry driveway are several large mature Spotted gums in good health and condition. This area is the larger car park area for the site and generally only has trees around the perimeter of the car park (Plate 7). South of Tree 16 are the trees numbered as 41 through to Tree group 64. This area is an open space with a central lawn area and a perimeter on the western edge of various *Eucalyptus* specimens. The southern boundary is dense growth that is mature along with sapling undergrowth (Plate 8). Species in this area include: Spotted gum (*Corymbia maculata*), Bloodwood (*Corymbia gumiffera*), Sydney peppermint (*Eucalyptus piperita*), White stringy bark (*Eucalyptus globoidia*) and Scribbly gum (*Eucalyptus sclerophylla*).

Plate 6: Trees 33-35 are in good health and condition with codominant canopies.

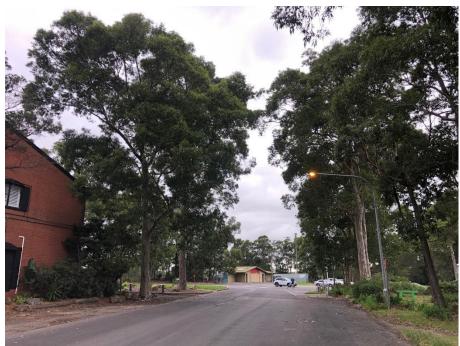
**Plate 7:** Trees 13 and 14 on the left and Trees 16 and 17 on the right of the image (P. Vezgoff).

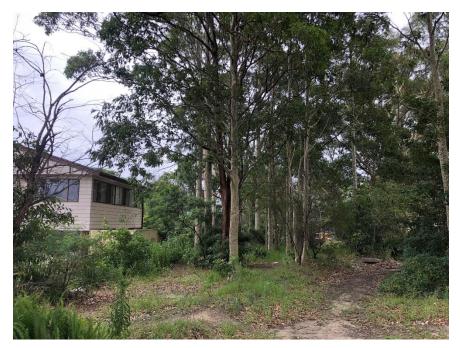
Plate 8: Image showing the vegetation to the south of the study area that extends to Centaur Avenue. P. Vezgoff.

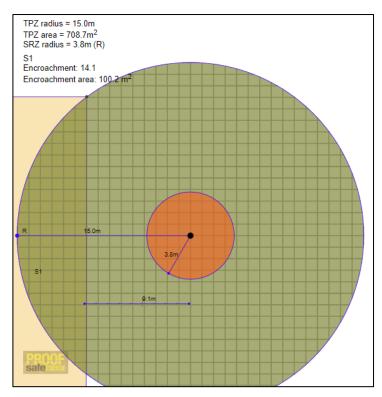
**Diagram 8:** TPZ incursion calculation for Tree 57 showing an incursion of 14%.

- **4.3** Numbered trees to be retained should be shown on the architectural site plans.
- **4.4** Levels within the TPZ of Trees 13, 38, 53 and 57 (to be retained) shall be retained as they currently are. The new road works are close to these trees and any large reduction in levels may damage structural woody roots of these trees.

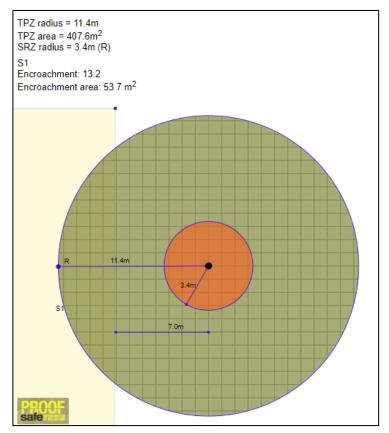
**Diagram 9:** TPZ incursion calculation for Tree 53 showing an incursion of 13.2%.
