Tree Report

Site Address: Albury Wodonga Private Hospital – 1125 Pemberton Street, Albury, NSW

Report Code : Awph070922

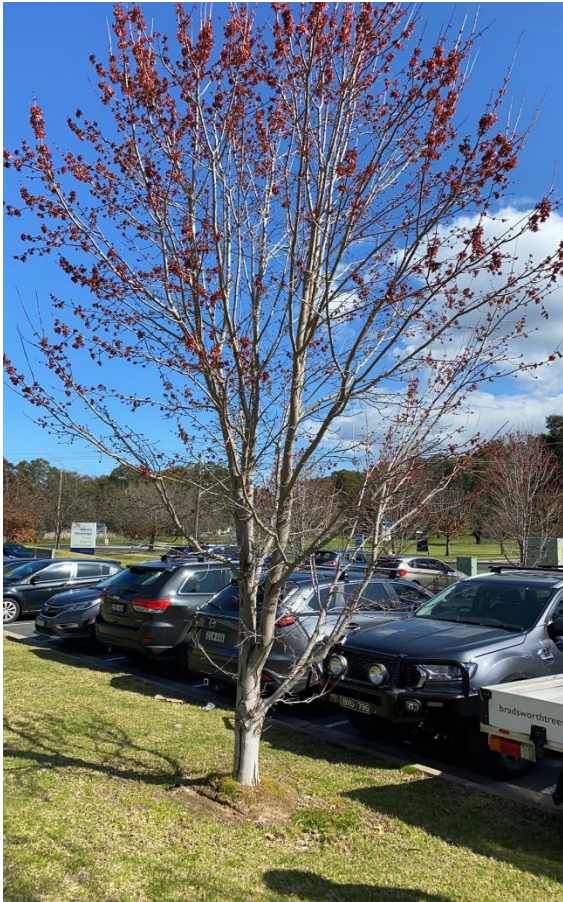
Tree #1

Tree #	Notes
1	Codominant leaders, codominant leaders with included bark union, included bark union
2	Damaged surface roots, girdling roots, codominant leaders
3	Damaged surface roots, codominant leaders, codominant leaders with included bark union, multiple leaders
4	Damaged surface roots, codominant leaders, codominant leaders with included bark union, poor unions
5	Damaged surface roots
6	Damaged surface roots, codominant leaders, codominant leaders with included bark union, included bark union
7	-
8	Cambial dieback on trunk, splitting in trunk, significant decay
9	Damaged surface roots, minor deadwood
10	History of limb failures, significant dieback in canopy, some cambial dieback
11	Damaged surface roots
12	Poor specimen, low value.
13	Semi mature ornamental
14	Semi mature ornamental
15	Semi mature ornamental
16	Semi mature ornamental

BTSC recommends that the removal of the trees be done in accordance with council requirements and be completed by a minimum AQF3 Arborist.

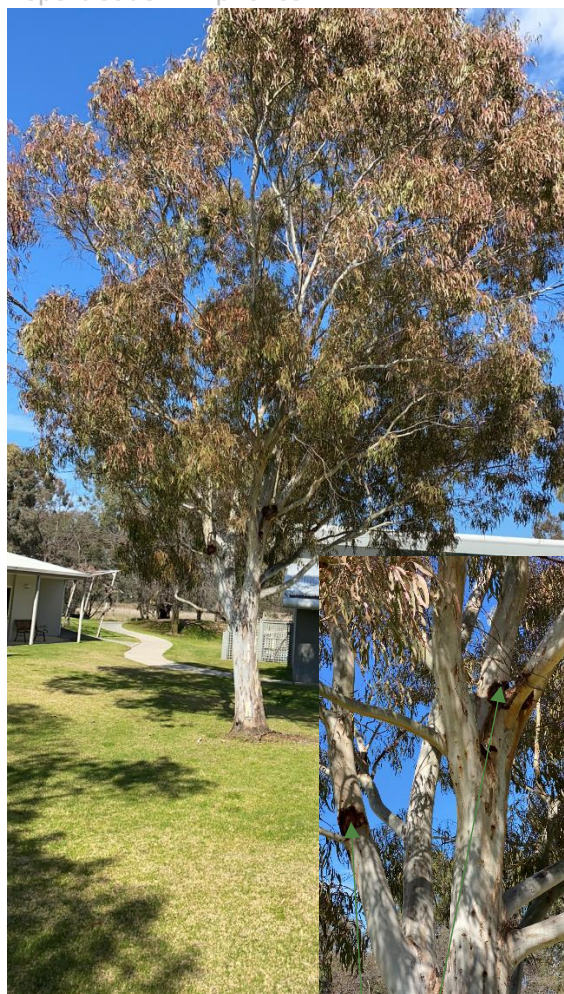
Tree #9

Cockatoo damage
in unions

Of the 16 subject trees in this report, there are 2 that are native (#9,#10) and the rest are exotic or introduced species between Juvenile and Semi-Mature age.

Trees #9 and #10 appear to be in a state of decline.

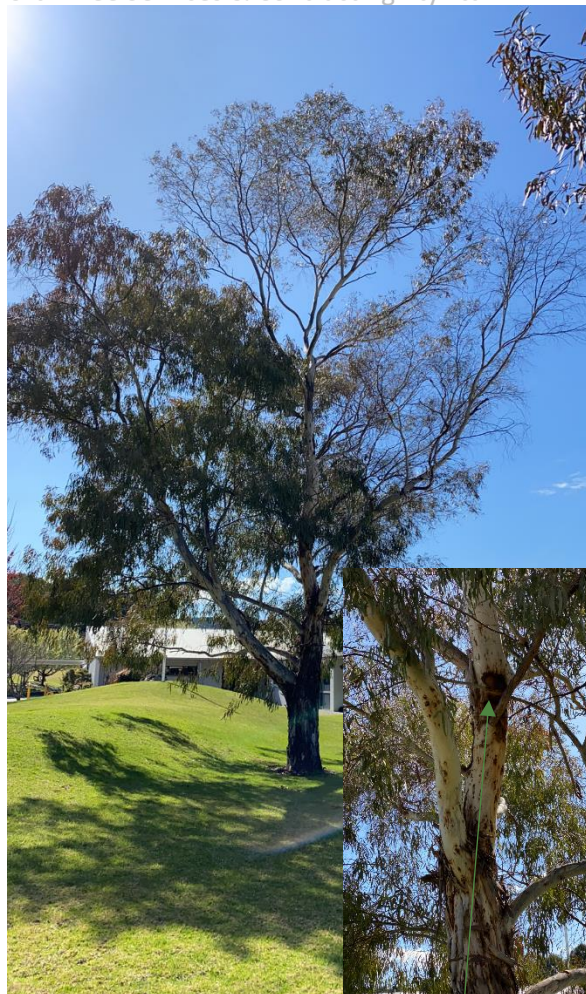
Tree #10

Cockatoo
damage
