TREE ASSESSMENT REPORT

**MR COLIN KRAMER & MRS SANDRA KRAMER
DIP. ARBORICULTURE
DIP. ENVIRONMENTAL SUSTAINABILITY
LOCAL TREE CARE
22 KOTHES LANE
BARANDUDA VIC 3691**

**JOSS CONSTRUCTION
ATT: MR MARTIN REID
DEVELOPMENT MANAGER JOSS GROUP
206 EAST STREET
ALBURY NSW 2640**

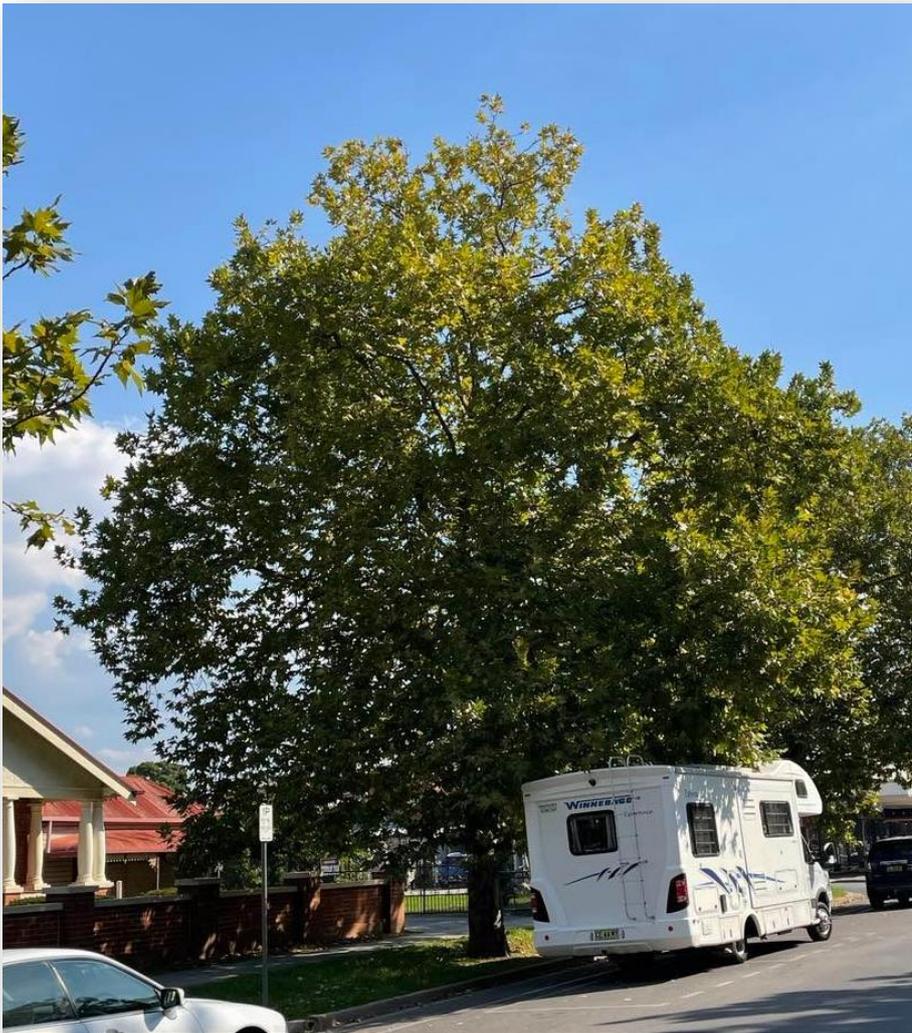
TREE ONE:

Botanical Name:	<i>Platanus acerifolia</i>
Common Name:	London Plane Tree
Canopy Height:	Approx. 13.8m
Canopy Width:	Approx: 14 metres (East - West) Approx: 17 metres (North - South)
Trunk DBH:	540mm
Tree Structure:	Good
Tree Health:	Acceptable
Tree Age:	Mature
SRZ Calculation:	2.9 metres
TPZ Calculation:	6.5 metres
TPZ Calculation for minor encroachment (10%)	4.5 metres
ULE:	20-40 years
Tree Retention Value:	Third Party Ownership
Tree Origin:	Exotic

- A large, single trunked tree,
- The tree is located approximately 4.3 metres from the boundary fence on the Southern side of the tree,
- Good buttressing was noted on the Northern, Southern, Eastern and Western regions of the lower trunk,

- The gravel driveway on the Eastern side, between the properties at 481-485 Swift Street, Albury is approximately 8 metres from the trunk,
- The structure of the tree was noted as 'Good' with no major structural defects noted, good branch attachment, the trunk was noted as sound with no wounds observed, good root buttressing was noted and no evidence of damage to the roots was found during our inspection.

- The health of the tree was noted as 'Acceptable' with a good coverage of foliage noted, good overall structure and vigour, no serious structural defects were noted with the trunk, scaffold and lateral branches or branch unions. There was evidence of pest damage with the Sycamore Lace Bug noted, although not noted as a significant infestation.

- No soil cracking or heaving was noted around the lower trunk / root plate,
- The SRZ radius of the tree was calculated at 2.9 metres,
- The kerb located on the Northern side encroachment of the TPZ is calculated at 41.2% though the tree would have been planted in situ as a juvenile tree and the root system would have grown to facilitate the concrete kerbing, concerns have been noted of root disturbance between 2017-2019 when there appears to have been upgrades to the Swift Street adjacent to the tree, although no specific information could be located to confirm if any kerb upgrades occurred resulting in root damage,

- The TPZ radius of the tree is calculated at 6.5 metres,
- To meet the acceptable minimum encroachment of 10% of the TPZ, the minimum area where no construction or encroachment of the root zone should occur is calculated as 4.5 metres from the trunk,
- From our review of the specifications provided, a new building with a basement carpark is designated to be installed approximately 4.3 metres from the trunk, this would equate to an encroachment of 11.1%,
- Consideration to the provision of selective pruning practices to the canopy on the Southern side of the canopy has been noted to reduce the risk of damage to the scaffold and lateral branches directing over the proposed construction site.

- The selective pruning recommended for trees one and three, and the removal of tree two should be undertaken prior to the commencement of any construction or development works within proximity to the tree,

- It is our consideration that the trees one and three be retained and all efforts to preserve and maintain the health and structure of the trees be undertaken. We would further recommend a review of the health and structural changes of the trees in two years, with the exception being if major storm activity or damage during the construction process results in further structural changes or concerns prior to the two-year review.

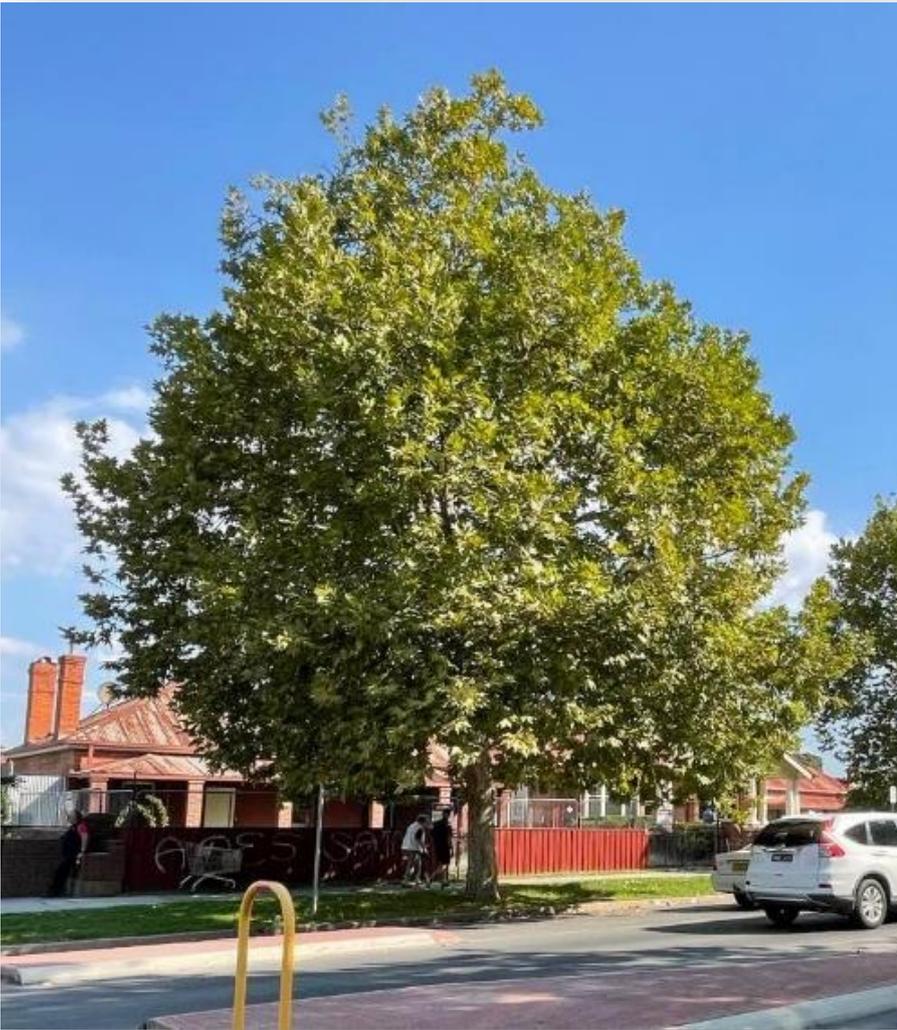
TREE TWO:

Botanical Name:	<i>Platanus acerifolia</i>
Common Name:	London Plane Tree
Canopy Height:	Approx. 12.3m
Canopy Width:	Approx: 14 metres (East - West) Approx: 17 metres (North - South)
Trunk DBH:	550mm
Tree Structure:	Good
Tree Health:	Acceptable
Tree Age:	Mature
SRZ Calculation:	2.9 metres
TPZ Calculation:	6.6 metres
TPZ Calculation for minor encroachment (10%)	4.5 metres
ULE:	20-40 years
Tree Retention Value:	Third Party Ownership
Tree Origin:	Exotic

- A large, single trunked tree,
- The tree is located approximately 4.3 metres from the boundary fence on the Southern side of the tree,
- Good buttressing was noted on the Northern and Southern regions of the lower trunk and stronger buttressing was noted on the Western region, no buttressing was noted on the Eastern side which is consistent with the heavy lean noted with the trunk directing North-East,

- A drain is located on the Western side approximately 1.9 metres from the trunk,
- Two service pits were also noted on the Western side of the tree, one approximately 2.8 metres and the other 3.9 metres from the trunk,

- The trunk was noted with a heavy lean directing North-East with further inspection identifying the tree has a self-correcting lean, likely gravitropism or phototropism,

- The structure of the tree was noted as 'Good' with no major structural defects noted, good branch attachment, the trunk was noted as sound with no wounds observed, good root buttressing was noted and no evidence of damage to the roots was found during our inspection.

- The health of the tree was noted as 'Acceptable' with a good coverage of foliage noted, good overall structure and vigour, no serious structural defects were noted with the trunk, scaffold and lateral branches or branch unions. There was evidence of pest damage with the Sycamore Lace Bug noted, although not noted as a significant infestation.

- No soil cracking or heaving was noted around the lower trunk / root plate,
- The SRZ radius of the tree was calculated at 2.9 metres,

- The kerb, located on the Northern side, encroachment is calculated at 41.3% though the tree would have been planted in situ as a juvenile tree and the root system would have grown to facilitate the concrete kerbing, concerns have been noted of root disturbance between 2017-2019 when there appears to have been upgrades to the Swift Street adjacent to the tree, although no specific information could be located to confirm if any kerb upgrades occurred resulting in root damage,

- Consideration has been given to recommending the alteration of the proposed plans to enable retention of the tree but concerns were noted after taking into account the TPZ radius allowing for a 10% encroachment at 4.5% and the services located between 1.9 – 3.9 metres from the trunk, we cannot identify a suitable alternative location for the basement entrance to be situated.

- With respect to tree two, the driveway is located directly adjacent to the tree. Consideration has been given to transplanting the tree, but excavation of the root ball would be difficult given the location of services in proximity to the tree and given the size of the tree, concerns have been noted on the survivability of the tree,

- Therefore, taking into consideration the concerns noted, the future development in proximity to the trees and the impact to the health and structure of the trees as a result, it is our determination that trees one and three can be retained in their positions and selective pruning will be necessary to minimise the risk of limb damage from the construction processes for tree one, and is a consideration if the construction process and machinery used is likely to impact the canopy and possibly cause damage. Tree two cannot be retained in its present location and transplanting is not considered a feasible option, therefore removal of the tree is considered the only option.

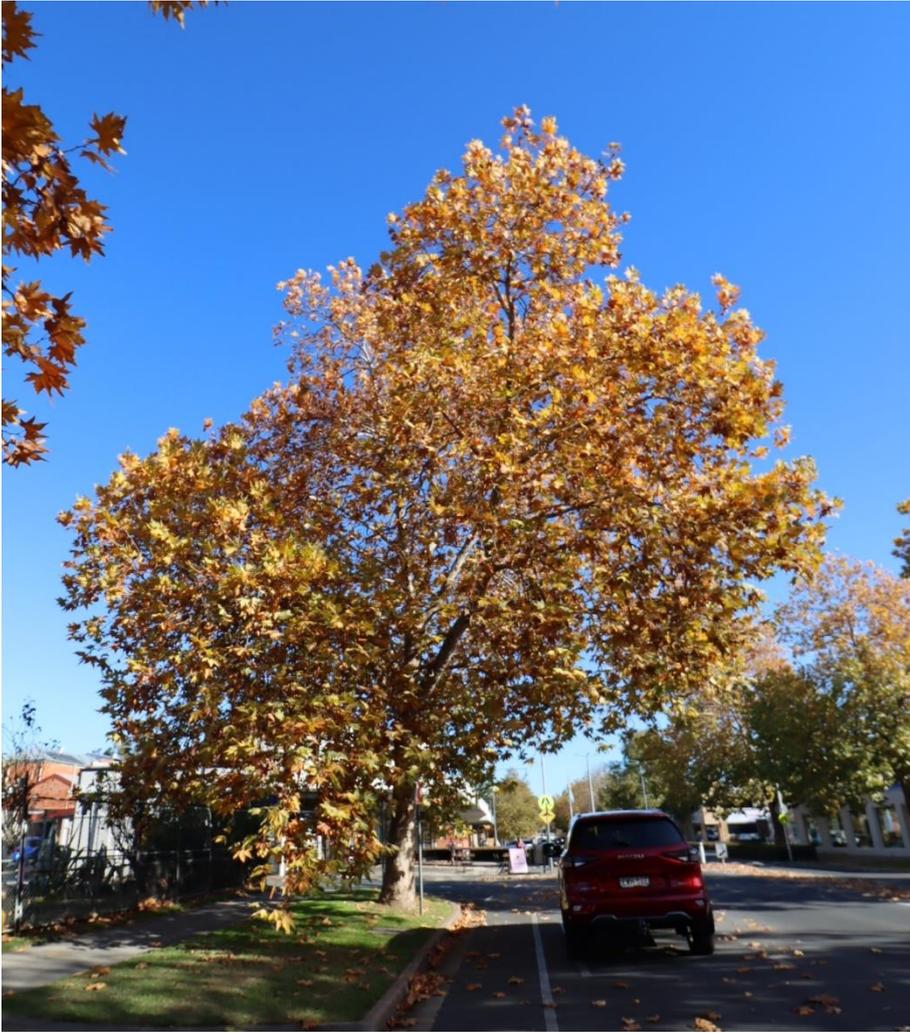
TREE THREE:

Botanical Name:	<i>Platanus acerifolia</i>
Common Name:	London Plane Tree
Canopy Height:	Approx. 13.9m
Canopy Width:	Approx: 15 metres (East - West) Approx: 16 metres (North - South)
Trunk DBH:	615mm
Tree Structure:	Good
Tree Health:	Acceptable
Tree Age:	Mature
SRZ Calculation:	3 metres
TPZ Calculation:	7.4 metres
TPZ Calculation for minor encroachment (10%)	5.1 metres
ULE:	20-40 years
Tree Retention Value:	Third Party Ownership
Tree Origin:	Exotic

- A large, single trunked tree,
- The tree is located approximately 4.4 metres from the boundary fence on the Southern side of the tree,
- Good buttressing was noted on the Northern, Southern and Western regions of the lower trunk. The Eastern side was noted with a minor region of buttressing at the lower trunk,

- The driveway on the Eastern side, between the properties at 487-485 Swift Street, Albury is approximately eleven metres from the trunk,
- The trunk was noted with a slight lean directing North,

- The structure of the tree was noted as 'Good' with no major structural defects noted, a large co-dominant directing North-East was noted approximately 3.5 metres from the trunk base, good branch attachment, the trunk was noted as sound with no wounds observed, good root buttressing was noted and no evidence of damage to the roots was found during our inspection.

- The health of the tree was noted as 'Acceptable', given the tree is defoliating with the Autumn season we consider that, from our previous inspection dates, the tree had a good coverage of foliage, good overall structure and vigour, no serious structural defects were noted with the trunk, scaffold and lateral branches or branch unions. There was evidence of pest damage with the Sycamore Lace Bug noted.

- No soil cracking or heaving was noted around the lower trunk / root plate,
- Deadwood was noted on the Eastern side of the lower canopy, in proximity to the large co-dominant noted directing North-East,

- No significant structural issues were noted although a small limb failure on the co-dominant directing North-East was documented,

- Pruning practices have previously been undertaken on the Northern and Western regions of the upper trunk/ lower canopy with occlusion of those wounds noted,

- The SRZ radius of the tree was calculated at 3 metres,
- The kerb, located on the Northern side, encroachment is calculated at 42.3% though the tree would have been planted in situ as a juvenile tree and the root system would have grown to facilitate the concrete kerbing, concerns have been noted of root disturbance between 2017-2019 when there appears to have been upgrades to the Swift Street adjacent to the tree, although no specific information could be located to confirm if any kerb upgrades occurred resulting in root damage,

- From our review of the specifications provided, a new building with a basement carpark is designated to be installed approximately 4.4 metres from the trunk, this would equate to an encroachment of 14.4% of the TPZ.

- Tree two has been recommended to be removed prior to the commencement of any development,
- Tree three has been recommended to be retained and selective pruning is recommended if the proposed construction and machinery are likely to impact the canopy and cause any damage to the canopy directing over the boundary of the property at 487 Swift Street, Albury,
