# Construction Impact Report

Assessment of trees adjacent to 257 Crawford Street,  
Queanbeyan

**Homewood Consulting Pty Ltd**

17 September 2019

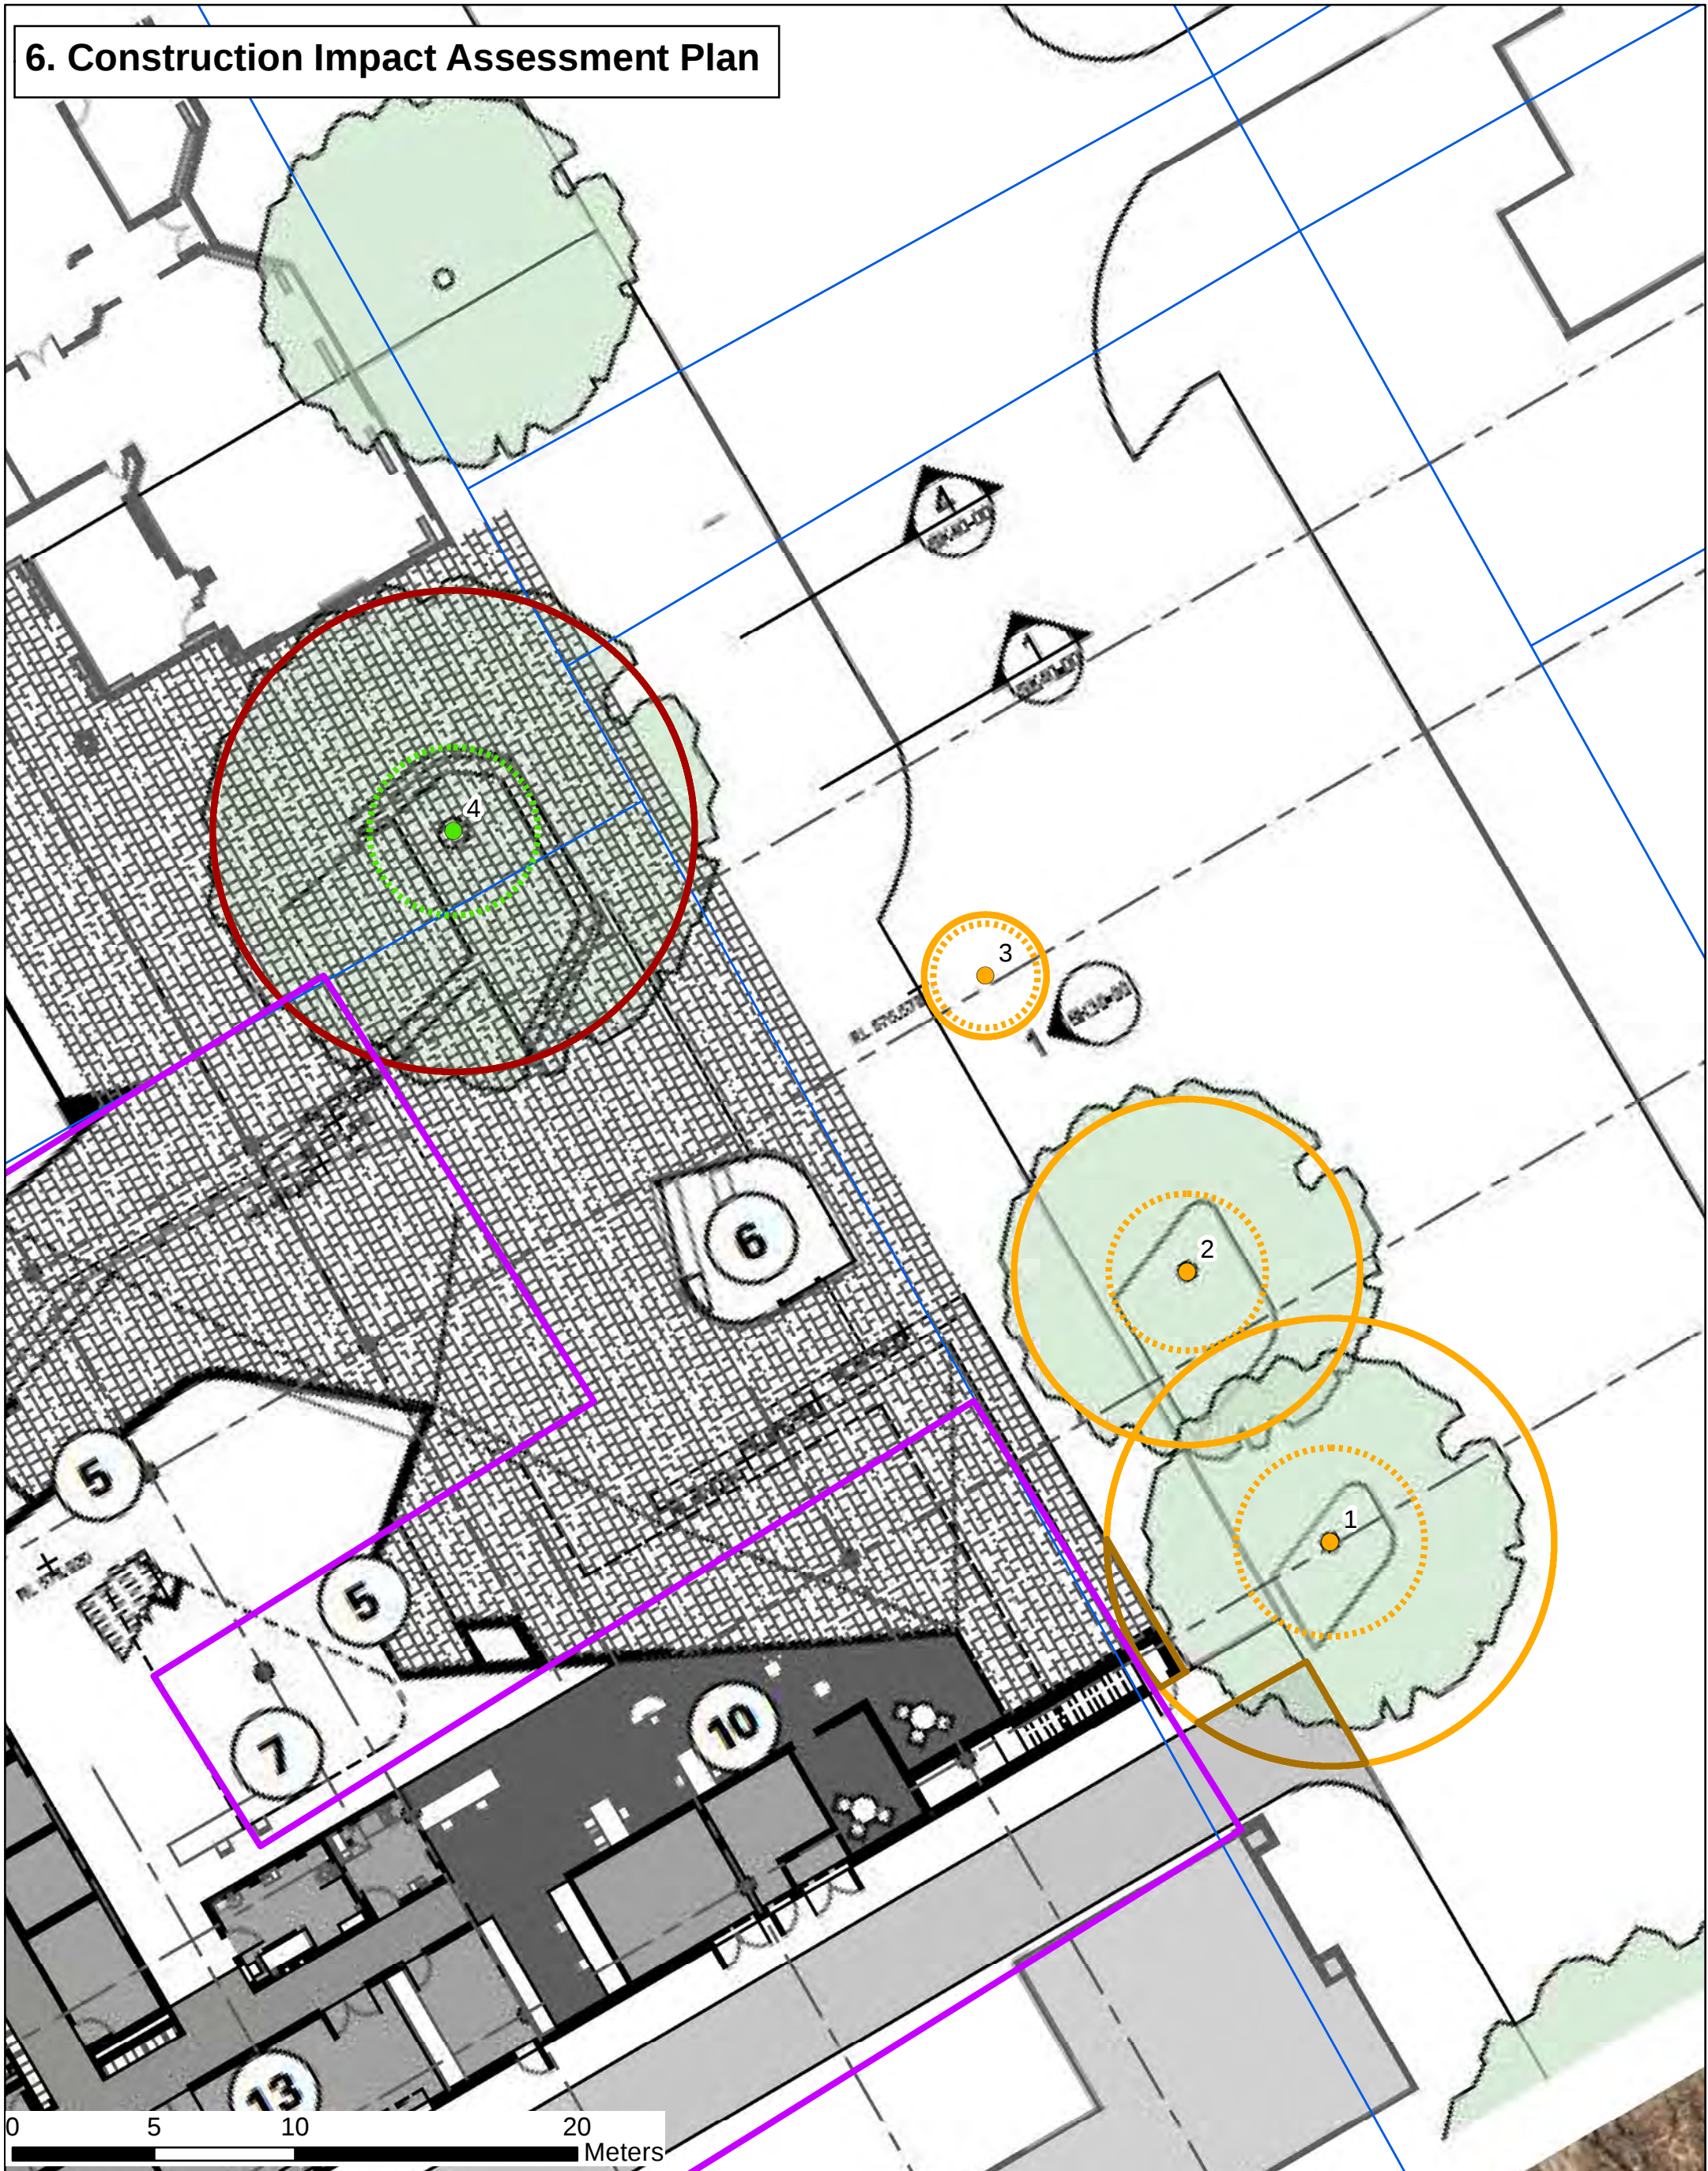
Assessment of TPZ encroachment adjacent to 257 Crawford Street, Queanbeyan

- The tree has a 'High' retention value and all efforts should be made to retain and protect it throughout the construction process. Recommendations to minimise impact to this tree are provided in Section 8.

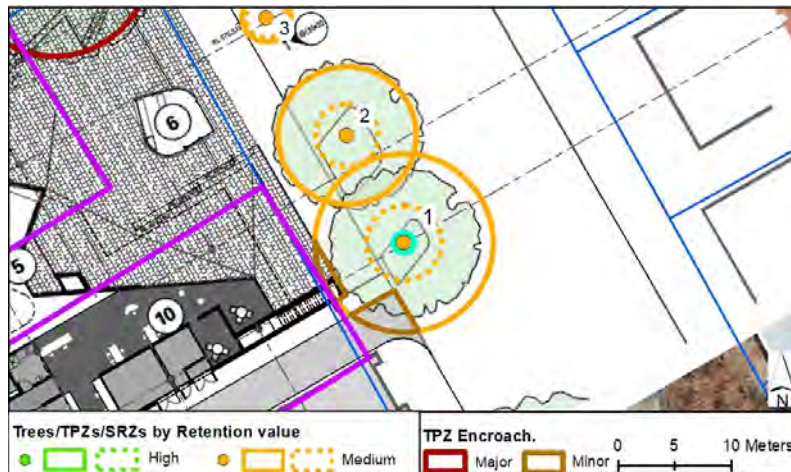
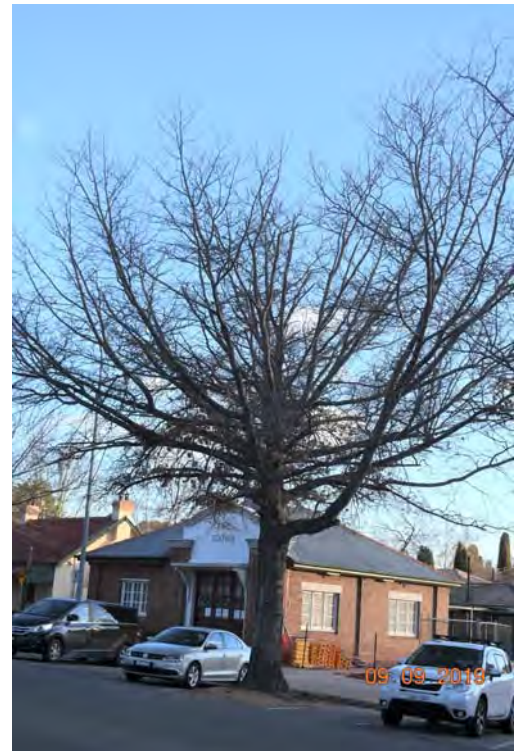
| <b>Asset ID:</b> | <b>1</b> | | |

| <b>TPZ Impact (AS 4970):</b> | Minor | <b>SRZ radius (m):</b> | 3.34 |
| <b>Retention Value:</b> | Medium | | |

8. Where within the TPZ of Tree 1, the proposed crossover/kerb replacement works are undertaken under direct arborist supervision with all major roots (over 40mm dia.) cleanly pruned.

- 9.2 In addition, Tree 1 has a number of low branches (3-4m above ground level) that may require vertical clearance pruning if machinery are accessing the site within the vicinity of the tree. Clearances of 5m above ground level is recommended to provide adequate clearance for machinery.

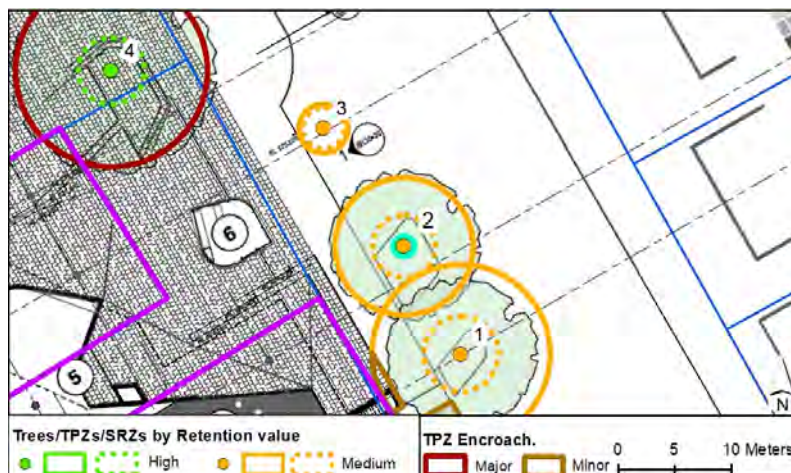
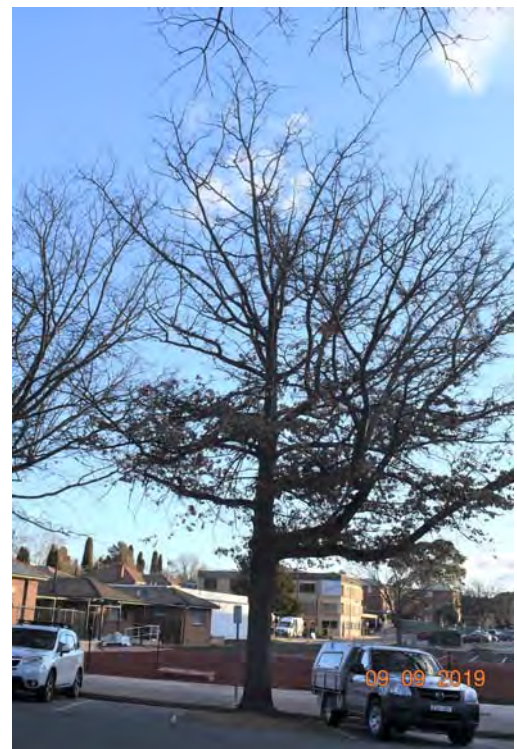
| <b>Asset ID:</b> | <b>2</b> | | |

| <b>TPZ Impact (AS 4970):</b> | No impact | <b>SRZ radius (m):</b> | 2.78 |
| <b>Retention Value:</b> | Medium | | |

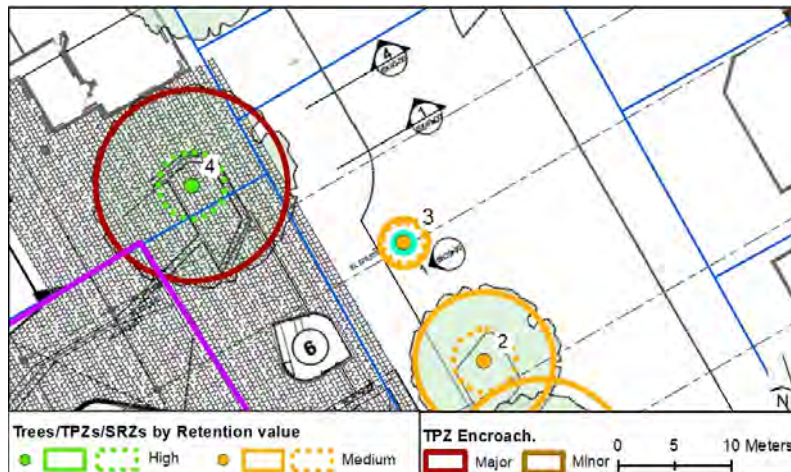
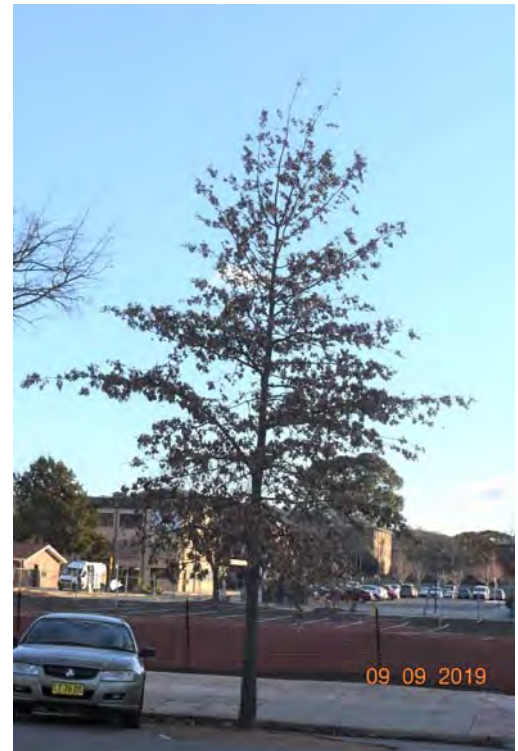
| <b>Asset ID:</b> | <b>3</b> | | |

| <b>TPZ Impact (AS 4970):</b> | No impact | <b>SRZ radius (m):</b> | 1.85 |
| <b>Retention Value:</b> | Medium | | |

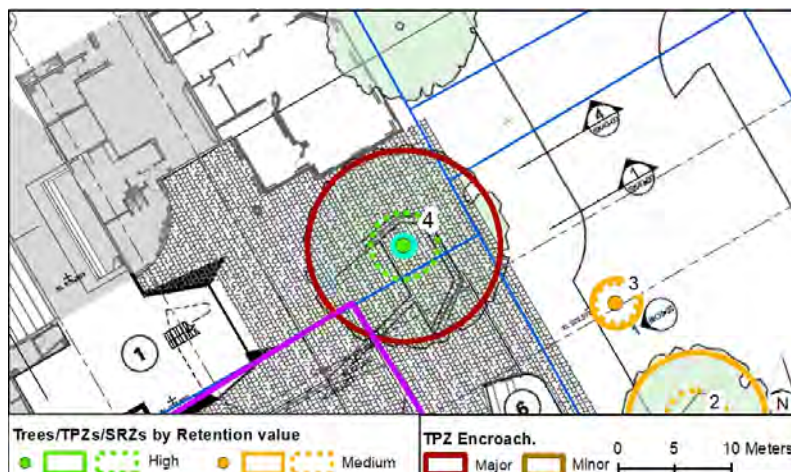
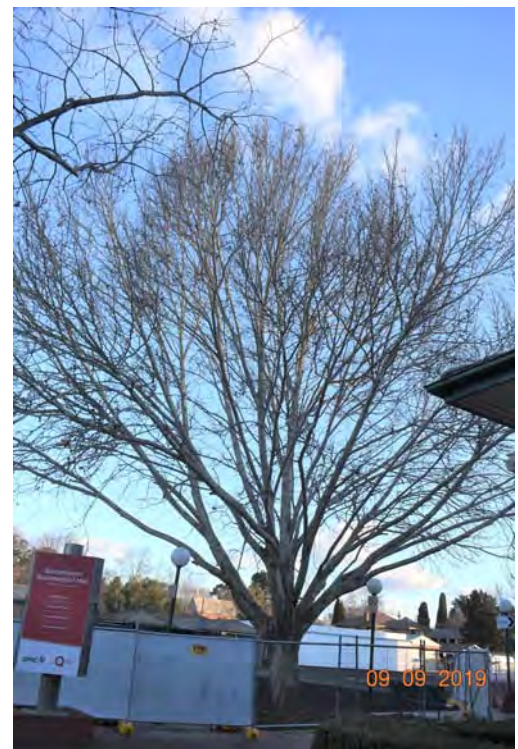
| <b>Asset ID:</b> | <b>4</b> | | |

| ID | Botanical Name | Origin | Height & Width (m) | DBH (cm) | Age Class | Health | Structure | ULE (years) | Retention Value | Comments | TPZ Radius (m) | SRZ Radius (m) | TPZ Encroachment (%) | TPZ Impact |
|---|---|---|---|---|---|---|---|---|---|---|---|---|---|---|
| 4 | <i>Platanus x acerifolia</i> | Exotic | 14 x 14 | 71 | Mature | Good | Fair | 20 - 40 | High | SRZ mulched, Shallow fill over much of TPZ, Pruned from removed building | 8.52 | 2.98 | 100 | Impact Major - not viable |

| <b>TPZ Impact (AS 4970):</b> | Major | <b>SRZ radius (m):</b> | 2.98 |
| <b>Retention Value:</b> | High | | |

3. All underground services are located outside of TPZs of retained trees or bored to a depth of 600mm (top of bore).
4. The design for the proposed brick retaining wall/seating adjacent to Tree 4 is modified to a lighter construction type void of a concrete strip foundation and subsequent excavation (e.g. stump foundations). These foundations should be installed in a tree sensitive manner:

5. The proposed garden bed at the base of Tree 4 is a mulched bed at grade, with no soil profile changes or deposition of fill.
  - 5.1 Any planting within the garden bed is done sensitively with holes manually excavated to avoid damage to roots.

9. Canopy pruning is undertaken on Trees 1 & 4 to limit the potential for mechanical damage to branches during the construction process.
  - 9.1 Both trees will require pruning of branches to the south-east of the trunk that are abutting the proposed building footprint. Clearance of 2m from the proposed works footprint is recommended.
