# PRELIMINARY SITE INVESTIGATION

50 MOISSET STREET  
QUEANBEYAN, NSW

**Prepared for:** Lockbridge  
**Date:** 18 November 2024  
**Reference:** JC1605\_PSI.01  
**Version:** Issue

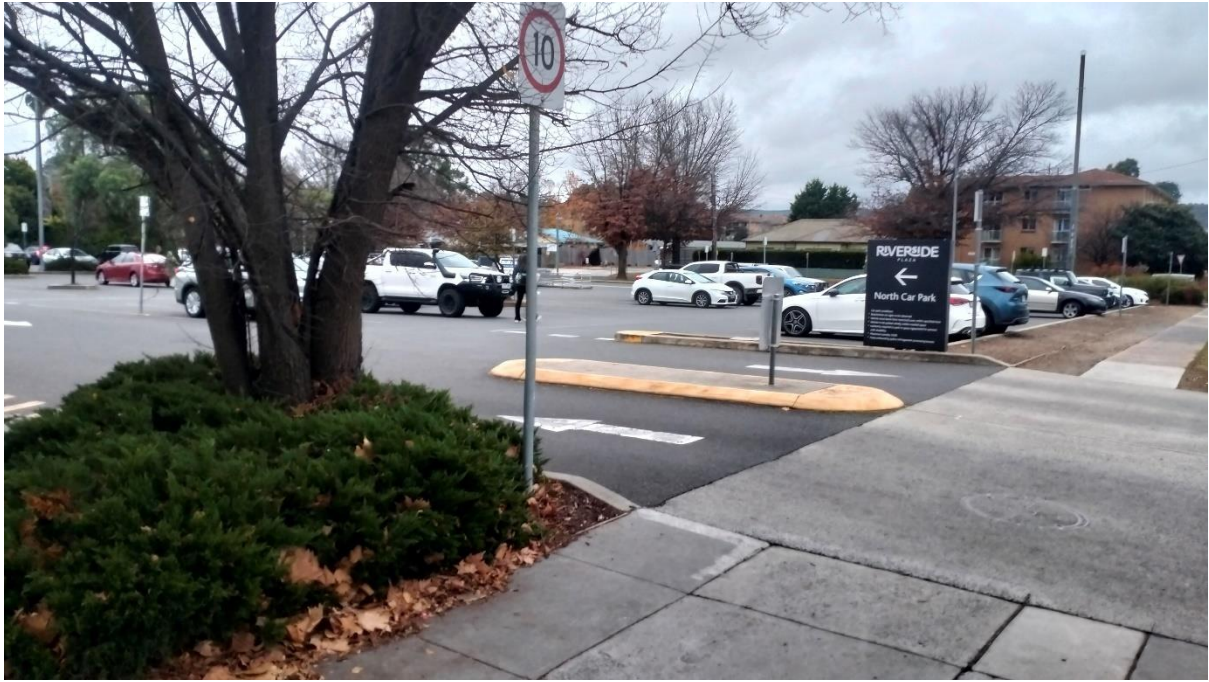
**Photograph 1:** Car park entry/exit fronting Morisset Street.

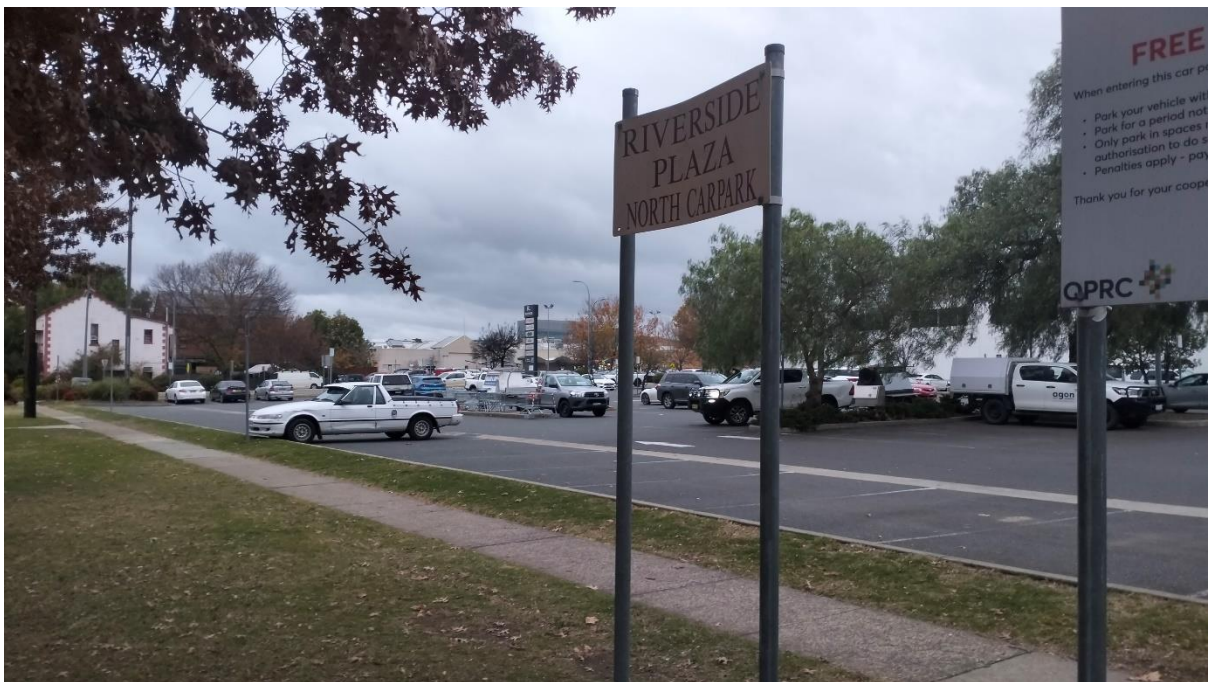
**Photograph 2:** Eastern portion of car park facing south from Collet Street.

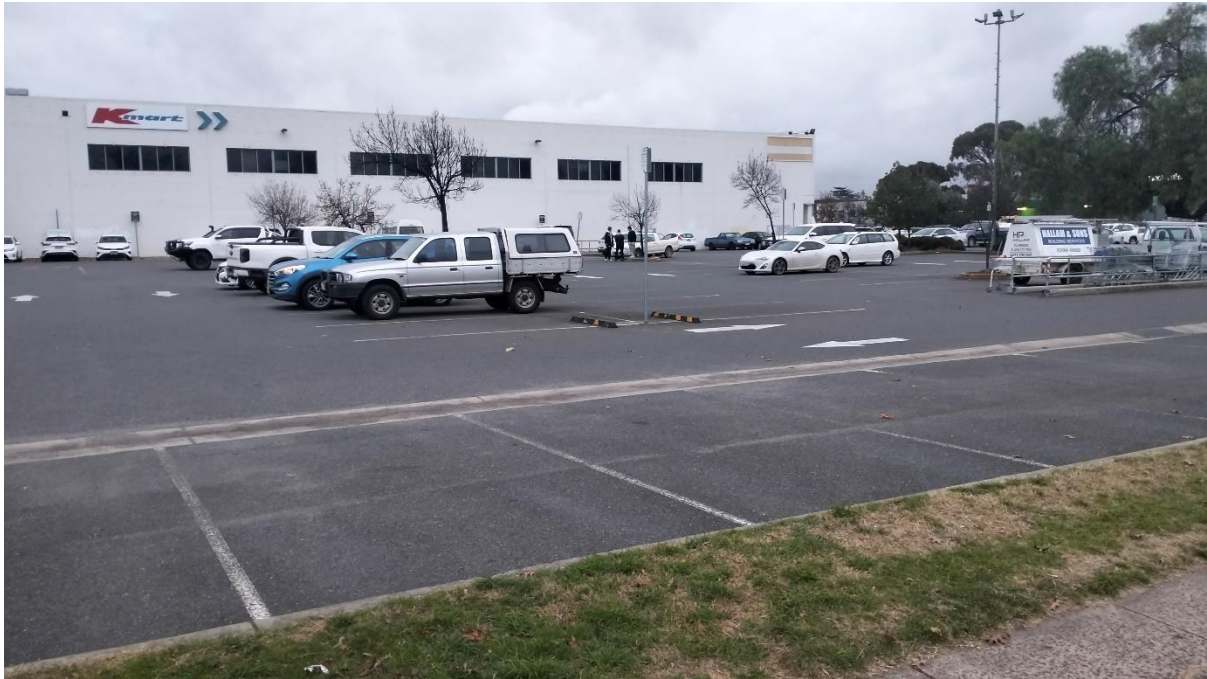
**Photograph 3:** Central portion of car park facing southwest.

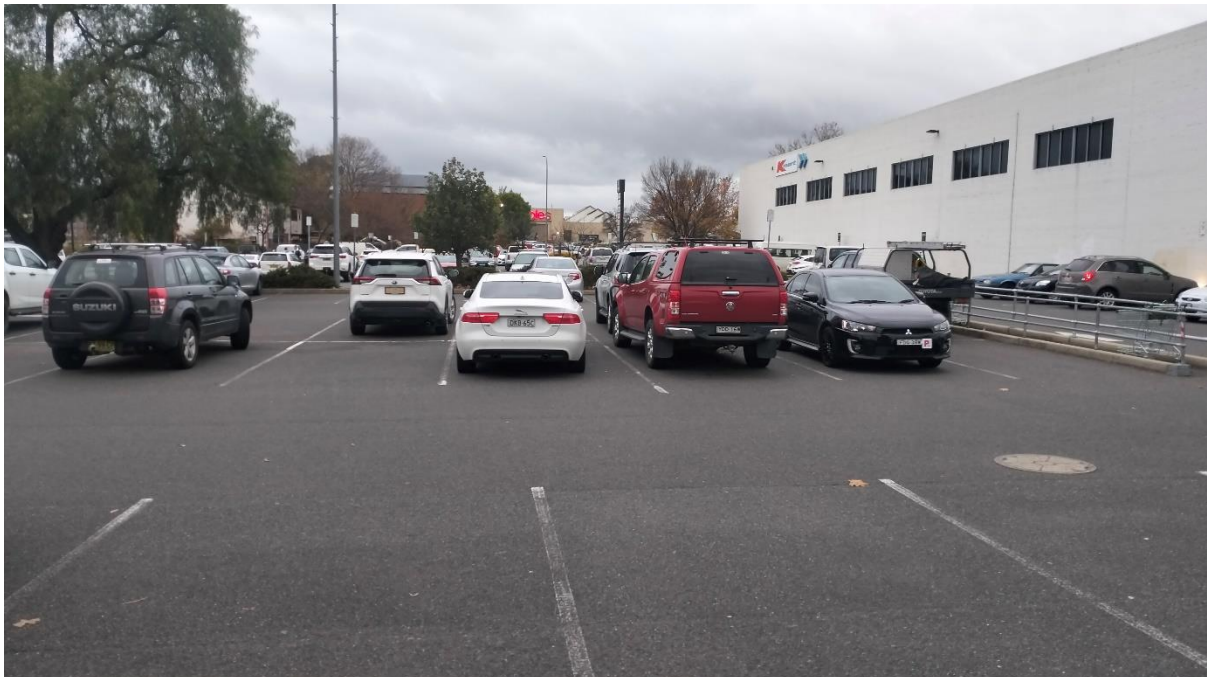
**Photograph 4:** Western portion of car park facing to the southeast.

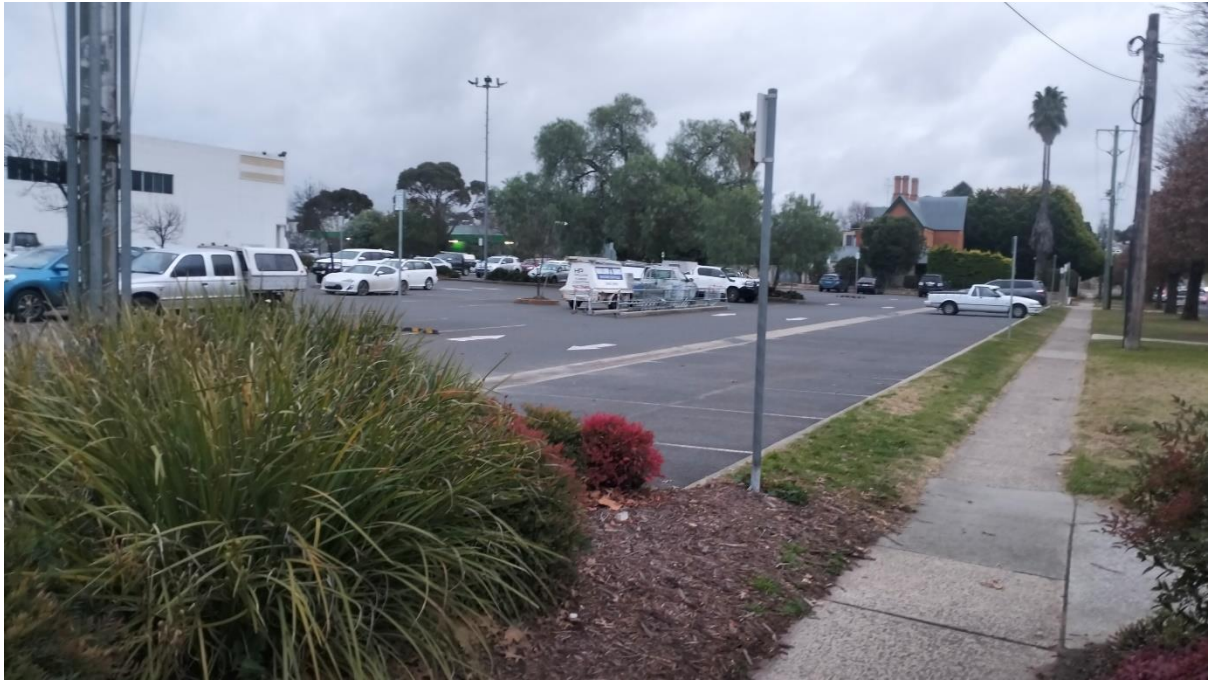
**Photograph 5:** Southern portion of car park facing to the northwest.

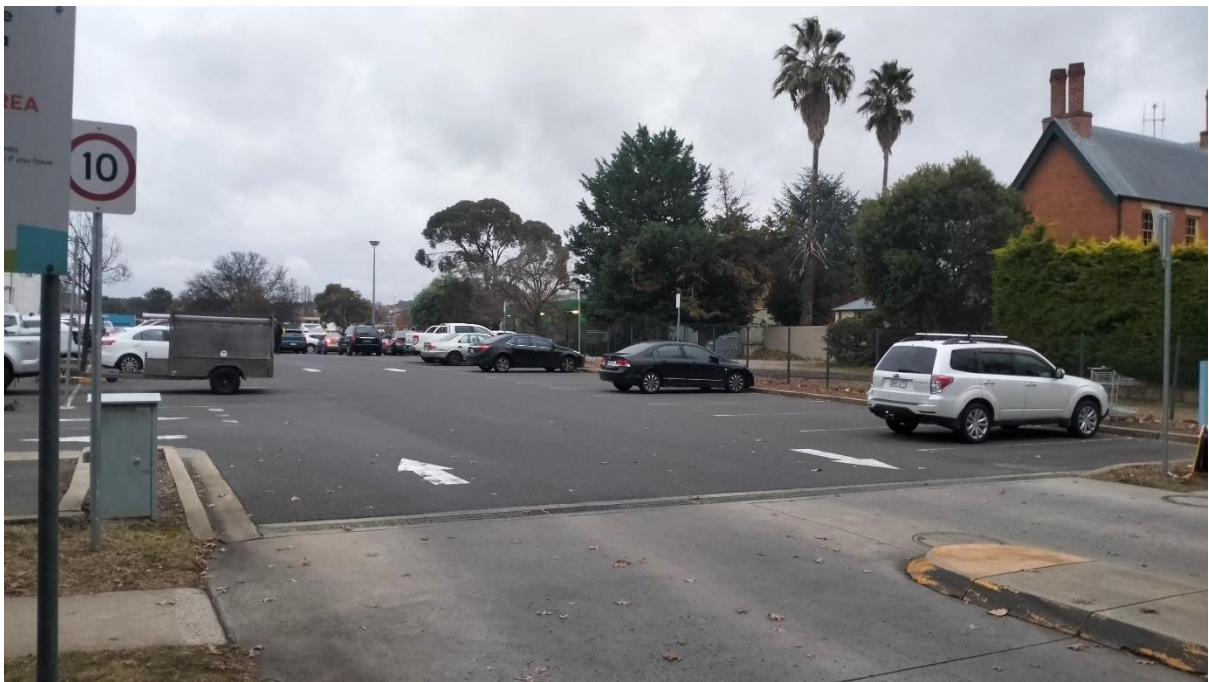
**Photograph 5:** Car park entry/exit fronting Collett Street.
