# *Ulmus procera* (English Elm) adjacent to the CIVITAS Stage 3 development site

## Arborist Report

May 2024,  
Ref 24/475A.

# *Ulmus procera* (English Elm) adjacent to the CIVITAS Stage 3 Development Site – corner of Murray and Morgan Streets, Wagga Wagga.

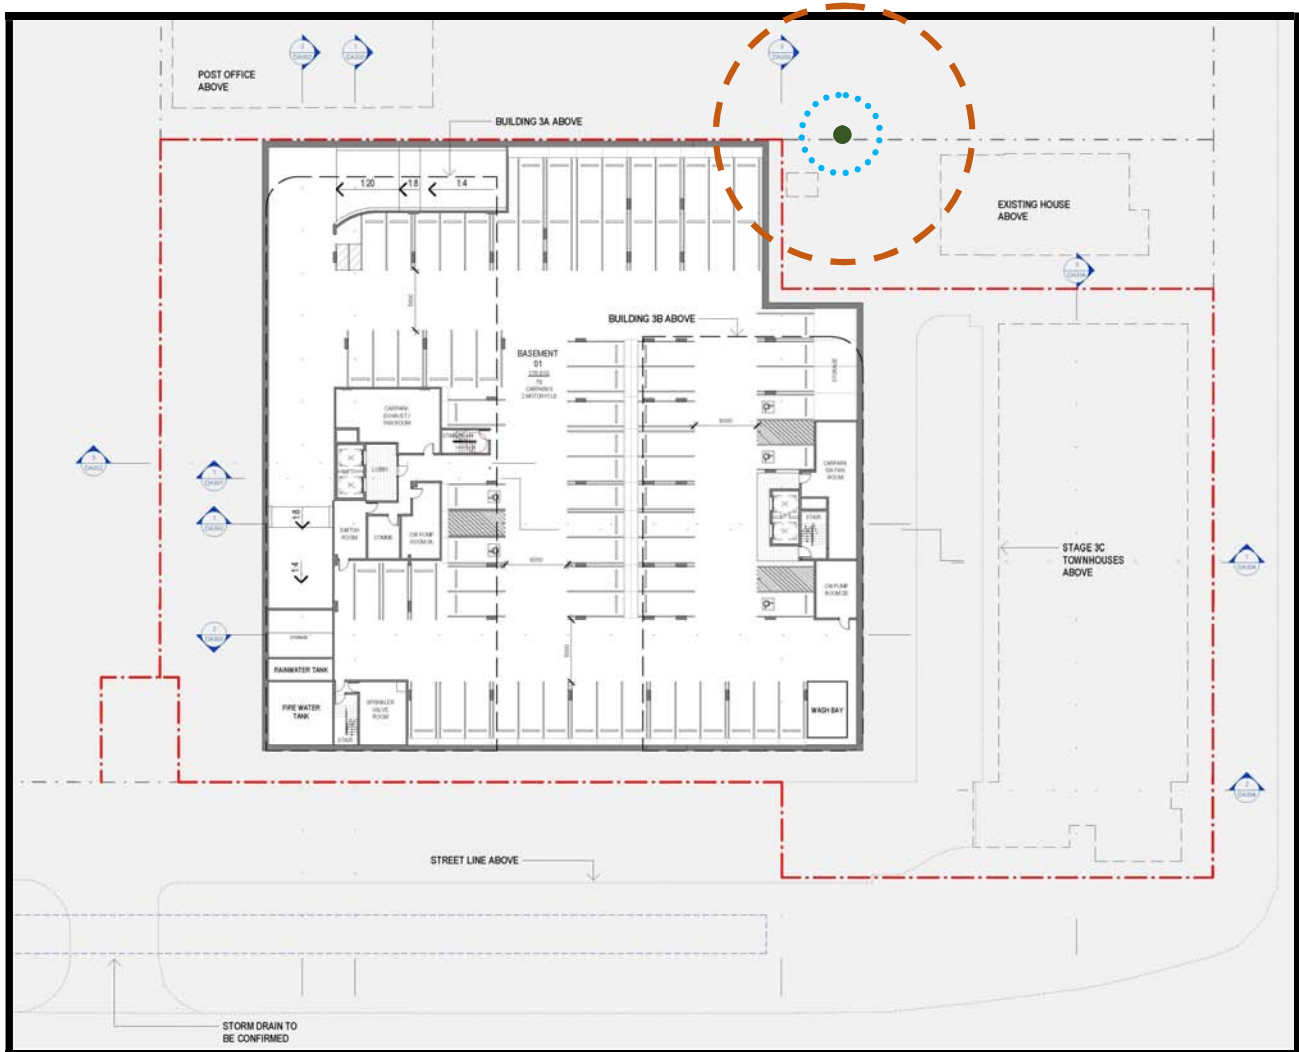
**Exhibit 2** – An extract of CIVITAS Stage 3 DA Plans (Floor Plan – Basement 01), with the approximate position of the subject tree’s stem shown in **Green**. The tree’s Tree Protection Zone (TPZ) and Structural Root Zone (SRZ) are also shown diagrammatically – the TPZ in **Brown** and the SRZ **Blue**.

Based on the tree measurements given in Section 3 the radius TPZ for the subject English Elm is 12 metres (1.0m X 12). This TPZ is illustrated diagrammatically in the development plan included as Exhibit 3.

The existing English Elm tree has a TPZ area of approximately 450m<sup>2</sup> and the area of the segment of that (TPZ) area that could be disturbed by the proposed development is approximately 24.3m<sup>2</sup>. This equates to an encroachment of approximately 5.7%. It should be noted that this area of disturbance is currently occupied by a building, the construction of which would have impacted on the tree's root plate which is probably now limited in this area (due to unfavourable ground conditions).

AS4970-2009 allows for minor encroachment (less than 10%) of a tree's TPZ with the area of encroachment lost compensated for elsewhere contiguous with the TPZ, which is possible to the tree's east and south.

The resultant SRZ for the subject English Elm is 3.64 metres. This SRZ is also illustrated diagrammatically in the development plan included as Exhibit 3. It is expected that it should not be impacted by the proposed development. Again, it is noted that the tree's SRZ may have been encroached by the paving and kerbing of the concrete carpark that now exists to its north (see Exhibits 5 and 6).

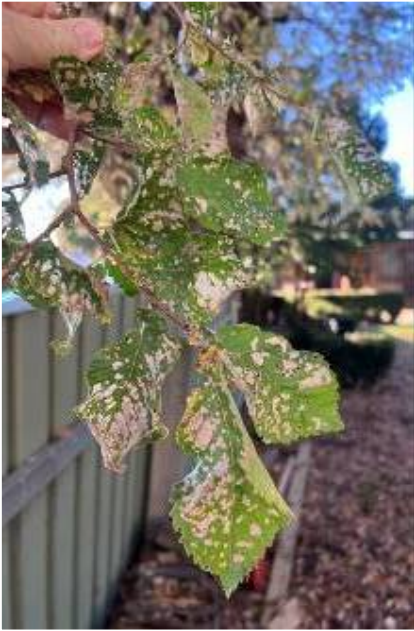
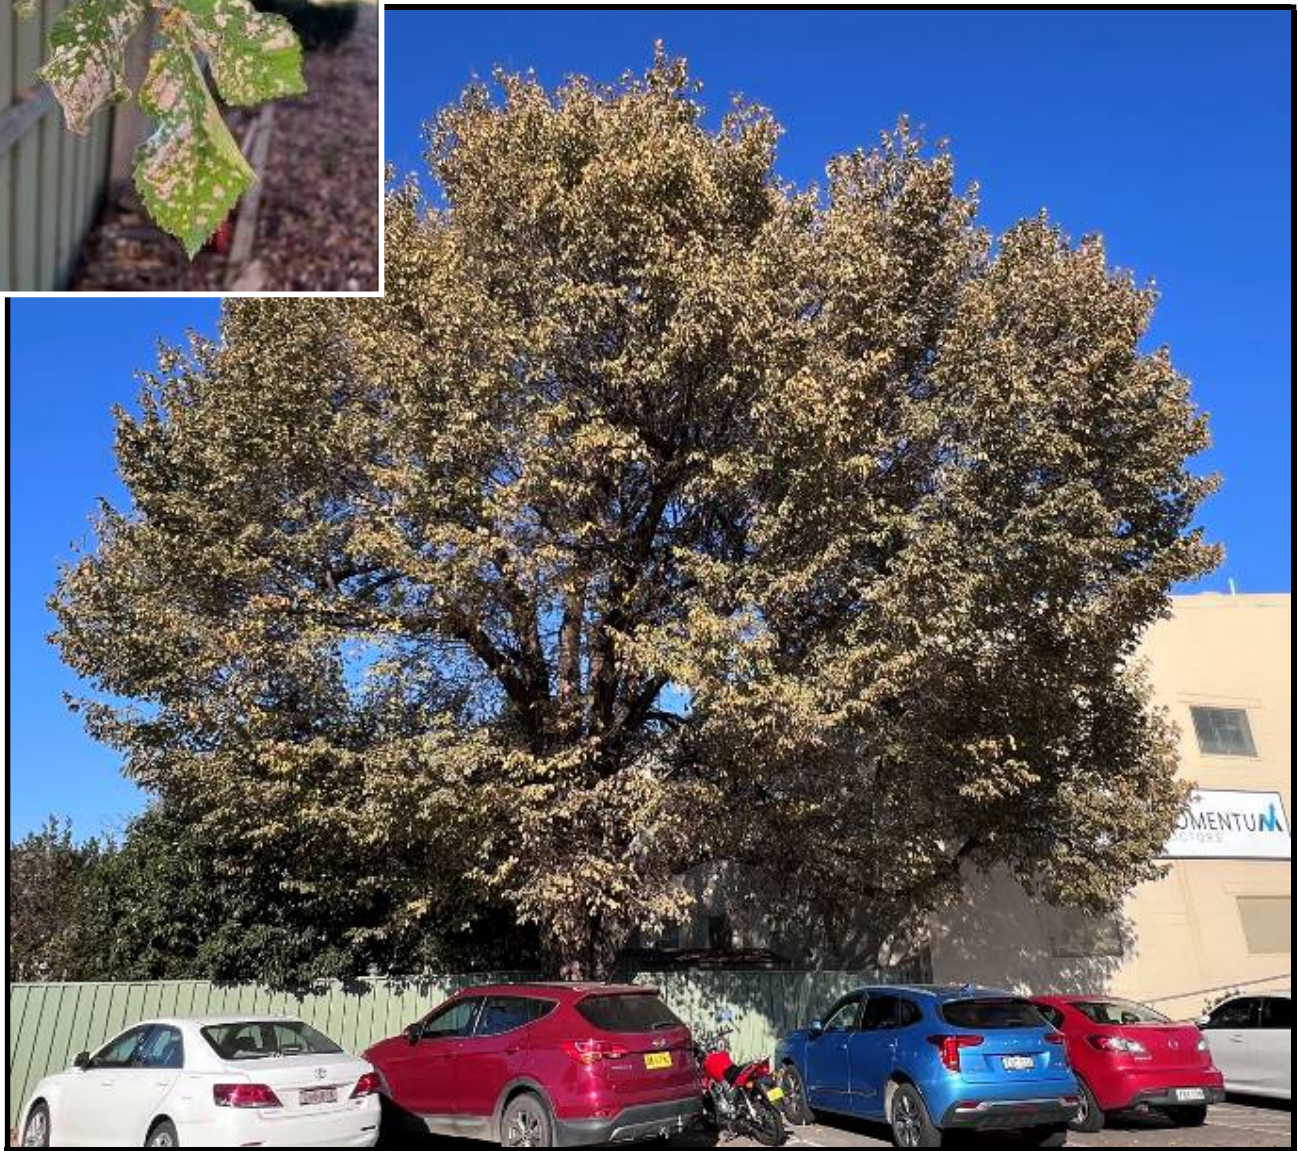
There is also evidence of the recent season foliage's skeletonisation (Exhibit 4), the effect of the emergent larvae of the Elm Leaf Beetle (*Pyrrhalta luteola*). This pest is now naturalised in south-east Australia with its impact on Elm trees varying season to season. The current season's impact would be described as minor.

Overall the tree can be described as being in Good Condition – a tree of good habit, a form not severely restricted for space and light, physically free from the adverse effects of predation by pests or disease, obvious instability or structural weaknesses, and is expected to continue to live in much the same condition as at the time of inspection provided conditions around it do not alter greatly. As noted previously, it can potentially provide amenity to its setting for another sixty to eighty-five years.

**Exhibit 4** – The tree is a large English Elm (*Ulmus procera*) that is a prominent landscape element in its setting (**Main** image). Despite the on-going impact of the Elm Leaf Beetle (**Inset** image) the tree is in Good condition.

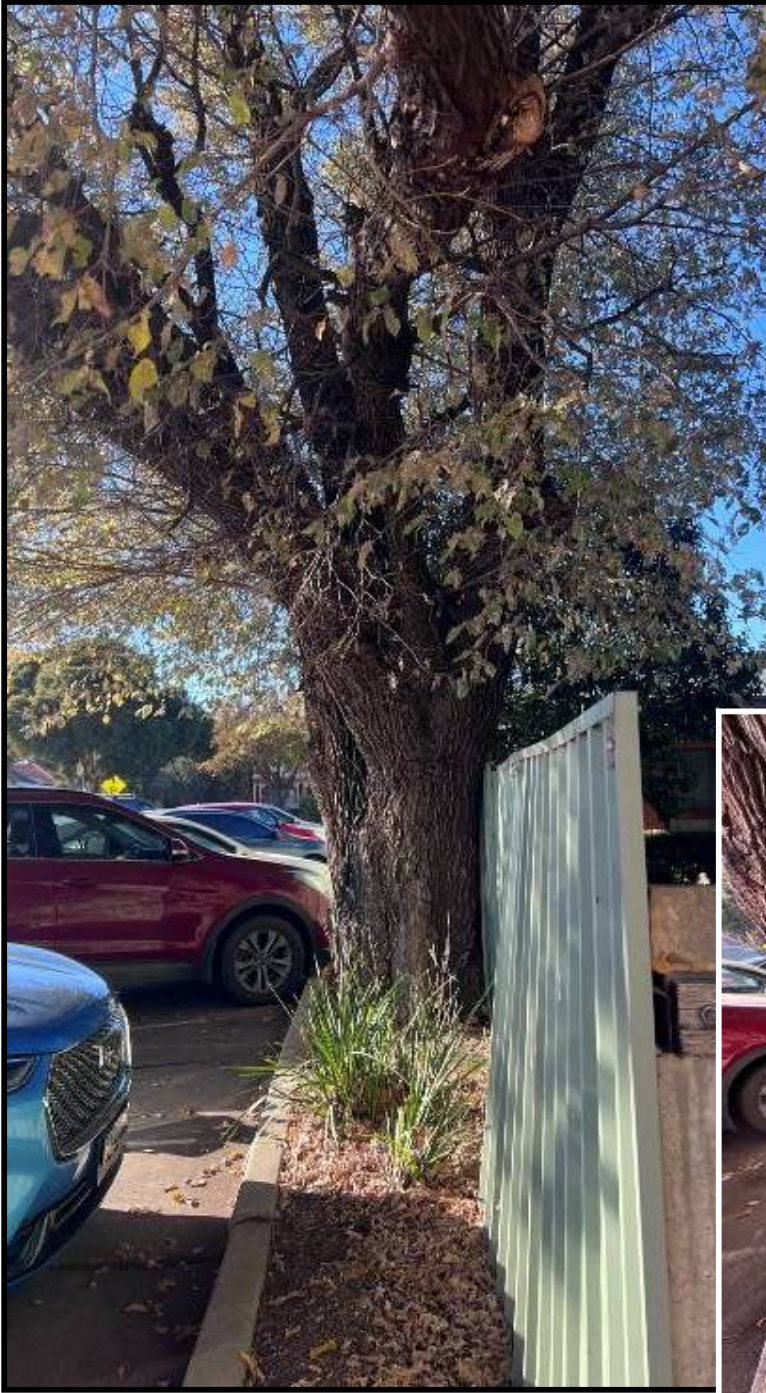
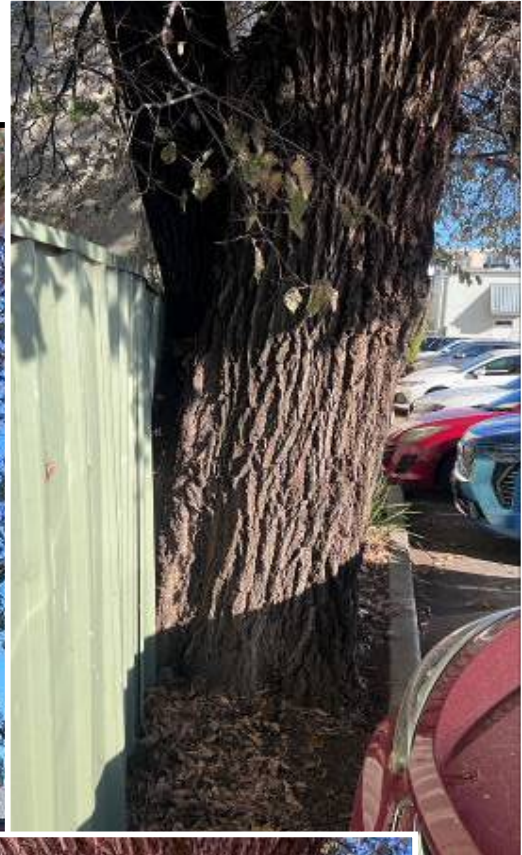
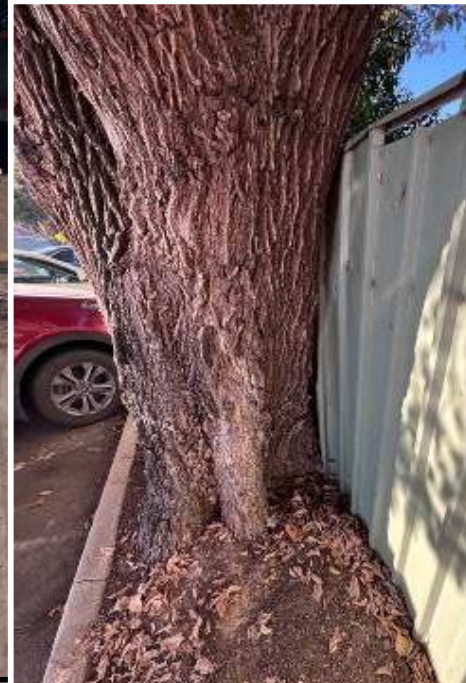
The tree's northern root plate has been "sealed" by the construction of a concrete surfaced car park (see Exhibit 6), and its stem is displacing a boundary fence to its immediate south (see Exhibit 5)

**Exhibit 5** – Various images of the tree’s lower stem and its positioning in relation to a boundary fence, which is being displaced by the trees’s growth.

The implementation of a more suitable construction detail, which accommodates the expanding tree stem, for the existing boundary fence that the tree is next to is also recommended.

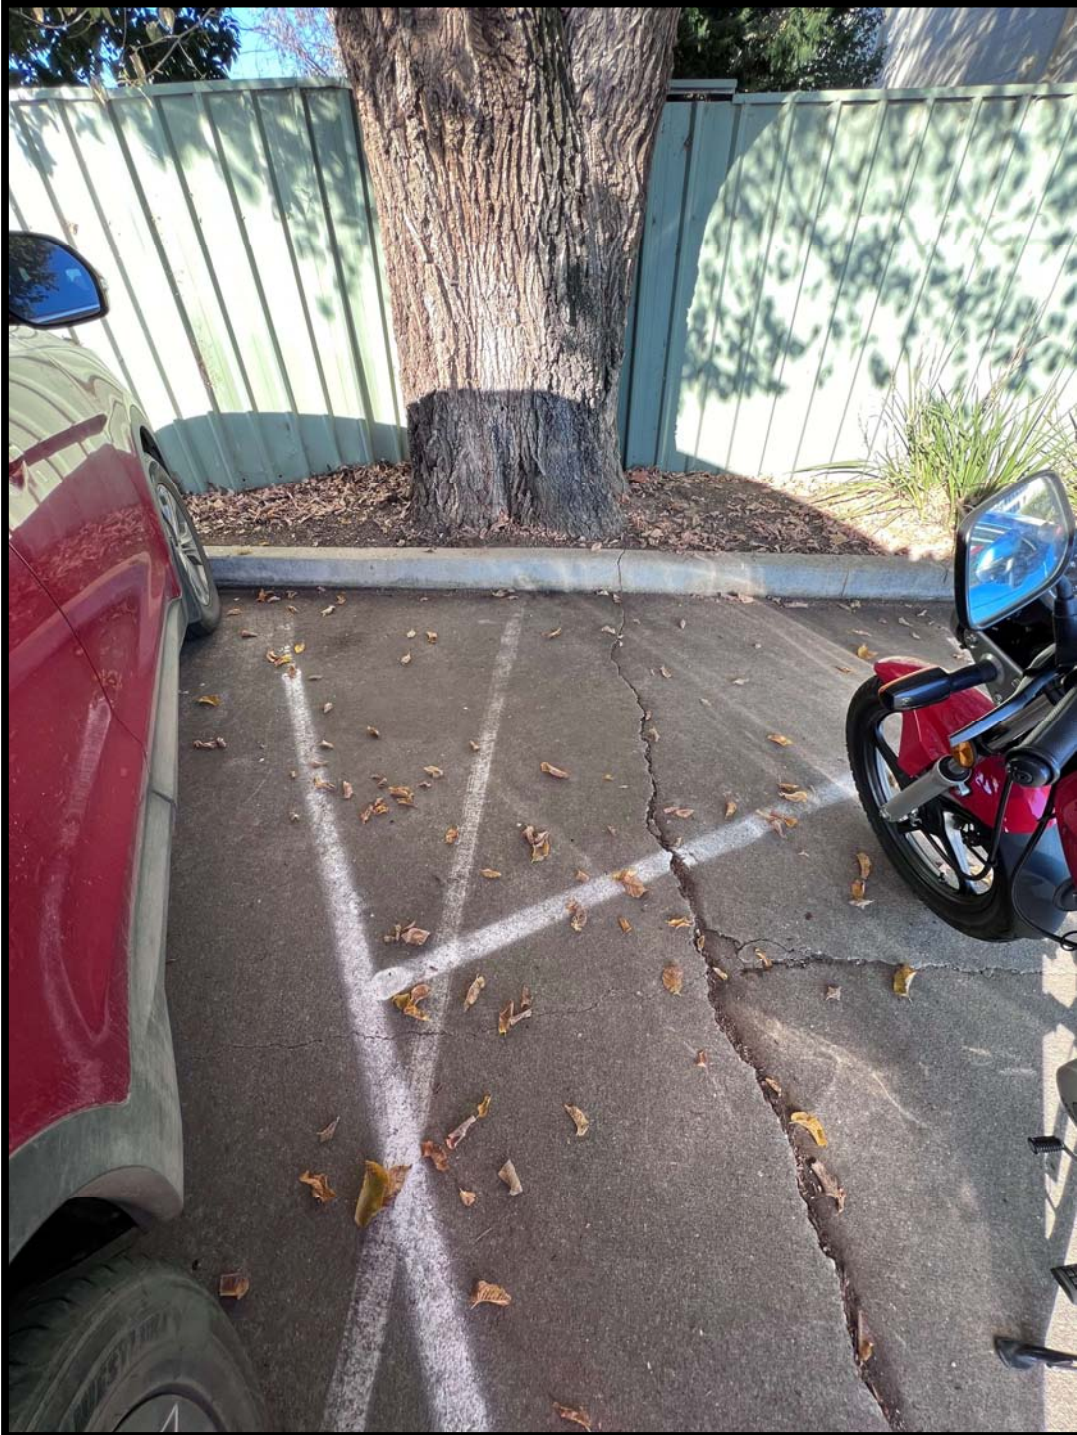
**Exhibit 6** – The tree’s northern root plate has been “sealed” by the construction of a concrete surfaced car park. The cracking and displacement of the concrete surface (and kerb) is probably attributable to the continued growth of the tree’s structural roots.

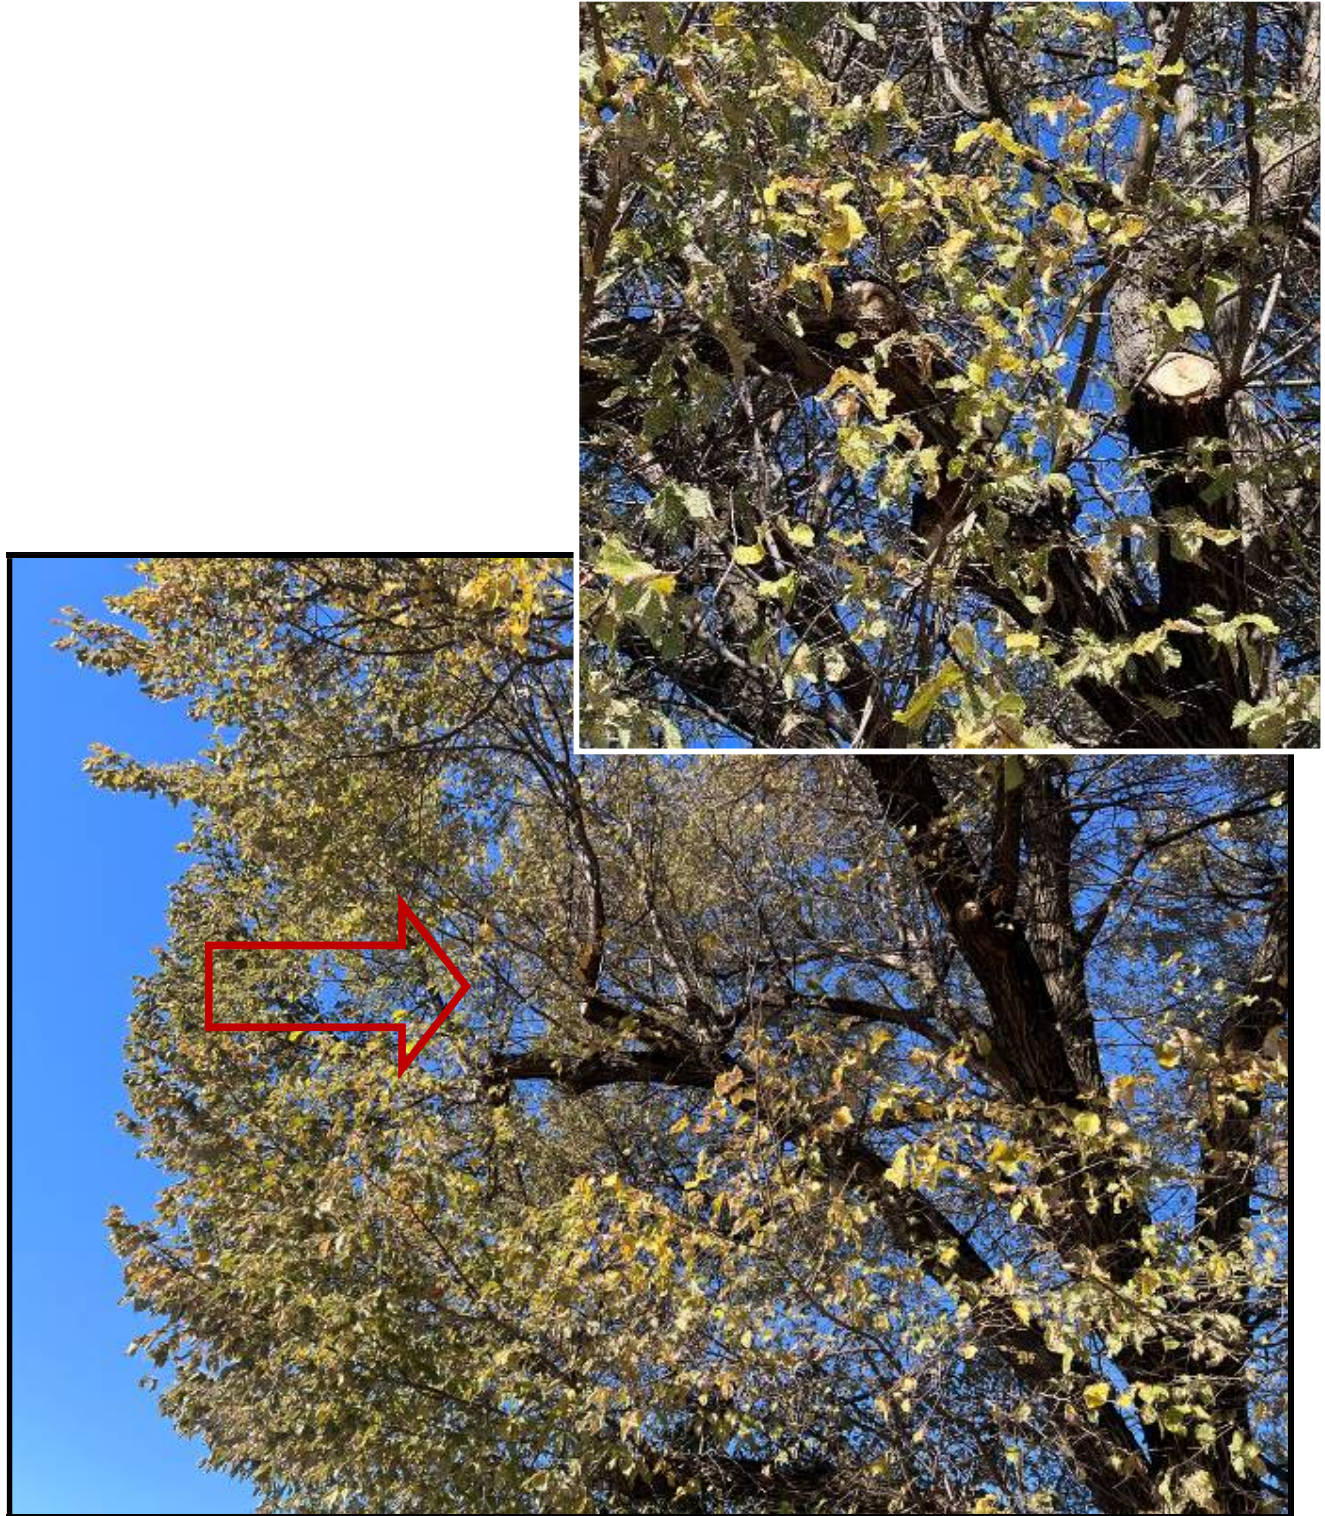
The tree has experienced some previous pruning events, with contemporary evidence of weight reduction pruning by shortening some of its leaders to around 6 to 10 metres from the ground (see Exhibit 7). There is also evidence of (minor) storm damage in its crown (see Exhibit 8).

**Exhibit 7** – Sites of previous weight reduction pruning by shortening some of the tree’s leaders to around 6 to 10 metres from the ground. The pruning cuts show healthy occluding tissue and no signs of decay (**Upper right**)

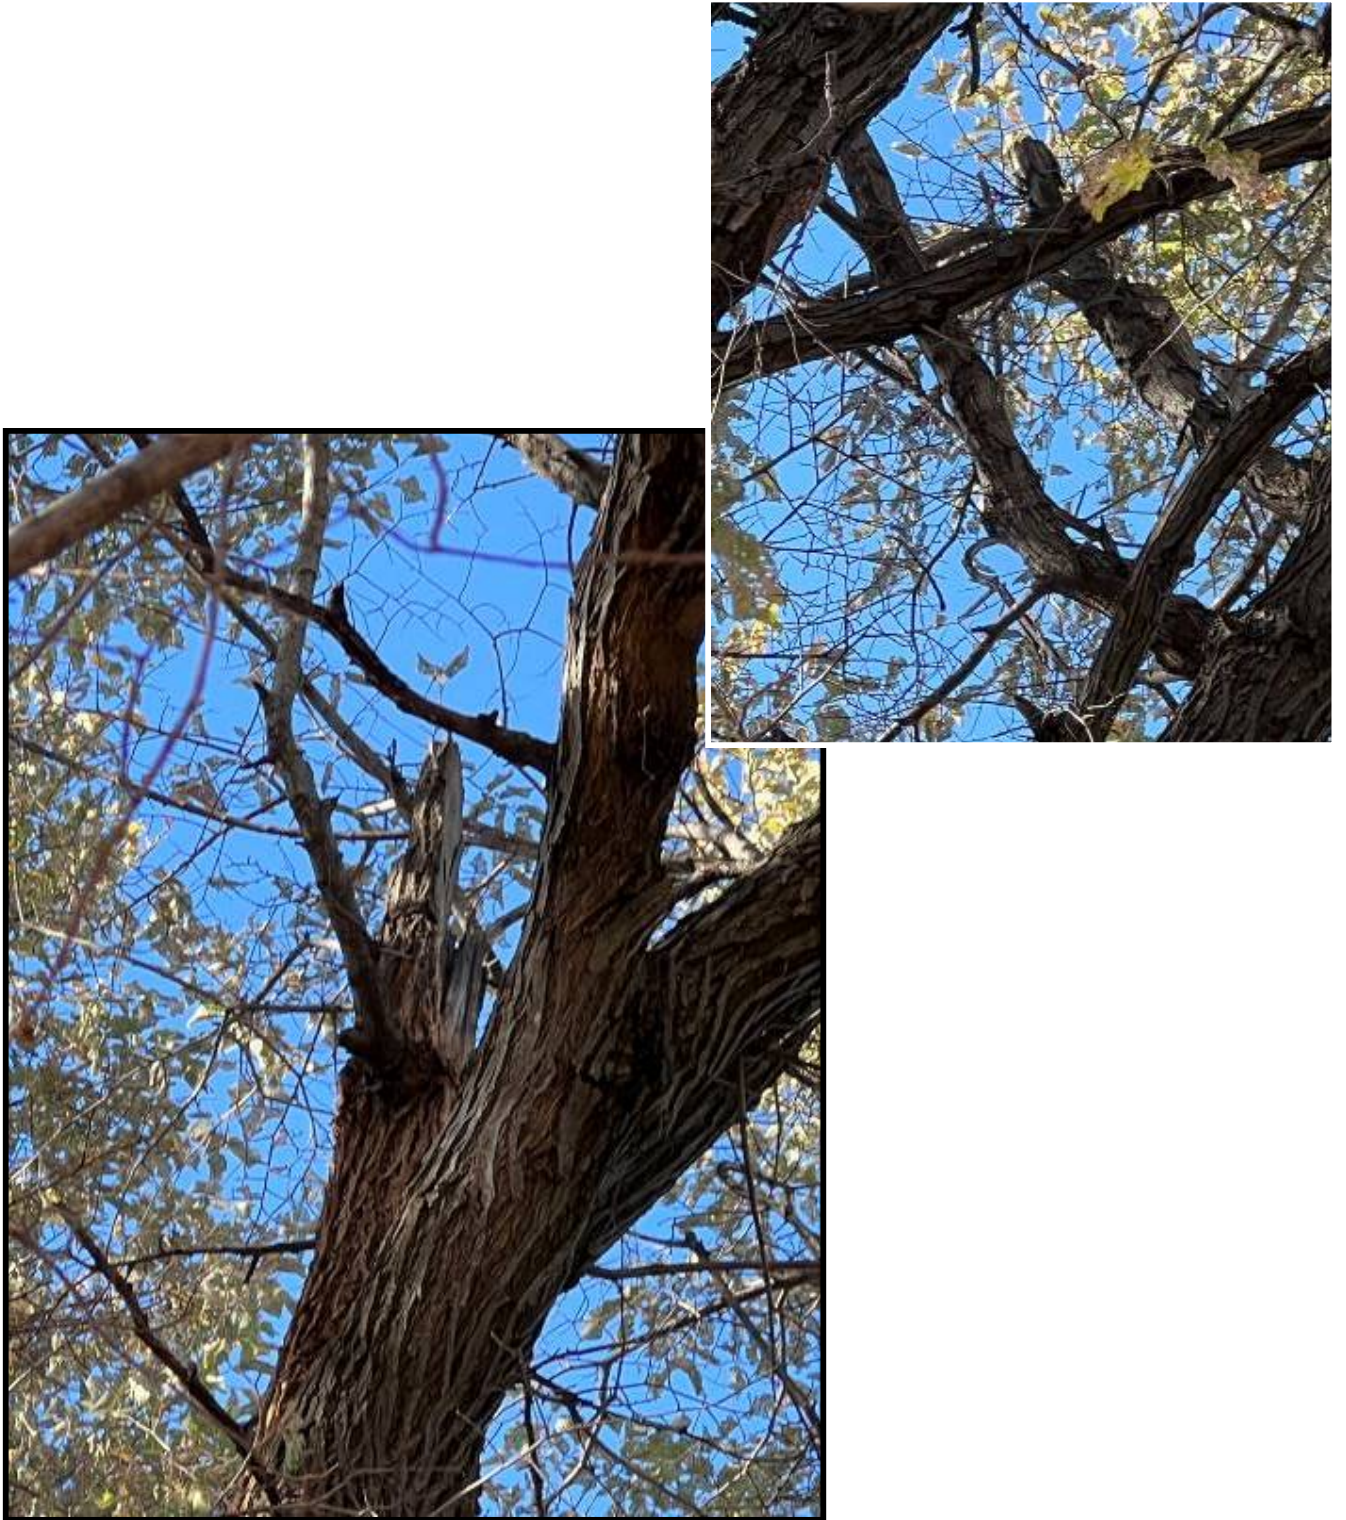
**Exhibit 8** – Sites of previous (minor) storm damage in the tree’s crown. A (south) central leader (**Left**) and in the upper southern crown (**Upper right**)

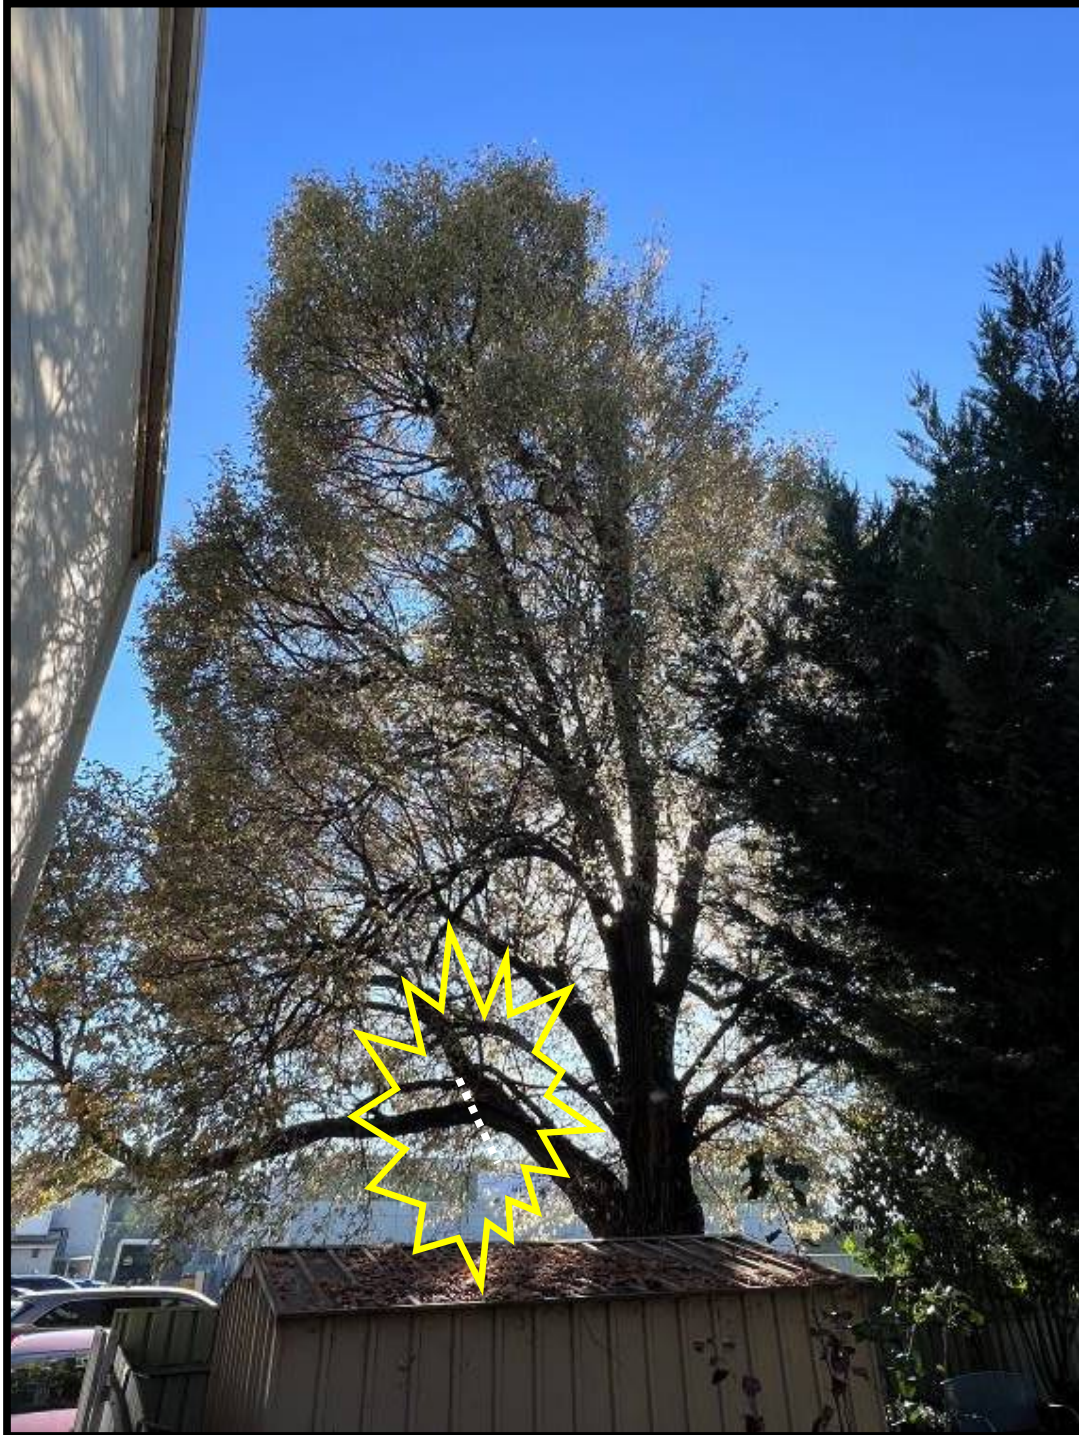
**Exhibit 9**– The tree’s current canopy, viewed from the south-west. Pruning off the lower western lateral, as indicated by the **broken white line**, would remove most canopy encroachment of the existing building and of the proposed construction site.

The canopy spread of the subject tree already encroaches on a building to its west. This building will be demolished with new construction work to be undertaken within its footprint. The tree should be pruned to limit this encroachment. An appropriate approach to this work is illustrated in Exhibit 9. Any necessary pruning work should respect and retain the tree's natural form and amenity, and be performed in accordance with AS4373 – 2007 *Pruning of amenity trees*.

The size, streetscape amenity value, and current condition warrants that the tree should be retained in the post development landscape, with minor pruning to remove any encroachment of its crown on the construction site of the proposed building (see Exhibit 9).
