CIVITAS Stage 3 – Cnr Murray & Morgan Streets, WAGGA WAGGA

Arborist Report

February 2024,
Ref 24/475.

Trees on the CIVITAS Stage 3 Site – corner of Murray and Morgan Streets, Wagga Wagga.

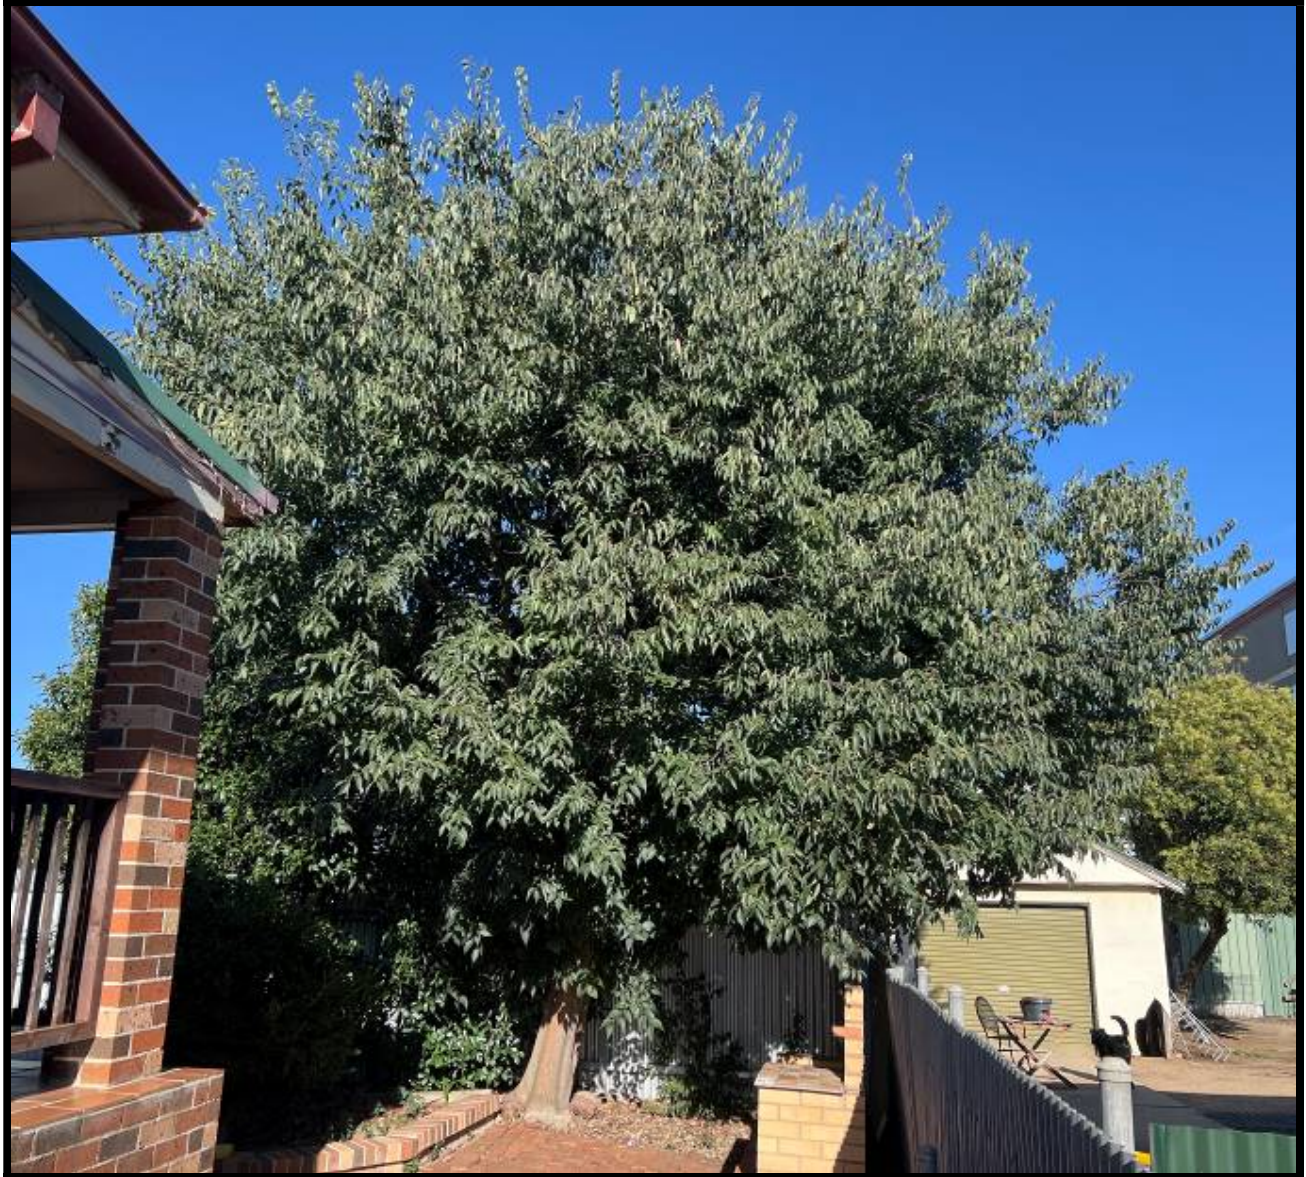
4.1 – Tree 1

Exhibit 4 – Tree 1 is a Nettle Tree (*Celtis australis*). There are a number of shrubs (to 2 metres) under the tree's canopy, including *Photina*, *Buxus* & *Ligustrum* spp.. The tree is in Good condition.

Of the eleven trees requiring consent for removal only one was classified as being in “Good” condition and therefore a realistic consideration for retention in any altered landscape. That tree is, however, a species (*Celtis australis*) that is broadly considered as an “Invasive Environmental Weed” due to its propensity to “self-seed” after its seed is broadcast in the droppings of birds, a characteristic shared by a range of species listed as “undesirable plant species” in the Wagga Wagga Development Control Plan, 2010.

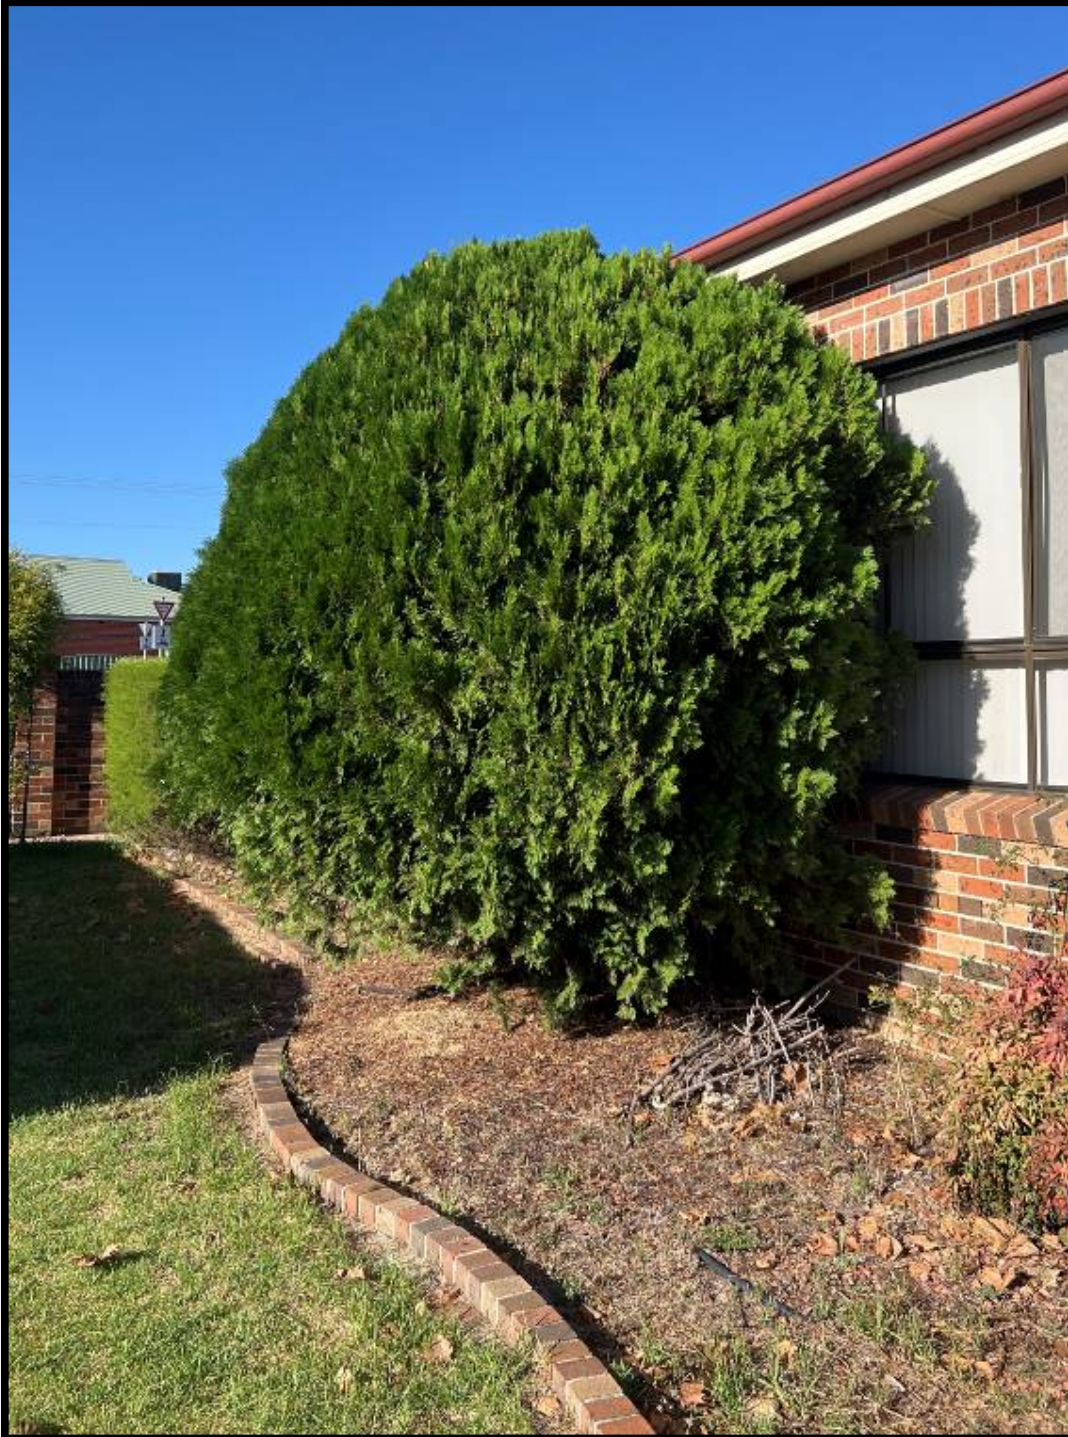
4.2 – Tree 2

Exhibit 5 – Tree 2 is a Bookleaf Pine (*Thuja orientalis*), located only about one metre off the residence (66 Murray Street).

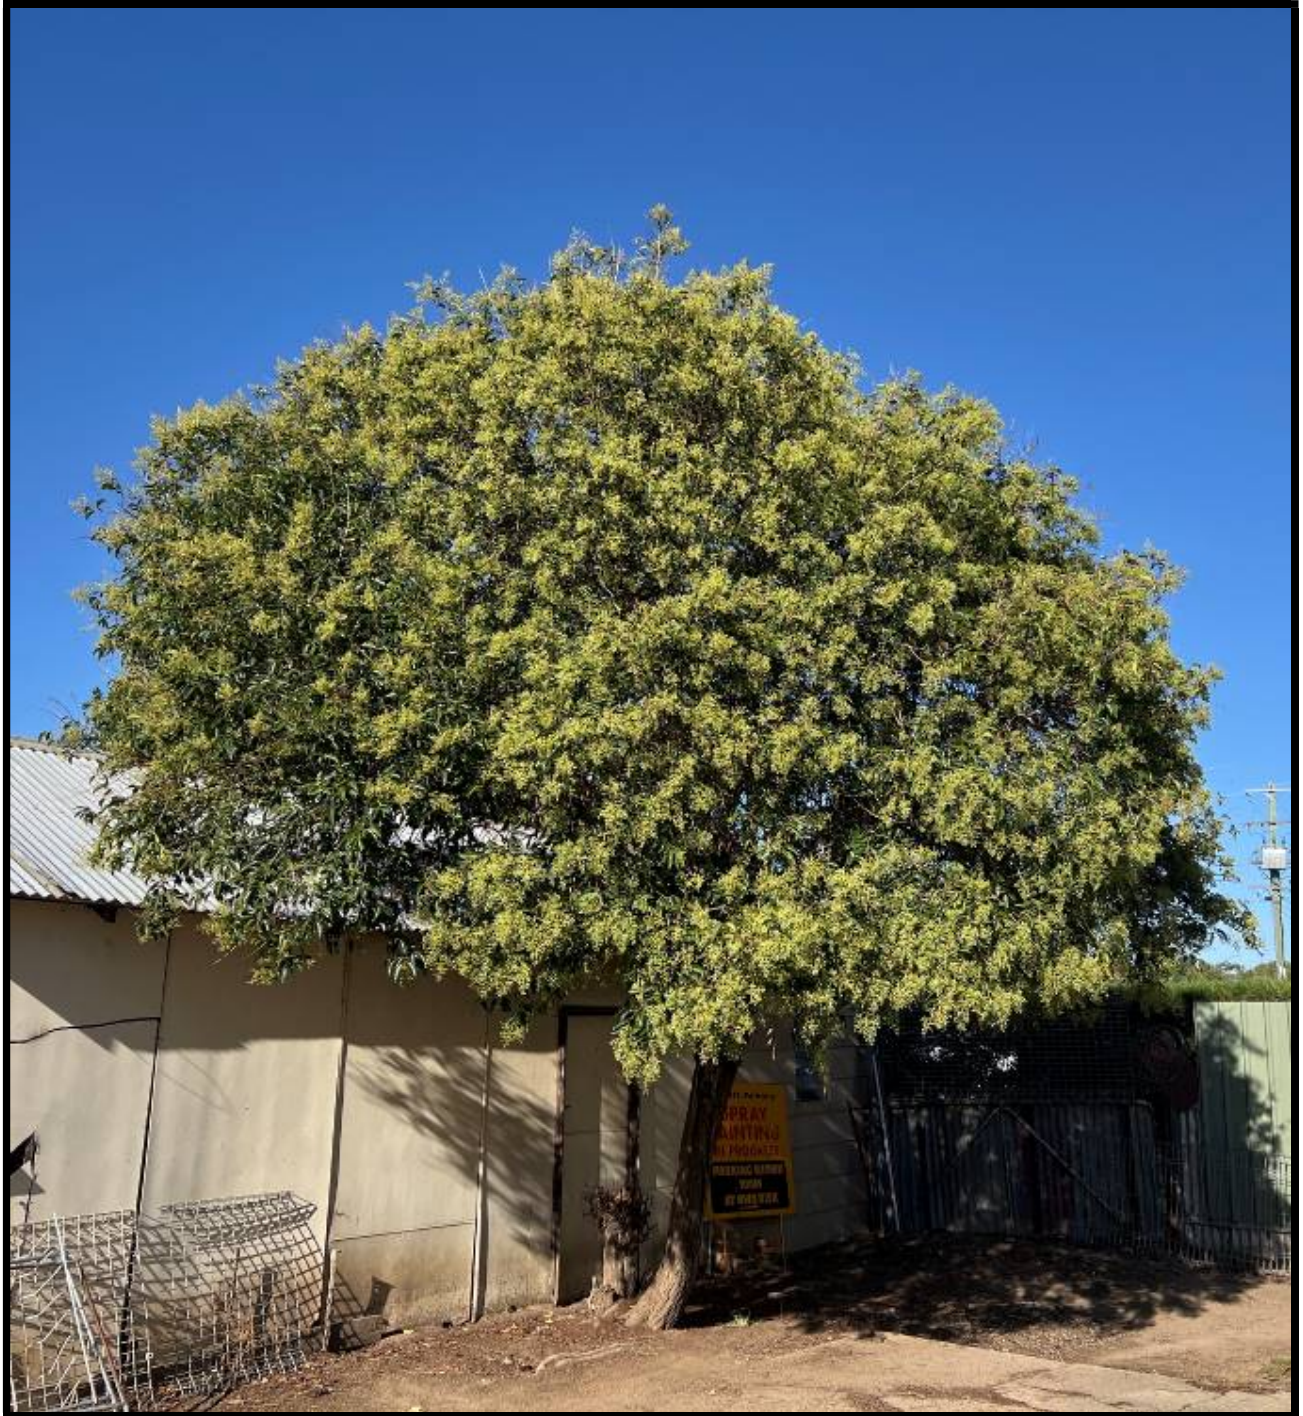
4.3 – Tree 3

Exhibit 6 – Tree 3 is a Broad-leaf Privet (*Ligustrum lucidum*).

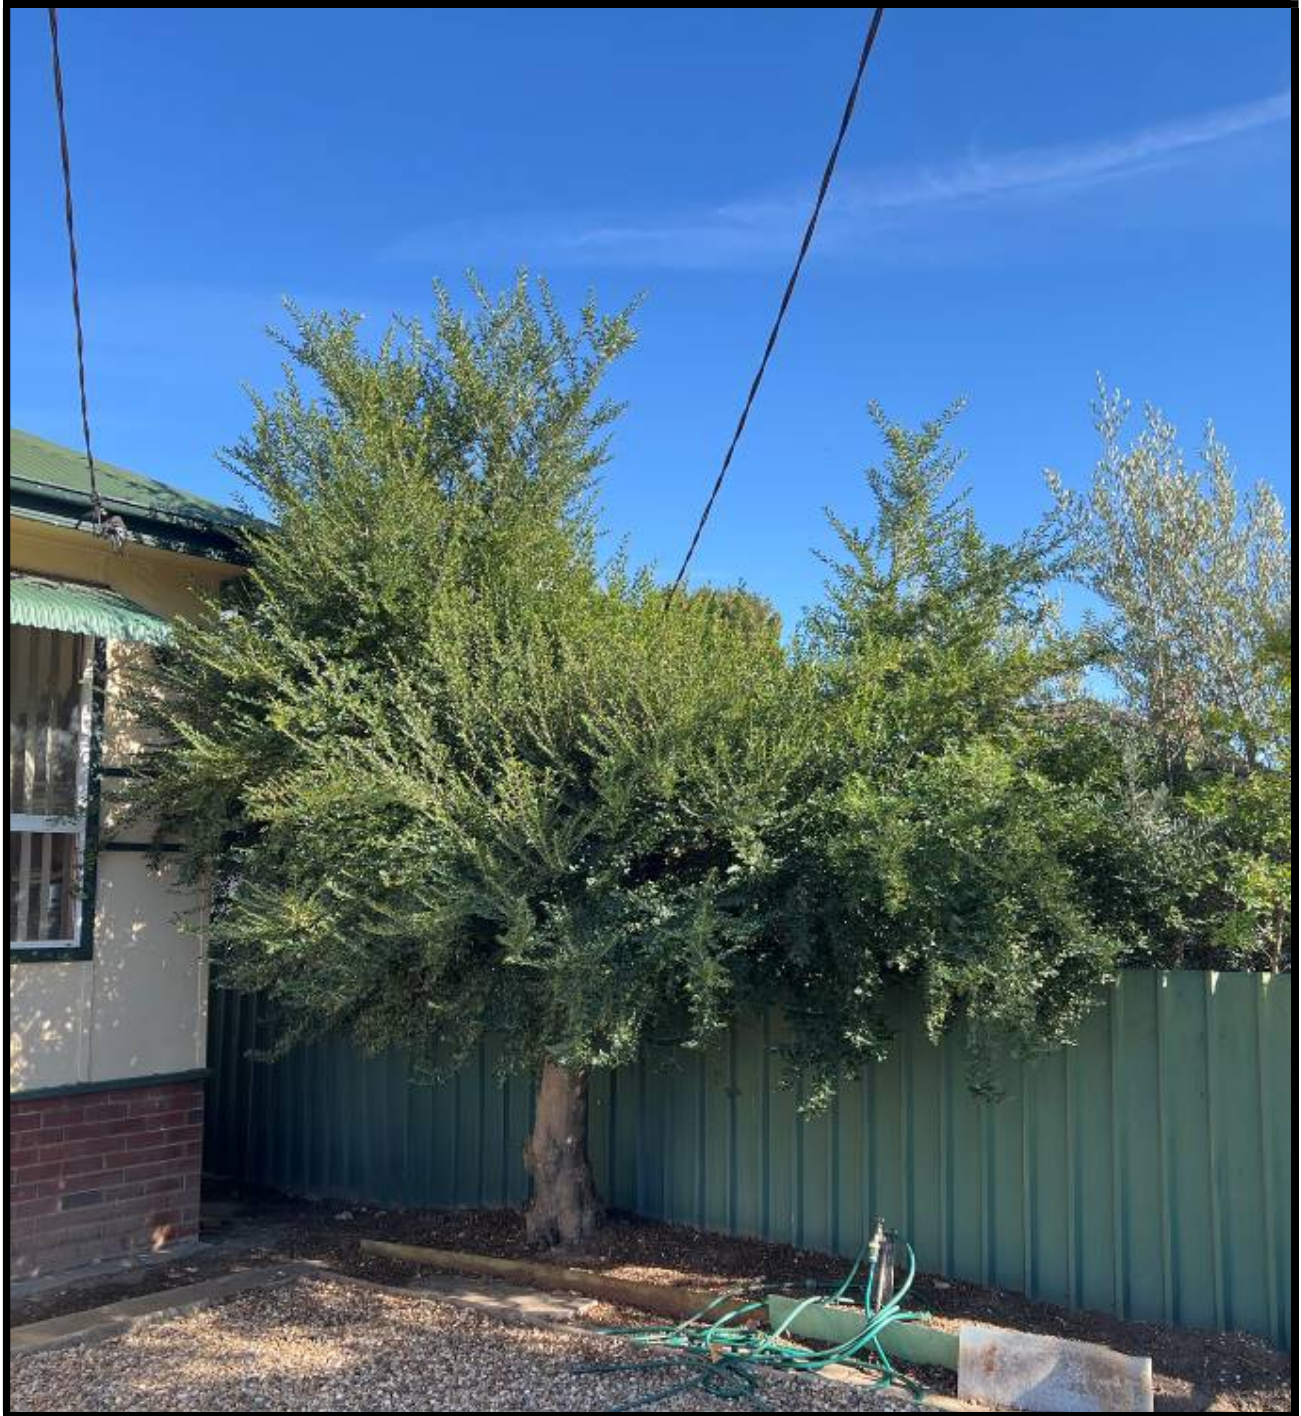
4.4 – Tree 4

Exhibit 7 – Tree 3 is a Small-leaf Privet (*Ligustrum sinense*). The tree has been previously lopped at 1.6 metres.

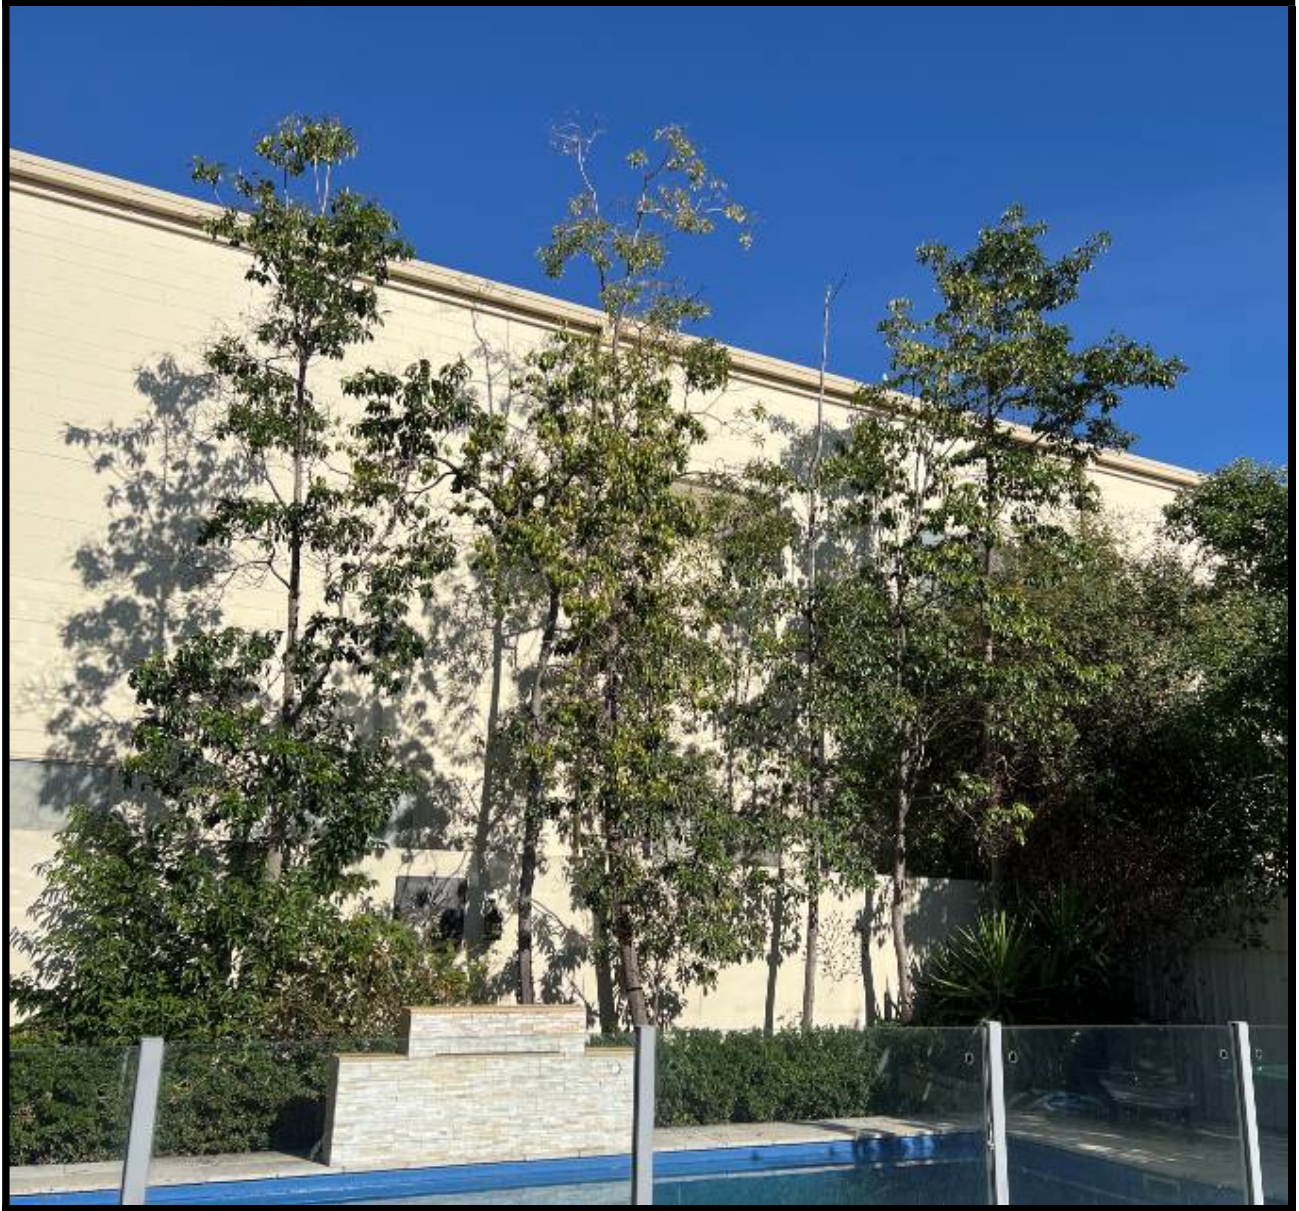
4.5 – Tree 5

Exhibit 8 – Tree 5 is a line of six (6) Native Frangipanis (*Hymenosporum flavum*). The trees feature sparse crowns, apical dieback & sunburn damage to stems. Rated in Poor condition.

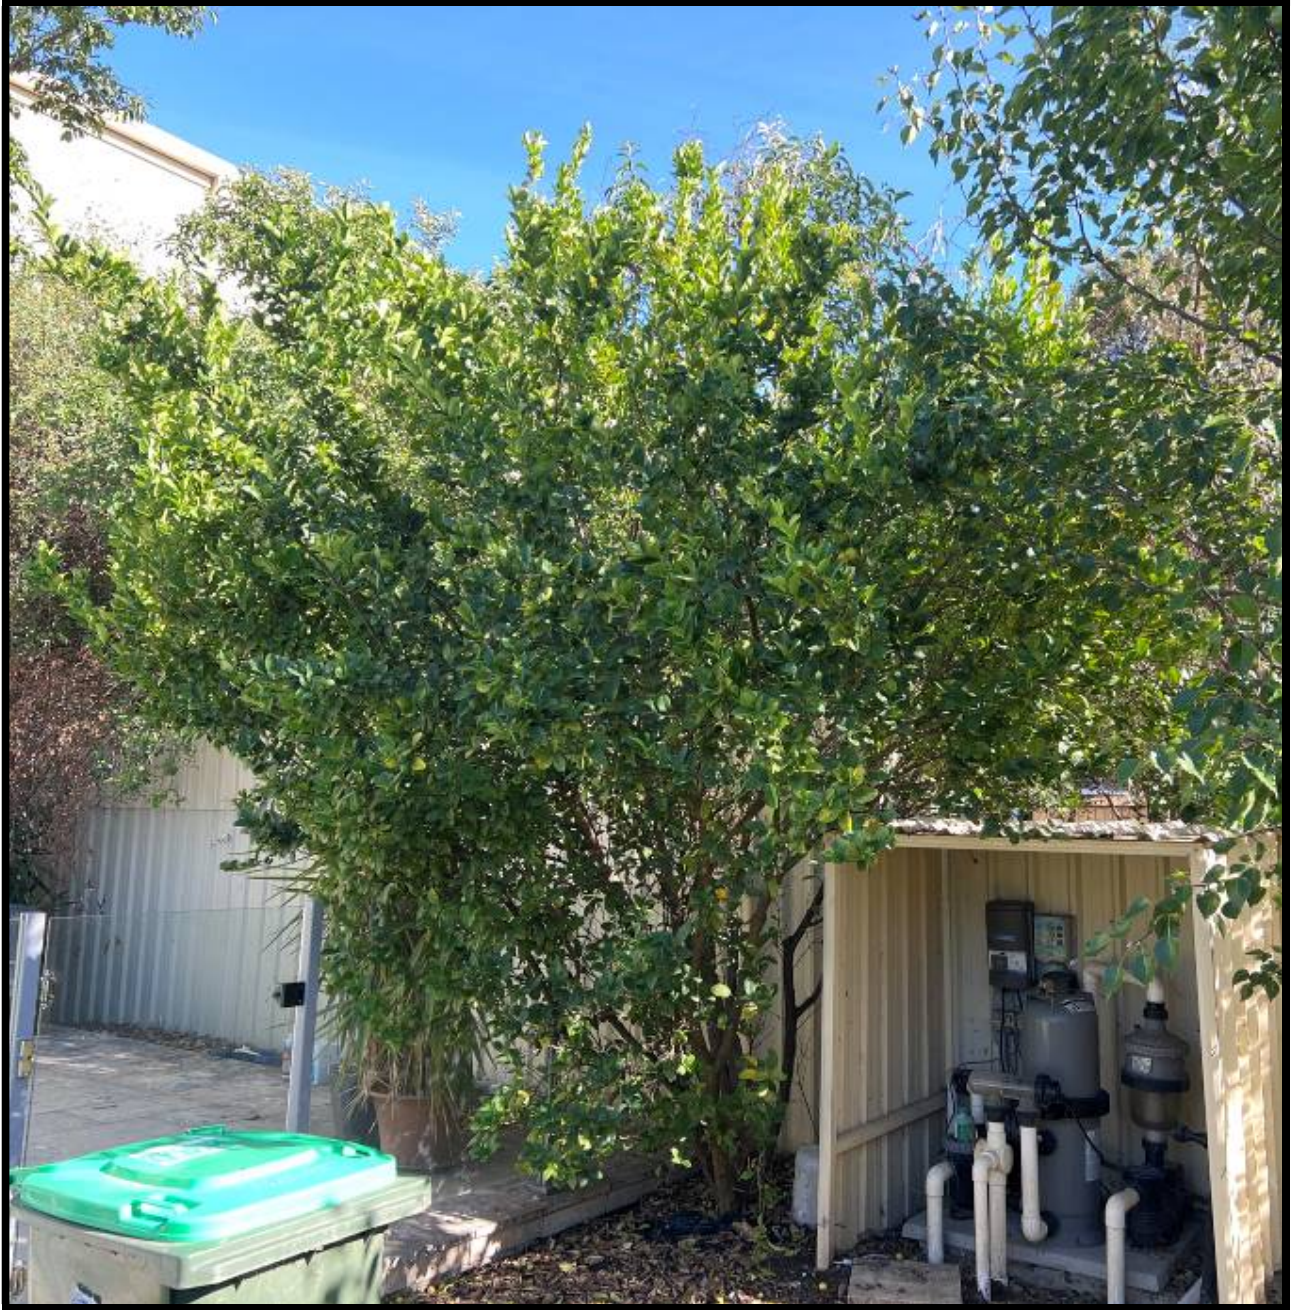
4.6 – Tree 6

Exhibit 9 – Tree 6 is a Lemon Tree (*Citrus* sp.). There is a Broad-leaf Privet growing through canopy of the tree and it is rated as in Fair condition.

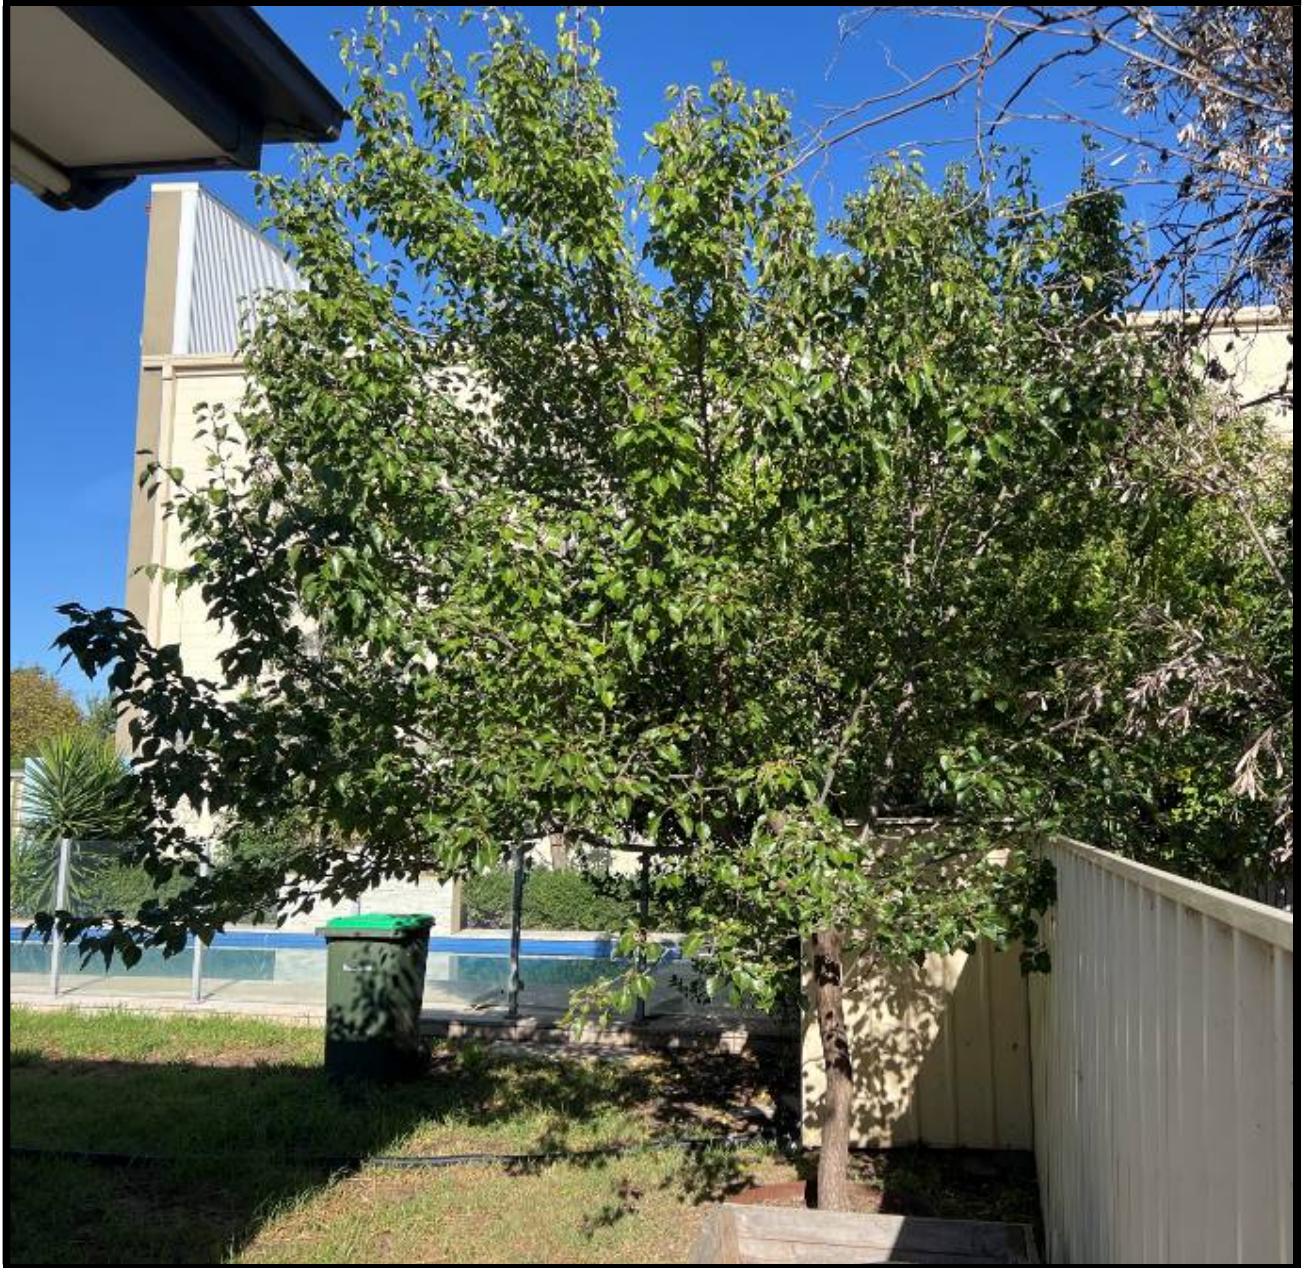
4.7 – Tree 7

Exhibit 10 – Tree 7 is an Ornamental Pear (*Pyrus* sp.). It is a healthy juvenile tree with spreading habit. Rated in Good condition.

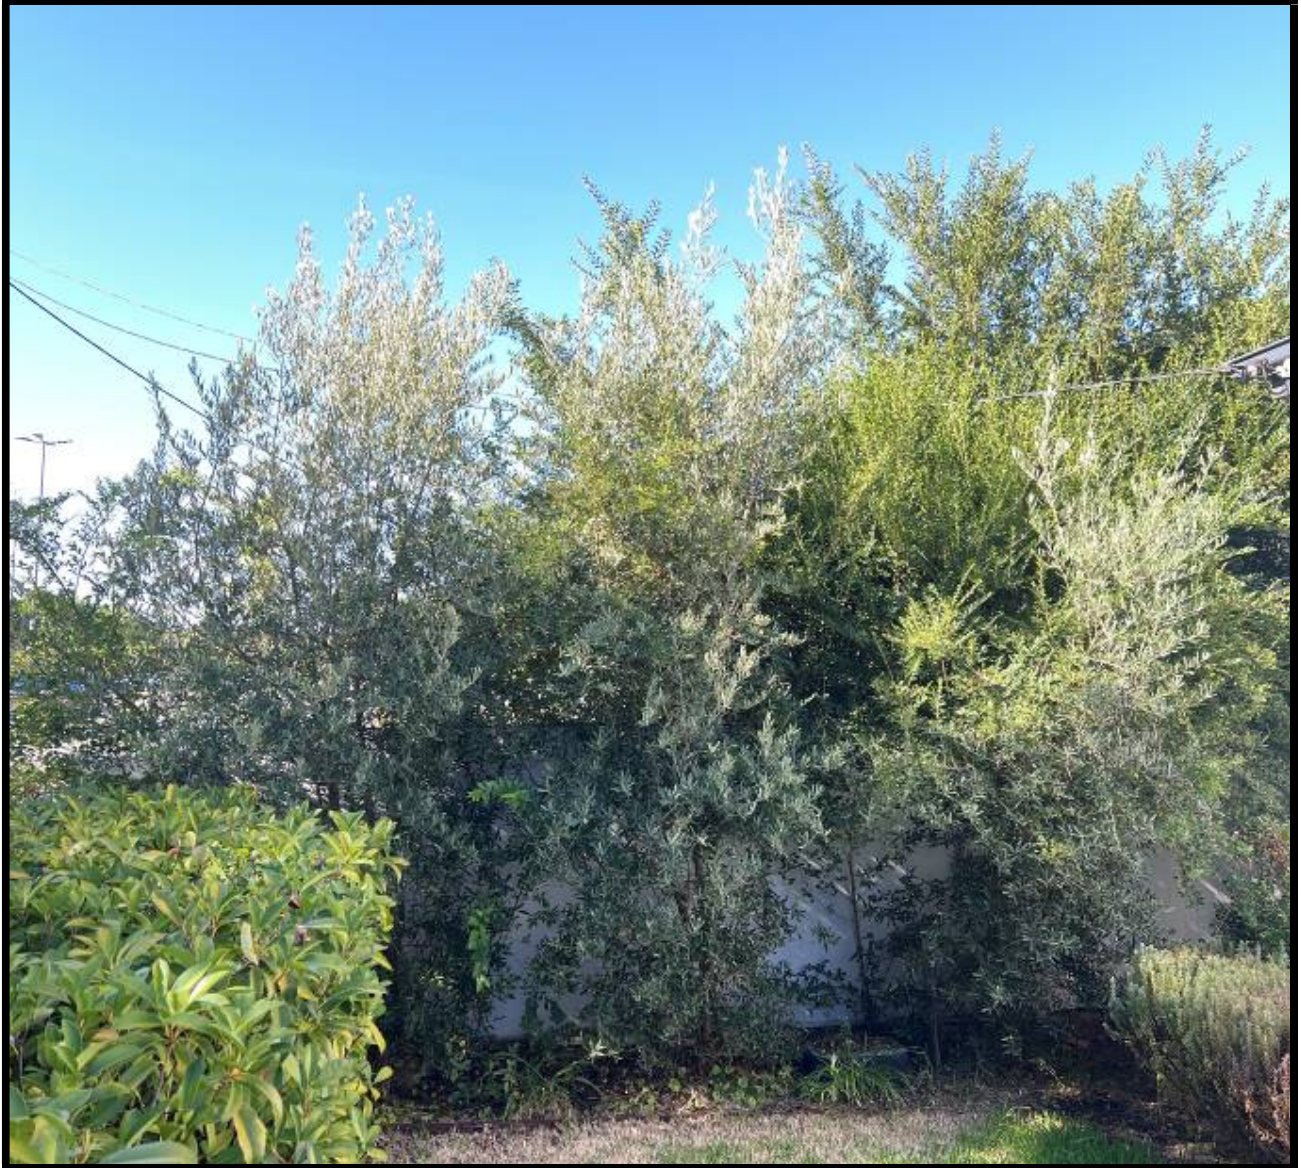
4.8 – Tree 8

Exhibit 11 – Tree 8 is a row of three (3) Olives (*Olea* sp.).

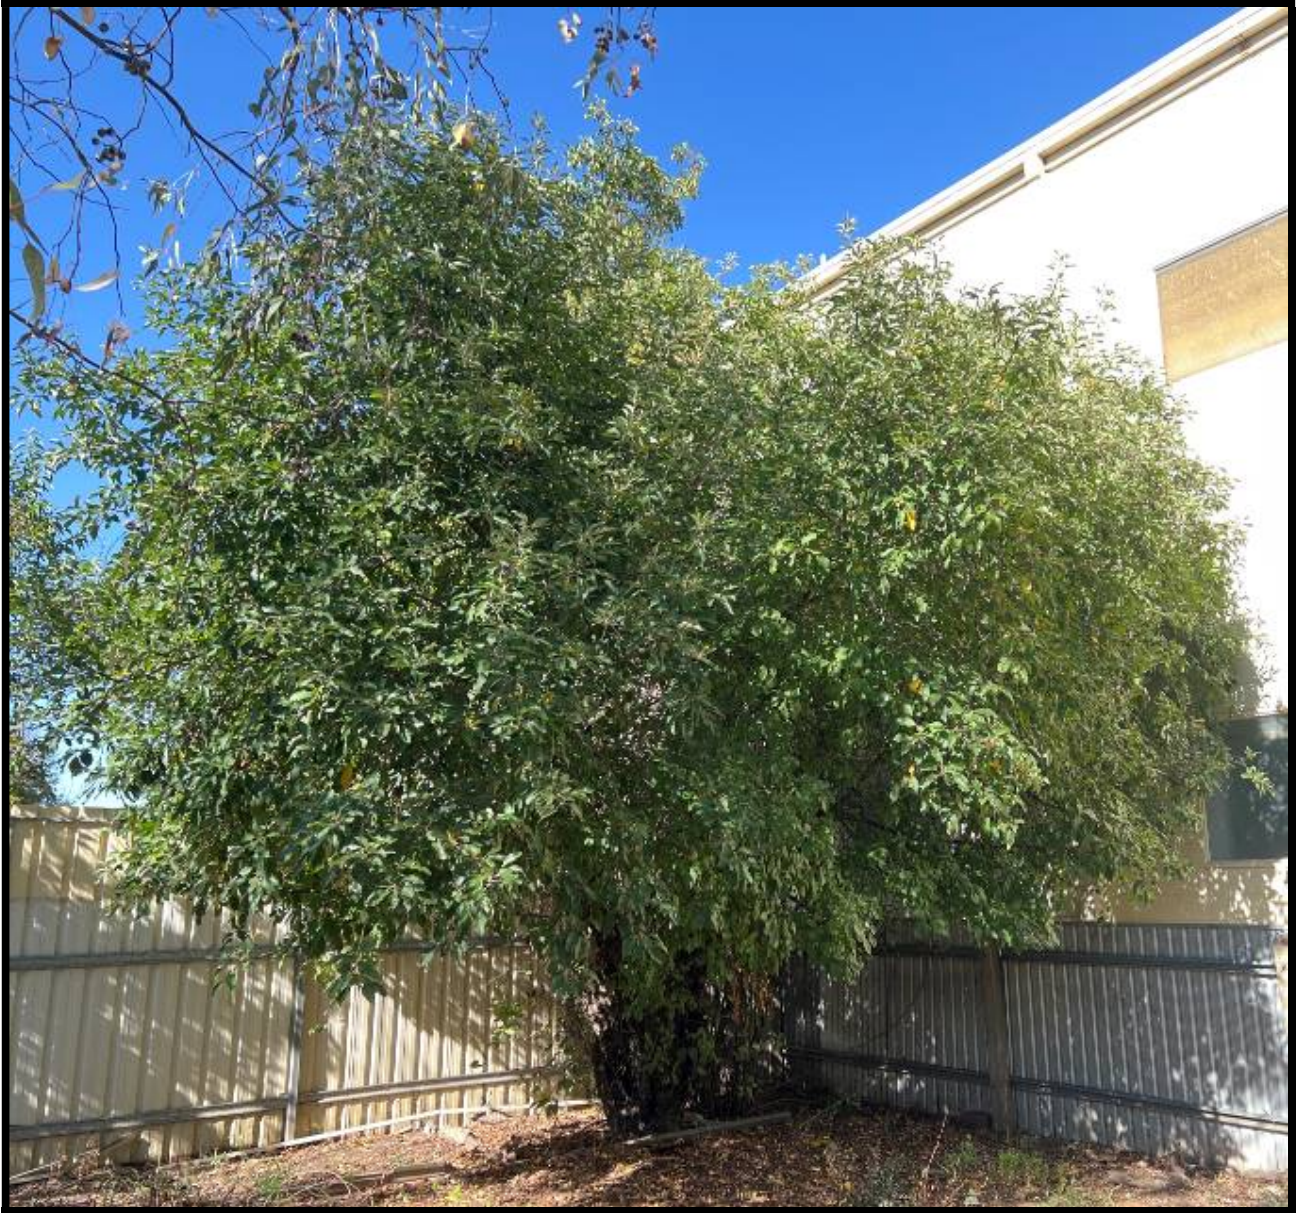
4.9 – Tree 9

Exhibit 12 – Tree 9 is a mature Apple Tree (*Malus domestica*) in Fair condition. There is also a multi-stem vine (*Rosa* sp.) at its (western) base.

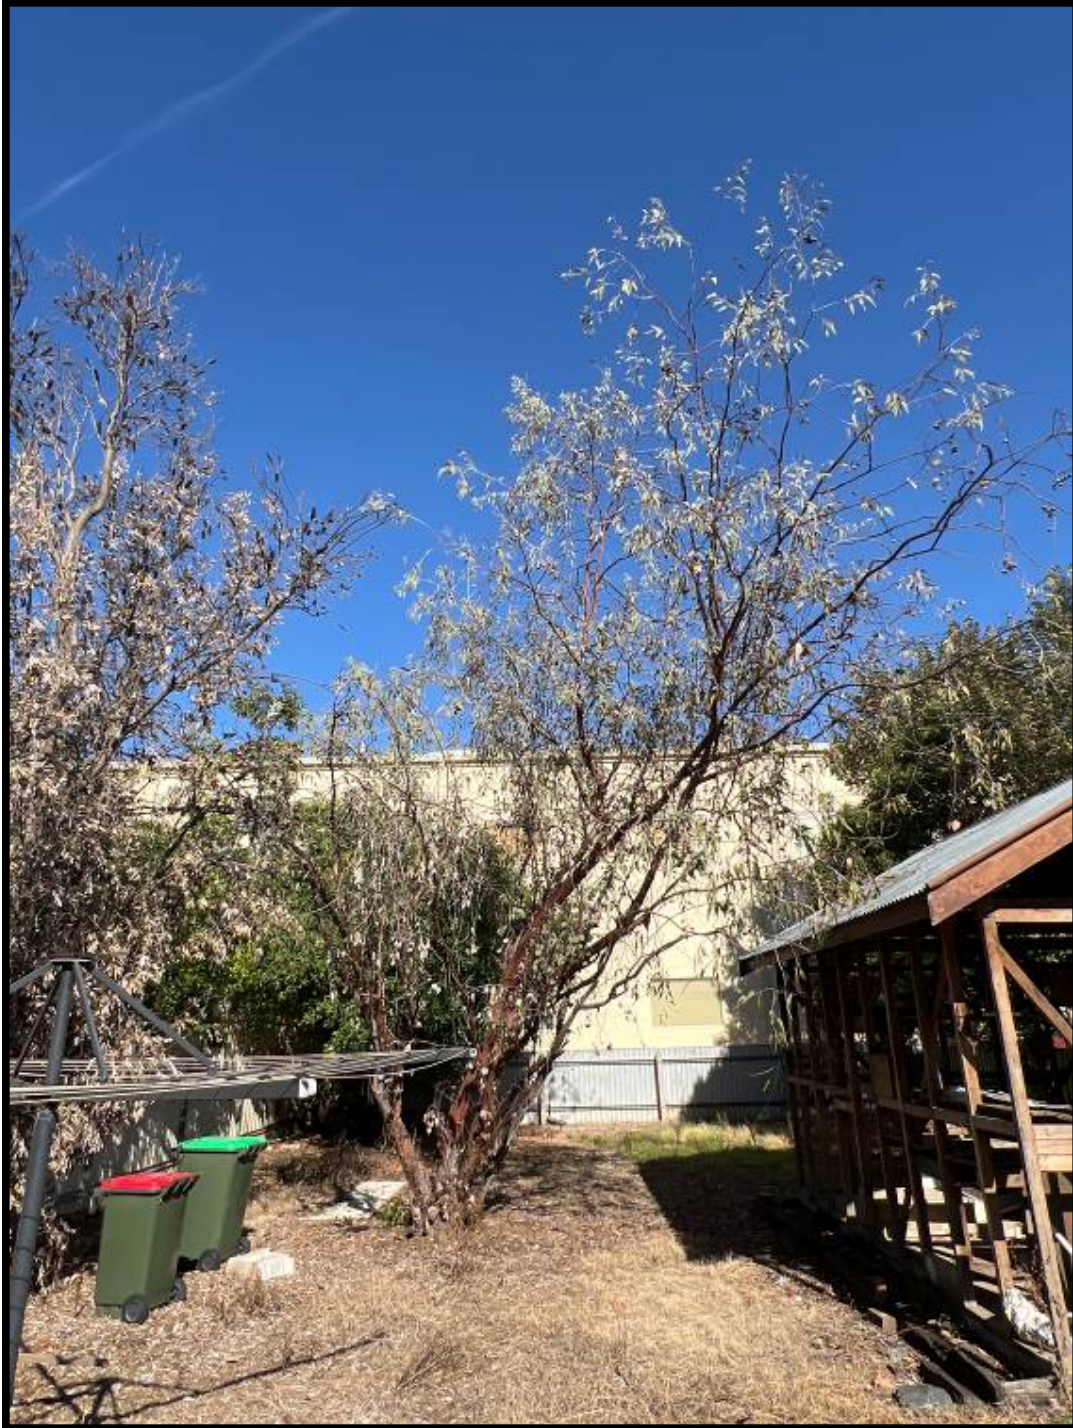
4.10 – Tree 10

Exhibit 13 – Tree 10 is a Silver Princess Gum (*Eucalyptus caesia* subsp *magna*). The tree is in Poor condition with sparse canopy & large lignotuber.

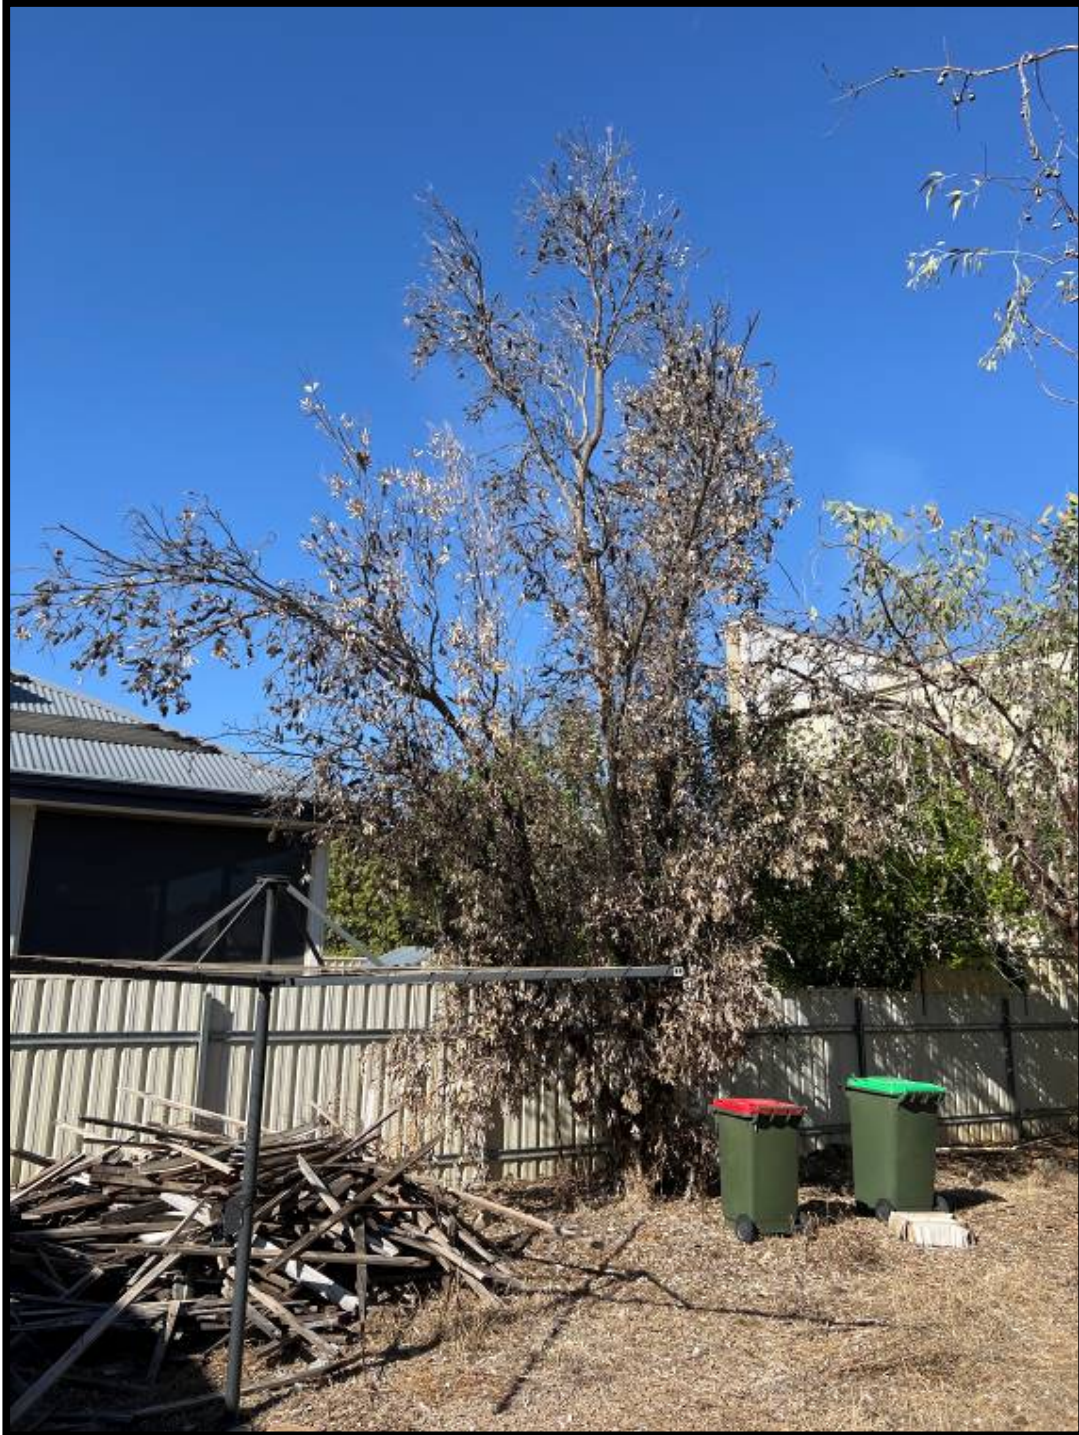
4.11 – Tree 11

Exhibit 14 – Tree 11 is a dead Coastal Banksia (*Banksia interifolia*).

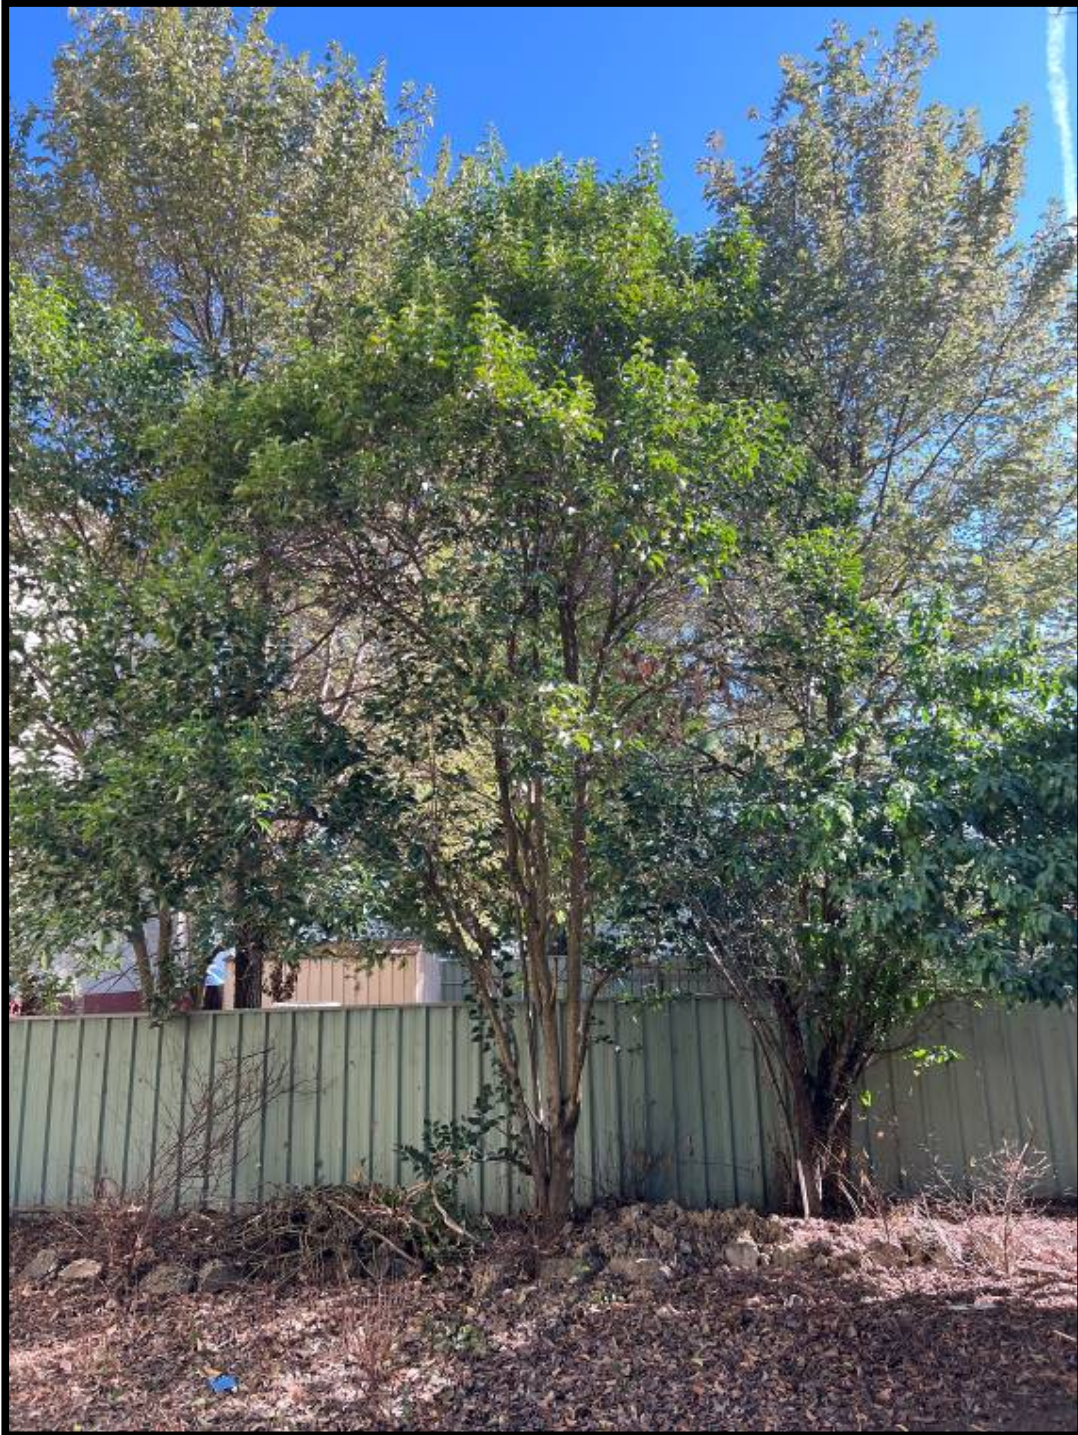
4.12 – Tree 12

Exhibit 15 – Tree 12 is another Broad-leaf Privet (*Ligustrum lucidum*).

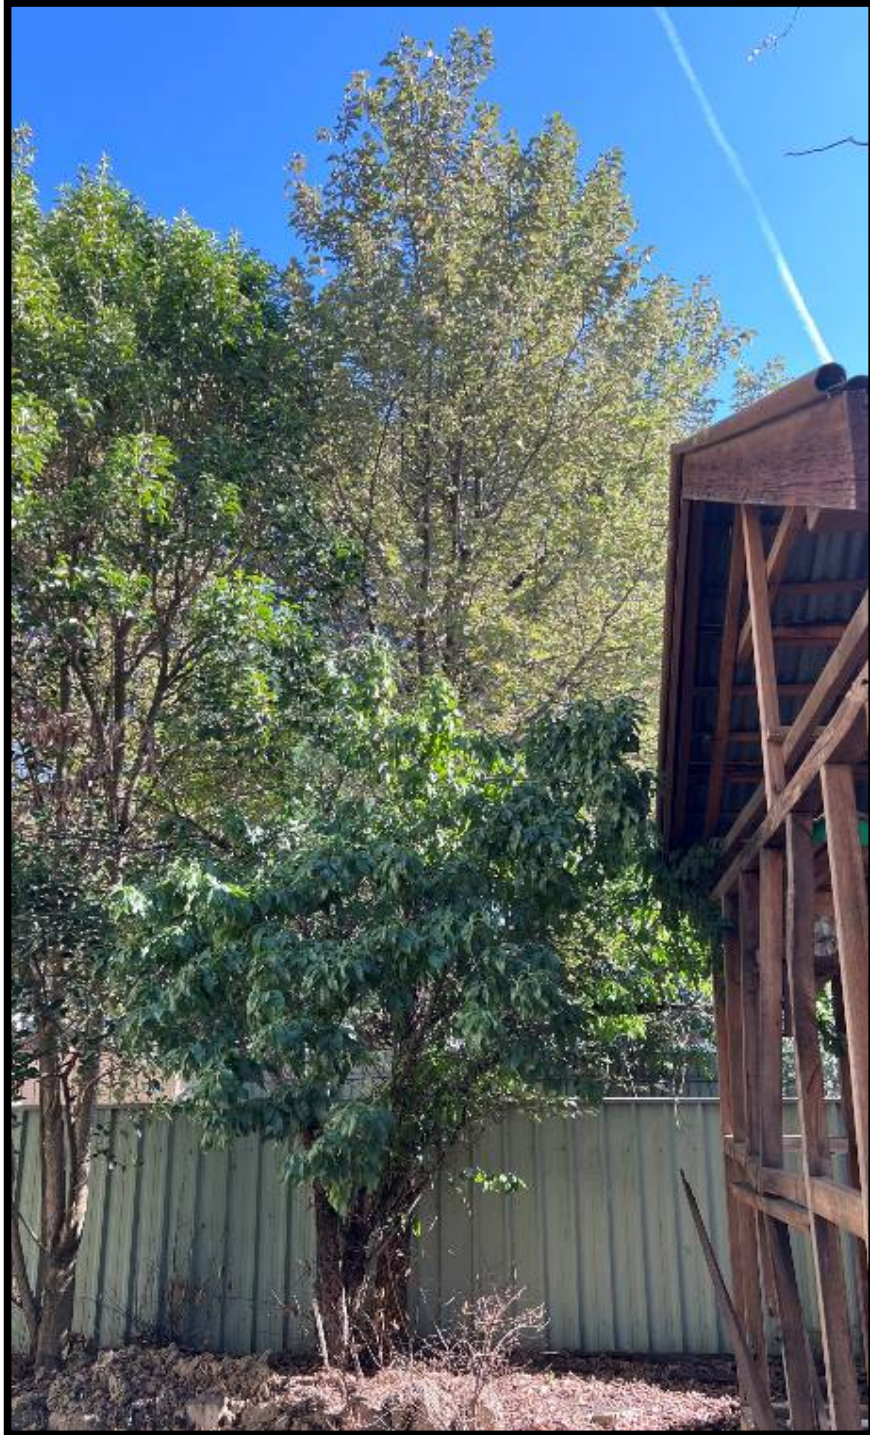
4.13 – Tree 13

Exhibit 16 – Tree 13 is a young English Elm (*Ulmus procera*). The tree’s current season foliage heavily damaged by Elm Leaf Beetle (ELB) and there is an Almond (*Prunus* sp.) growing from its base. The tree is probably a root sucker of a large established Elm tree to the north. Rated in Fair condition..

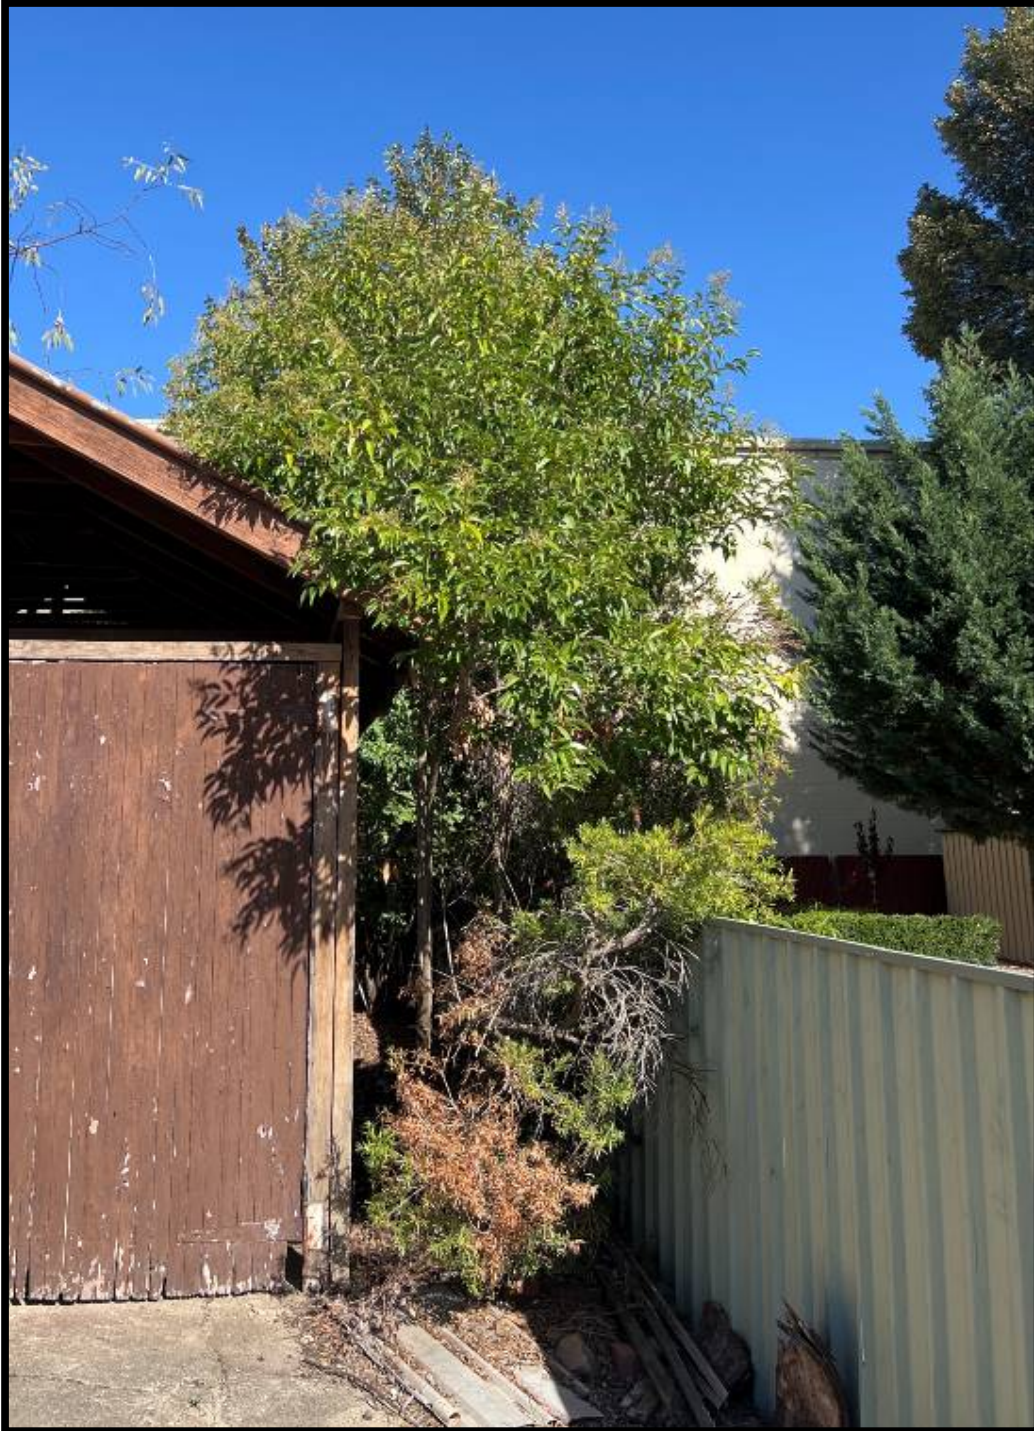
4.14 – Tree 14

Exhibit 17 – Tree 14 is another Broad-leaf Privet (*Ligustrum lucidum*).
