CIVITAS Stage 3 – Cnr Murray & Morgan Streets, WAGGA WAGGA

Arborist Report

February 2024,
Ref 24/475.

Trees on the CIVITAS Stage 3 Site – corner of Murray and Morgan Streets, Wagga Wagga.

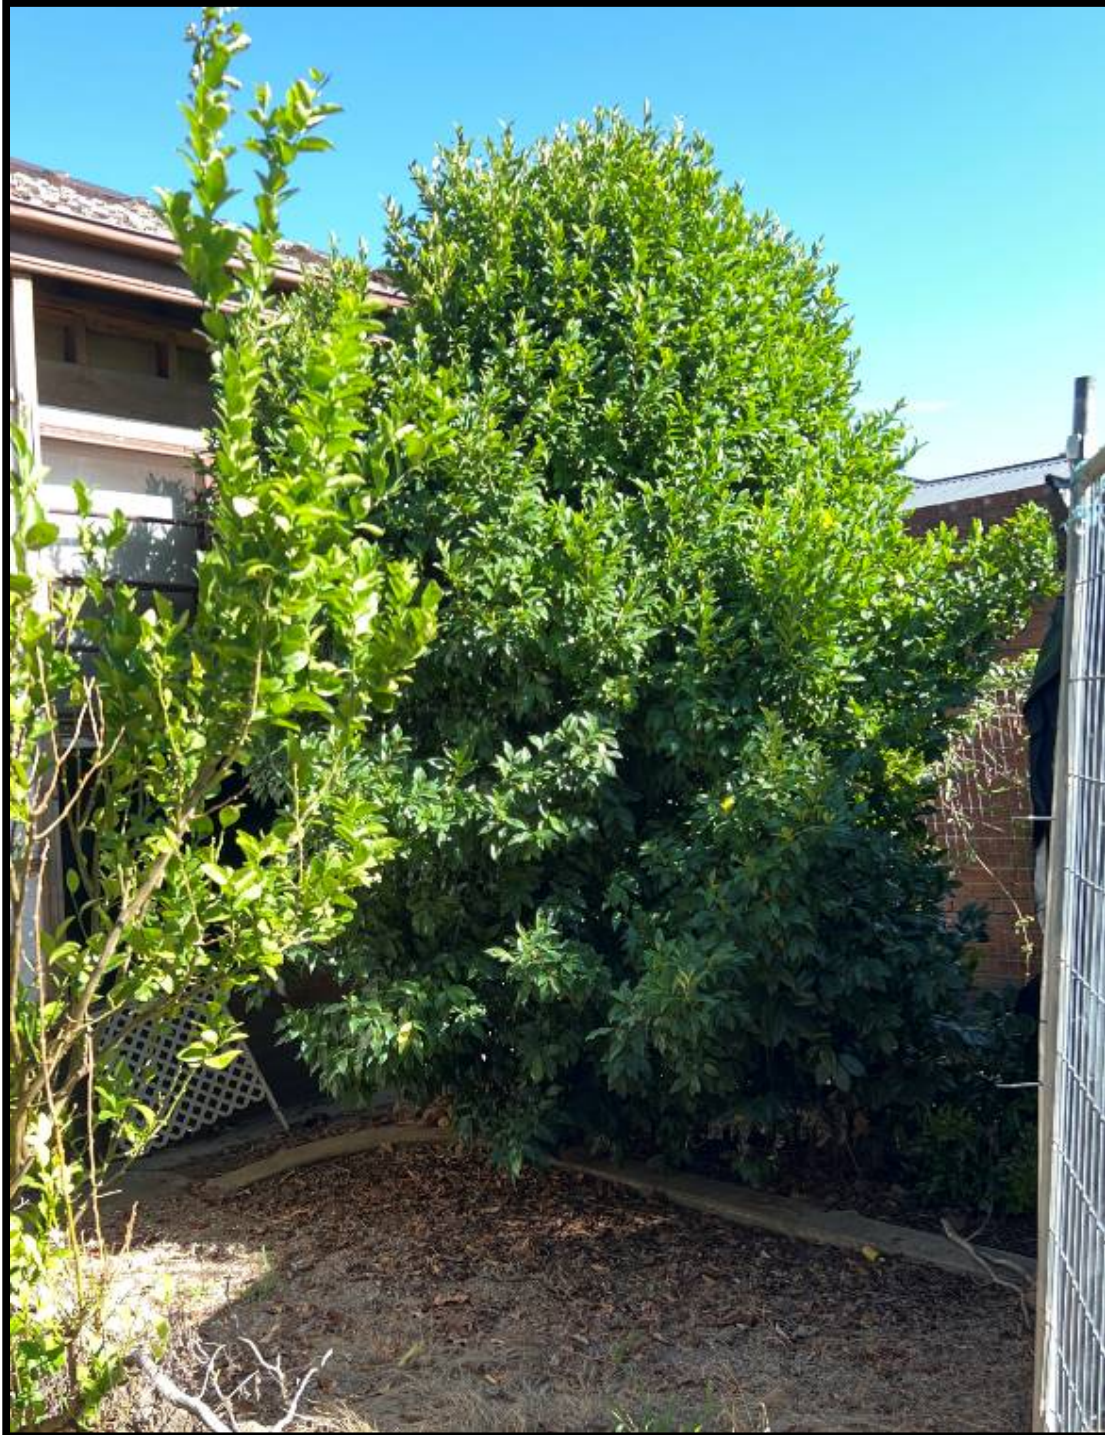
4.15 – Tree 15

Exhibit 18 – Tree 15 is a Port Wine Magnolia (*Magnolia figo*). Rated in Good condition.

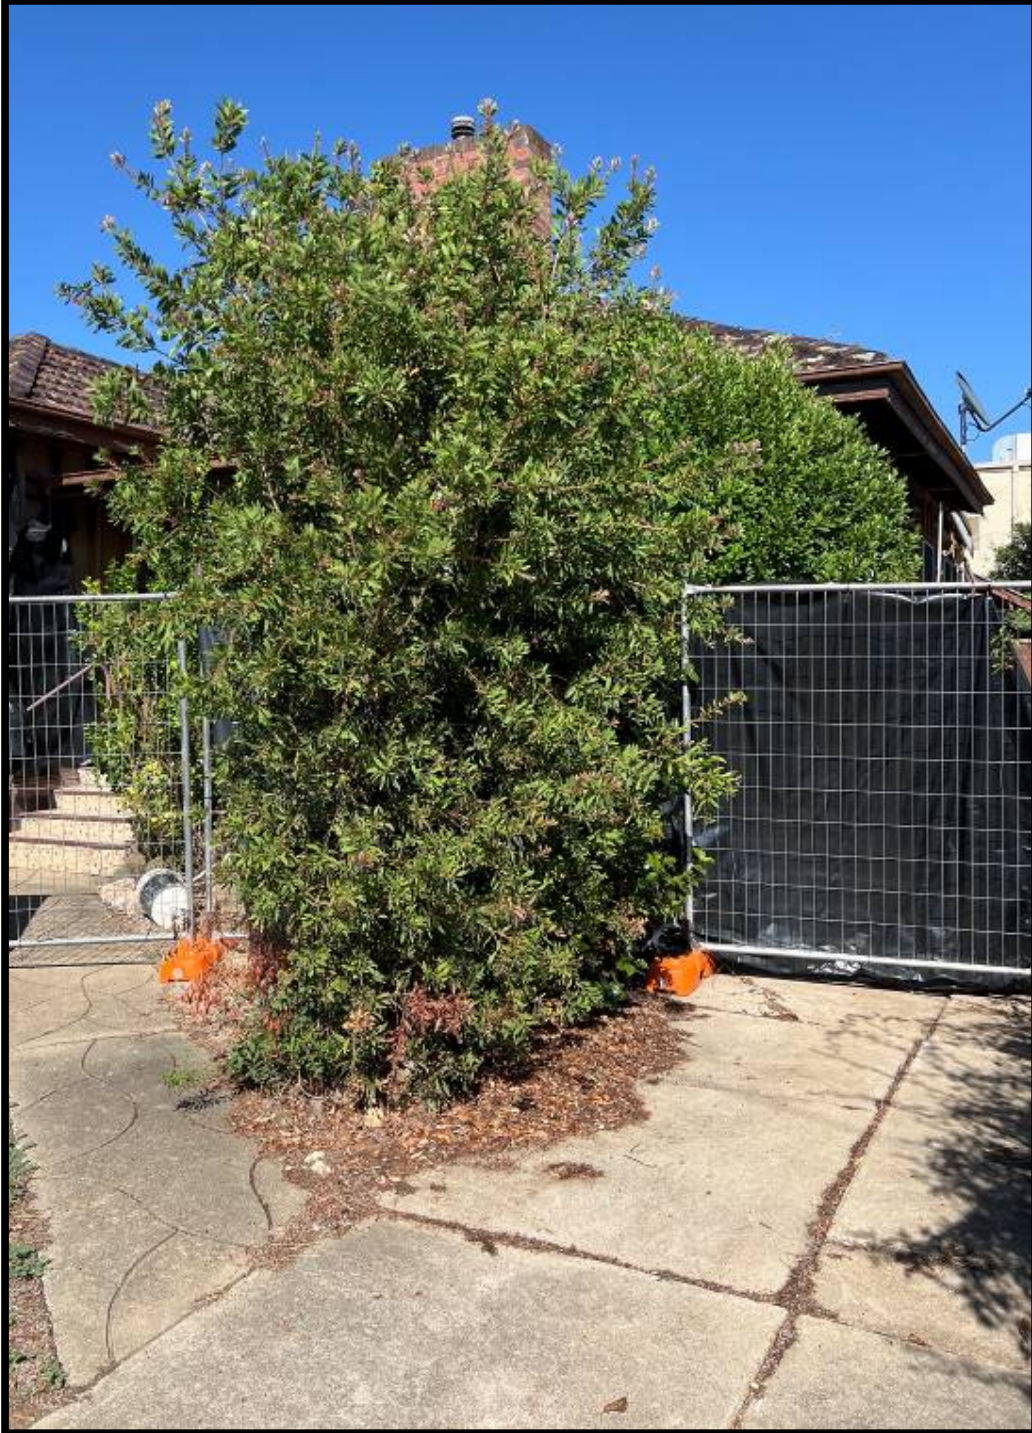
4.16 – Tree 16

Exhibit 19 – Tree 16 is a Bottlebrush (*Callistemon citrinus*) in Fair condition. It has been previously lopped at 2 metres

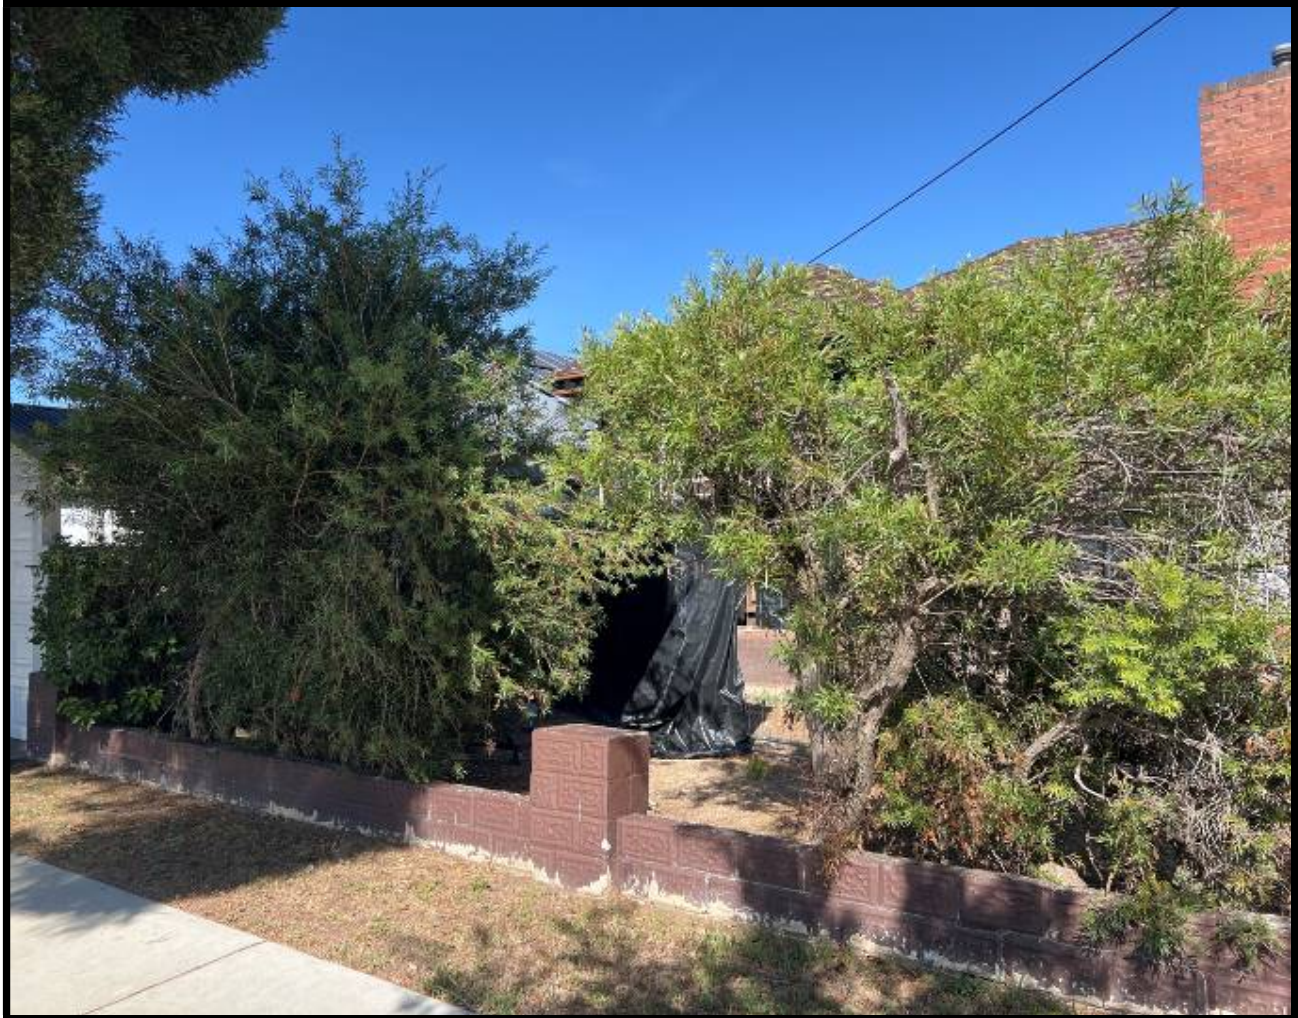
4.17 – Tree 17

Exhibit 20 – Tree 17 is a grouping of four (4) Bottlebrushes (*Callistemon viminalis cv.*). Most have been previously lopped at 1.5 metres and are rated in Fair condition.

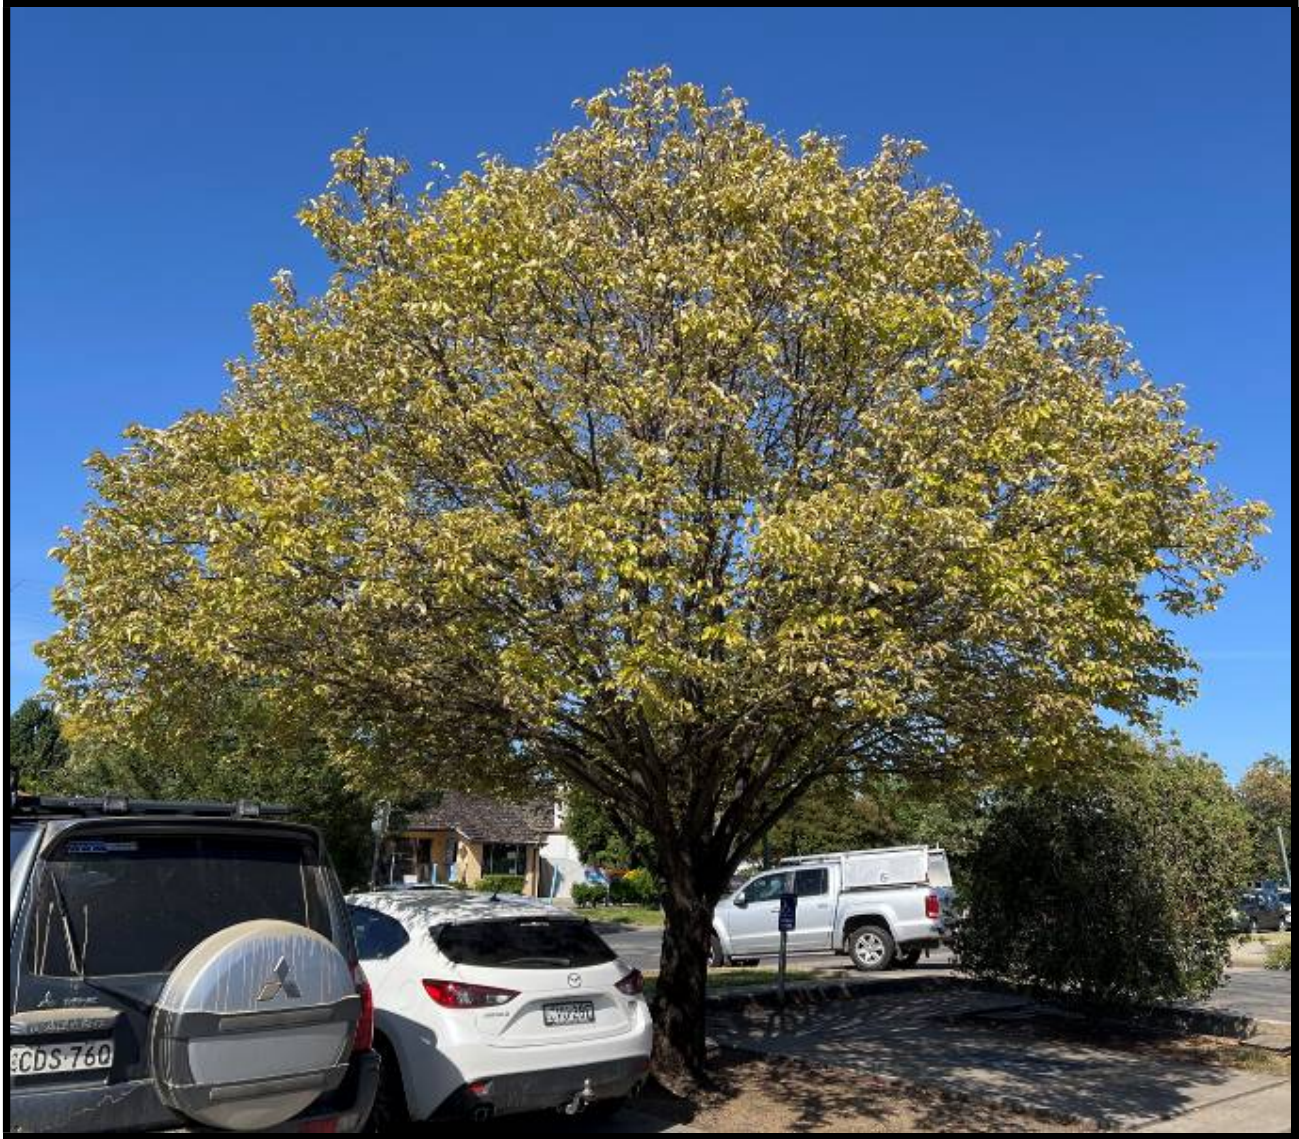
4.18 – Tree 18

Exhibit 21 – Tree 18 is a Golden Elm (*Ulmus glabra* 'Lutescens'). The tree's current season foliage is heavily damaged by ELB. Condition rating Fair.

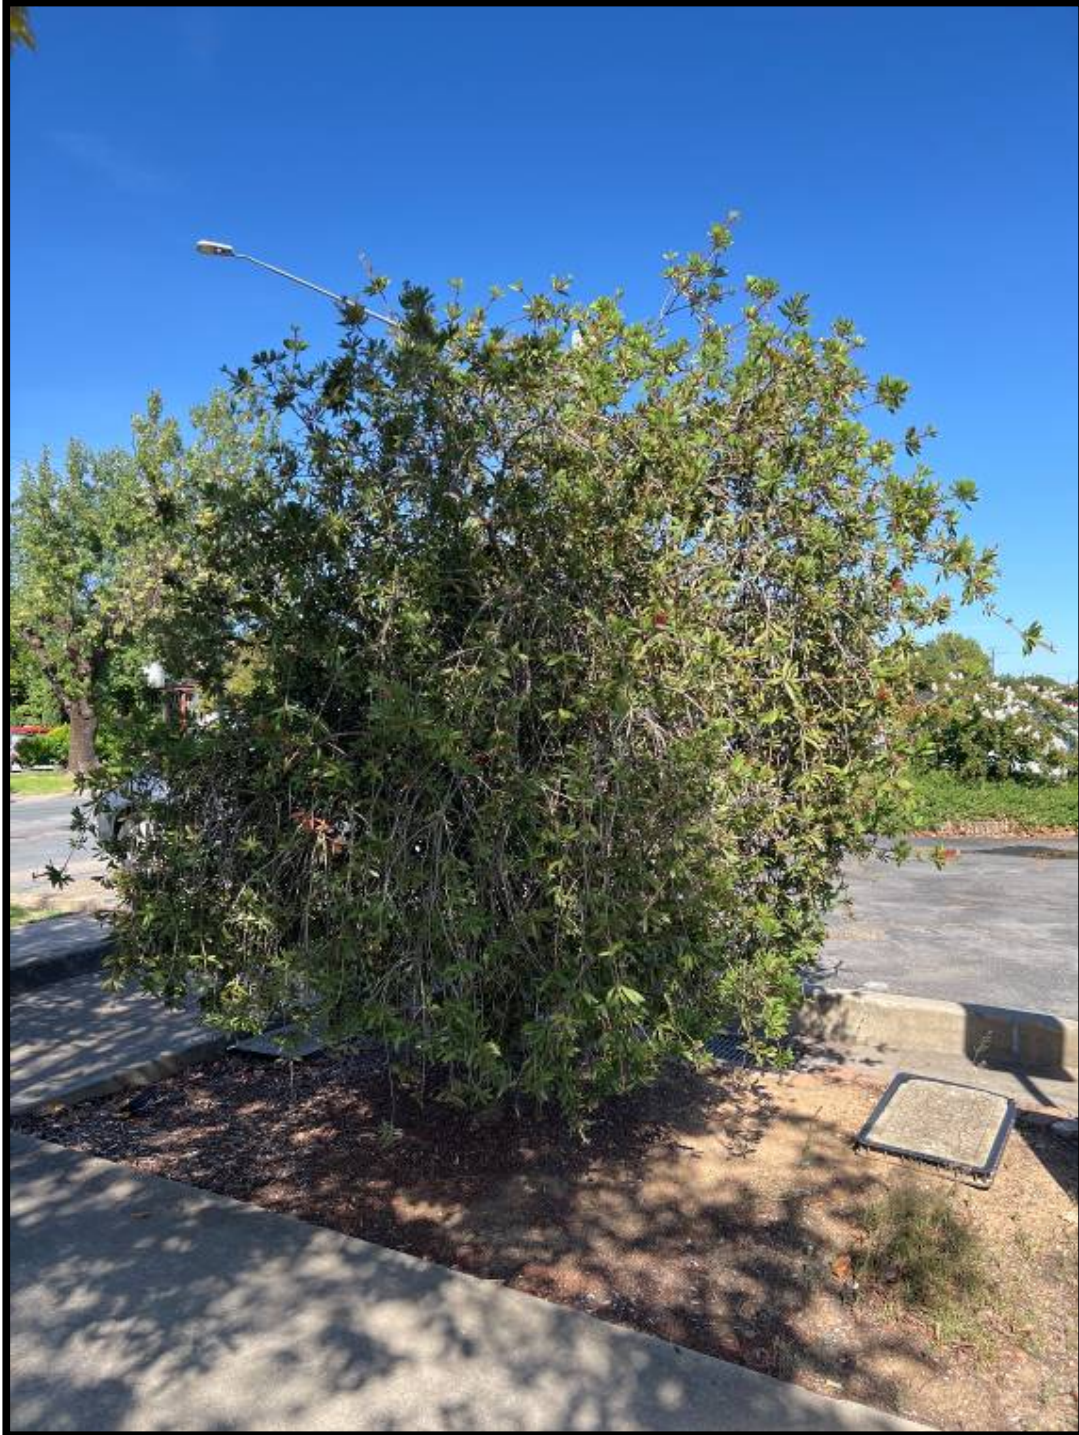
4.19 – Tree 19

Exhibit 22 – Tree 19 is another Bottlebrush (*Callistemon citrinus*). The tree is rated in Good condition.

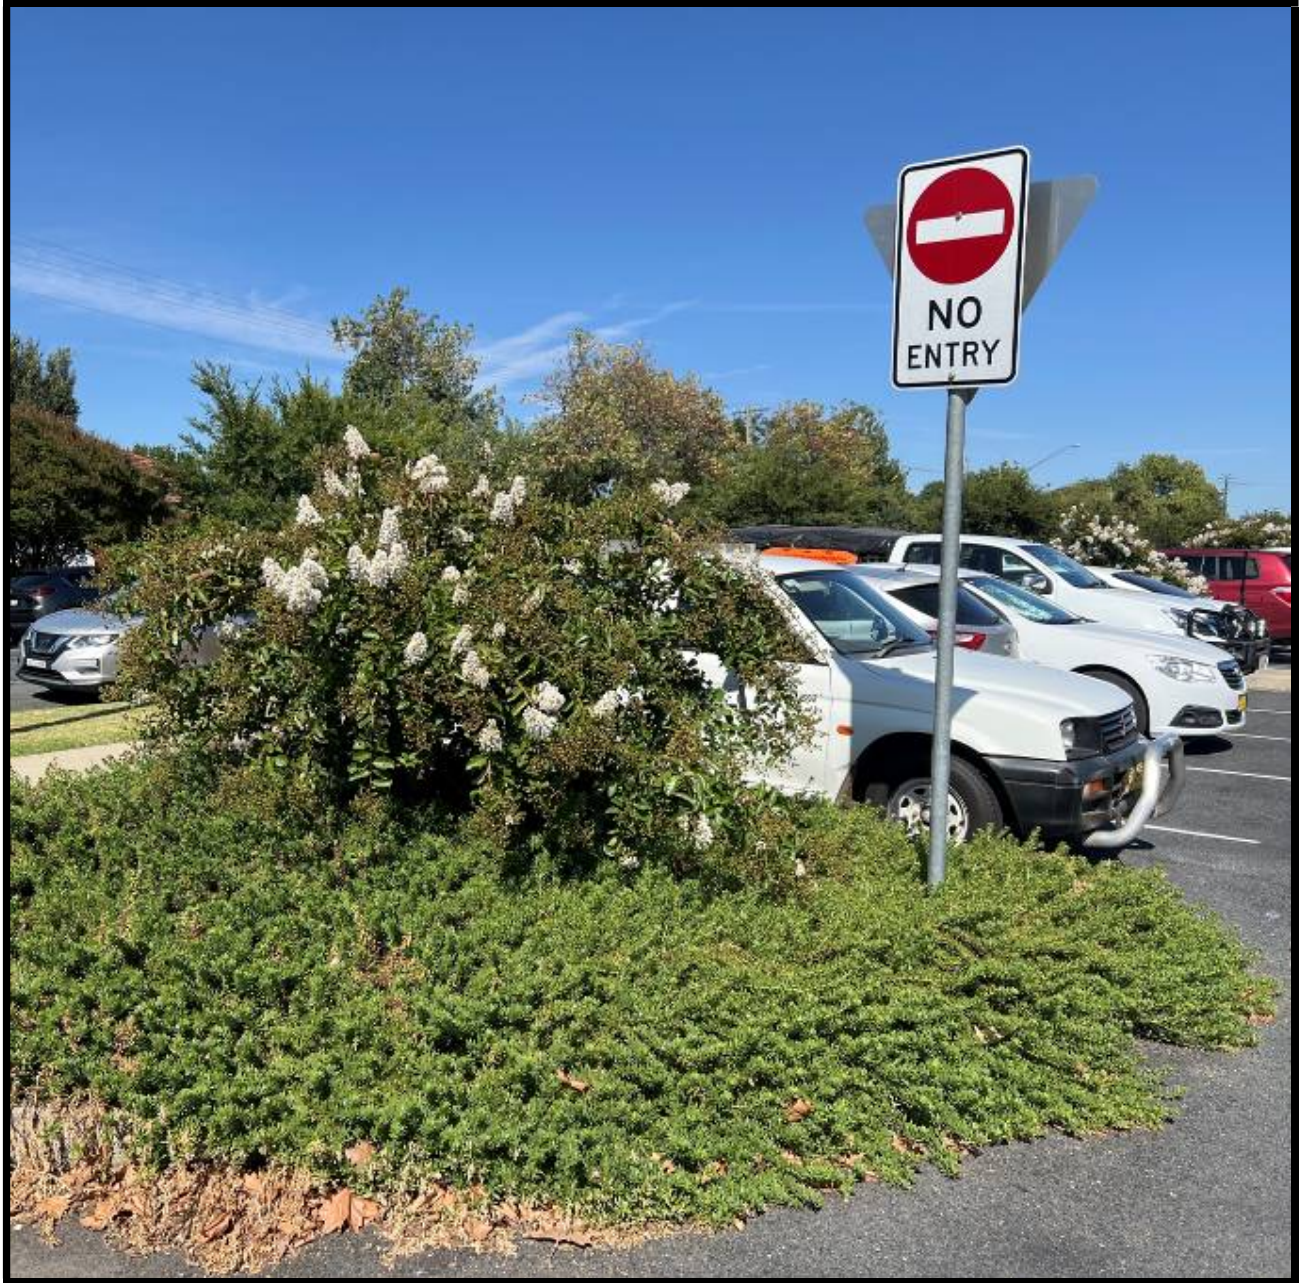
4.20 – Tree 20

Exhibit 23 – Tree 20 is a juvenile Crepe Myrtle (*Lagerstroemia cv.*), recently planted in car park island with surrounding ground cover planting. The tree is in Good condition.

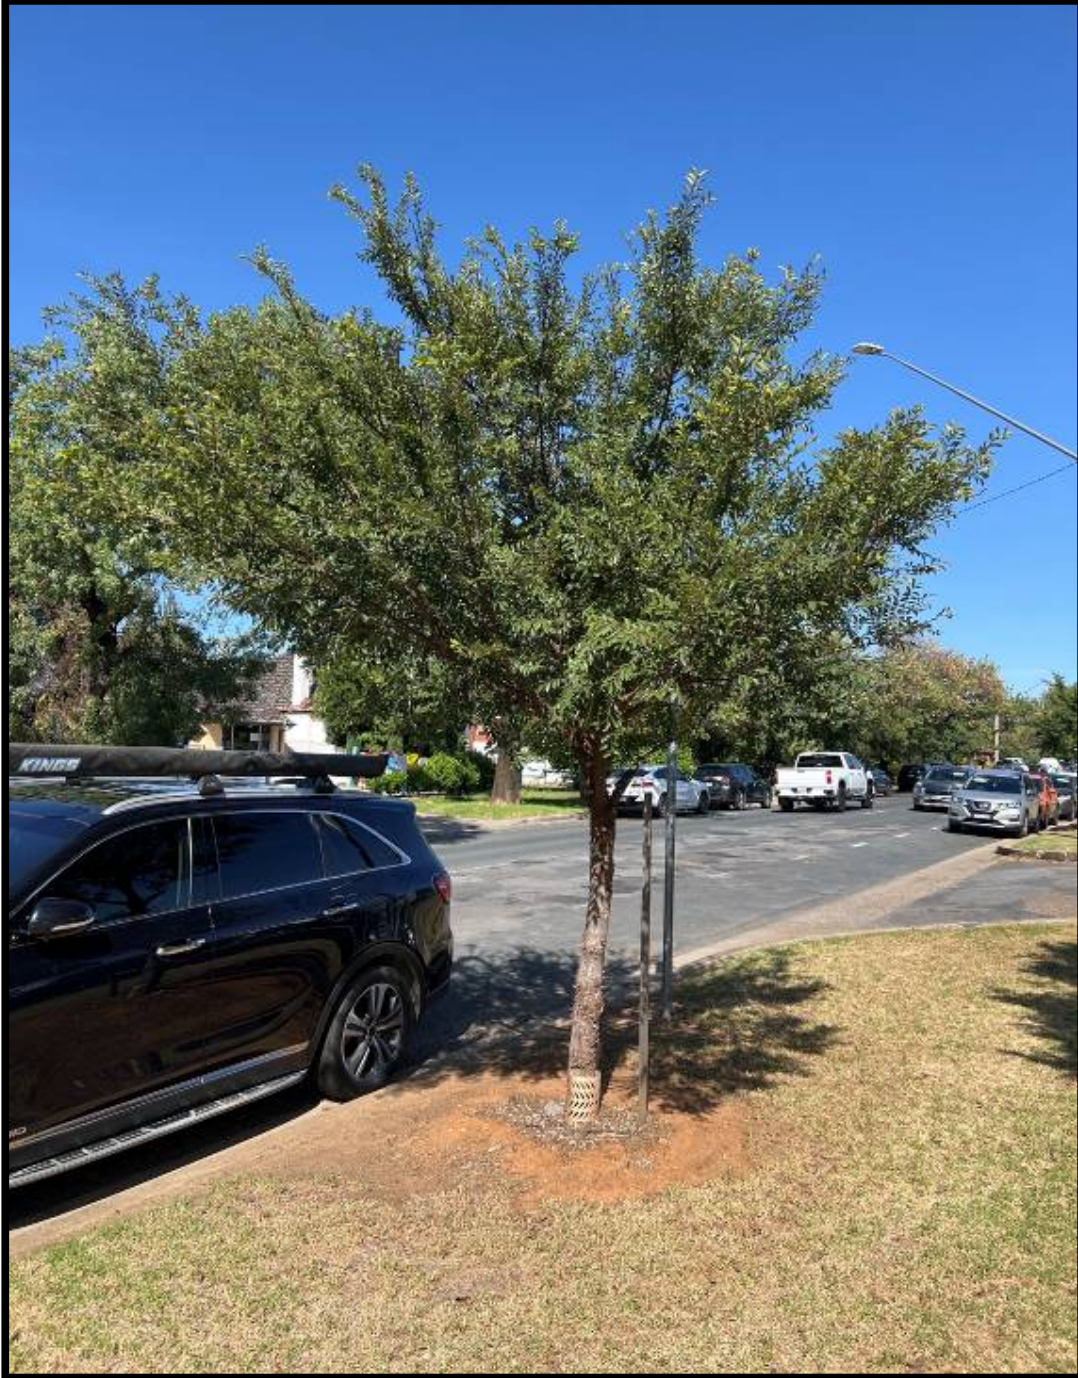
4.21 – Tree 21

Exhibit 24 – Tree 21 is a Chinese Elm (*Ulmus parvifolia*), and is a recently planted street tree in Good condition.
