# The Dog on the Tucker Box Redevelopment

## Addendum to Tree Inventory

January 2024  
Ref. 23/452A.

# Additional Trees on The Dog on the Tucker Box Site, Five Mile, via Gundagai.

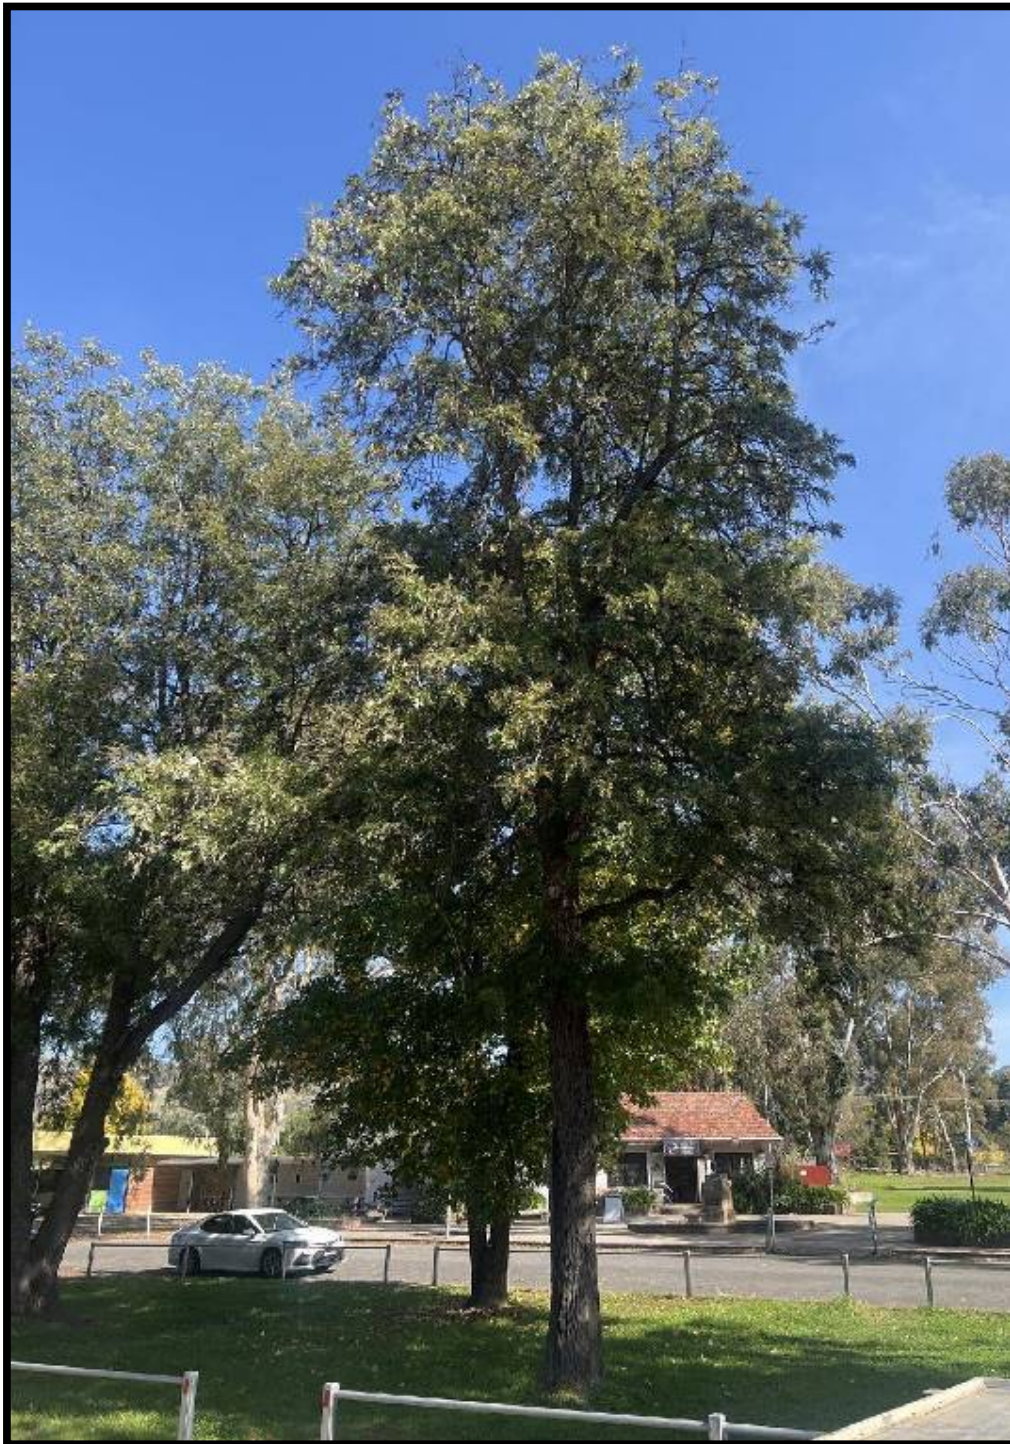
**Tree No. 26**

| 26 | <i>Grevillea robusta</i> | Silky Oak | 14 | 40 | Good | Smallest diameter in avenue of five Silky Oaks; small diameter internal deadwood and tip dieback |

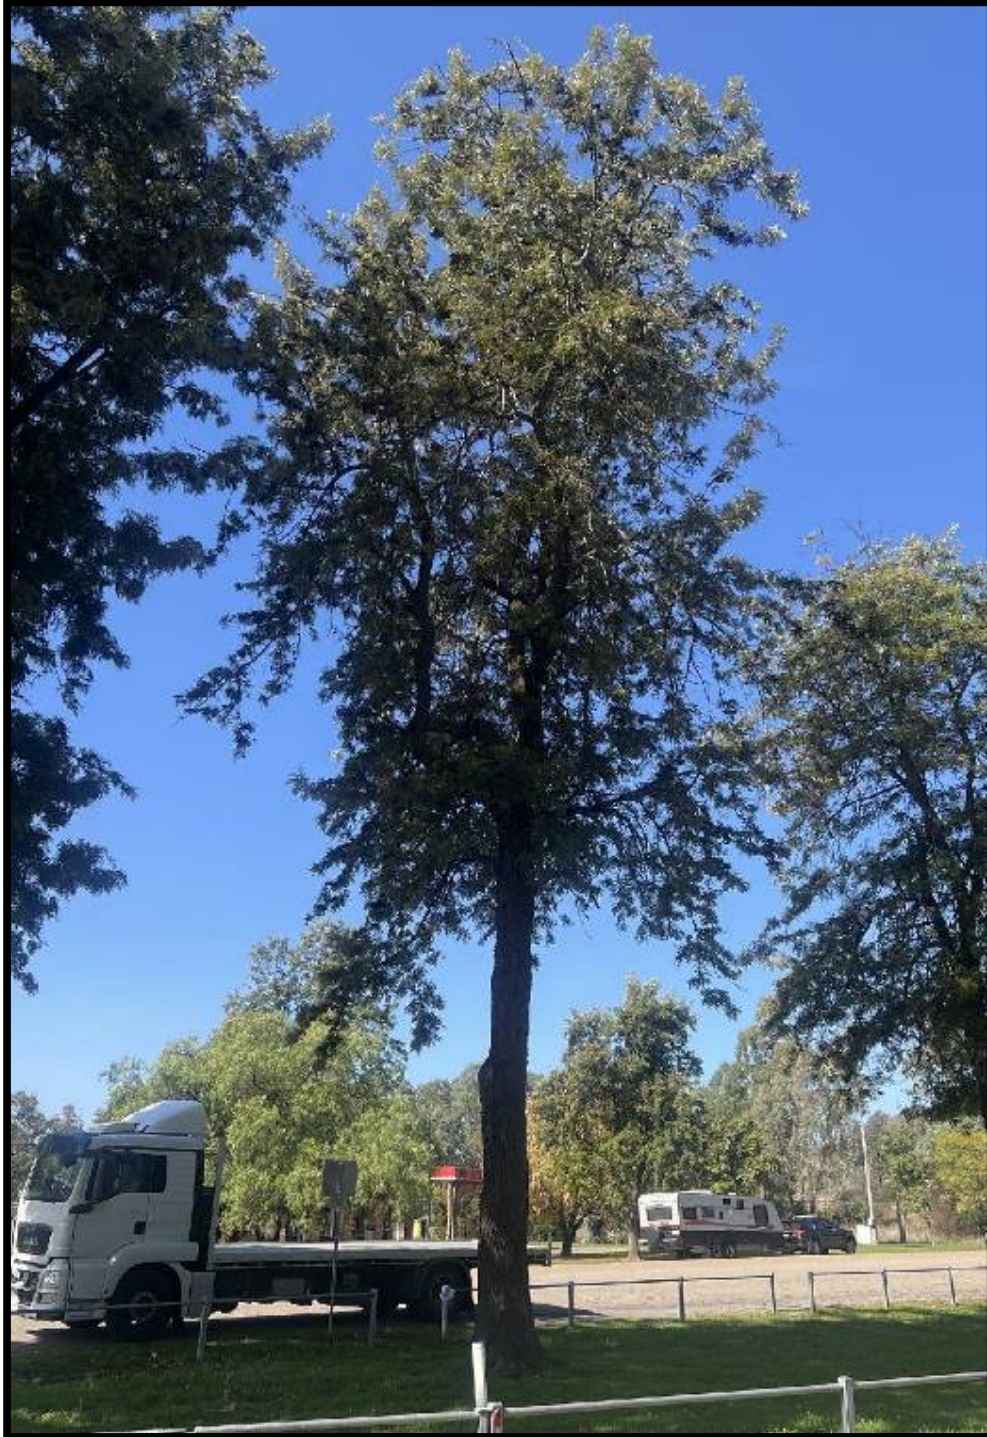
**Tree No. 27**

| 27 | <i>Grevillea robusta</i> | Silky Oak | 14 | 40 | Good | High crown & condition and features as other Silky Oaks (Nos. 23, 24, 26 & 28) |

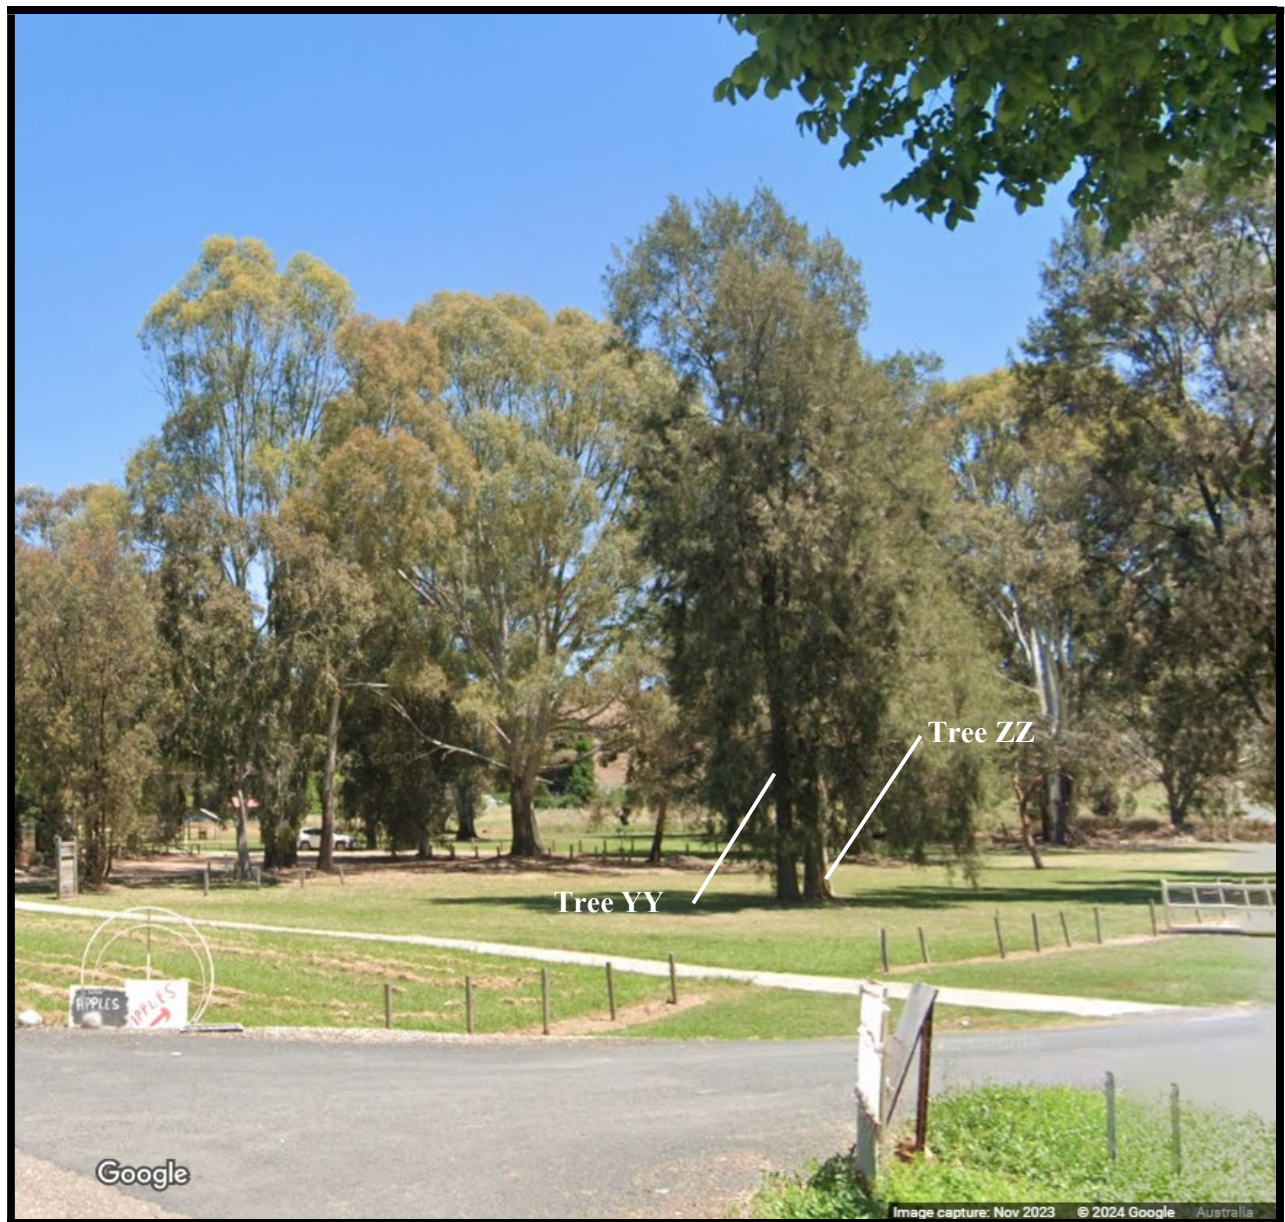
## Tree YY and ZZ

| YY | <i>Casuarina cunninghamiana</i> | River Oak | 15 | 55 | Fair | Storm damage to leader at approximately 10m |
| ZZ | <i>Casuarina cunninghamiana</i> | River Oak | 15 | 55 | Fair | |

Tree YY (**Left**) and Tree ZZ (**Right**), November 2023. The two trees are very closely planted and hence have an intertwined single canopy
