AMBS Ref: 18584

18 September 2019

***Condition Report: Beach Road Scarred Tree, AHIMS site #52-5-0886***

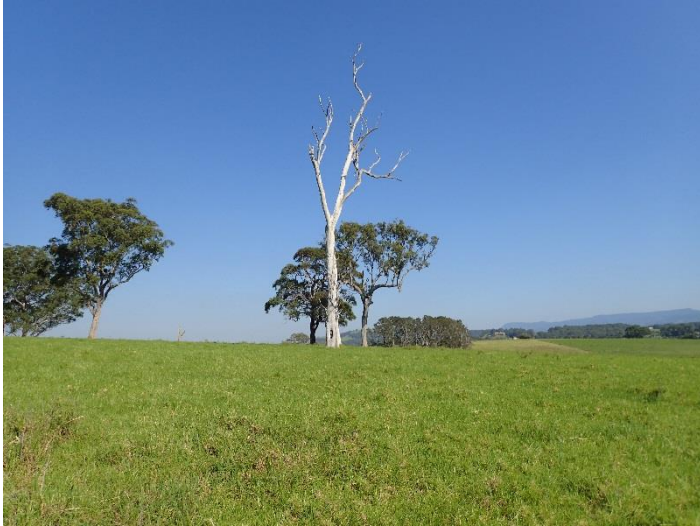
**Figure 3** Scarred tree as recorded during survey on 20/04/2018. View to south west.

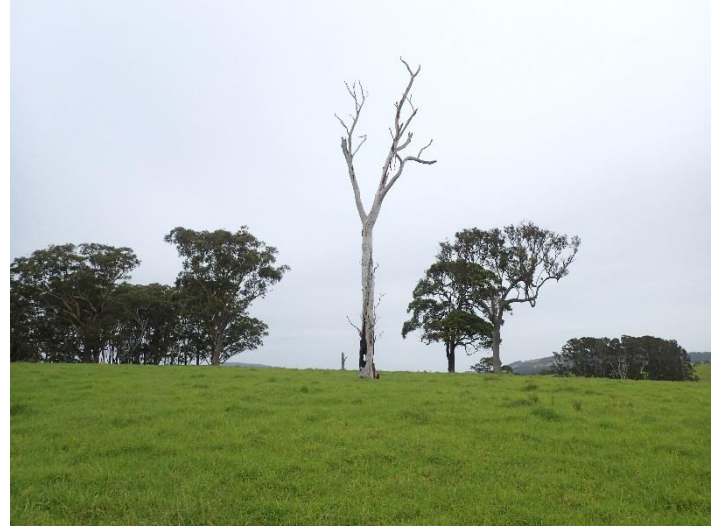
Fragments of wood are present on the ground up to approximately 30m to the north west the tree as a result of the lightning strike, which is likely to have significantly damaged and destabilised the upper branches of the tree.

Given the extensive damage to the tree, and the cultural scars, it is likely that exposure to the weather will cause ongoing degradation to the tree, and the remaining visible cultural scar on the southern side of the tree is likely to degrade completely. The damage to the upper branches of the tree from the lightning strike, and the significant fire damage inside the trunk, suggest that the tree is at risk of branches falling, or collapse of the trunk itself.

**Figure 4** Current condition of scarred tree as recorded 20/02/2019. View to south west.

In the absence of advice from the Jerrinja LALC and their nomination of a suitable keeping place, AMBS recommends that the culturally scarred tree be trimmed to a height that will render it safe, and the remaining tree trunk be retained in place and allowed to decay naturally. The extent of the trimming of the tree should be limited to that necessary to prevent the risk of limb fall or collapse of the trunk, and should be guided by advice from a suitably qualified arborist, however the portion of the trunk containing the cultural scars should remain.

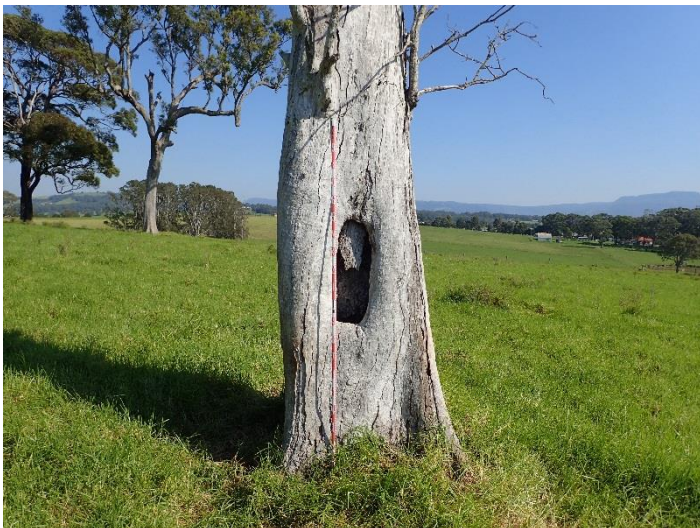
**Figure 5** Scar on eastern side of tree as originally recorded on 20/04/2018. View to west.

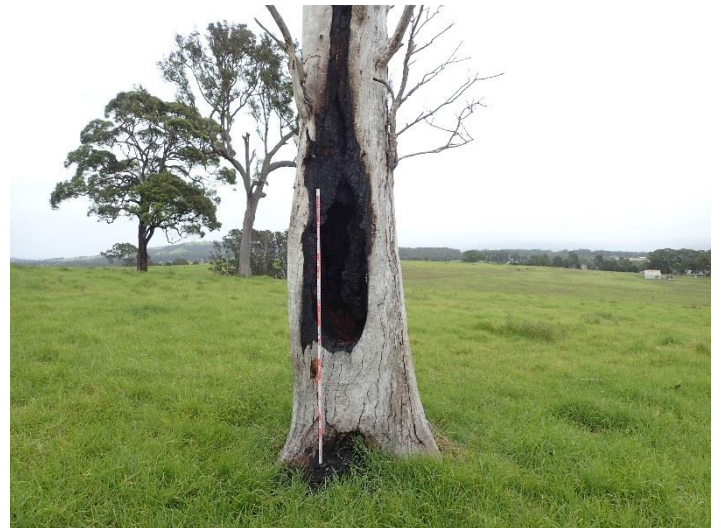
The tree shows evidence of extensive fire damage within the trunk and around the natural and cultural scars. The interior of the trunk and edges of the cultural scars have been significantly charred and damaged by the fire (see Figure 6, Figure 8, Figure 10 and Figure 12).

The larger cultural scar on the eastern side of the tree is no longer possible to identify, and the entirety of the identifiable extent of the scar has been consumed by the fire. Additional damage to the tree at this point was caused during RFS efforts to extinguish the fire, and it appears that water hoses were placed inside this cultural scar to access fire inside the trunk.

**Figure 6** Current condition of scar on eastern side of tree as recorded on 20/02/2019. View to west.

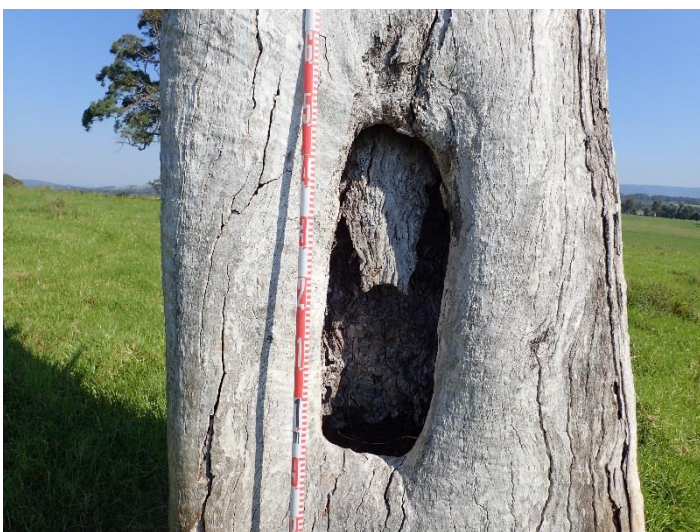
**Figure 7** Detail of scar on eastern side of tree as originally recorded on 20/04/2018. View to west.

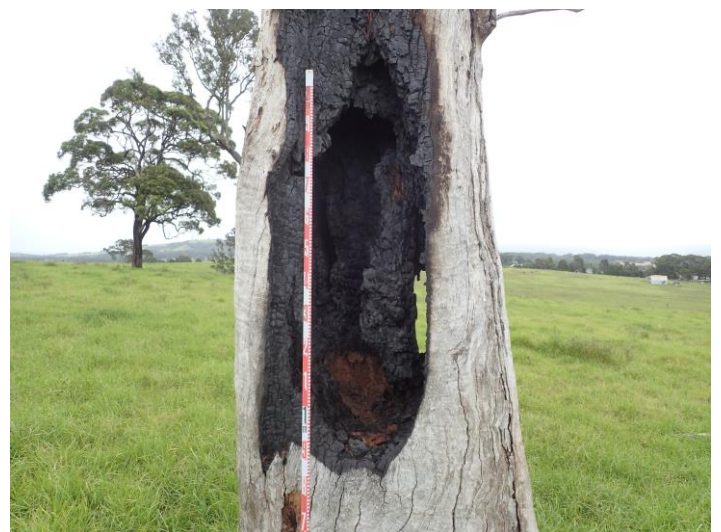
**Figure 8** Detail of current condition of scar on eastern side of tree as recorded on 20/02/2019. View to west.

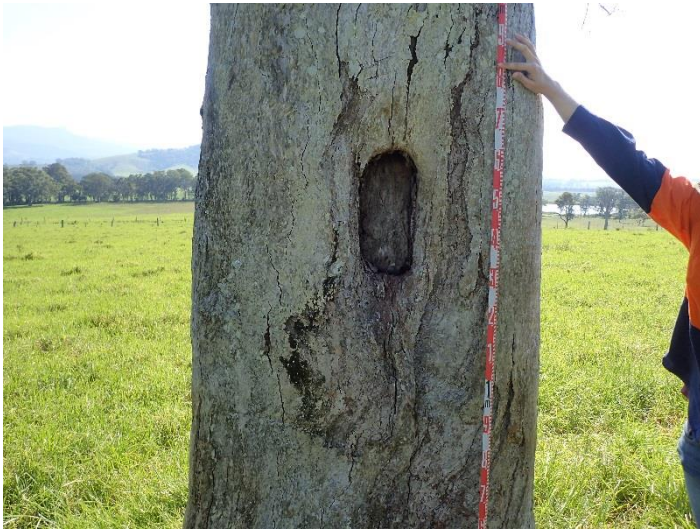
**Figure 9** Scar on southern side of tree as originally recorded on 20/04/2018. View to north.

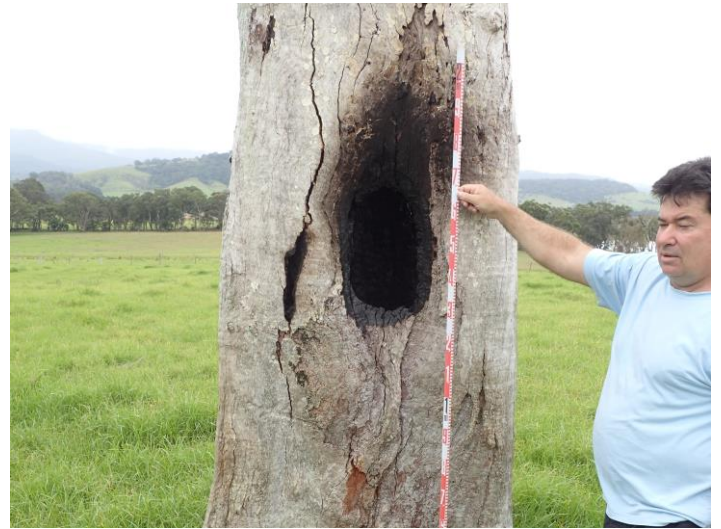
The shape of the cultural scar on the southern side of the tree is still identifiable, however the scar is now completely hollow, and its edges have been charred between 5 to 10cm from the original edge of the scar, with additional charring extending up the trunk from the scar. The charcoal edge of the scar is highly fragile and friable.

**Figure 10** Current condition of scar on southern side of tree as recorded on 20/02/2019. View to north.

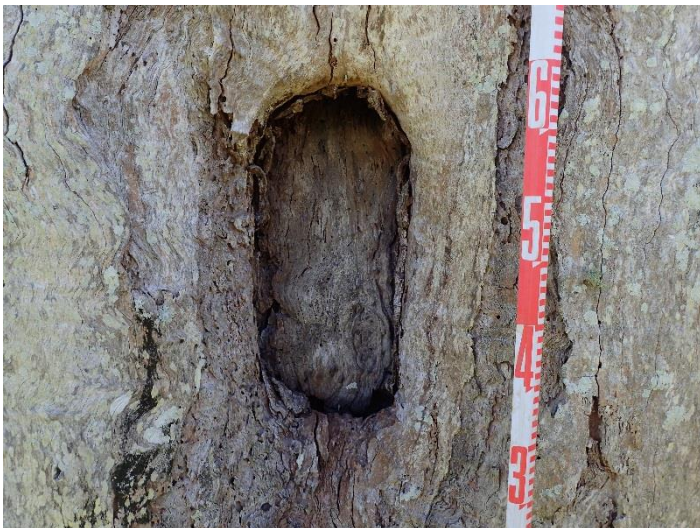
**Figure 11** Detail of scar on southern side of tree as originally recorded on 20/04/2018. View to north.

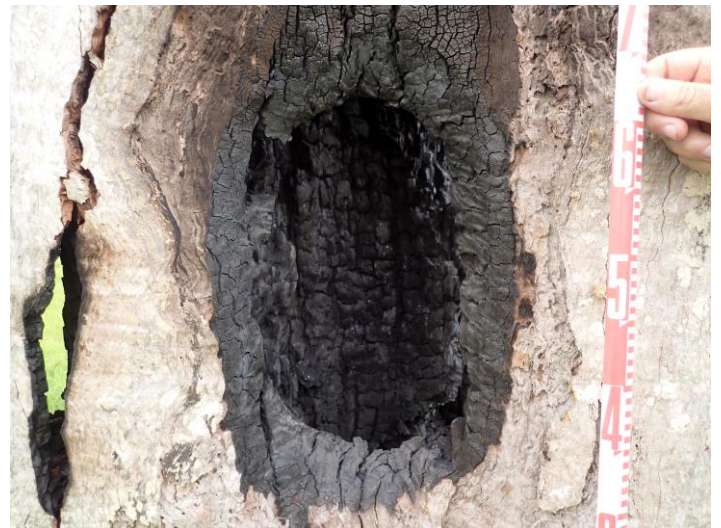
**Figure 12** Detail current condition of scar on southern side of tree as recorded on 20/02/2019. View to north.

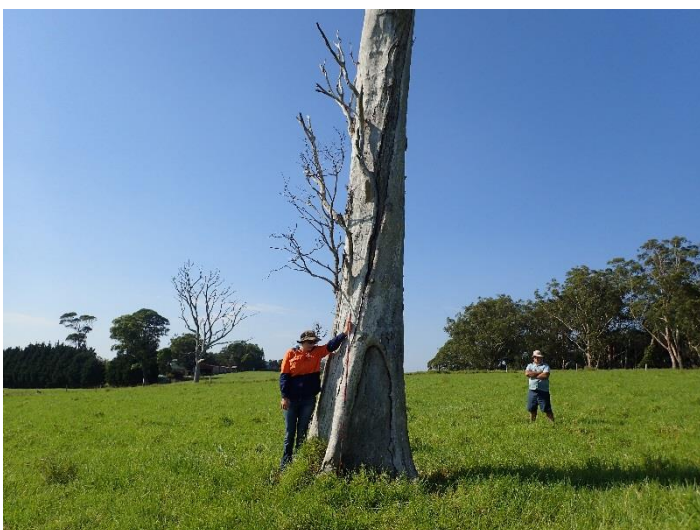
**Figure 13** View of western side of scarred tree as recorded during survey on 20/04/2018. View to east.

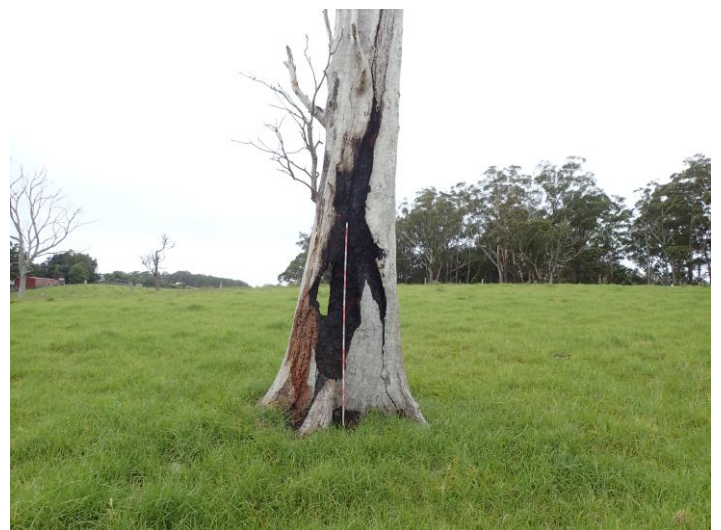
**Figure 14** Current condition of the western side of scarred tree as recorded on 20/02/2019. View to east.
