DA Structural Report

Malthouse 3

The Maltings, Mittagong

Colliers International / 6 February 2024

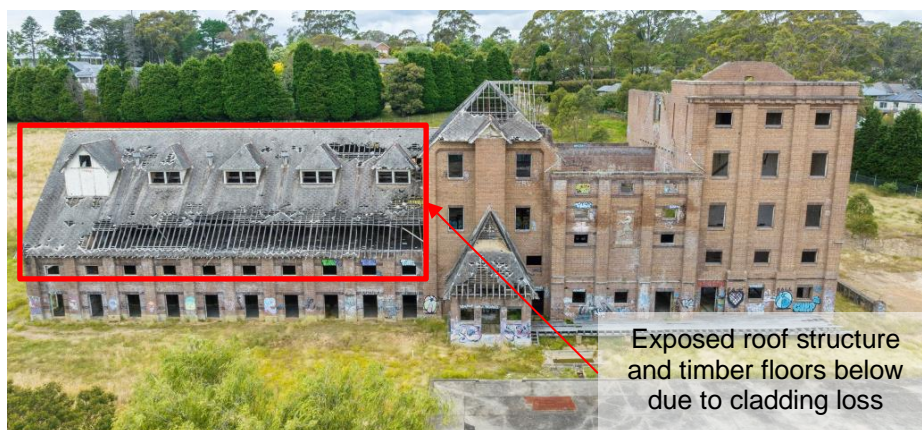
The timber structure within the M3 machinery room is overall in very poor condition due to the high levels of exposure experienced. Much of the roof framing is deteriorated and there has been significant loss of roof cladding; this has allowed water ingress to all levels of roof framing, timber support posts and timber flooring. These elements are exhibiting signs of rot throughout.

On the basis of site inspections conducted in March 2023, BCRC advise that less than 5% of existing timber including timber floor structure, timber posts and roof framing is likely to be able to be re-used. We recommend that all timber elements of M3 be replaced on this basis. The timber inspection report for M3 is provided in Appendix A.

The timber floor structure, timber posts and timber roof framing are overall unacceptable to be re-used.

Figure 3: M3 machinery room timber roof condition

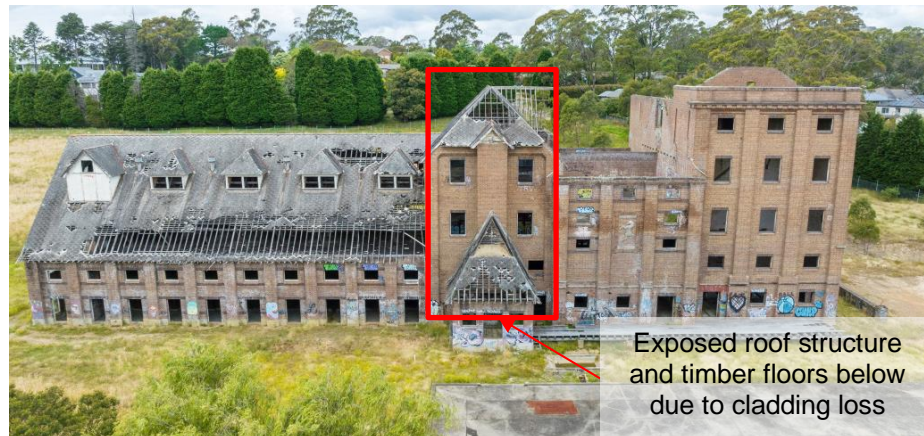
Timber floor framing at first floor level is in very poor condition, with several joists and nogging pieces out of alignment in addition to widespread rot. These timbers should not be retained.

Timber roof elements have experienced significant weather exposure due to a loss of almost all roof cladding, and is therefore expected to be in a more severe condition than the machinery room roof framing, which is itself severely deteriorated. It is therefore considered that these timbers are unsuitable for re-use and should be removed.

Figure 4: M3 kiln room timber roof condition

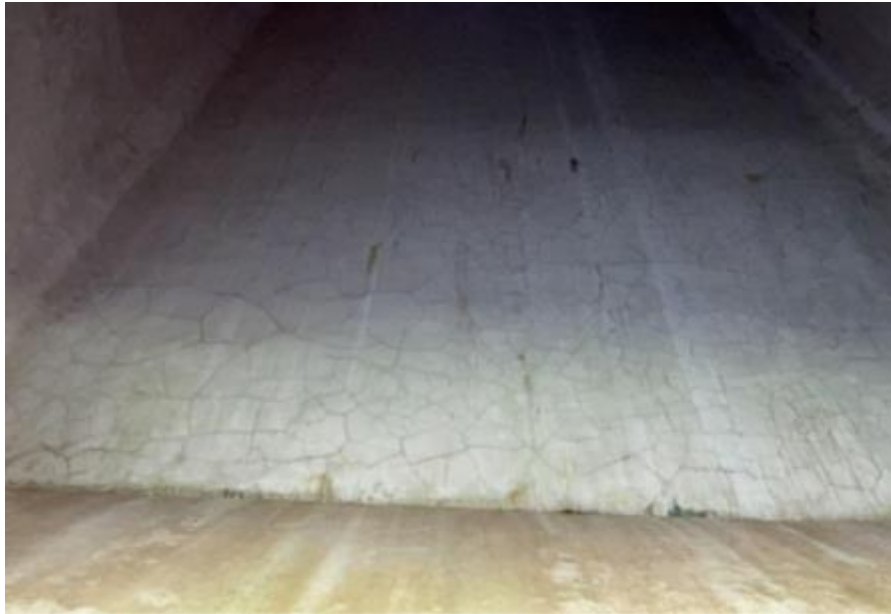
The silo wall concrete is carbonated to approximately 35mm, i.e. through the cover provided to reinforcement in this area. It is expected that surface corrosion of reinforcement has initiated, however we note that the wall itself still appears generally sound with minimal spalling observed over reinforcement at this time. Cracking typical of an alkali-carbonate reaction in the concrete (ACR) was identified by BCRC on the concrete topping within the silo (refer Figure 5), however, as this was observed in the concrete topping rather than the structural concrete it is not considered a significant concern. Concrete samples extracted from the silo wall were found to have a mean strength of 28.6 MPa.

Figure 5: Map cracking on M3 silo internal topping

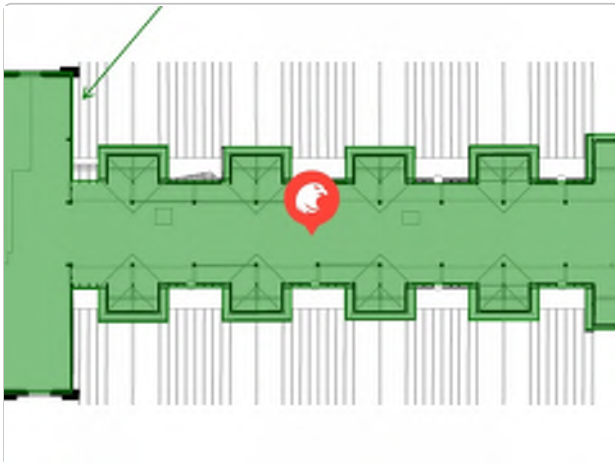
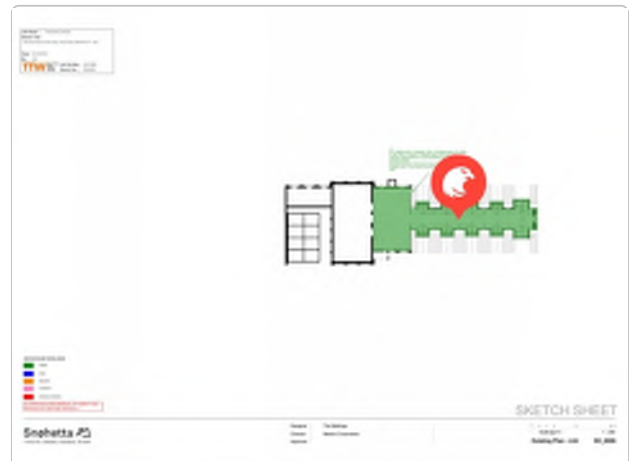
Unable to be assessed close up
Due to broken roof structure is exposed to the elements
Rot can be observed from a distance

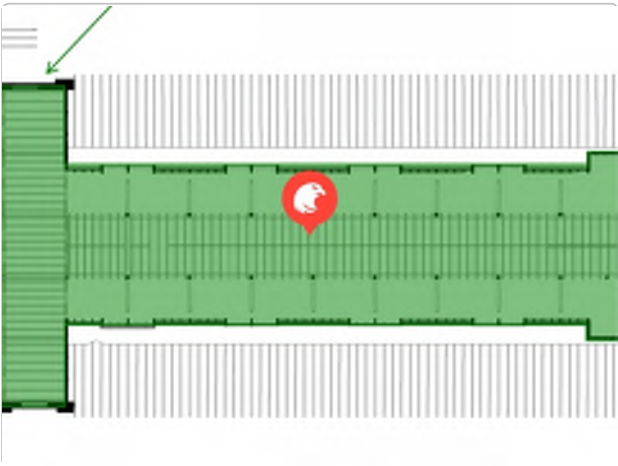
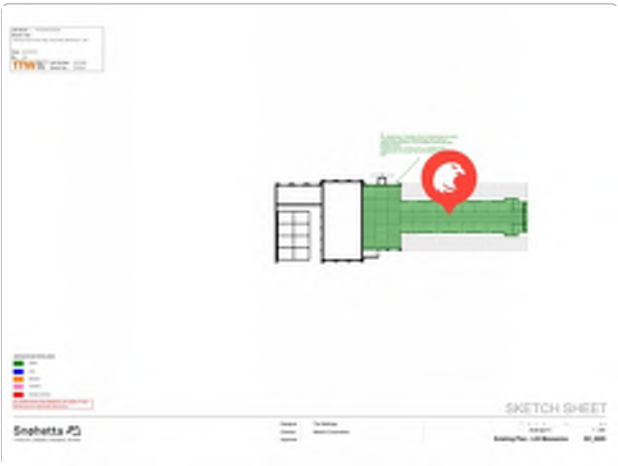
REMARKS
Size: 250x50mm
Weather exposure and rot on many joists
Been exposed to elements

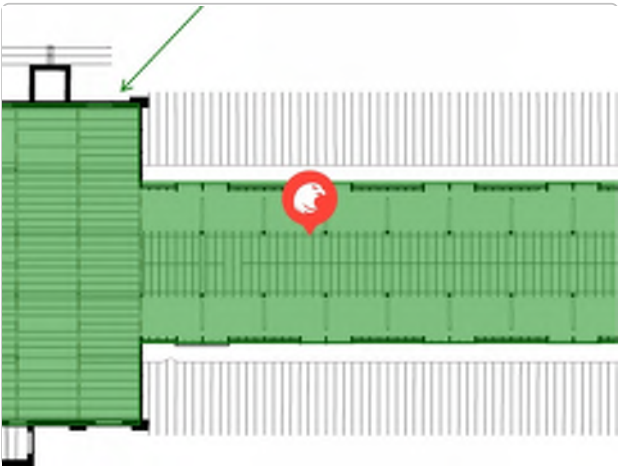
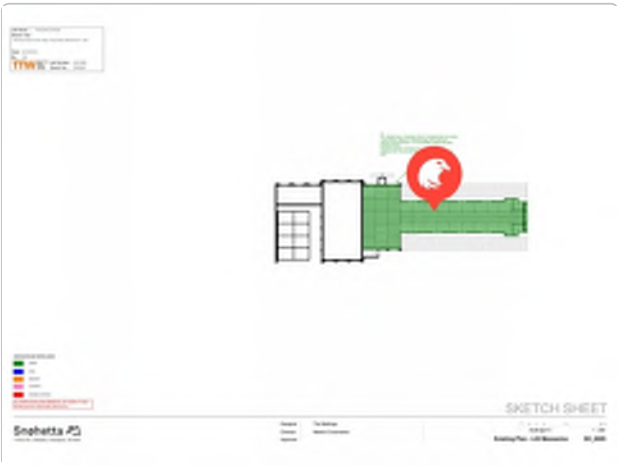
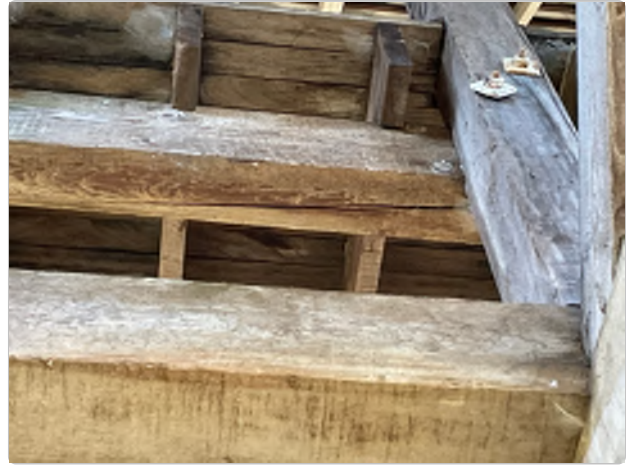
REMARKS
Size 250x200mm
Severe weather exposure
Water damage and rot

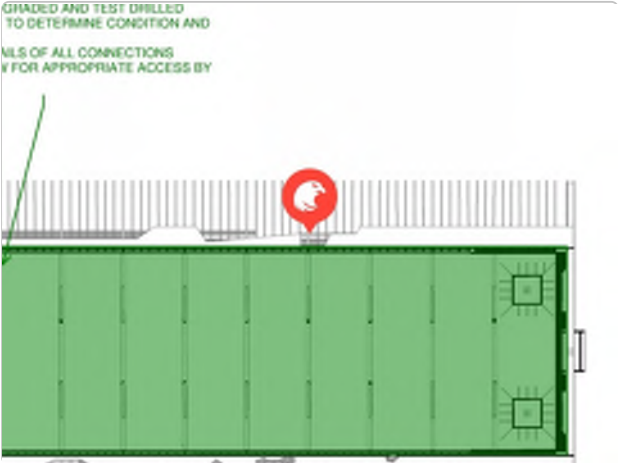
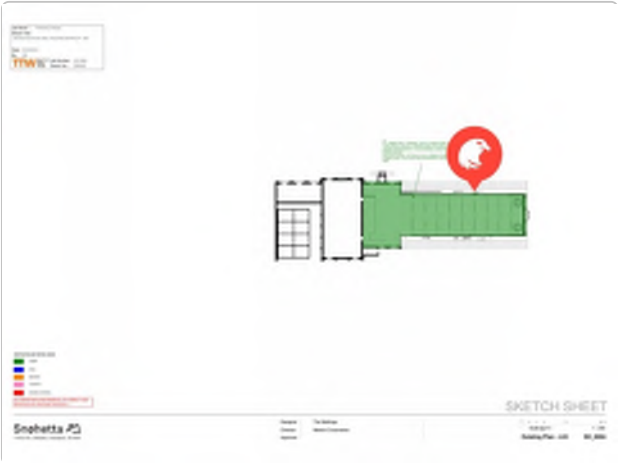
REMARKS
Size: 120x50
Severe weather exposure and rot in some places

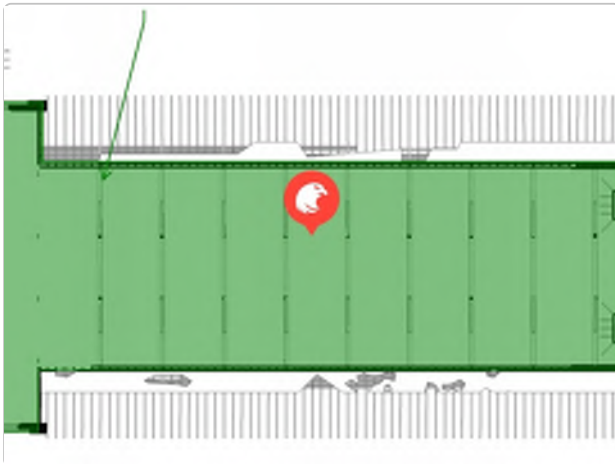
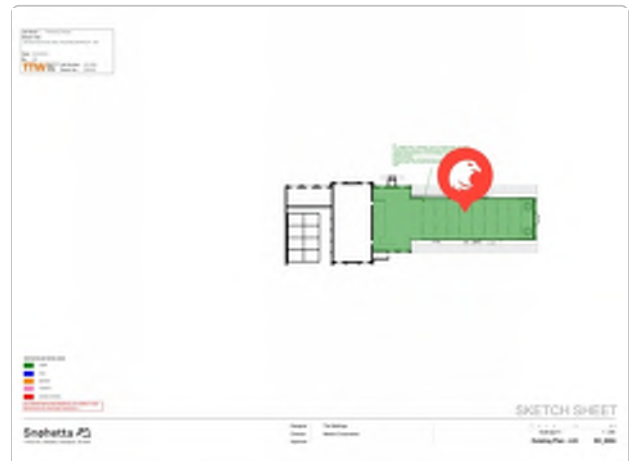
REMARKS
Size 300x200mm
Severe water damage/rot
Severe checks

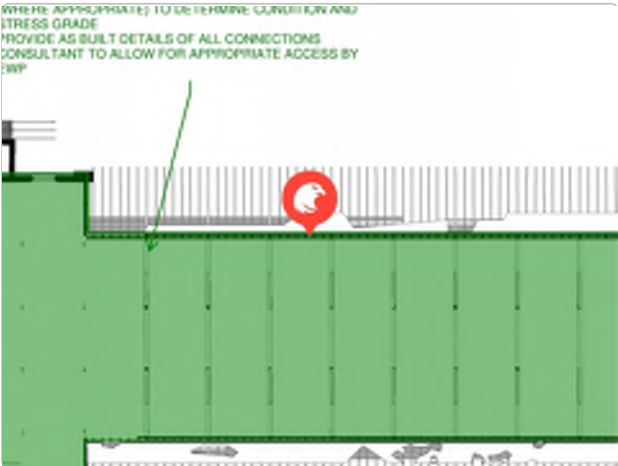
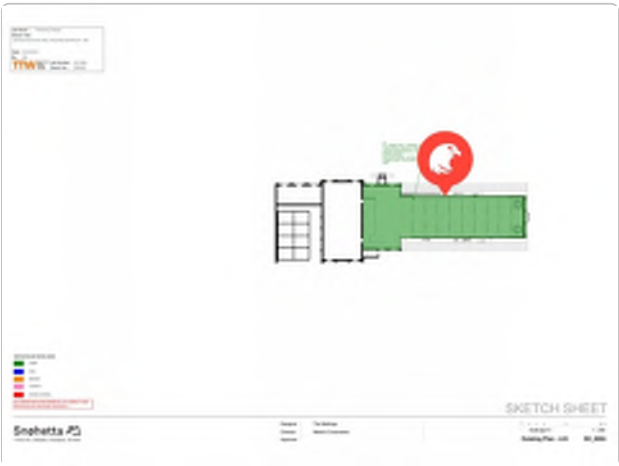
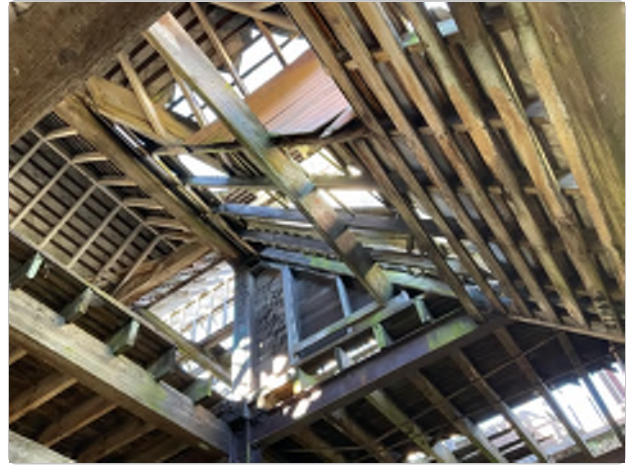
REMARKS
Size: 200x105mm
All purlins severe water damage and degradation due to exposure to elements
When probed at least 10mm section loss

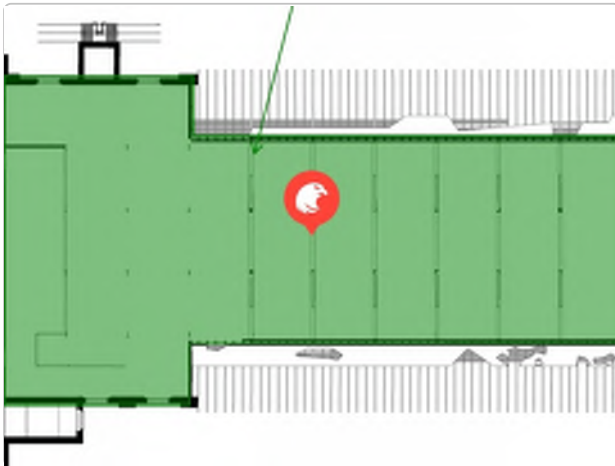
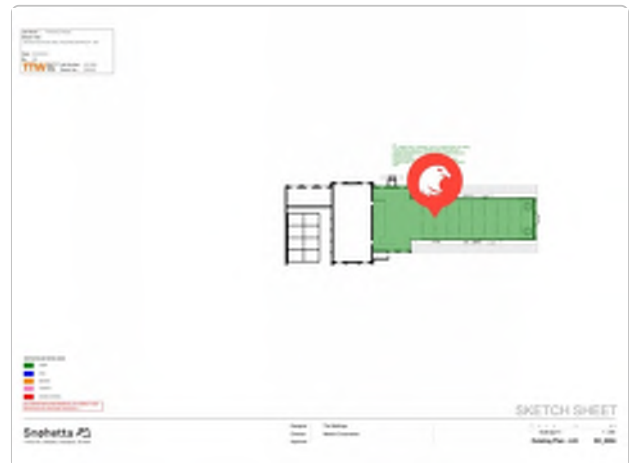
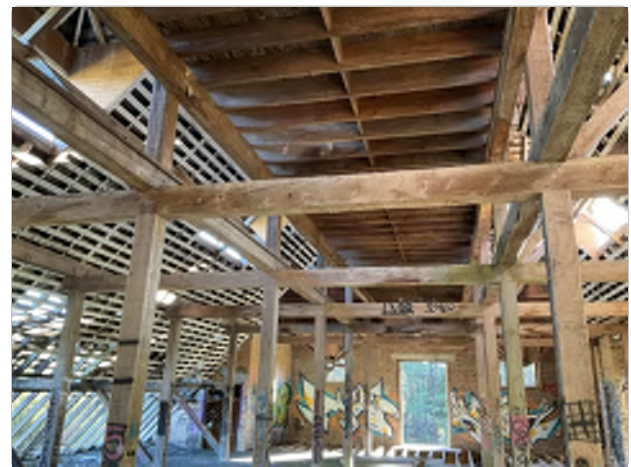
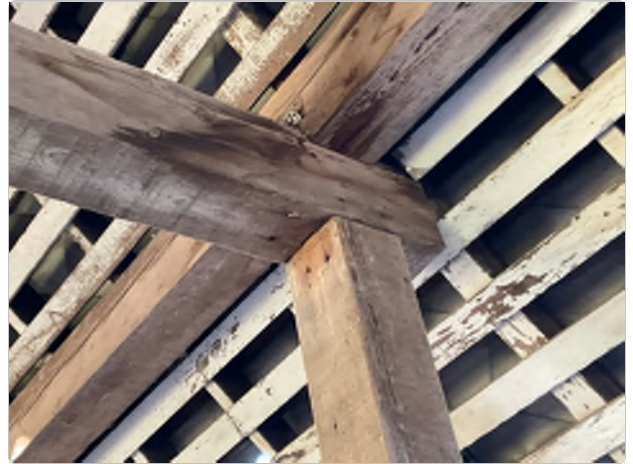
All beams show signs of rot or water damage due to exposure to the elements
Severe checks through middle of chord

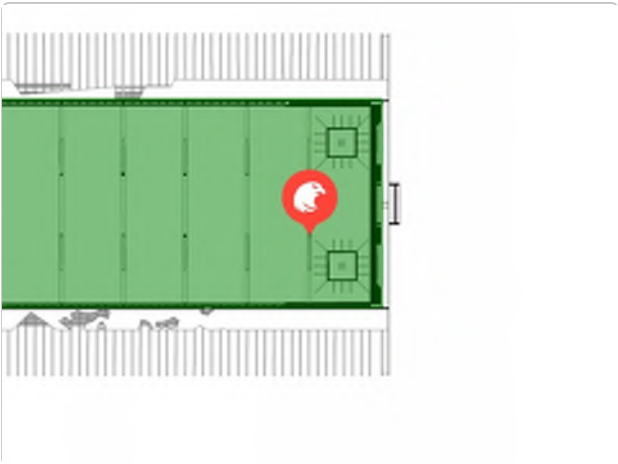
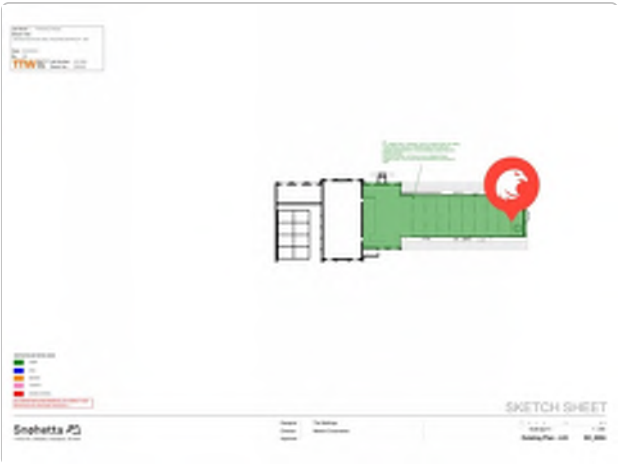
REMARKS
Missing post

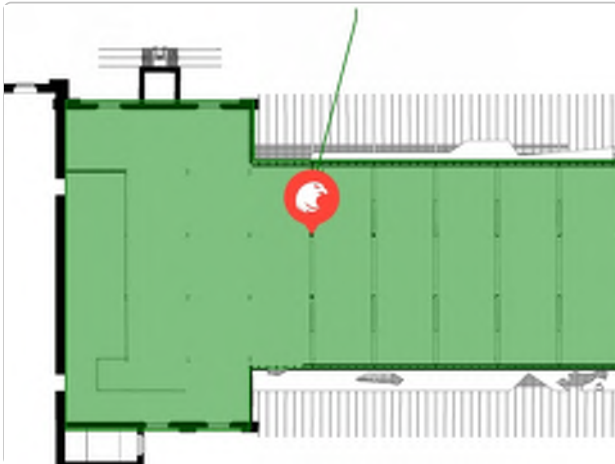
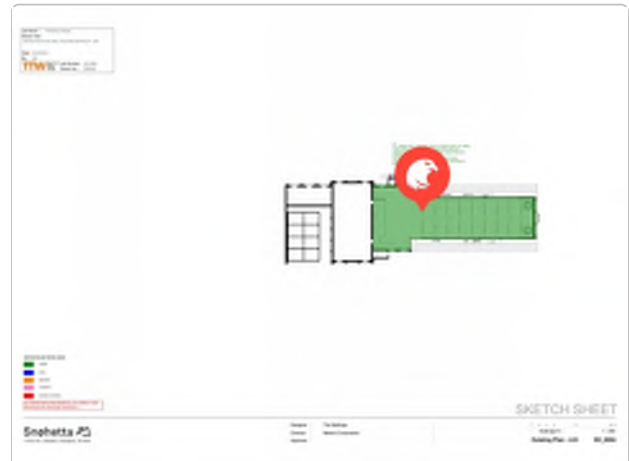
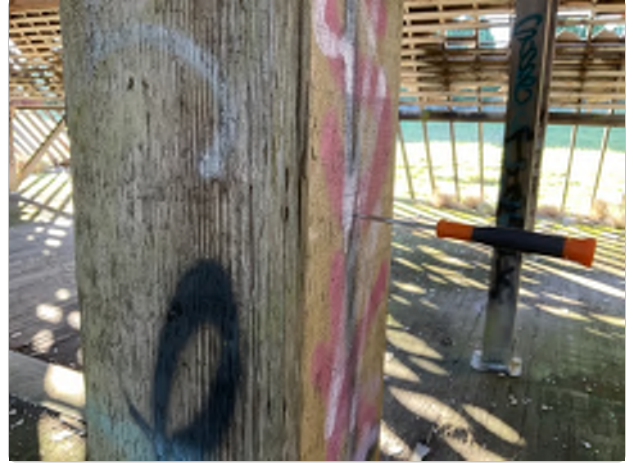
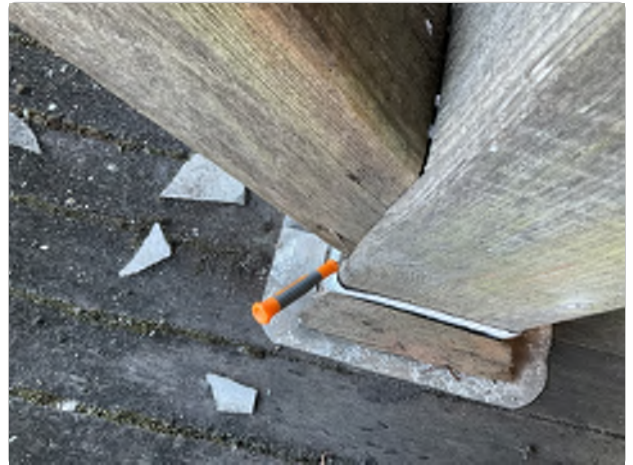
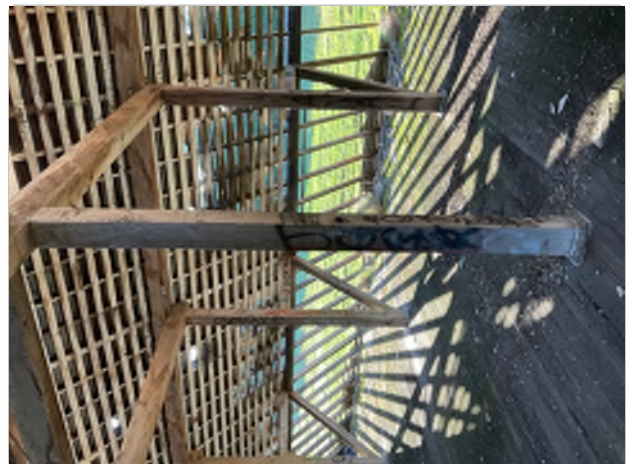
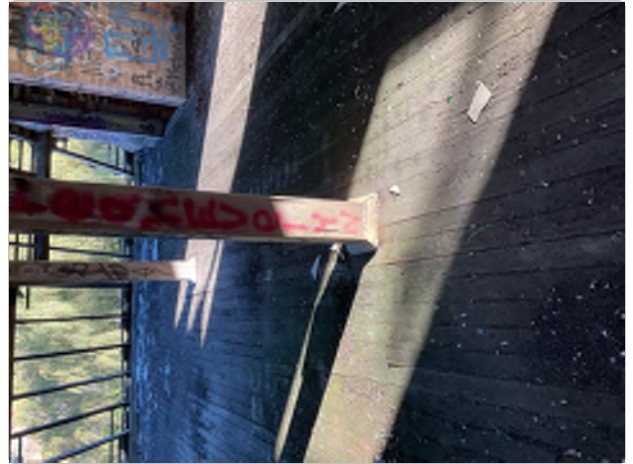
Inclined struts removed in the past led to complete rot in indented sections

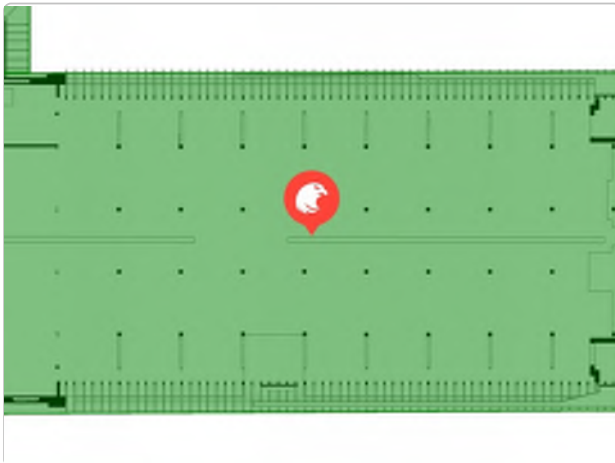
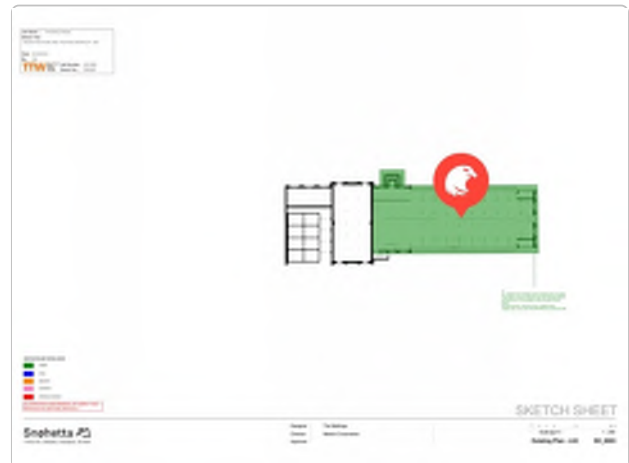
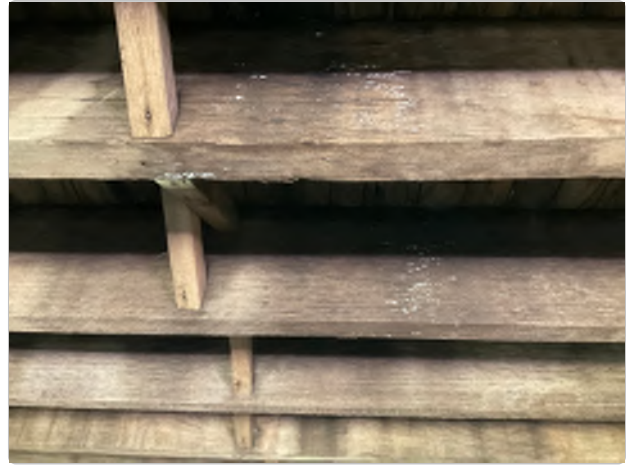
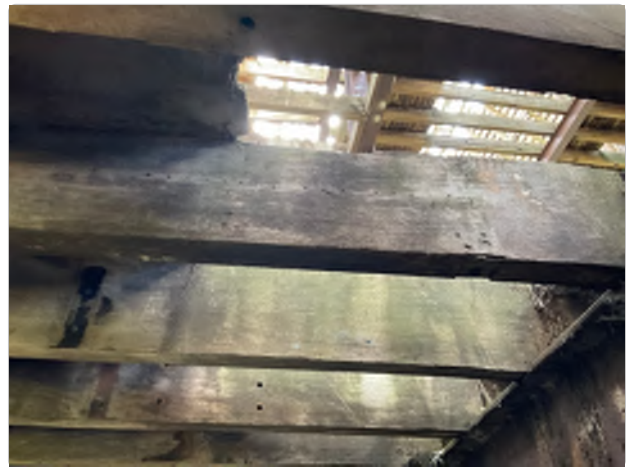
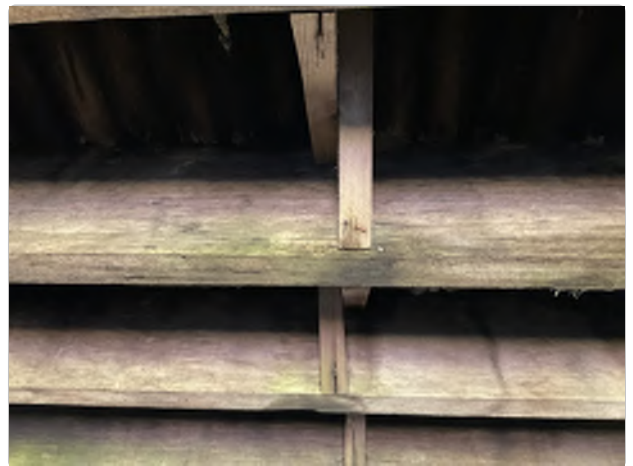
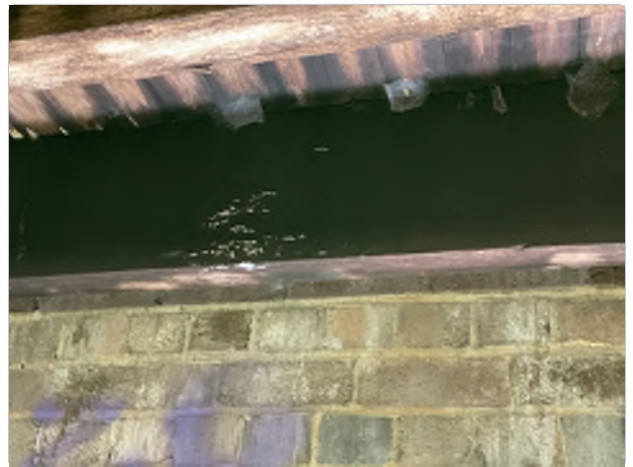
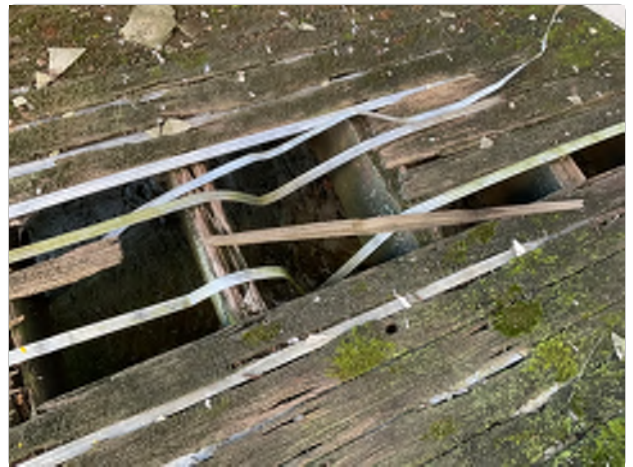
Top of joists unable to be inspected in most places but viewed from bottom show signs of water damage or rot

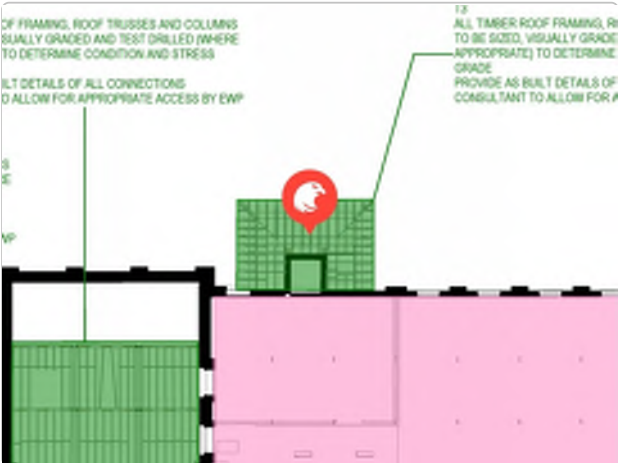
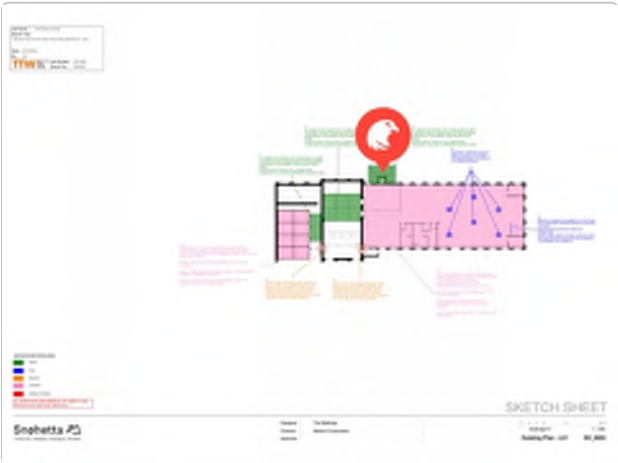
REMARKS
Oregon and pine has been previously repaired
Size 125x50mm
Weather exposed
Rot and water damage

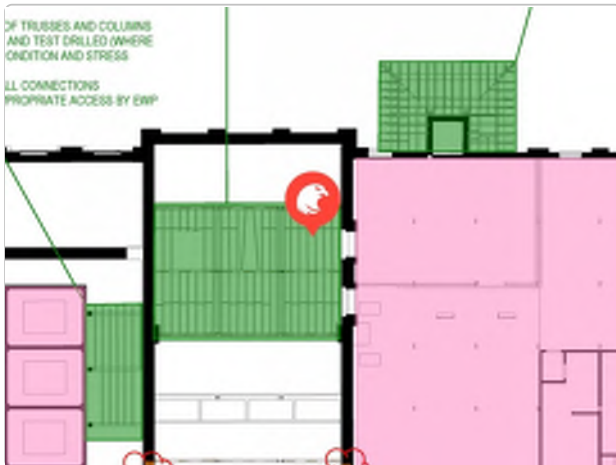
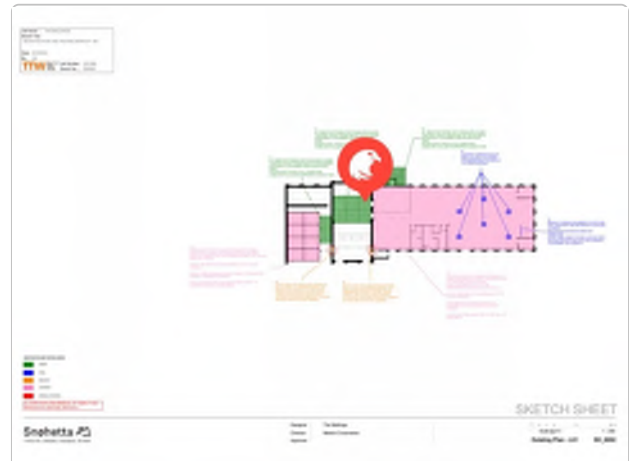
REMARKS
Waterlogged bearers
Exposed to elements
Fracture in member 5
End splits

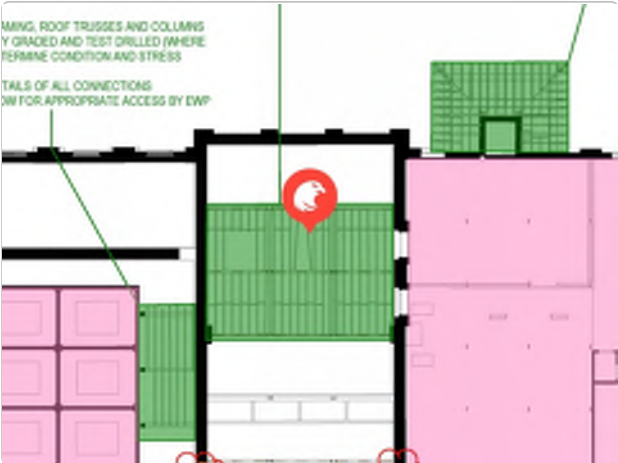
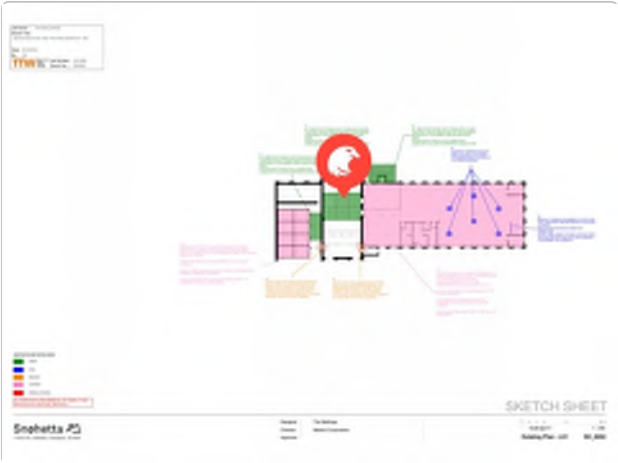
REMARKS
Rot and water damage
Exposed to elements

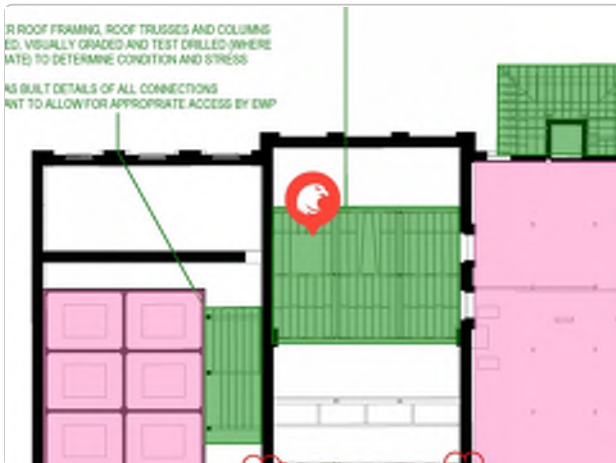
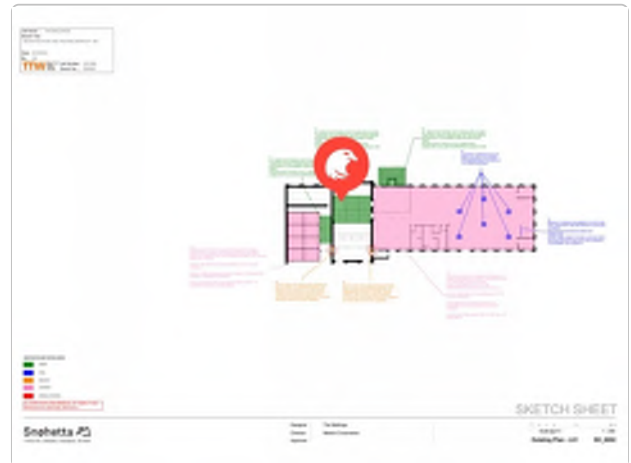
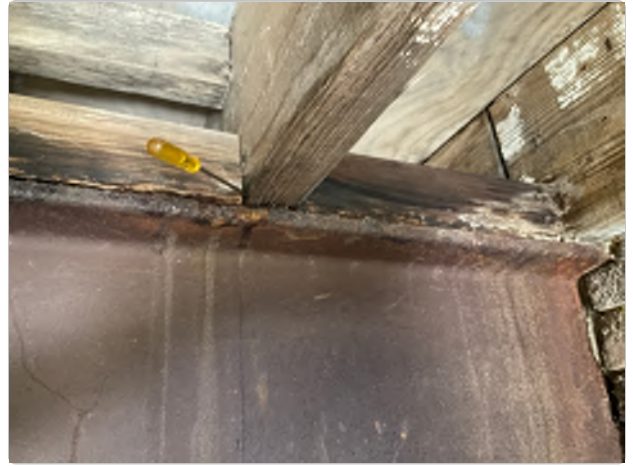
REMARKS
Size 270x60
Span 3500
Exposed to elements
Rot and water damage especially at bearers

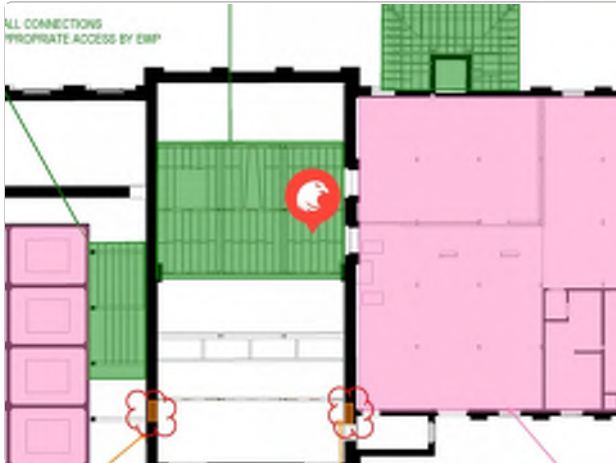
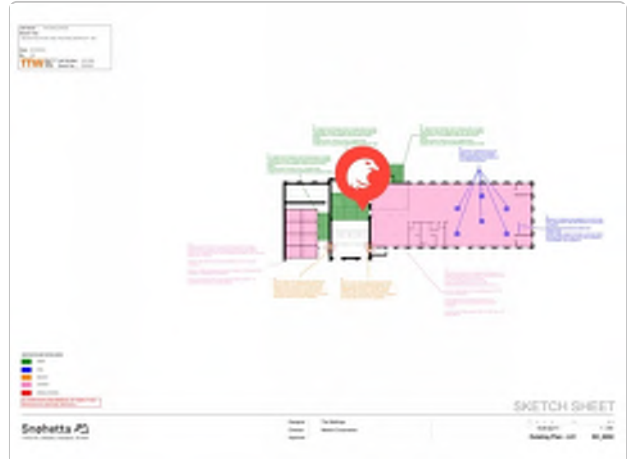
REMARKS
Exposed to elements
Signs of rot and water damage

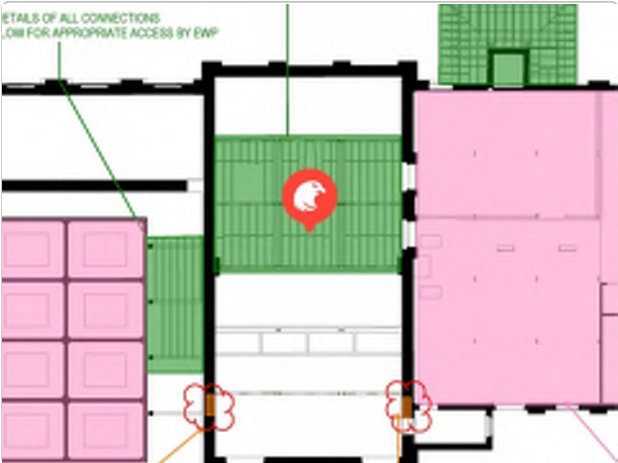
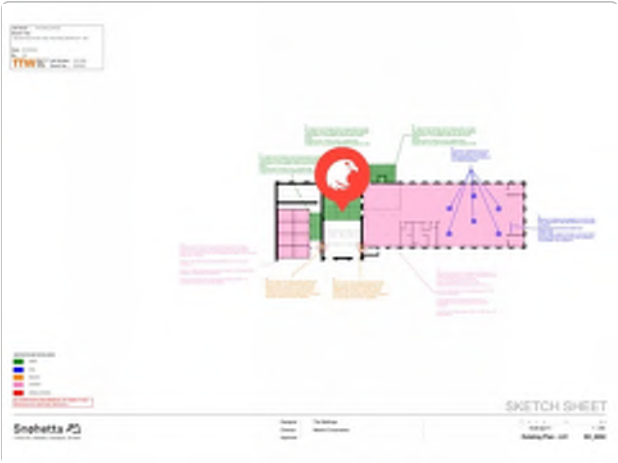
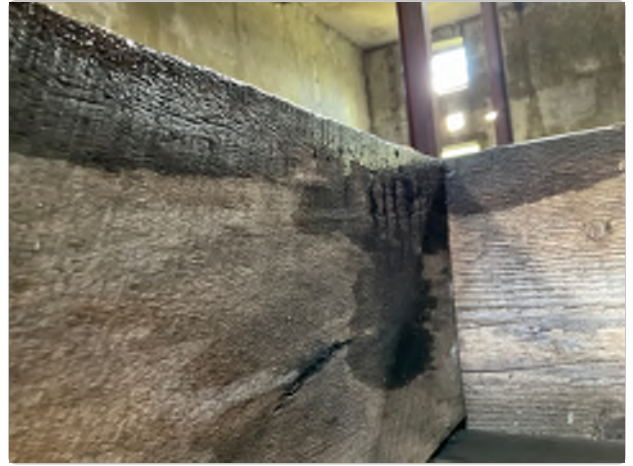
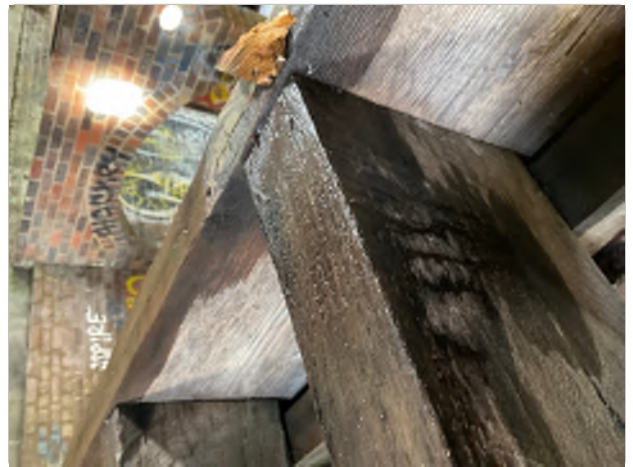
REMARKS
Joists are exposed to elements
Bearers show signs of water damage and rot

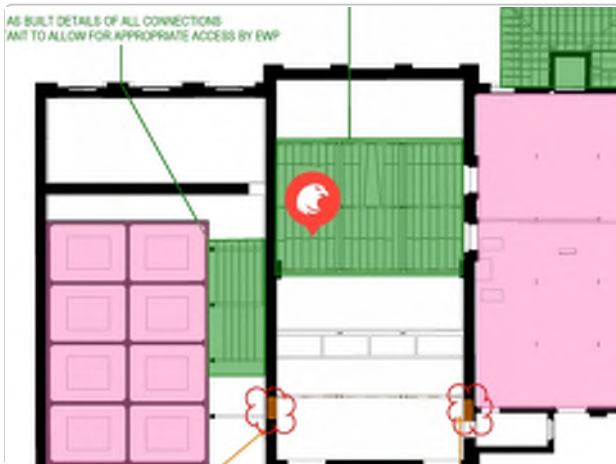
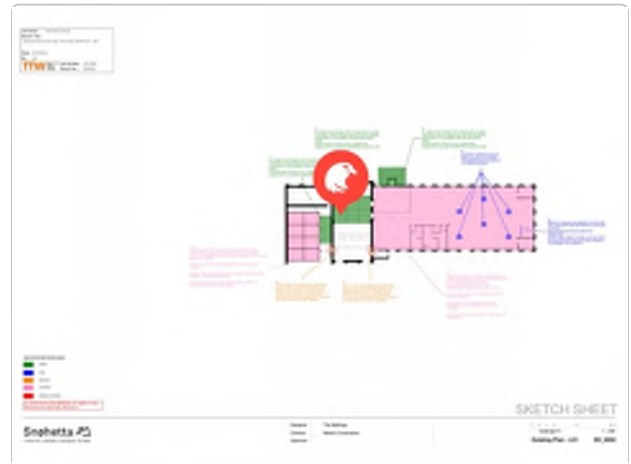
REMARKS
Oregon
Size 220x75mm
Span 3450mm
Weather exposed
Rot

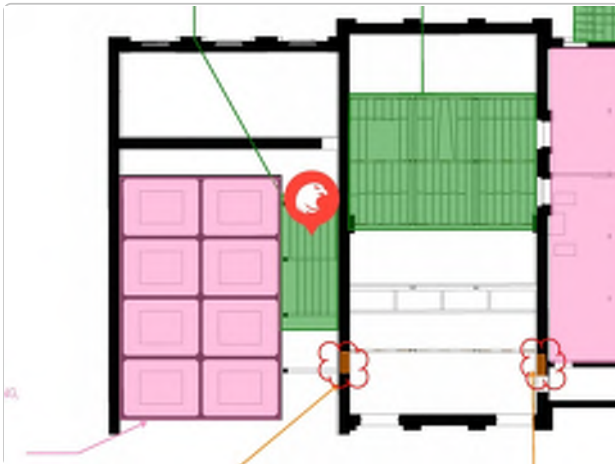
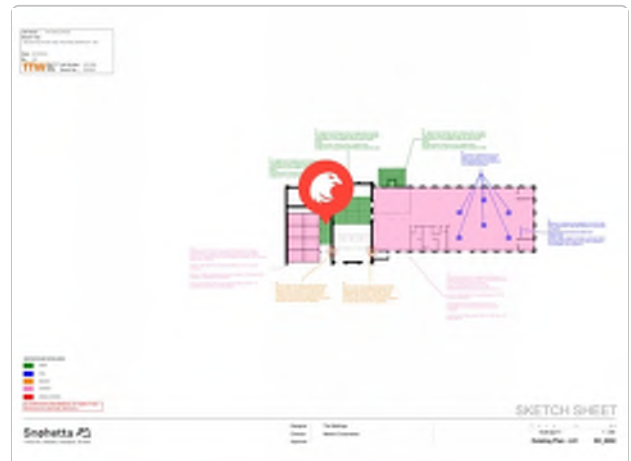
REMARKS
Size 205x75mm
Span 3500mm
All members exposed to elements. Rot

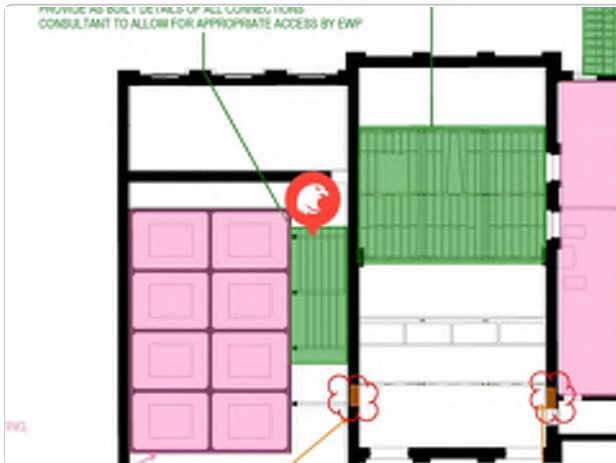
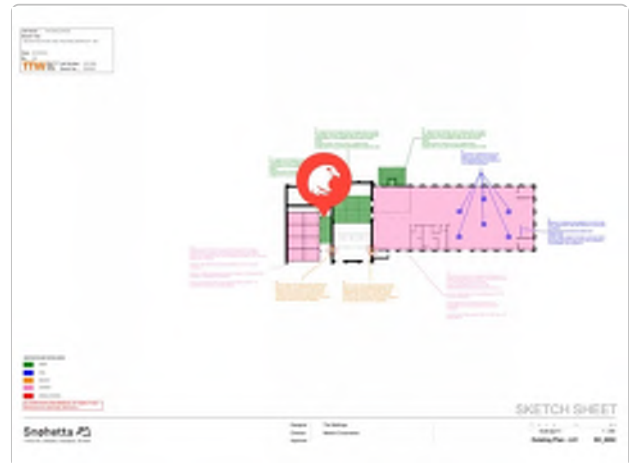
Rot at bearing location

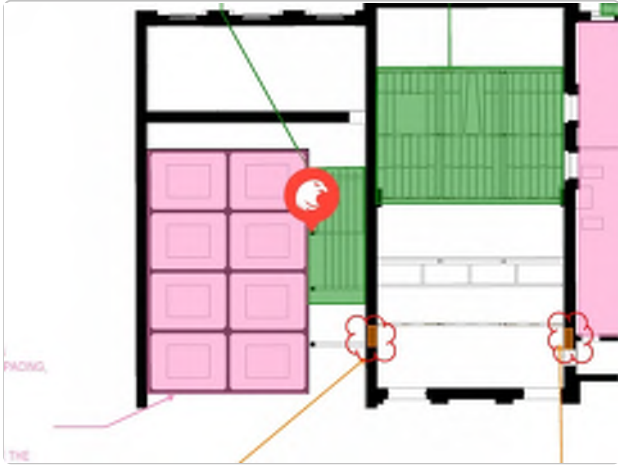
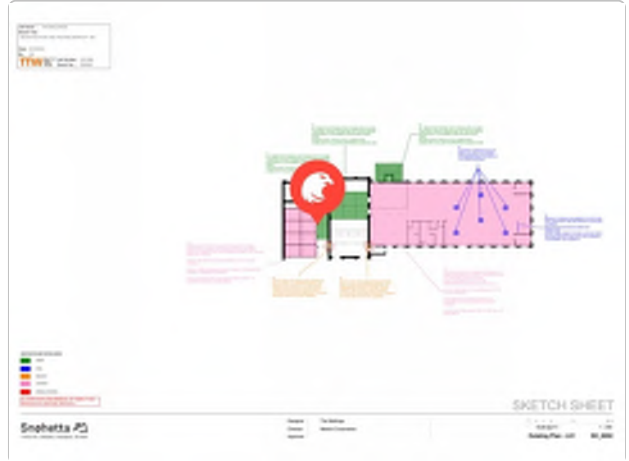
All posts (Upper and Lower) have been exposed to the elements. Severe rot at the ground connection of all the columns. Section loss of at least 50mm all round
