DA Structural Report

Malthouses 1, 2 and Maltsters House The Maltings, Mittagong

Colliers International / 29 August 2024

221582

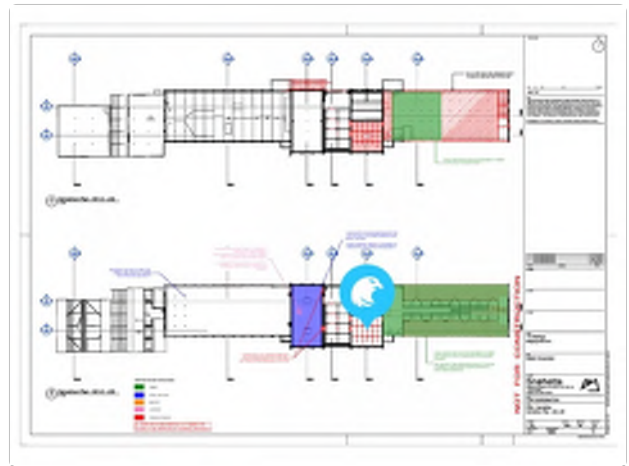
Spot 54

REMARKS
Unsafe to inspect close up
Species hard to identify but is mixed nsw hardwood originally SG2 F22
End of rafters

SEVERITY
Minor

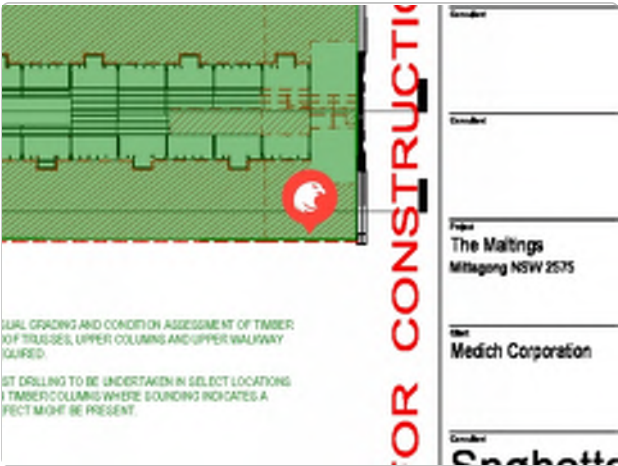
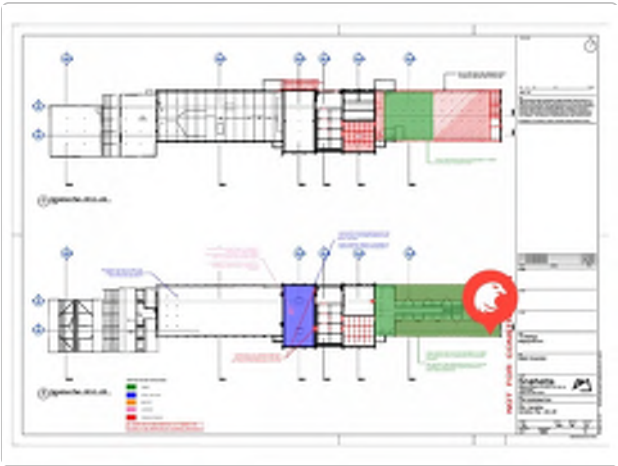
DEFECT
split

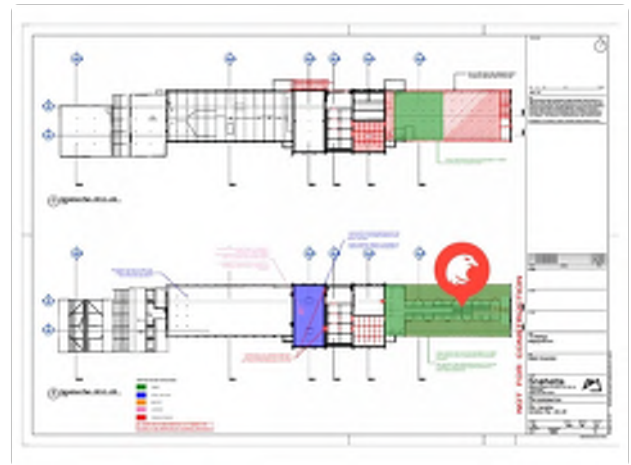
REMARKS
Centre section of bottom chord 5 splits face to face
Repair

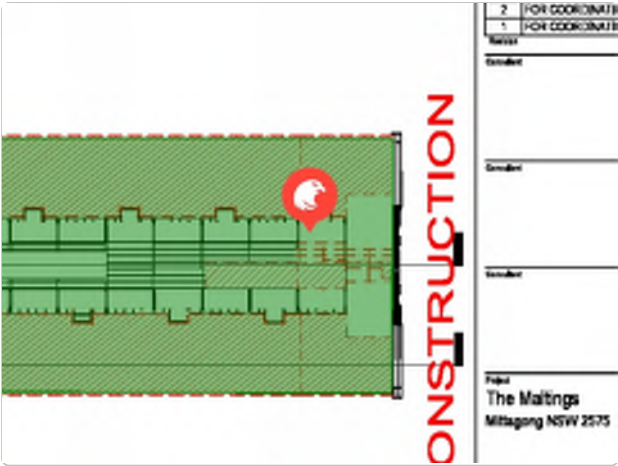
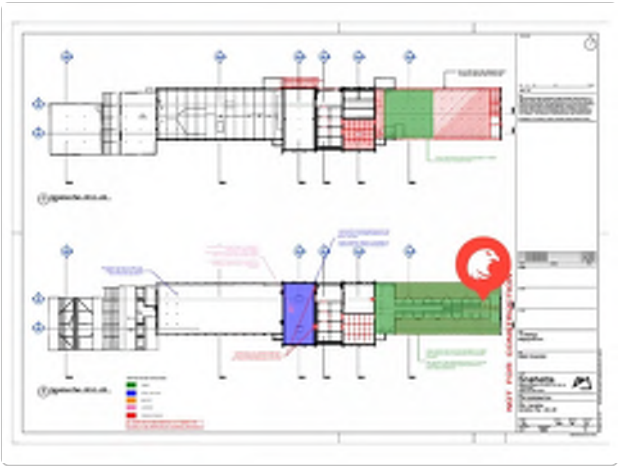
REMARKS
Every post that has metal bracing/repairs is considered Out of grade
Span 3430

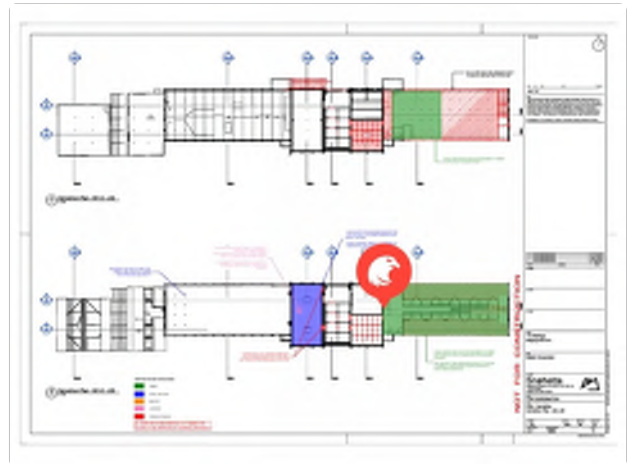
REMARKS
As with the decay in the lower floor end beams are all suspect to rot and decay

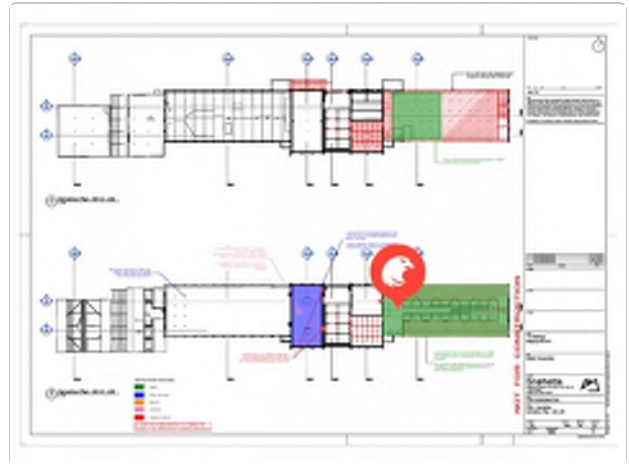
DEFECT
Split

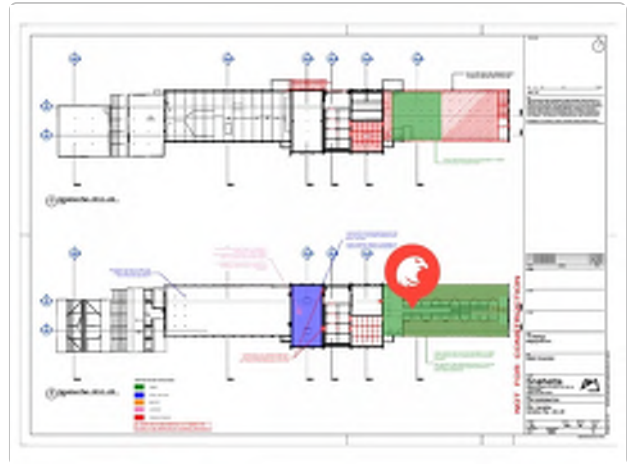
DEFECT
Split

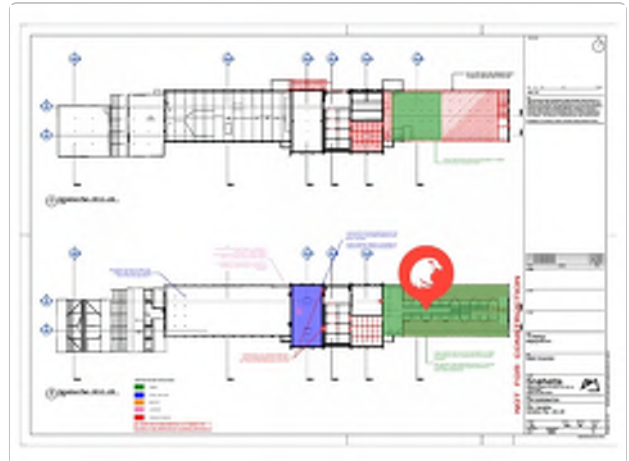
DEFECT
Check

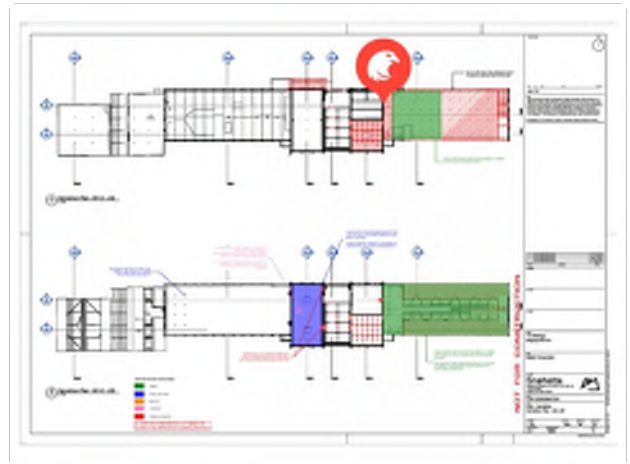
REMARKS
Decayed

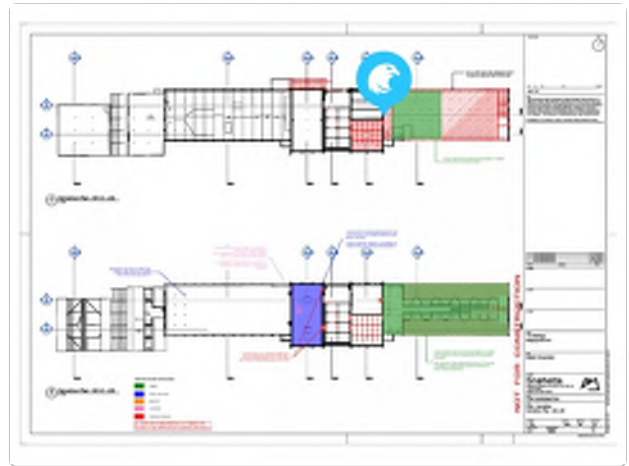
Spot 32 [↗](#)

SEVERITY
Major

REMARKS
Recommend ledger plate to be installed under and connected back into solid timber

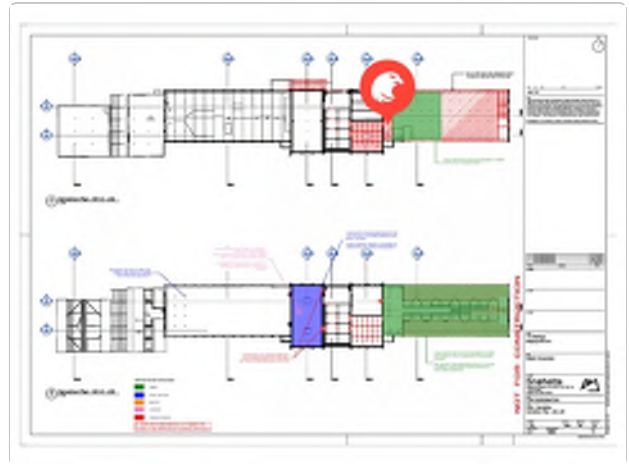
DEFECT
Fire damage

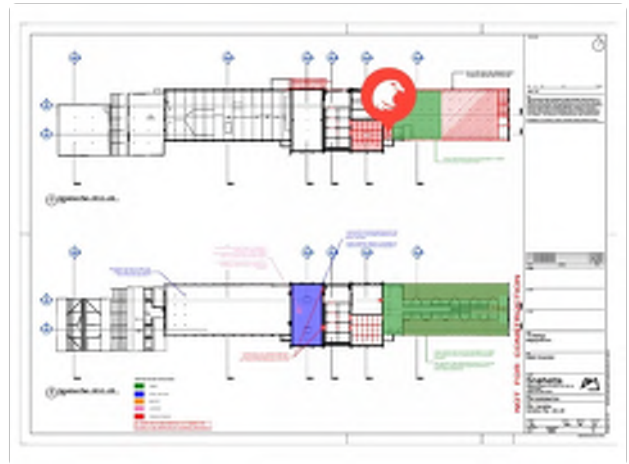
REMARKS
1-4 missing, 5 fire damage, 6 and 7 ok, 8 fire damage

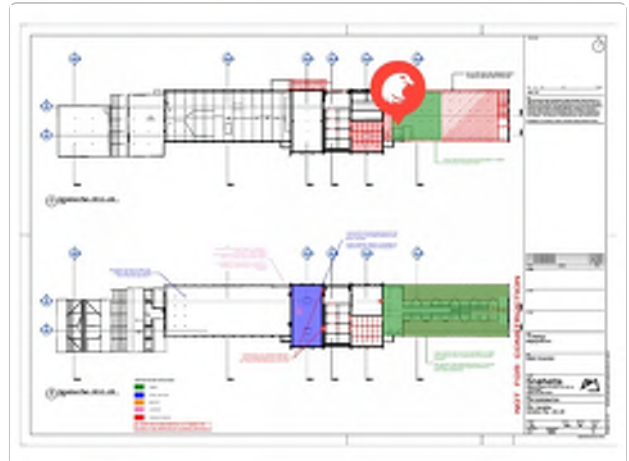
DEFECT
Fire Damage

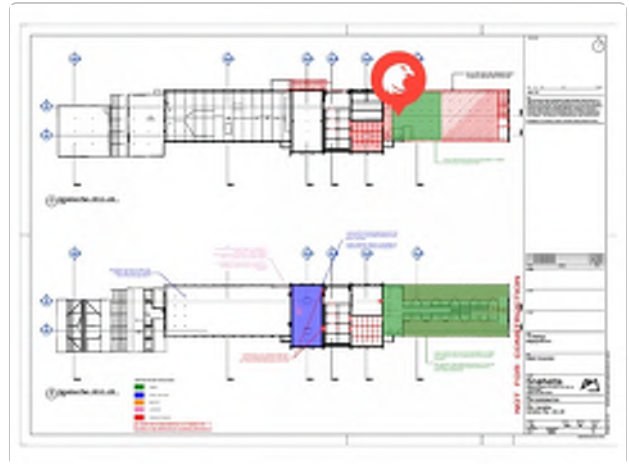
DEFECT
End Split

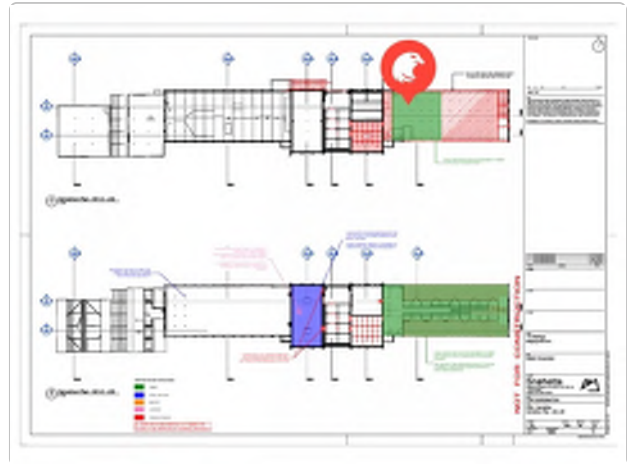
DEFECT
Fracture/shake

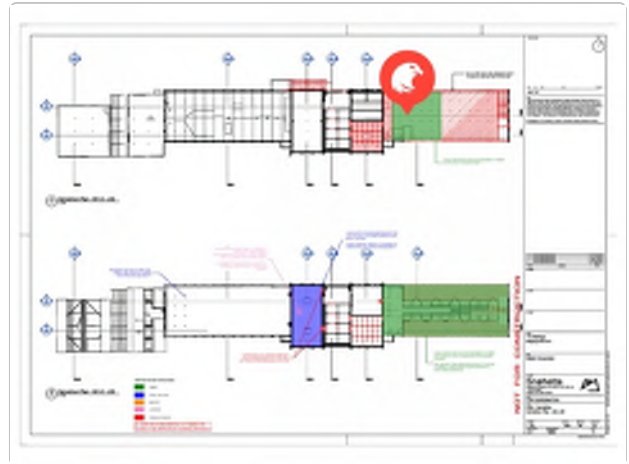
DEFECT
End Split

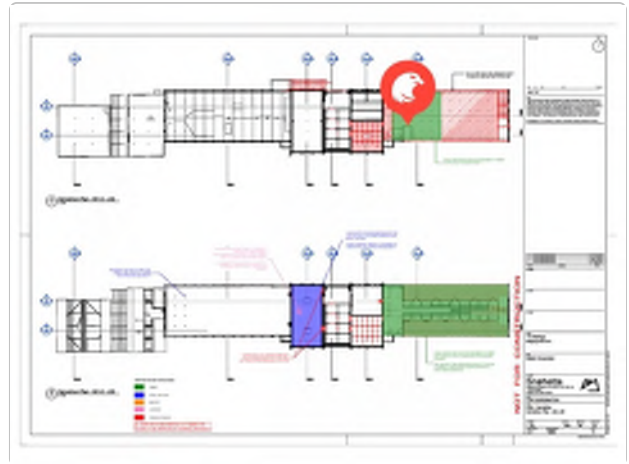
DEFECT
Fracture/split

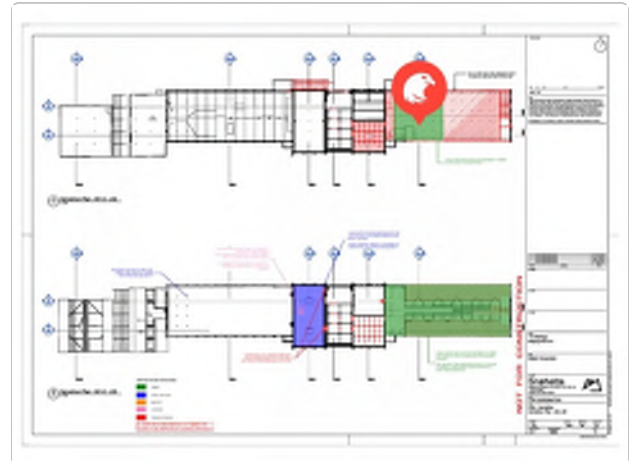
DEFECT
Check

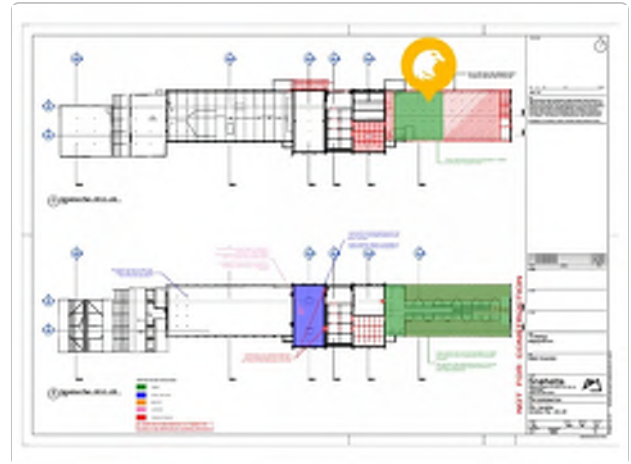
DEFECT
Check

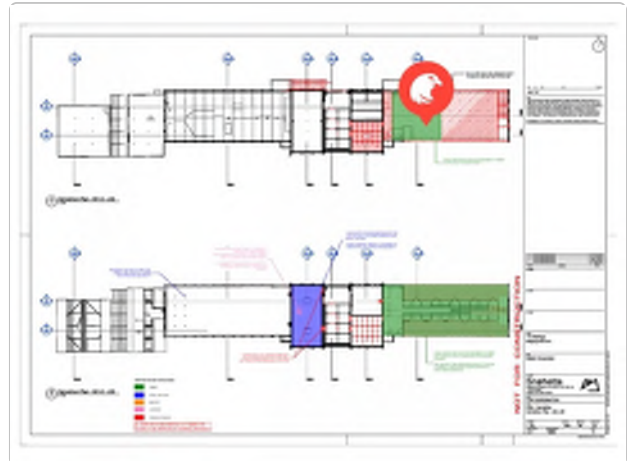
DEFECT
Fracture

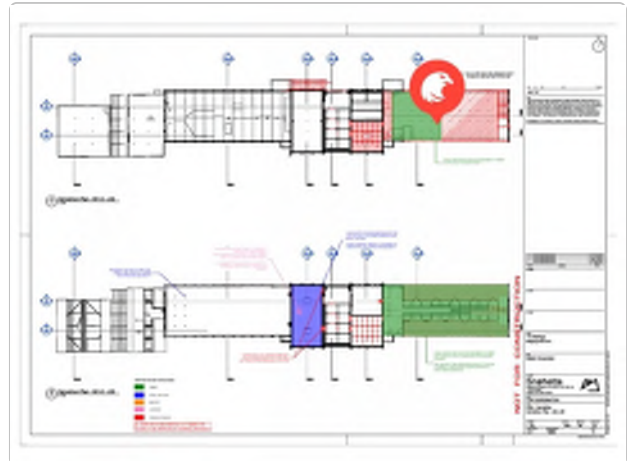
DEFECT
Fracture

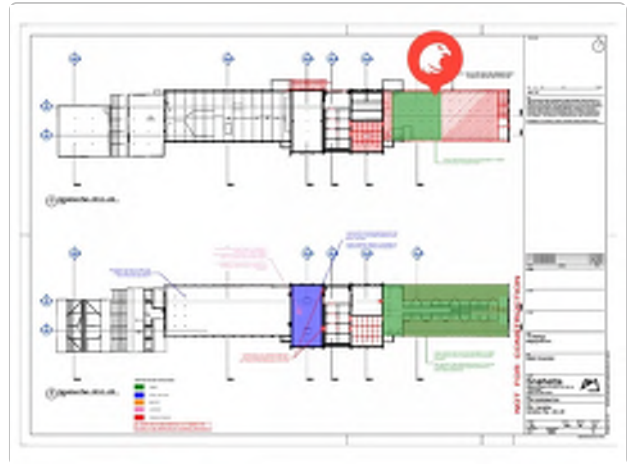
DEFECT
Split face to face

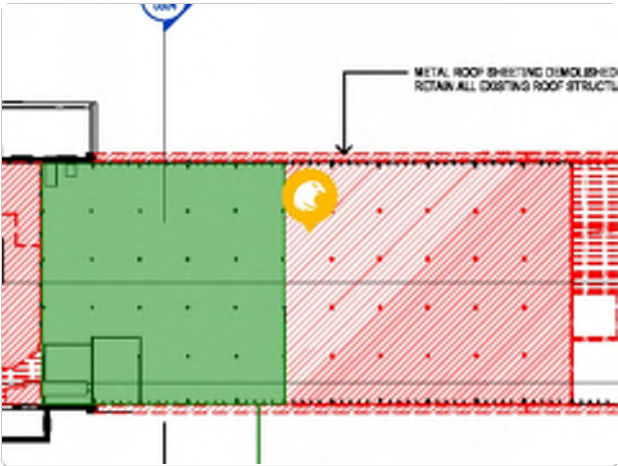
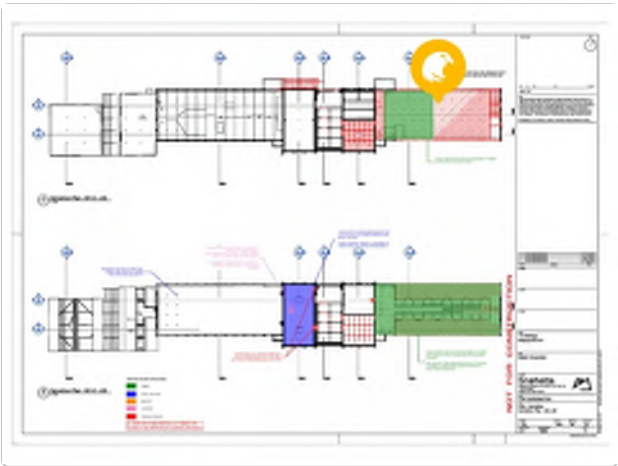
Spot 12

REMARKS
30mm deep, repair

SEVERITY
Major

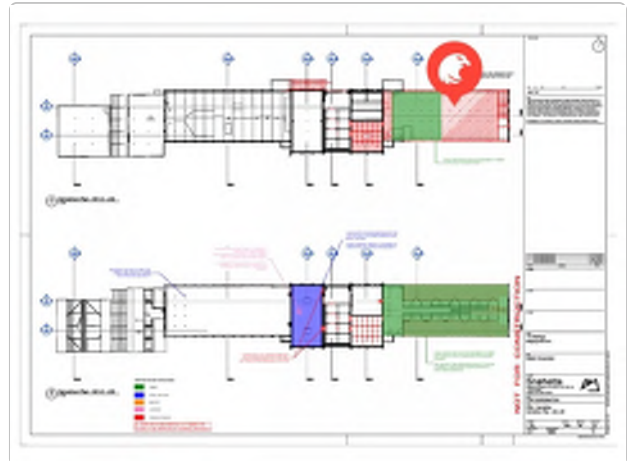
DEFECT
fracture

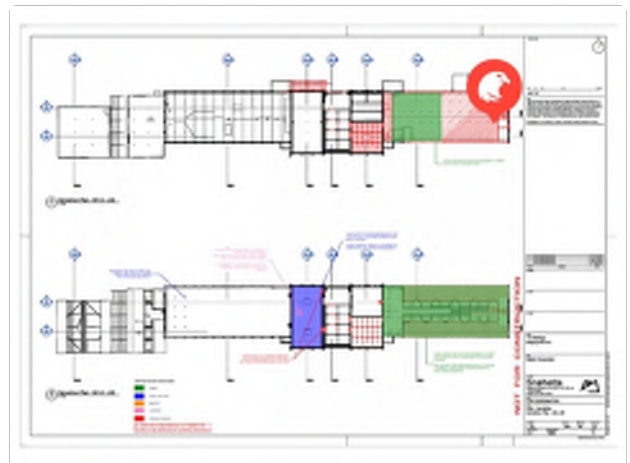
REMARKS
1 and 3 rot
Short bearers
notches are not affecting structural grade
Connections are sitting on bolt

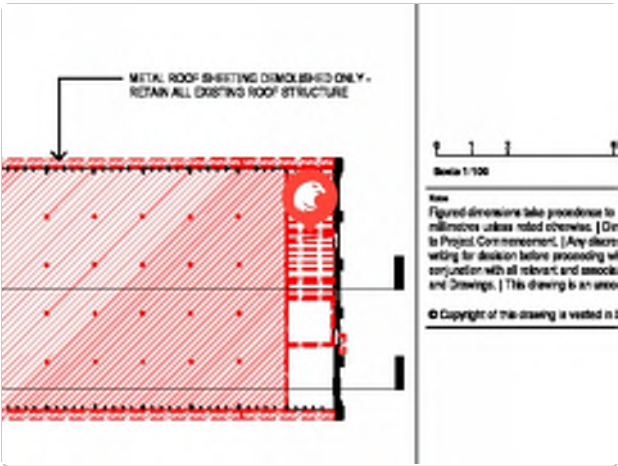
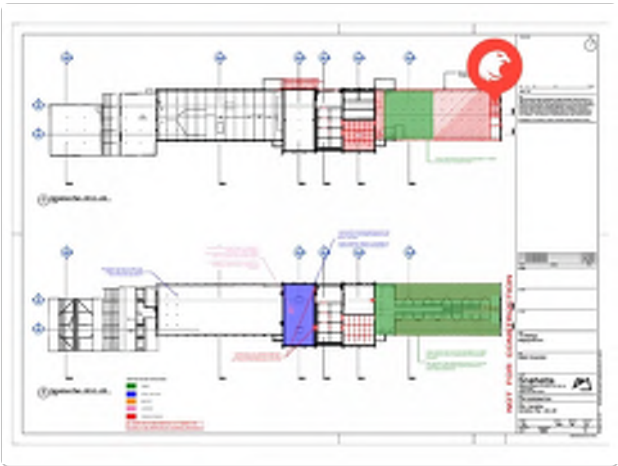
REMARKS
Decayed top 75mm for all members, plate besides

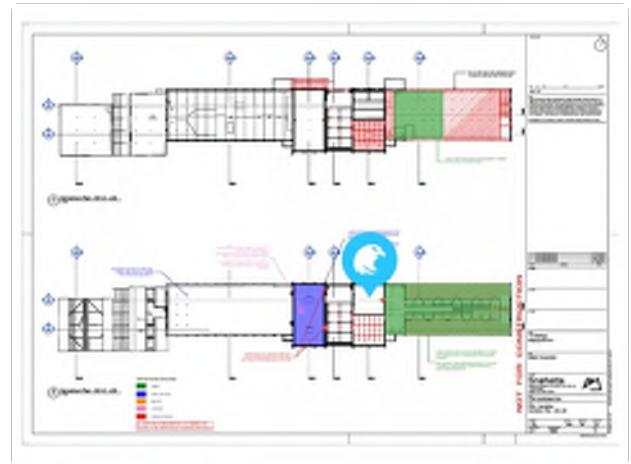
REMARKS
Unsafe for physical inspection

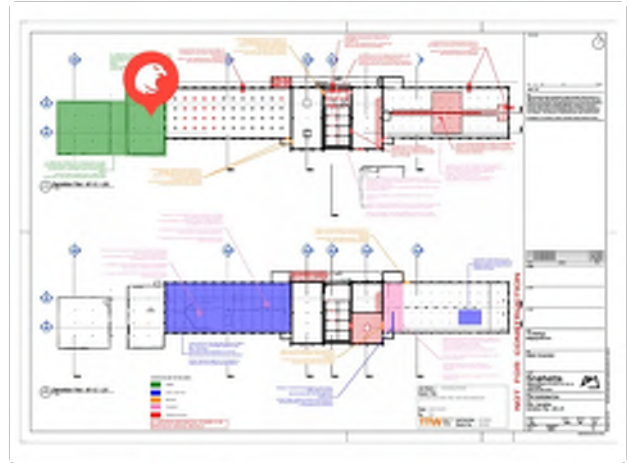
Rot at top of post under walkway and connected bottom cord and joists
This post 170x170mm
Joist 110x75

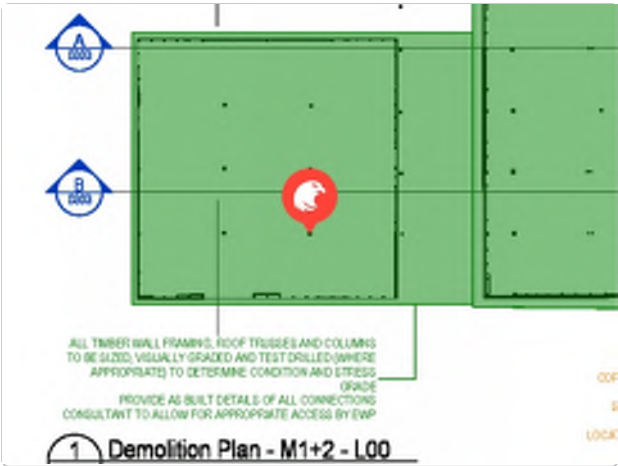
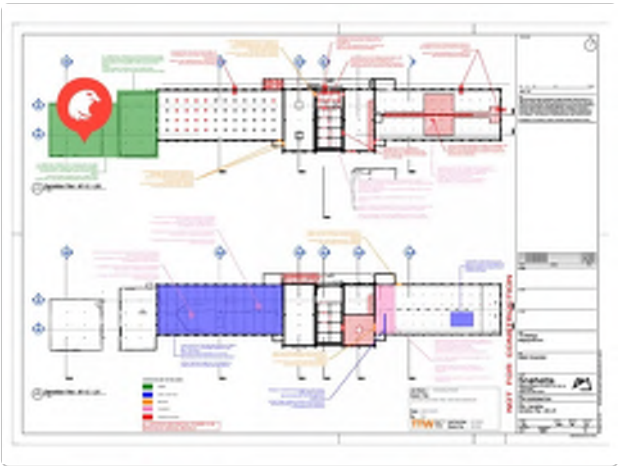
REMARKS
Severe decay 50mm

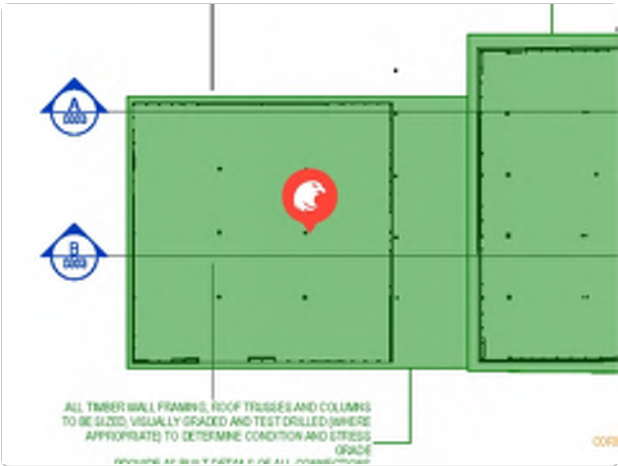
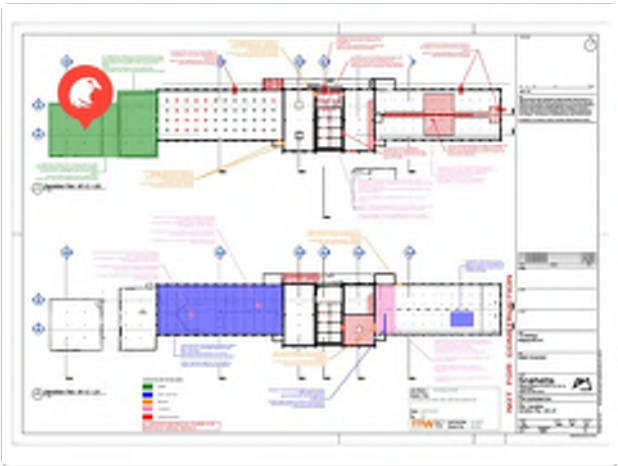
REMARKS
Severe decay at ground 50mm

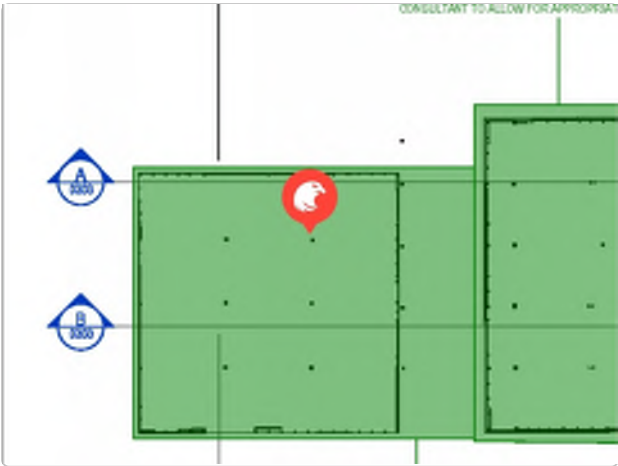
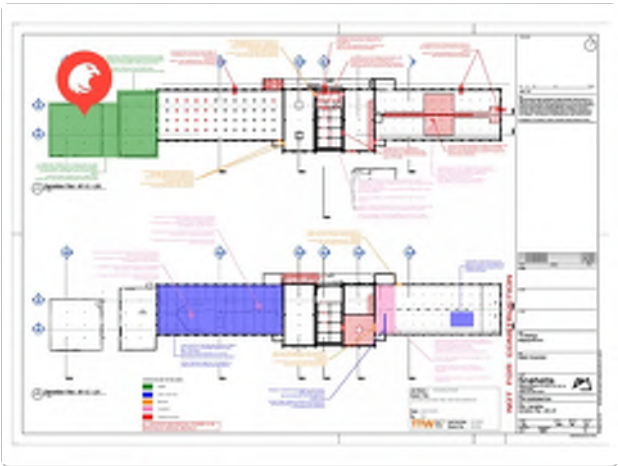
REMARKS
Severe decay at ground

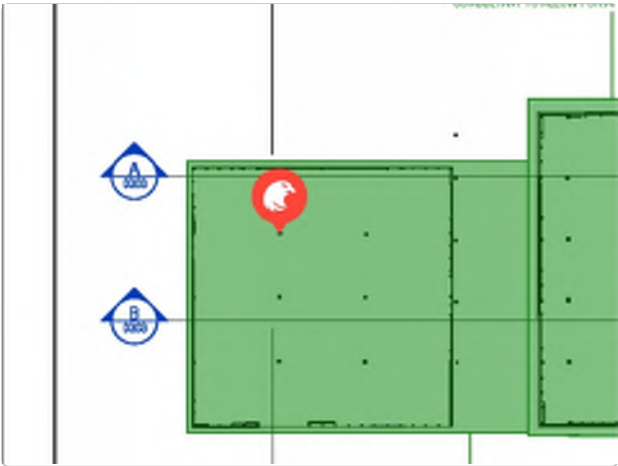
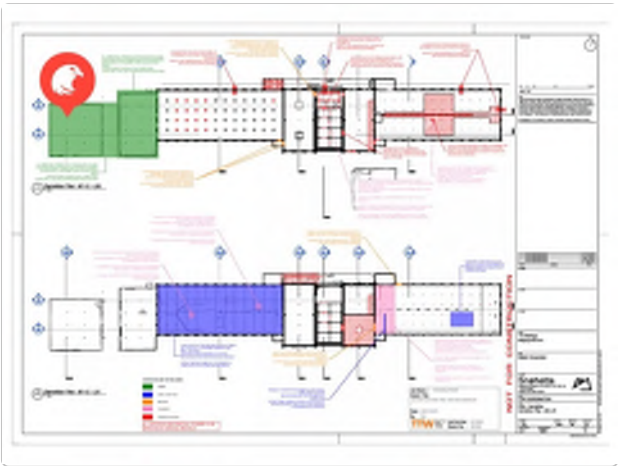
REMARKS
Severe decay at ground level

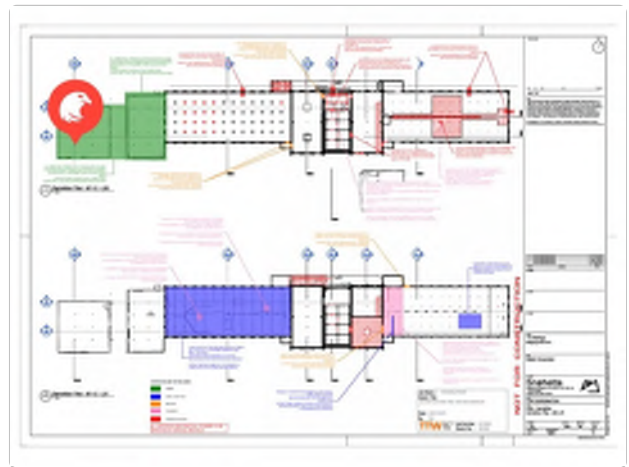
Decay 25mm

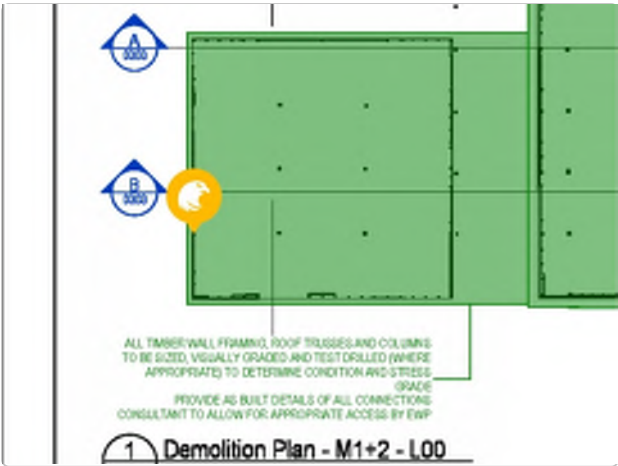
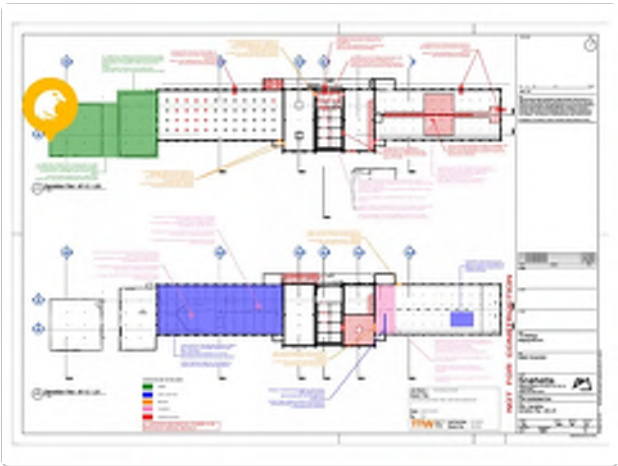
REMARKS
Minor decay in corner

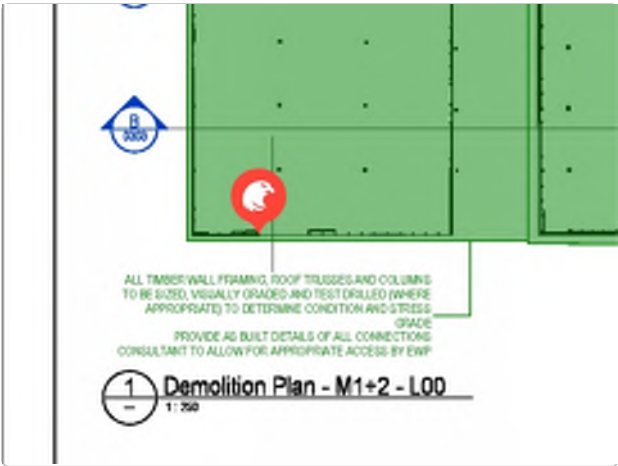
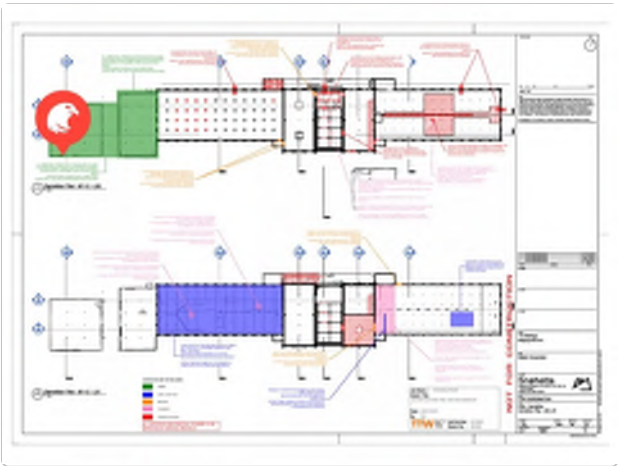
REMARKS
Rot at ground level

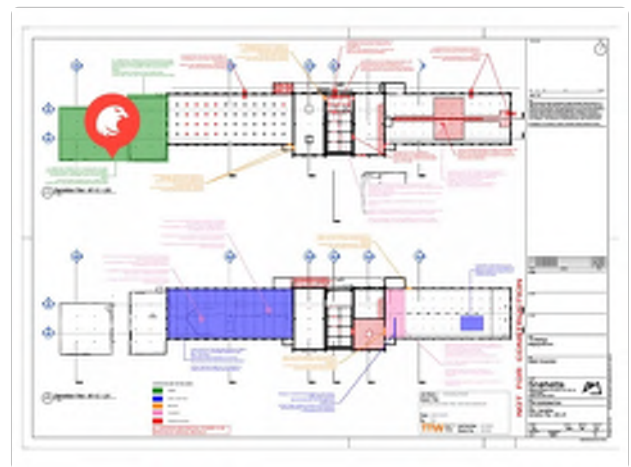
Termite damage minimal and in battening
Battening around the post 75x38
Belt rail 75x38 @1000mm c-c
Stud framing 95x75 @900mmc-c
Cross brace 145-50mm

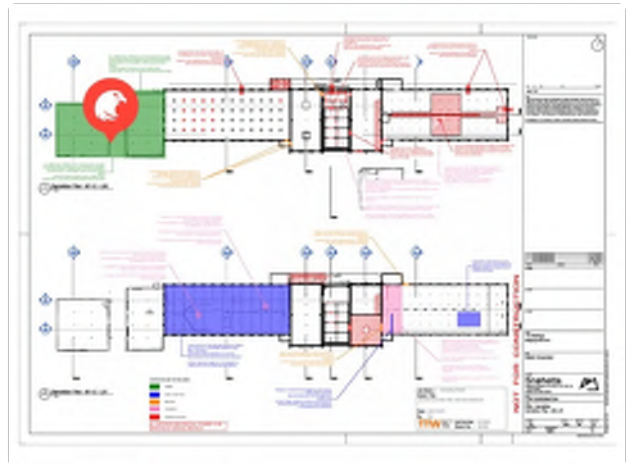
REMARKS
Decay in bottom plate

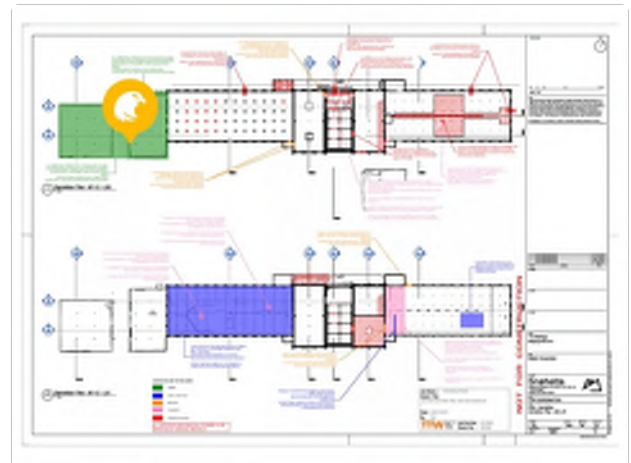
REMARKS
Hardwood post
20mm decay

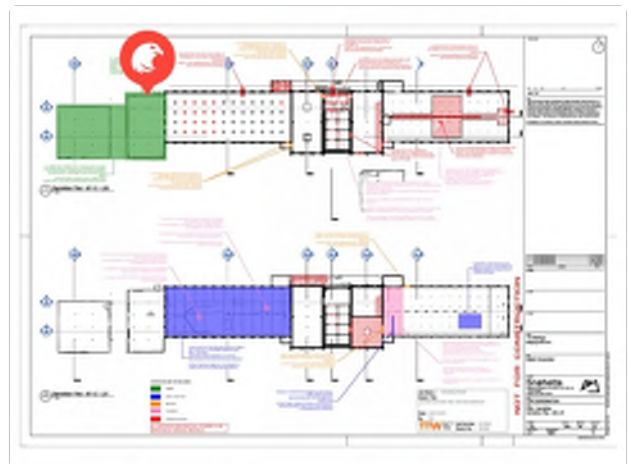
REMARKS
Rot at the bottom of some end wall framing set in concrete, repair

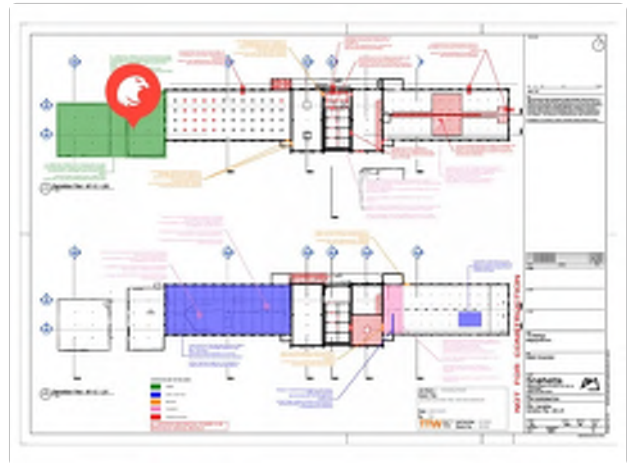
Decay at the bottom at ground level about 30mm deep
Size: 250mm x 240mm
75mm x 120mm
240 mm x 110mm

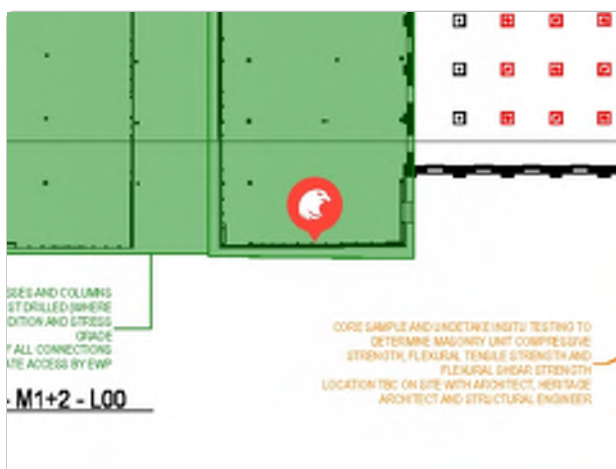
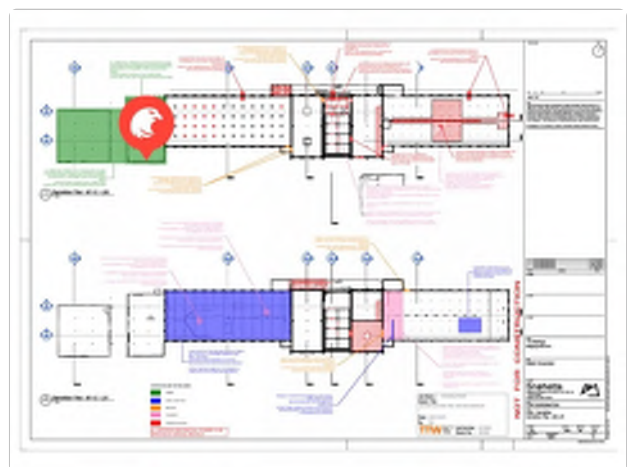
End wall framing decayed at ground line
Wall framing Oregon
Sizes: centre hardwood 210x100, 75x50 notches
Vertical Oregon 120x75 @1060c-c
Horizontal Oregon 75x50 @1080c-c
Diagonal brace Oregon 100x75

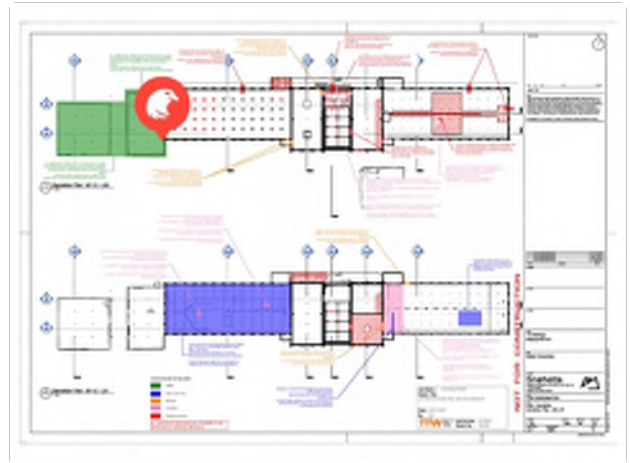
Extent of termite damage hard to determine OOG
