**Date:** 20 March 2025

**Project No.:** 2025 - 012

Coral Park Earthmoving and Landscape Supplies  
28 Coral Park Road,  
Wolumla, NSW, 2550

**Geotechnical Assessment for Development Application (DA2024.109)**  
**for Proposed Blasting and Extension of Existing Quarry**

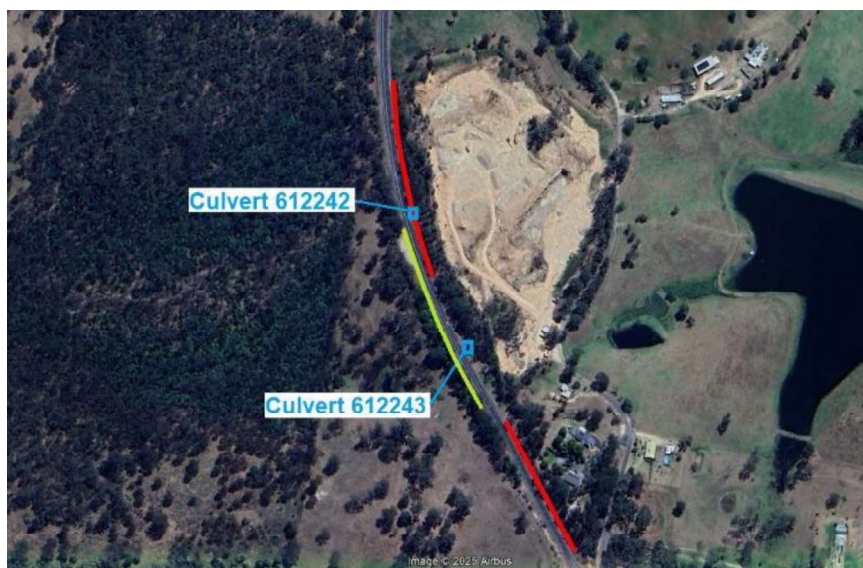
The two culverts in question (No. 612242 and 612243) are defined within TfNSW documents and are shown below in Figure: 1.

Figure: 1 – Google Earth view showing TfNSW culverts below Princes Highway in proximity to quarry and road cutting (red) and embankment position (green) along road reserve.

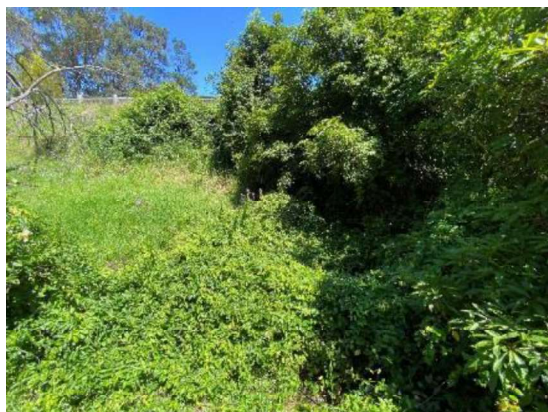
The culverts eastern side could not be inspected due to extensive weed vegetation (see Photographs: 1 and 2) however its western side was visible. This culvert's numbering was also visible, and it comprises a concrete wing wall with approximately 400mm diameter concrete pipe that extends through the filled road embankment see Photographs: 3 and 4. It is assumed that the eastern side of the culvert is of similar construction.

Photograph: 1 – culverts eastern end, formed into drainage gully but completely obscured.

As the southern culverts eastern side is currently completely obscured and inaccessible due to vegetation/weed growth this culvert location will require clearing prior to installation of the monitoring equipment.

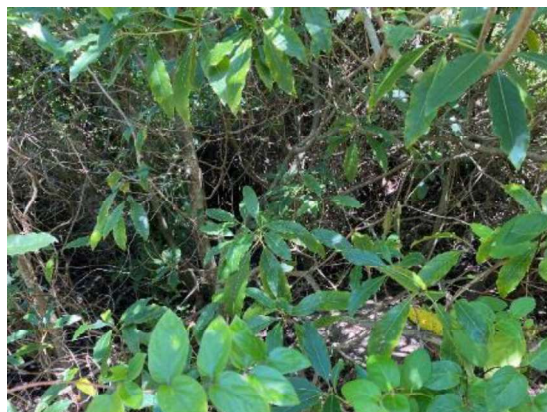
Photograph: 2 – close in view of eastern side of culvert.

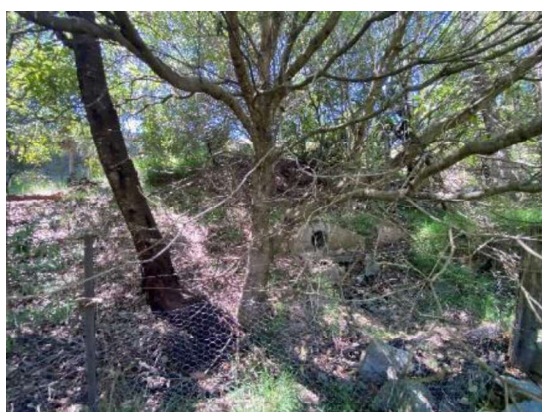
Photograph: 3 – culverts western end, formed at base of embankment.

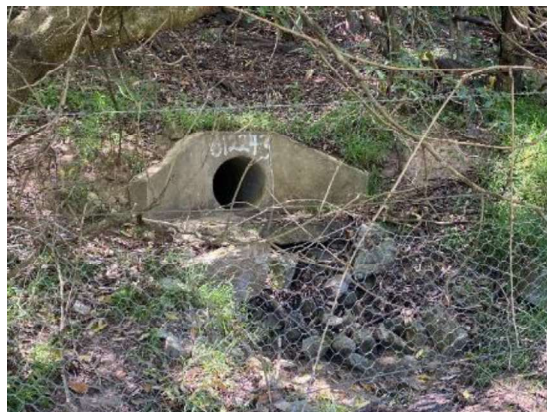
Photograph: 4 – showing exposed culvert on western side.

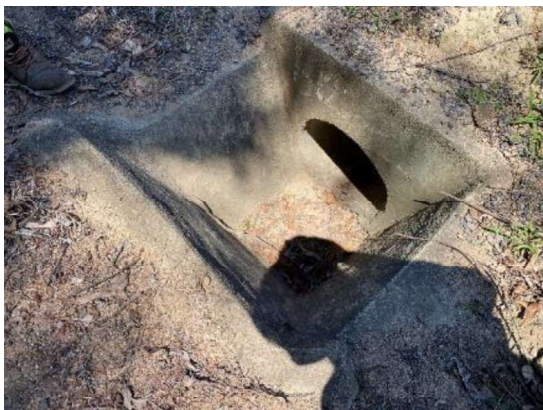
The northern culvert is approximately 50m north and involves a similar 400mm diameter concrete pipe that extends west below the Princes Highway. It extends from a concrete box on its eastern side (Photograph: 5 and 6) that is formed into the road drainage channel within the base of a cutting with the western side appearing to comprise a concrete wingwall formed in the base of a 3.0m high filled embankment, however inspection was limited by slope and vegetation (Photograph: 7 and 8).

Photograph: 5 – culverts eastern end, formed at base of cutting with pipe extending across road.

The northern culvert is located directly adjacent to the road pavement, within a location of high traffic speed. As such, traffic control will need to be implemented to ensure a safe working environment for both set-up and removal of the monitoring equipment in this location.

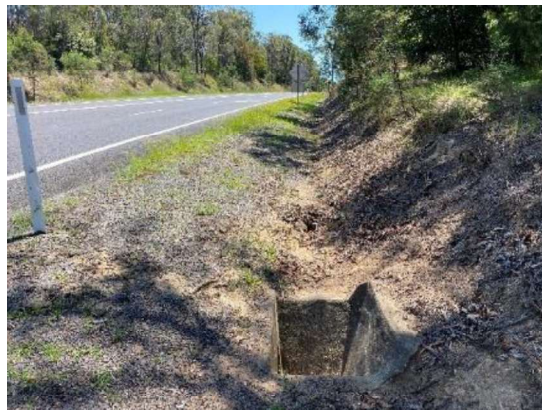
Photograph: 6 – culverts eastern end, formed at base of cutting with pipe extending across road

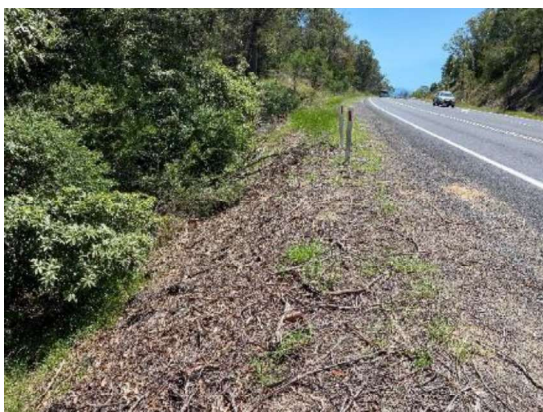
Photograph: 7 – culverts western side position, crest of road embankment.

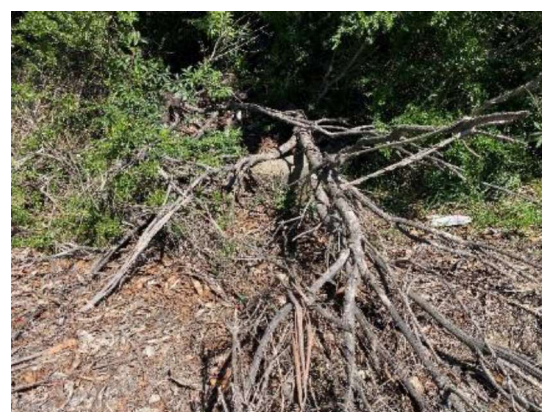
Photograph: 8 – culverts western side, as visible from crest of 3.0m high embankment, viewed west.

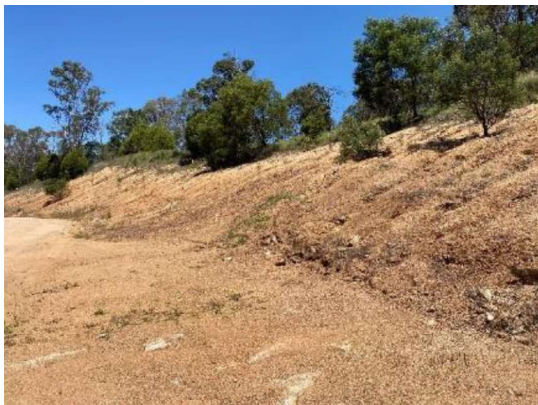
The quarry is formed with steep ( $\approx 26$  to  $32^\circ$ ) excavated batters around its upslope western edges, which extend through surficial soils and extremely weathered granite material to very low strength granite bedrock (Photographs 9 and 10). These batters are understood to have been formed at least 5 years prior to the inspection and show limited erosion and no signs of slope instability (circular failures, tension cracking etc).

Photograph: 9 – existing batter slopes through residual soils and weathered bedrock around central to southern portion of western quarry side.

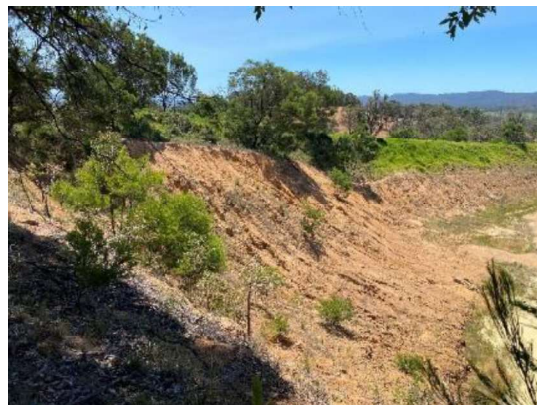
Photograph: 10 – existing batter slopes through residual soils and weathered bedrock around northern portion of western quarry side.

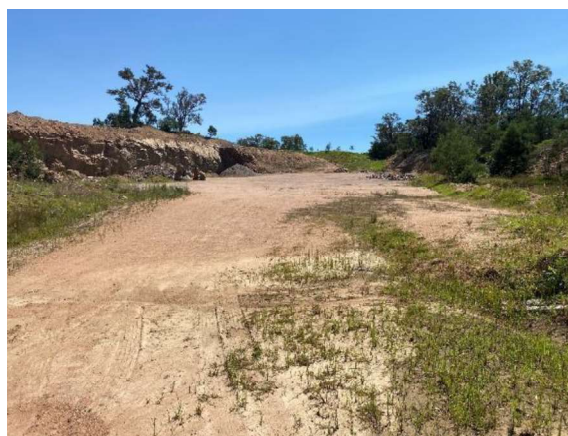
The eastern side of the quarry is formed close to Coral Park Road levels at the south-east corner with a gentle rise in the quarry floor towards the north, resulting in an increased variation to the road. This portion of the quarry is formed below a vertical excavated/quarried face of up to approximately 8.0m in height that strikes north-south across the quarry and exposes the granite bedrock (Photograph: 11).

Photograph: 11 – quarry floor across eastern side, formed close to RL 152 with quarried vertical face to west and Coral Park Road to east.

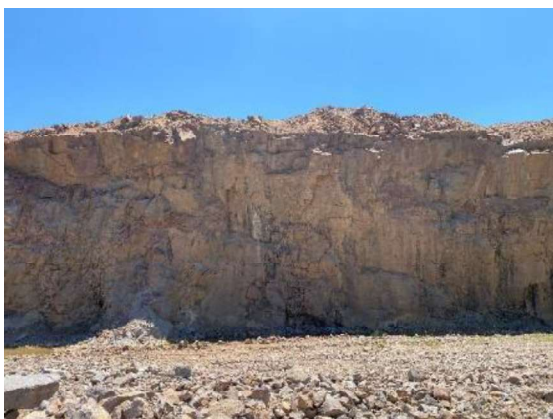
Photograph: 12 – existing quarry, as viewed west at approximate mid-point.

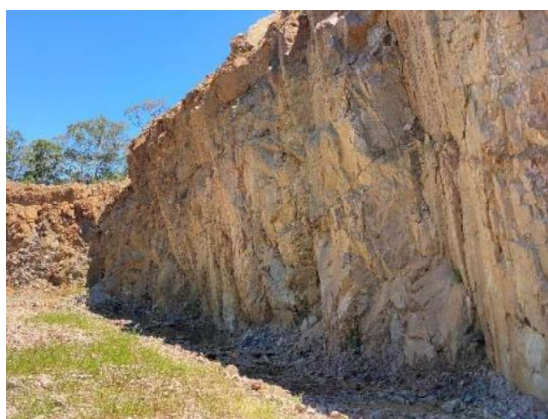
The quarried rock face exposes generally fresh to moderately weathered bedrock with extensive discontinuous fracturing and several orientations of relatively continuous planar defects. As a result of these defects the quarry face is in parts formed overhanging, as seen in Photograph: 15.

Photograph: 13 – existing quarried face viewed south-west showing over-hang due to defect orientation.

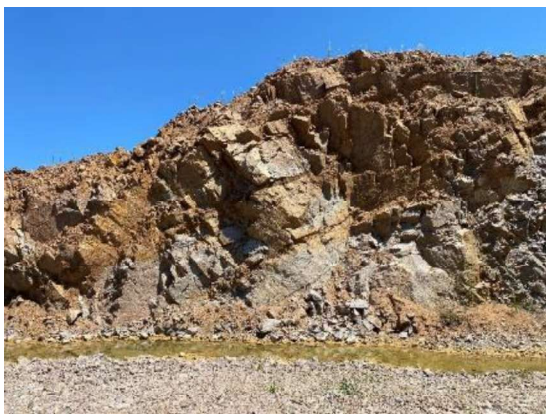
Only limited mapping of defects was undertaken during the inspection however it identified within the rock mass exposed on the eastern side of the quarry that a set of planar joint defects dip steeply (30°) east-south-

east with high continuity (Photograph: 14 and 15) whilst an apparent different set of planar very steeply ( $40 - 45^\circ$ ) north-east dipping joint defects of lower continuity were exposed in the north-east corner of the quarry near surface (Photograph 15).

Photograph: 14 – existing quarried slope, southern end, showing continuous planar joint defects dipping east-south-east.

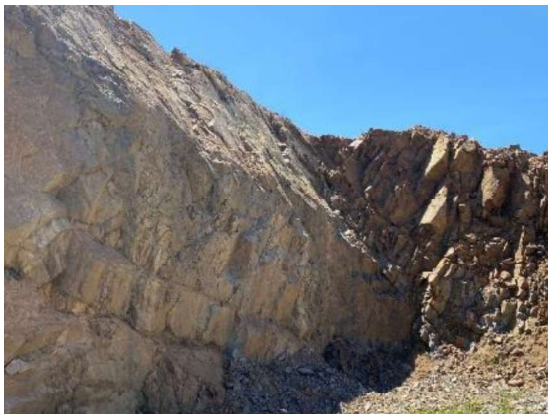
Photograph: 15 – existing quarried slope, northern end, showing continuous planar joint defects in lower slope and second set in upper slope.

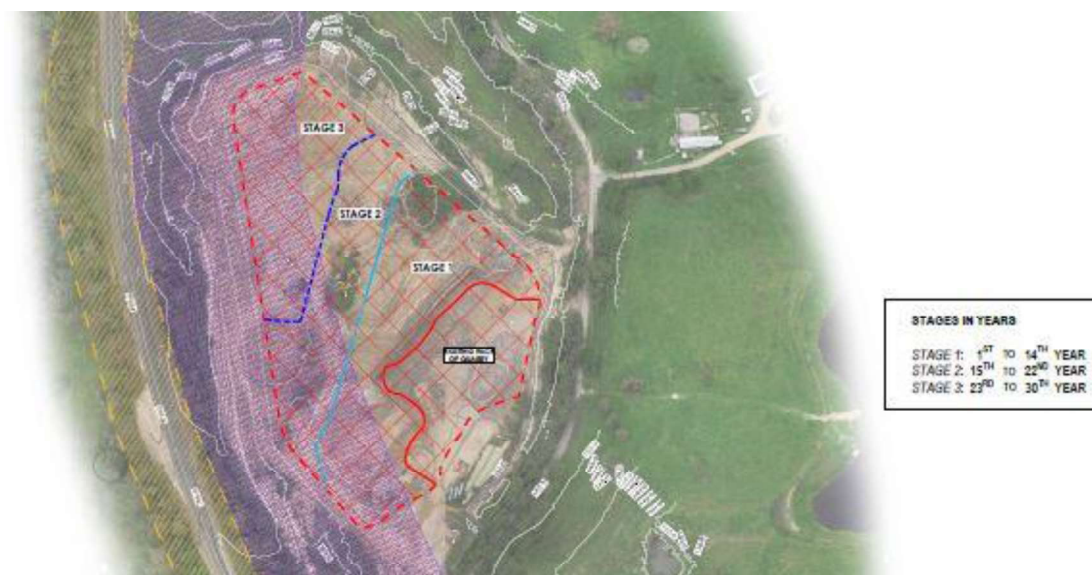
The stages proposed are outlined within the BSE report and are as per the site plan reproduced below (Figure: 2), with the estimated minimum separation distances of the proposed quarry stages to the Princes Highway road reserve defined on the plan.

Figure: 2 – BSE plan of extraction stages showing estimated minimum distances of stage to Princes Highway road reserve.

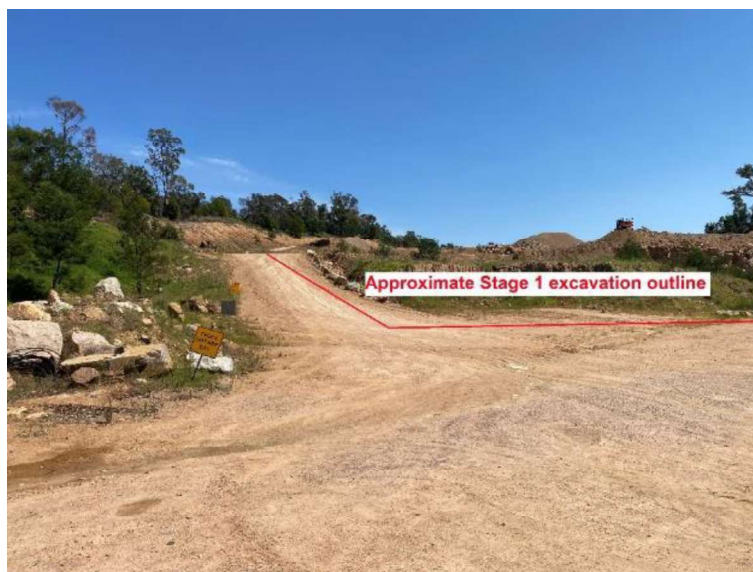
The majority of Stage 1 is located well inside the existing quarry confines with the western portion of the quarry hard rock surface of relatively low height (<6.0m) with respect to the proposed base quarry level due to prior excavation of near surface soils and the local topography, see Photograph: 16.

Photograph: 16 – showing southern end of Stage 1, as viewed from south-east corner of quarry at the approximate base quarry level (RL152).

Based on the quality of the bedrock exposed in the existing quarry and the defects identified, the likelihood for instability as a result of Stage 1 to impact the Princes Highway road reserve is considered to be 'Rare' (AGS 2007).

It is therefore considered that Stage 1 can be completed without further investigation, assessment or monitoring until its completion, at which time geotechnical inspection and mapping of defects within the rock mass must occur.

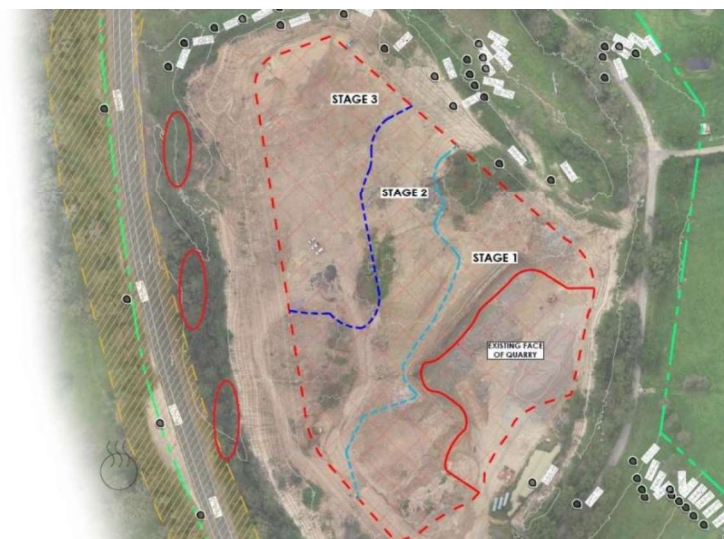
Figure: 3 – Recommended locations for drilling and installation of inclinometer casing for ongoing measurement of bedrock deformation during the proposed quarry works.

These bores should be undertaken using NMLC triple tube core under geotechnical supervision and logging to provide a profile of ground conditions and actual defects. These boreholes should extend to a minimum of RL 145. Access to these areas is limited therefore actual positions for the three bores should be defined at the time of investigation based on rig accessibility, approximate positions are detailed below in Figure: 3.

Following completion of each borehole, the installation of inclinometer casing to the base of the hole should occur with measurement of casing alignment approximately 1 week after installation to provide a baseline reading.
