# Memorandum

**From:** Robert de Jong (Arbor Express) – AQF  
Level 5 Arborist

**Subject:** Removal of 2 trees

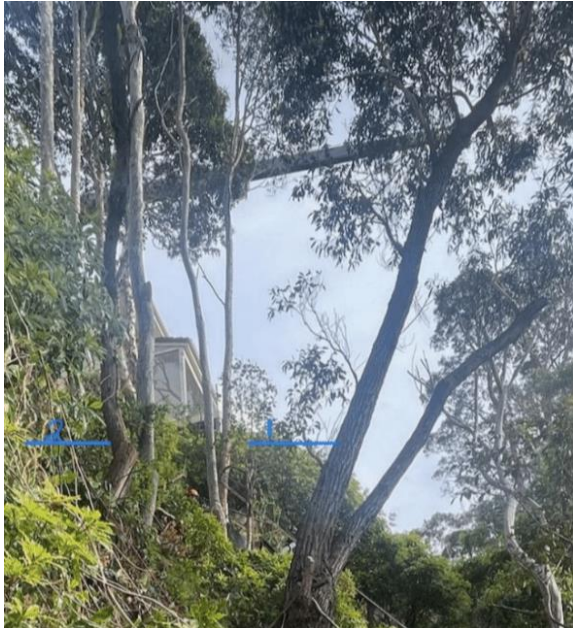
Photo 1: Photos provided by builder showing Tree 1 and 2

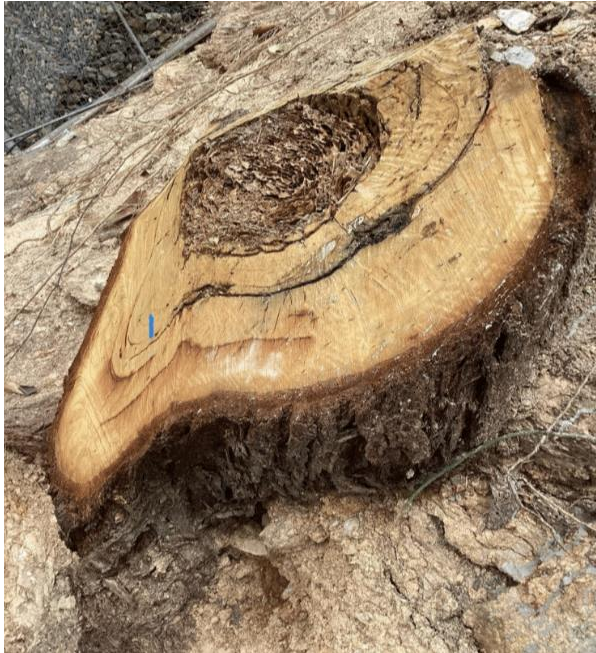
Photo 2: Tree 1 showing major termite damage

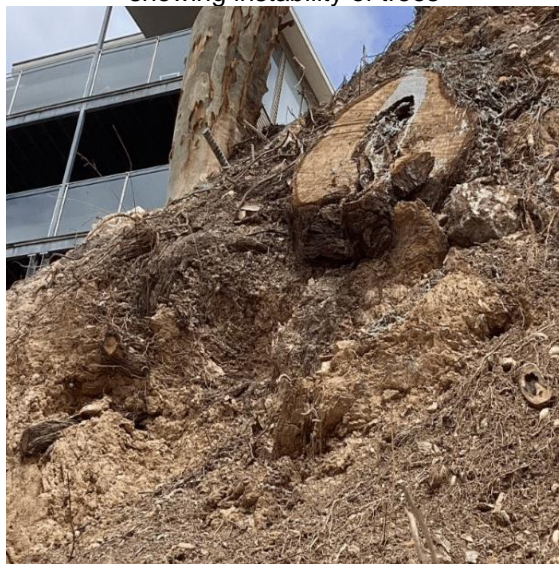
Photo 3: Tree 2 showing major termite damage with landslide and basal roots exposed showing instability of trees

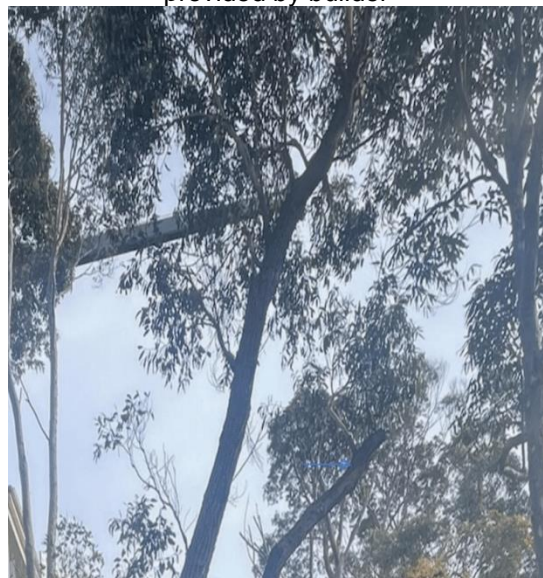
I have been asked to examine the removal of 2 Iron Bark trees. I have 2 stumps located on the cliff face. Both stumps show clear evidence of major termite infestations. Given the size of the stumps with photos provided, they were mature trees. Tree 1 in the photos shows evidence of limb failure with epicormic growth. The tree closest to the top Tree 2, is in very poor condition with the top part mostly dead. There has been a major landslide around the trees basal roots as indicated by the photos. Again, this area is being strategically drilled with large bolts into the cliff face with terra mating to secure the area.

Photo 4: Tree 1 showing evidence of limb failure and epicormic growth due to stress. Photo provided by builder

Given the situation the builder has been presented with, the removal of the trees appears to be necessary.

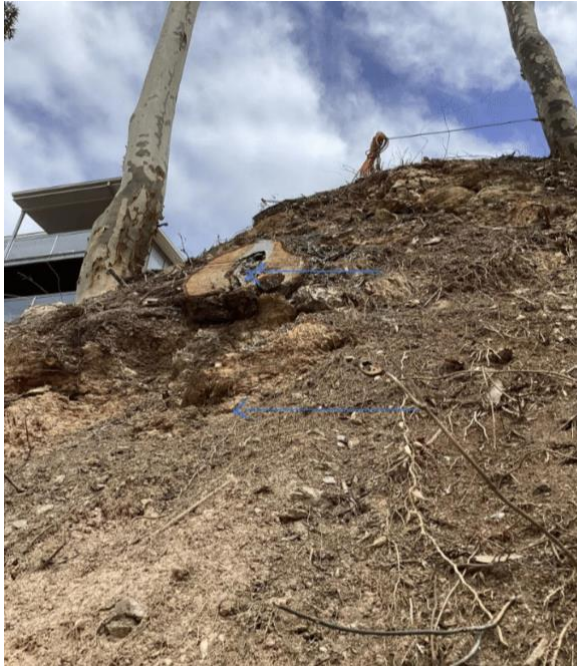
Photo 5: Tree 2 showing further evidence of landslide

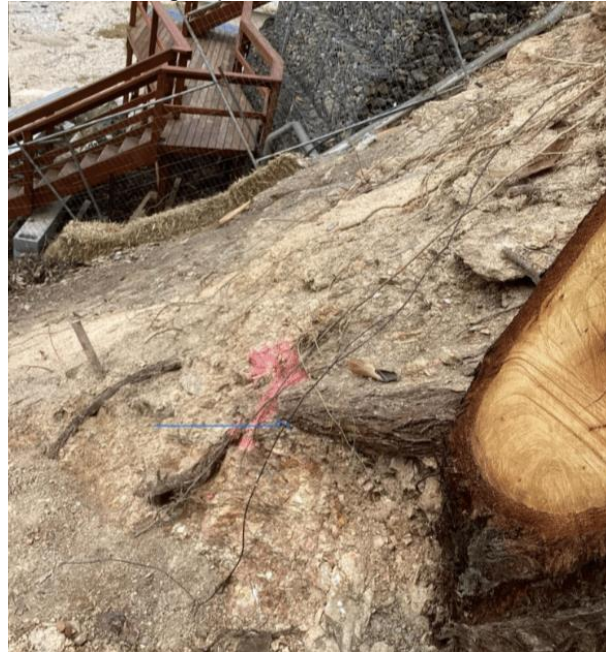
Photo 6: Tree 2 showing close up of basal roots being exposed due to landslide
