REPORT TO
AUSTRALIAN EXECUTIVE APARTMENTS PTY LTD

ON
GEOTECHNICAL ASSESSMENT

FOR
PROPOSED REDEVELOPMENT
OF ROBERTSON HOTEL

AT
1 FOUNTAINDALE ROAD, ROBERTSON, NSW

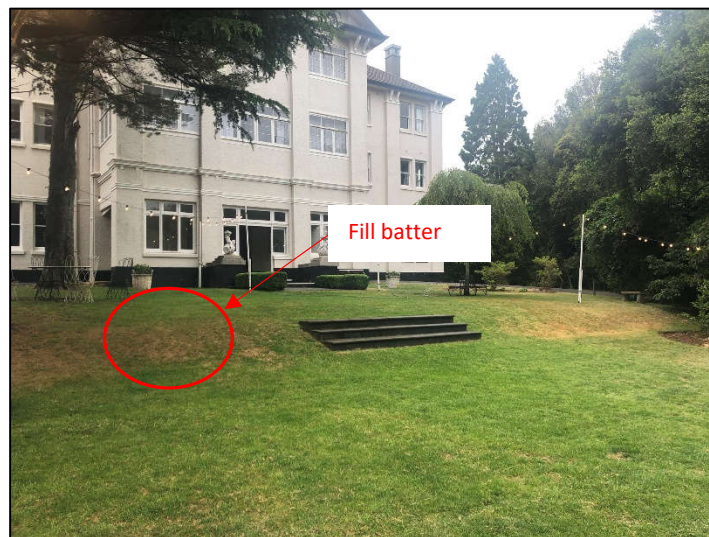
The southern portion of the site was characterised by a hill with a relatively flat crest at about RL774.0m. The existing Robertson Hotel, which comprises a one to three-storey rendered brick building, was located along the crest of the hill, and appeared to be in generally good external condition, based on a cursory inspection from ground surface level within the site. Refer to Plate 1 below. The area on the western side of the hotel had been filled to a maximum height of about 1m and regraded to form two gently sloping lawn areas. The fill batter shown in Plate 1 below, graded at about 16° (Blue circle 1).

Plate 1: View looking east from the western side of the Robertson Hotel.

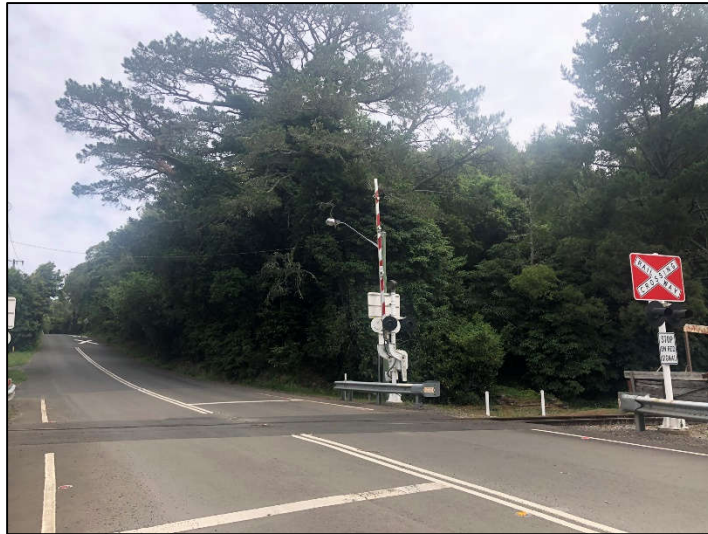
Plate 2: View looking north at the intersection of Fountaindale Road & the railway line, showing dense vegetation cover within site.

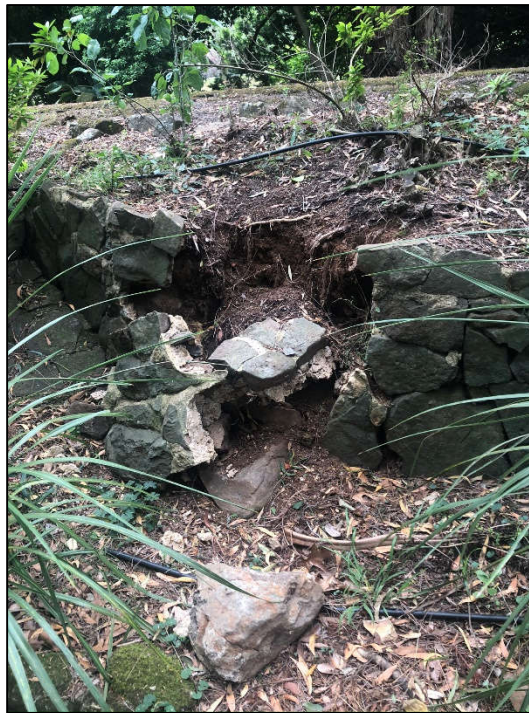
A single storey timber clad building was located towards the southern corner of the site and was in a dilapidated condition (Blue circle 3). An in-ground pool was located mid-length along the eastern side of the site. An approximate 1m high brick retaining wall supported the ground surface to the south. Surrounding the hotel were several asphaltic concrete (AC) or gravel surfaced internal roads, and some were in poor condition, with potholes and cracking observed. Some areas had been regraded and filled slightly for landscaping purposes, with these areas supported by stone and timber retaining walls generally to a maximum height of about 1m, but locally to a maximum height of about 1.5m. The retaining walls were often in poor condition, with localised collapsed sections, blocks and timber panels missing (Blue circles 2, 4 and 5) exposing the backfill, and sections which had rotated outward. Refer to Plate 3 below.

Plate 3: View looking north showing localised collapsed of retaining wall (Blue circle 2).

2. All existing retaining walls, the majority of which were in poor condition, would be demolished and replaced with properly designed engineered retaining walls.

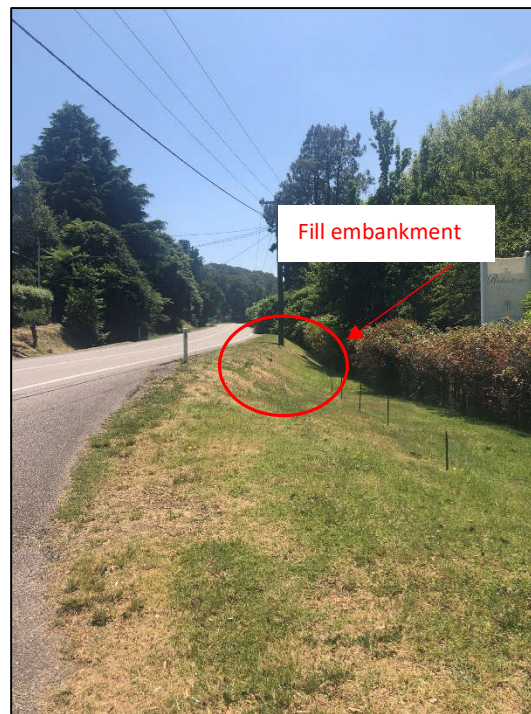
The Illawarra Highway along the southern end of the western site boundary, sloped down to the south at about 2°. The eastern side of the highway was supported on a fill embankment, ranging in height from about 1m at its southern end, to about 4m high mid-length along the western site boundary and then appears to taper away toward the northern end of the western boundary. Where the embankment was visible from the entrance into Robertson Hotel, the sides sloped down to the east at between 32° and 35°. As the embankment extended further to the north, the toe of the embankment extended into the site and it became more difficult to inspect due to the dense vegetation. Refer to Plate 4 below (Blue circle 6). We did not observe any obvious signs of fill batter slope instability, such as slumping, tension cracks behind the crest, etc, though our observations were largely obscured by dense vegetation.

Plate 4: View looking north along Illawarra Highway from the hotel entrance, showing the eastern side of the fill embankment.

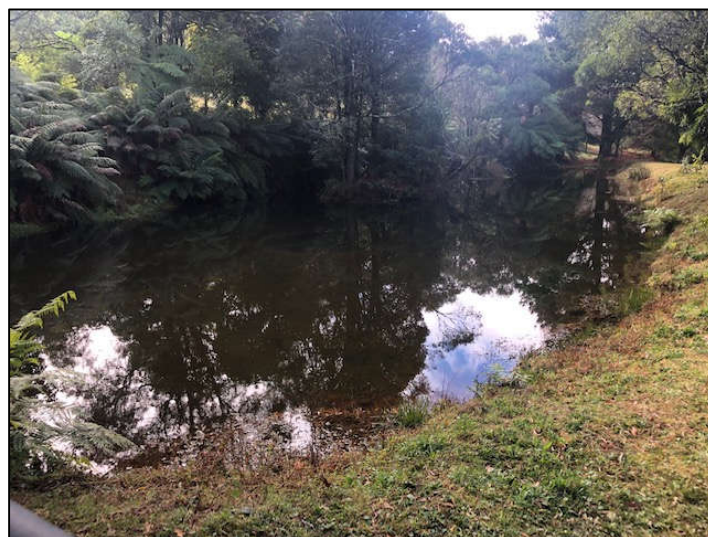
Toward the northern corner of the site was a dam (Blue circle 7), with the embankment on its south-eastern side, which was up to about 2.5m high. The crest width ranged between about 2m and 5m. The downstream shoulder graded at between about 14° and 17°. The north-western (high) side of the dam was obscured by dense vegetation. The storage area contained water, with the water level being within about 0.8m of the crest of the downstream shoulder. There was no formal spillway and the outlet comprised a small diameter PVC pipe, which discharged water directly onto the ground, immediately along the toe of the downstream shoulder. The downstream shoulder was vegetated with grass and small to medium sized trees. Sections of the downstream shoulder, as well as the area immediately beyond the downstream toe of the embankment was 'boggy' under foot, indicating dam leakage. Refer to Plates 5 & 6 below.

Plate 5: View looking east across dam from its western end.

Based on the results of our inspection, we consider that the existing dam located towards the northern corner of the site is in poor condition for the following reasons:

1. **Presence of trees and other vegetation on the embankment:** Existing trees on the embankment can cause seepage, internal erosion and ultimately piping failure along decaying tree roots. An abundance of tree roots through the embankment can also result in loosening of the earthfill and increased surface erosion. Furthermore, trees which topple over as a result of strong winds and/or bushfire, could remove support, or cause a breach of the embankment. The vegetation may also attract burrowing animals into the embankment and obscure the entrances.

In our opinion, if the existing dam is to be incorporated into the proposed development, then significant rehabilitation will be required. It is possible that a breach could occur at anytime, though would be more likely during or shortly following a storm event. We strongly recommend that the embankment be replaced with a properly engineered embankment.

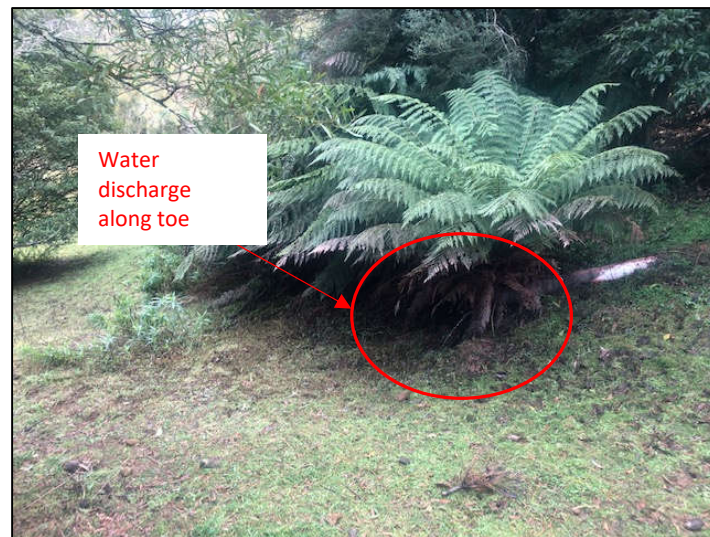
Plate 6: View looking west along toe of the downstream shoulder, showing water discharge directly onto ground surface.

2. **Evidence of seepage through the embankment and foundation material:** There was evidence of seepage through the embankment and foundation material. Based on the nature of the dam, it is unlikely that any measures to control seepage and erosion through the foundation (eg. cut-off trench, etc.) were ever constructed. The implication of the seepage and the likely elevated pore pressures below the embankment relates to the stability of the downstream shoulder. If the pore pressures are high, then uplift pressures below the embankment may be present, thus potentially compromising stability. Furthermore, internal erosion and ultimately piping failure through the foundation material and/or earthfill material may occur. These factors could cause a breach of the embankment.

3. **Lack of a formal spillway:** The dam did not have a formal spillway structure, and water from the dam was being discharged in an uncontrolled manner through a PVC pipe along the toe of the embankment, both of which can cause scour and erosion of the downstream shoulder, and ultimately a breach of the embankment. The erosion would be exacerbated if trees toppled during the discharge due to erosion.

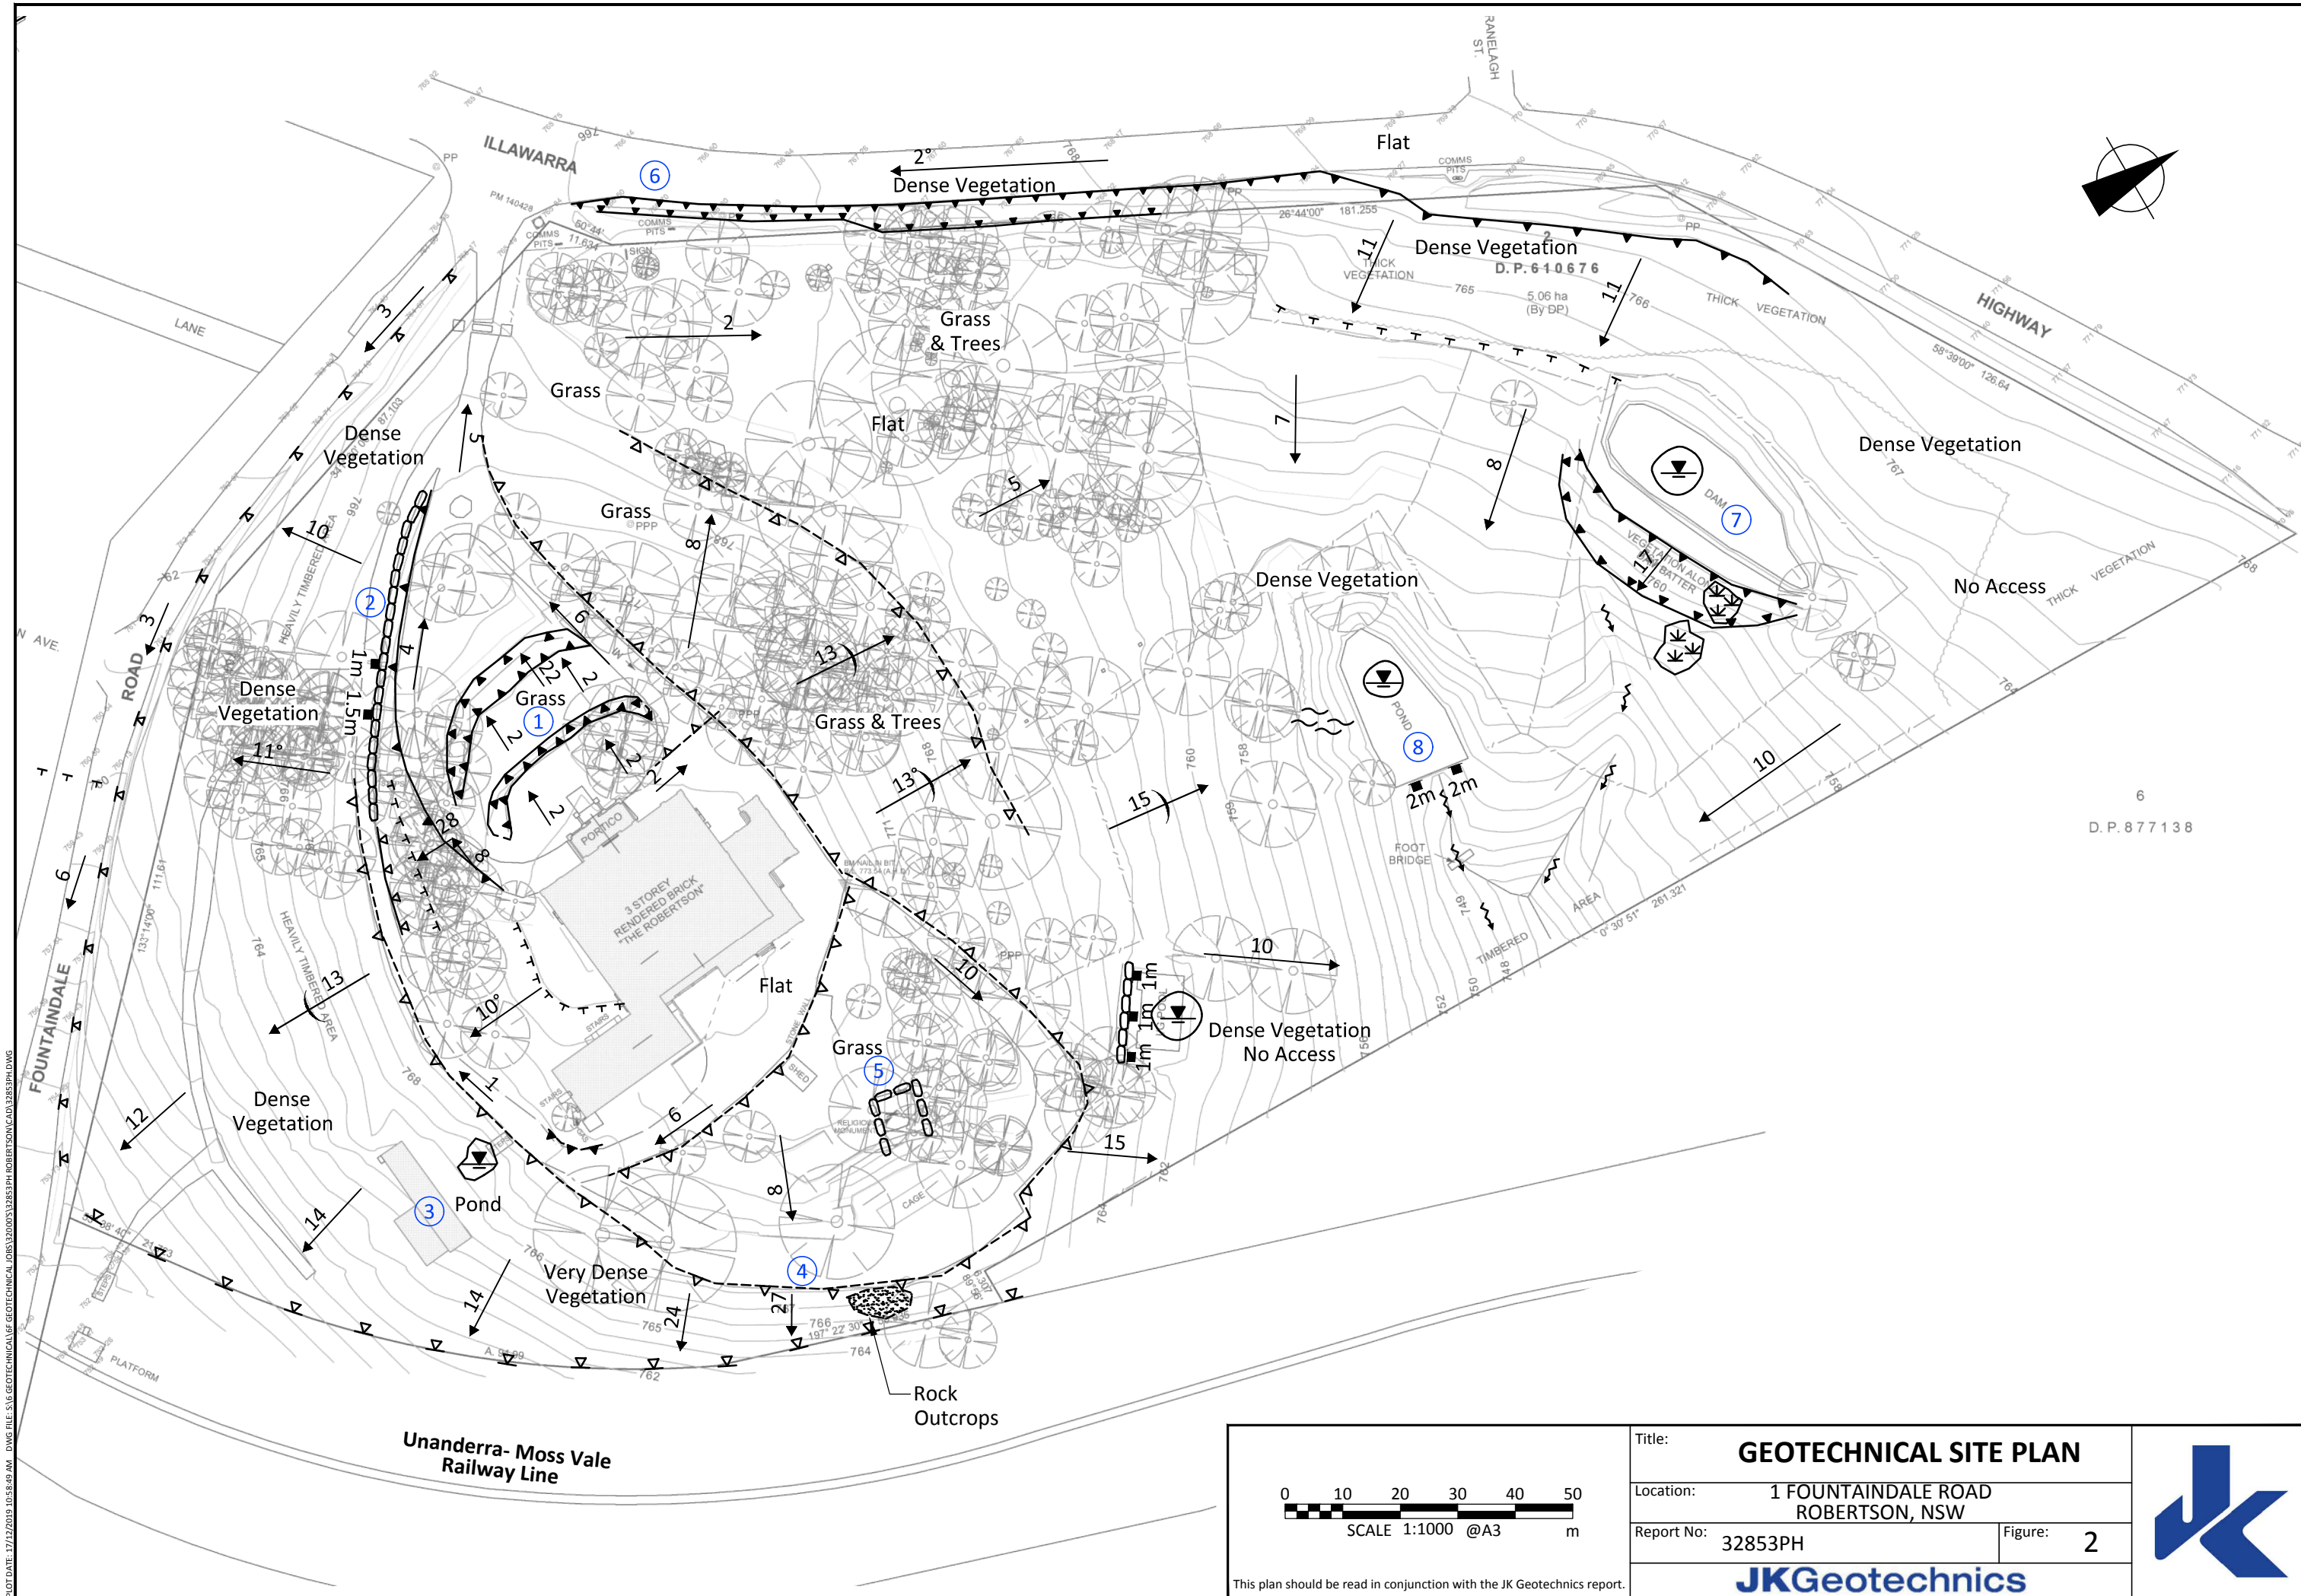
Title: GEOTECHNICAL SITE PLAN	
		Location: 1 FOUNTAINDALE ROAD ROBERTSON, NSW	
Report No: 32853PH		Figure: 2	
This plan should be read in conjunction with the JK Geotechnics report.

We recommend that the summary of observations which follow be read in conjunction with the attached Figure 2. The blue circled numbers on Figure 2, refer to specific features and are referred to in the text below.
