# **217A Beach Road Denhams Beach NSW 2536**

## **Arboriculture Assessment & Report**

<b>Project Name</b>	217A Beach Road Denhams Beach NSW 2536 Arboriculture Assessment & Report
<b>Project Number</b>	AAR25/02/2025
<b>Prepared by</b>	Robert de Jong
<b>Status</b>	Final
<b>Version</b>	v1
<b>Last saved on</b>	5/03/2025

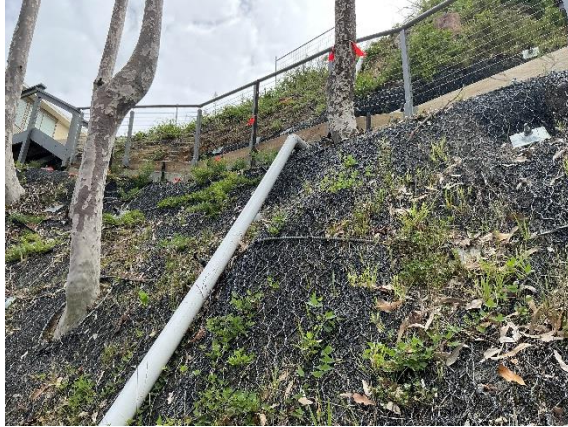
Photo 5: Area Around Base of Trees showing  
Adequate Room for Growth

As the photos illustrate, the installation of the steel mesh around the six trees was completed without any noticeable damage. There are no visible wounds on their trunks, and their canopies are intact and healthy. The large steel cables surrounding the base of each tree are sufficiently sized to allow for future growth. The seventh tree has a cut in the trunk, and its canopy has been pruned in the past, resulting in epicormic growth with poor structure.

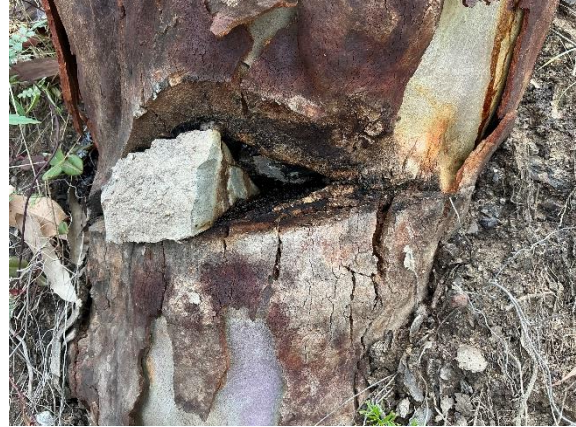
Photo 6: Wound 1 meter up

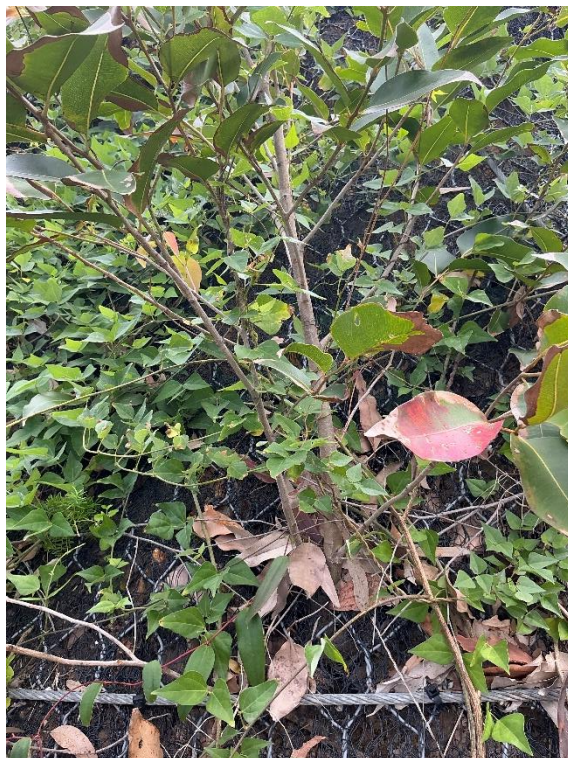
Photo 7: Old Stump with Epicormic Growth

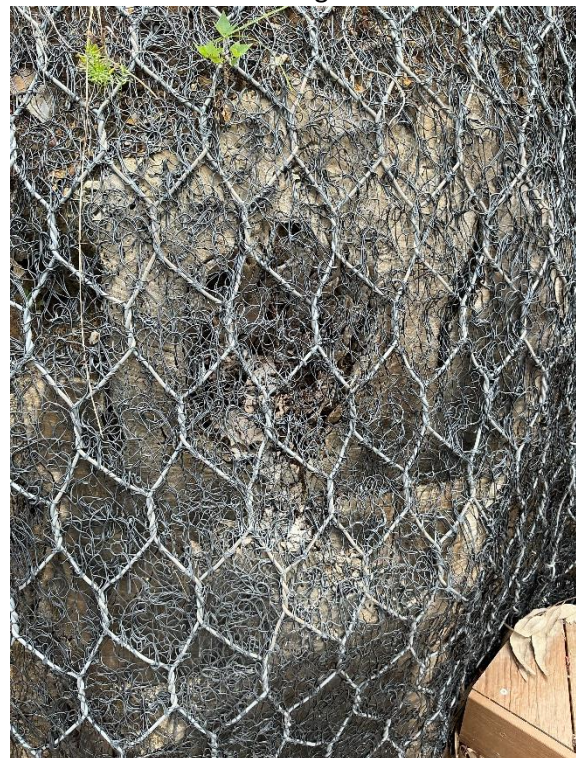
Photo 8: Old Stump showing Severe Termite Damage
