# Memorandum

Subject: Conclusion Going Forward

# 217A Beach Road Denhams Beach NSW 2536

## Arboriculture Assessment & Report

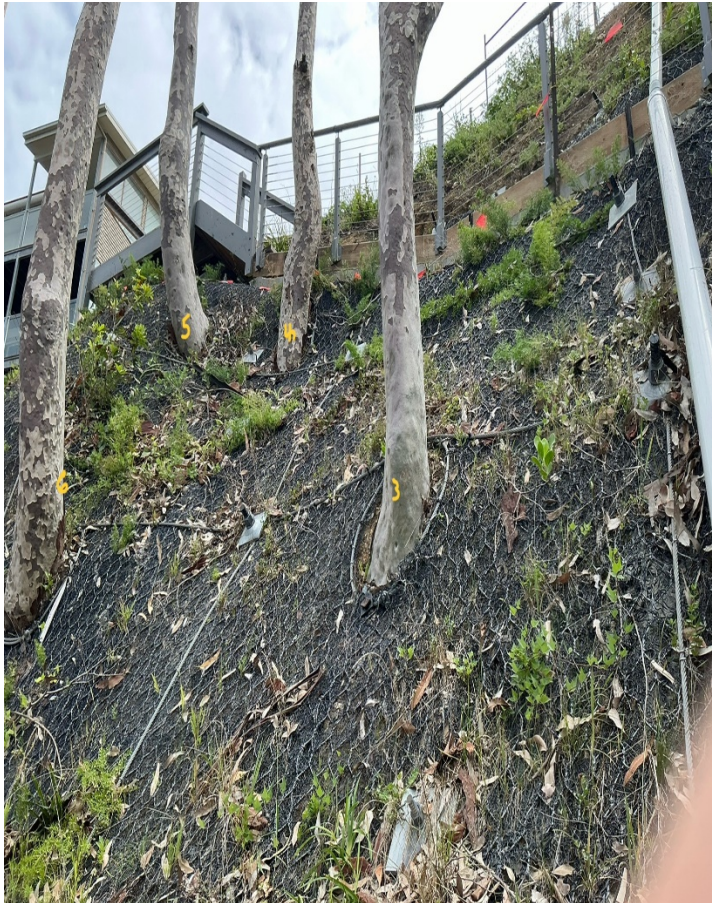
Photo 1 above

Photo 1: Taken February 2025 showing stabilisation of the cliff face, trees in good health with no bark damage and healthy canopy cover due to the soil being able to breath and takes up moisture with self-seeded plants clearly establishing themselves.

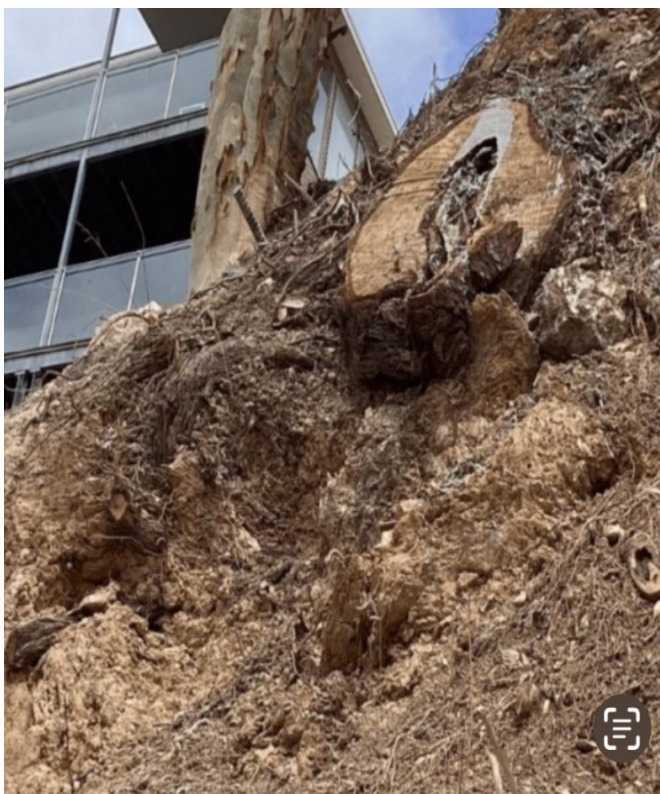
Photo 2 above

The decision to remove two trees in 2023 (see attached memorandum) due to structural issues was prudent given the circumstances, as any failure later may add to the destabilisation. The photos taken in December 2023 showed evidence of soil erosion that was exposing the basal roots. The placement of heavy mesh required to hold the cliff face appears to be working. With the torrential downpours lately, there are no signs of erosion with new self-seeded plants clearly establishing themselves in between the mesh. The effort to stabilise the neighbouring cliff face is clearly evident; the expansive concrete slab is quite extraordinary.

Photo 2 Taken December 2023 showing soil erosion and termite damage.

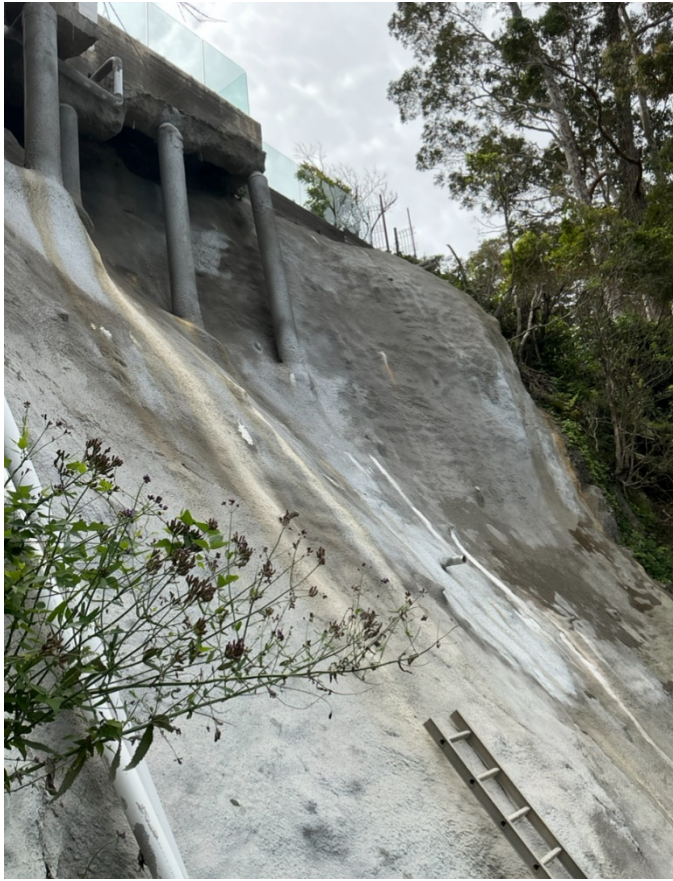
Photo 3 above

Photo 3 Taken February 2025 show neighbour cliff face 217 Beach road

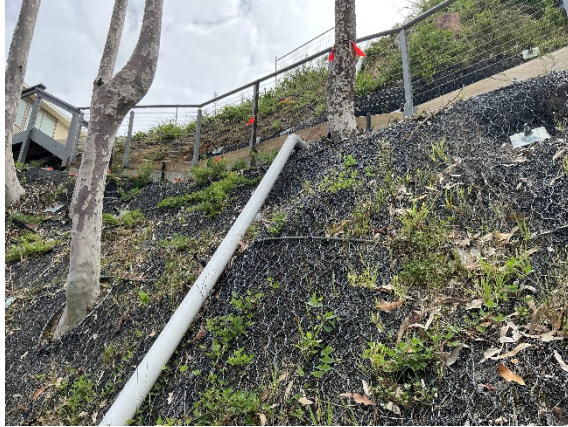
Photo 5: Area Around Base of Trees showing  
Adequate Room for Growth

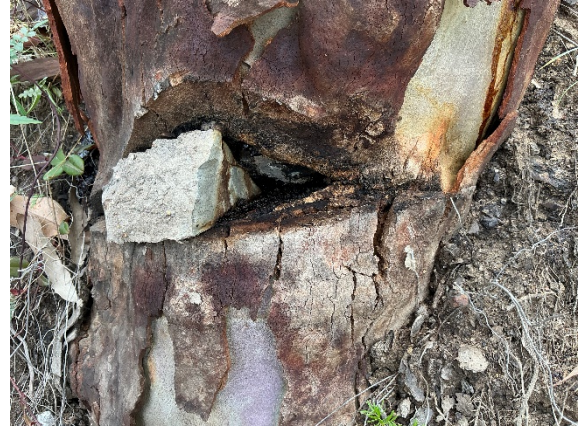
Moving forward, the remaining trees labelled 1 to 6 are in excellent condition. However, Tree 7, located at the base of the cliff, has a V-shaped cut approximately one meter up, which may indicate that it has been vandalised.

Photo 6: Wound 1 meter up

Trees 1, 2, 3, 4, 5, and 6 are showing strong vitality and good vigour. The care taken to stabilise the area under difficult conditions has enabled these trees to flourish. However, the seventh tree should be removed as it poses a danger to people.

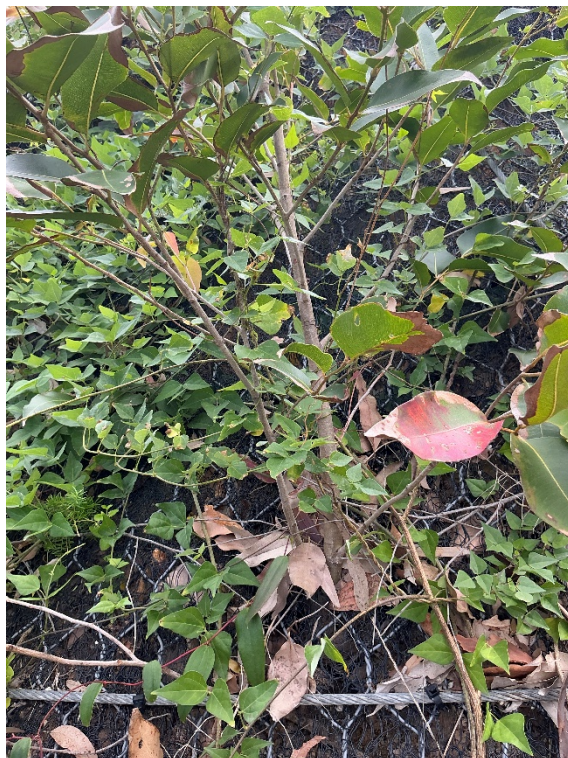
Photo 7: Old Stump with Epicormic Growth

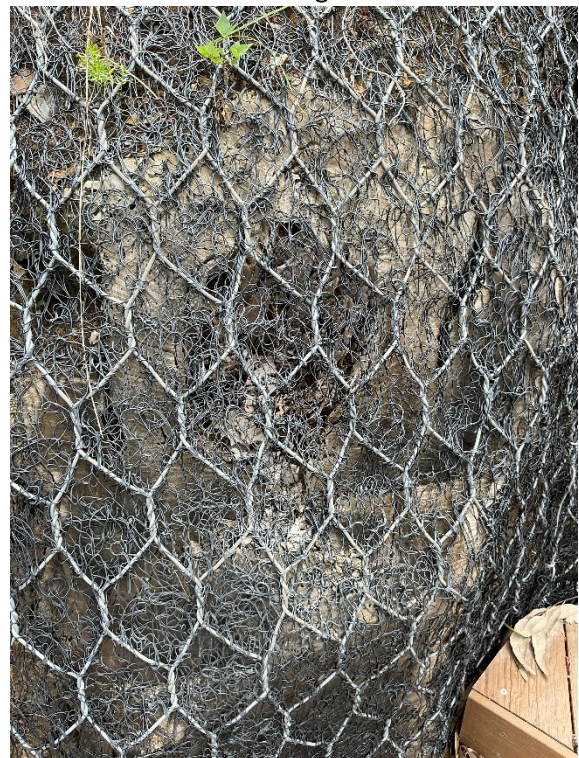
Photo 8: Old Stump showing Severe Termite Damage

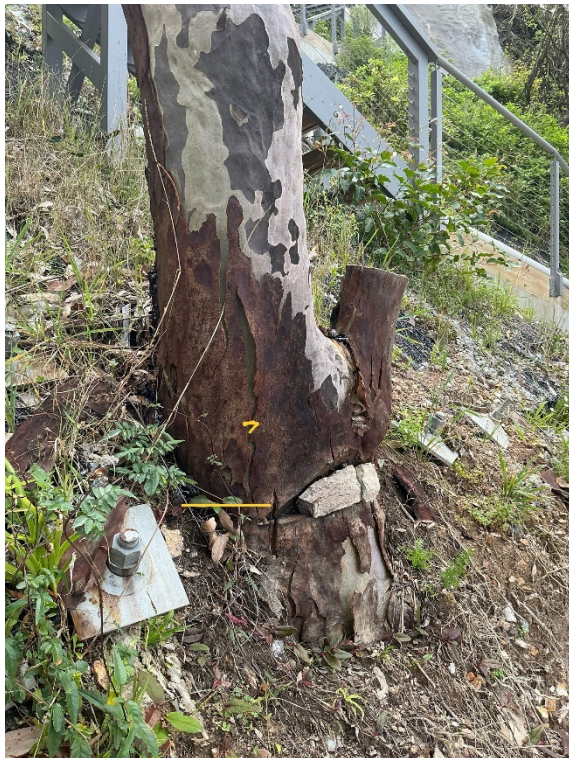
Photo 9: Tree 7

| Tree # | Botanical Name (Common Name) | Height (m) | Canopy (m) | DBH (mm) | DAB (mm) | TPZ SRZ (m) | SULE | Retention Value | Action | Notes |
|---|---|---|---|---|---|---|---|---|---|---|
| 7 | <i>Corymbia maculata</i> (Spotted Gum) | 13 | 4 | 180 | 200 | 2.16<br>1.68 | 4B | Low | Remove | DBH & DAB are approximate due to access |

The six Spotty Gums growing close together are in good condition following the completion of the work to lay steel mesh to stabilise the area. There is a seventh gum at the bottom of the cliff. As the photos illustrate, the installation of the steel mesh around the six trees was completed without any noticeable damage. There are no visible wounds on their trunks, and their canopies are intact and healthy. The large steel cables surrounding the base of each tree are sufficiently sized to allow for future growth. The seventh tree has a cut in the trunk, and its canopy has been pruned in the past, resulting in epicormic growth with poor structure.

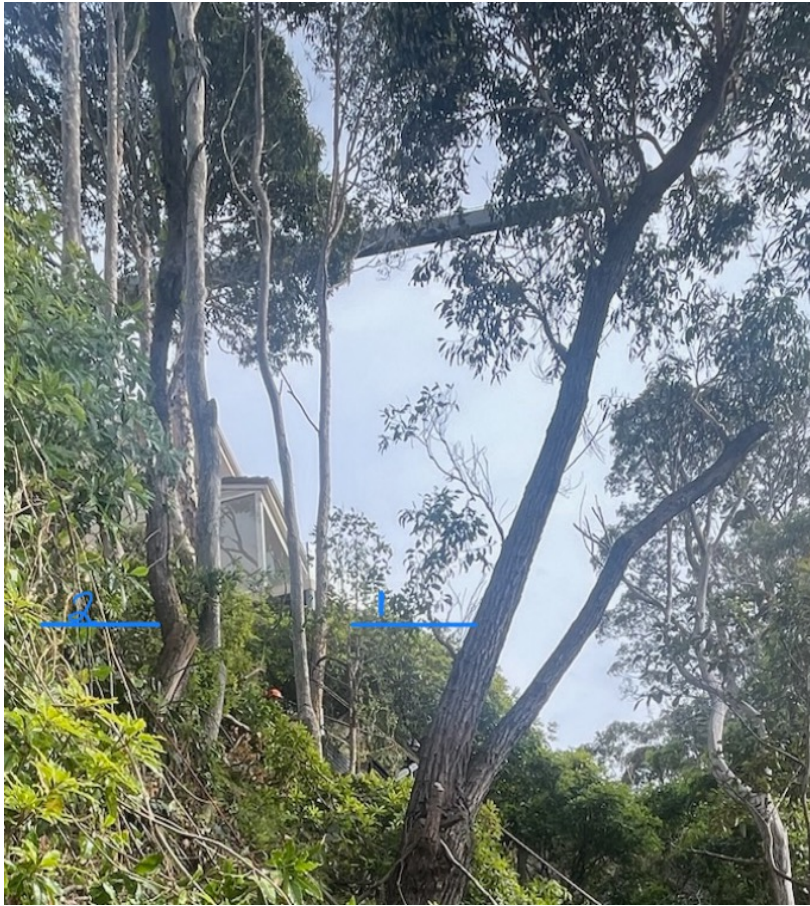
Photos Provided by Builder Showing Tree 1 and 2

I have been asked to examine the removal of 2 Iron Bark trees. I have 2 stumps located on the cliff face. Both stumps show clear evidence of major termite infestations. Given the size of the stumps with photos provided, they were mature trees. Tree 1 in the photo shows evidence of limb failure with epicormic growth. The tree closest to the top, Tree 2, is in very poor condition with the top part mostly dead. There has been a major landslide around the trees basal roots as indicated by the photos. Again, this area is being strategically drilled with large bolts into the cliff face with terra mating to secure the area. Given the situation the builder has been presented with, the removal of the trees appears to be necessary.

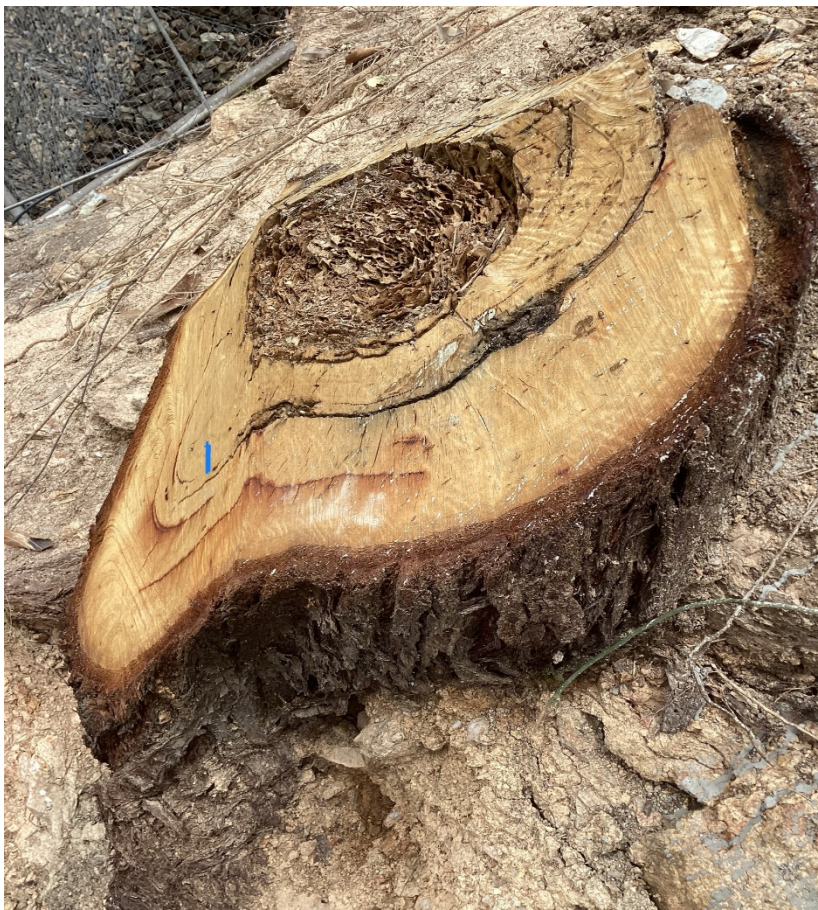
Tree 1 showing major termite damage

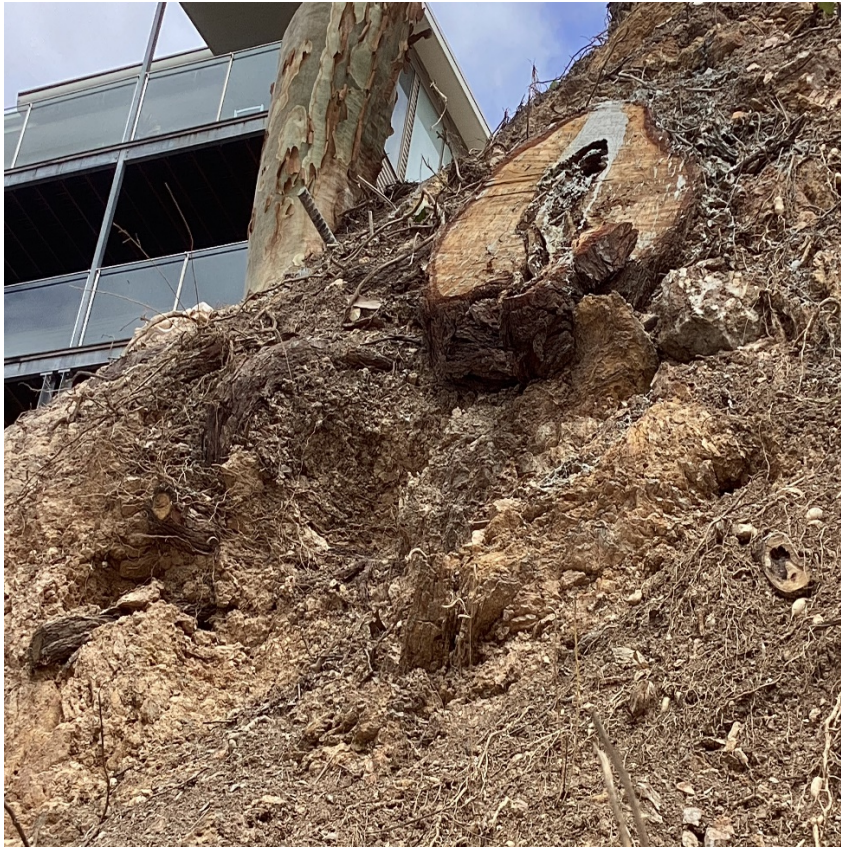
Tree 2 Showing major termite damage with landslide and basal roots exposed showing instability of tree

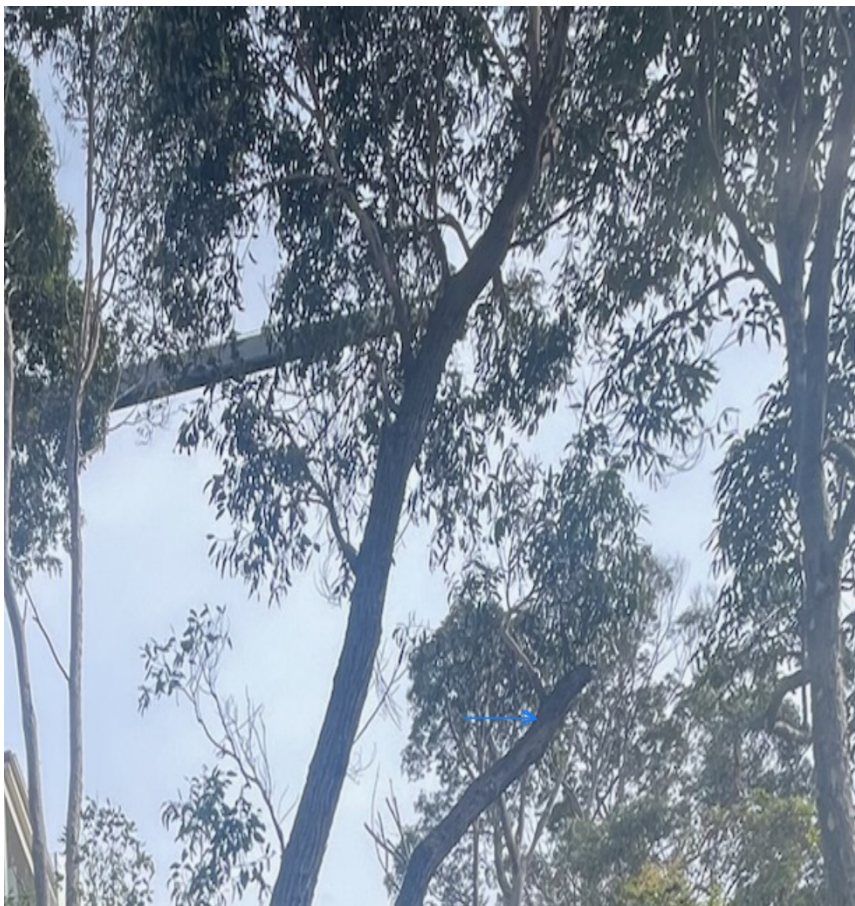
Tree 1 showing evidence of limb failure and epicormic growth due to stress. Photo provided by builder.

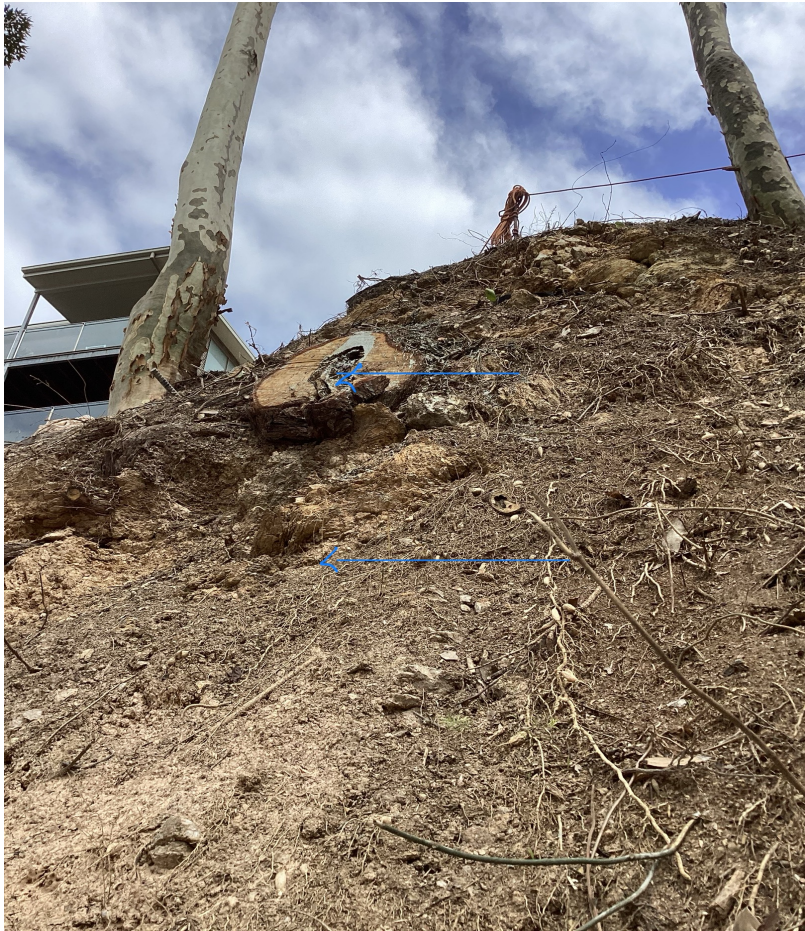
Tree 2 showing further evidence of landslide

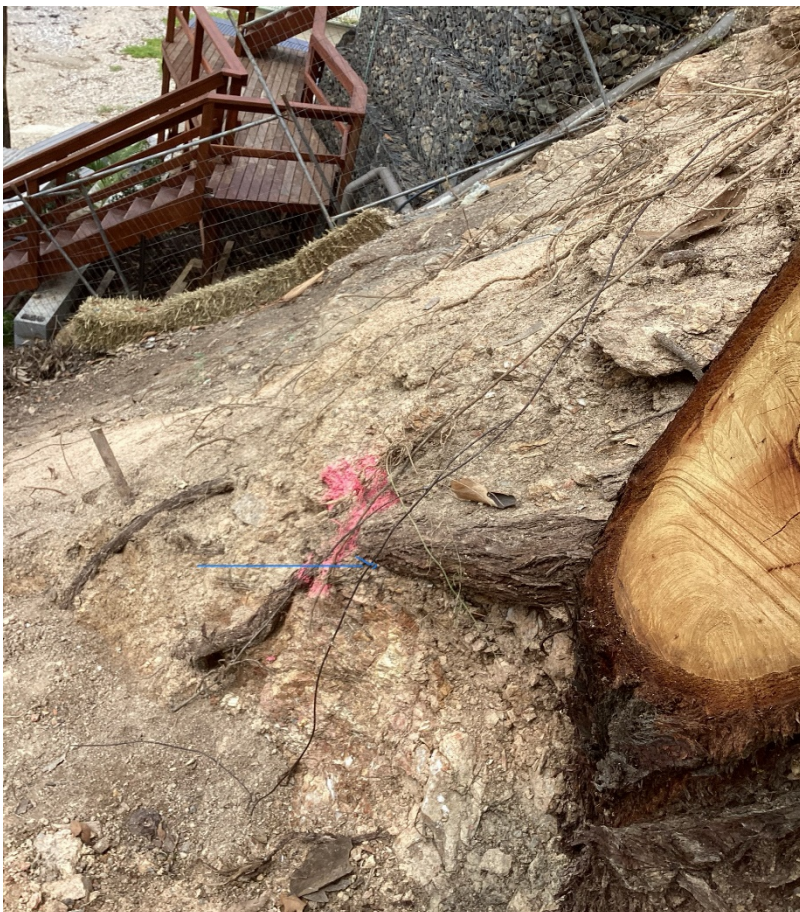
Tree 2 showing close up of basil roots being exposed due to landslide.
