EROSION CONTROL PLAN

Jumping Creek QUEANBEYAN

Version 3

29 January 2019

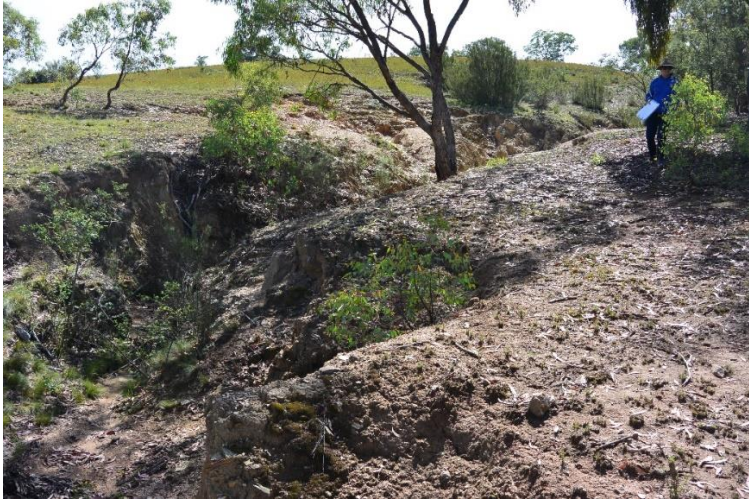
<p>DSC 3806: Small areas of bare eroding bank</p> </div> <div style="text-align: center;">

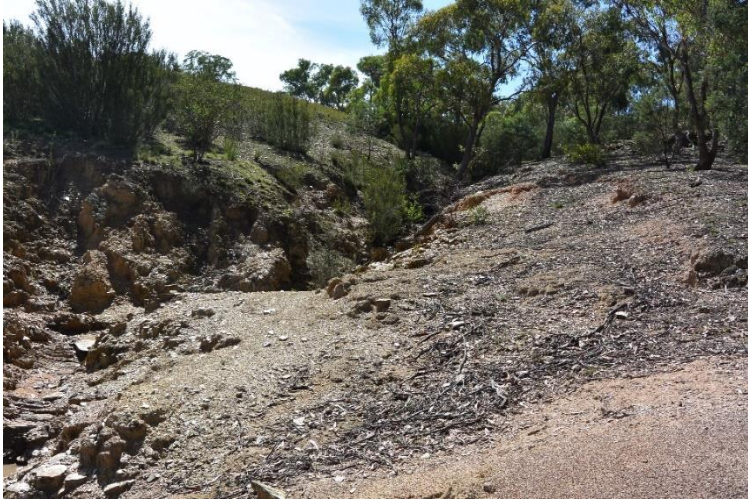
<p>DSC 3807: Small active gully heads in gully line</p> </div> </div>

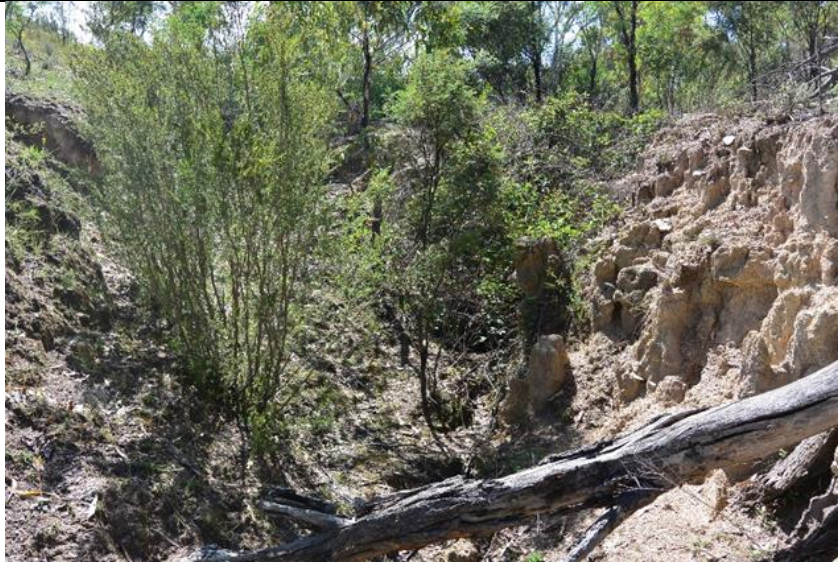
DSC 3808: Actively eroding vertical creekbank

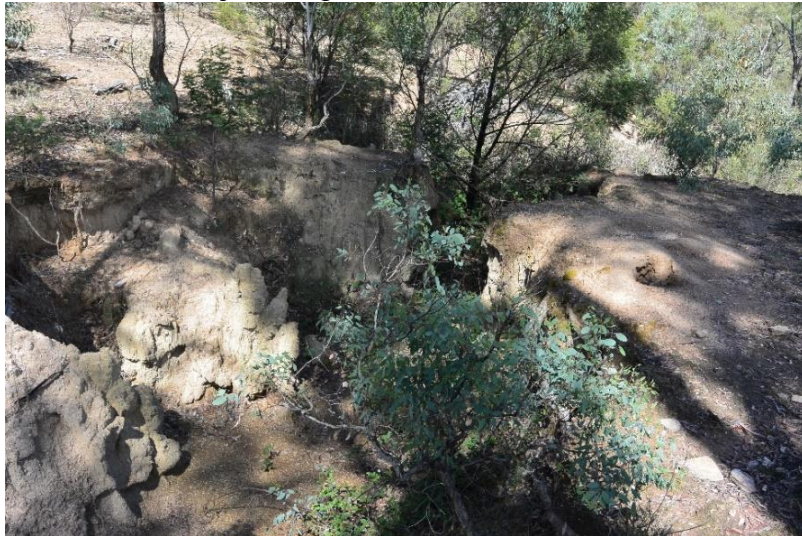
DSC 3810: Areas of eroding bank collapsing into creek bed

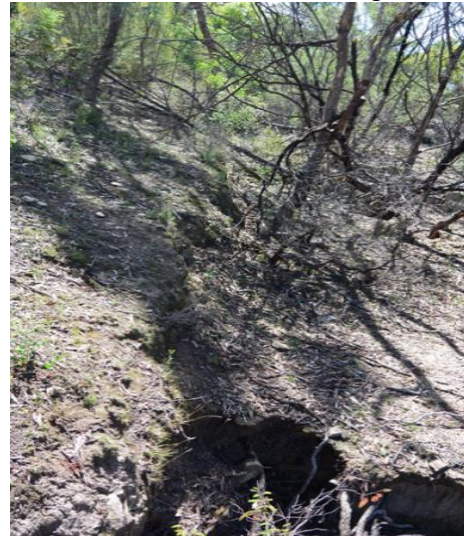
DSC 3811: Small active gully head

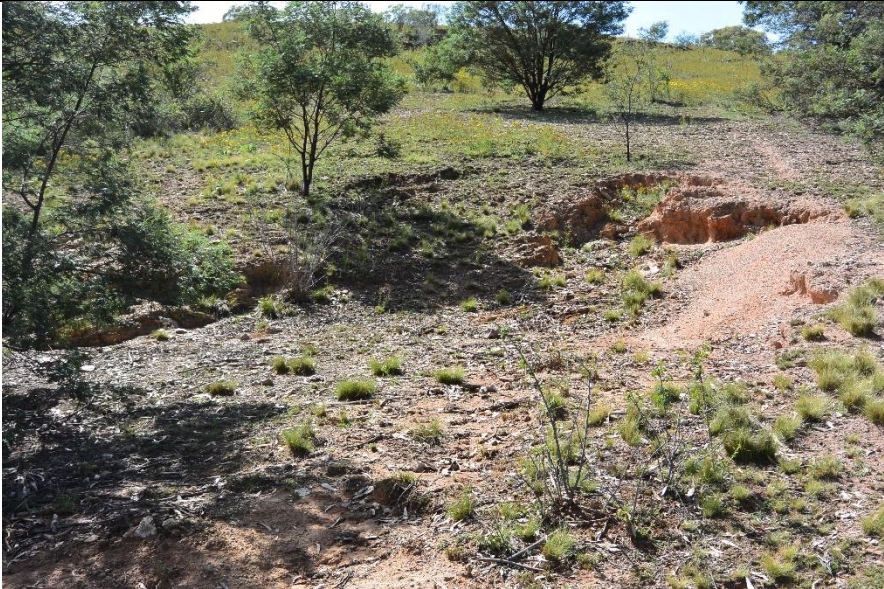
Lat -35.378787° Lon 149.252293°	Eroding gully head in small drainage depression.	Moderately active gully head.	Low to medium priority (small depth of gully may naturally regenerate overtime)	Construct a small earth diversion bank upslope of the gully head to divert runoff in the drainage depression around the active gully head. Lightly rip the area around the gully head below the diversion bank, then seed and mulch the area with suitable species mix, consistent with the Vegetation Management Plan.

DSC 3803: Small active gully head in base of drainage depression

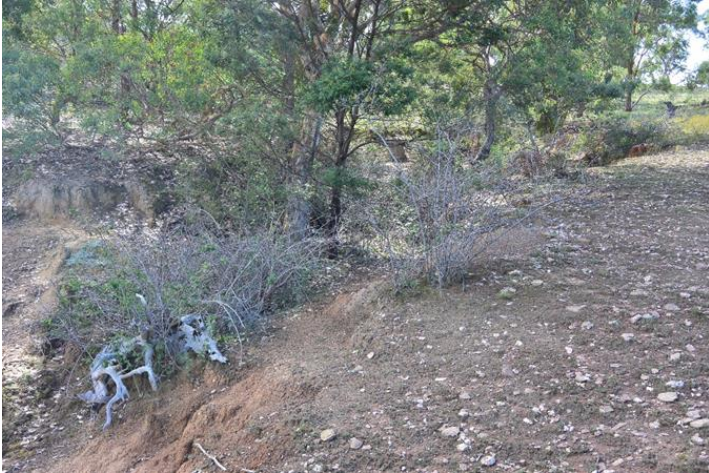
<p>DSC 3801: Long section of active bank erosion</p> </div> <div style="text-align: center;">

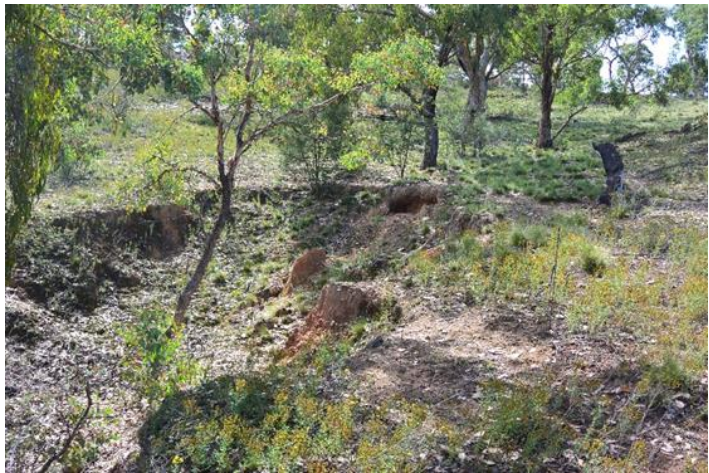
<p>DSC 3802: Active gully head at the top of the gully line</p> </div> </div>

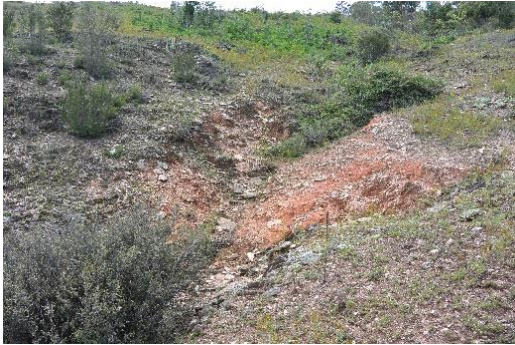
E3A: Stable gully head	Stable	Low	Lightly scarify the surface then seed and mulch areas of bare gully and bank
E3B Lat -35.377410 Lon 149.254253	Small area of gully erosion in minor drainage depression

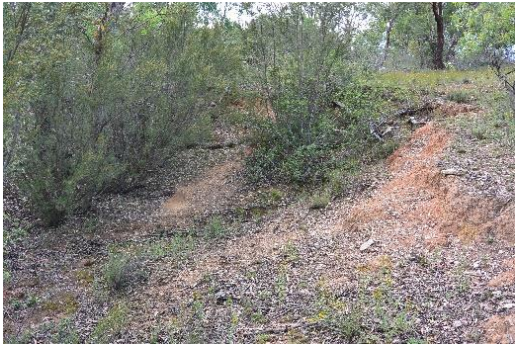
E3B: Active minor gully head	Minor active gully erosion	Low to medium	Construct small earth diversion bank upslope of gully head. Lightly scarify the area below the diversion bank then seed and mulch areas of bare earth

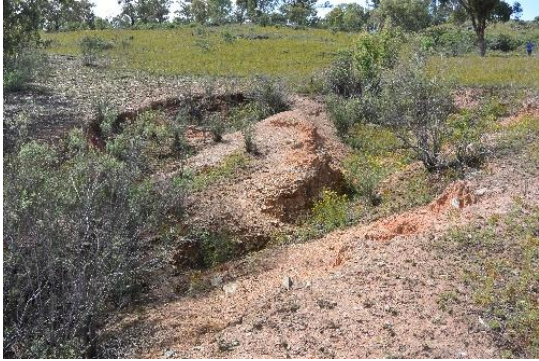
E3C: Active gully head and banks	Minor active gully and bank erosion	Medium	Lightly scarify the area below the gully head and along the areas of bare bank, then seed and mulch areas
--	---	-------------------------------------	--------	---

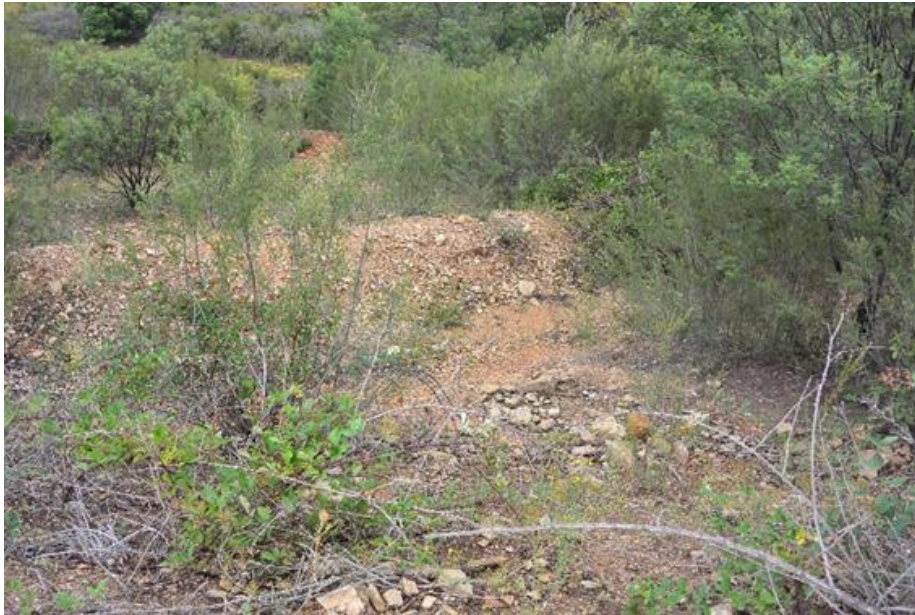
DSC 3770: Deposition in erosion bank channels

SITE REF	EROSION WORKS
E4	Maintain the existing erosion control earthworks by cleaning out bank channels and topping up bank freeboard.

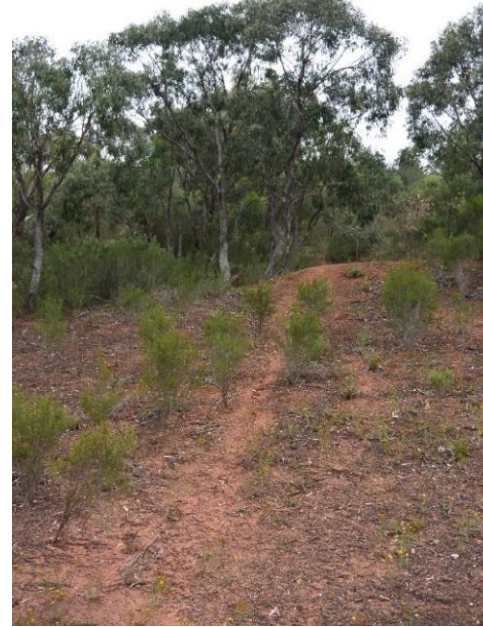
DSC 3775: Tracks eroding bank freeboard

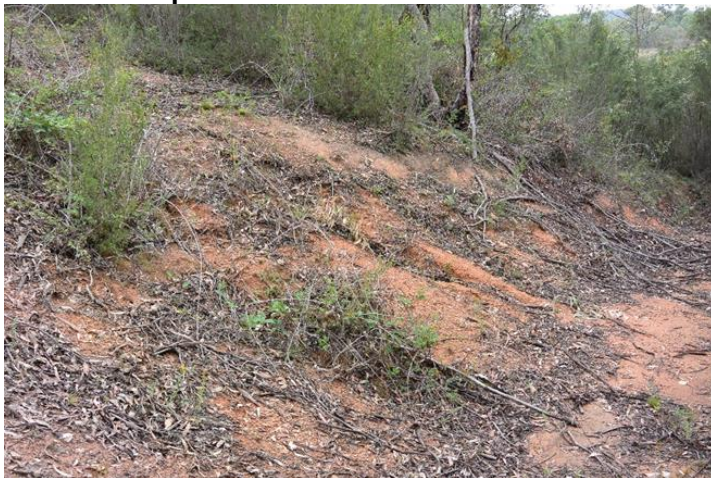
DSC 3777: Minor erosion on back batter of erosion control bank

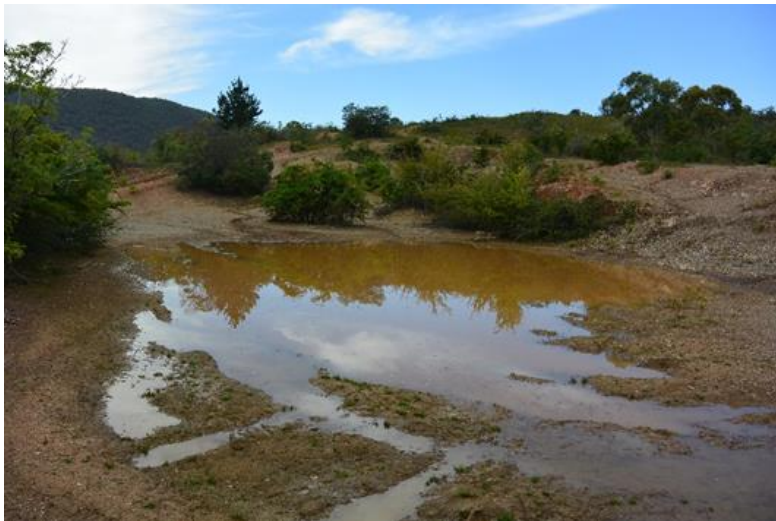
DSC 3789: Quarry site ponding water in the base

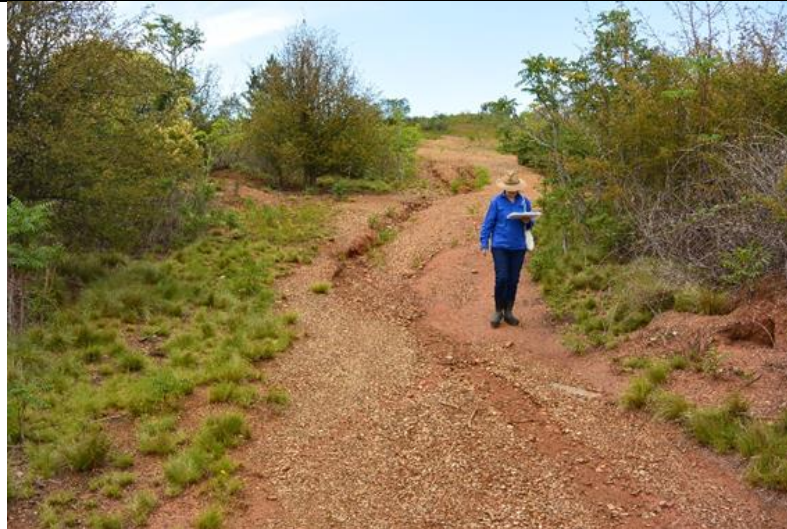
DSC 3781: Eroding trails leading into the quarry site

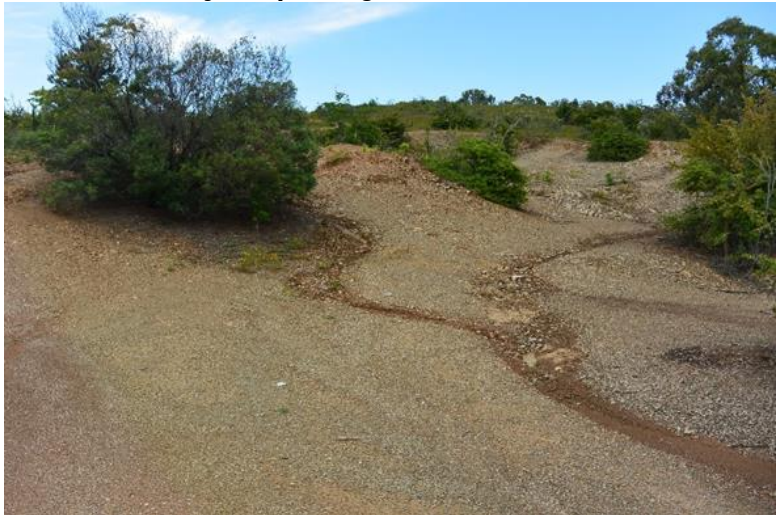
DSC 3790: Sheet and rill erosion across the quarry site

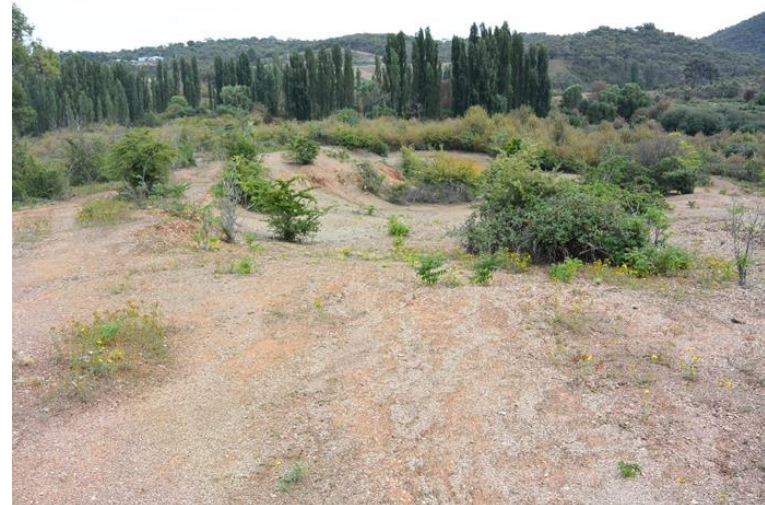
DSC 3792: Diversion of upslope runoff will prevent clean water entering the site and exacerbating erosion and sediment mobilisation

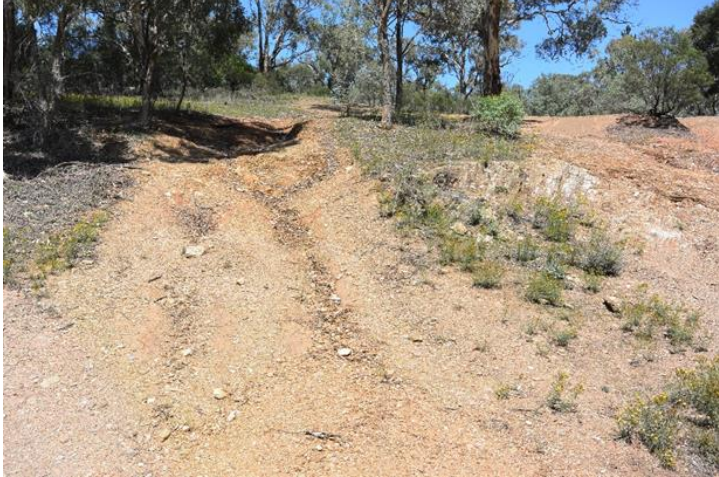
DSC 3830: Extensive bare area with sheet and rill erosion	High (large extent of erosion and proximity to creek resulting in direct mobilisation of sediment to watercourse)	Construct an earth diversion bank to direct upslope runoff away from the site. Construct multiple graded banks across the site to control local water and convey this to a safe disposal area. Shape and deep contour rip the site below and between banks. Where possible import topsoil and spread on areas which have eroded to the subsoil level. Seed the area with suitable species, refer Vegetation Management Plan. Mulch all bare seeded areas to reduce erosion and promote germination.

E6	Construct earth diversion bank upslope of the eroded area to divert run-on water away from site. Construct graded banks (three) across the eroded area to intercept local run-off water and convey to a safe disposal area. Deep rip the area on the contour and spread imported topsoil where erosion has reached subsoil. Revegetate by seeding and mulching.
E7	Deep rip the area on the contour and spread imported topsoil where erosion has reached subsoil. Revegetate by seeding and mulching.

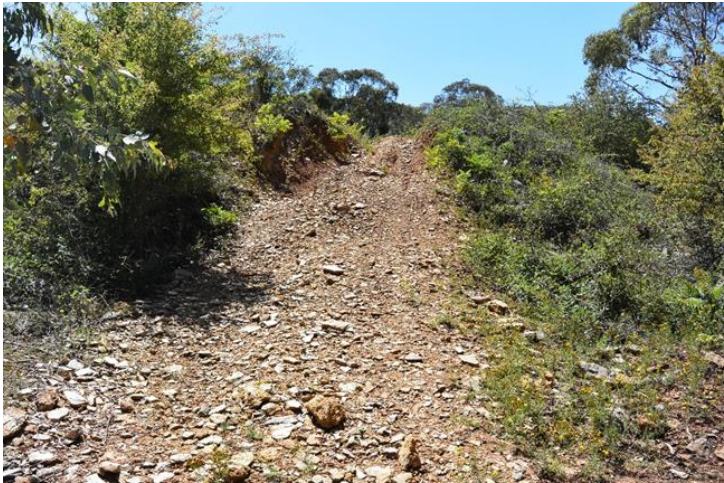
</div> <div> DSC 3831: Erosion of steep redundant trails DSC 3832: Concentration of trails causing erosion </div>

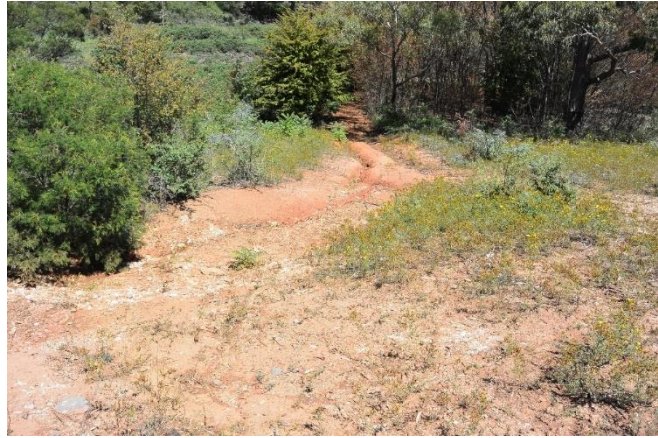
DSC 3833: Sheet and rill erosion across the site

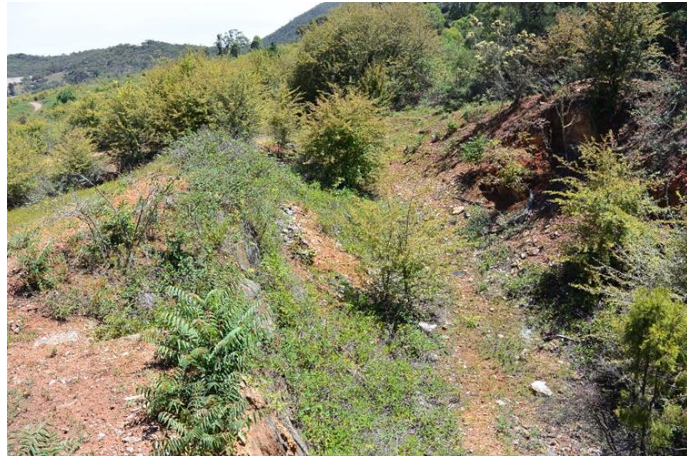
DSC 3835: Eroding vertical edges on old mine site.

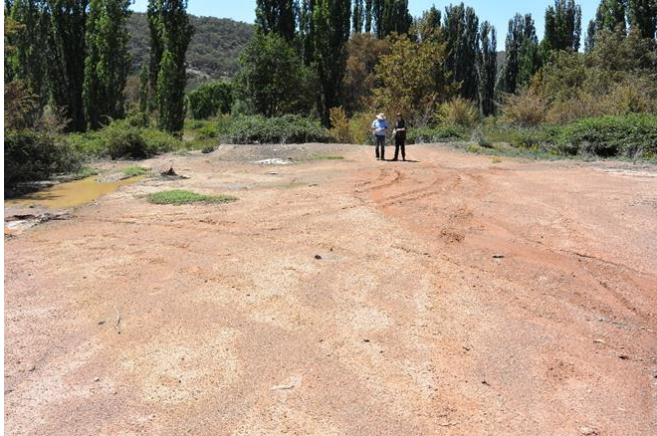
Lat -35.372430° Lon 149.254476°	Extensive area of sheet and rill erosion formed by the concentration of track and trails and vehicle traffic on moderate slopes.	Active moderate erosion

DSC 3844: Large area of bare sheet erosion

SITE REF	EROSION WORKS
E8	Construct an earth diversion bank upslope of the eroded area. Deep rip the area on the contour and spread imported topsoil where erosion has reached subsoil. Revegetate by seeding and mulching. NB: The eastern portion of this area will become a sediment basin in Phase 2 of the development and therefore erosion control works should be concentrated upslope of this area and completed in conjunction with the construction of the basin.
E9	Fill and vegetate mine adits and any other bare areas by capping with coarse ballast rock then topsoiling, seeding and mulching.

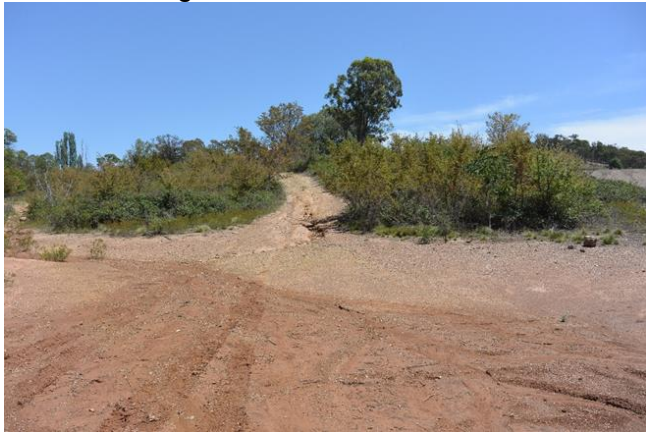
DSC 3845: Sedimentation from upslope track erosion	Medium (active sheet and rill erosion with close proximity to the creek)	Construct an earth diversion bank to direct upslope runoff away from the site. Shape and deep contour rip the site below the bank. Where possible import topsoil and spread on areas which have eroded to the subsoil level. Seed the area with suitable species, refer Landscape Plan. Mulch all bare seeded areas to reduce erosion and promote germination. NB: The eastern portion of this area will become a sediment basin in Phase 2 of the development and therefore erosion control works should be concentrated upslope of this area and completed in conjunction with the construction of the basin.

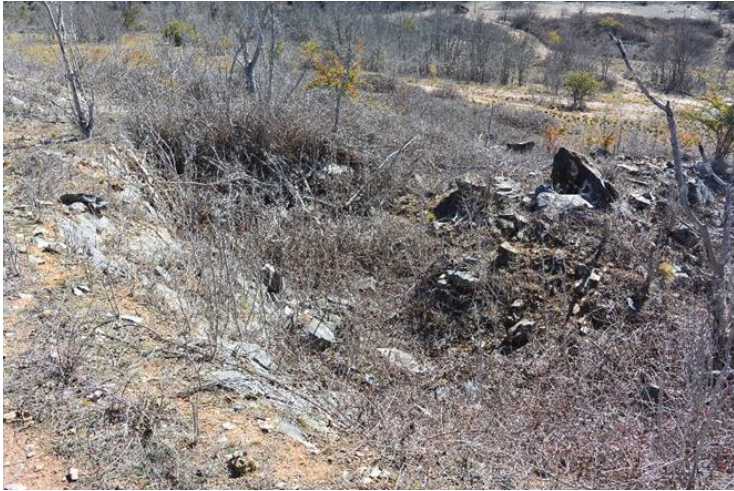
DSC 3010: Mine adits revegetated with blackberries	High (safety risk and potential risk with surface water accessions into mine adits creating potential groundwater issues)	Mine adits should back filled with coarse ballast material then capped with topsoil and revegetated with appropriate species, refer Landscape Plan. Any bare areas associated with the previous mining activity should be capped with coarse ballast rock (to create a hydraulic break and prevent capillary rise in soils) then topsoiled and seeded. Seeded areas should be mulched to reduce erosion and promote germination.

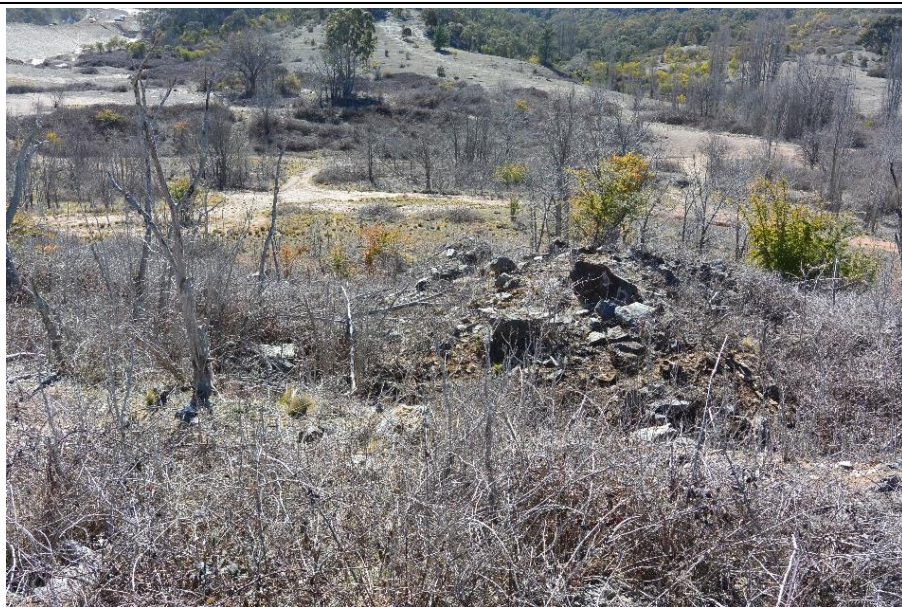
DSC 3011: Areas of mine spoil material stockpiled on surface

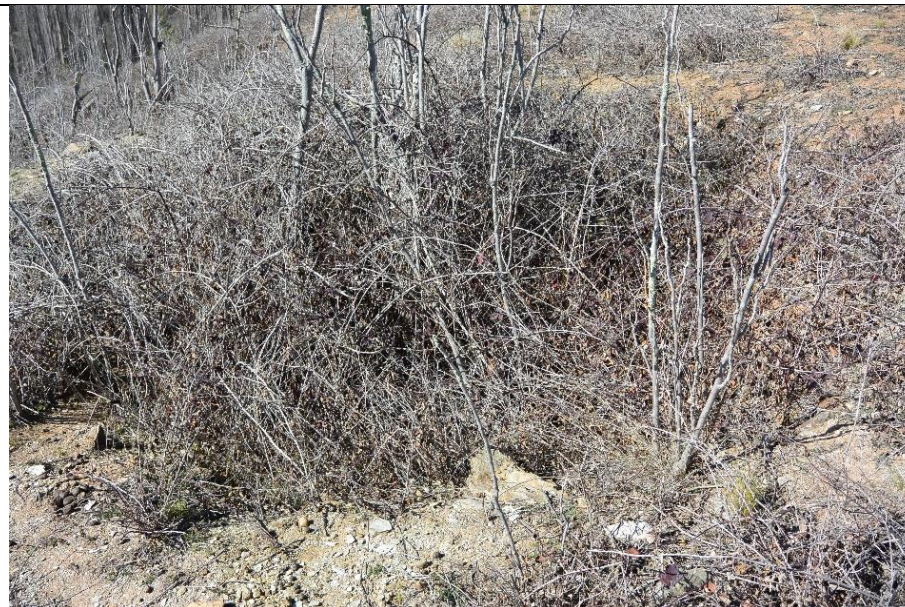
DSC 3012: Partially obscured mine adit creating safety hazard
