**336-344 Edward Street
Wagga Wagga NSW**

**Hazardous Materials
Assessment and
Register**

June 2020

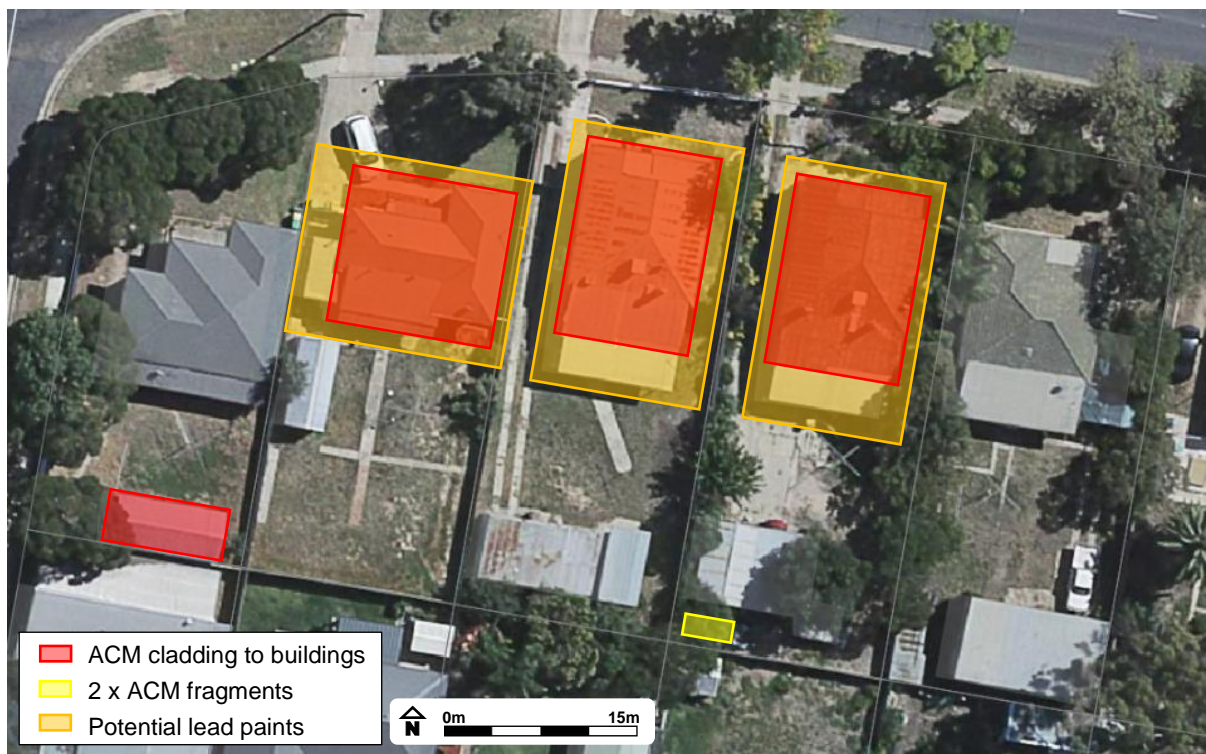
Figure 8: Areas of concern

From the site inspection and by reference to the SEPP 55 Guideline (1998) and NSW OEH (2011), the areas of concern have been developed for the site based on potential contamination sources, **Figure 8**. Further areas of concern may also be present but were unable to be assessed, including all building internals (except for 342 Edward Street) due to active tenancies across the site. These areas may harbour further ACM material including lagging, service pipes and insulation and may cause contamination during demolition if not identified prior. 338-342 Edward Street were suspect for potential lead based paints based on building age and likely paint systems in use at the time.

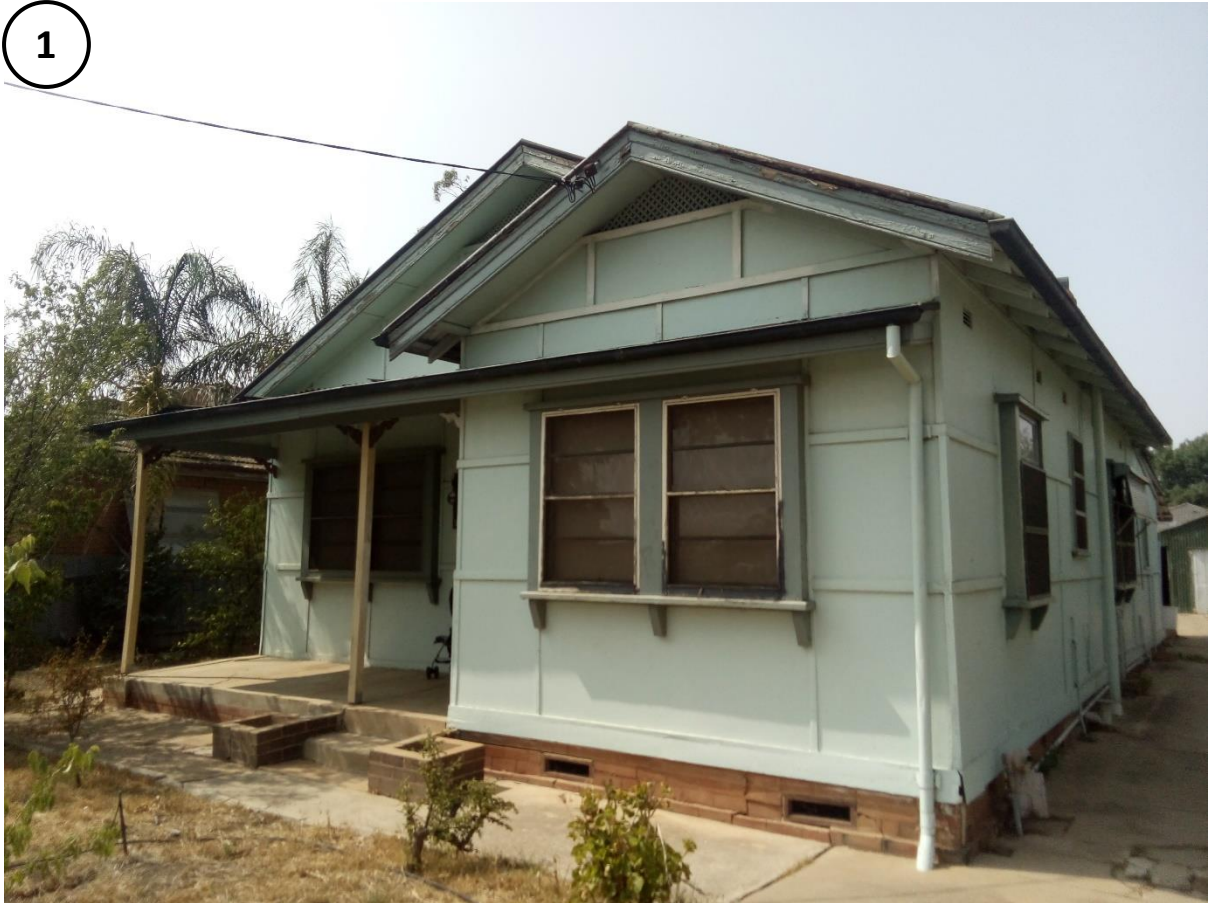
1. 338 Edward Street, external cladding likely ACM
2. 338 Edward Street, external cladding likely ACM
3. 338 Edward Street, 1 of 2 small ACM fragments behind back shed
4. Internal construction of 336 Edward Street rear shed
5. 340 Edward Street, external cladding likely ACM
6. 342 Edward Street, eaves likely to contain ACM
7. 344 Edward Street, gable ends to garage are made of ACM
