Report on  
Geotechnical Investigation

Proposed Residential Subdivision  
32 Lovelle Street and 141 Yarrowa Road,  
Moss Vale

Prepared for  
Prime Moss Vale Pty Ltd

Project 40494.03  
April 2020

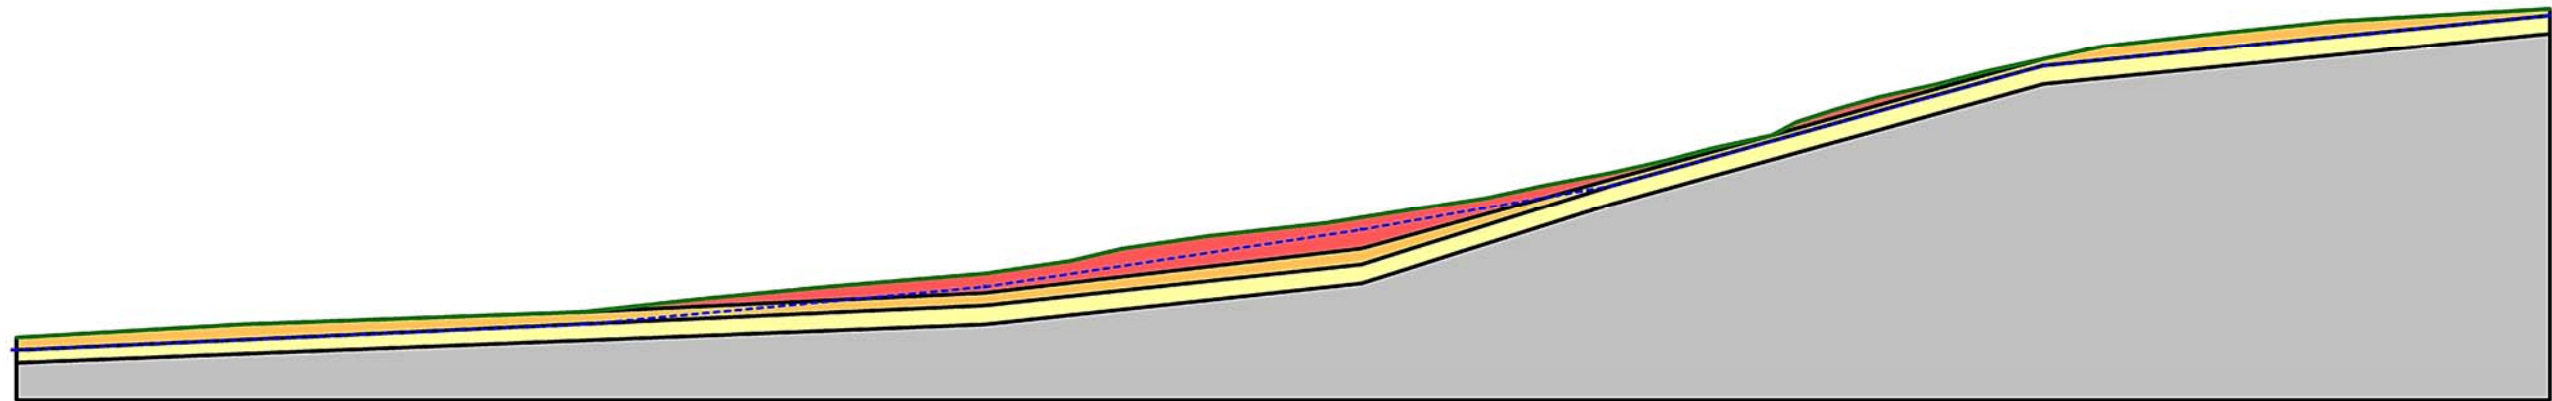
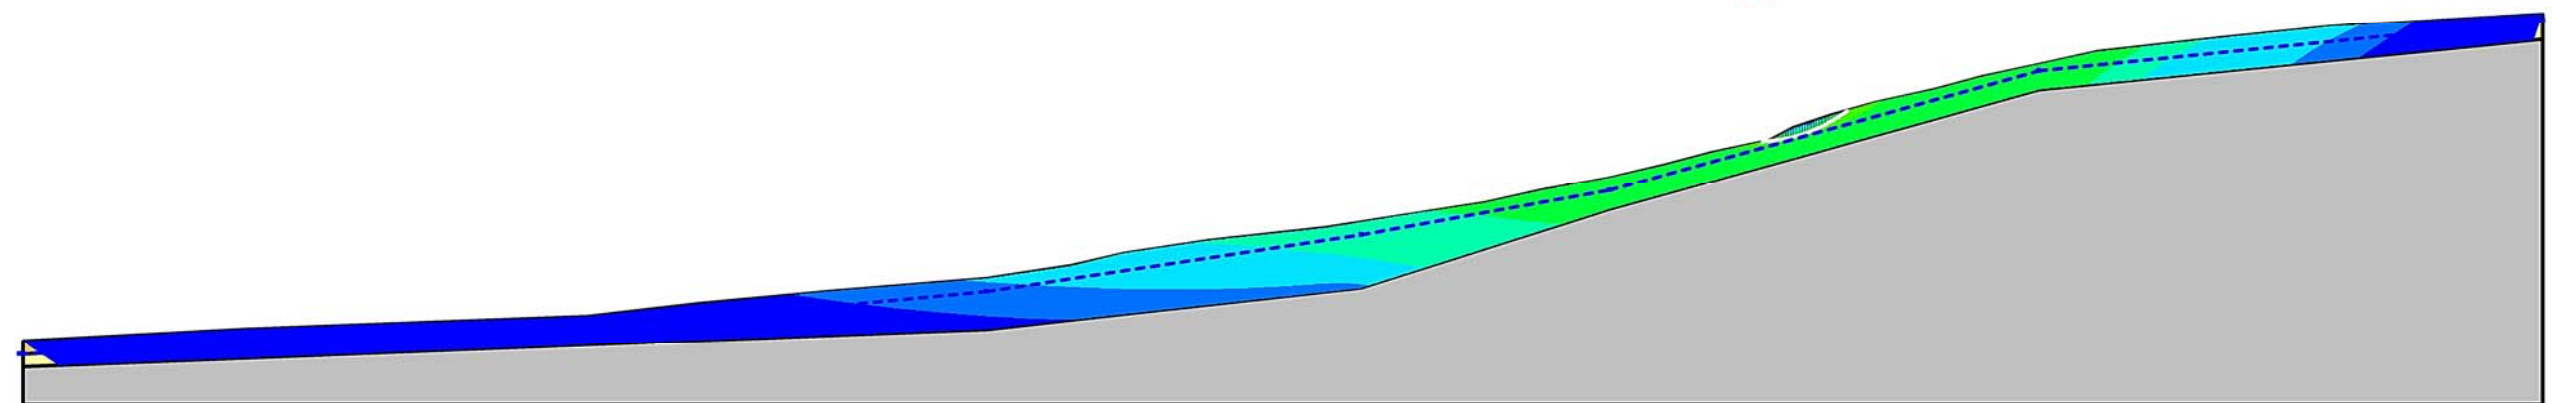
FoS = 1.352

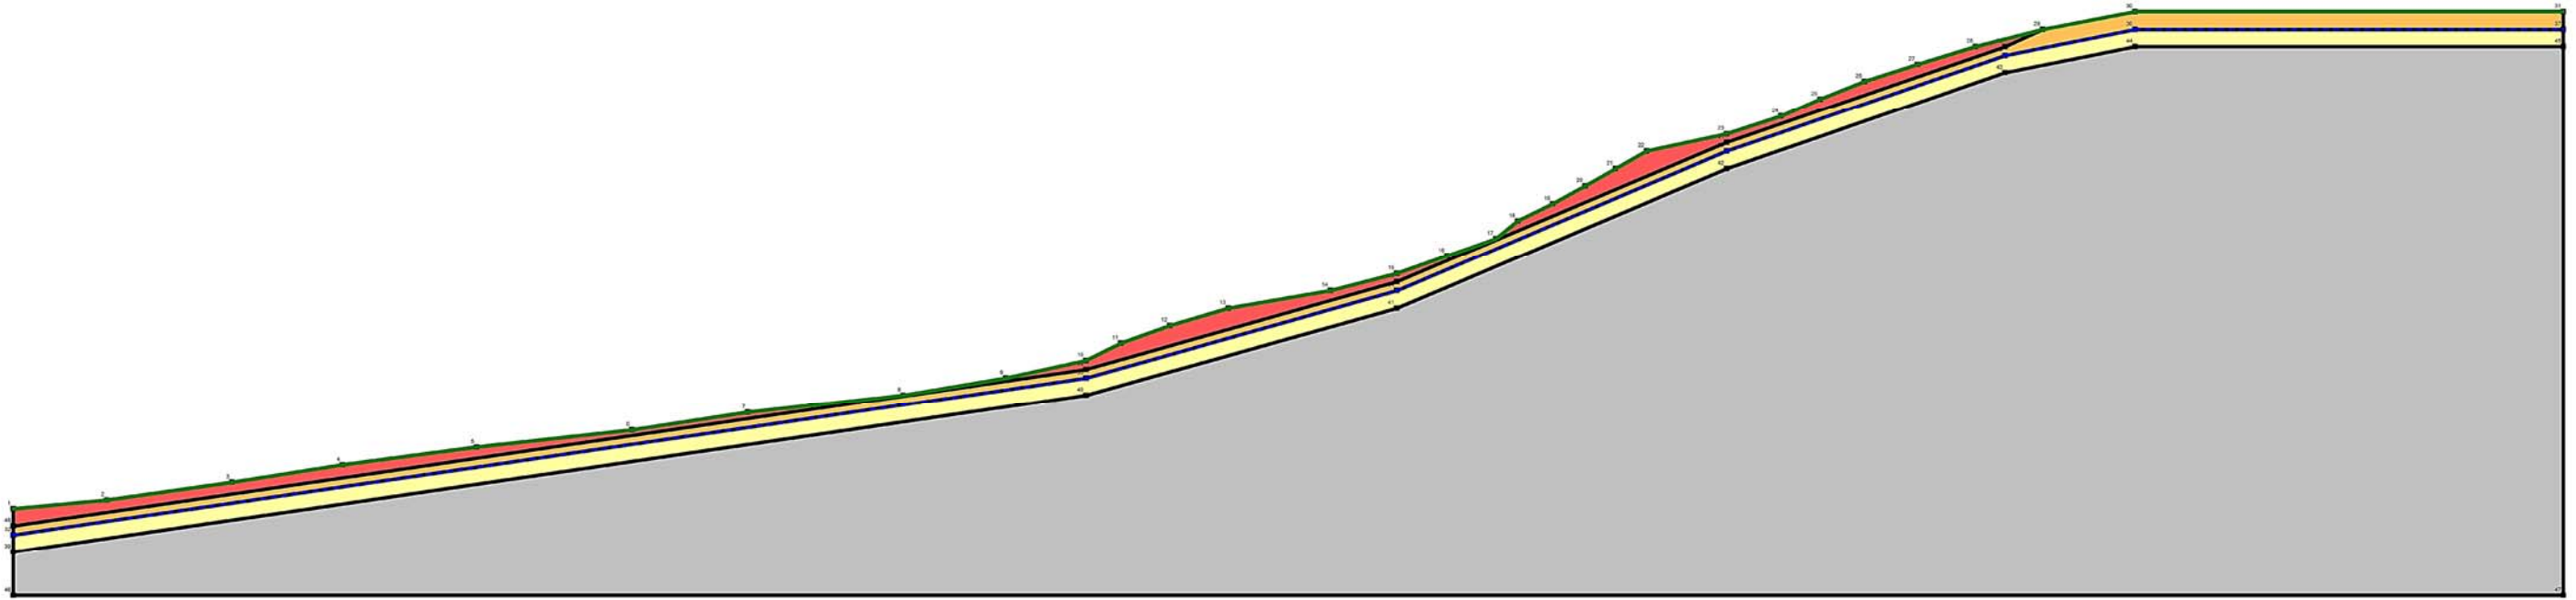
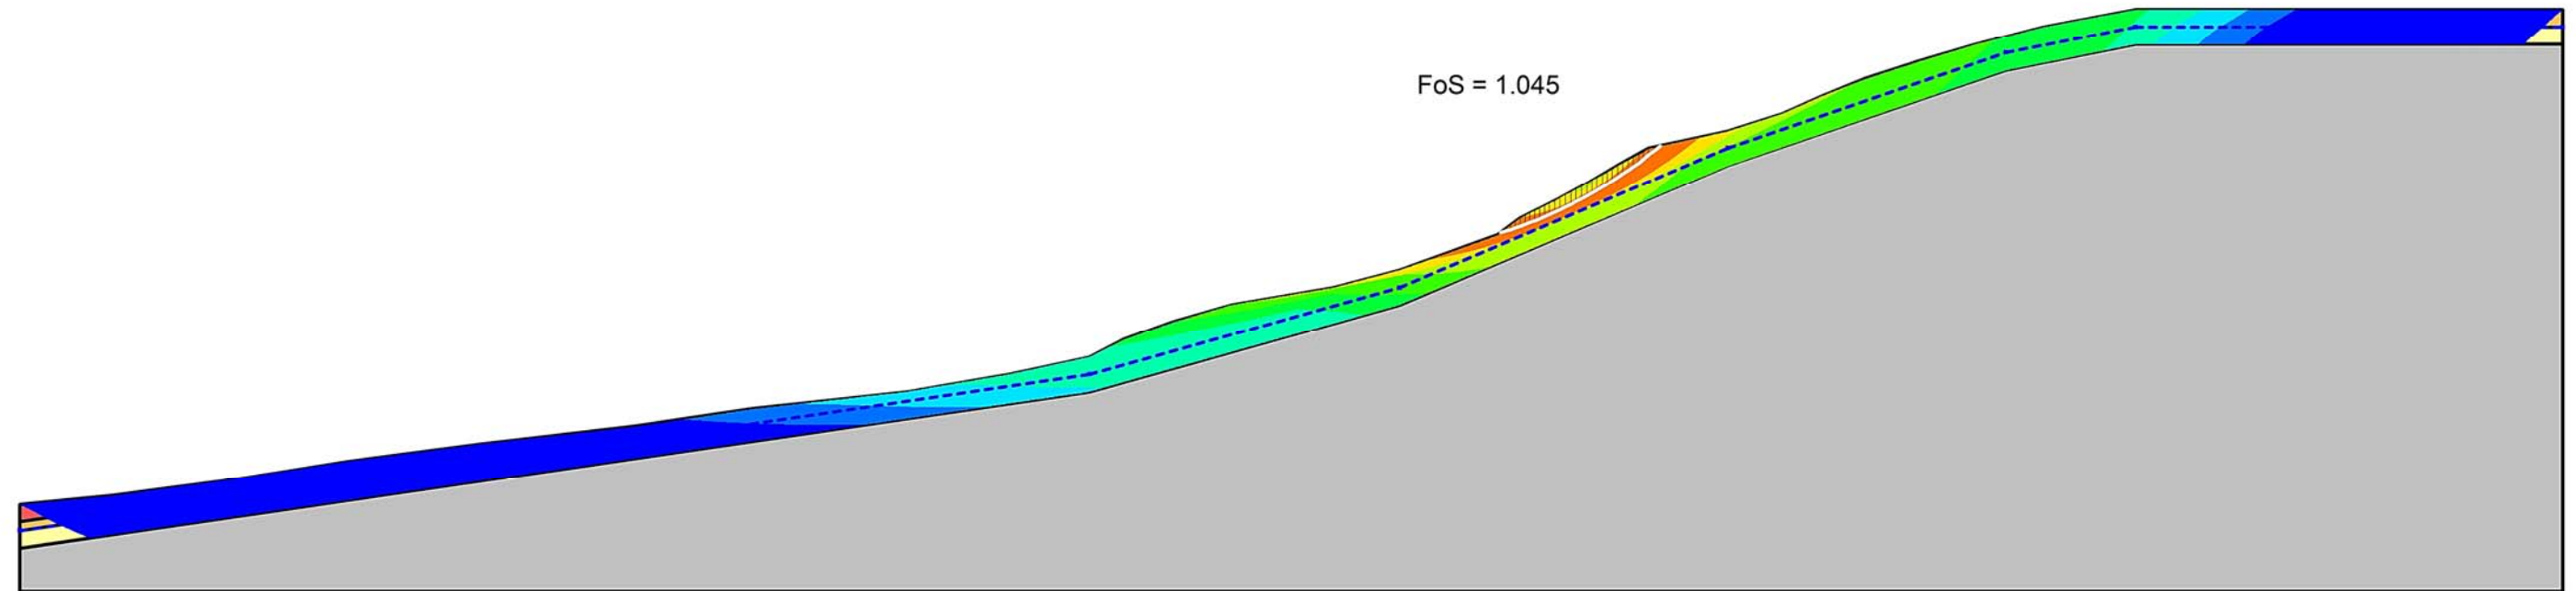
FoS = 1.045

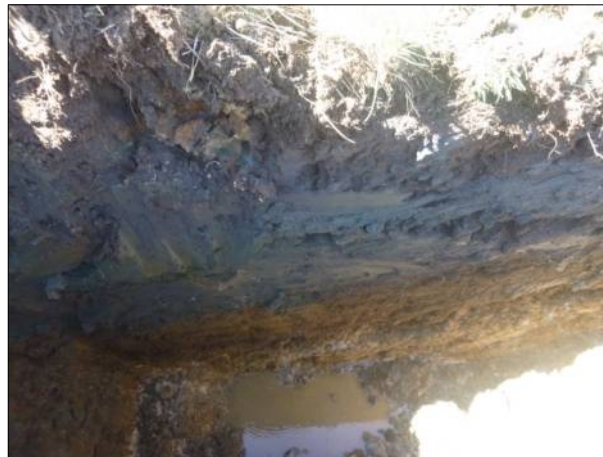
Pit 1 excavation.

Seepage was previously observed during DP's preliminary investigation in September 2018 in Pit 1 in an active area of slumping in the steep hillside. Seepage was also inferred during mapping and from a review of aerial photography:

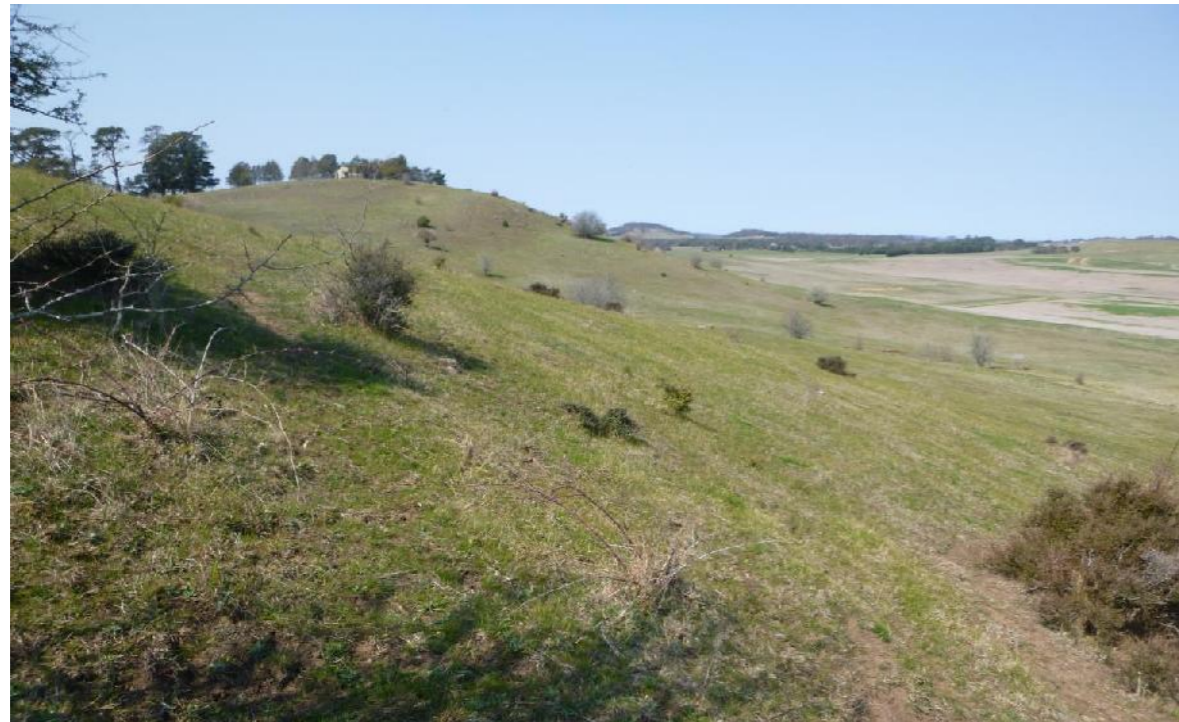
Photo 3: View looking southeast across the steep to very steep hillside in the northern part of the site.

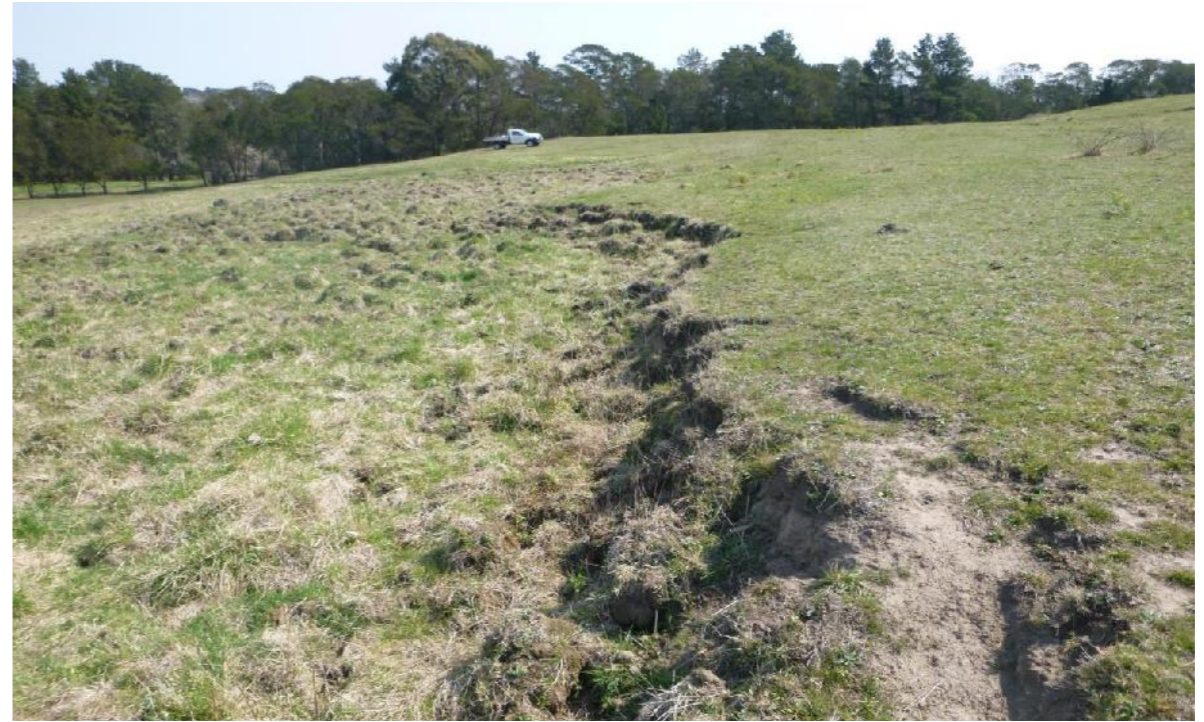
Photo 4: View looking northwest across the active scarp in the lower-middle part of the hillside in the northern part of the site.

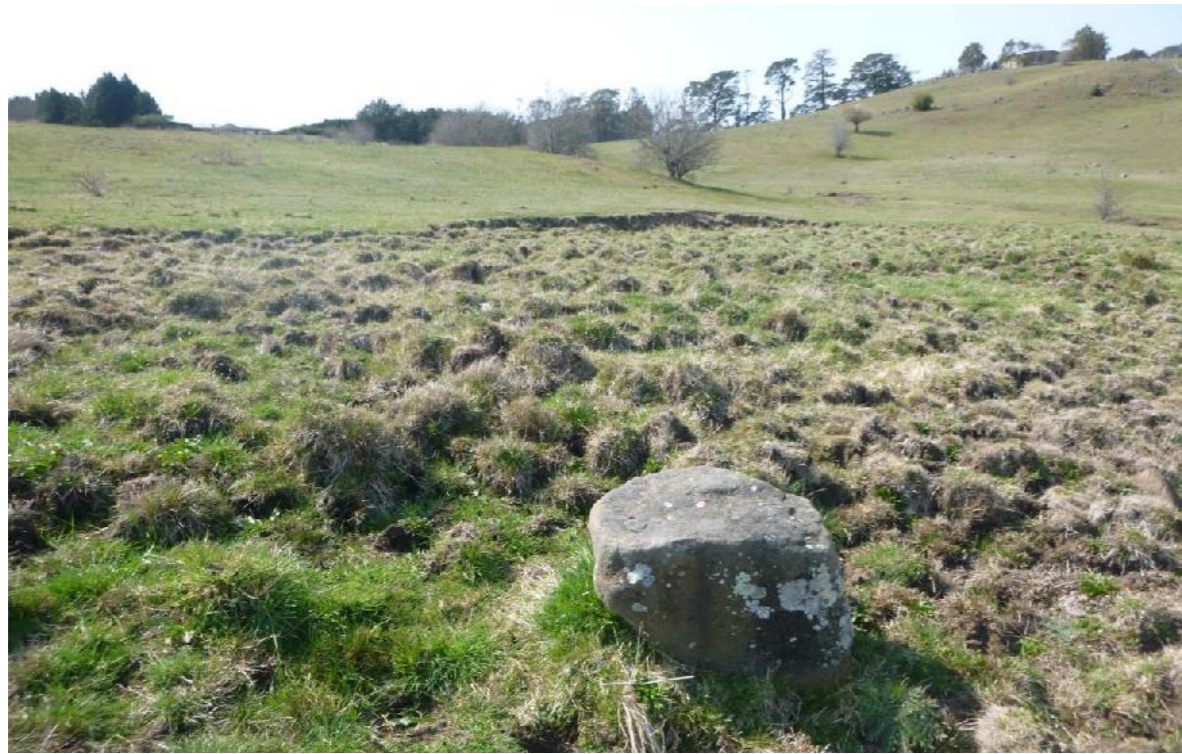
Photo 5: View looking northeast across the active scarp in the lower-middle part of the hillside in the northern part of the site. Note: the igneous boulders lying on the surface.

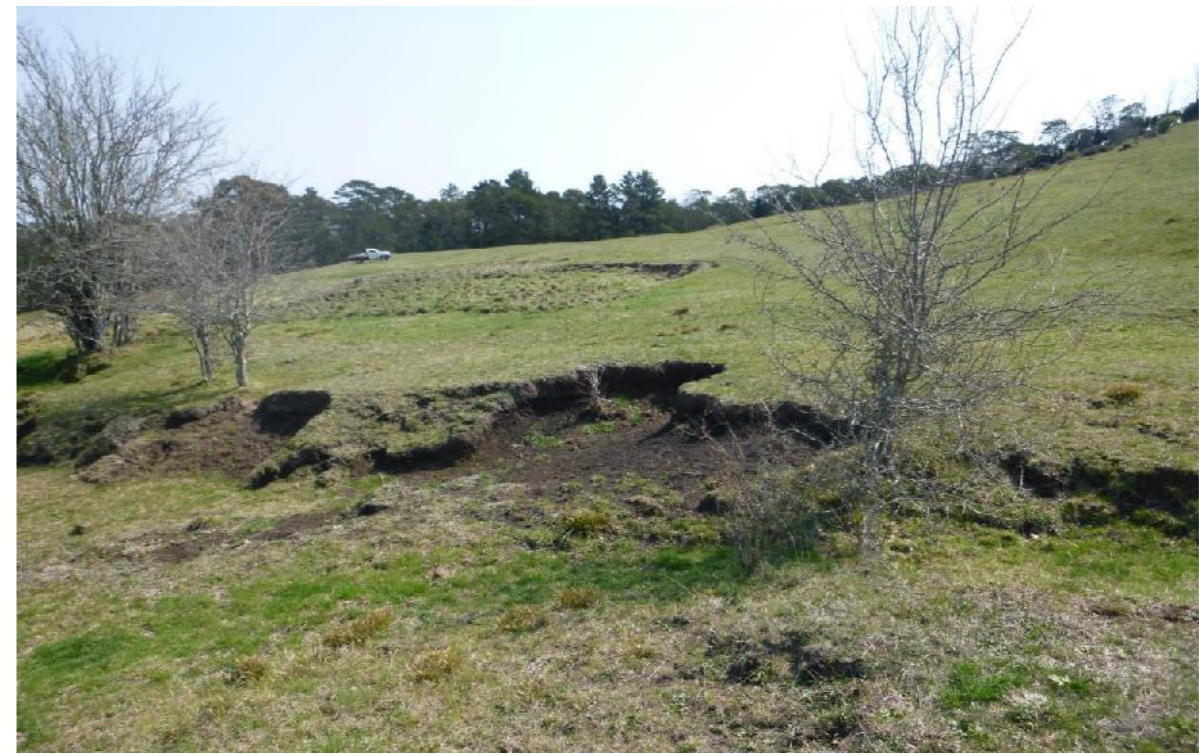
Photo 6: View looking at slumping in a drainage depression in the steep to very steep hillside in the northern part of the site.

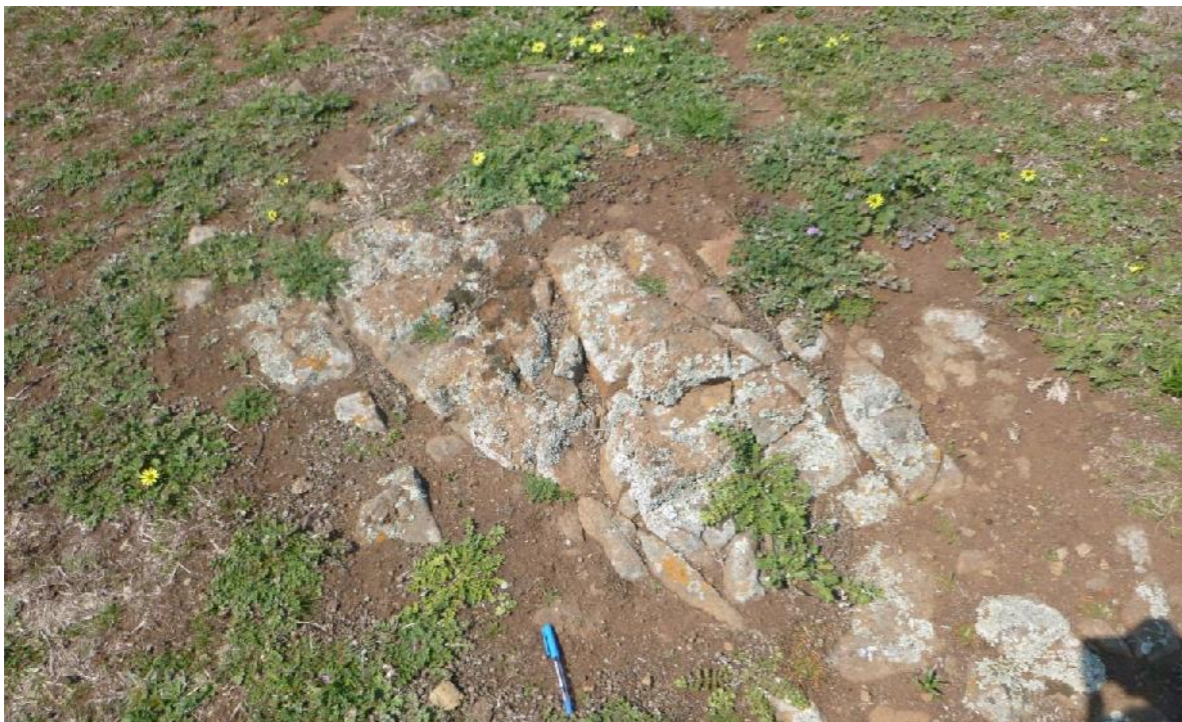
Photo 7: View looking at bedrock exposed near the crest of the steep to very steep hillside near the small water reservoir in the northern part of the site.
