# WAGGA WAGGA HOSPITAL CARPARKS

## Tree Survey

03 November 2020,  
Ref 20/387C.

# Trees on the Sites of Proposed Carparks, Wagga Wagga Health Services

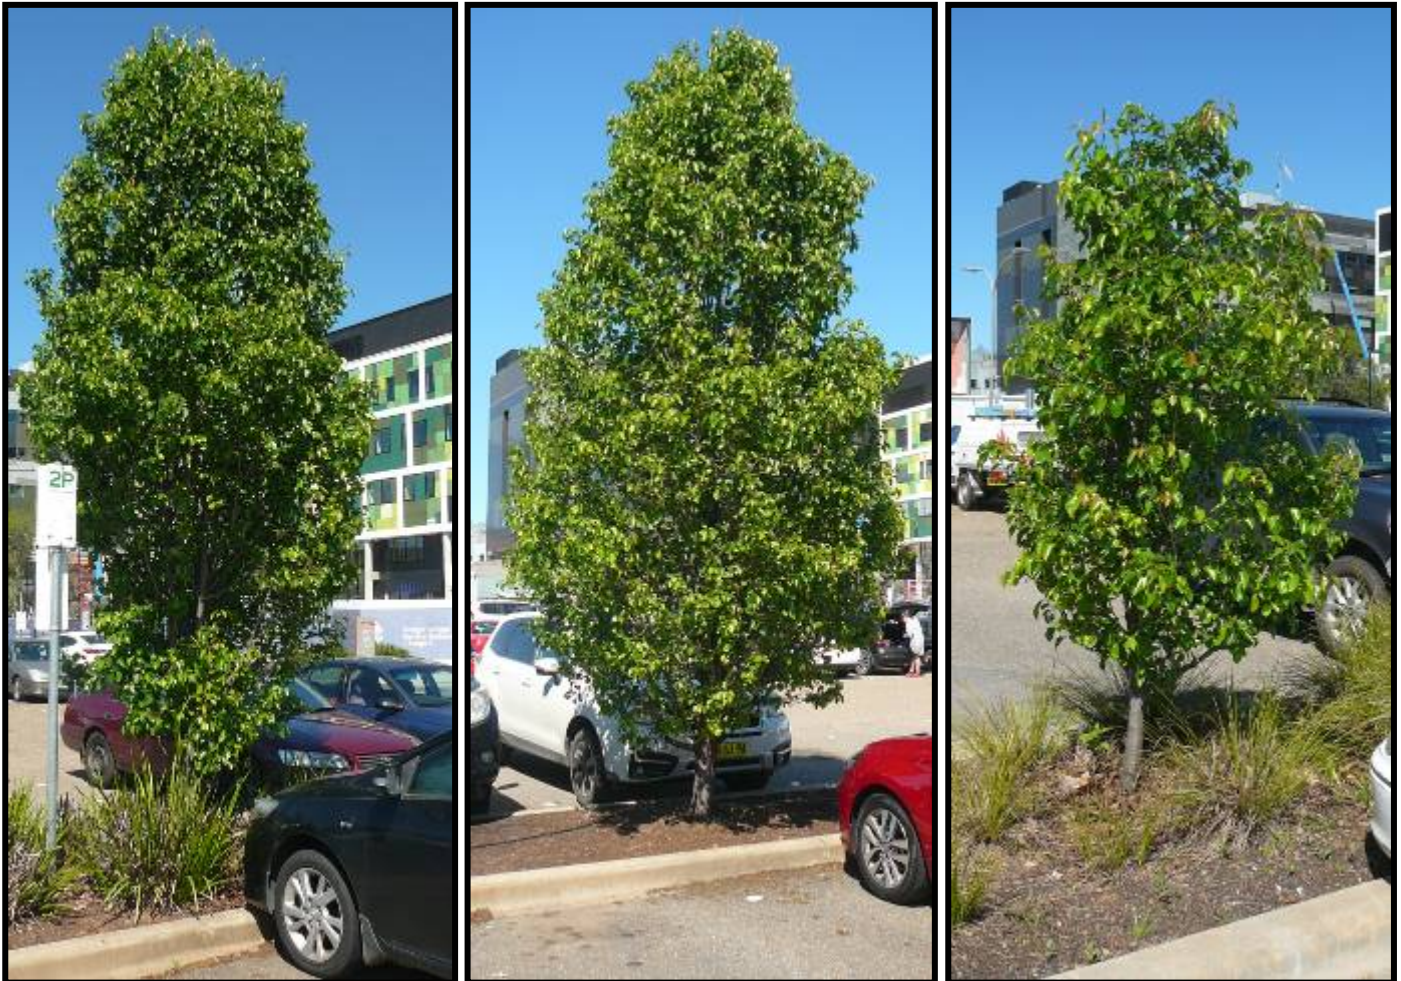
#### 4.1.1 – Tree Nos. 2 to 4

**Exhibit 5** – Tree Nos 2 to 4 are three young specimens of Ornamental Pear cultivars (*Pyrus calleryana* Cleveland Select), planted within an “island” of the existing car park in the north-east sector of the Health Services property.

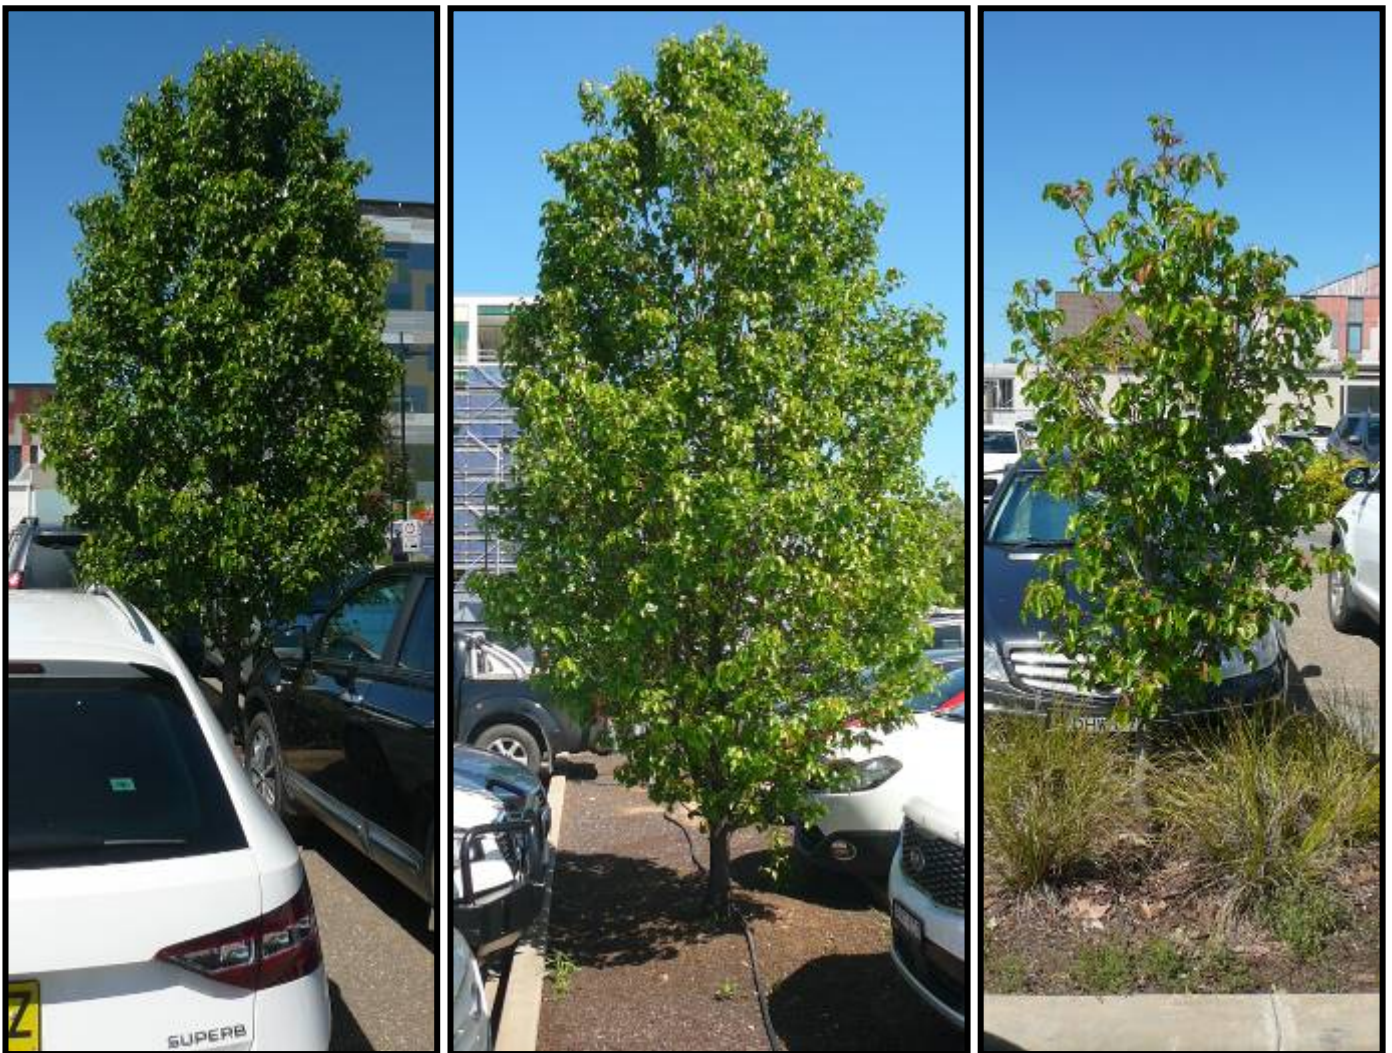
#### 4.1.2 – Tree Nos. 5 to 7

**Exhibit 6** – Tree Nos 5 to 7 are three more young specimens of Ornamental Pear cultivars (*Pyrus calleryana* Cleveland Select), planted within an “island” of the existing car park in the north-east sector of the Health Services property.

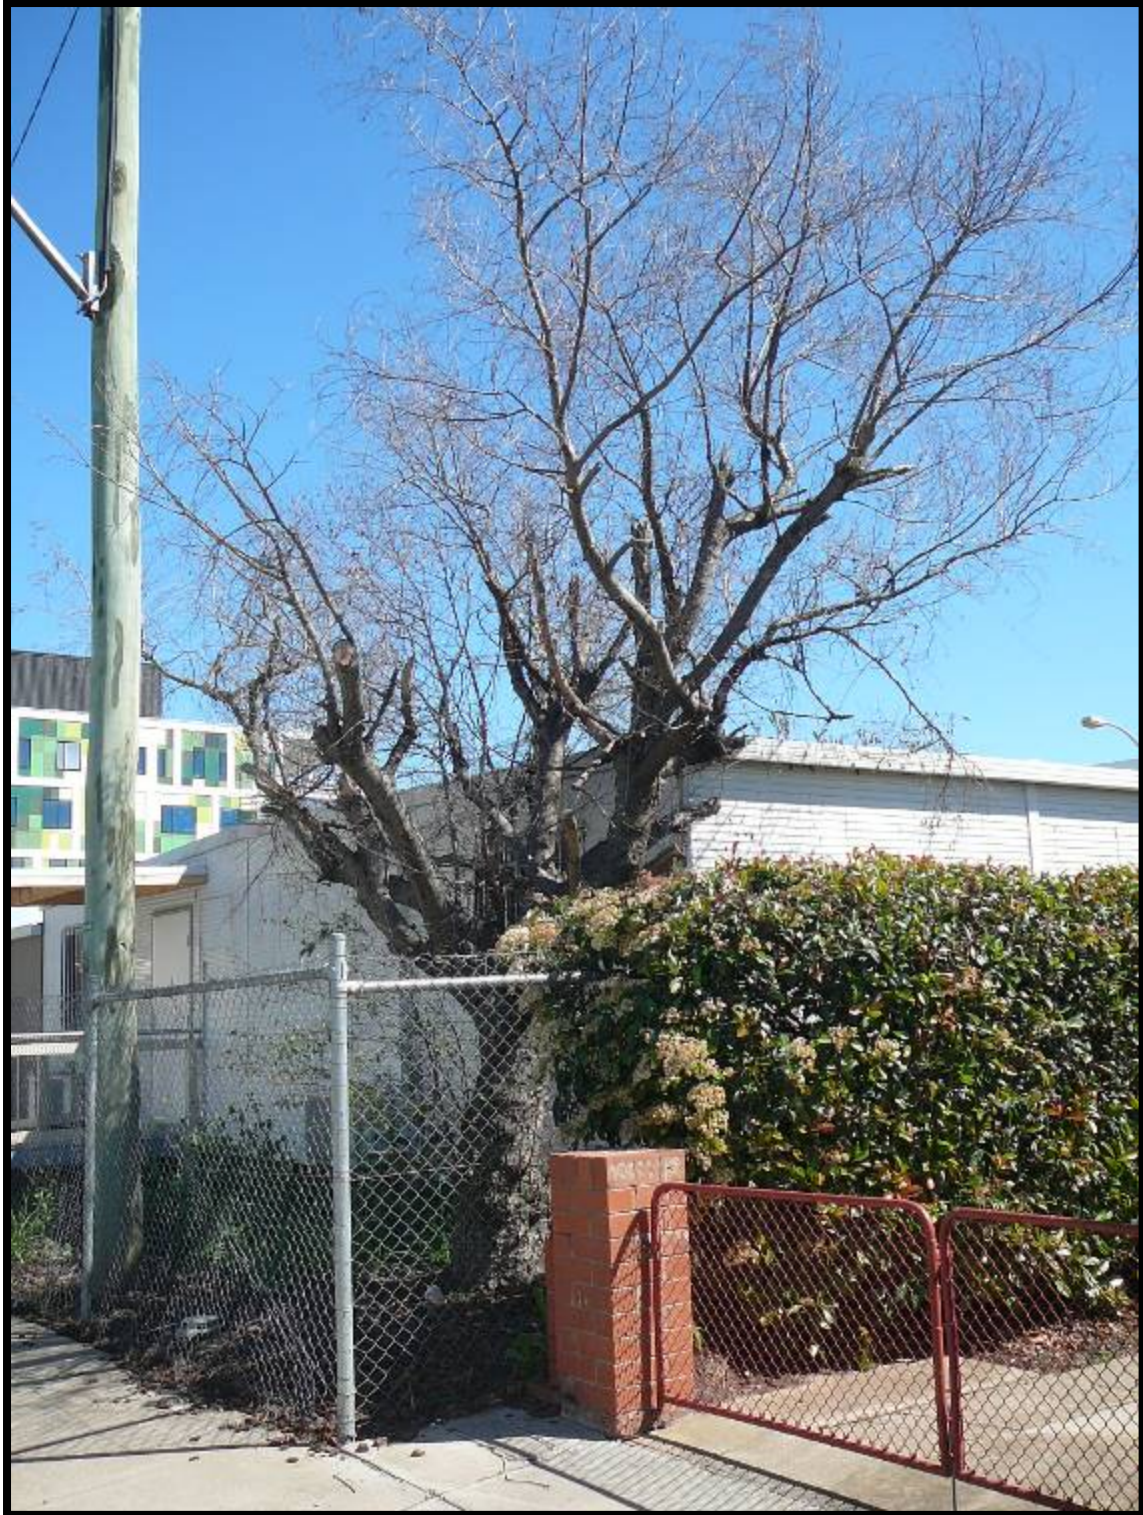
#### 4.1.3 – Tree No. 8

**Exhibit 7** – Tree 8 is an Evergreen Alder (*Alnus jorullensis*). The tree has been rated as in Poor condition however, with the exception of some live shoots low on the stem, it is dead.

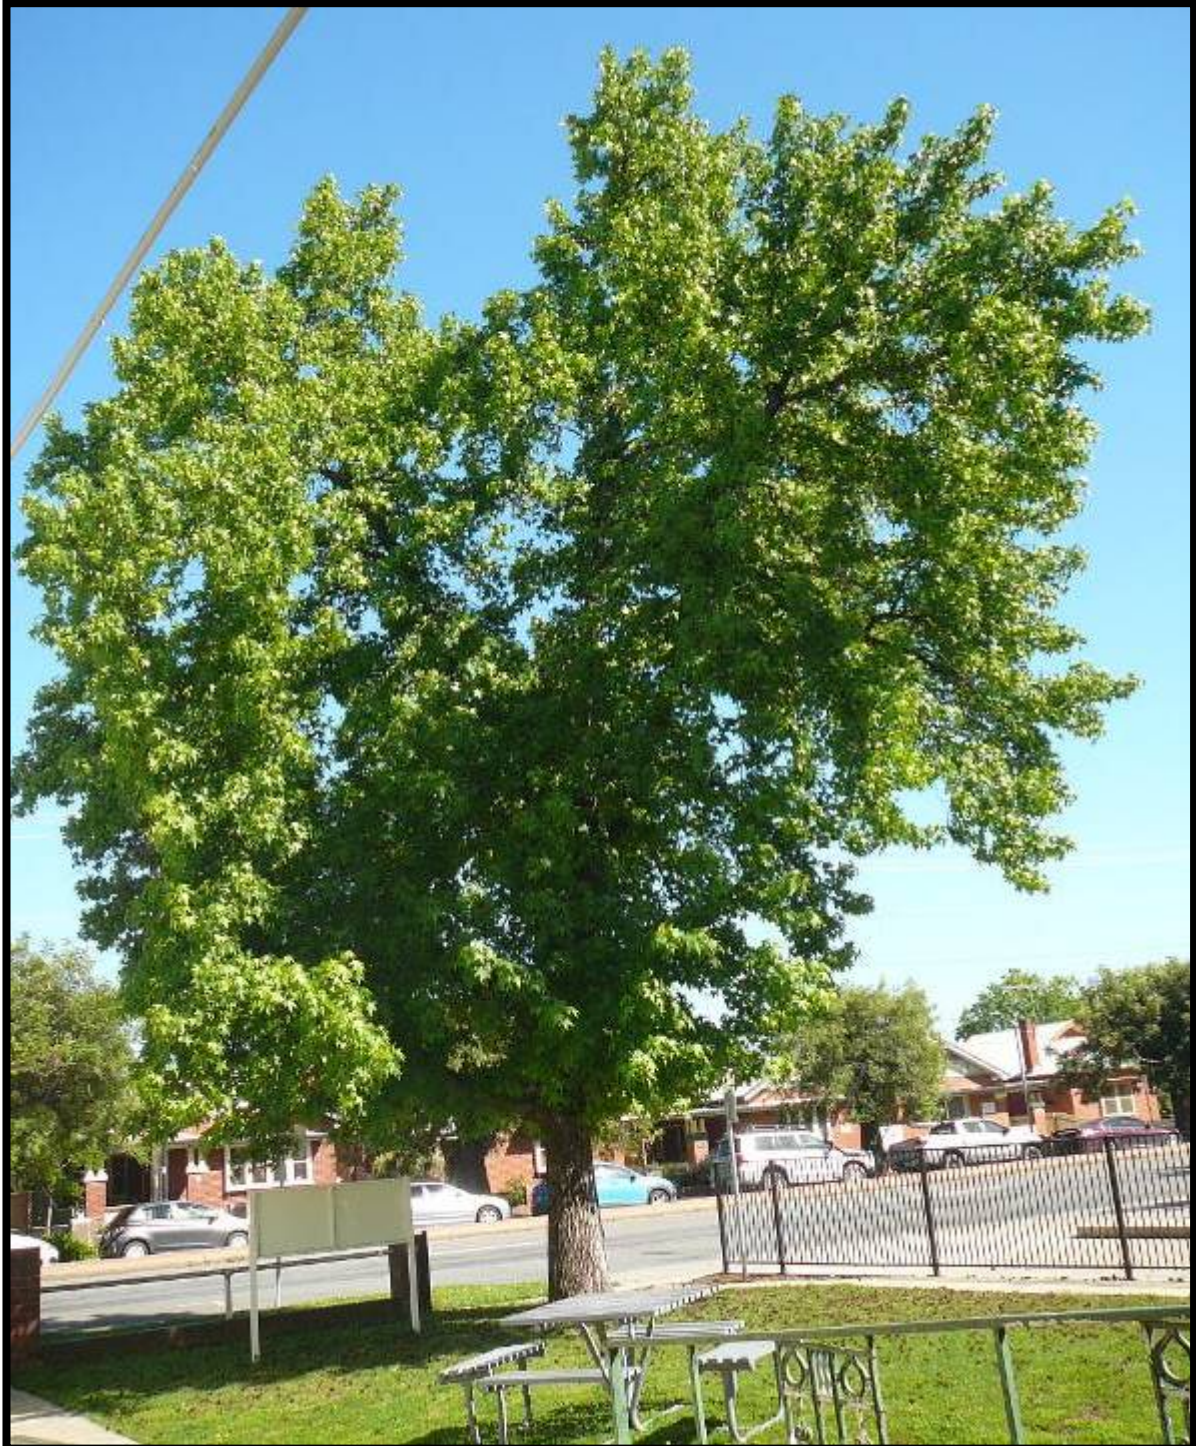
#### 4.2.1 – Tree No. 9

**Exhibit 8** – Tree 9 is a fine specimen of Liquidamber (*Liquidambar styraciflua*). Despite its “atypical” form for the species, with 3 dominant leaders, the tree is in Good condition.

- On the Docker Street On-grade Carpark site – Tree Nos. 9 (*Liquidambar styraciflua*), 17 and 18 (young *Fraxinus* Raywoods) and
- On the Yathong Street On-grade Carpark site – Tree Nos. 19 (*Juniperus chinensis* cv.), 23 to 26 (*Pyrus calleryana* cvs.), 38 (*Callistemon viminalis* cv.), 39 (*Ulmus parvifolia*) and 40 (*Juniperus chinensis* cv.).

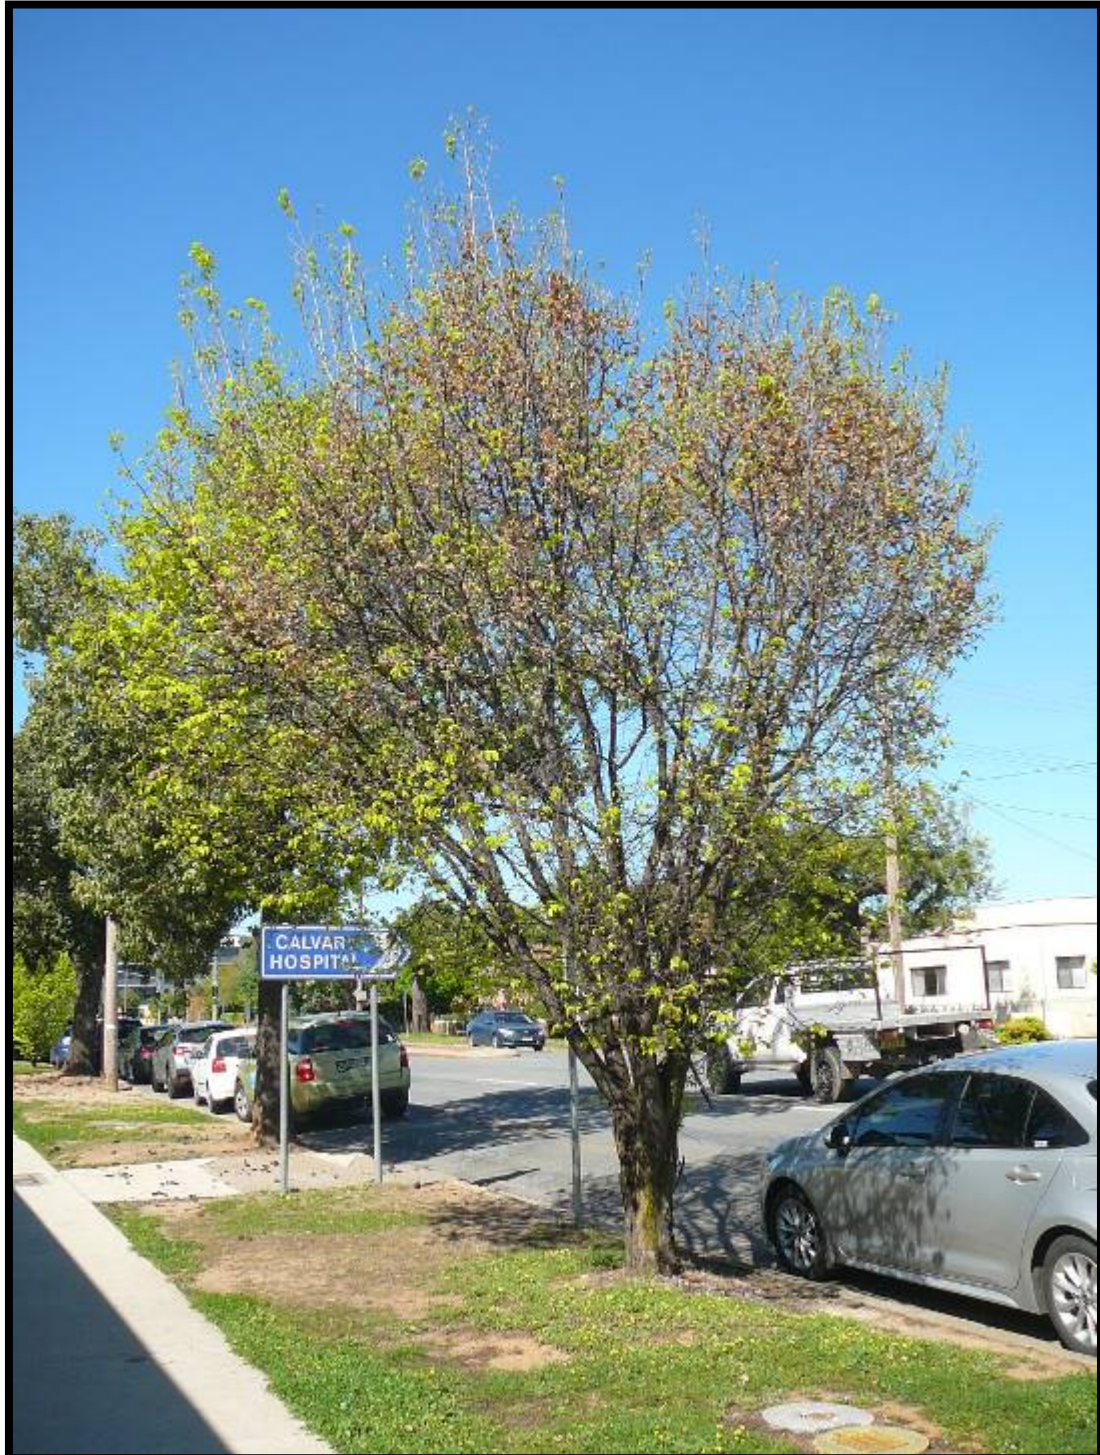
#### 4.2.2 – Tree No. 10

**Exhibit 9** – Tree 10 is a Golden Elm (*Ulmus glabra Lutescens*) with a very heavy scale infestation in its crown, leading to its low vigour and attributing to its Poor condition rating..

A number of the documented trees are street trees managed by Wagga Wagga City Council, viz. six trees on Docker Street. The WWCC Street Tree Policy, 2018, notes that Council will consider removing a street tree where “the tree is in a state of decline to the point that survival is unlikely”. Due to their current condition it is recommended that three of the Docker Street street trees, Tree Nos. 10, 13 (both *Ulmus glabra* Lutescens’) and 15 (*Fraxinus excelsior*) be removed and replaced.

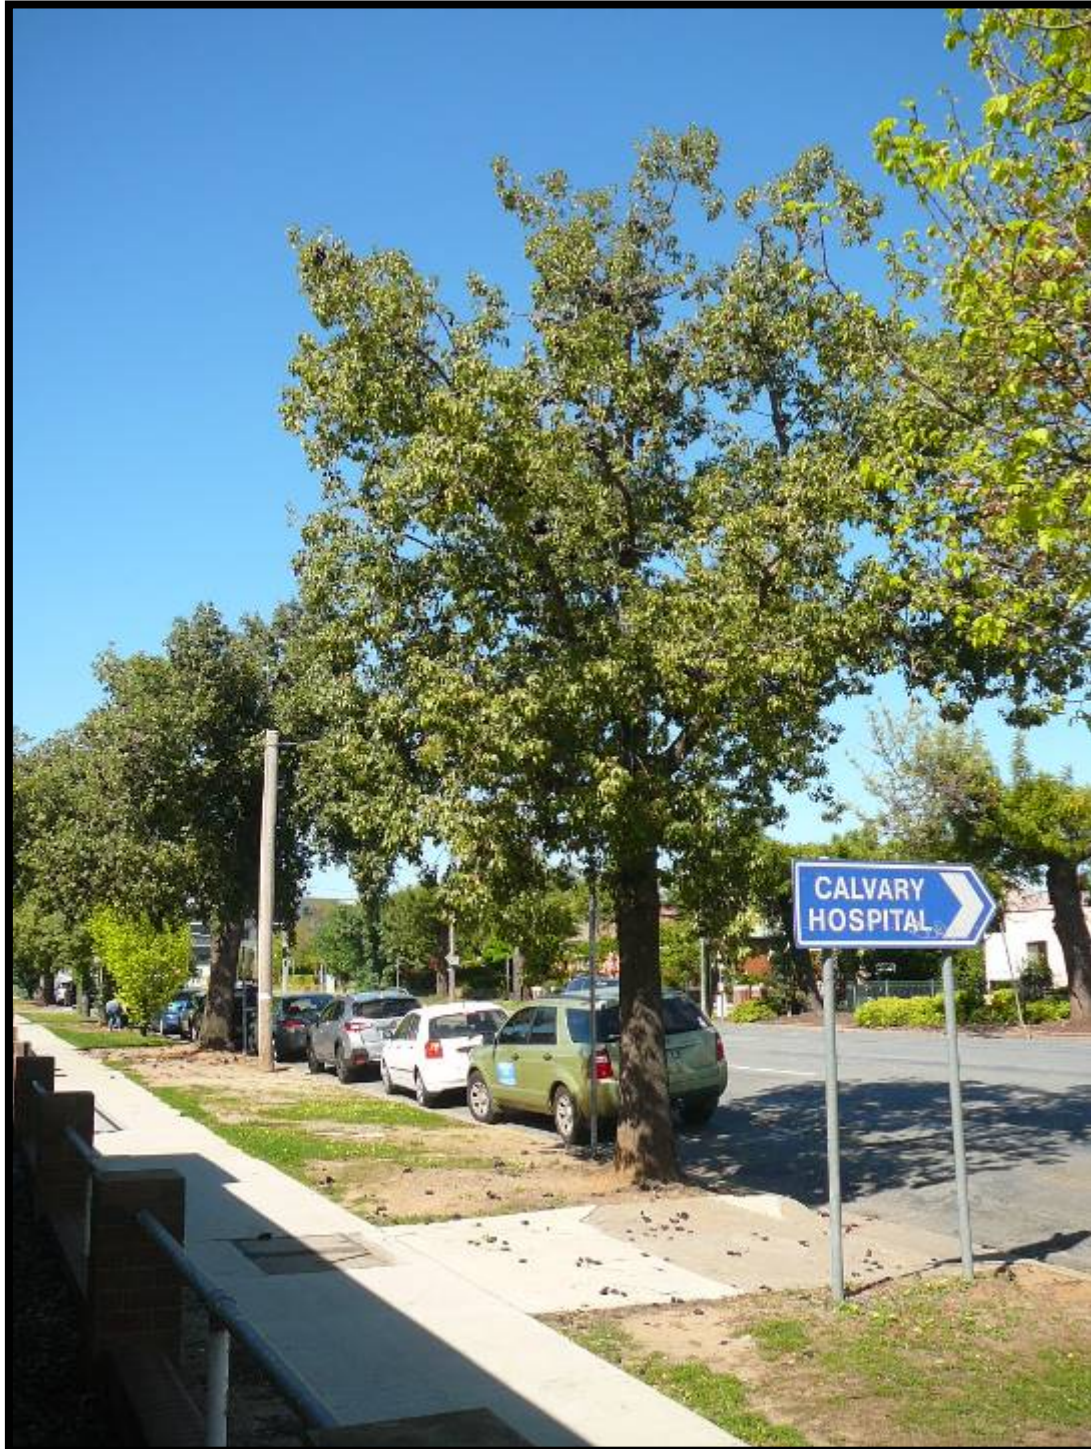
#### 4.2.3 – Tree No. 11

**Exhibit 10** – Tree 11 is a Kurrajong (*Brachychiton populneus*) of good health and vigour.

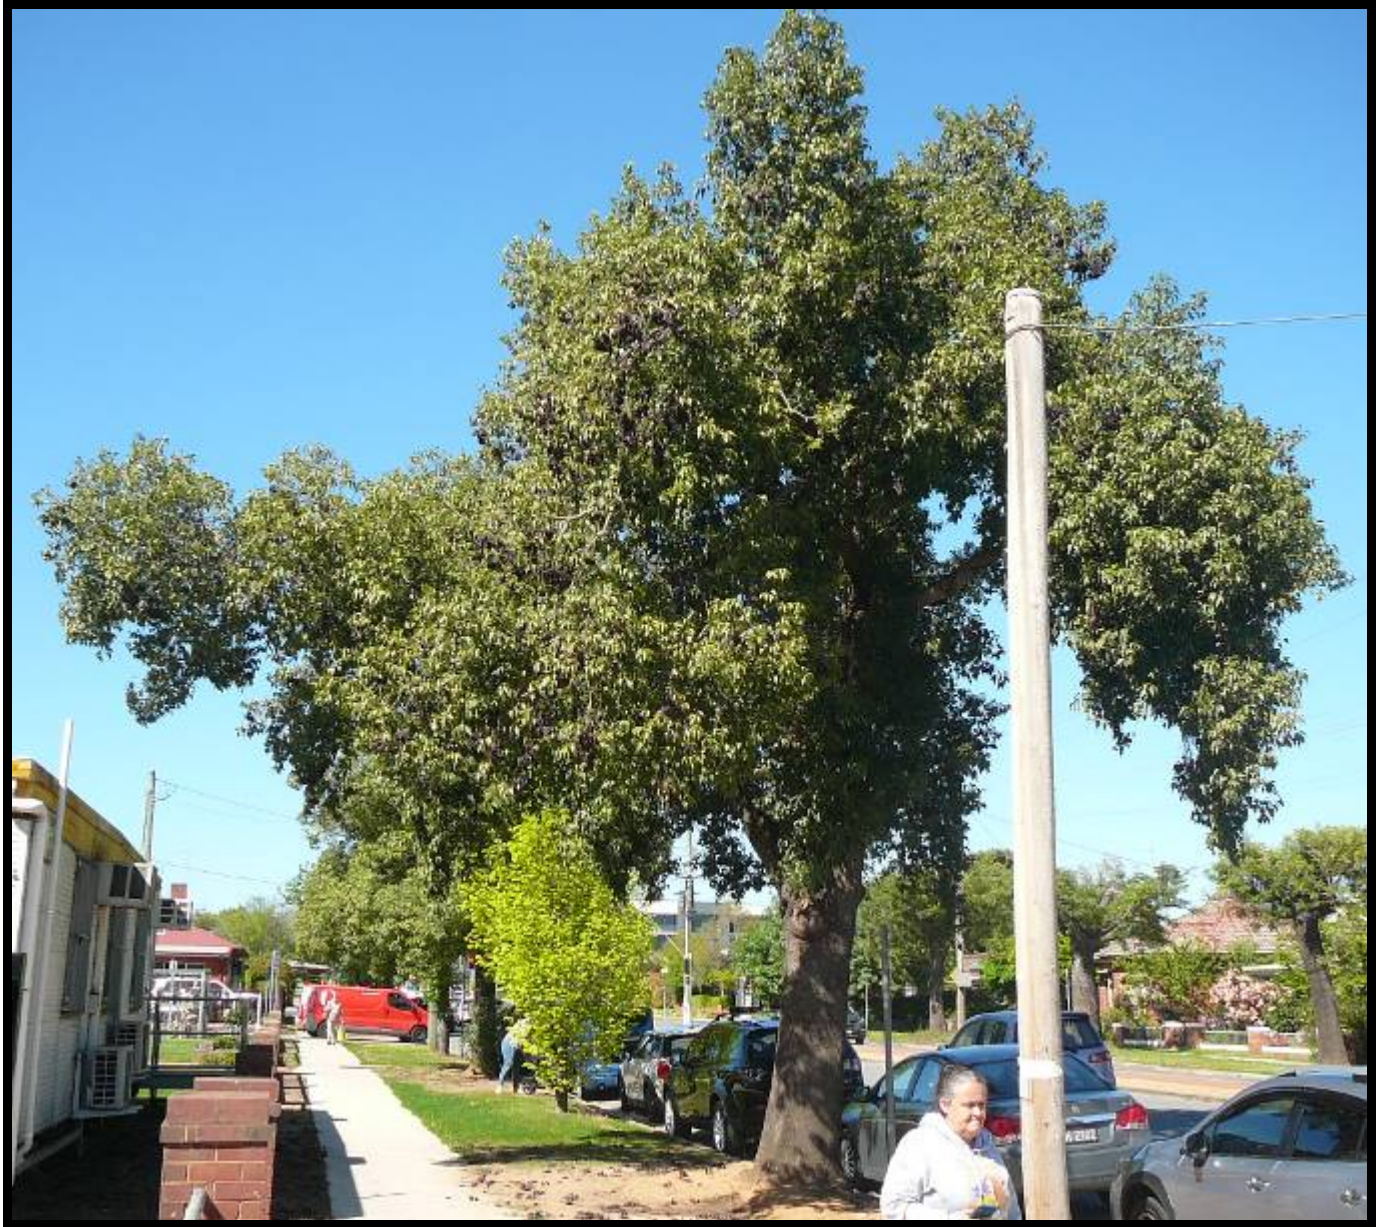
#### 4.2.4 – Tree No. 12

**Exhibit 11** – Tree 12 is another Kurrajong (*Brachychiton populneus*) of good health and vigour.

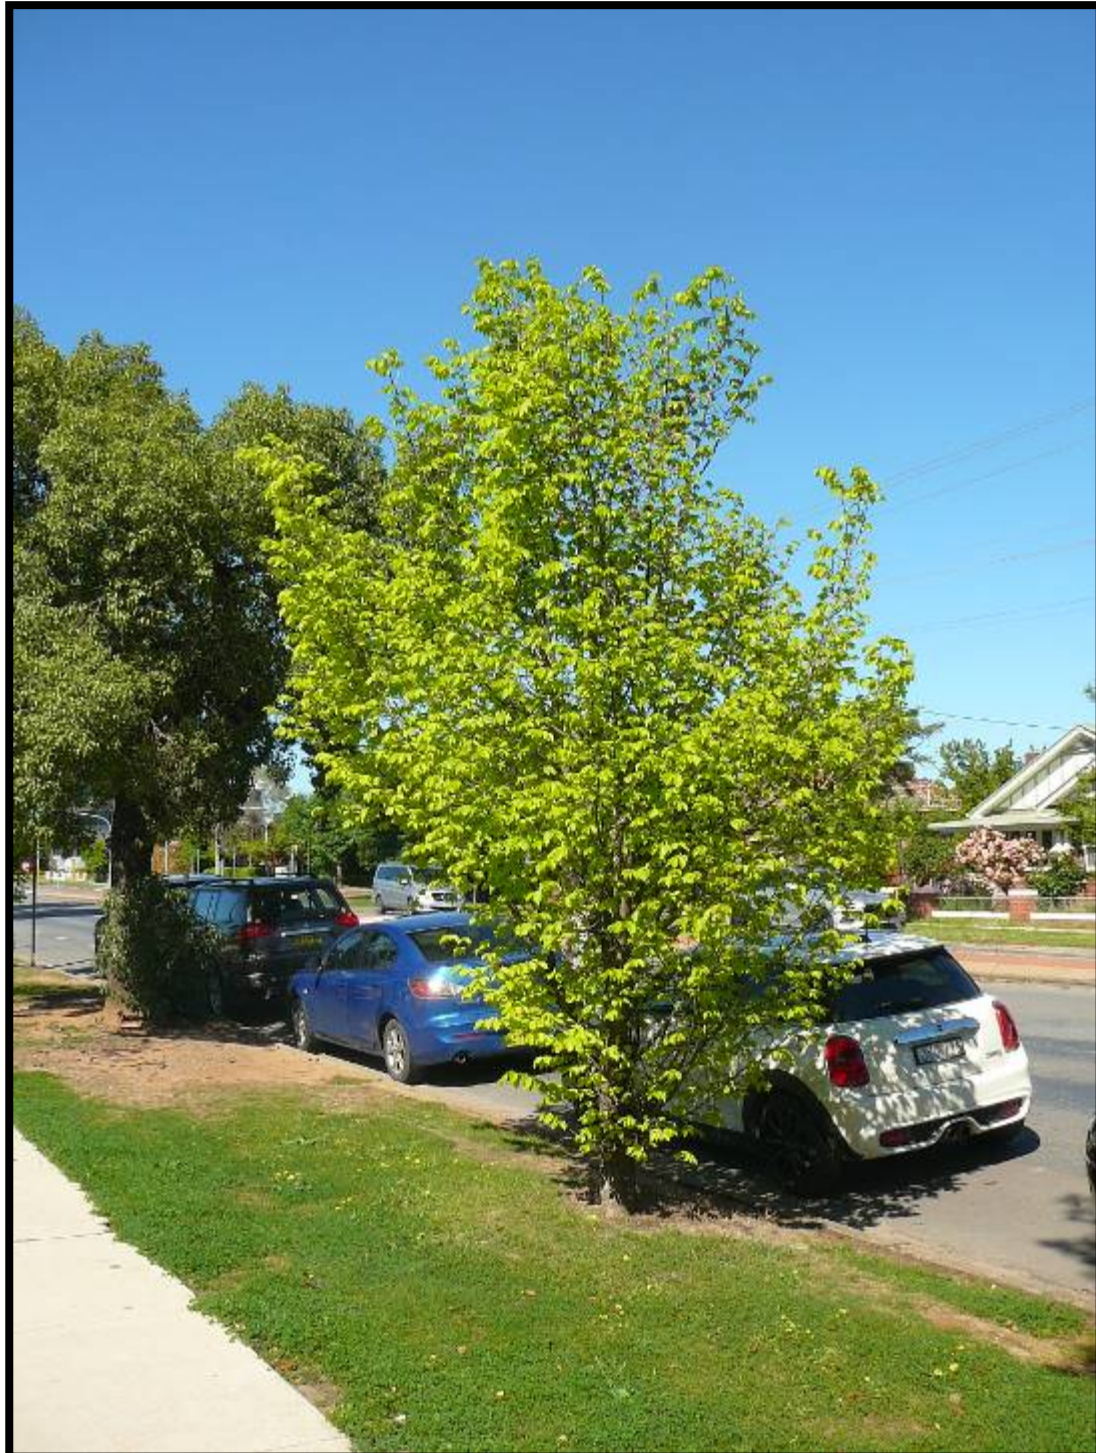
#### 4.2.5 – Tree No. 13

**Exhibit 12** – Tree 13 is another Golden Elm (*Ulmus glabra* Lutescens) that has been compromised by multiple poor pruning of its lower branches. It is rated as in Fair condition.

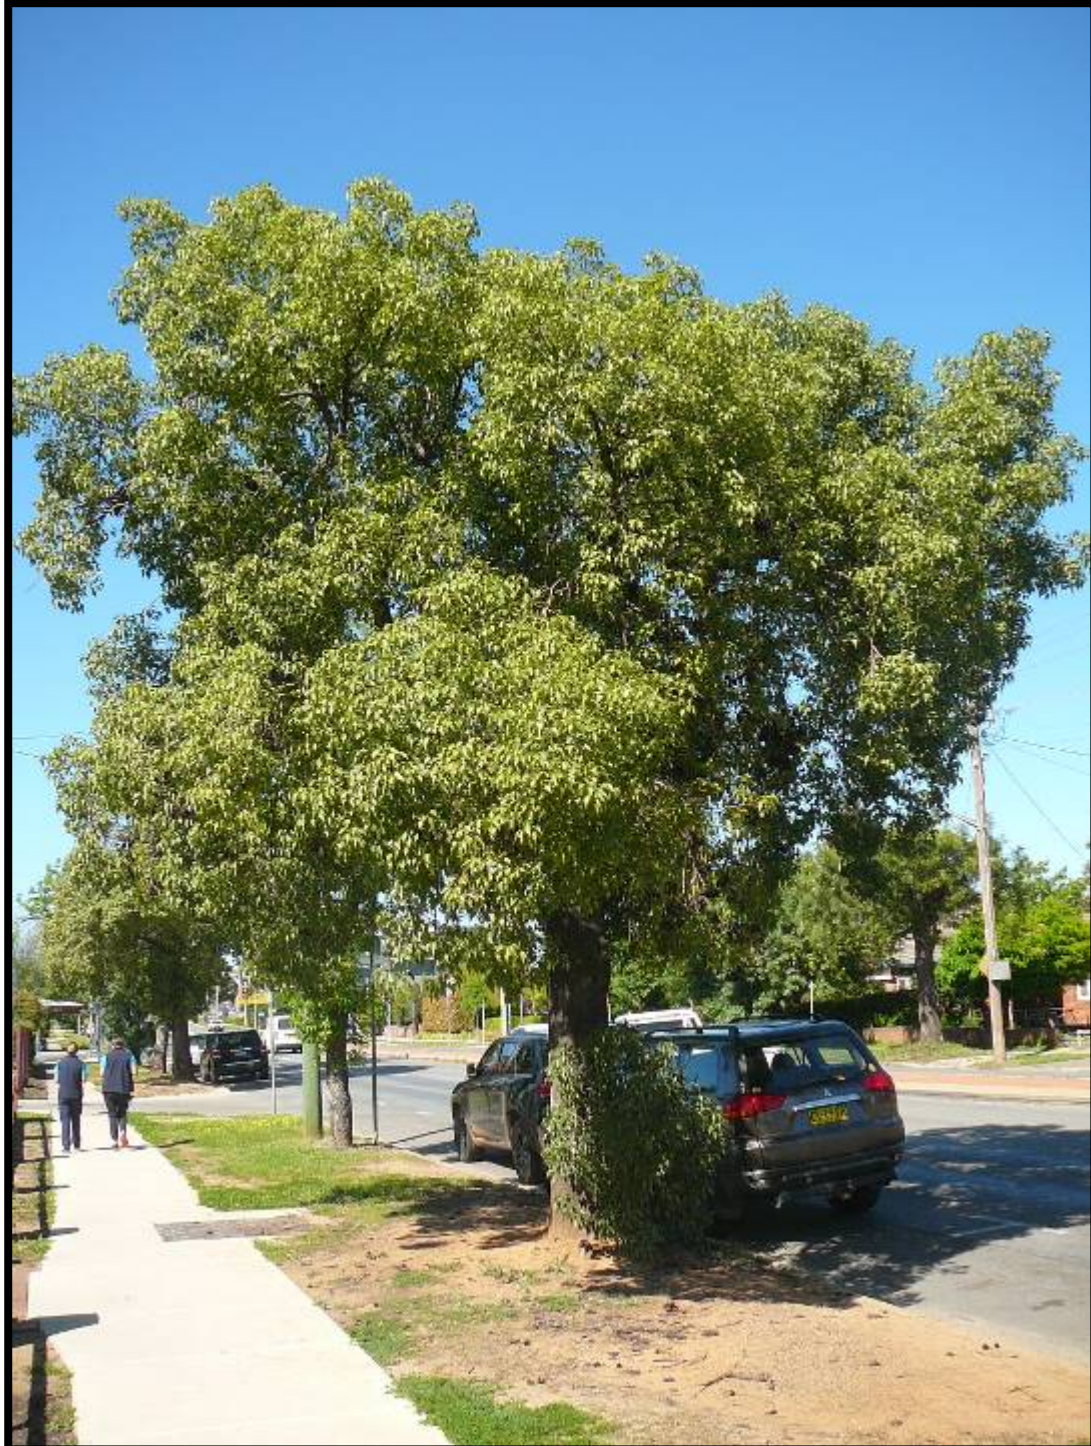
#### 4.2.6 – Tree No. 14

**Exhibit 13** – Tree 14 is another Kurrajong (*Brachychiton populneus*) of good health and vigour.

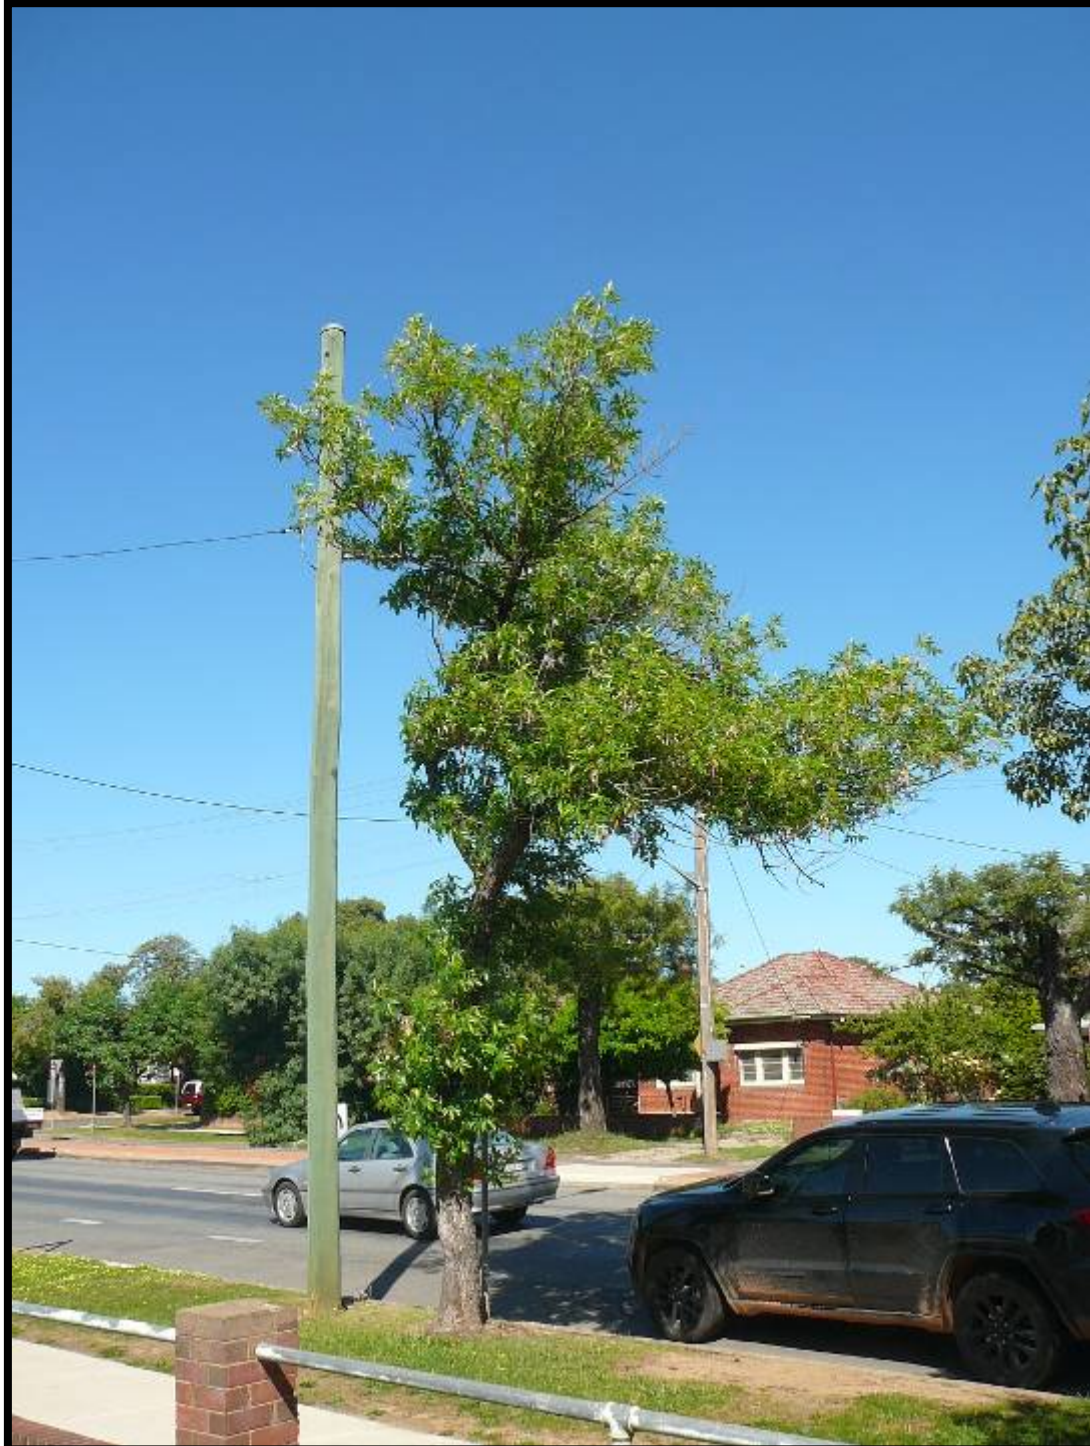
#### 4.2.7 – Tree No. 15

**Exhibit 14** – Tree 15 is an Ash tree (*Fraxinus excelsior*) in Poor condition, lacking vigour, with the majority of its live tissue being epicormic shoots.

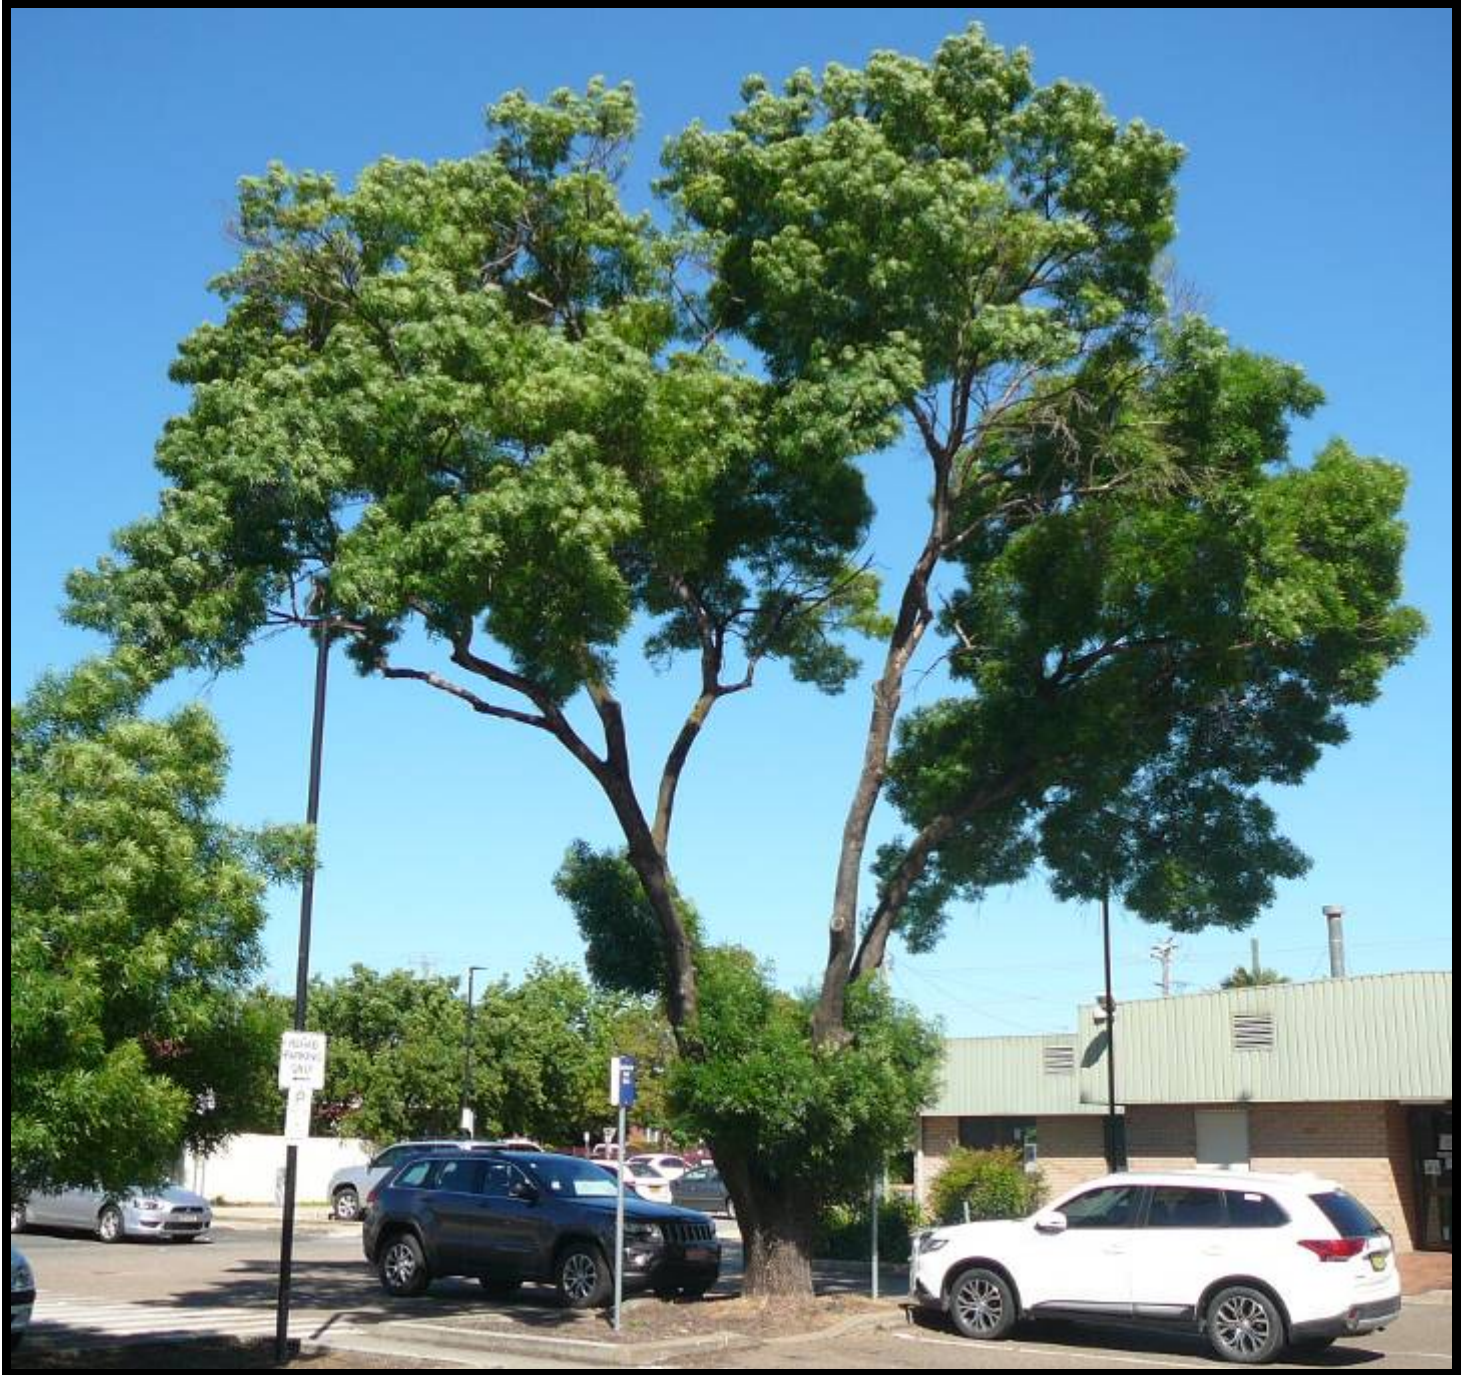
#### 4.2.8 – Tree No. 16

**Exhibit 15** – Tree 16 is a large specimen of Claret Ash (*Fraxinus Raywood*) of reasonable health and vigour. The tree has some deadwood high in its crown and has had multiple pruning of its leaders that has created a “lion’s tail” formation in the tree (see Section 5 and Exhibit 43).

One of the larger specimens whose positioning would allow its retention, in view of the proposed works, is Tree No. 16, a Claret Ash (see Section 4.2.8). However, contemporary practice in the pruning of mature trees has highlighted the risk of what has been termed “lions-tailing”. Gilman describes lions-tailing as overthinning or stripping out the interior of a tree with little or nothing being removed from the ends of limbs. Lions-tailing can cause structural weakness, unbalancing the crown and creating poor mechanical properties (Gilman, 2012). As shown in Exhibits 15 & 43 various “crown lift” pruning of Tree No. 16 has led to its major lateral limbs having foliage (and growth) concentrated at its extremities, which compromises the safety of the tree. The removal and replacement of this tree is the most sensible management approach.

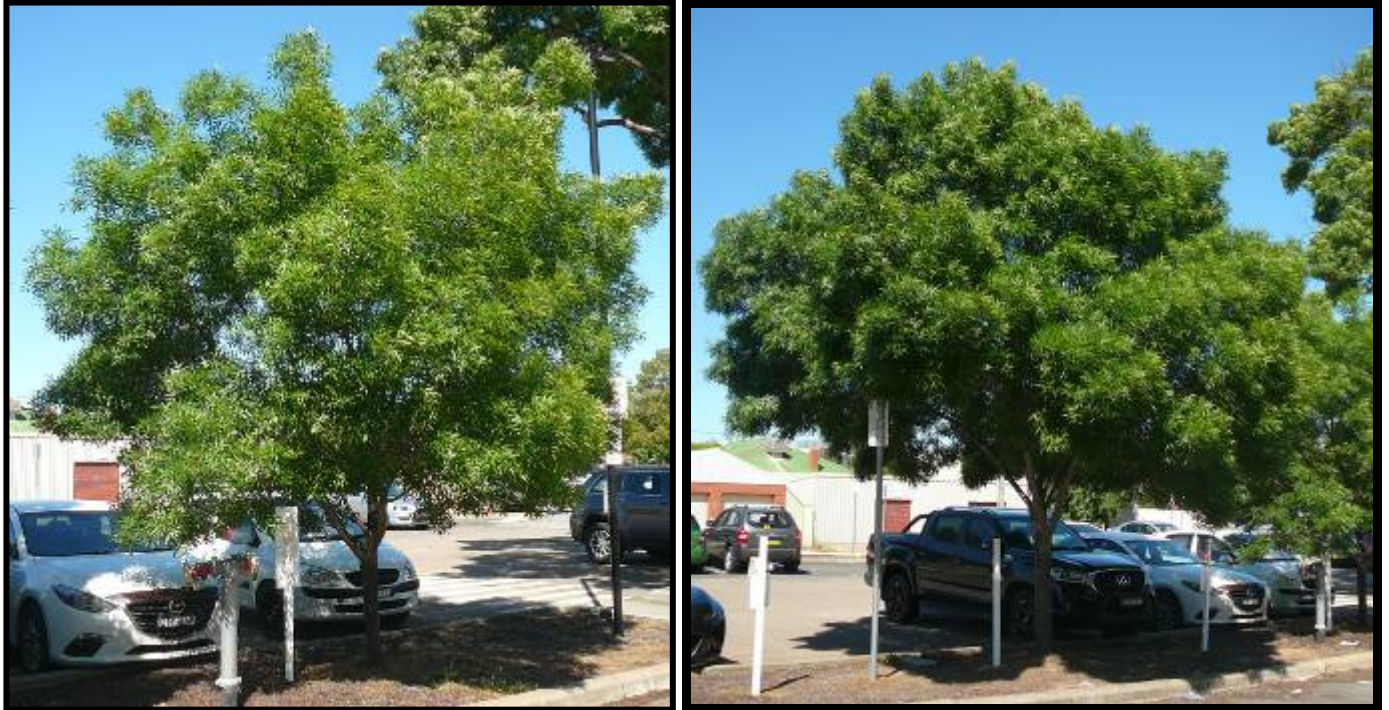
#### 4.2.9 – Tree Nos. 17 and 18

**Exhibit 16** – Tree Nos. 17 and 18 are young specimens of Claret Ash (*Fraxinus Raywood*) of good form, health and vigour.

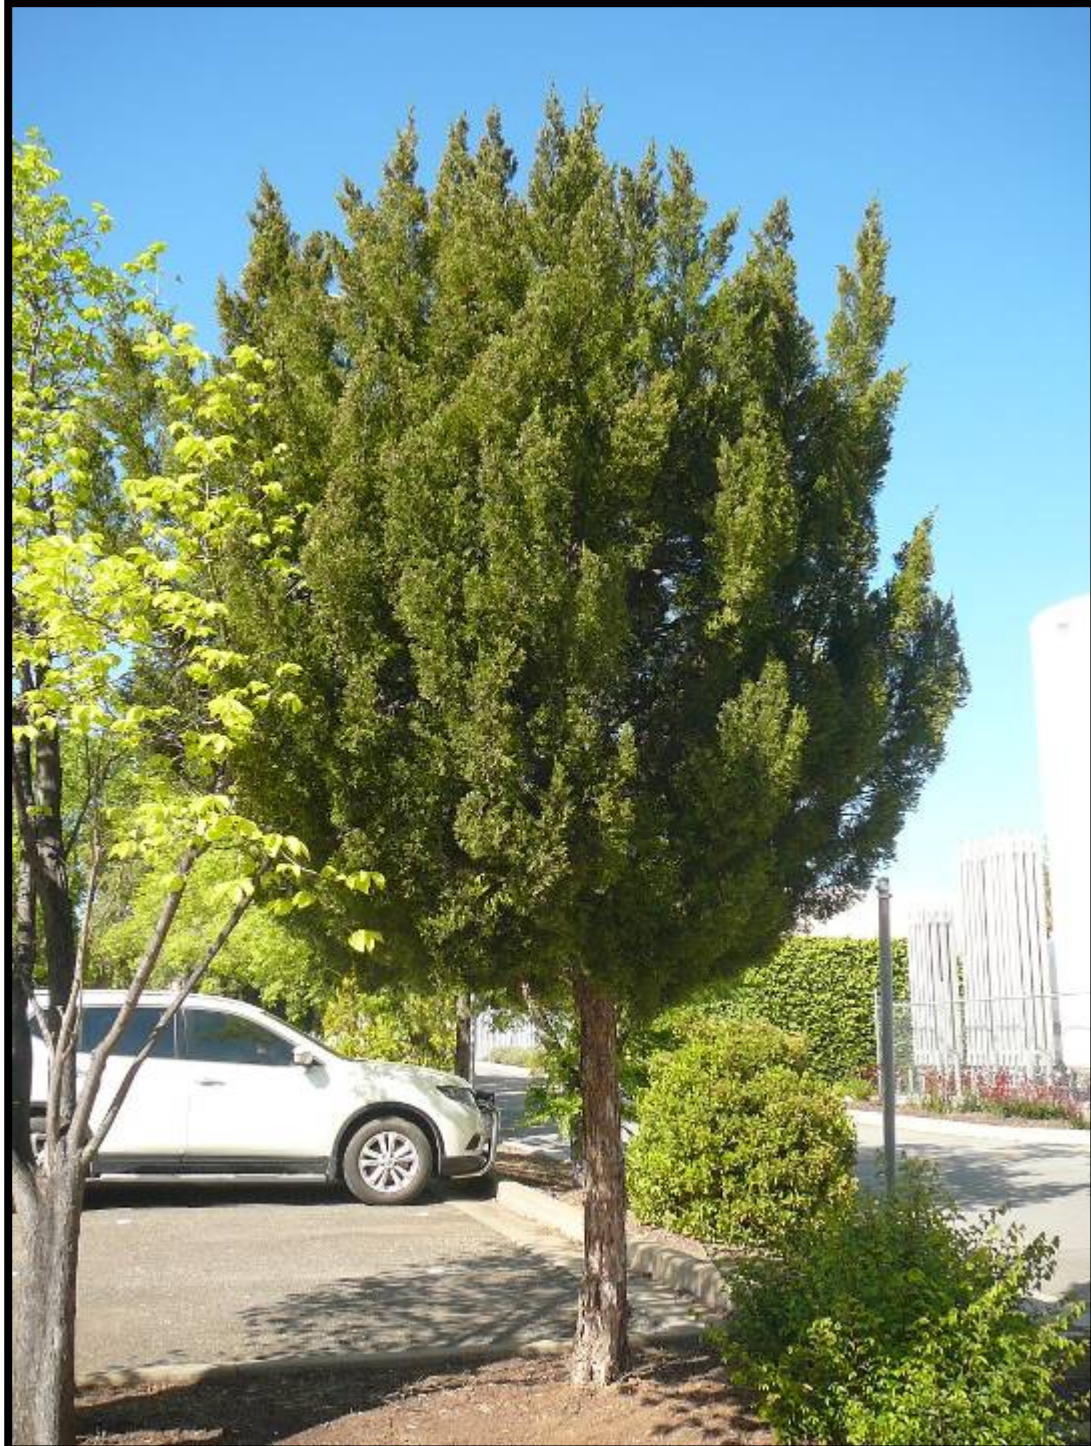
#### 4.3.1 – Tree No. 19

**Exhibit 17** – Tree 19 is a Chinese Juniper (*Juniperus chinensis* cv) within the perimeter “island” of the existing car park of Yathong Lodge.
