# WAGGA WAGGA HOSPITAL CARPARKS

## Tree Survey

03 November 2020,  
Ref 20/387C.

# Trees on the Sites of Proposed Carparks, Wagga Wagga Health Services

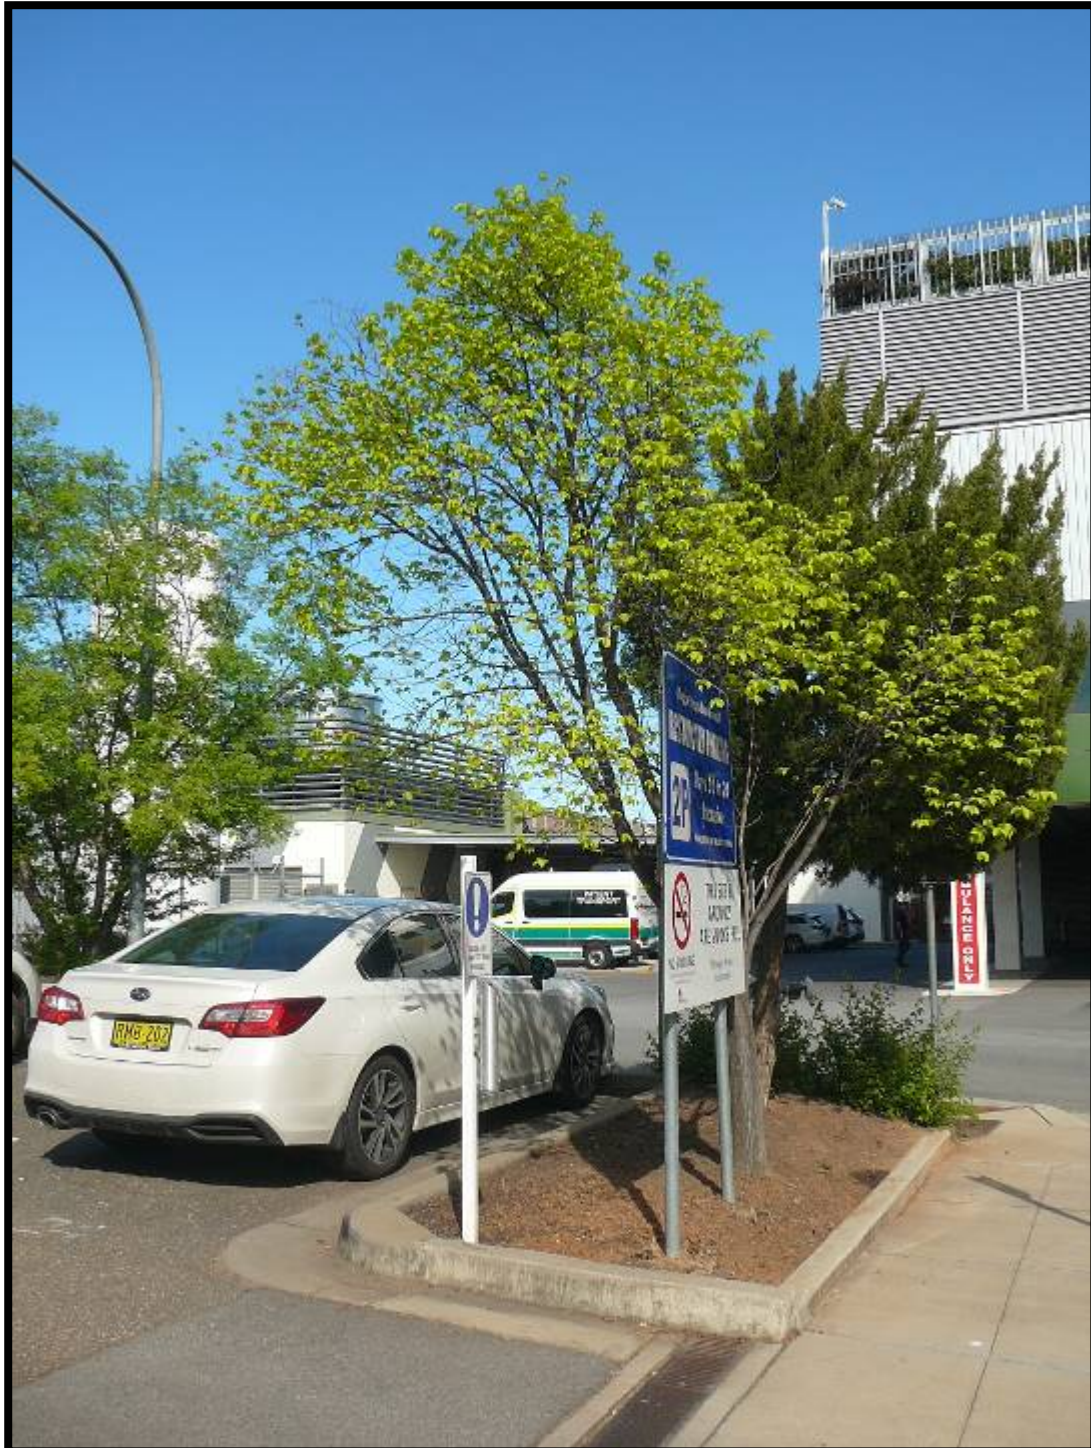
#### 4.3.2 – Tree No. 20

**Exhibit 18** – The crown of Tree 20 has, like other Golden Elms on the site, heavy scale infestation and has been misshapen due to suppression by the adjacent Tree 19, attributing to its Fair condition rating.

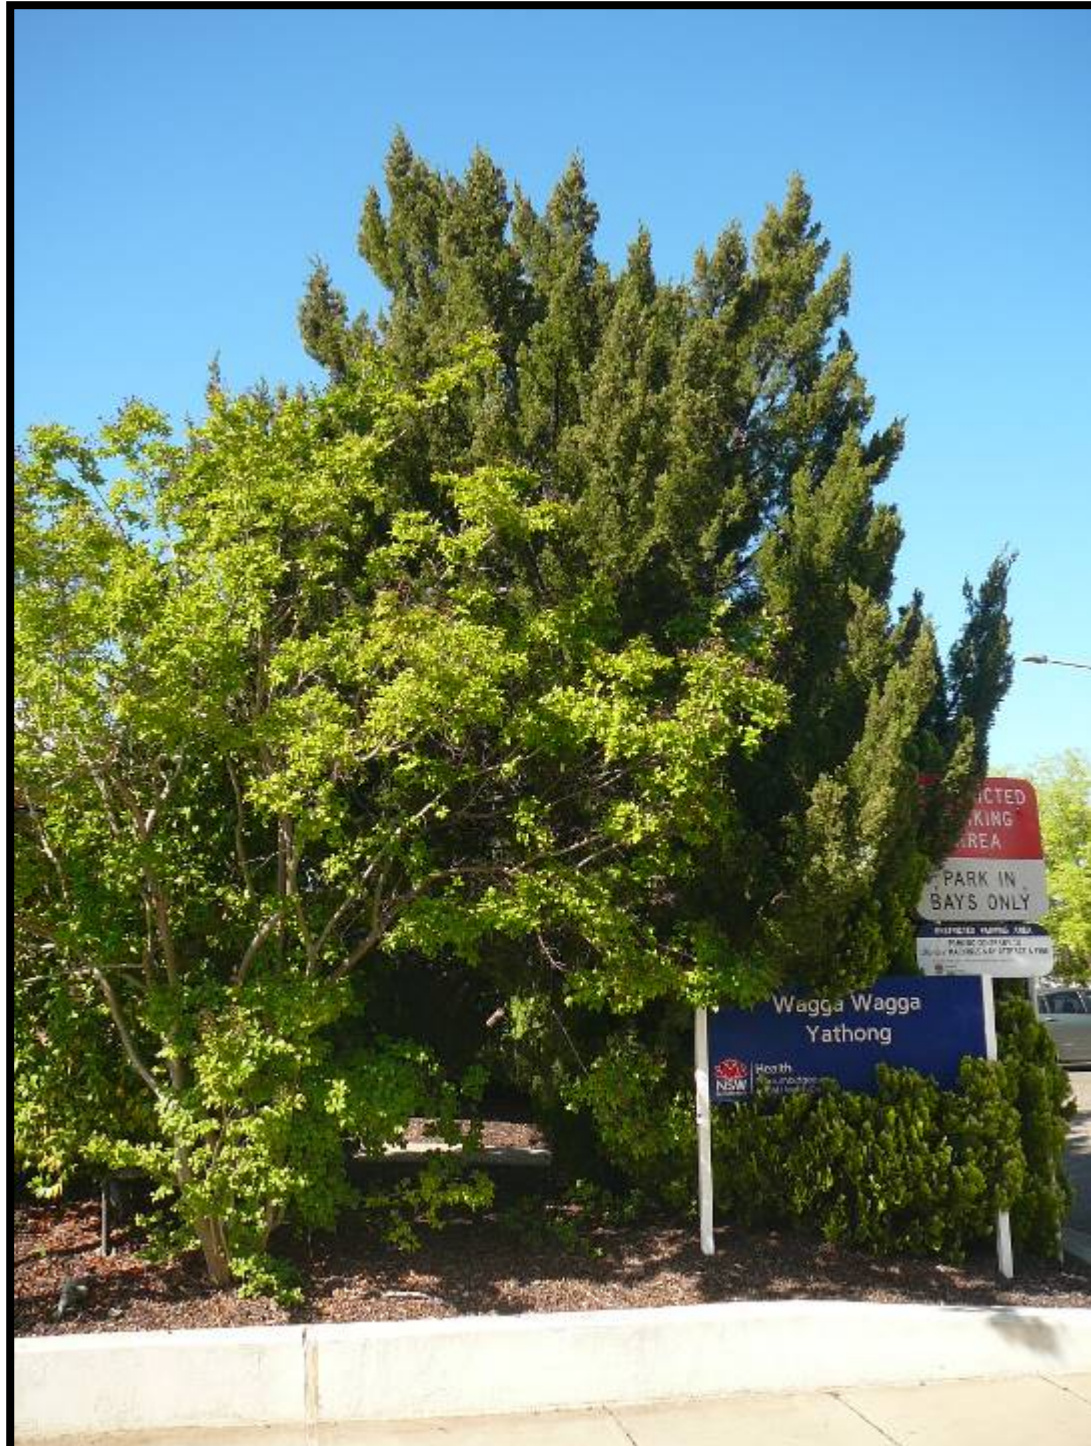
### 4.3.3 – Tree No. 21

**Exhibit 19** – Tree 21 is another specimen of Chinese Juniper (*Juniperus chinensis* cv) of good form, health and vigour. Sections of the garden bed surrounding Yathong Lodge is densely planted with trees and woody shrubs, as illustrated in this picture.

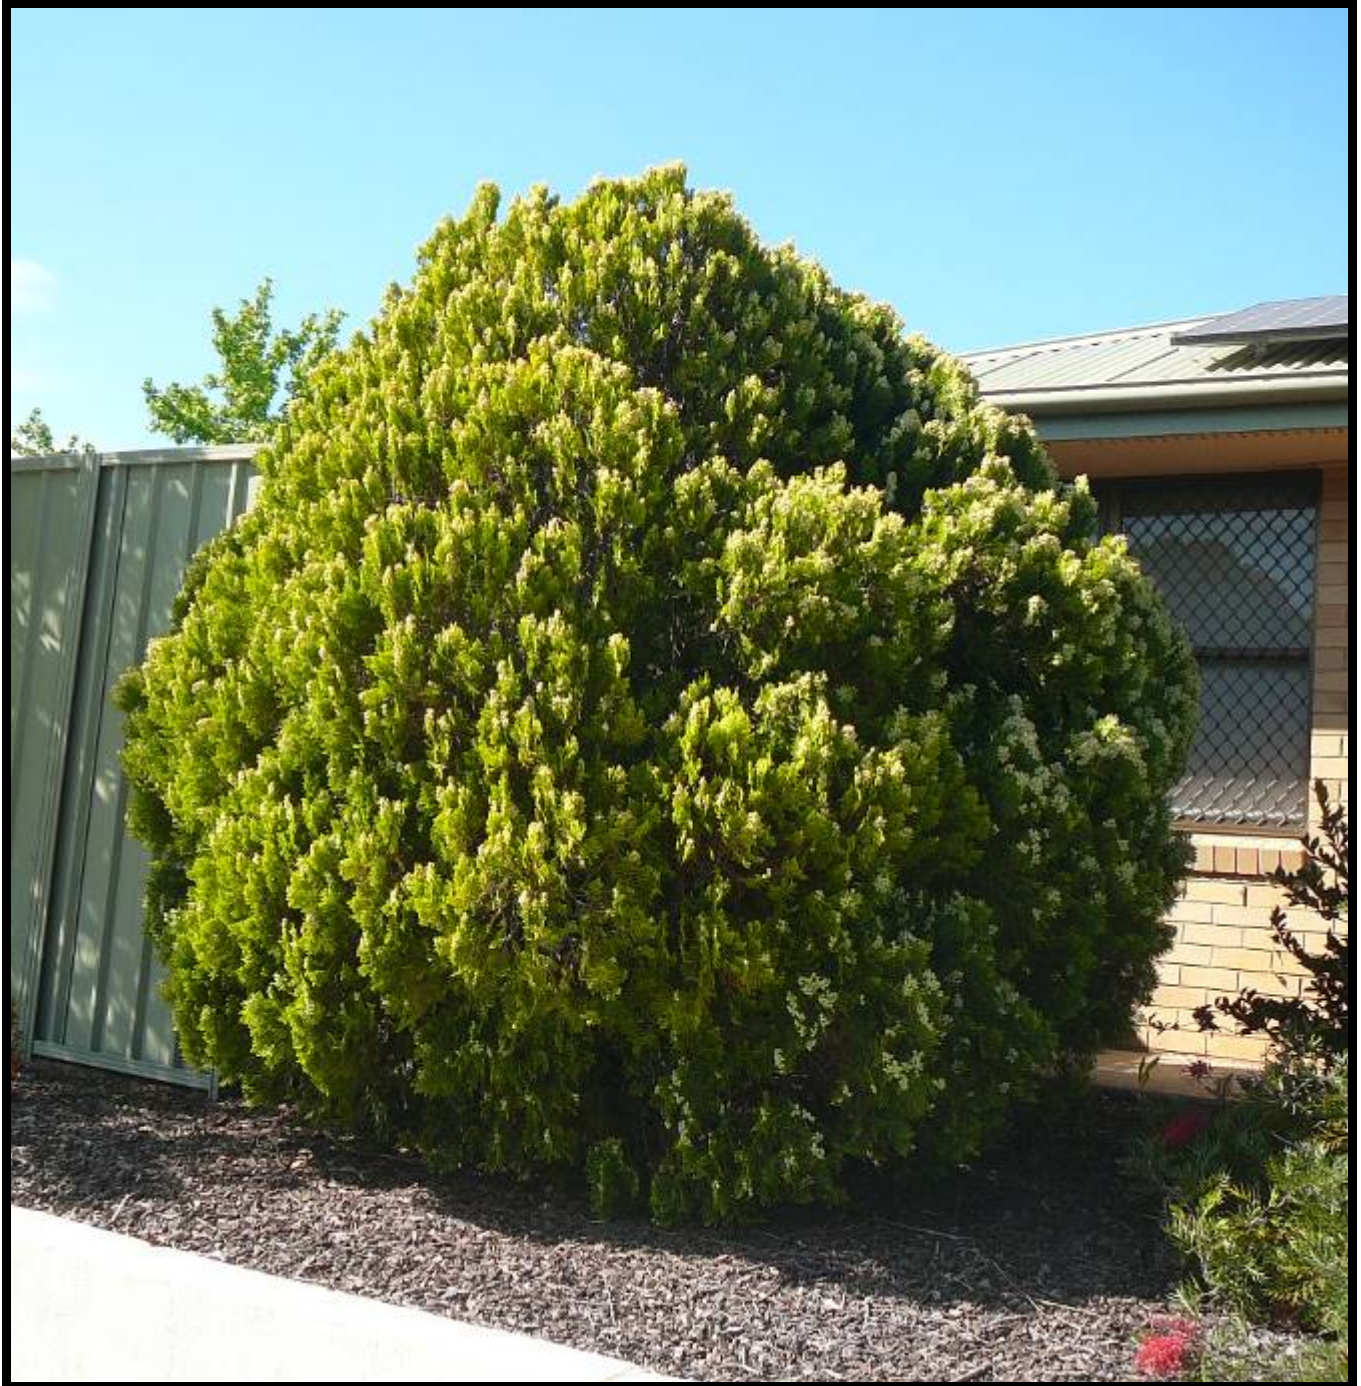
#### 4.3.4 – Tree No. 22

**Exhibit 20** – Tree 22 is specimen of Oriental Arbor-vitae (*Platycladus orientalis* cv.) with a compact, rounded form.

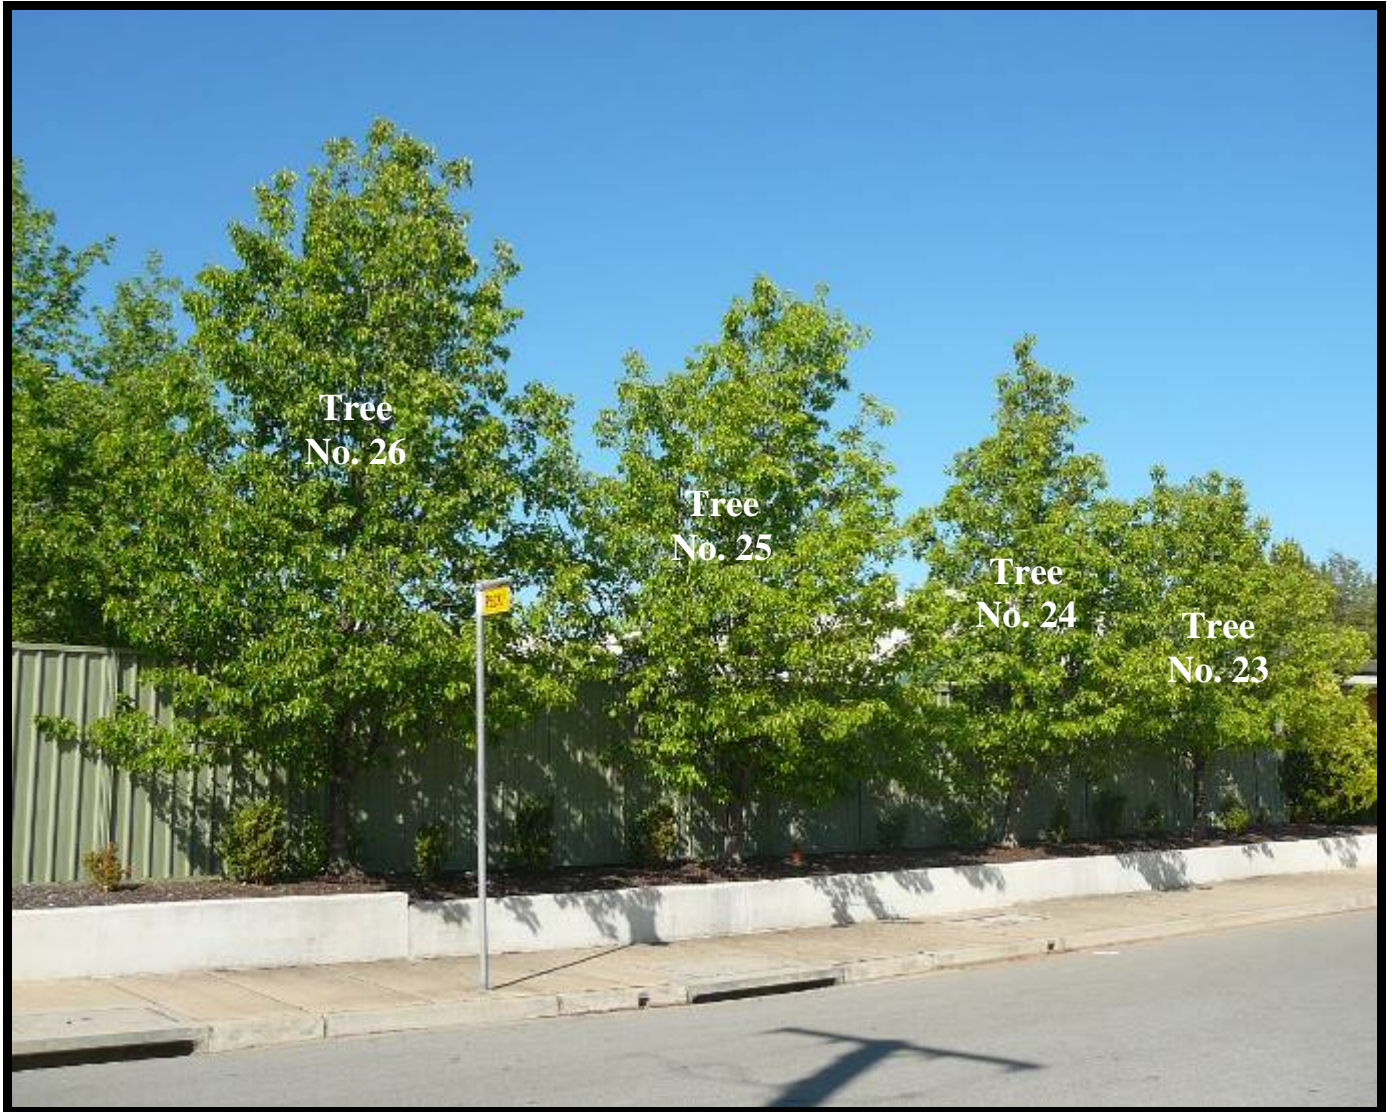
#### 4.3.5 – Tree Nos. 23 to 26

**Exhibit 21** – Tree Numbers 23 to 26 are all young healthy specimens of Ornamental Pear cultivars (*Pyrus calleryana* cv.).

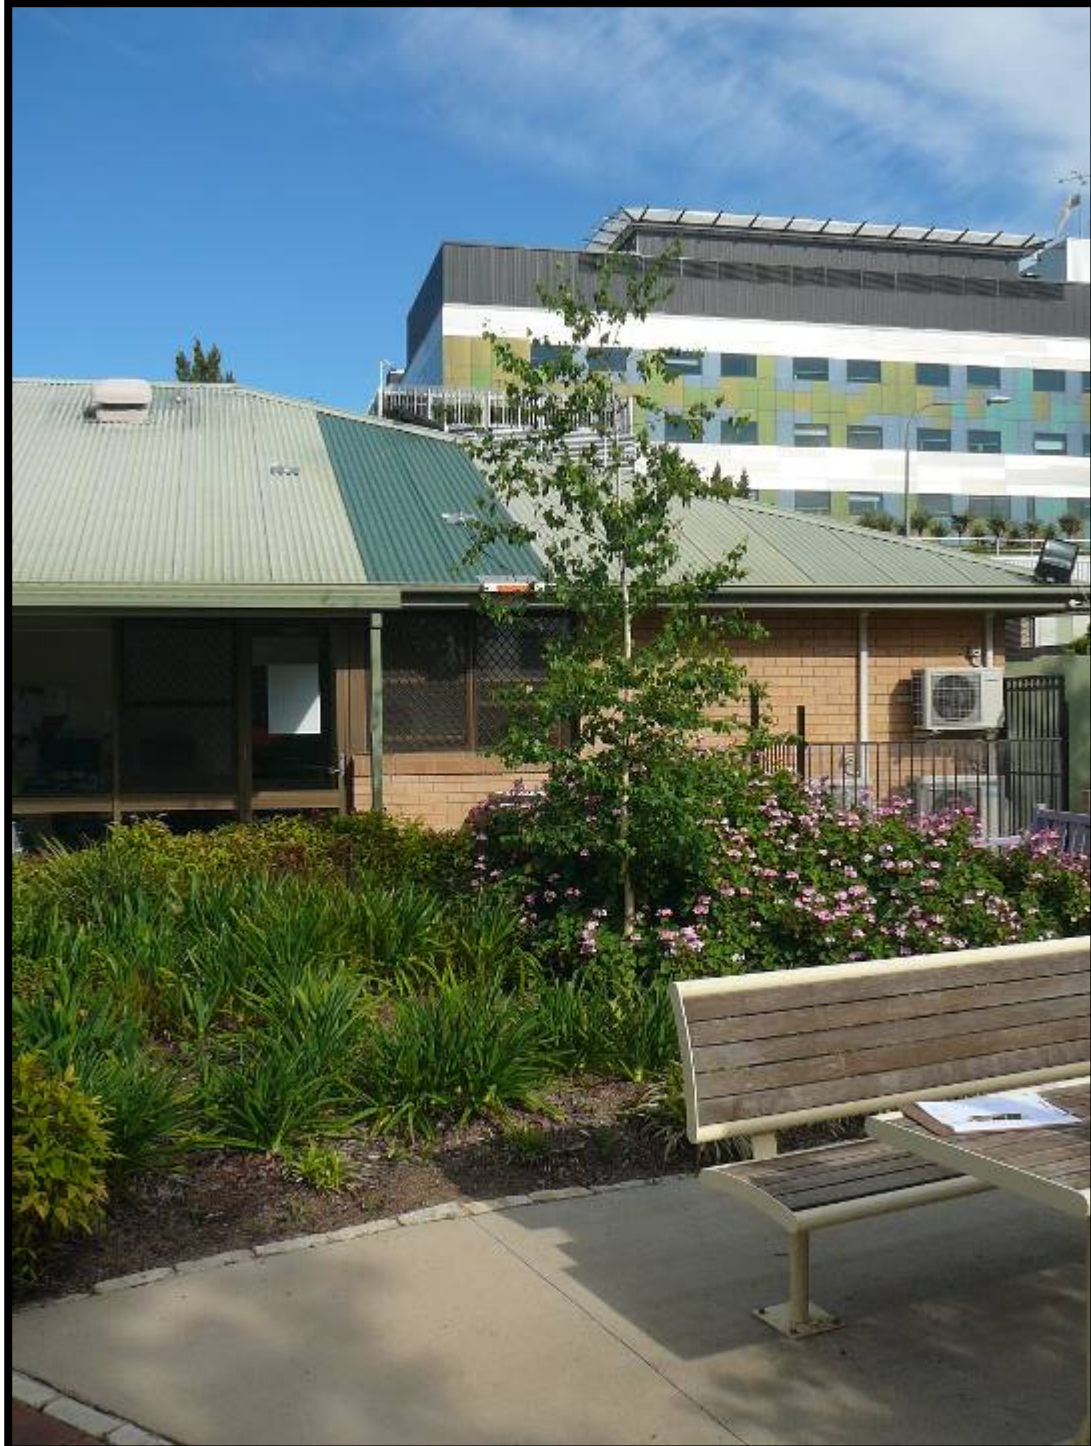
#### 4.3.6 – Tree No. 27

**Exhibit 22** – Tree 27 is a recently planted specimen of Silver Birch (*Betula pendula*) of good form, health and vigour.

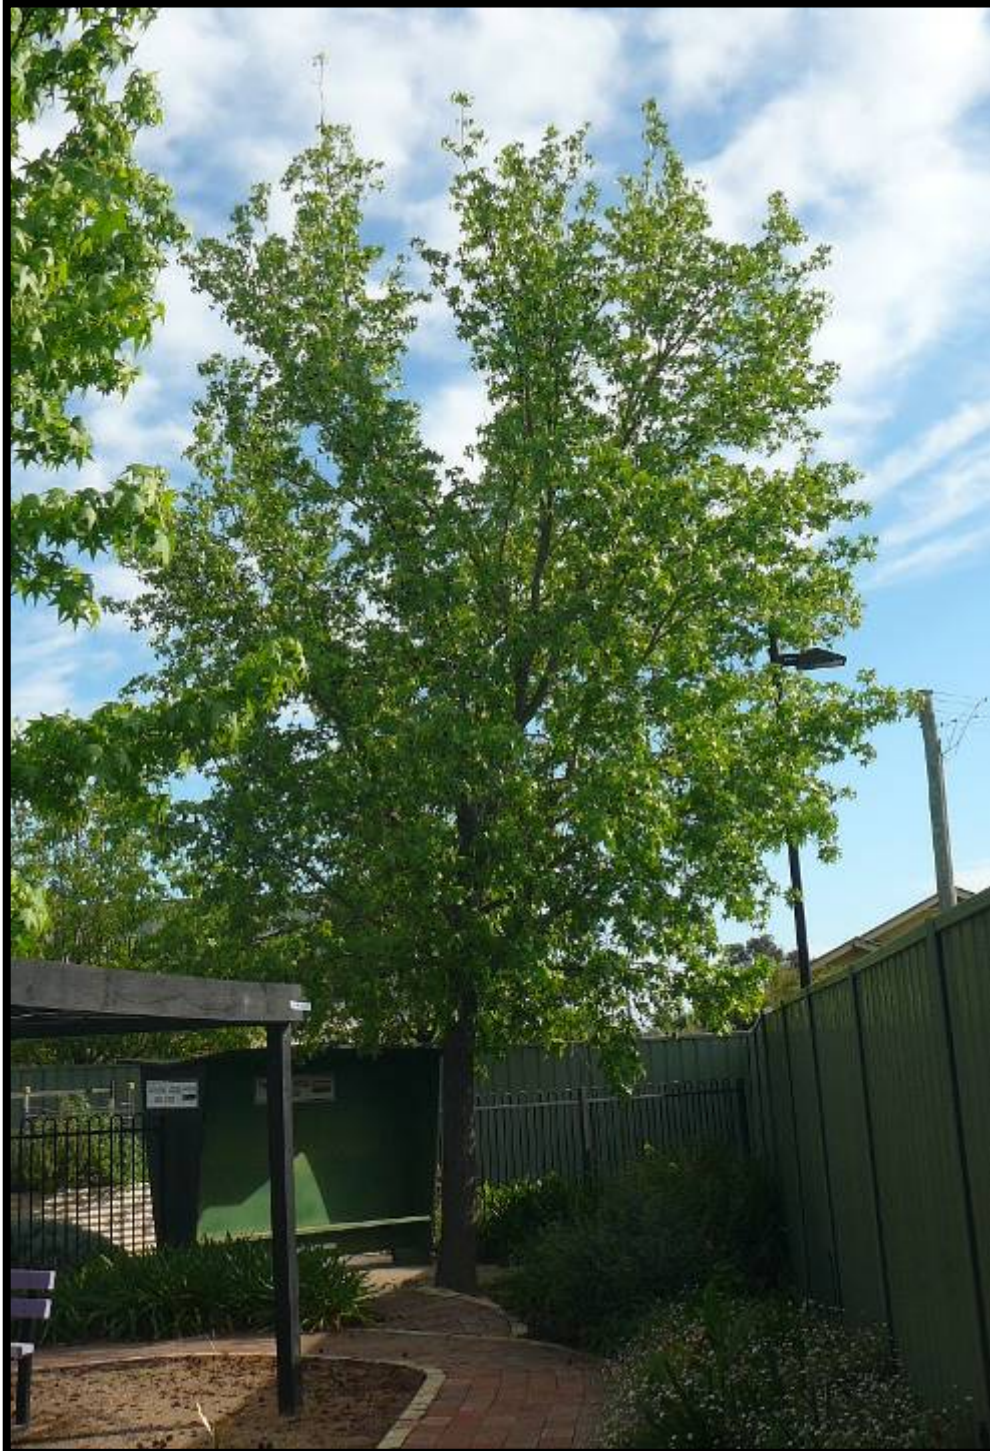
#### 4.3.7 – Tree No. 28

**Exhibit 23** – Tree 28 is mature specimen of Liquidambar (*Liquidambar styraciflua*). The tree has suffered storm damage in the past which has seen the removal of its dominant apical leader.

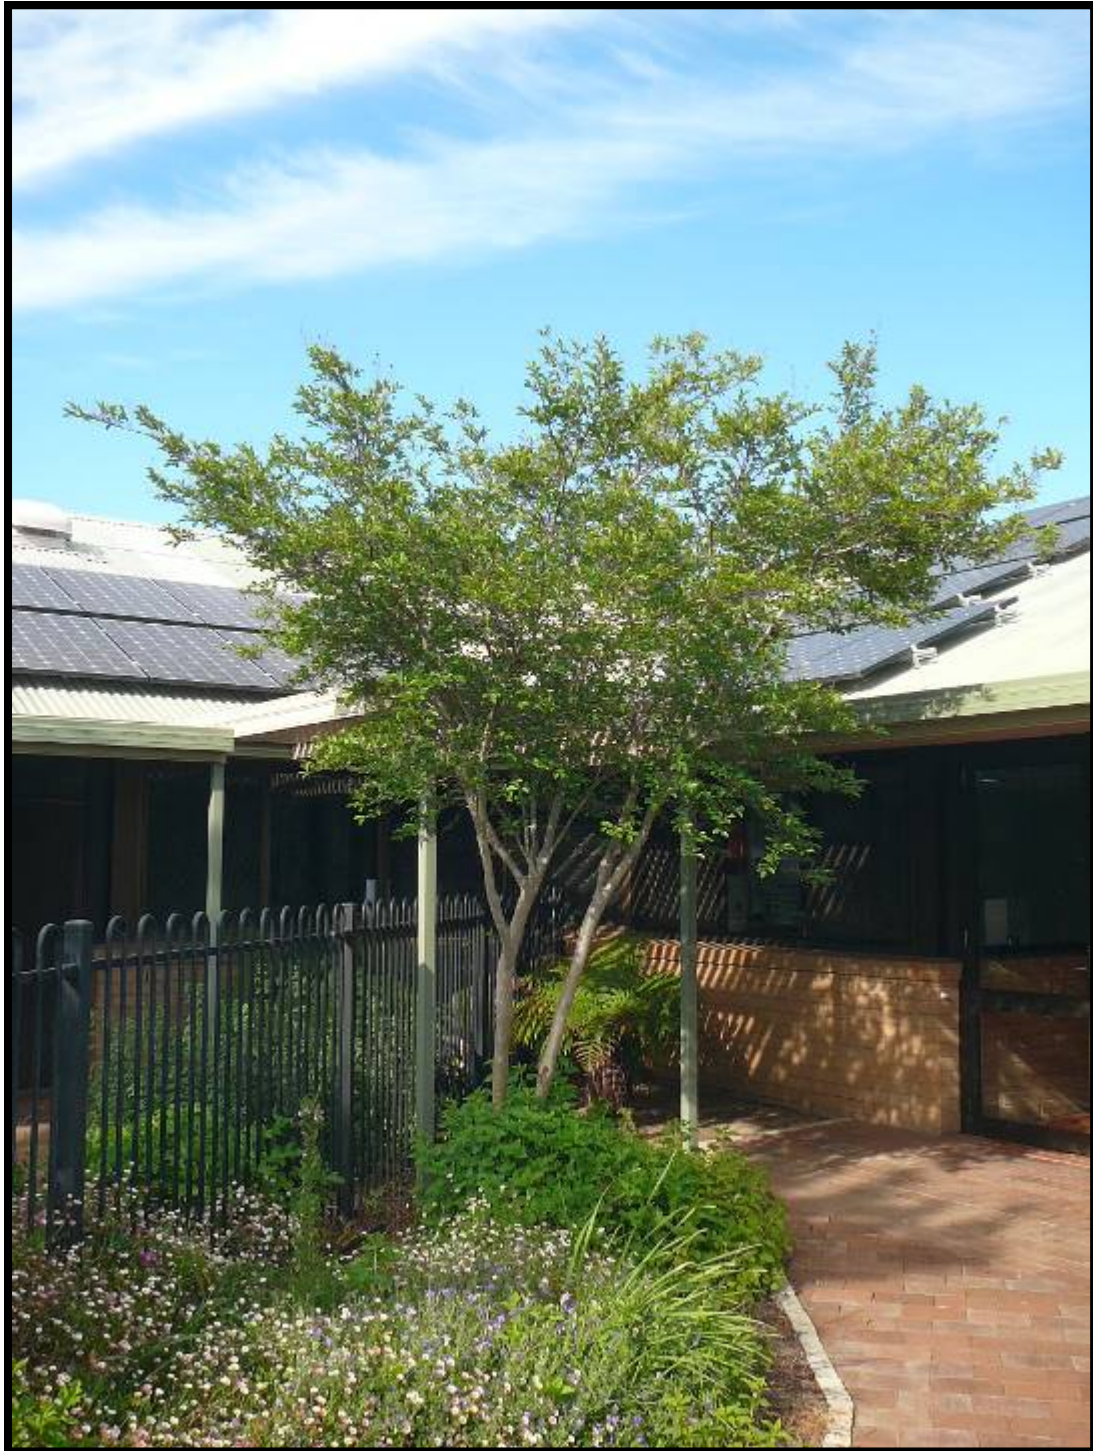
#### 4.3.8 – Tree No. 29

**Exhibit 24** – Tree 29, a Crepe-myrtle (*Lagerstroemia indica* cv.) in Good condition.

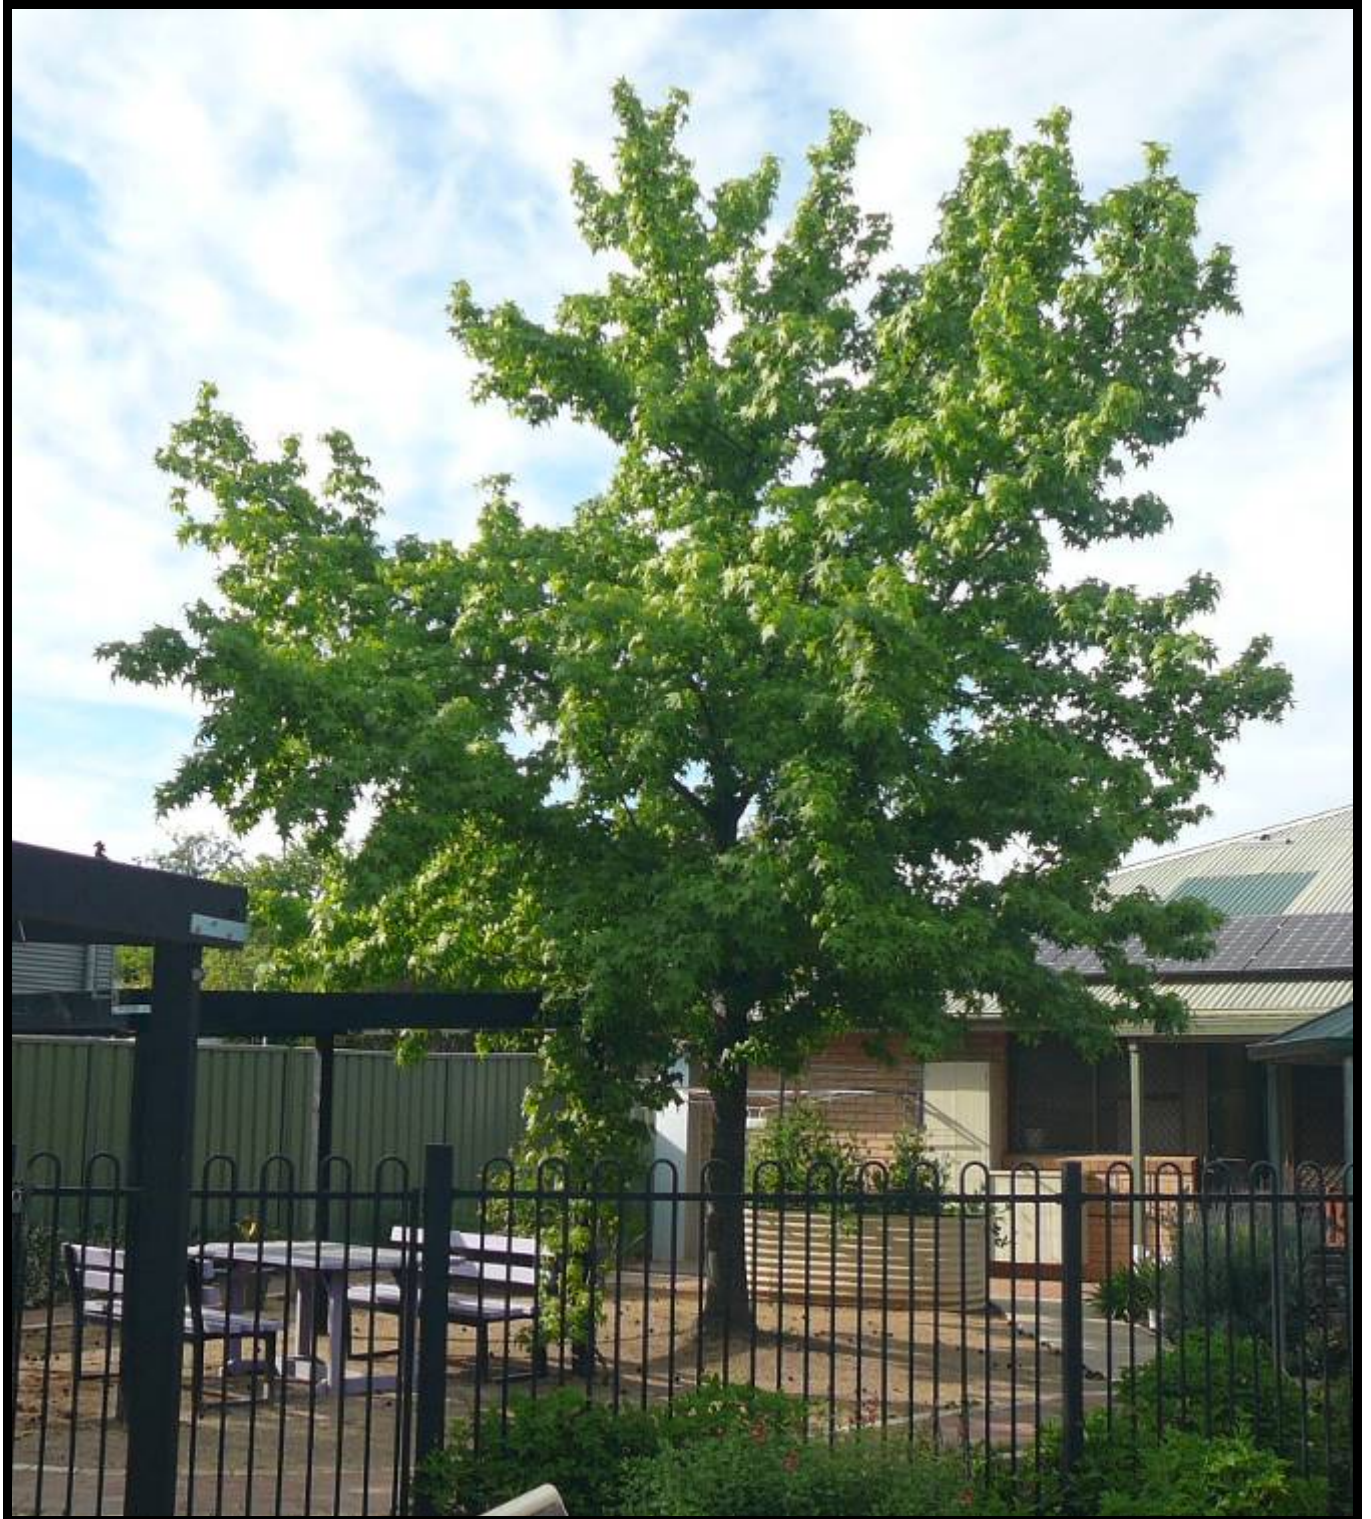
#### 4.3.9 – Tree No. 30

**Exhibit 25** – Tree 30 is fine specimen of Liquidambar (*Liquidambar styraciflua*) in Good condition.

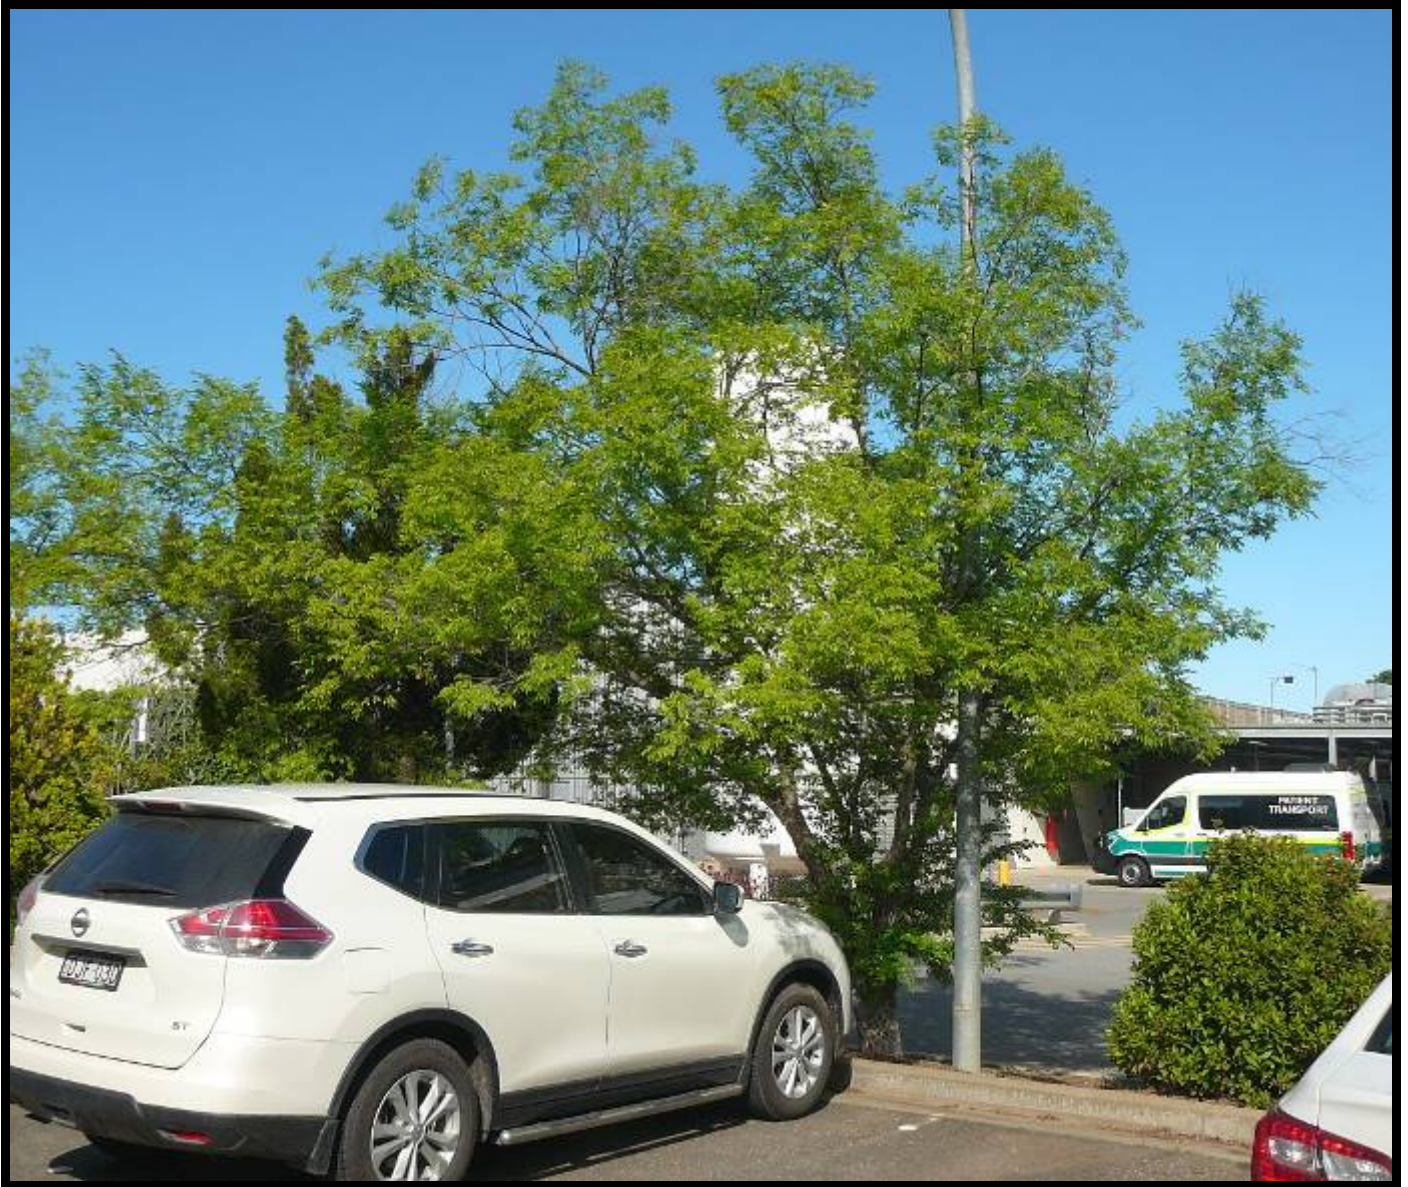
#### 4.3.9 – Tree No. 31

**Exhibit 26** – Tree 31 is a low branching specimen of Chinese Elm (*Ulmus parvifolia*) within the perimeter “island” of the existing car park of Yathong Lodge. The tree’s “sub-optimal” form limits its usefulness in the altered landscape as its low branching, which encroaches on adjacent roadways and the car park, would be difficult to remedy with pruning.

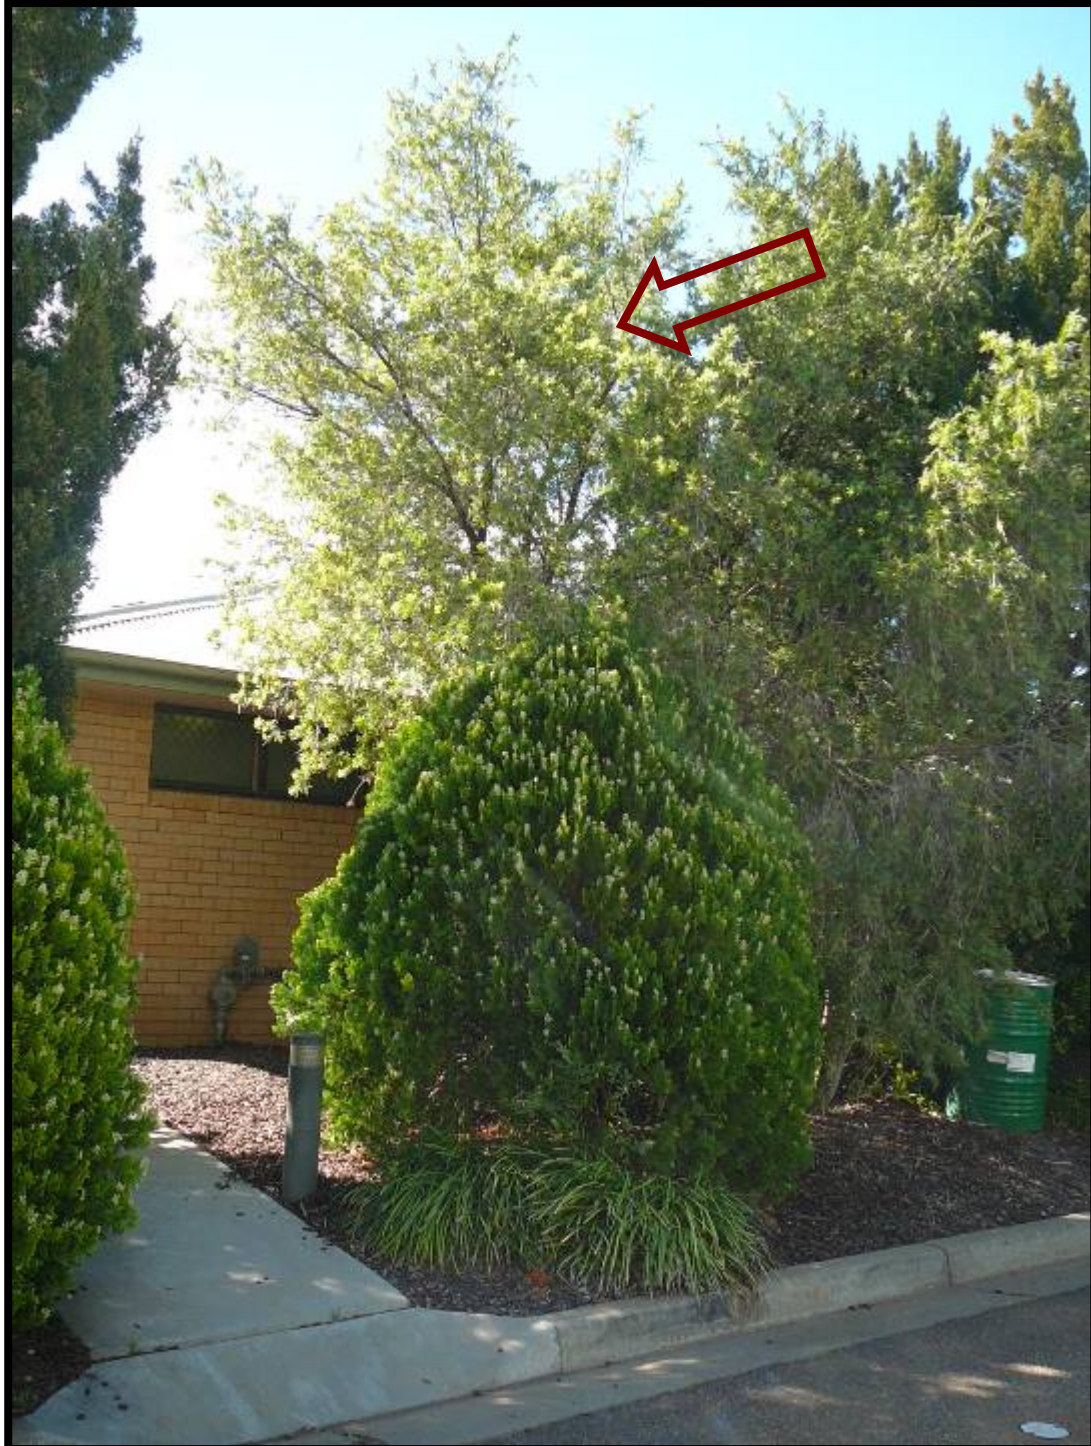
#### 4.3.10 – Tree No. 32

**Exhibit 27** – Tree 32 (arrowed) is a Weeping Bottlebrush (*Callistemon viminalis* cv.) whose form has been suppressed by adjacent planting in the garden beds surrounding Yathong Lodge.

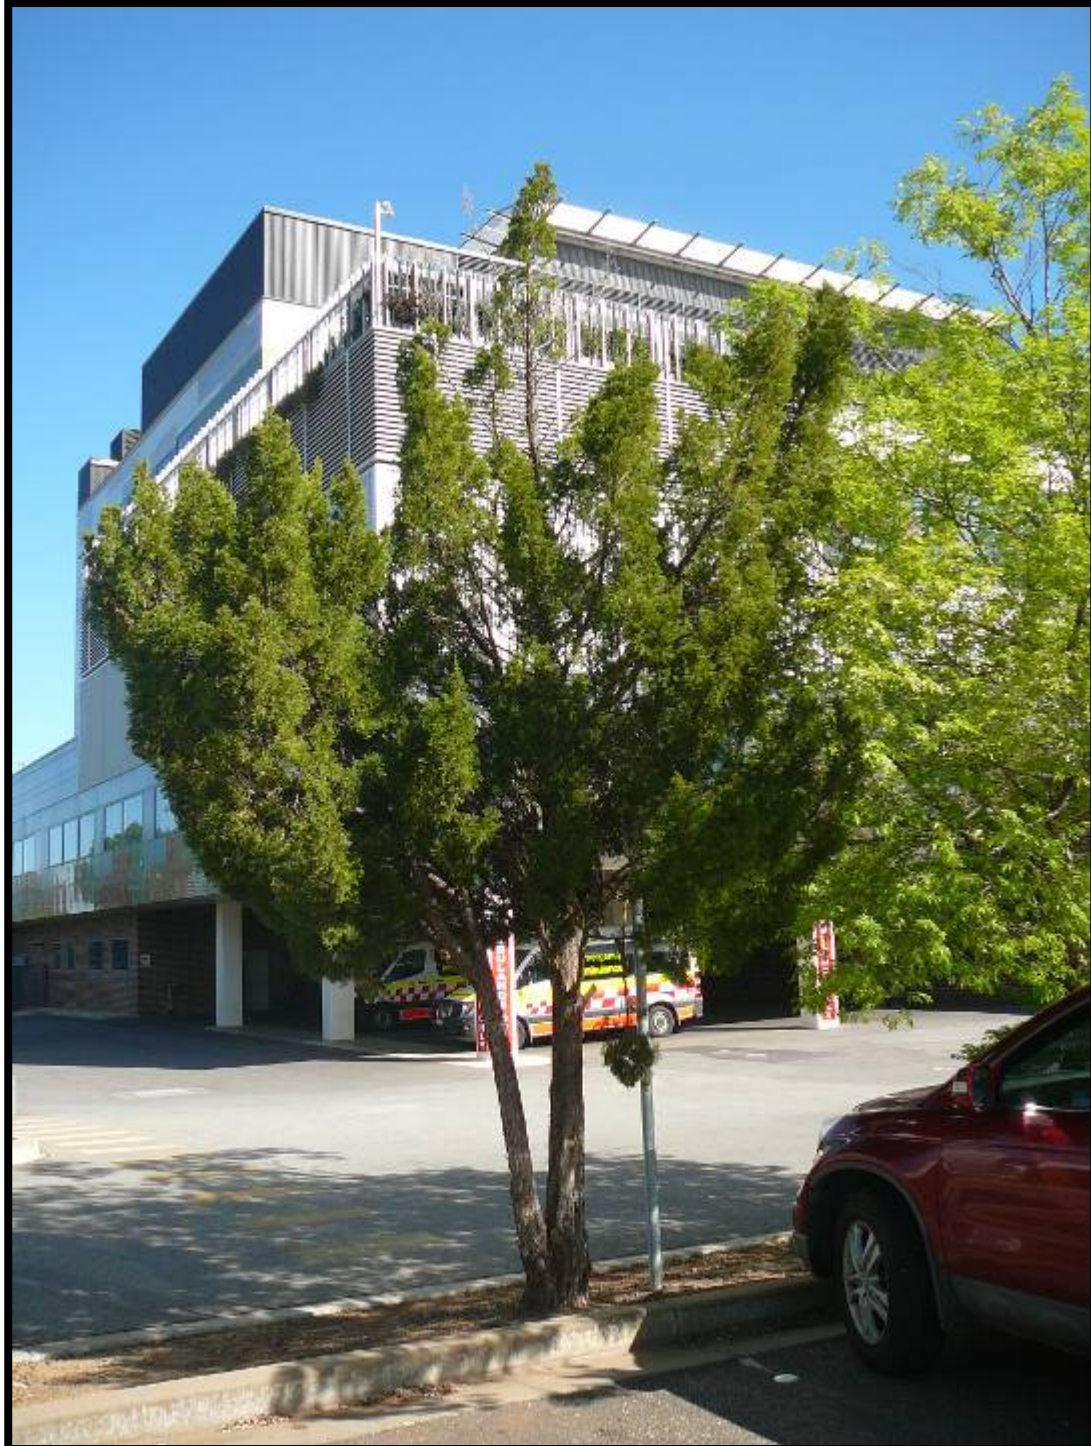
#### 4.3.11 – Tree No. 33

**Exhibit 28** – Tree 33 is another is a Chinese Juniper (*Juniperus chinensis* cv) within the perimeter “island” of the existing car park of Yathong Lodge. The tree’s low vigour and senescent apex attribute to its Fair condition rating.

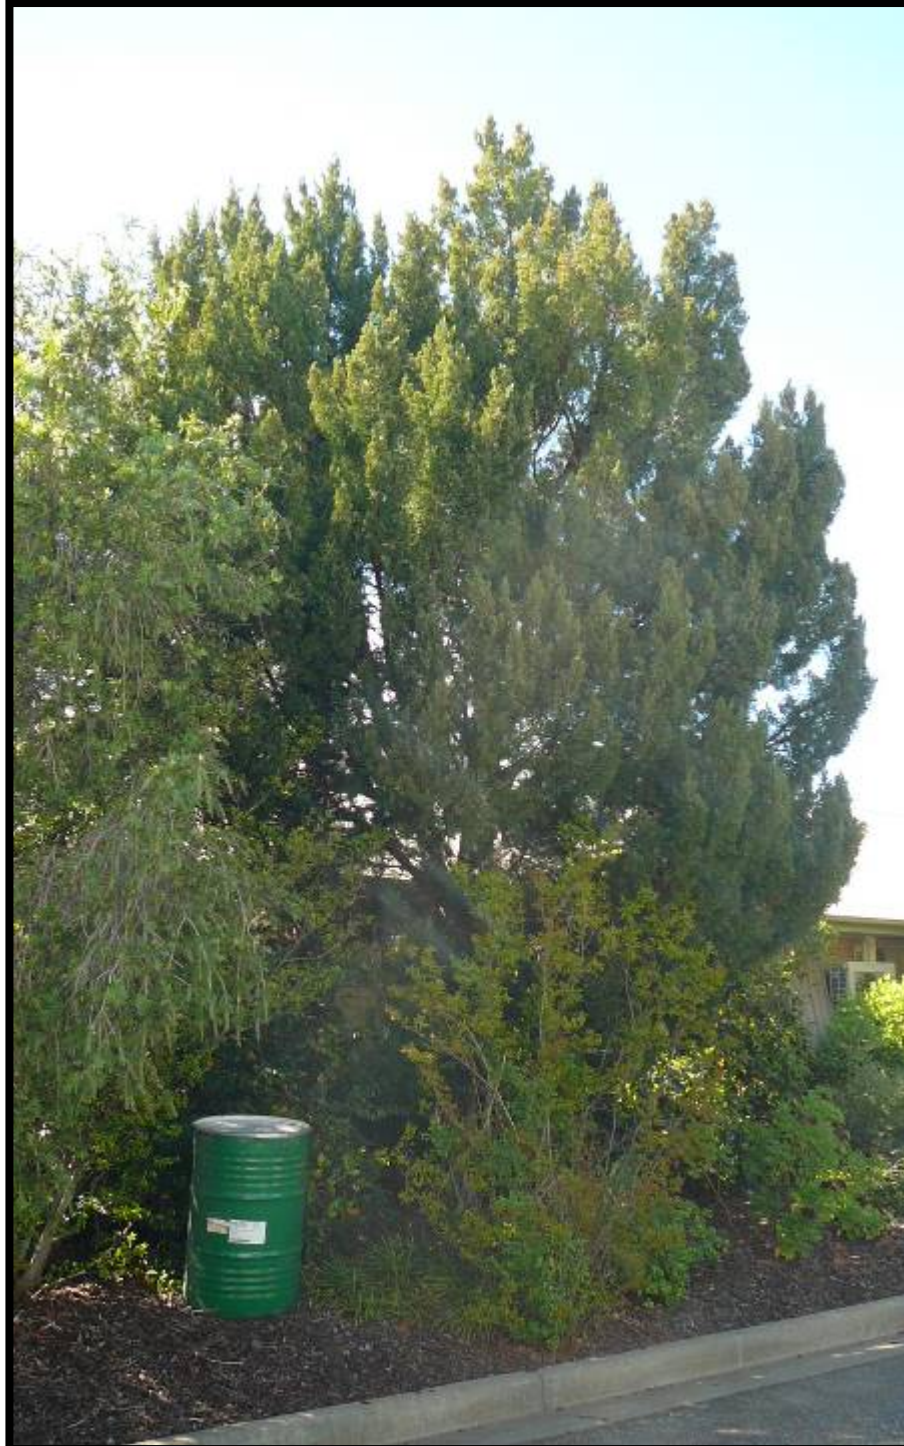
#### 4.3.12 – Tree No. 34

**Exhibit 29** – Tree 34 is another specimen of Chinese Juniper (*Juniperus chinensis* cv) of good form, health and vigour, within the garden beds surrounding Yathong Lodge.

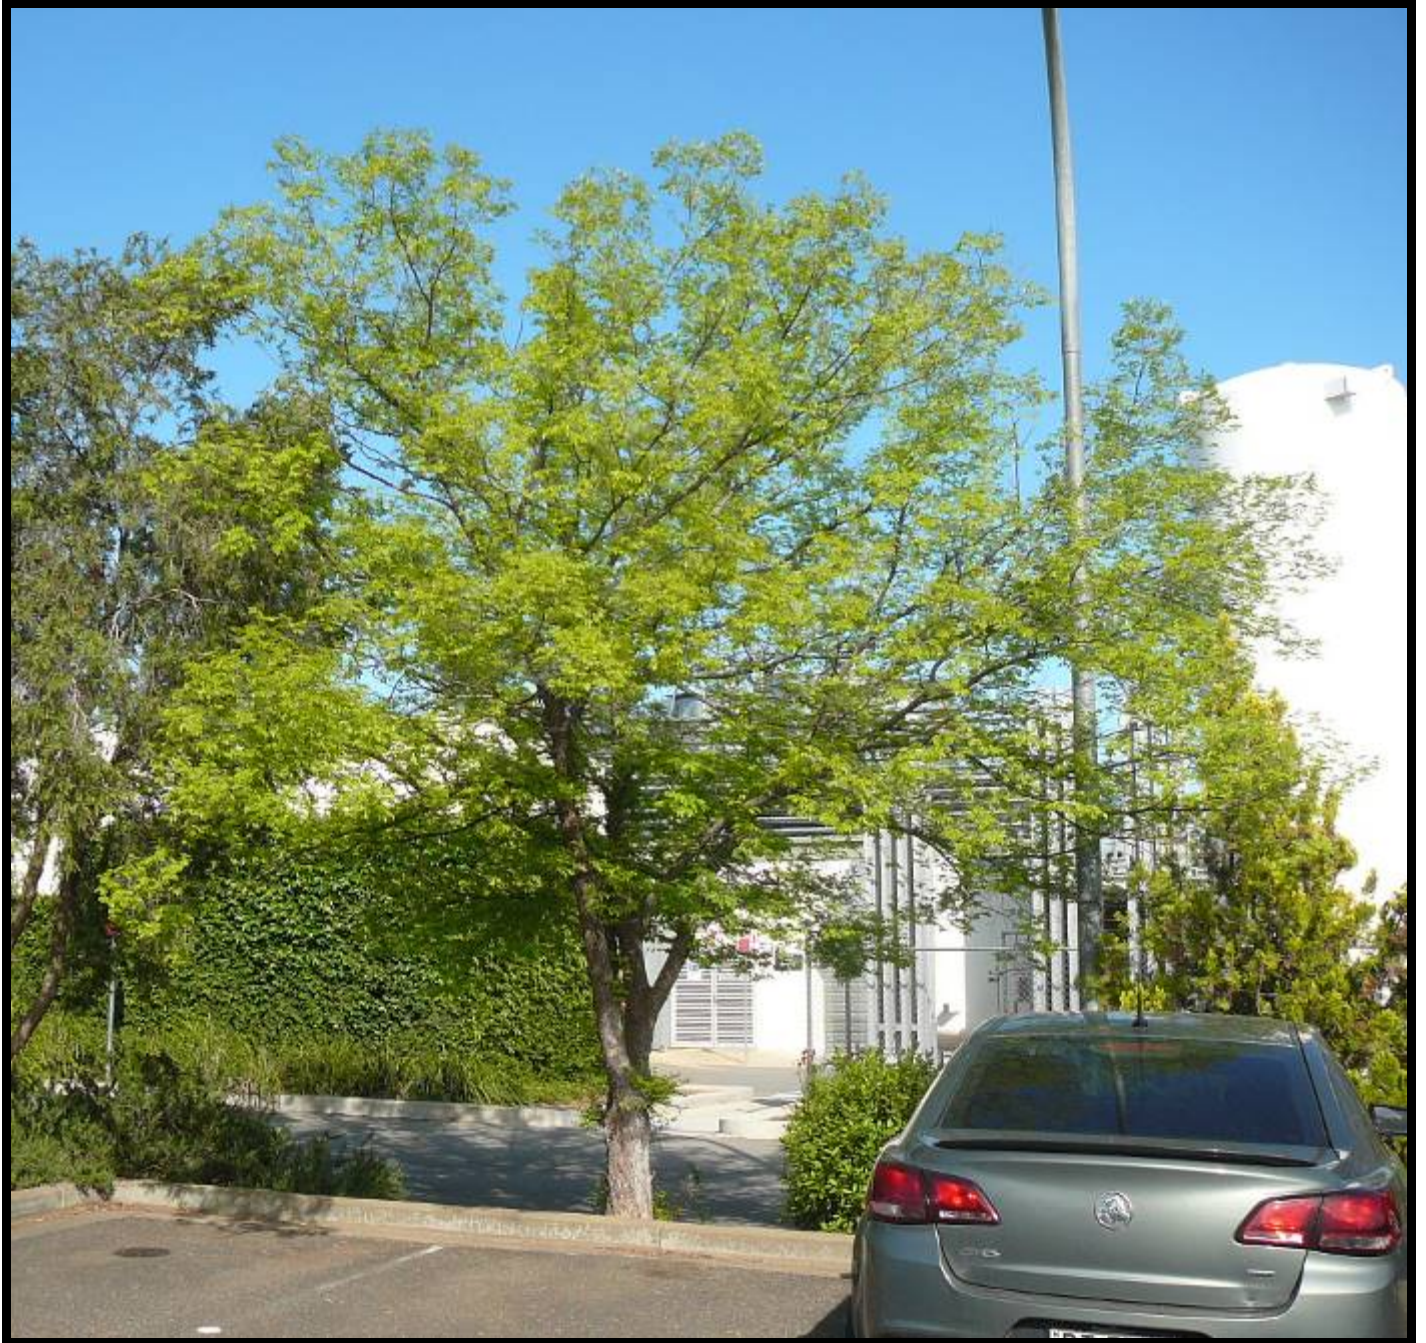
#### 4.3.13 – Tree No. 35

**Exhibit 30** – Tree 35 is another specimen of Chinese Elm (*Ulmus parvifolia*) within the perimeter “island” of the existing car park of Yathong Lodge. This tree also has a “sub-optimal” form with bifurcated co-dominant leaders low on its stem. This growth habit will probably lead to a major failure in the future and thus limits the tree’s usefulness in the altered landscape.
