# WAGGA WAGGA HOSPITAL CARPARKS

## Tree Survey

03 November 2020,  
Ref 20/387C.

# Trees on the Sites of Proposed Carparks, Wagga Wagga Health Services

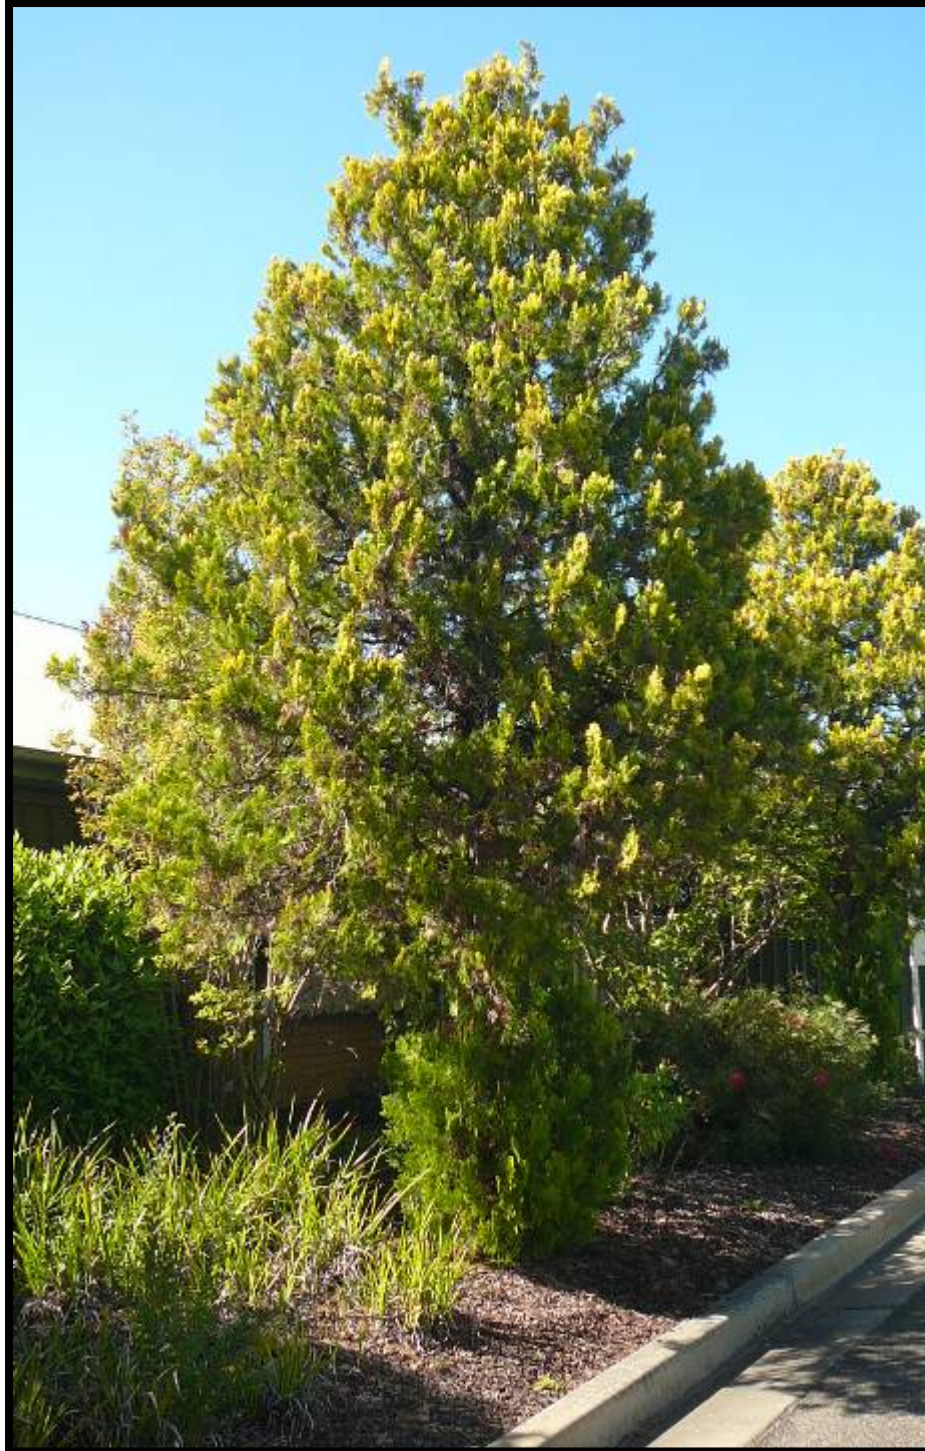
#### 4.3.14 – Tree No. 36

**Exhibit 31** – Tree 36 is an upright form of Oriental Arbor-vitae (*Platycladus orientalis* cv.) in Fair condition.

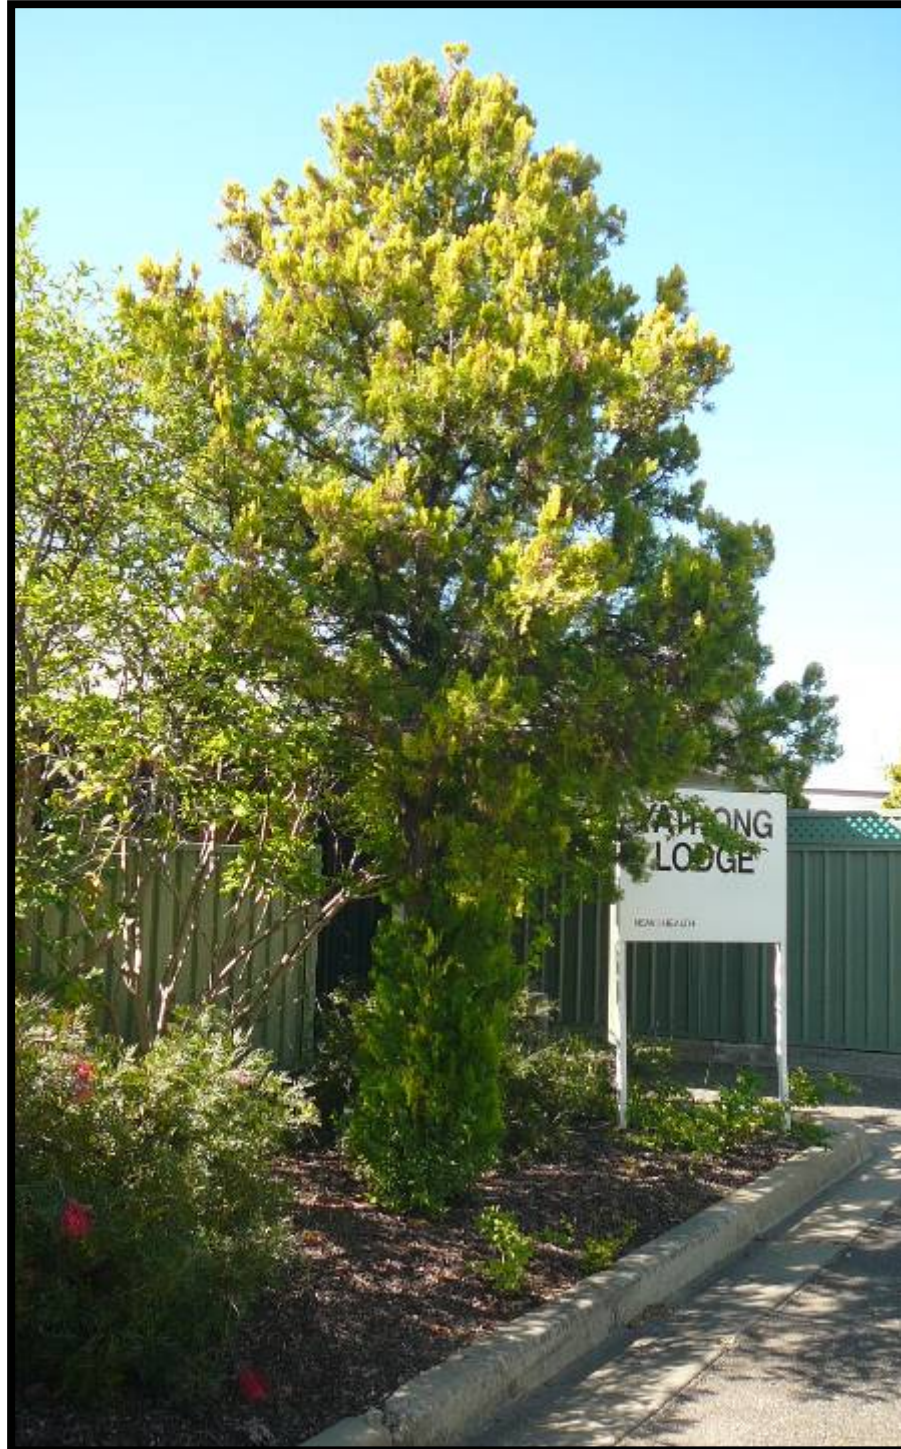
#### 4.3.15 – Tree No. 37

**Exhibit 32** – Tree 37, another upright form of Oriental Arbor-vitae (*Platycladus orientalis* cv.) in Fair condition.

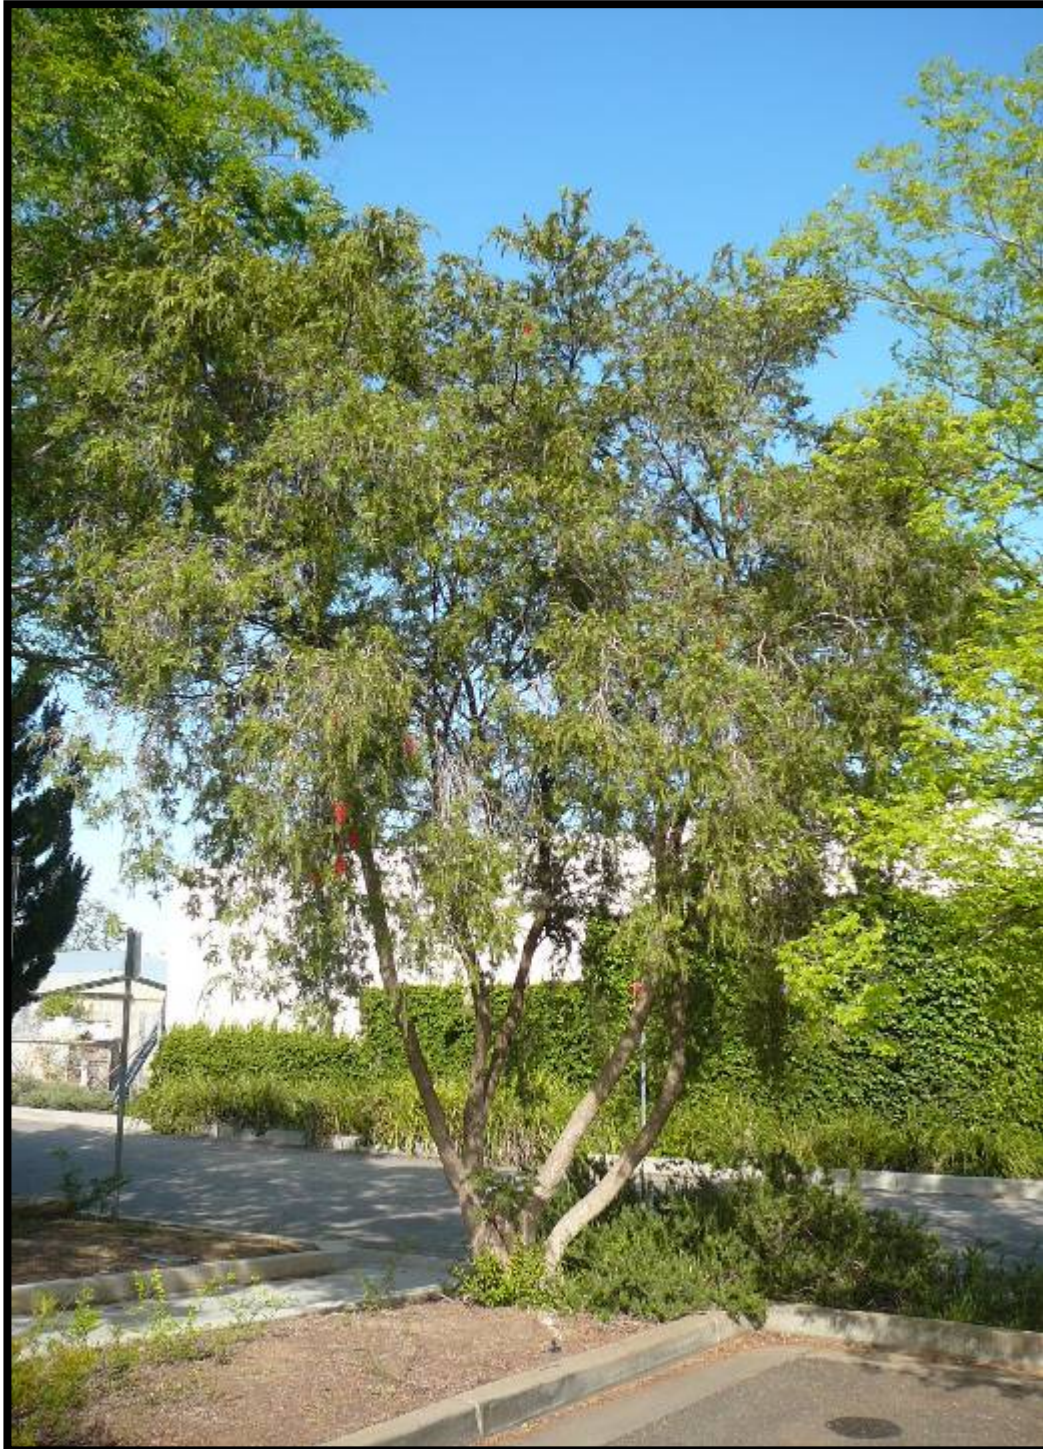
#### 4.3.16 – Tree No. 38

**Exhibit 33** – Tree 38, another Weeping Bottlebrush (*Callistemon viminalis* cv.), with a multi-stem form typical of the species. The tree is rated in Good condition.

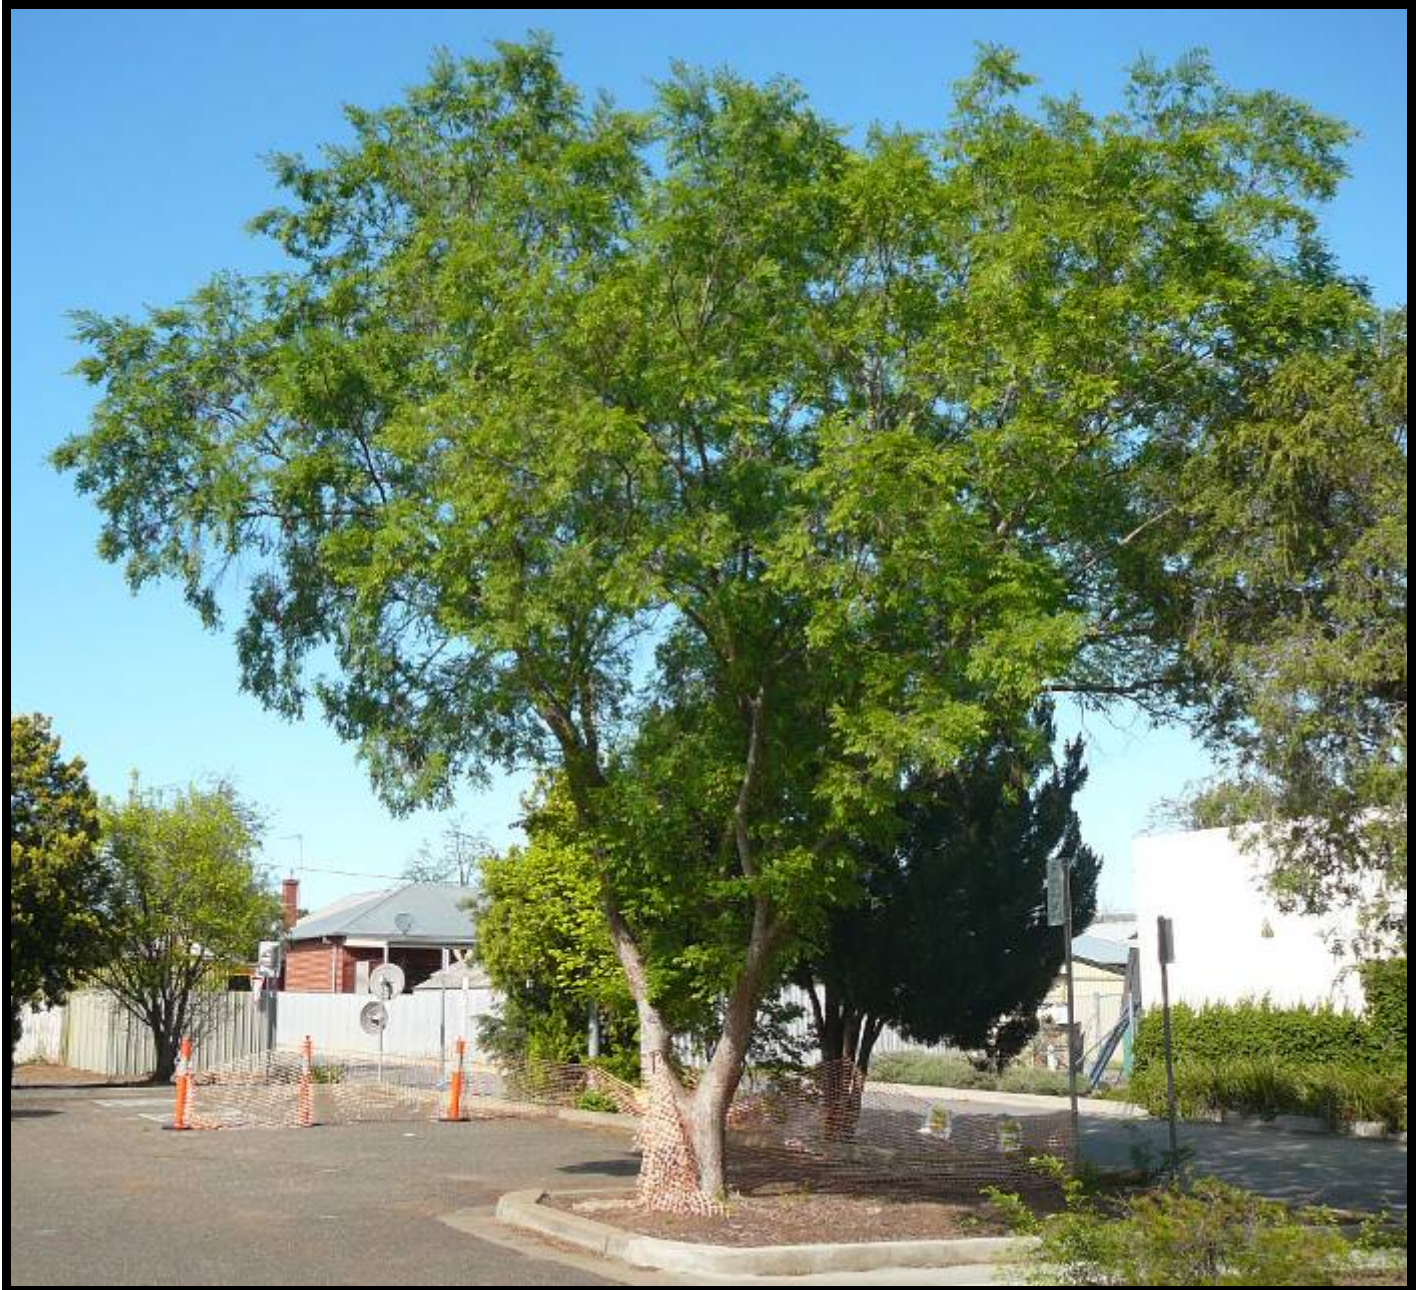
#### 4.3.17 – Tree No. 39

**Exhibit 34** – Tree 39, a fine specimen of Chinese Elm (*Ulmus parvifolia*) in Good condition. This tree should be retained in the altered configuration of the proposed on-grade car park.

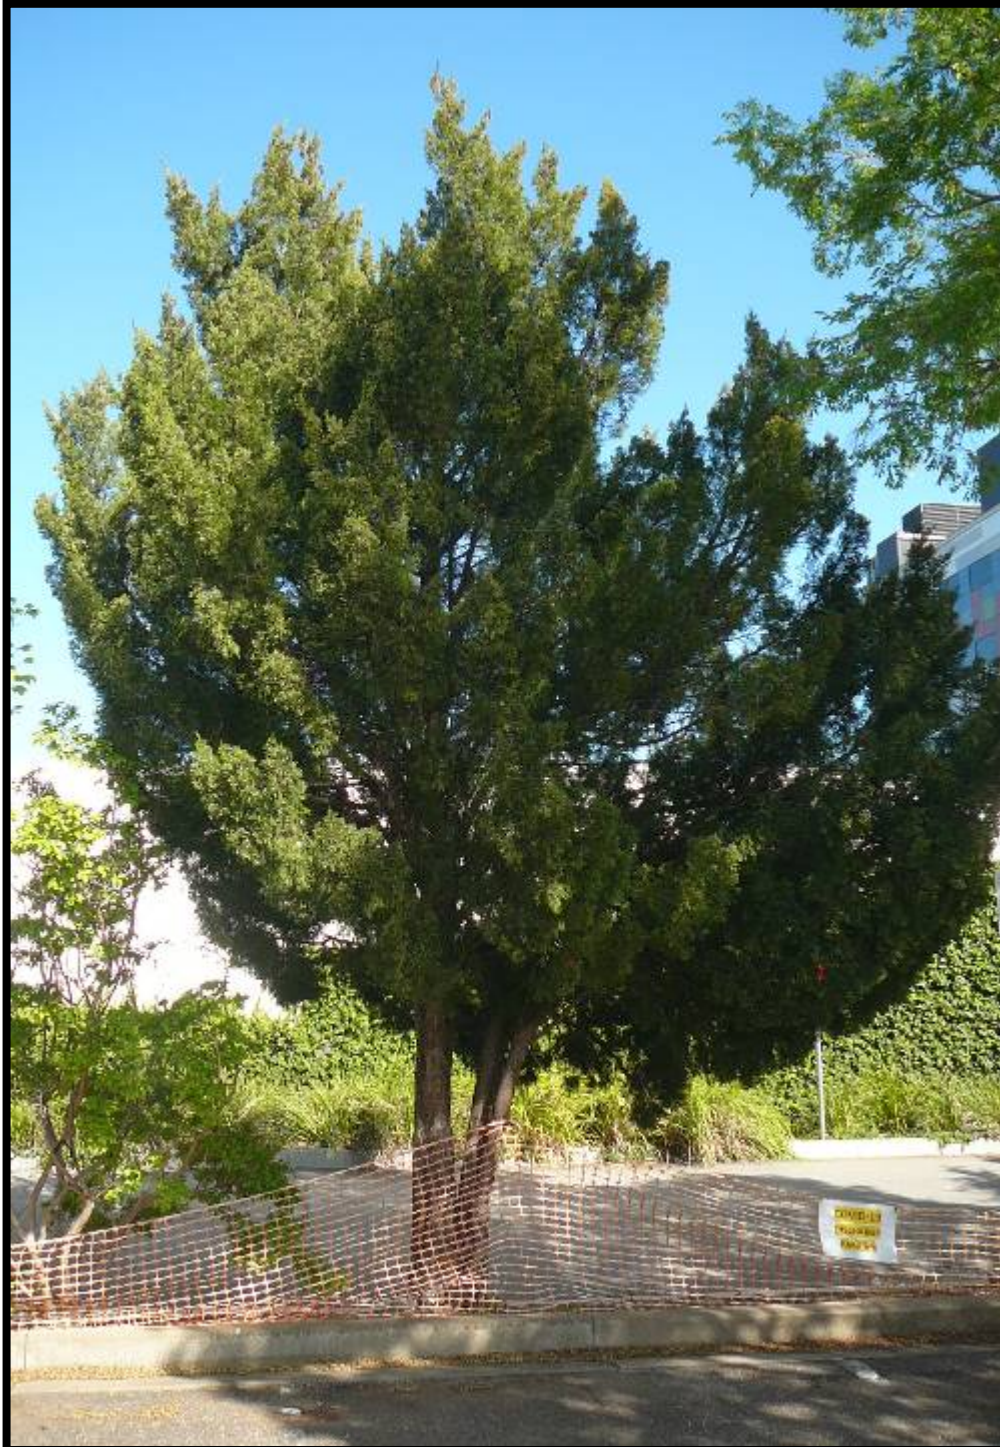
#### 4.3.18 – Tree No. 40

**Exhibit 35** – Tree 40 is another is a Chinese Juniper (*Juniperus chinensis* cv.) within the perimeter “island” of the existing car park of Yathong Lodge. The tree’s dual stem attribute to its Fair condition rating.

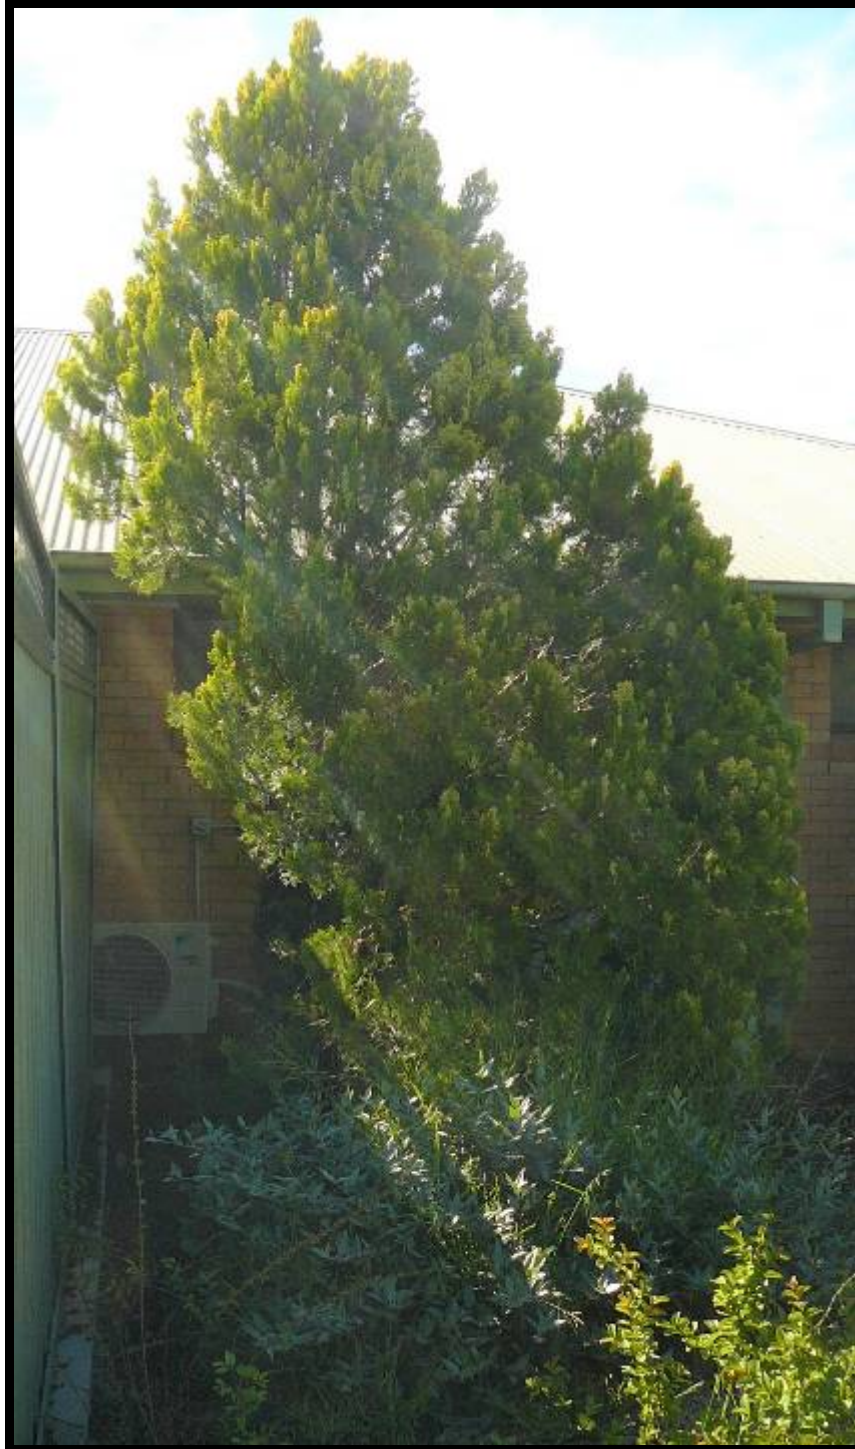
#### 4.3.19 – Tree No. 41

**Exhibit 36** – Tree 41 is another upright form of Oriental Arbor-vitae (*Platycladus orientalis* cv.). The tree has been heavily pruned for clearance from the adjacent building and its air conditioning units and is rated in Fair condition.

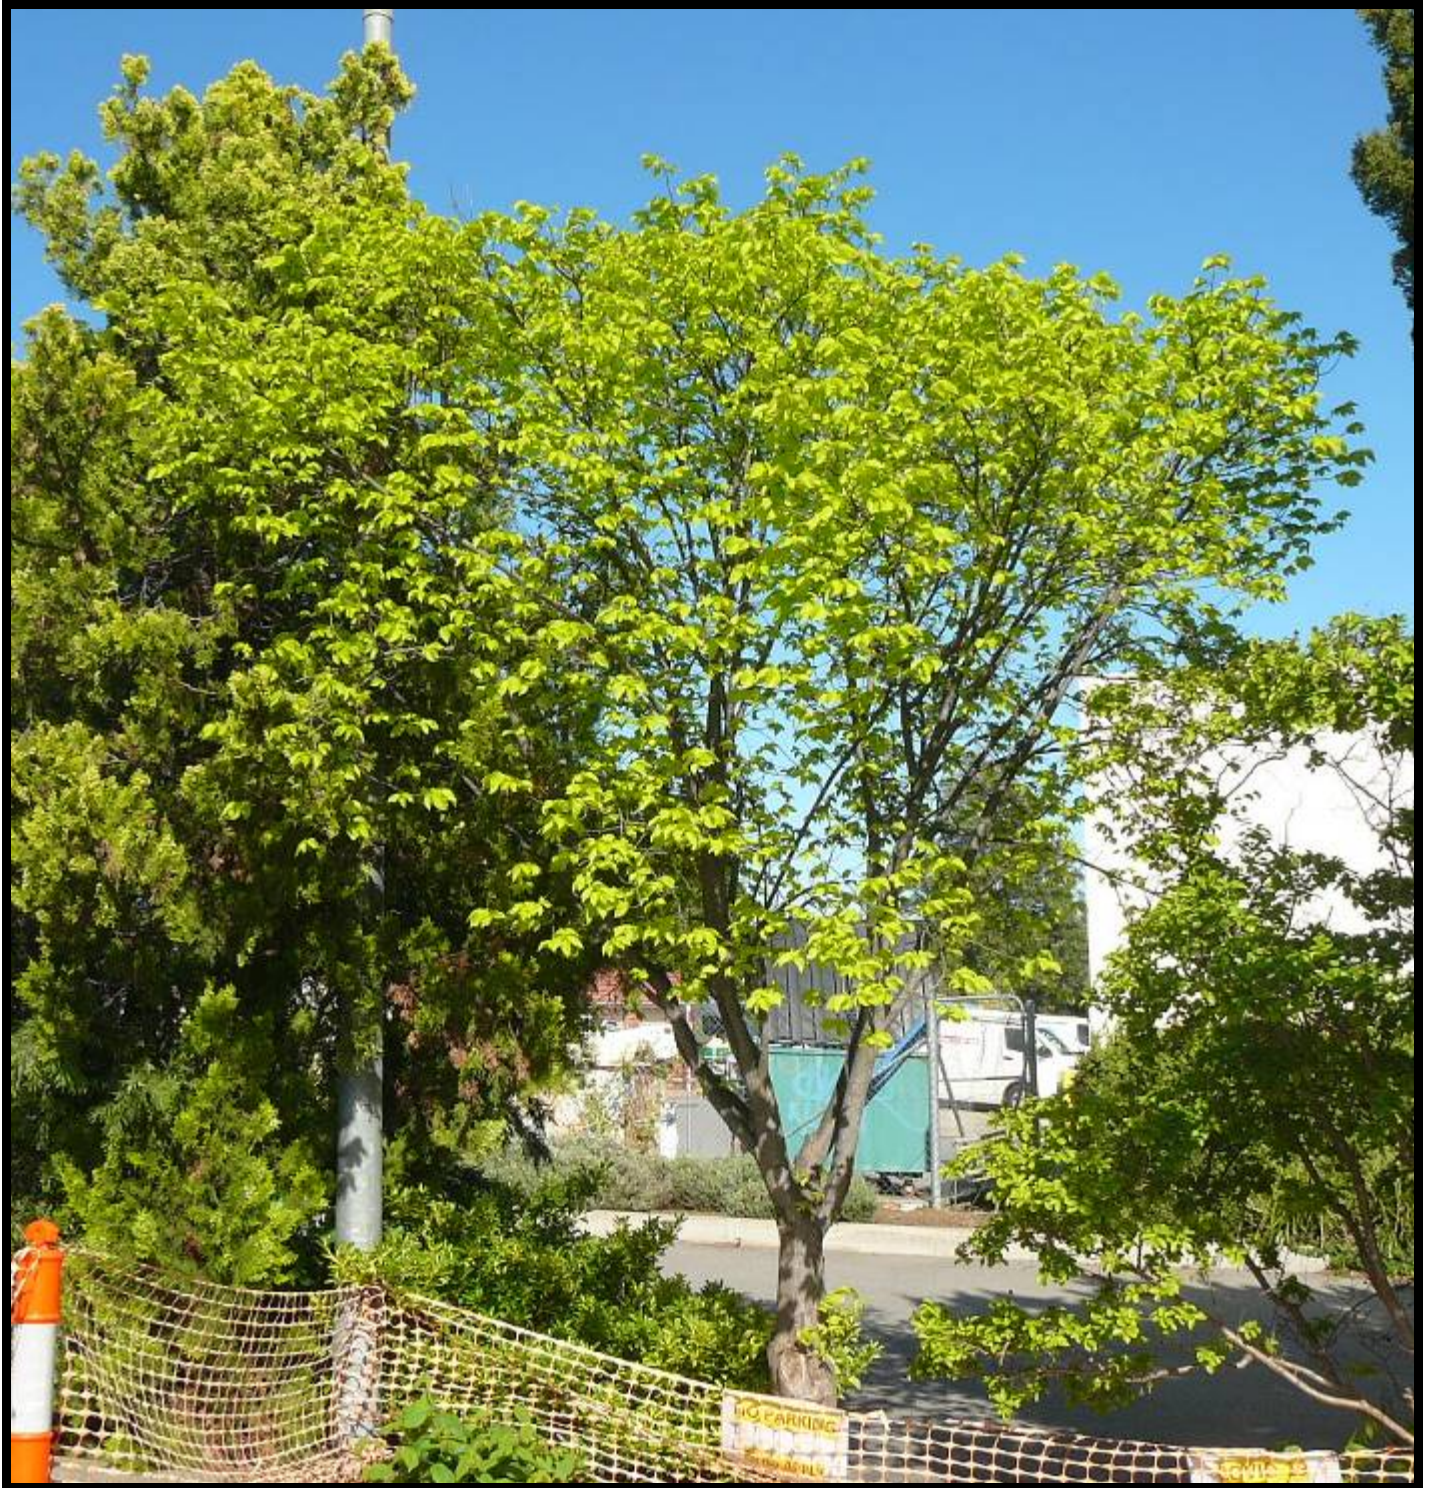
#### 4.3.20 – Tree No. 42

**Exhibit 37** – Tree 42, a Golden Elm in Fair condition. The tree’s form has been compromised by competition from neighbouring trees and is close to a car park light standard.

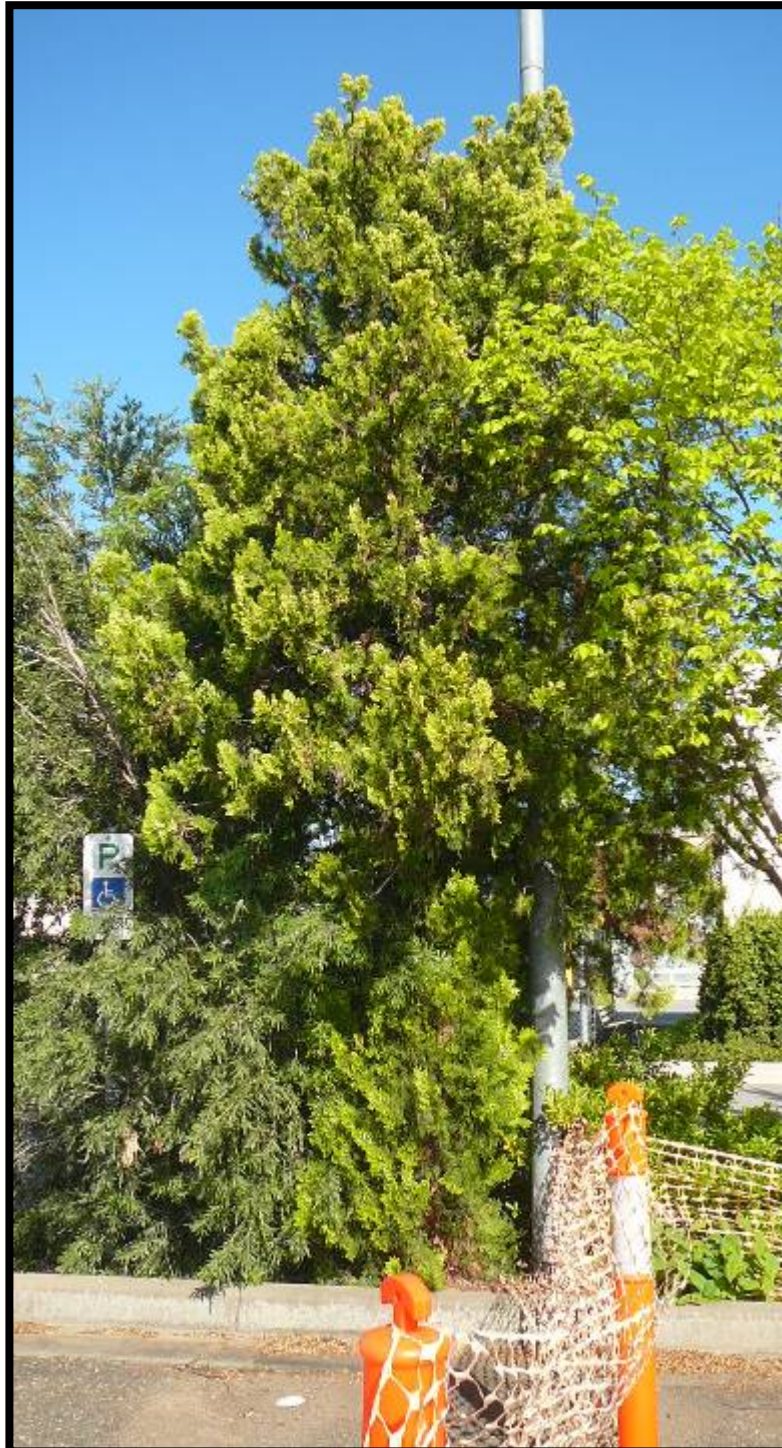
#### 4.3.21 – Tree No. 43

**Exhibit 38** – Tree 43 is another upright form of Oriental Arbor-vitae (*Platyclusus orientalis* cv.). Like the neighbouring Tree Nos. 42 & 45, it is compromised by competition from neighbouring trees and its proximity to a car park light standard.

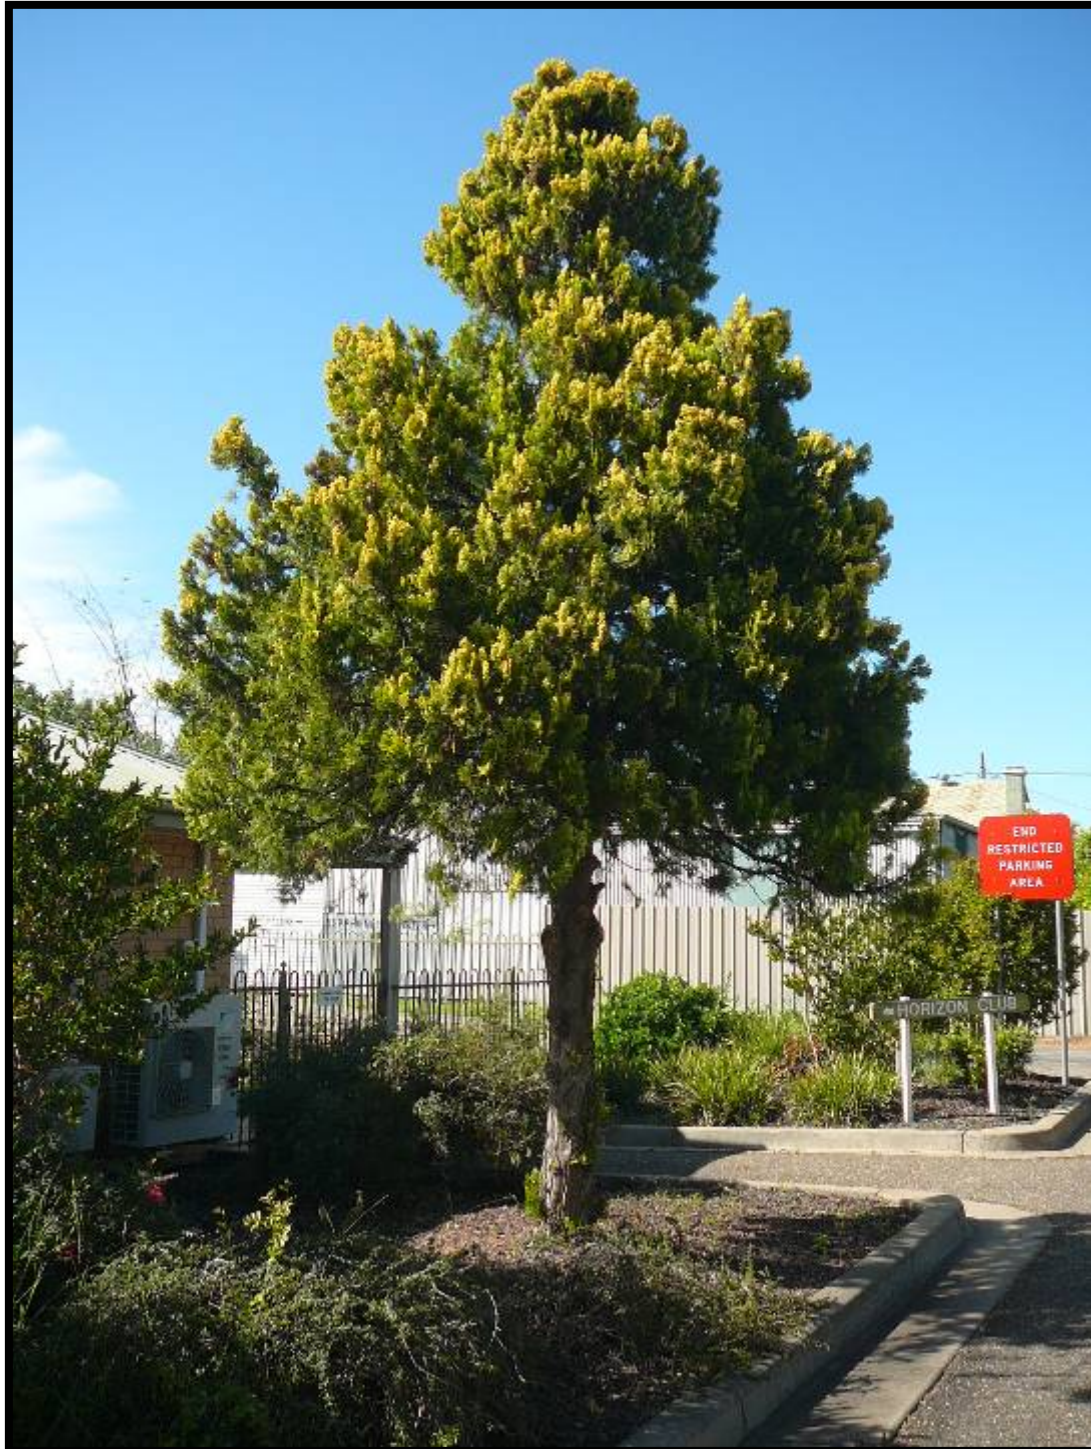
#### 4.3.22 – Tree No. 44

**Exhibit 39** – Tree 44 is another upright form of Oriental Arbor-vitae (*Platycladus orientalis* cv.) in Fair condition.

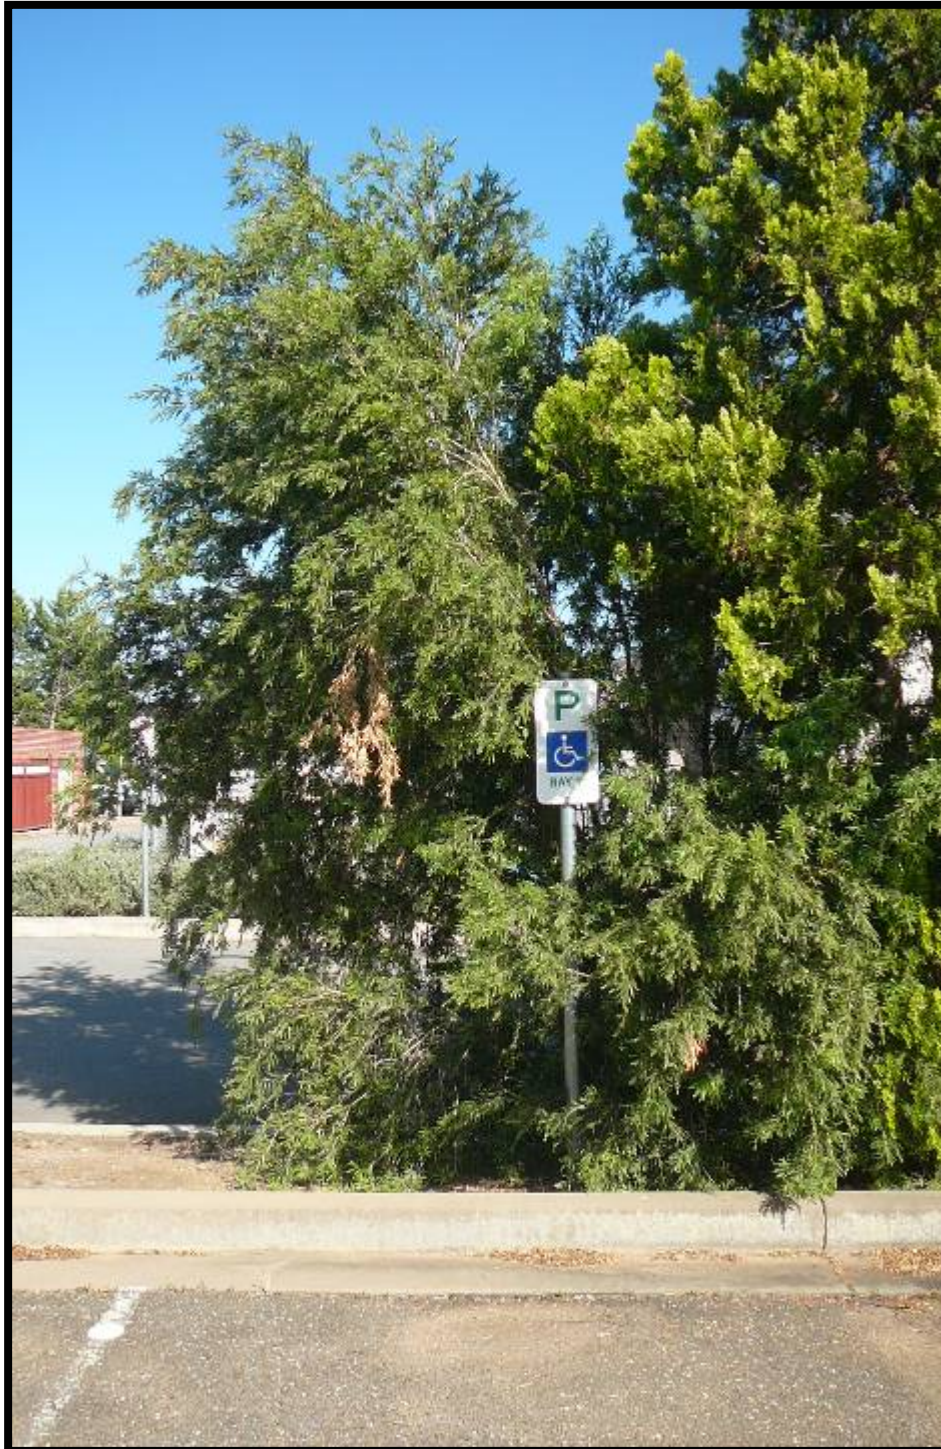
#### 4.3.23 – Tree No. 45

**Exhibit 40** – Tree 45, another Weeping Bottlebrush (*Callistemon viminalis* cv.) compromised by competition from neighbouring trees which is rated as Fair condition.

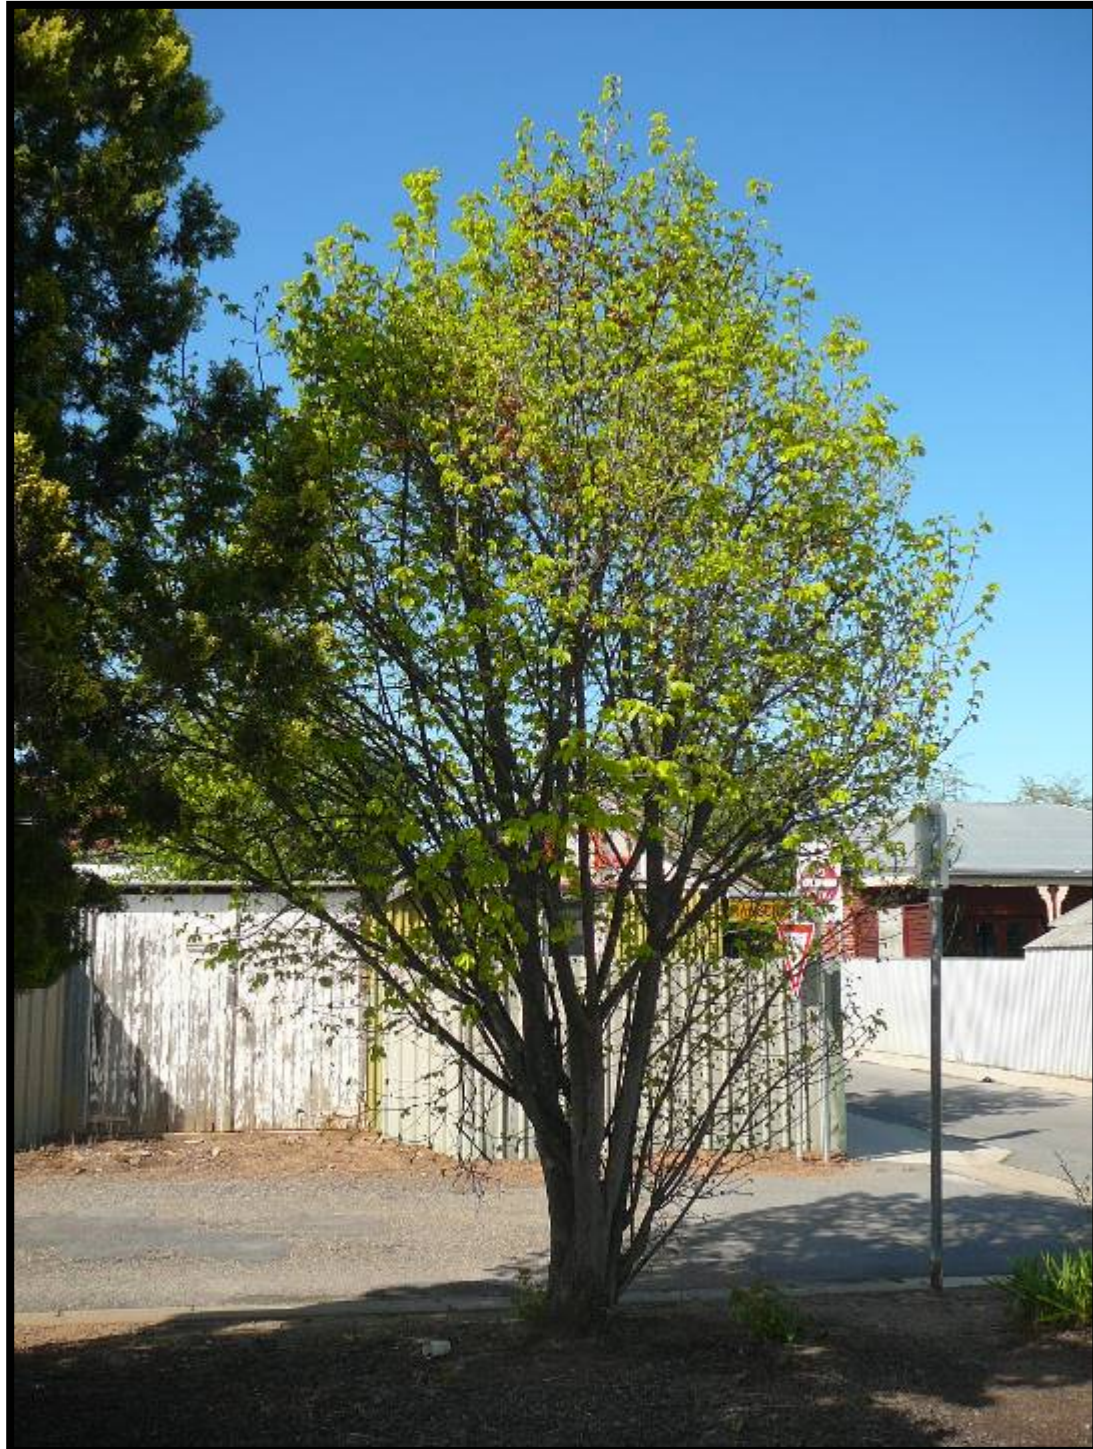
#### 4.3.24 – Tree No. 46

**Exhibit 41** – Tree 46 is another Golden Elm (*Ulmus glabra* Lutescens) with scale infestation of its crown and “sub-optimal” form with multiple stems and low watershoots, attributing to its Poor condition rating.

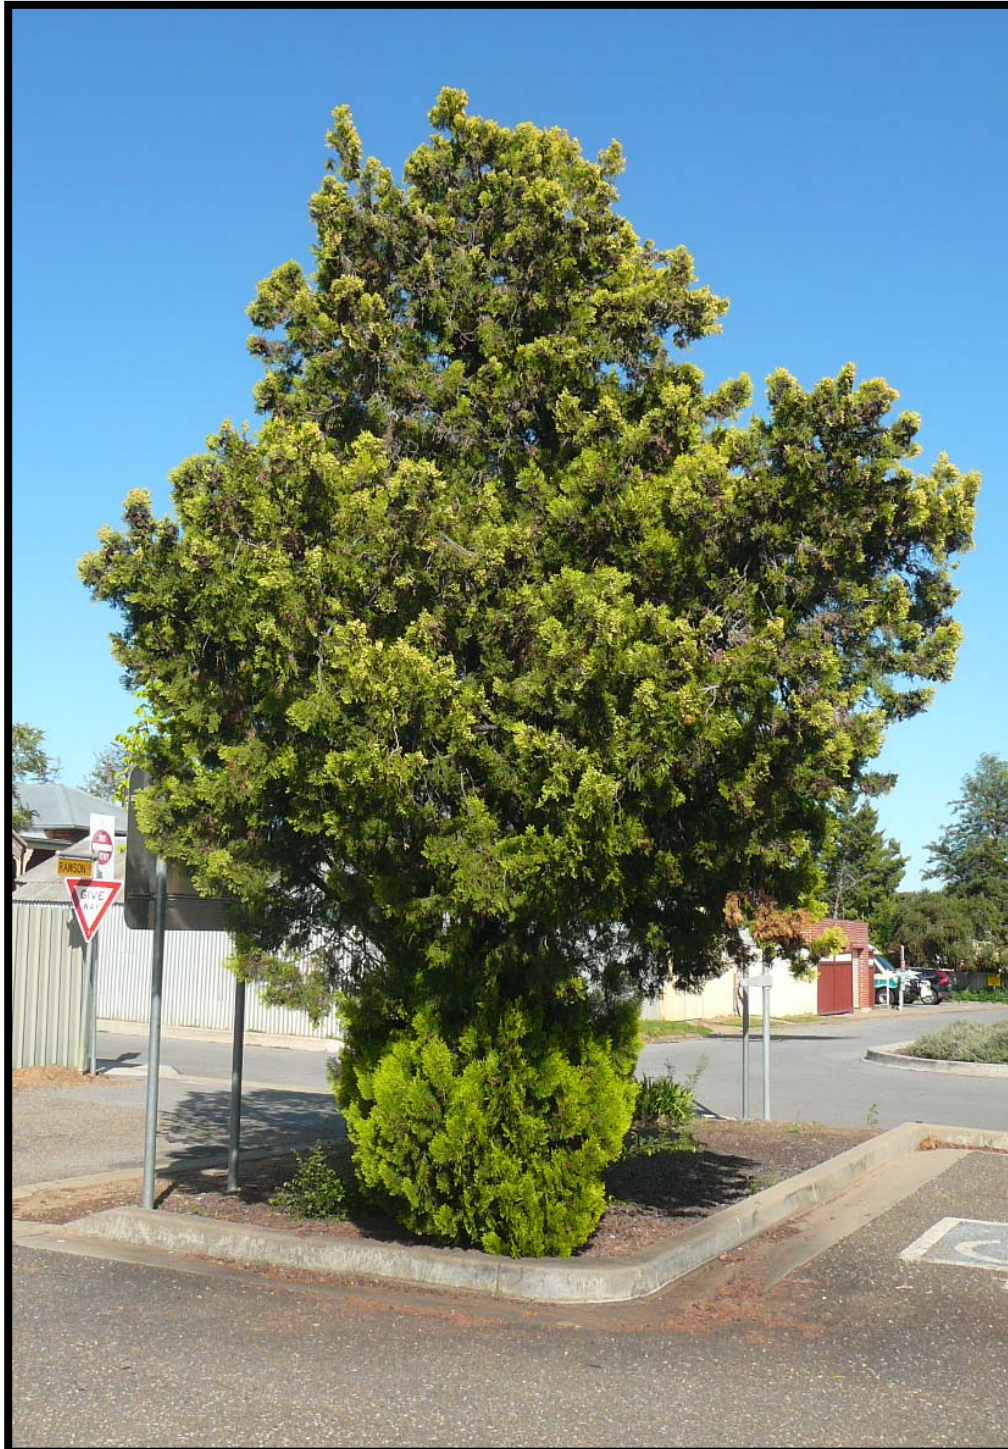
#### 4.3.25 – Tree No. 47

**Exhibit 42** – Tree 47 is another upright form of Oriental Arbor-vitae (*Platycladus orientalis* cv.) in Fair condition.

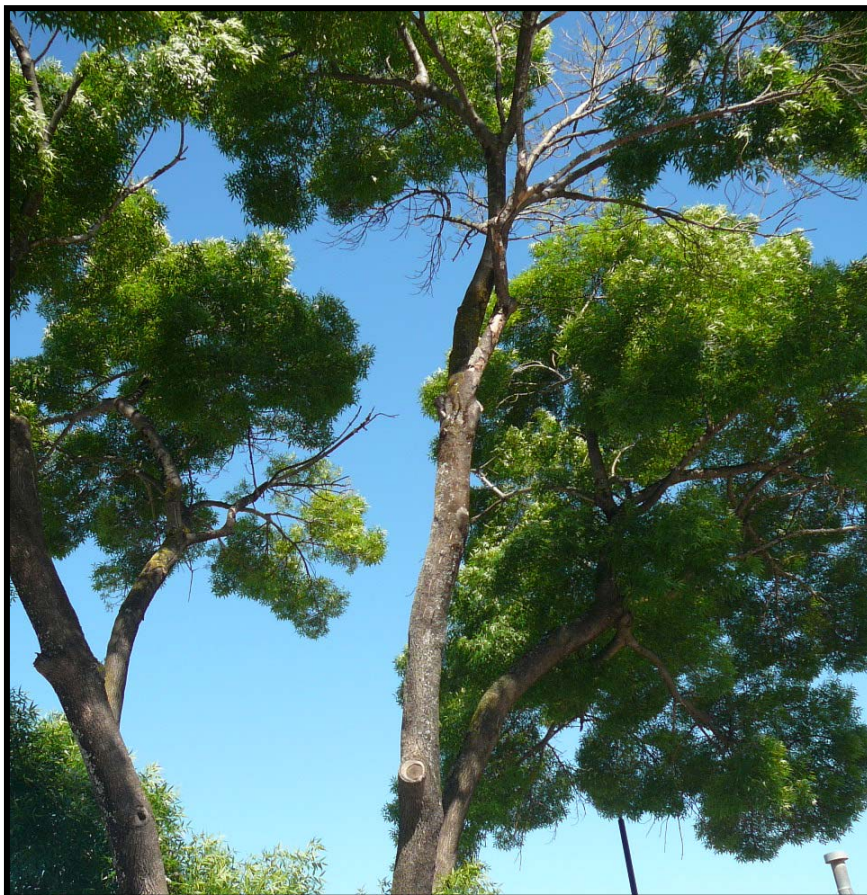
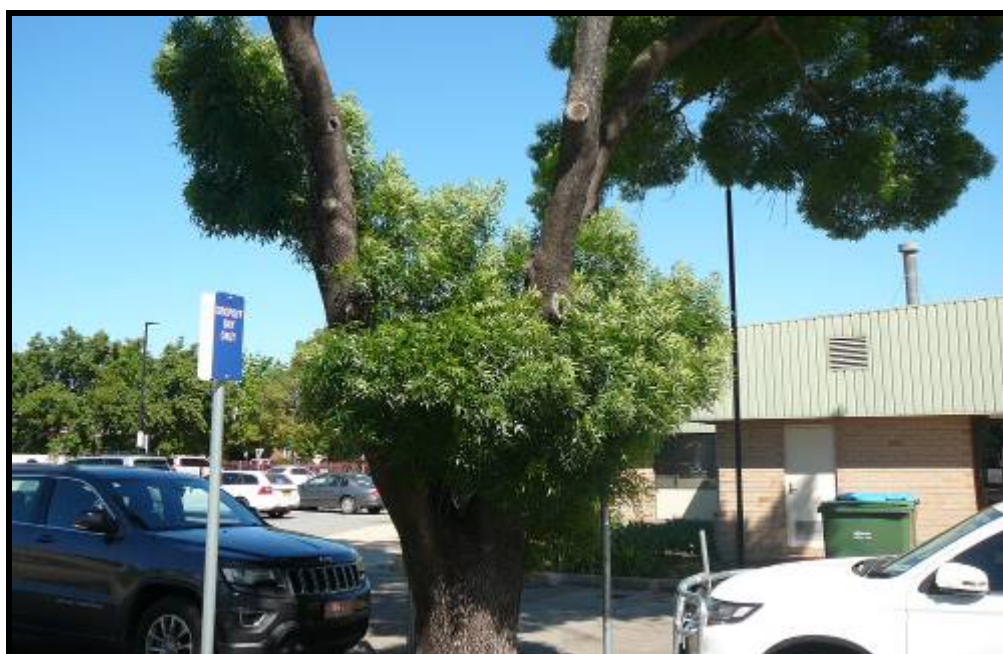
**Exhibit 43** – Tree 16. Deadwood high in the crown, and pruning that has overthinned and stripped out the interior of a tree (**Upper** image), which has prompted vigorous epicormic shoots at the base (**Lower** image) of the tree. The tree is consequently not considered suitable for retention in the altered landscape.

One of the larger specimens whose positioning would allow its retention, in view of the proposed works, is Tree No. 16, a Claret Ash (see Section 4.2.8). However, contemporary practice in the pruning of mature trees has highlighted the risk of what has been termed “lions-tailing”. Gilman describes lions-tailing as overthinning or stripping out the interior of a tree with little or nothing being removed from the ends of limbs. Lions-tailing can cause structural weakness, unbalancing the crown and creating poor mechanical properties (Gilman, 2012). As shown in Exhibits 15 & 43 various “crown lift” pruning of Tree No. 16 has led to its major lateral limbs having foliage (and growth) concentrated at its extremities, which compromises the safety of the tree. The removal and replacement of this tree is the most sensible management approach.

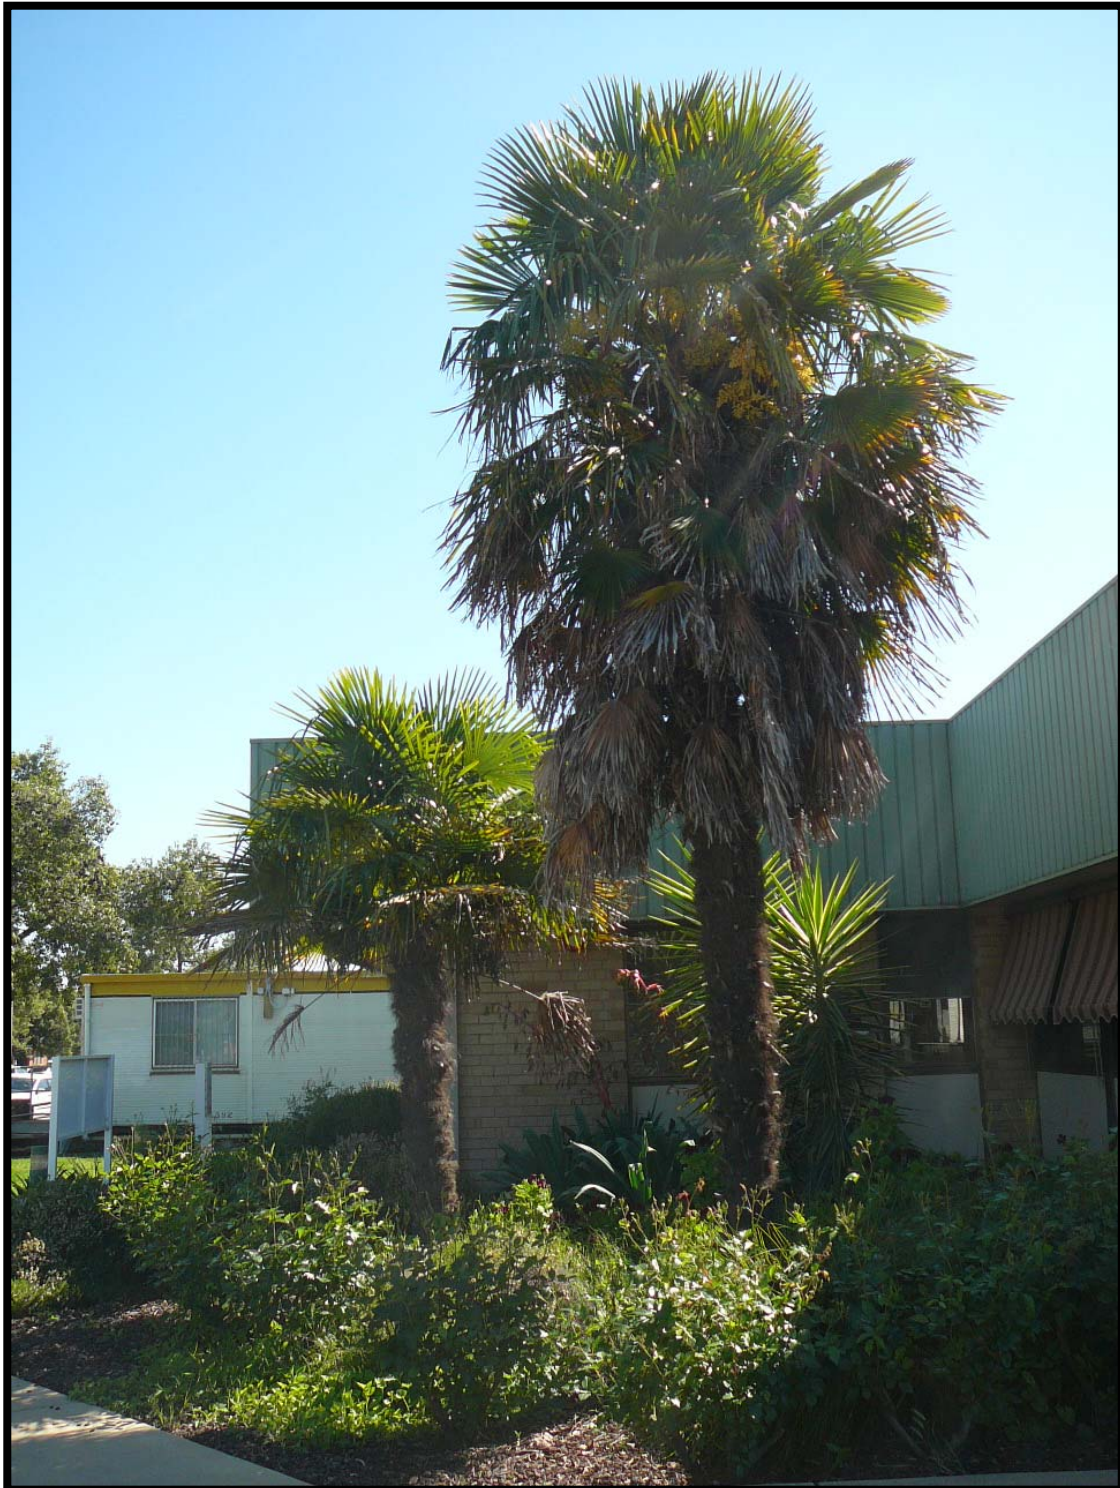
**Exhibit 44** – Two specimens of Windmill Palms (*Trachycarpus fortunei*) sited on the Docker Street frontage of the existing Dental Clinic. These trees could be transplanted to a suitable position within the Wagga Wagga Health Services property.

Two specimens of Windmill Palms (*Trachycarpus fortunei*) on the Docker Street On-grade Carpark site are illustrated in Exhibit 44. These are two fine specimens of a slow growing species and the transplanting of Palm species is a reasonably straightforward and achievable exercise, even with specimens of great maturity. Grounds Maintenance personnel on the Wagga Wagga Health Services site have expressed a willingness (pers. comm.) to relocate these trees within the property and it is recommended that the scheduling of demolition works during the implementation of the proposed works give due consideration to facilitating this relocation.
