TREE SURVEY & REPORT

40-46 EVAN ST & 96-98 LETHBRIDGE ST

PENRITH

05/08/19
Ref. # 2042

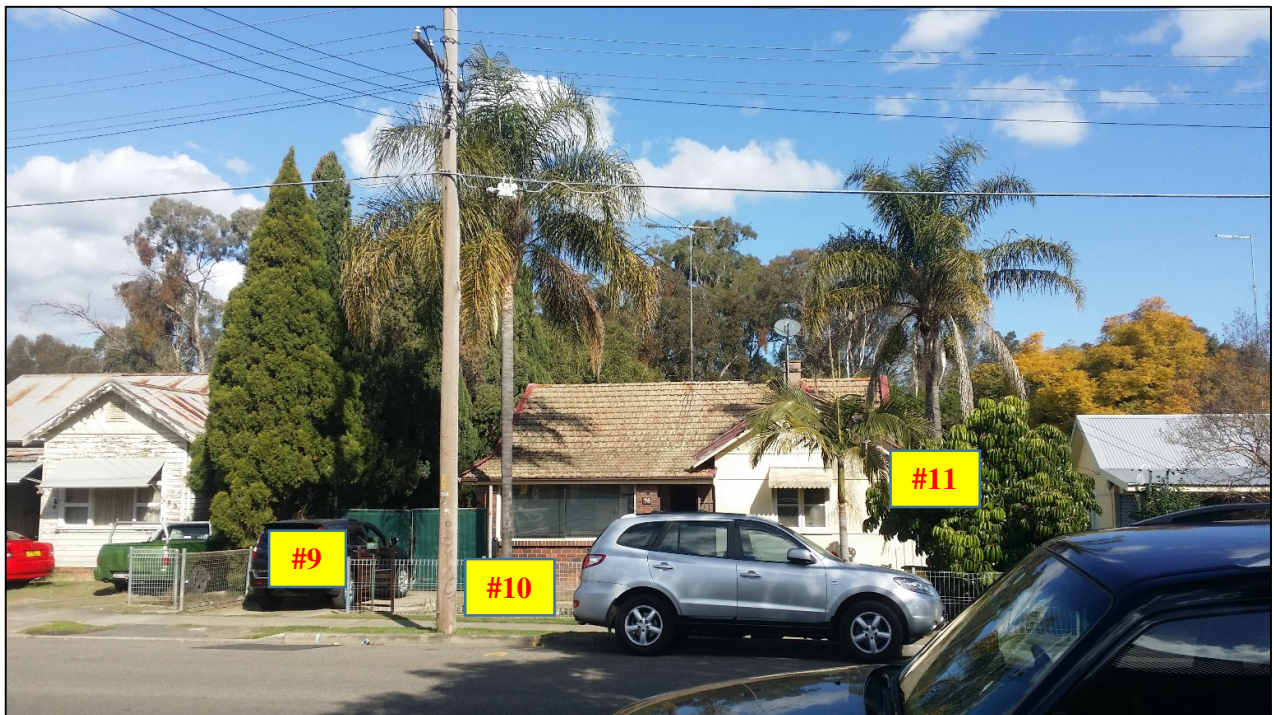
- a. **Health & Vitality:** Low – these trees are showing typical symptoms of Cypress Canker, and are in irreversible decline (see Plate 2 & 3).
- b. **Tree Form:** these trees combine to form a hedgerow with an east/west axis that is 18m in height, and a crown spread of 25x6m
- c. **Structural Condition:** Poor, retainable for 0 – 5 years

Plate 2 – showing tree No's 9 – 11

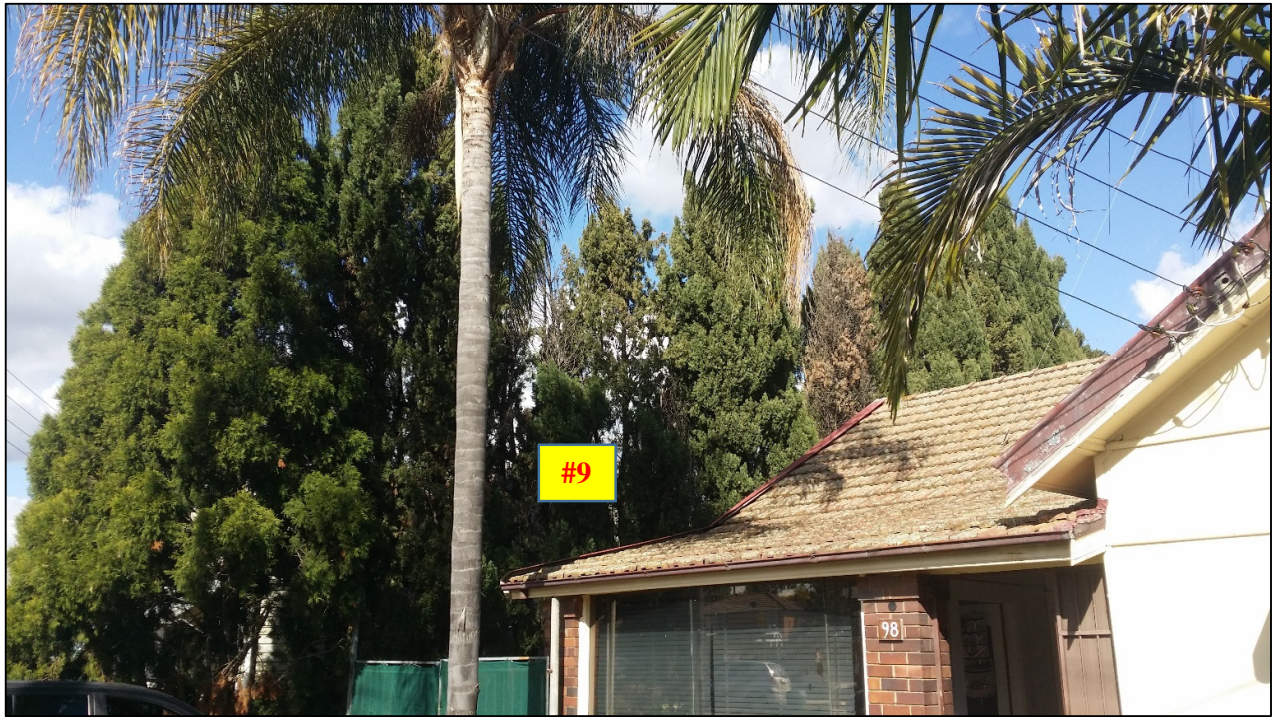
- **Tree No. 9 (*Cupressus sempervirens*)** is an over-mature hedgerow. They have typical symptoms associated with Cypress Canker, of which there is no effective control (see Appendices 9.7)
- **Tree No. 18 (*Eucalyptus moluccana*)** is in advanced stages of decline and has typical symptoms of Armillaria Root Decay (see Appendices 9.8)
- **Tree No's 21 (*Melaleuca quinquenervia*)** This tree is dead and is exempt from Clause 5.9 of Penrith LEP 2010
- **Tree No. 22 & 23 (*Melaleuca quinquenervia*)** have sparse foliage, and appear to be in declining health and vitality (see Appendices 9.9)
- **Tree No. 64 & 67 (*Grevillia robusta*)** are in advanced stages of decline, and treatment and or tree surgery techniques are unlikely to increase their safe life expectancies (see Appendices 9.9)

Plate 3 – showing tree No. 9 (over-mature hedgerow)

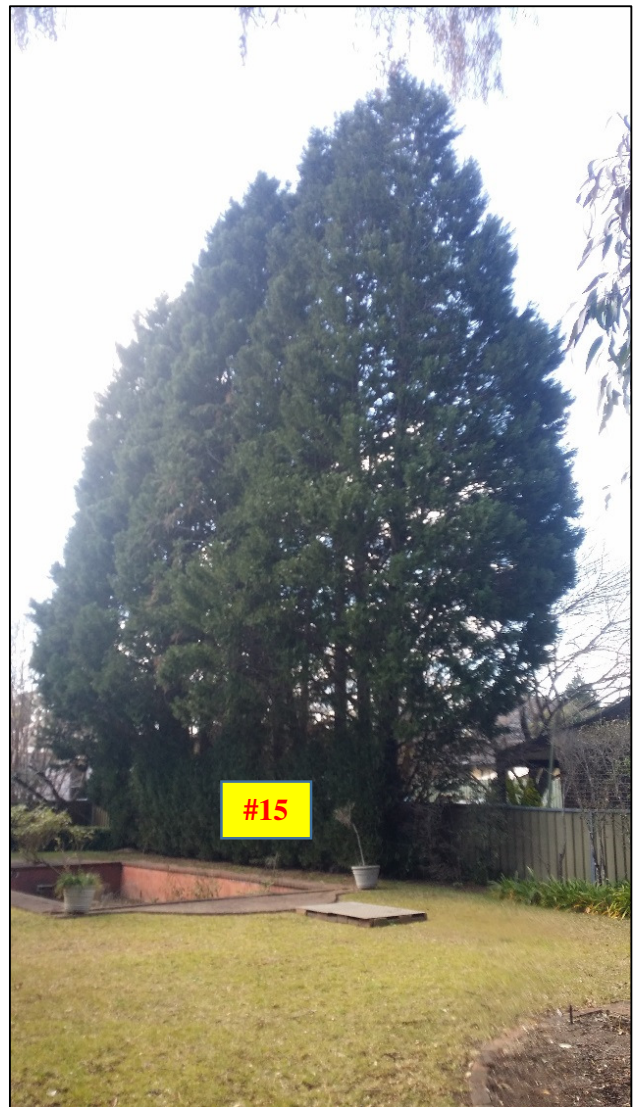
- a. **Health & Vitality:** – the foliage of these trees appears to be generally healthy and growing vigorously, with no visible symptoms of decline (see Plate 5).
- b. **Tree Form:** – these trees combine to form a hedgerow with a north/south axis that is 22m in height, and a crown spread of 22x5m
- c. **Structural Condition:** Average

Plate 5 – showing tree No. 15 (mature hedgerow)

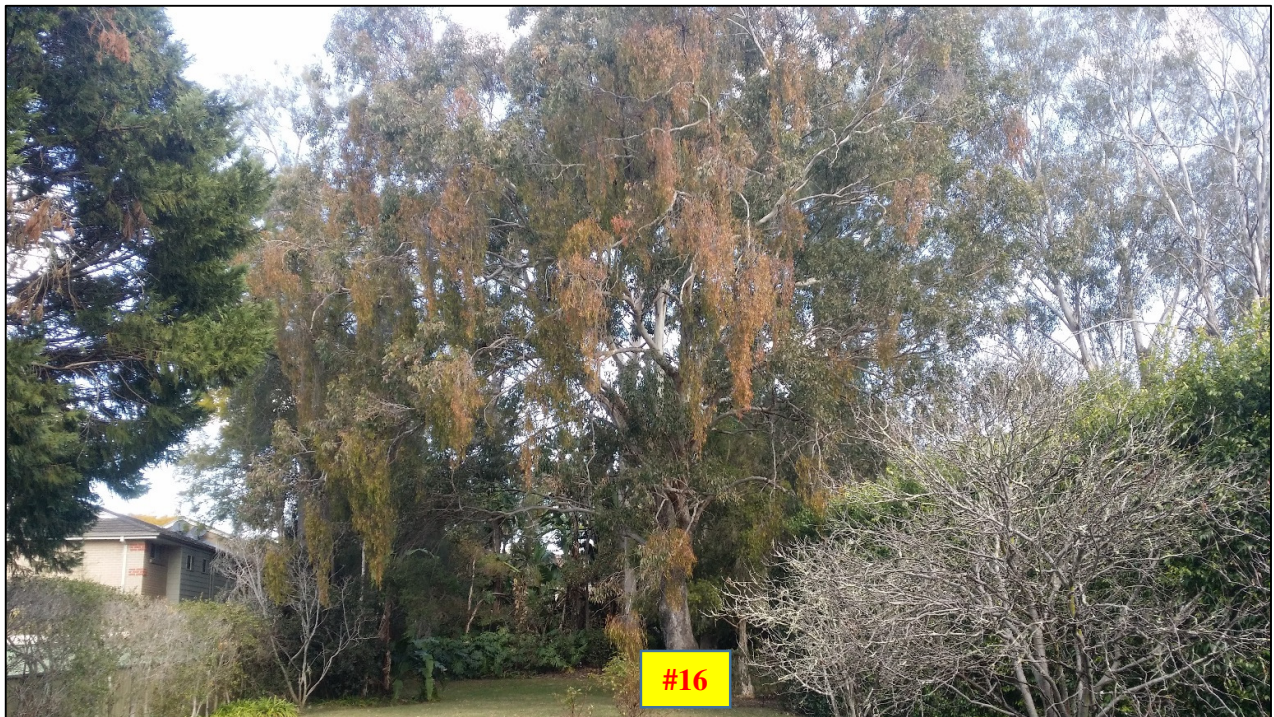
- a. **Health & Vitality:** – the foliage of this tree appears to be generally healthy and growing vigorously, with no visible symptoms of decline. However, it has been heavily colonised by mistletoe (see Plate 6).
- b. **Tree Form:** This tree has formed a single stem with DBH of 1100mm and a codominant, asymmetrical canopy towards the north that is 26m in height, with a crown spread of 33x29m.
- c. **Structural Condition:** Average to fair, this tree may be in the beginning of a decline spiral.

Plate 6 – showing tree 16 with a significant colonisation of mistletoe

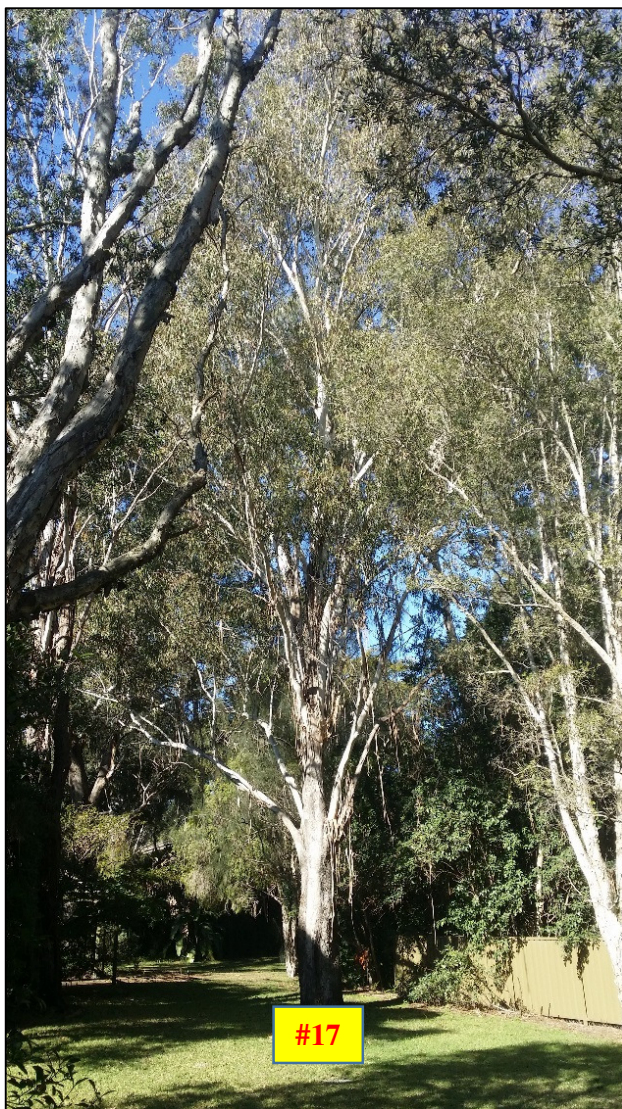
- a. **Health & Vitality:** Average – the foliage of this tree appears to be generally healthy and growing vigorously, with no visible symptoms of decline (see Plate 7).
- b. **Tree Form:** it has formed a single stem with DBH of 900mm and a codominant, asymmetrical canopy towards the north that is 29m in height, with a crown spread of 18x21m.
- c. **Structural Condition:** Average, retainable in the long term

Plate 7 – showing tree No. 17

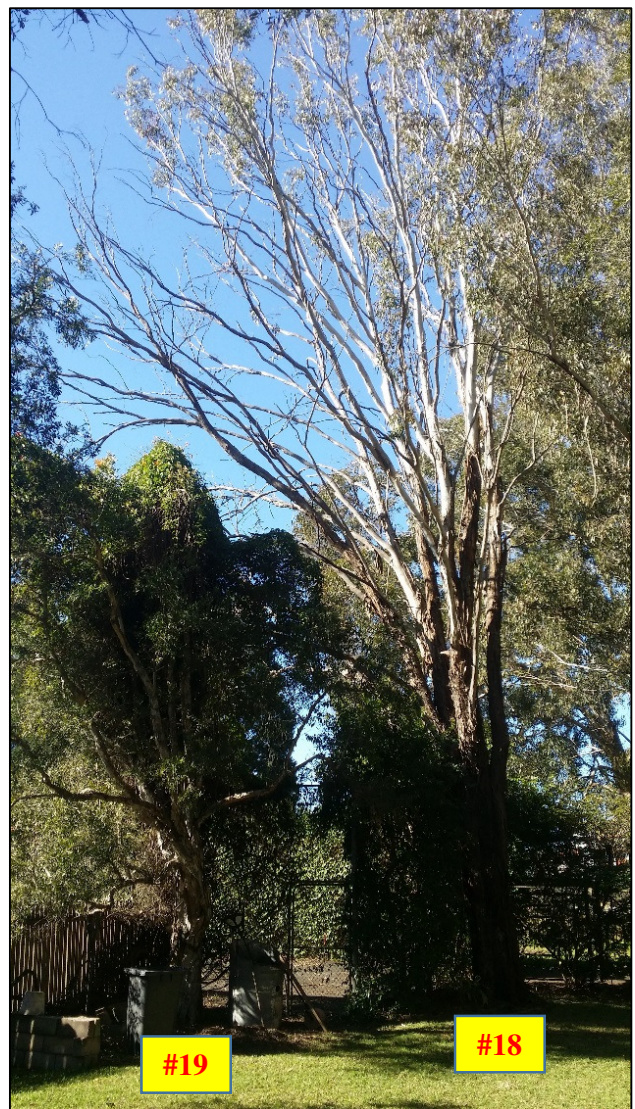
- a. **Health & Vitality:** Poor – this tree is in advanced stages of decline, and is considered to be unsuitable for retention (see Plate 8).
- b. **Tree Form:** This tree has formed a single stem with DBH of 750mm and a codominant canopy with a significant bias towards north that is 26m in height, with a crown spread of 13x17m.
- c. **Structural Condition:** Poor – A large canker wound originating from the root crown has killed a significant amount of cambium (sapwood). The symptoms are consistent with Armillaria Root Decay, and is highly probable that its root system is also compromised (see Plate 9 and [Appendices 9.](#))

Plate 8 – showing tree No. 18, in advanced stages of decline

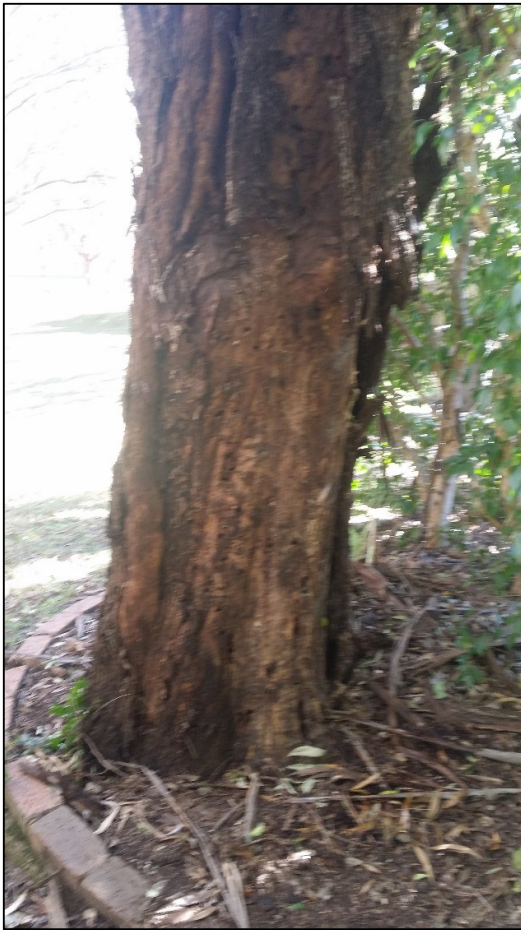
Plate 9 – Armillaria Root Decay on trunk of tree 18

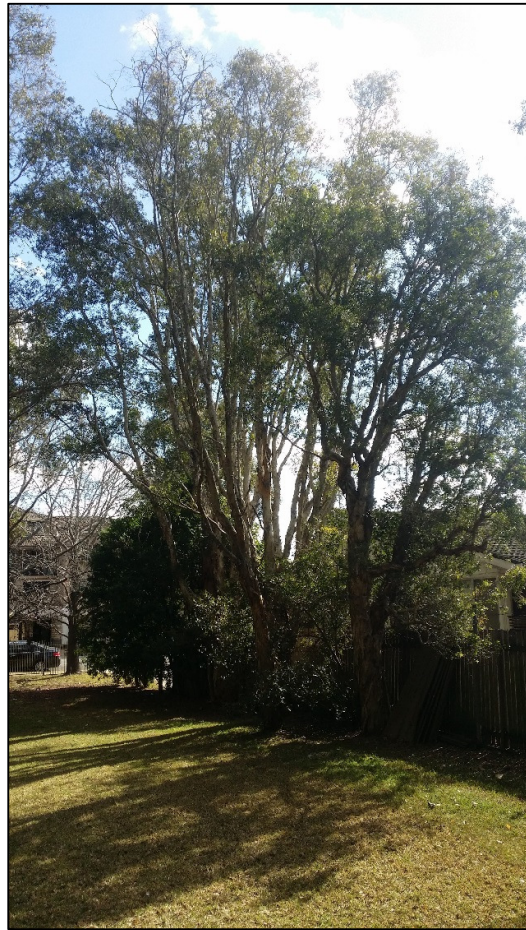
- b. **Health & Vitality:** Low – the dominant tree within the stand (No's 22 & 23) have very sparse foliage, while No. 21 is dead, and No. 20 has a significant asymmetrical canopy towards the east (see Plate 10).
- c. **Tree Form:** These trees have formed a codominant stand and No's 22 – 23 are considered to be unsuitable for retention.
- d. **Structural Condition:** Poor – The removal of No' 21 – 23 will leave the recently exposed asymmetrical canopy of No. 20 to unaccustomed wind loading, and this will increase its failure potential. Retainable for 0 – 5 years

Plate 10 – codominant stand of tree No's 20 - 23

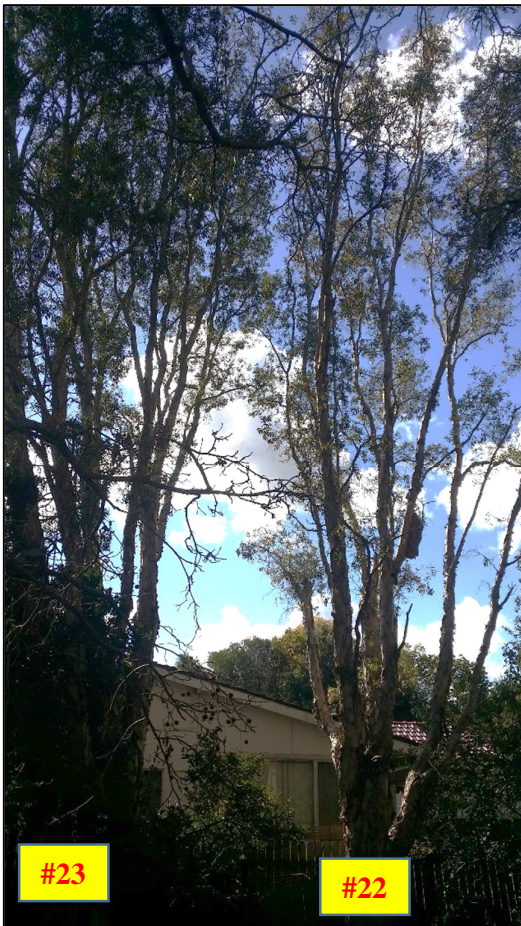
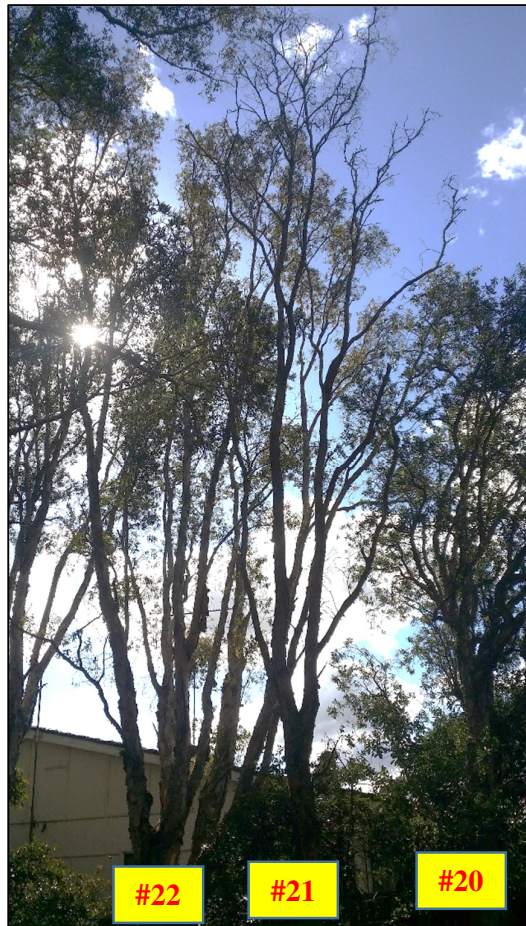
Plates 11 & 12 – showing dieback and decline of tree No's 21 - 23

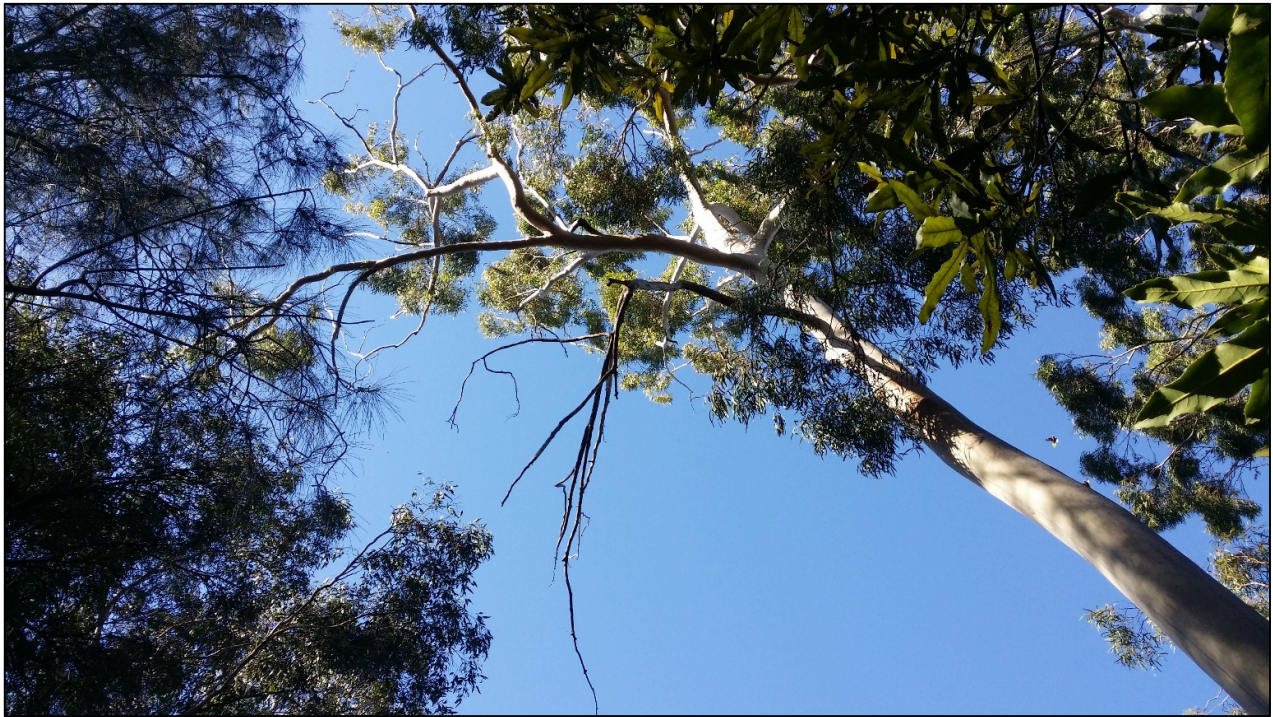
- **Tree No. 60 (*Corymbia citriodora*)** has significant dieback in its canopy and fruiting bodies of root decaying fungus on its root crown. The type of fungus was not identified, but another tree in close proximity (No. 18) has typical symptoms associated with Armillaria Root Decay (see additional information in Appendices 9.8)

Plate 22 – showing canopy of tree 60, in advanced stages of decline, with a natural trunk lean of 30° towards the north

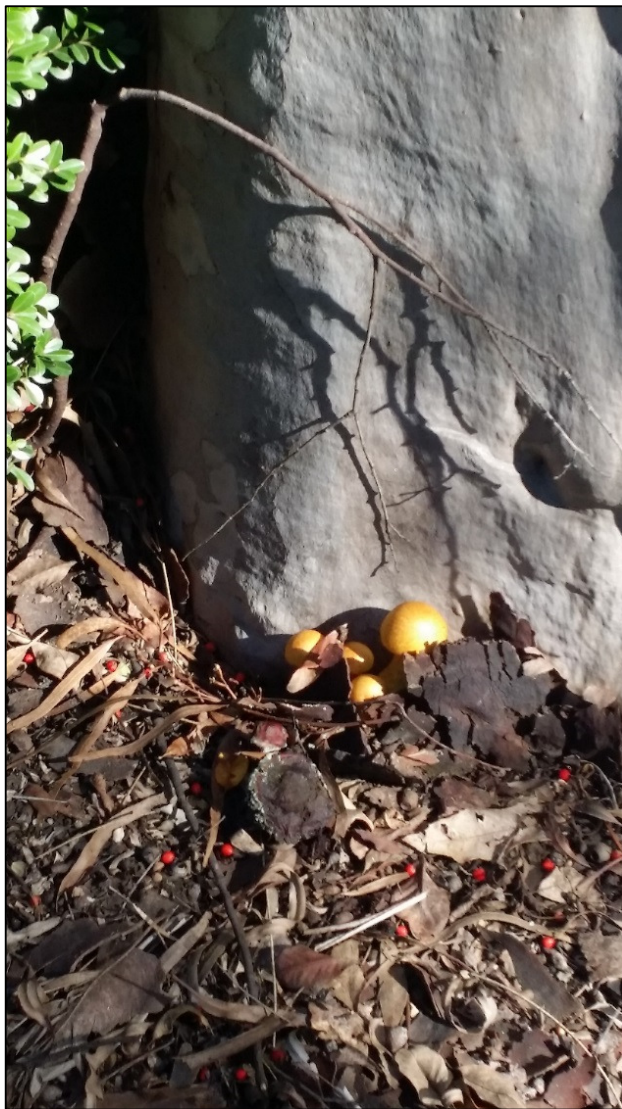
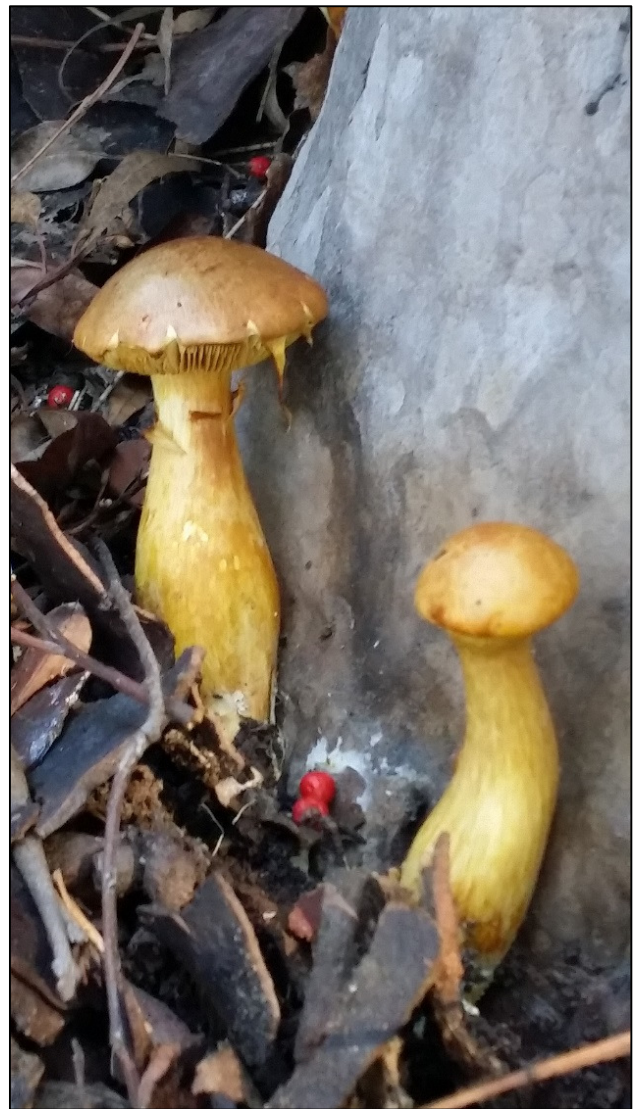
Plates 23 & 24 – showing fruiting bodies of *Meripilus* on rootcrown

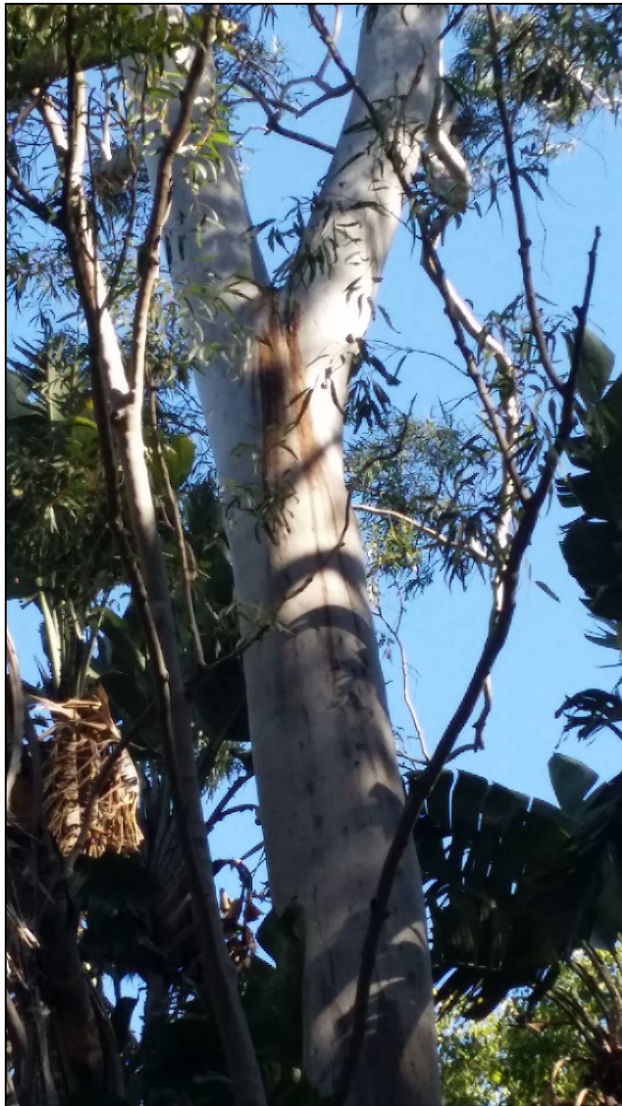
- **Tree No. 61 (*Corymbia citriodora*)** has a two equal sized, codominant ascending branches at about 15m high on the main trunk. Staining along the trunk beneath this junction is a symptom of an internal crack, and it has a possible to imminent potential of failure (see Appendices 9.10 & 9.11)
- **Tree No. 62 (*Corymbia citriodora*)** has been heavily suppressed by the more dominant forms of No's 60 & 61. This has resulted in the formation of a significant asymmetrical canopy towards the northwest, and it will have a probable to imminent potential of failure if the more dominant trees are removed.

Plate 25 – sap weeping from junction in of tree 61

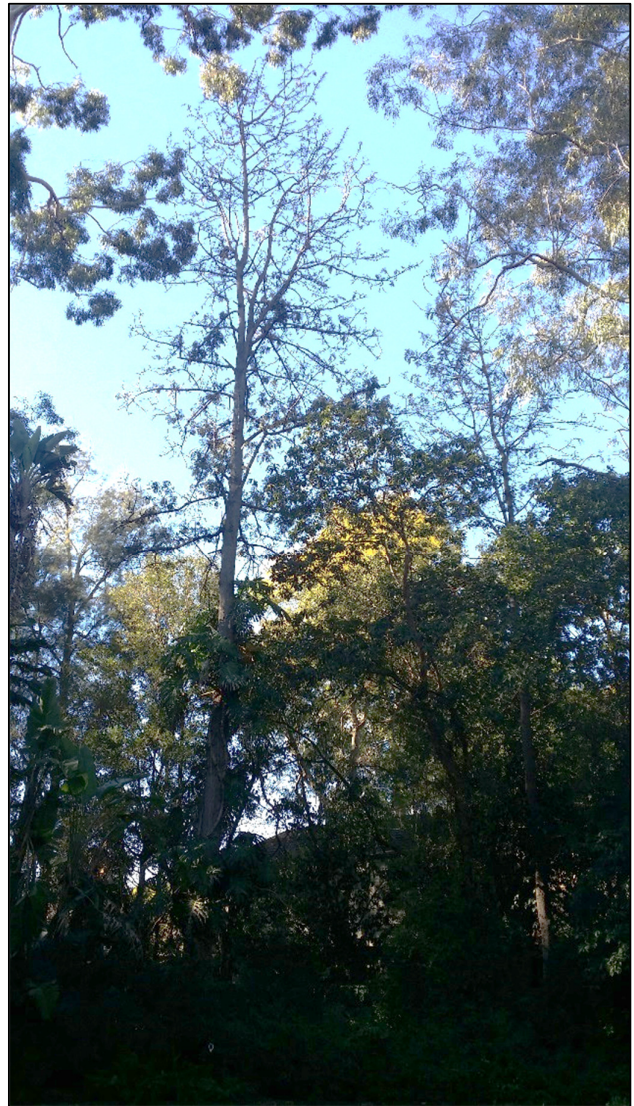
Plate 26 – showing dieback in canopy of tree No's 64 & 68

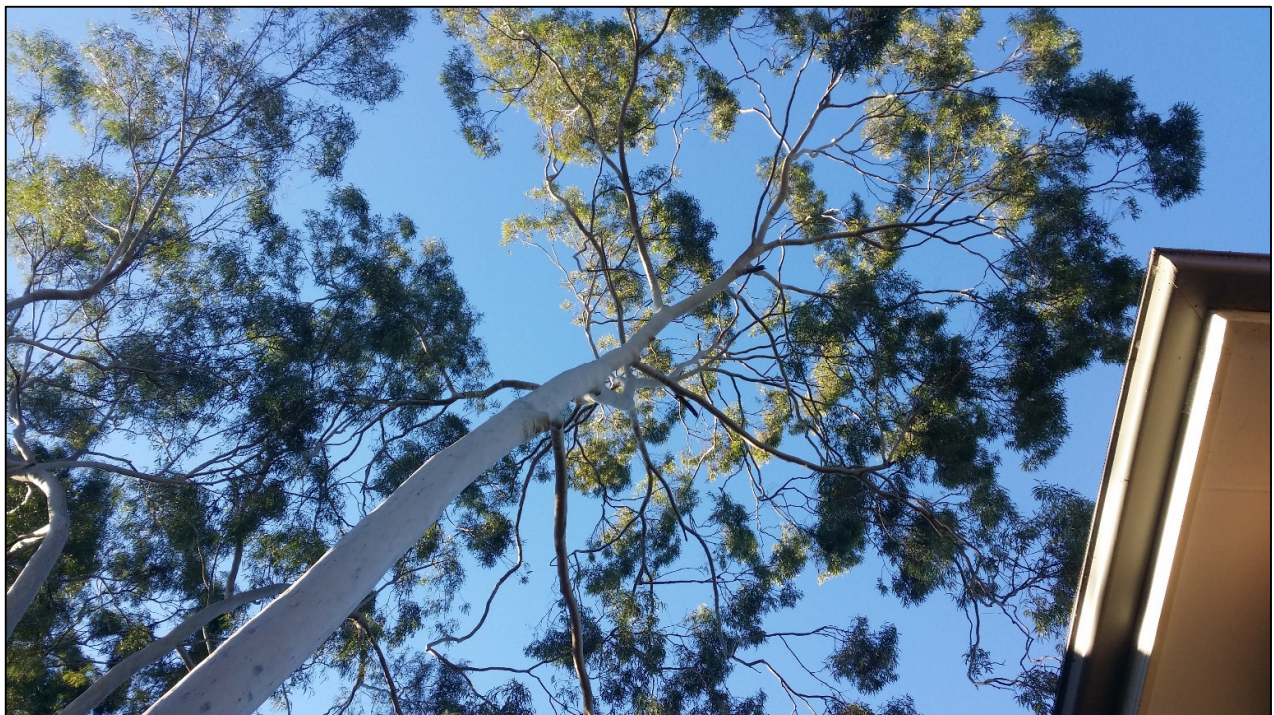
- **Tree No. 72 (*Corymbia citriodora*)** has formed a significant asymmetrical canopy towards the east, and most of its tall canopy overhangs a unit on No. Derby Street. The potential for a whole tree failure is considered unlikely at this stage, but the species is prone to Summer Branch Drop (Appendices 9.12)

Plate 27 – showing significant asymmetrical canopy of tree No. 72

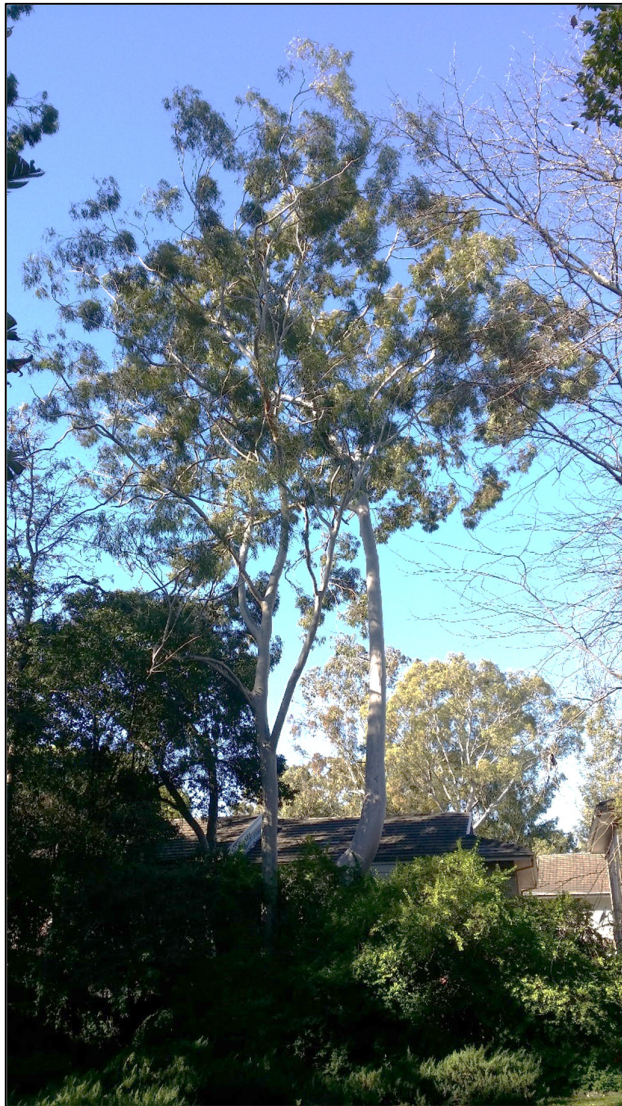
- **Tree No's 71 and 72 (*Corymbia citriodora*)** both have significant asymmetrical canopies, and their retention will be dependent on the retention of Tree No. 72. The removal of No. 72 will expose the edge type canopies of the remaining trees to uncustomed wind loading, and this will increase their failure potentials.

Plate 28 – showing codominant stand of tree No's 70 – 72

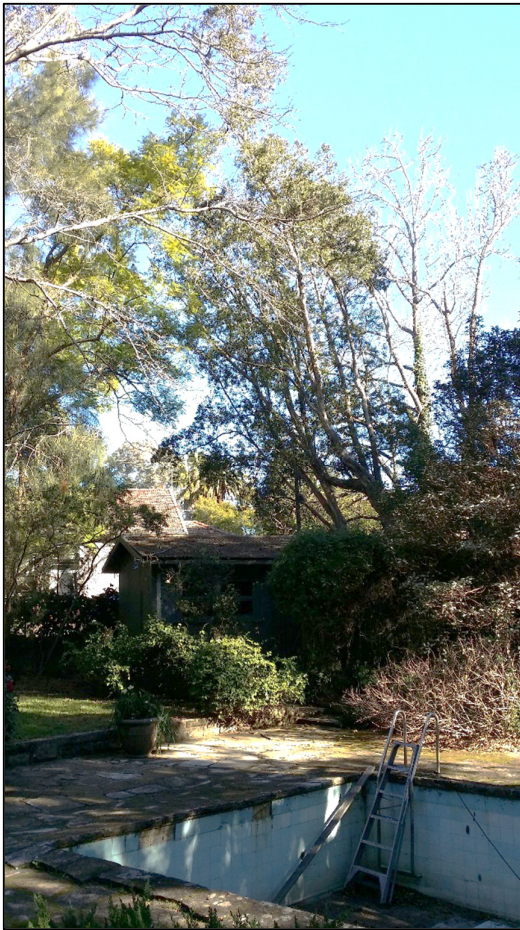
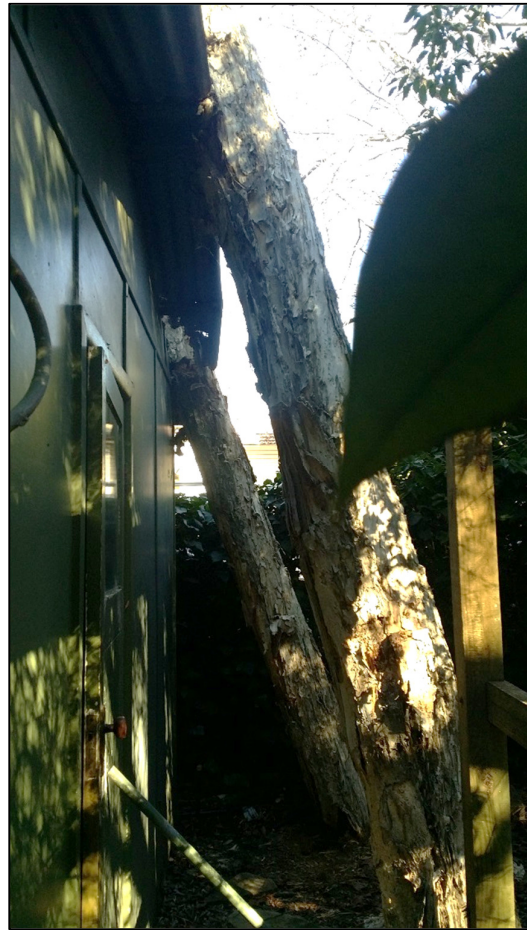
- **Tree No's 80 & 81 (*Melaleuca quinquenervia*)** are semi-mature trees with 25° leans towards the east. They are being supported by the change rooms within their driplines, and the proposed demolition of this building will result in probable to imminent failures

Plates 31 & 32 – showing tree No's 80 & 81, with a significant lean towards the east

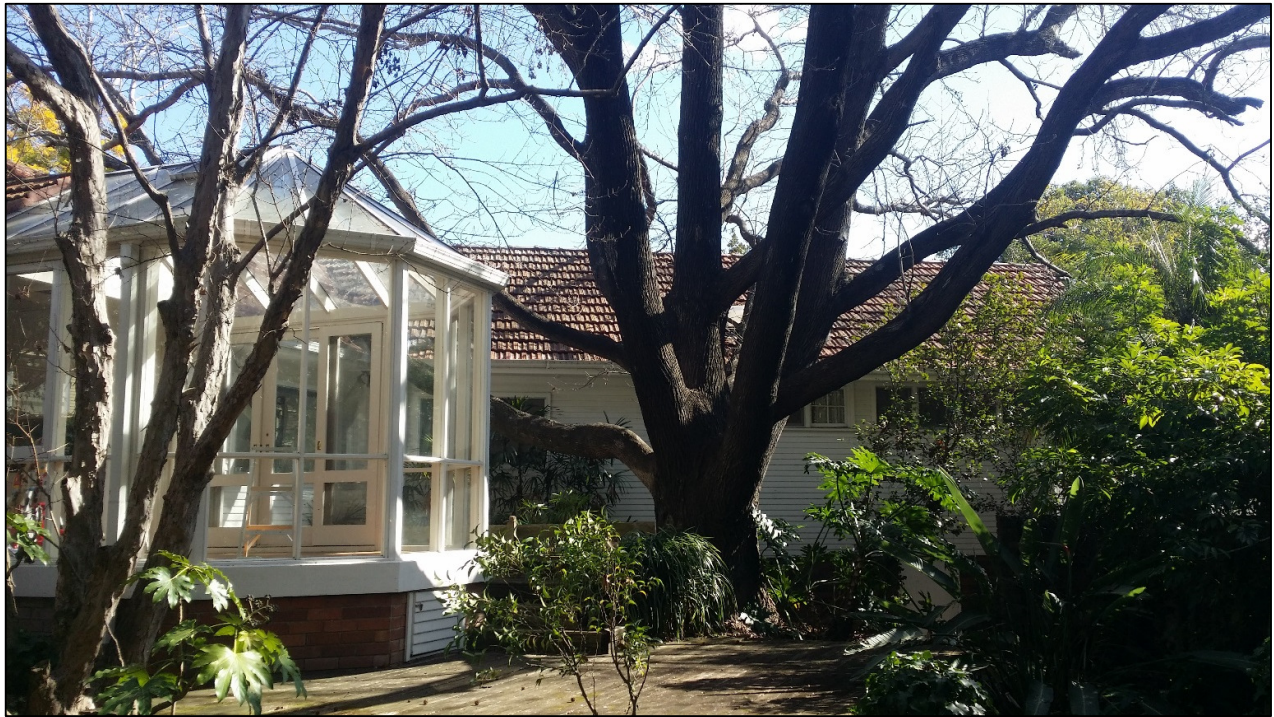
- **Tree No. 85 (*Liquidamber styraciflua*)** is a mature tree with a wide spreading canopy. Some of these branches are receiving mechanical support from the dwelling in its dripline, and the proposed demolition of this building will result in probable to imminent failures

Plate 35 – showing tree No's 84 & 85
