Arboriculture Impact Assessment

**35 - 47 Stennett Road, Ingleburn
Stage 3, Warehouse Development**

Date: 24 March 2022
Reference: 20221869
Revision: 3

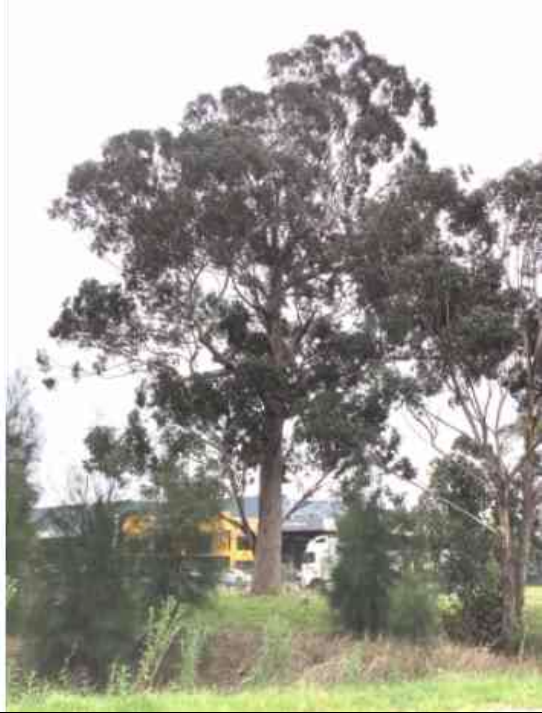
Species	<i>Eucalyptus moluccana</i> (Grey Box)	
Age	Mature	
Life Expectancy	40+ years	
Crown Class	Dominant	
Crown Condition	Average (3)	
Type	Indigenous	
TPO Protected	Yes	
Health & Condition	Minor previous failures / nest in upper canopy	
Location	On site	
TreeAZ	A2	
Proposed Works Comments	Services and 10m wide driveway	
TPZ	9.6m	
Total TPZ Area	Total TPZ Area	
Distance To Proposed Development	Approximately 8m to proposed road	
Proposed TPZ Encroachment	21%	
Proposed Status	Retain	Figure 3. Tree No. 5

- 6.4.1 Tree No. 5 *Eucalyptus moluccana* (Grey Box)
 - 6.4.1.1 This indigenous tree is located on site and is protected by council. The tree is mature in age with a dominant trunk and is in fair health with average (3) crown condition and fair structural condition. The tree has a minor level of previously failed branches and a nest was sighted in the in upper canopy. This tree has a 'TreeAZ' rating of 'A2' and an estimated life expectancy of 40+yrs.

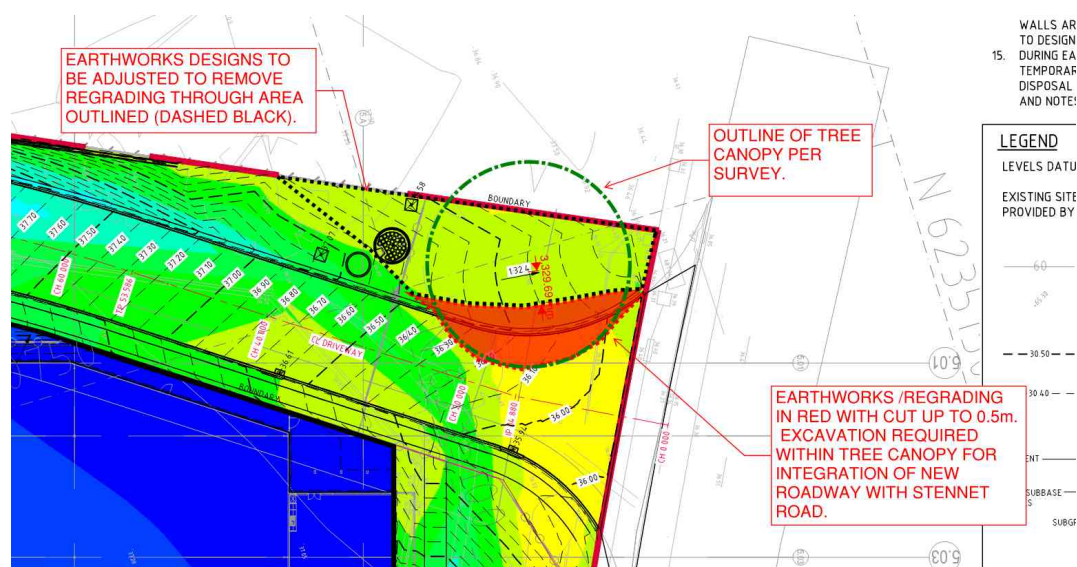
Figure 4. Tree No. 5 Proposed works

- 6.4.1.2 The proposed driveway and civil works are located approximately 2.5m from the trunk, inside the 3.2m SRZ and 9.6m TPZ with a 21% encroachment. The proposed encroachment is considered major in accordance with AS4970-2009. And likely to cause stress to the tree and potentially cause instability.

- 6.4.1.3 Excavations to integrate road levels for Stennett Road located approximately 2.5m from the trunk will cause root system disturbances. The proposed excavations must be performed with an air knife or hydraulic soil excavation to locate roots within the 9.6m TPZ. The root system must be protected during the proposed excavations, preventing damaged or severance to any root measuring over 40mm in diameter.
