Report on  
Preliminary Geotechnical Assessment

Proposed Residential Subdivision,  
Lots 99 and 100 D.P. 1243071, Gurner Avenue,  
Austral, NSW

Prepared for  
Landcom

Project 94562.00  
November 2019

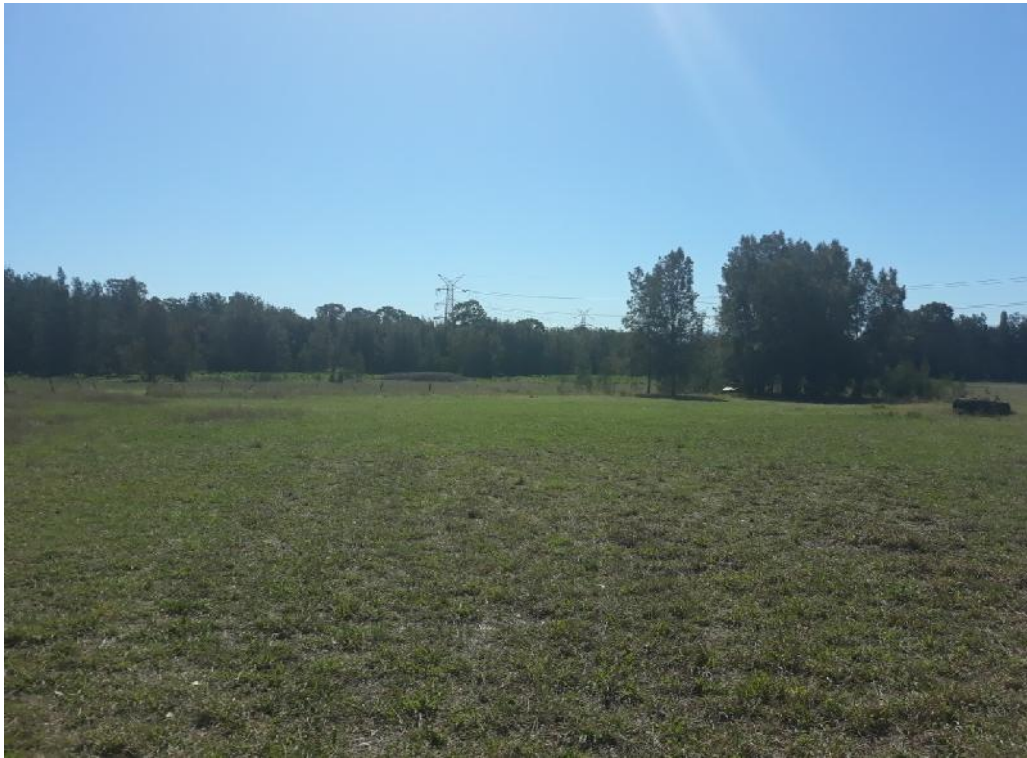
Photo 1 - General Site View

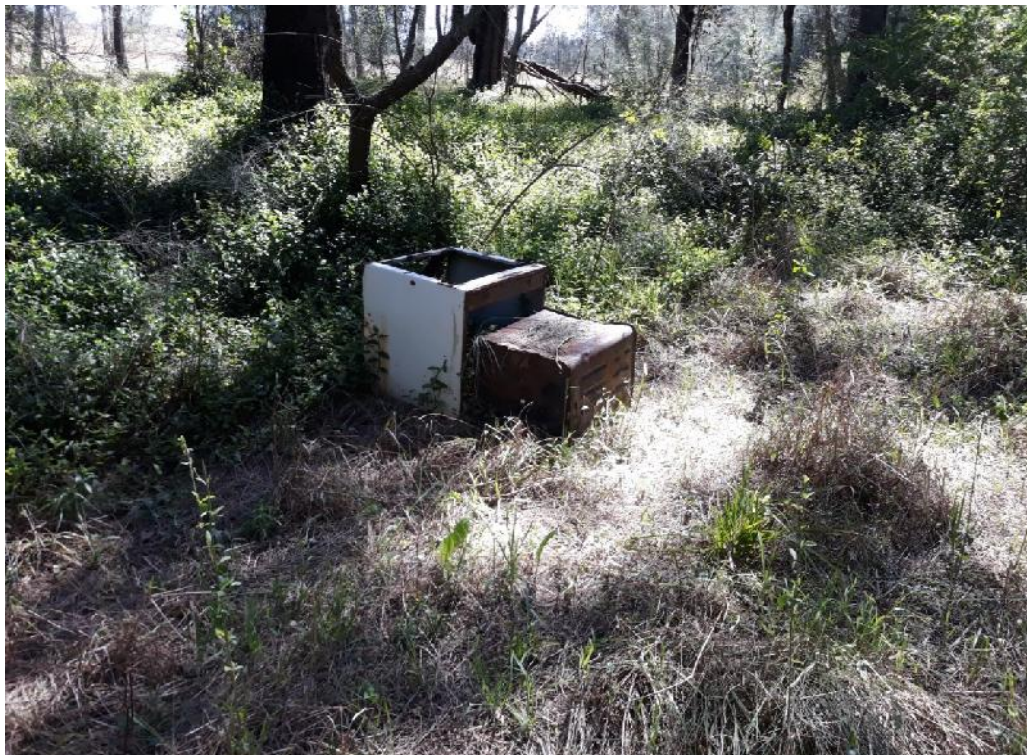
Photo 2 - Discarded white goods next to creek

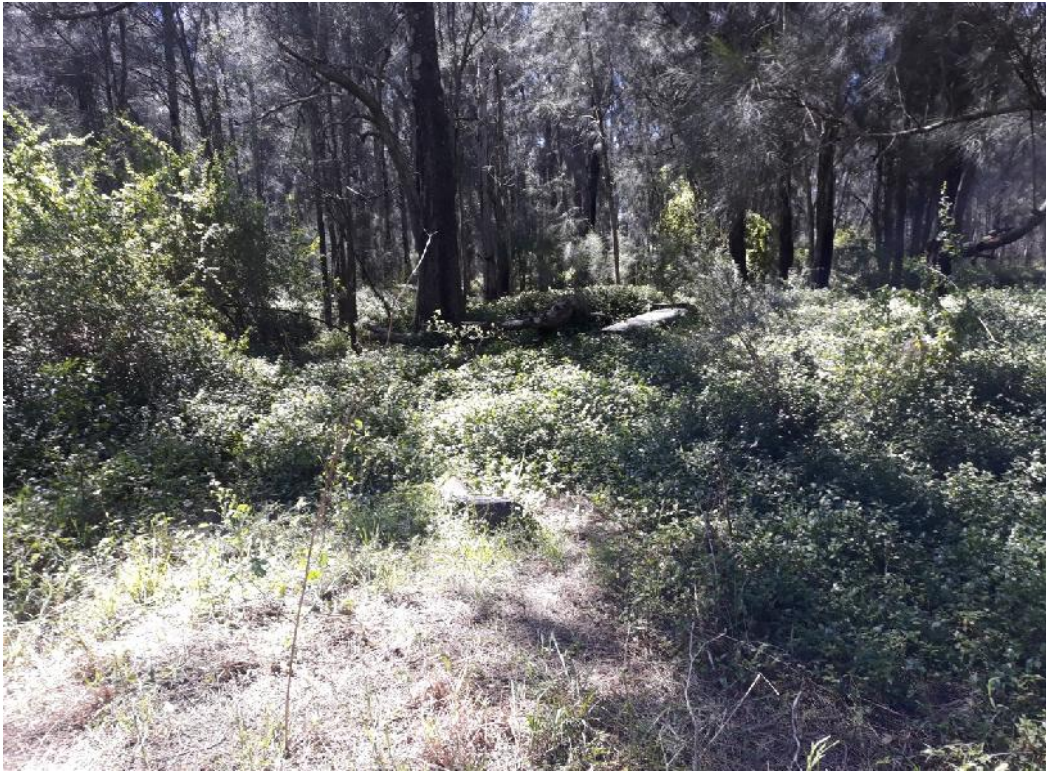
Photo 3 - Discarded wheelie bin in riparian corridor

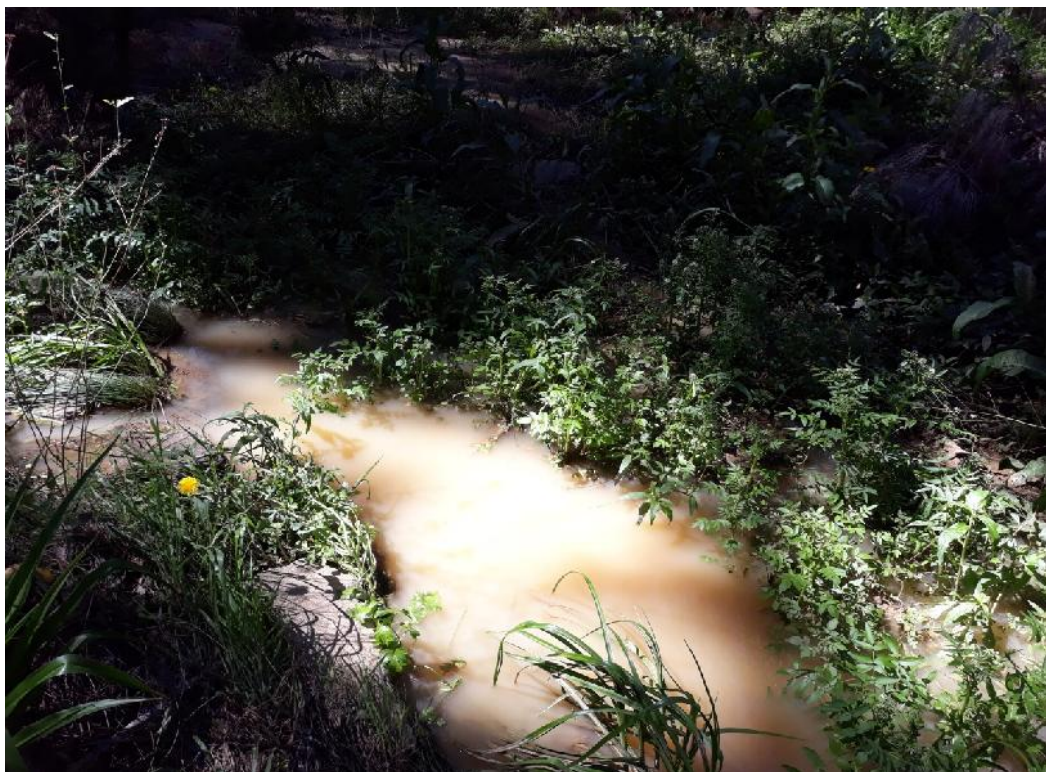
Photo 4 - High turbidity noted in creek throughout the site

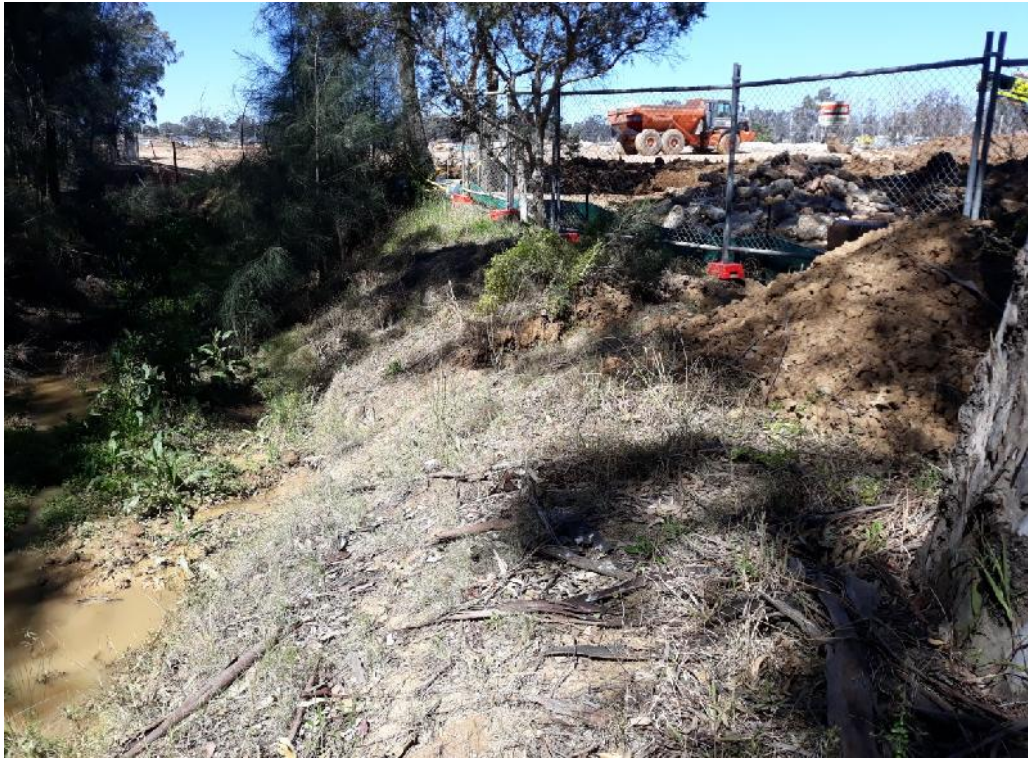
Photo 5 - Puddling next to residential subdivision being constructed immediately south west of the site

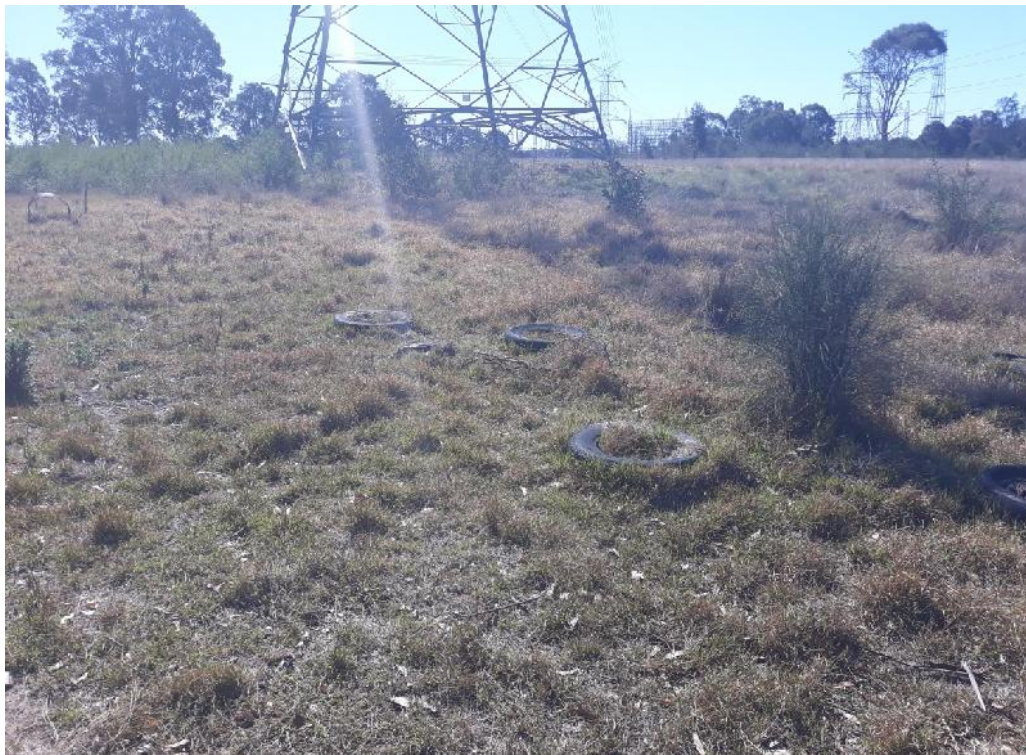
Photo 6 - Tyres and scrap metal on ground surface in north west portion of the site

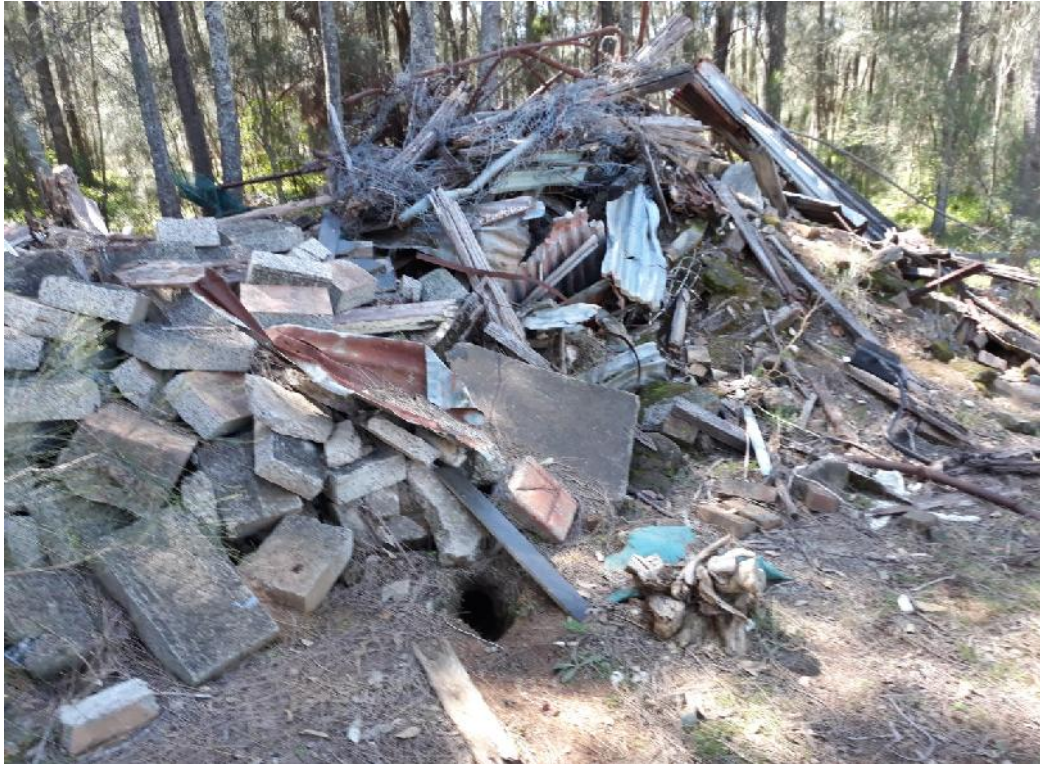
Photo 7 - Stockpile of construction and demolition materials in south west portion of the site

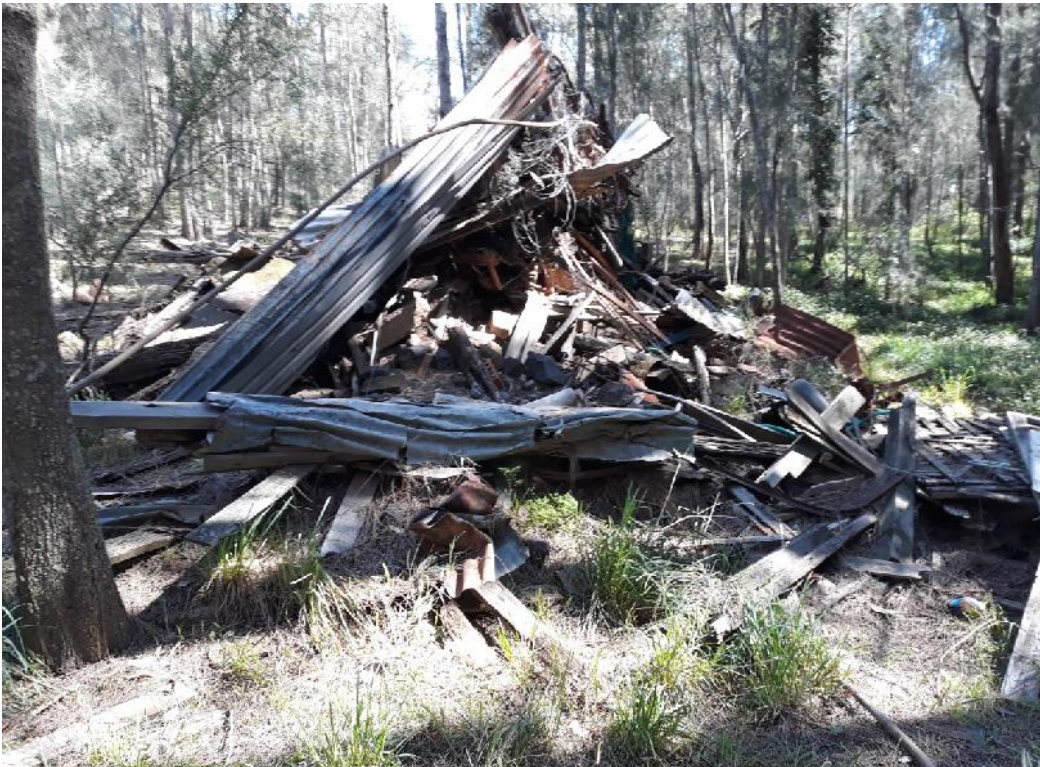
Photo 8 - Stockpile of scrap metal and timber in south west portion of the site

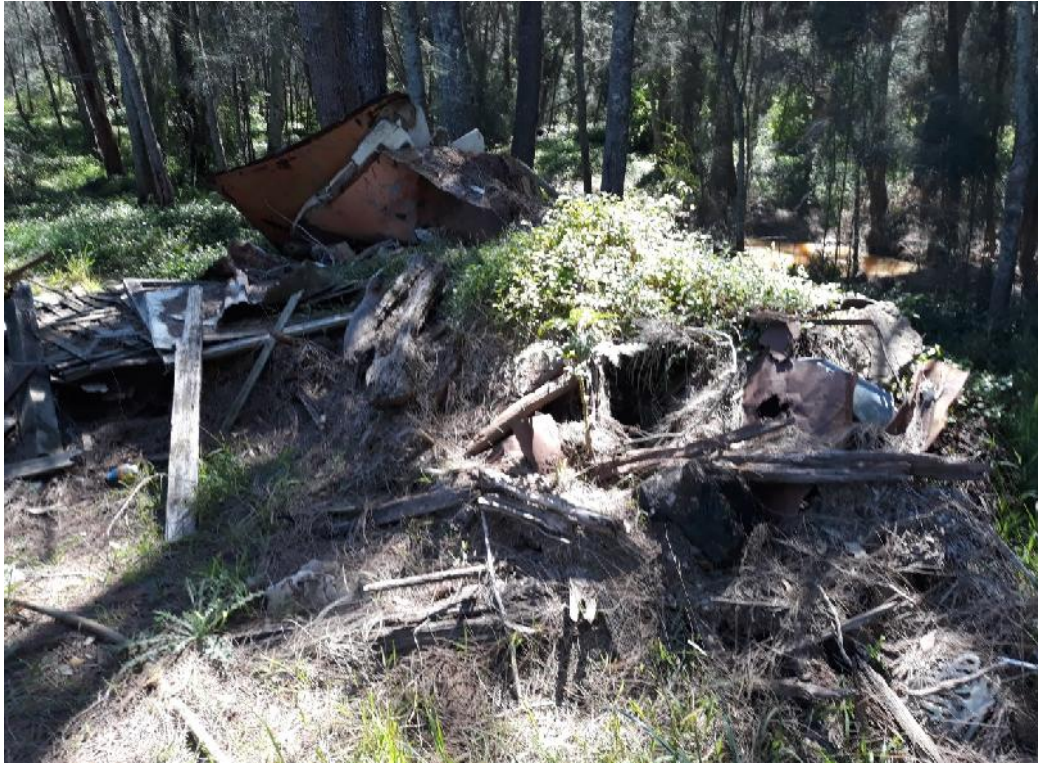
Photo 9 - Overgrown stockpile of timber and metal in south west portion of the site

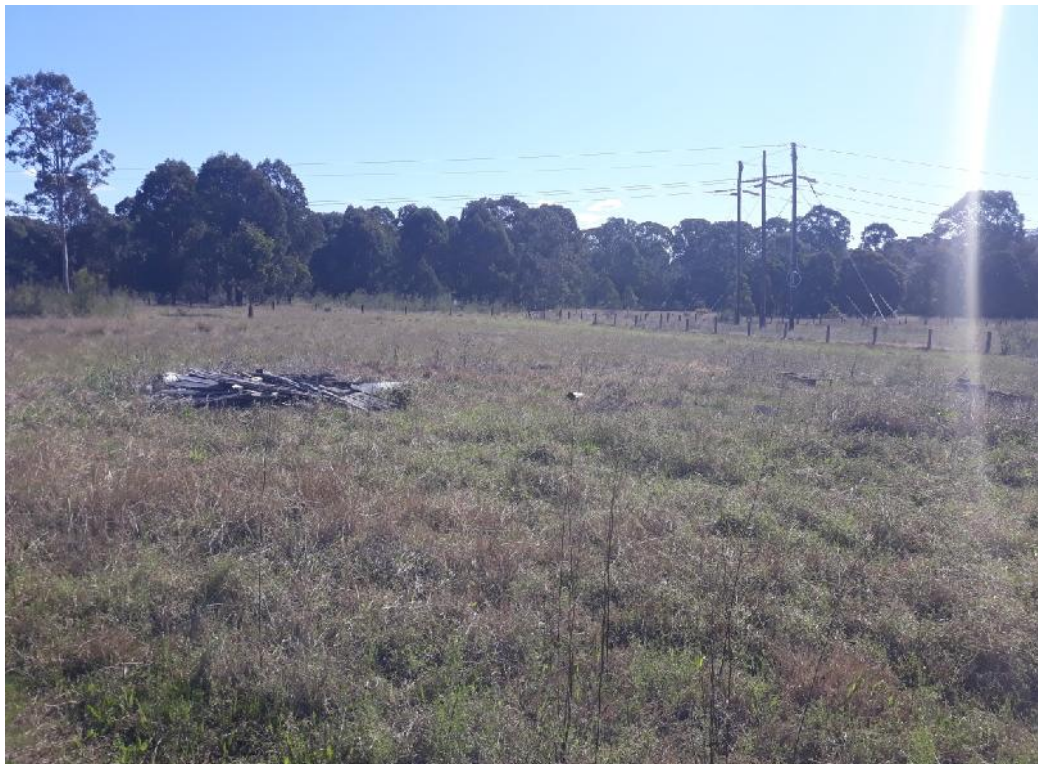
Photo 10 - Loose timber in field

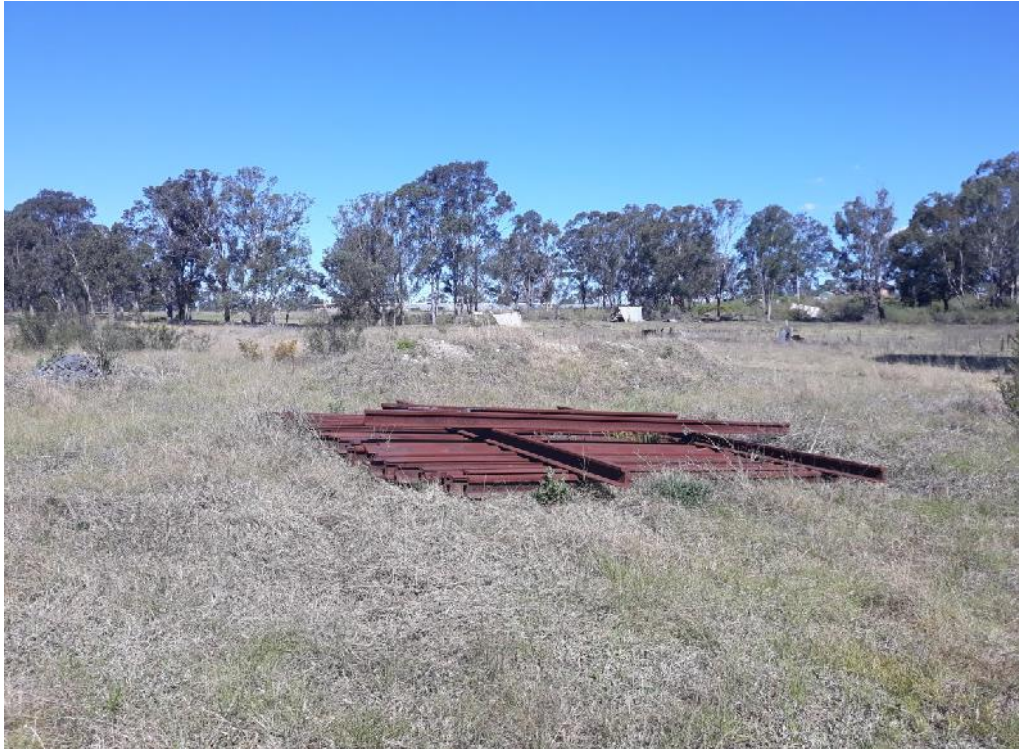
Photo 11 - Loose railway track on ground surface in south west portion of the site

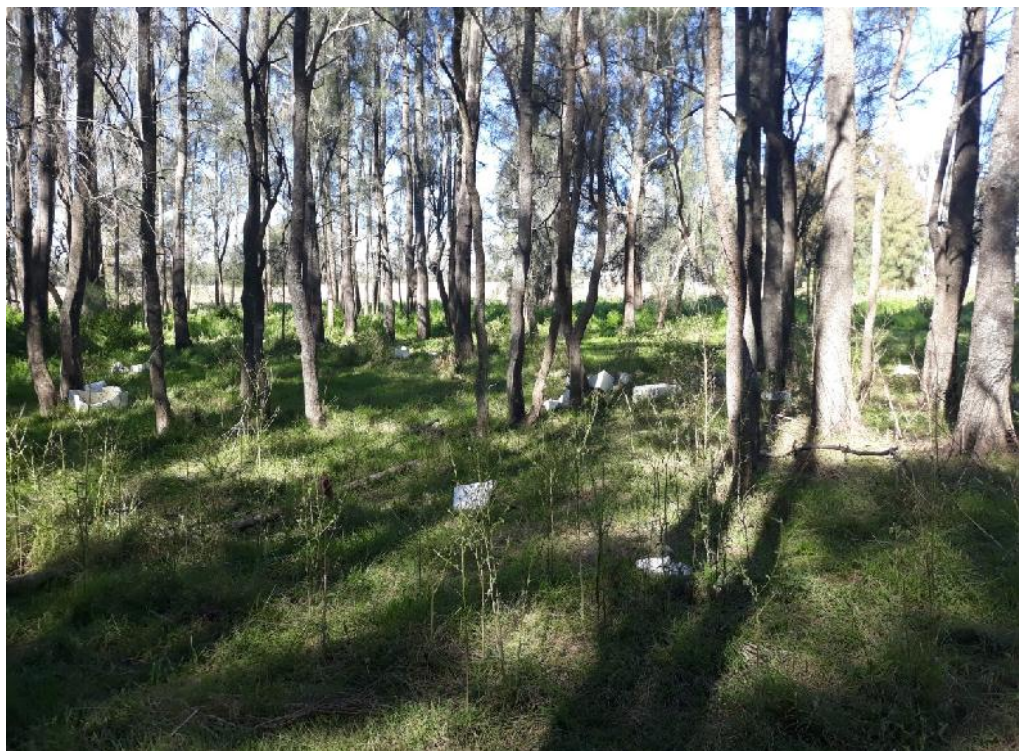
Photo 12 - Discarded polystyrene boxed in field in southern portion of the site

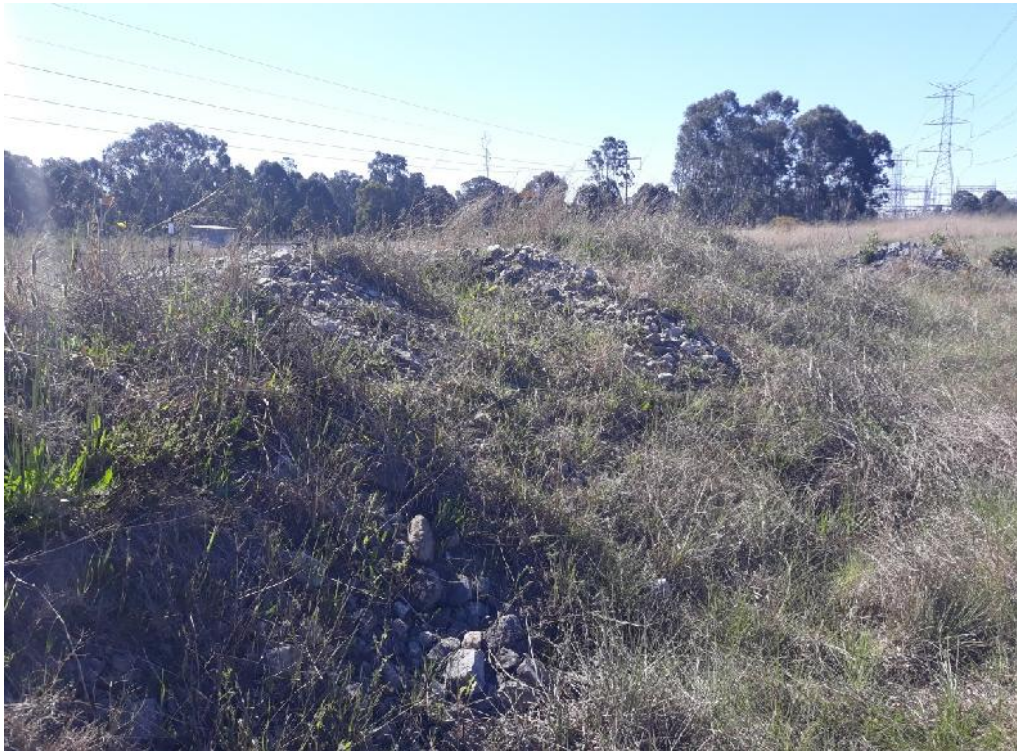
Photo 13 - Stockpile of construction and demolition material partially covered in grass, in south west portion of the site

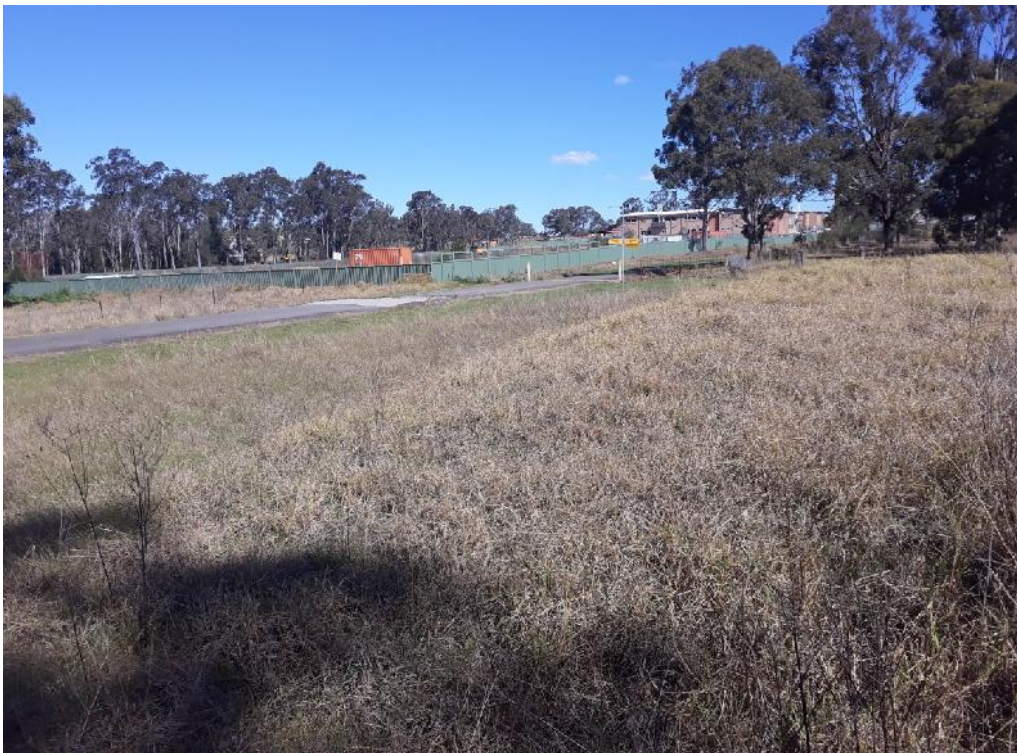
Photo 14 - Soil mound mostly covered with grass containing construction and demolition materials
