PRELIMINARY TREE INSPECTION REPORT.

**Location: 23 to 25 Charles Street
Liverpool NSW 2170**

For: Hume Community Housing
7 Hamilton Road, Fairfield NSW
C-/ Idraft Plans

On. 18/11/2020

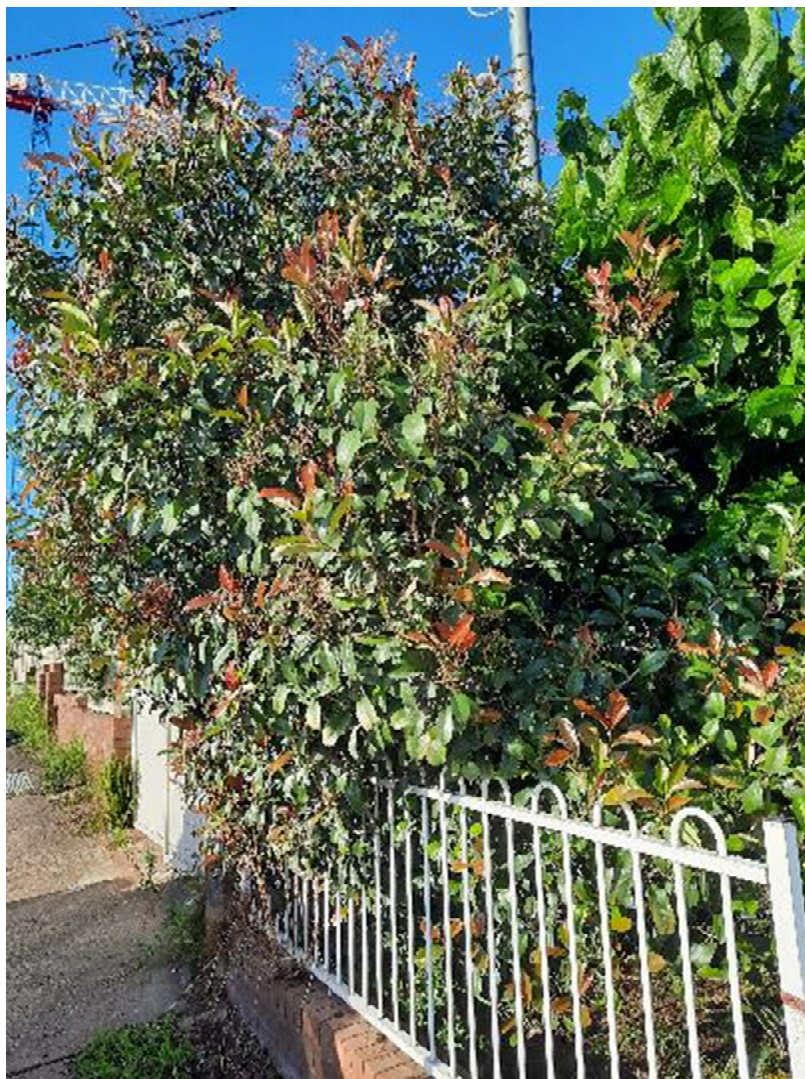
4.1 Tree **T1** is a *Photinia robusta* or 'Photinia' which is an exotic species endemic to Asia (See Fig. 2). The tree is located in the property to the East of the Site.

The tree was in good health and condition at the time of my inspection. The specimen is less than 3.5m in height and not subject to the TMP.

This tree would be subjected to Major Encroachment into its TPZ and is scheduled to be removed (See Appendix 2b)

Fig. 2. Photo of T1 a *Photinia robusta*

- 6.1.** For the development to proceed as planned trees **T1, T2 & T3** are recommended for removal.
- 6.2** 5 trees are proposed to be planted on the nature strip to the Northe and East of the Site and another 15 trees on the Site as complimentary plantings (See Appendix 2b).

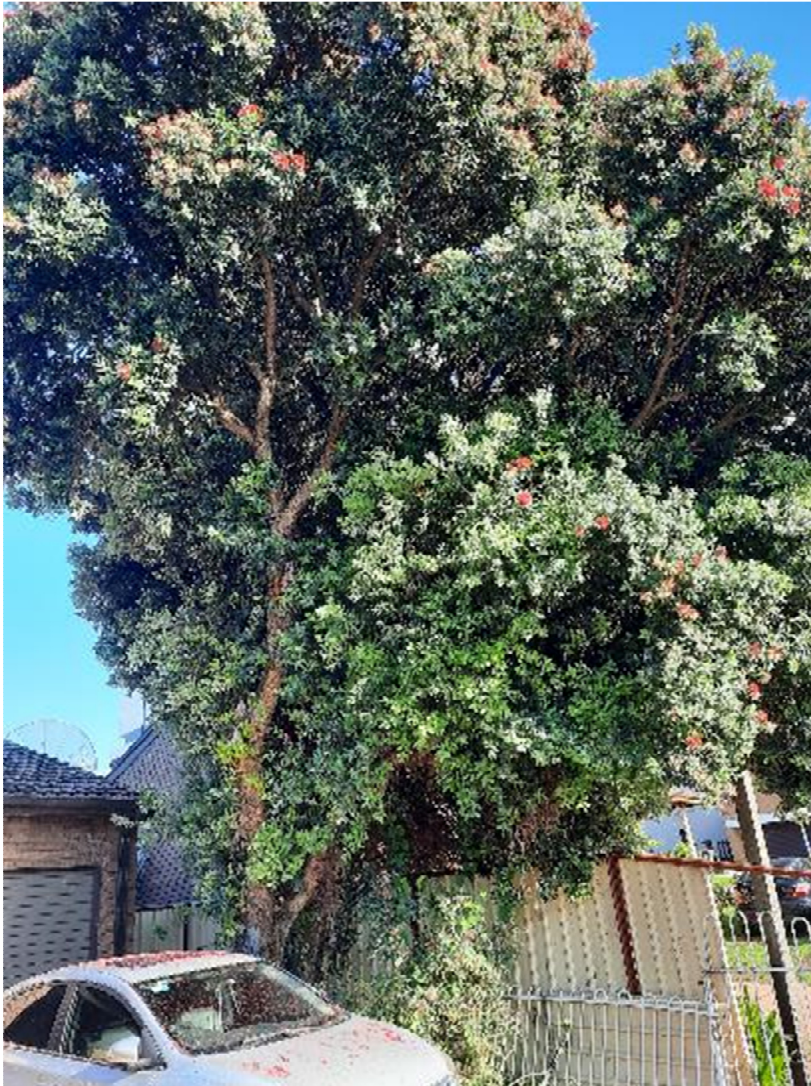
4.2 Tree **T2** is a *Metersiderous thomasi* or 'New Zealand Christmas Bush' which is an exotic species endemic to New Zealand (See Fig. 4).

The tree is located in the property to the North of the existing driveway.

This tree would be subjected to Major Encroachment into its TPZ and is scheduled to be removed (See Appendix 2b)

Fig. 4. Photo of T2 a *Metrosiderous thomasi*

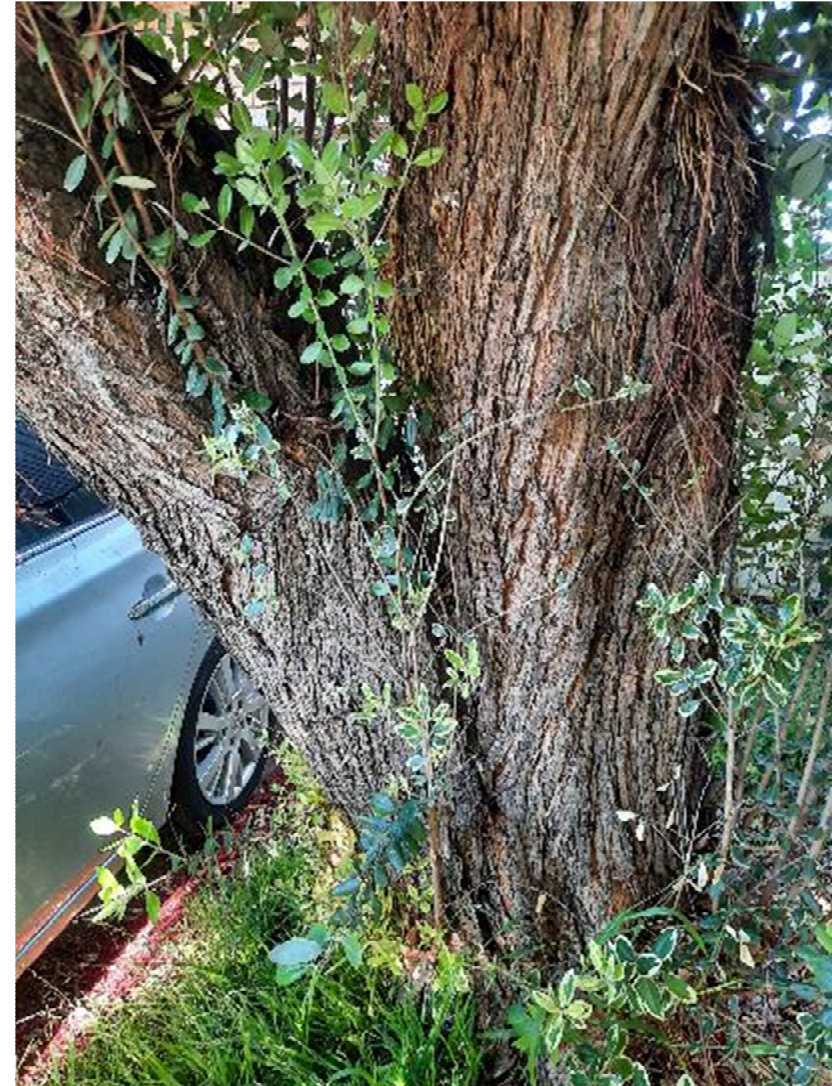
The specimen has a significant defect in the form of a 'V' shaped stem junction with included bark in the union (See Fig. 5).

5.3 Tree **T2** has a significant defect in the form of a 'V' shaped stem junction with included bark which is considered to be a weak union and prone to failure (Mattheck & Breloer 2005)

Fig. 5. Photo showing 'V' shaped stem junction with included bark

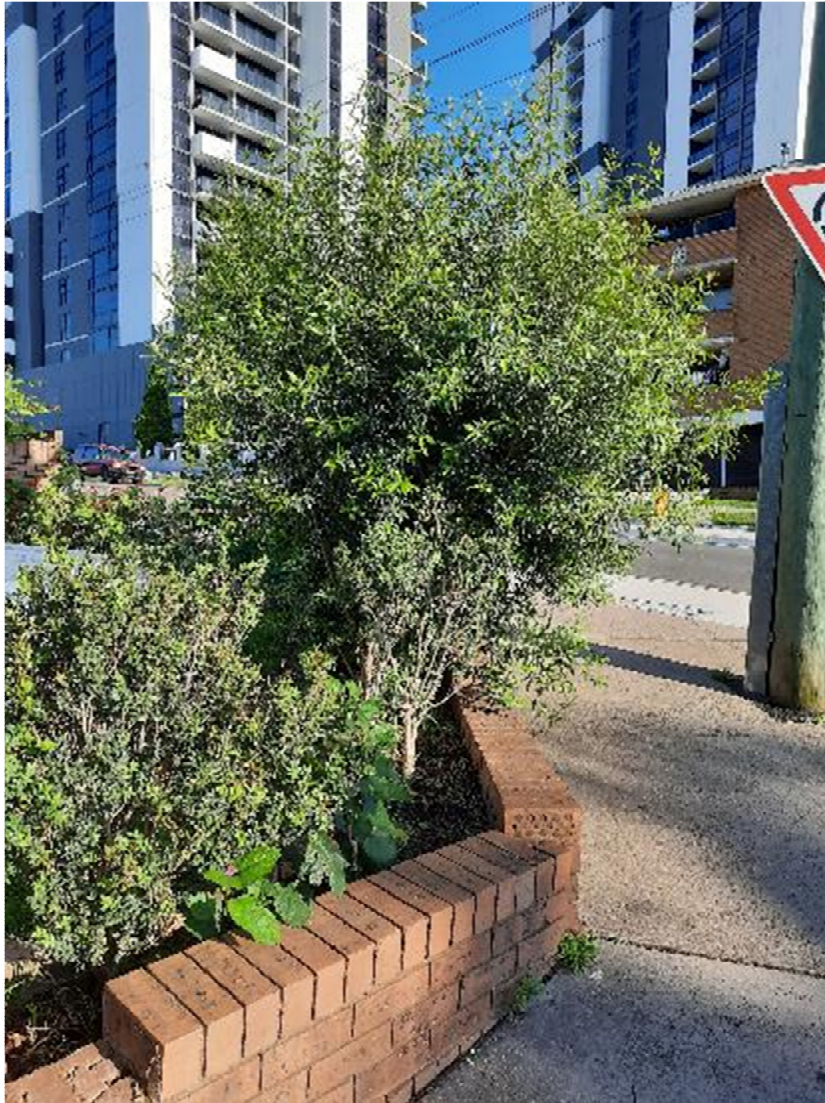
4.3 Tree **T3** is an *Olea africana* or 'African Olive' which is an exotic tree endemic to South Africa. The tree is located near the North East Corner of the site (See Fig. 6).

This specimen is in good health and condition what has assumed a 'shrublike habit'. The specimen is less than 3.5m in height and not subject to the TMP.

This tree would be subjected to Major Encroachment into its TPZ and is scheduled to be removed (See Appendix 2b)

Fig. 6. Photo of T3 an *Olea africana*.
